# Historic Railroad Structural Resources:

Chicago to St. Louis High Speed Rail

**IDOT Sequence #17337 & #17337A**

17 December 2014

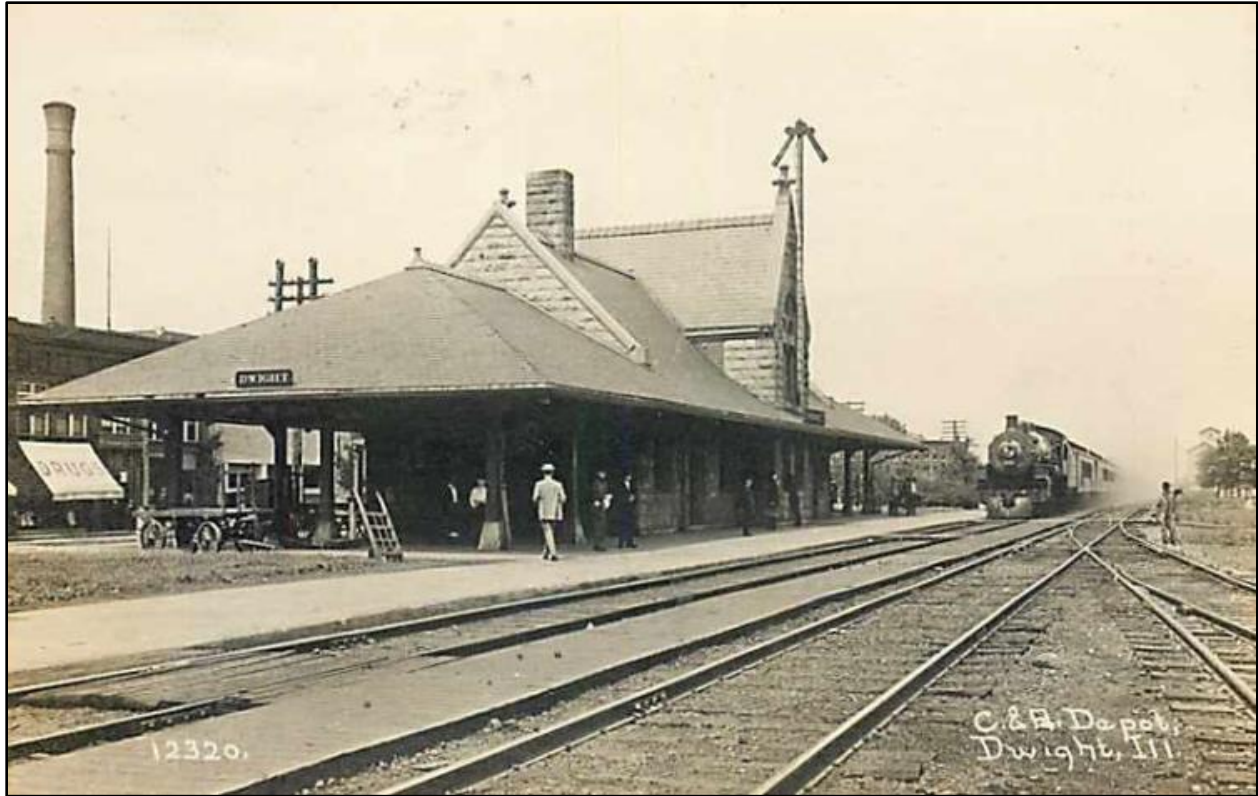
**Figure 6:** The Dwight depot, which is listed on the National Register of Historic Places, was constructed in 1891.

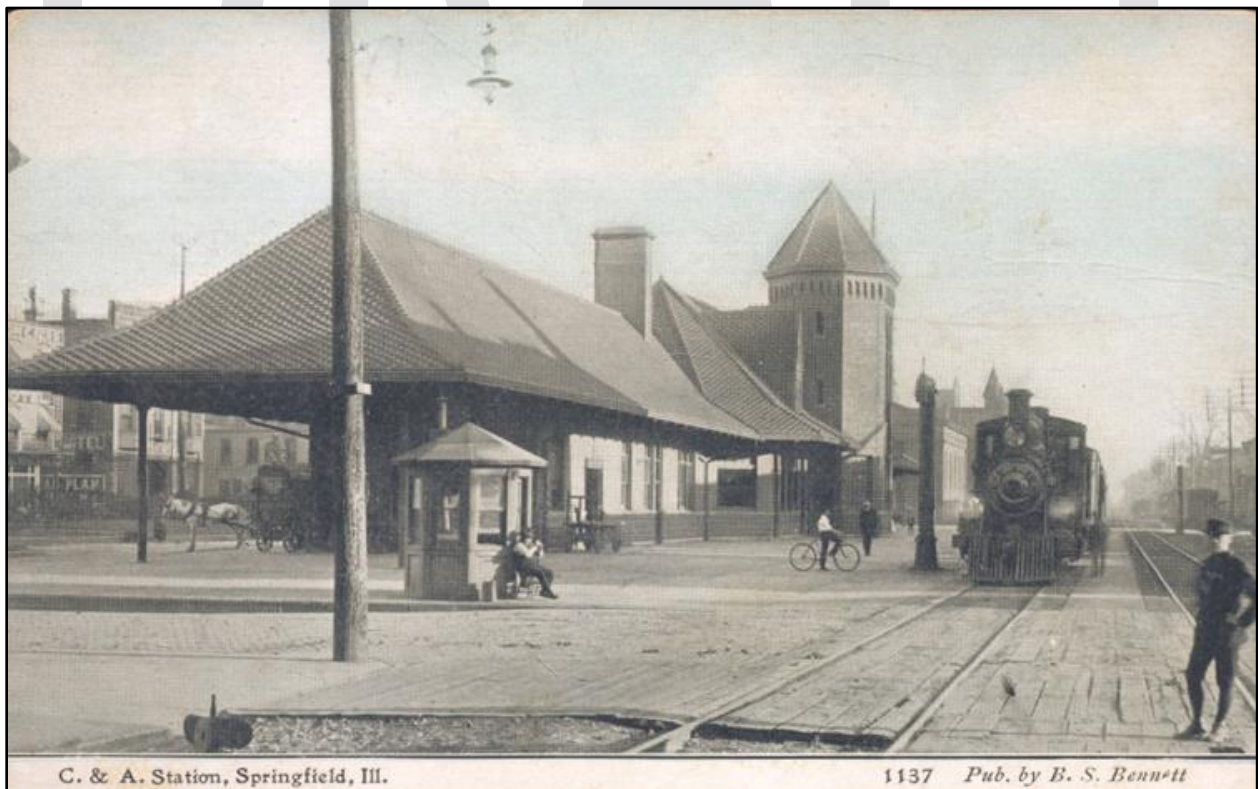
**Figure 7:** Constructed in 1898, the Alton's Springfield, National Register-listed depot serves passengers today.

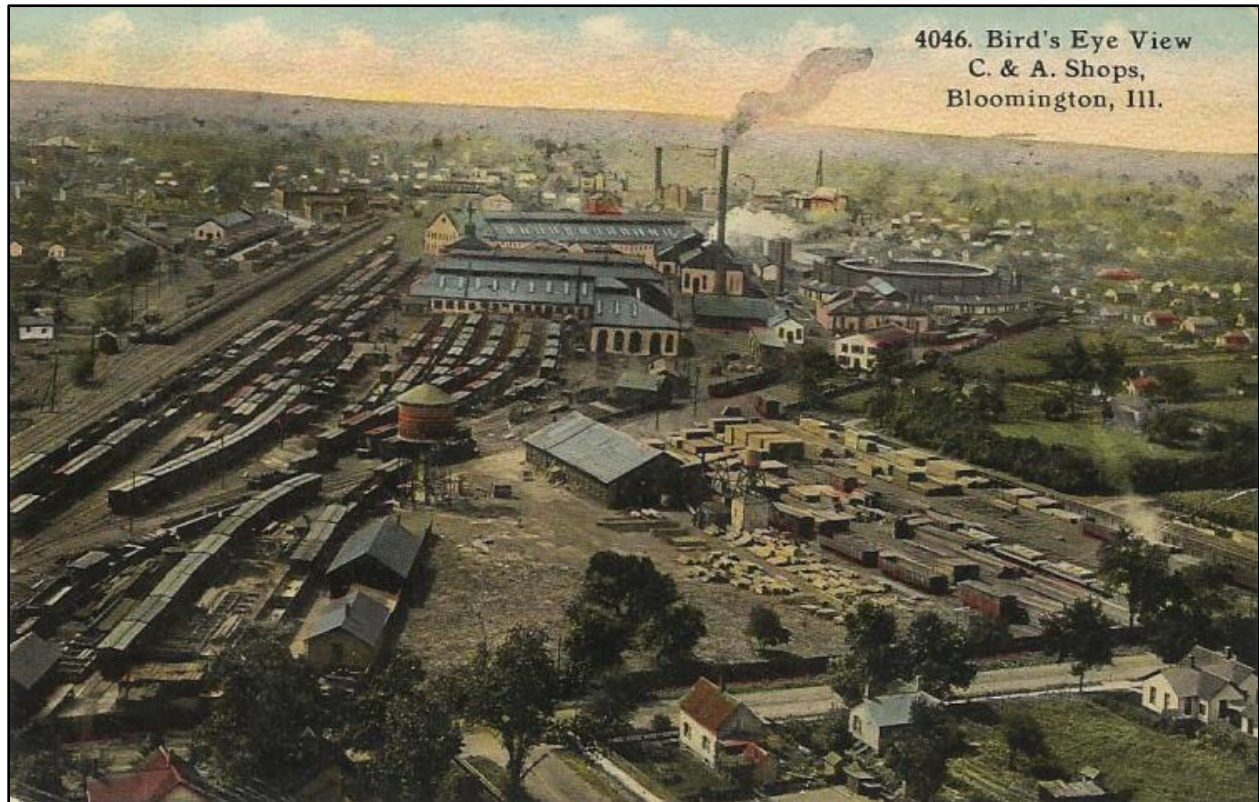
**Figure 8:** This image pictures the Chicago & Alton's primary shop complex in Bloomington. Based on the arrangement of cars and tracks, it appears that the transverse arrangement of tracks was prominently used as the shops were designed.

This brief context suggests how important a railroad's shop complex was to its successful operation. The primary shop for the Alton was located in Bloomington. Activity there started with construction in the late 1850s and continued until 1972 when the Gulf, Mobile & Ohio merged with the Illinois Central, although activity in one building continued until 1979 when it burned down. The complex was subsequently removed, although its sense of size, and the activity that occurred there, are implied in the image identified as Figure 8.<sup>71</sup> The

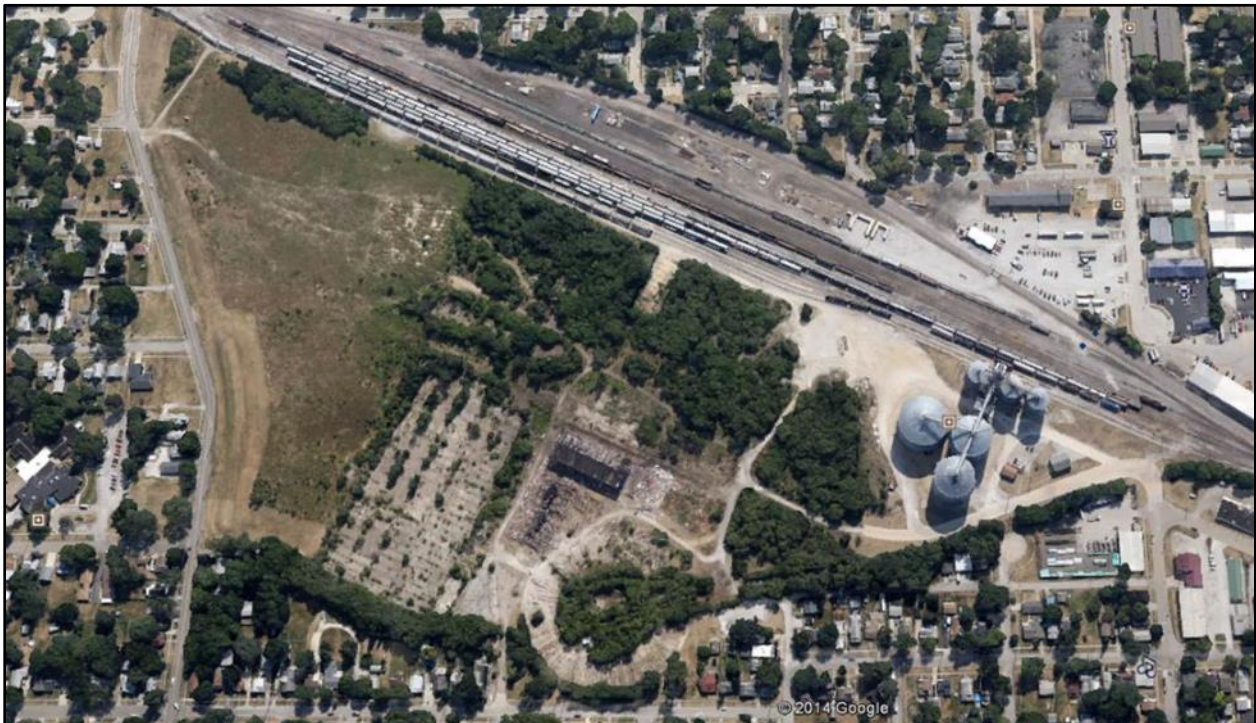
**Figure 9:** This 1994 image from Google Earth still shows some remaining features of the shop complex – the location of the roundhouse, for instance, in the lower center part of the picture. Immediately above (in the picture) the foundation of the roundhouse is a single, old building that is no longer extant.

ground on which the shop complex stood is today vacant and overgrown, as generally illustrated in Figure 9.

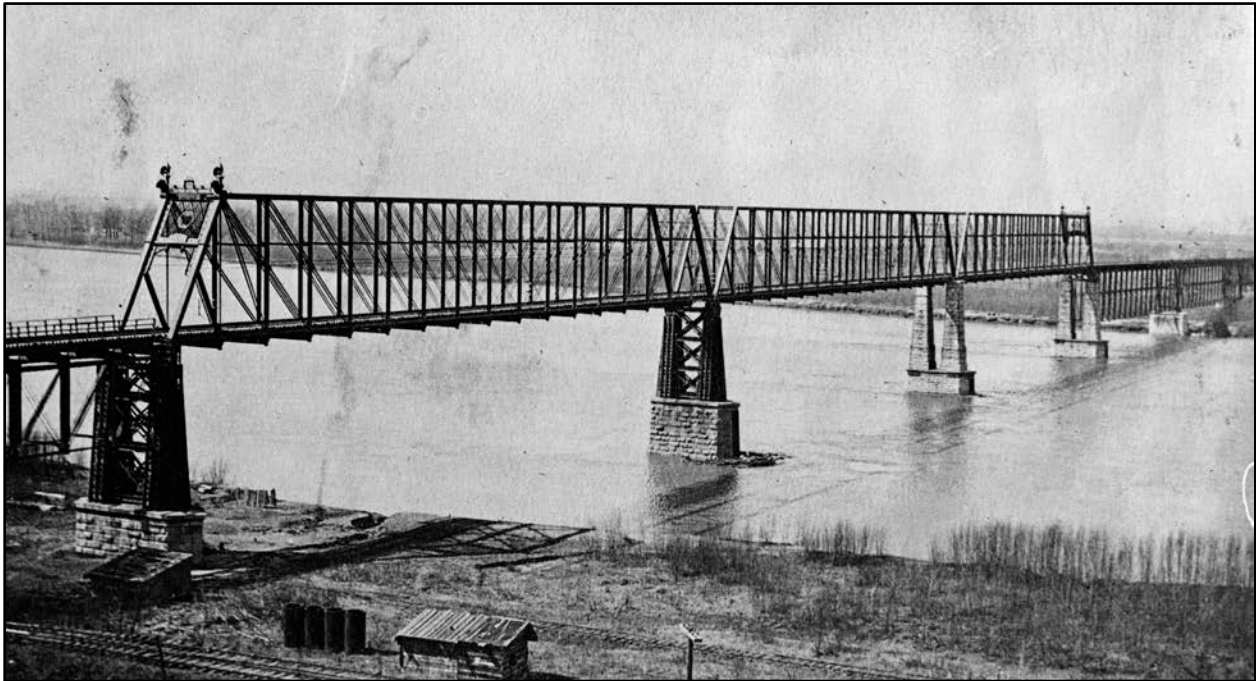
**Figure 10:** Constructed in 1879, the Chicago & Alton Bridge across the Missouri River, adjacent to the Missouri community of Glasgow, was the first such structure ever erected completely of steel. It was subsequently replaced about twenty years later by a four span Parker Through Truss (and its approaches) that could accommodate heavier trains. "Chicago and Alton Railway Bridge, Howard County, Missouri," HABS No. MO-1465, Included in the Historic American Building Survey, Library of Congress, Washington, D.C.

Francisco. Much has also been written about railroad bridges. A fine, late nineteenth century example is Theodore Cooper's *American Railroad Bridges*. A more contemporary work is Richard J. Cook's book *The Beauty of Railroad Bridges*. Another that also deals heavily with bridges is William D. Middleton's *Landmarks on the Iron Road: Two Centuries of North American Railroad Engineering*. Indeed, the Chicago & Alton's bridge across the Missouri River at Glasgow, Missouri is referenced briefly in Middleton's book and illustrated in Figure 10.<sup>72</sup>

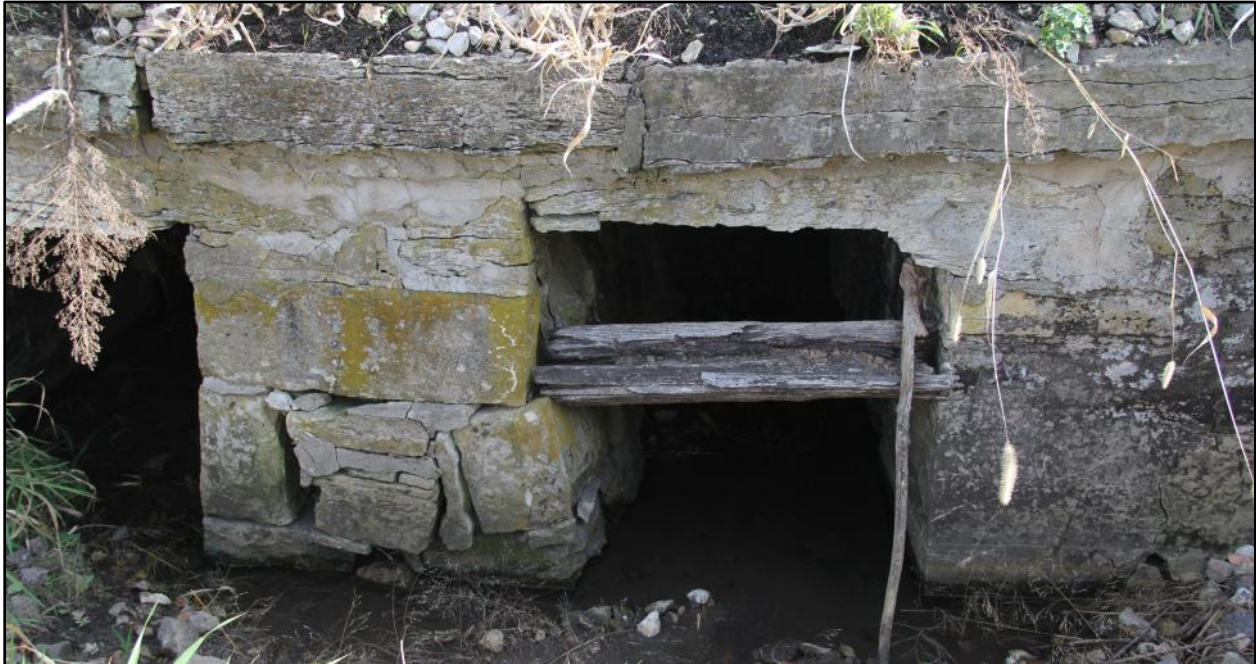
**Figure 13:** This small, two-opening structure located at mile post 46.95 (between Elwood and Wilmington) illustrates the second type of culvert noted.

The second type of culvert (see Figure 13) noted is a simple, nineteenth century structure that is built of stone and uses a post-and-beam structural system. While not technologically intriguing, it accomplishes its purpose, which is to accommodate the passage of water beneath the tracks and their embankment as it maintains the integrity of that embankment.

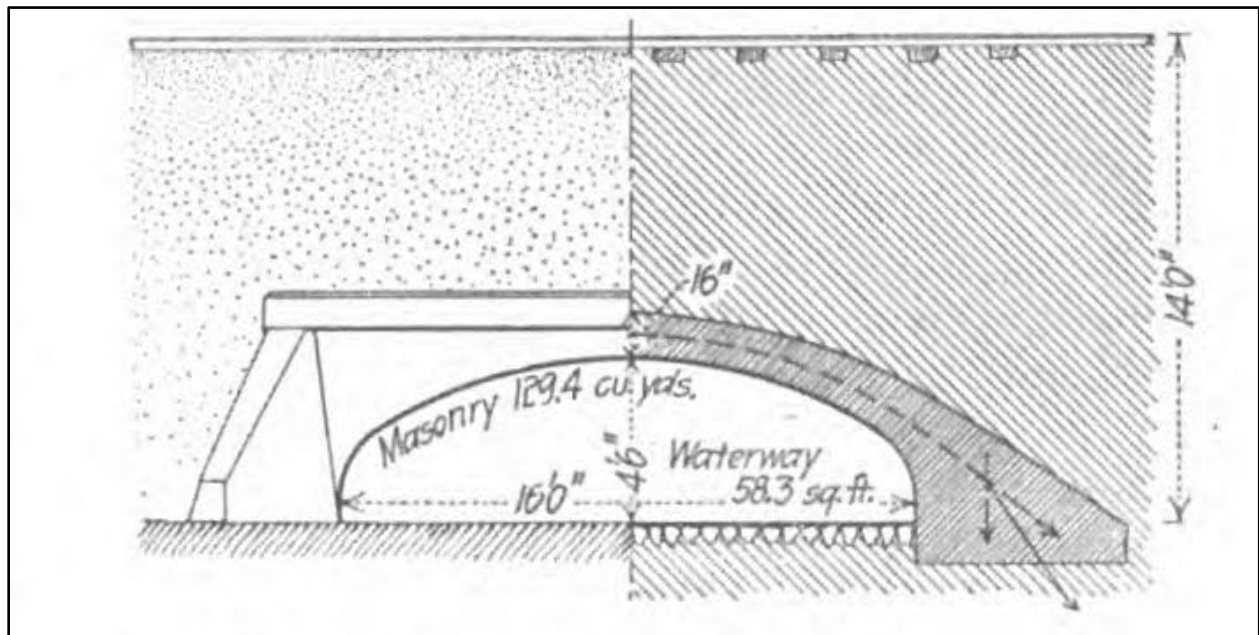
**Figure 14:** An example of a flatter-arched culvert. Daniel B. Luten, “The Design of Arch Culverts,” *Engineering News and American Railway Journal* 45, no. 24 (13 June 1901), 435.

established as an alternative to stone or brick culverts in the 1890s, became the primary material from which arched culverts were constructed in the twentieth century. Helping to validate the transition of construction materials was an article in the *Engineering News and American Railway Journal* which reported in 1895 that a concrete culvert built in Syracuse, New York in 1887 was “said to be as good now as when first built.” The stone to concrete transition notwithstanding, some railroads, the Chicago & North Western for example, continued to construct its culverts of stone into the twentieth century.<sup>77</sup>

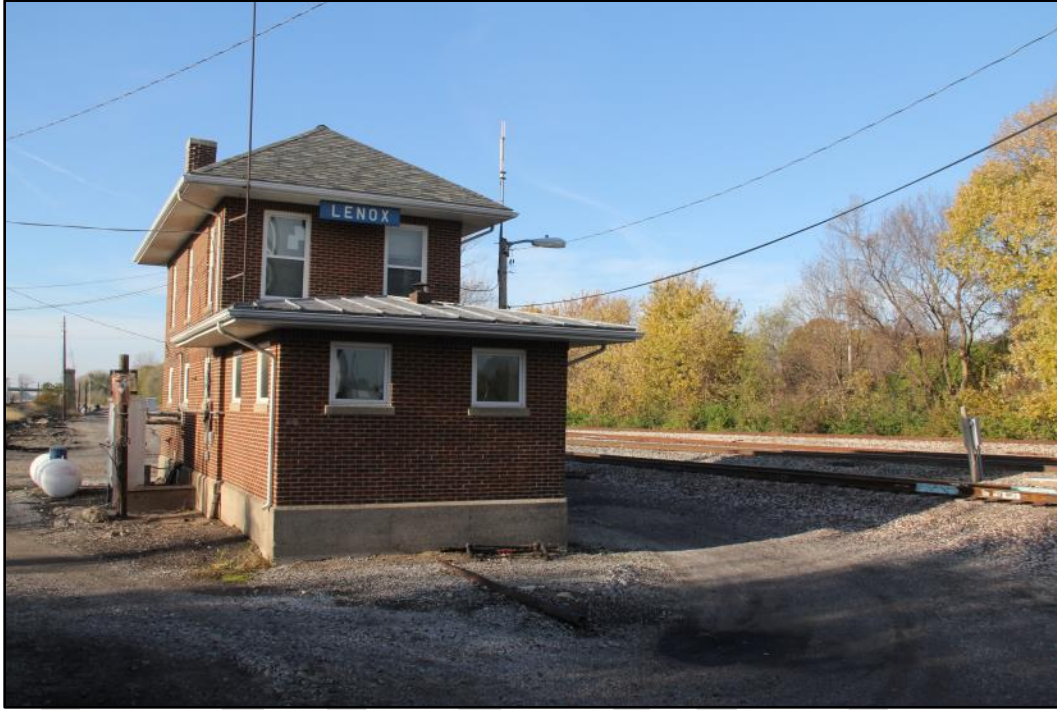
**Figure 15:** The Lenox Tower situated adjacent to the crossing of several railroads in Mitchell, Illinois (Photo 7245).

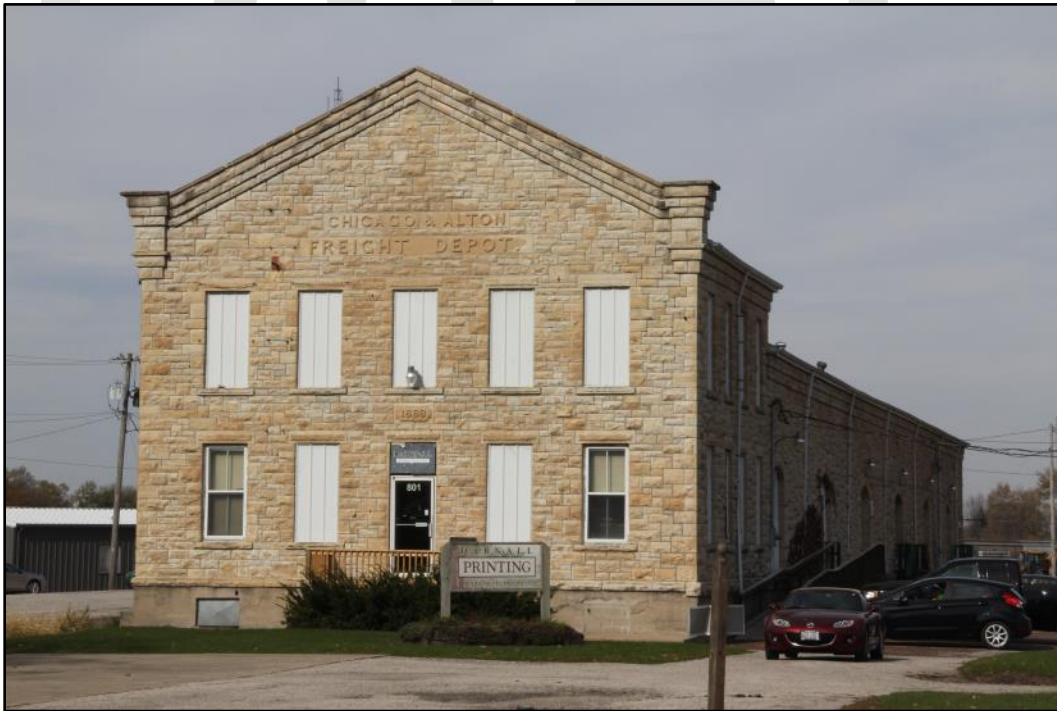
**Figure 16:** The remaining, 1888 Alton Freight Depot situated across the tracks from the location of the former railroad shops in Bloomington (Photo 7059).

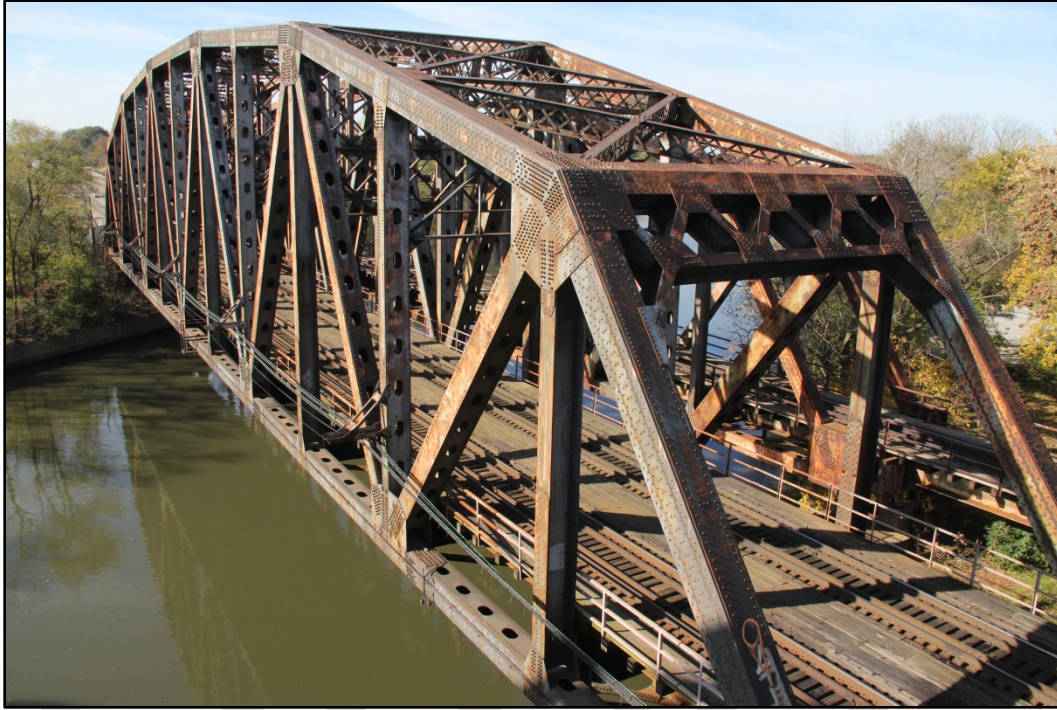
**Figure 17:** The only truss bridge located between Union Station in Chicago and Granite City, Illinois. Five similar bridges, on the Calumet SAG Canal immediately to the west have been documented for the Historic American Engineering Record (Photo 6933).

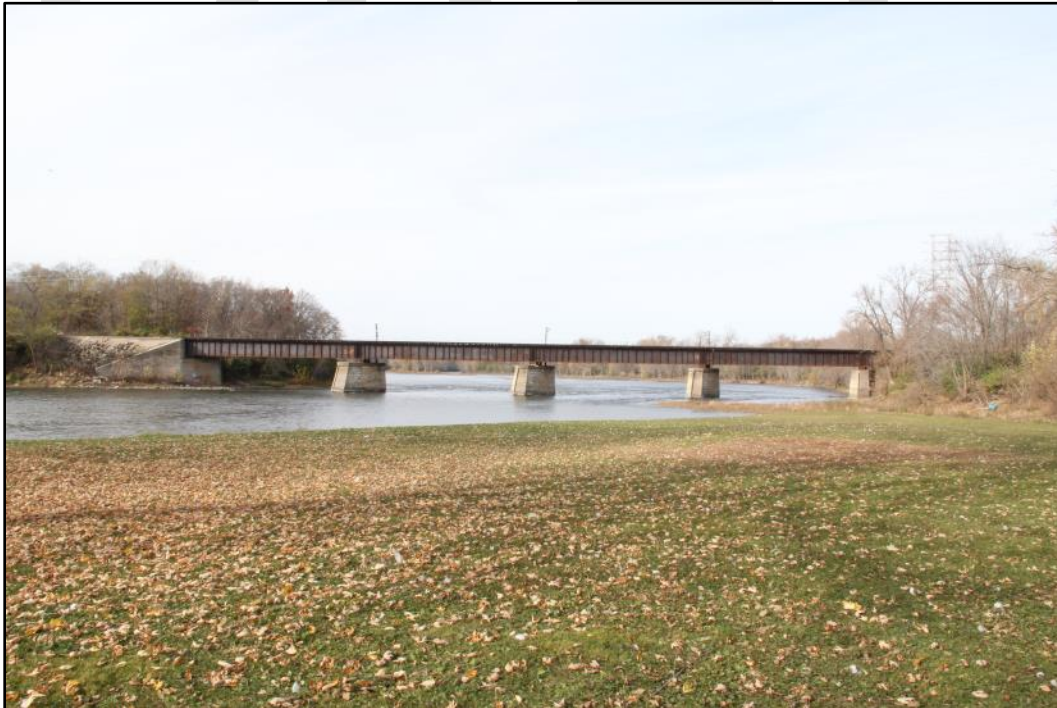
**Figure18:** Bridge over the Kankakee River in Wilmington (Photo 6964).

000.00	Wilmington	Will	B	SN/C/SL	P & B	Water St	--	N	Y	Unremarkable -- Photos 6971, 6972
052.70	Wilmington	Will	B	SN/C/SL	P & B	Kankakee Rvr	1930?	Y	Y	(American Bridge Co.?) Five Spans -- Photos 6964, 6965

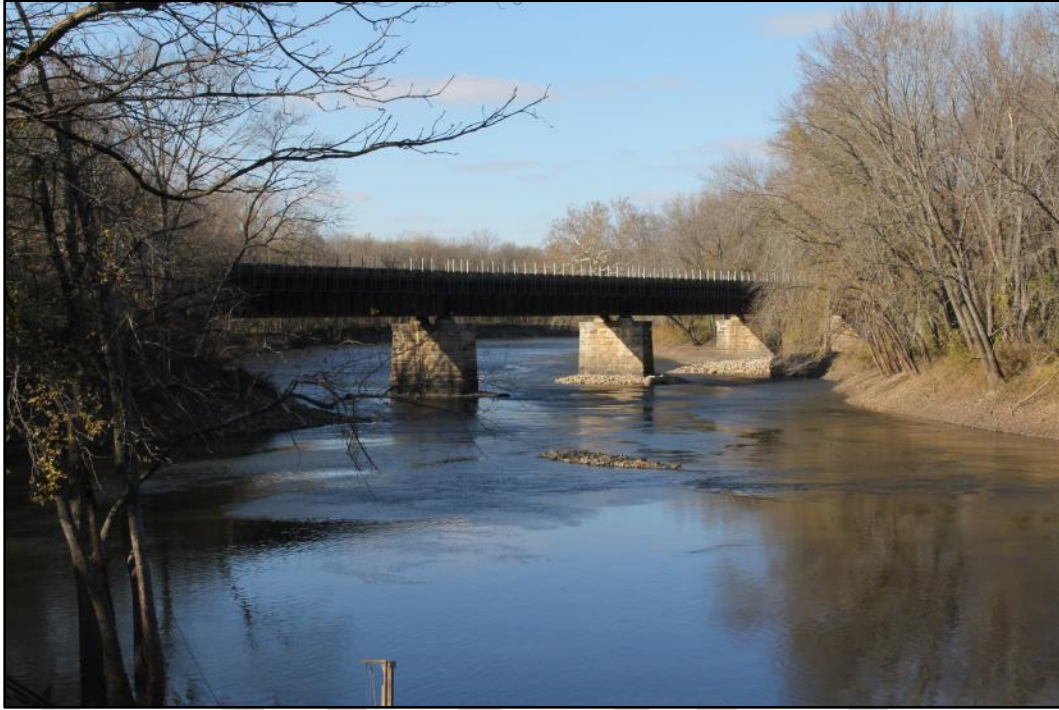
**Figure 19:** Five span structure across the Sangamon River immediately north of Springfield (Photo 7143).

and Bloomington by twelve feet. Further track improvements were made as ninety-pound rail was laid on the fifty-one miles between Joliet and Chicago, as well as between Bloomington and Chenoa. The five truss spans across the Sangamon River, immediately south of Sherman, were also replaced in 1912, the same year that Hawley died. It was also during his tenure that the Alton inaugurated on 22 January 1911 a fast mail train between Chicago and St. Louis, one in each direction. The trip was made in six hours and fifteen minutes and included stops at Joliet, Pontiac, Bloomington, Springfield and East St. Louis.<sup>57</sup>

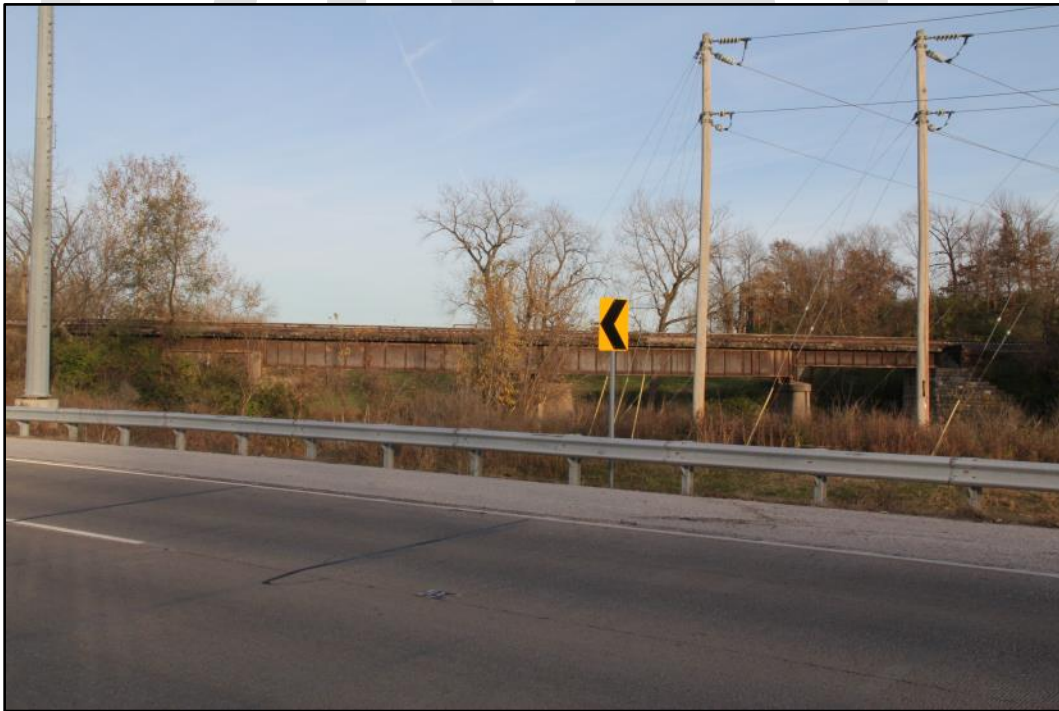
**Figure 20:** Lassig Iron Works 1890s bridge across the Wood River in Alton (Photo 7231).

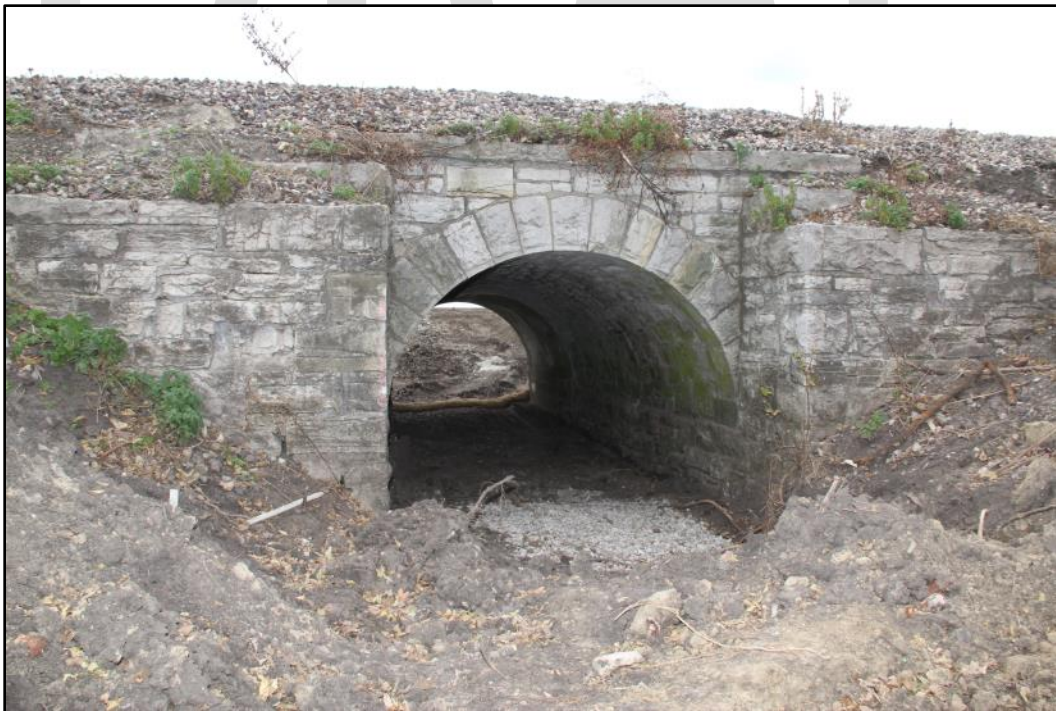
**Figure 21:** The east side of the culvert at MP 163.60 was constructed in 1876 of stone (Photo 7127).

An interesting example of a structure that evokes Blackstone's passion for a quality railroad with quality infrastructure is found at MP 163.60. Viewed from the west, this appears to be a concrete arch fabrication. Viewed from the east, however, the culvert reveals an original, cut-stone arch structure that was built in 1876. The concrete extension was constructed when the roadbed was widened to the west – likely post 1900. This edifice is illustrated in Photos, 21, 22, 23 and 24. Another stone arch, this one with more consistent integrity than the one at MP 163.60, but without a date stone, is located at MP 112.20. Its original construction was likely consistent with the construction of MP 163.60 (i.e., ca. late 1870s). Interestingly, the stonework of the arch on the east side of the structure differs stylistically from that on the west, which may be a bit more recent. Both arches are of stone, which clearly suggests nineteenth century construction. This arch is illustrated in Photos 25 and 26. It is thought that both of these structures may be eligible for listing on the National Register of Historic Places under both Criterion A and C.

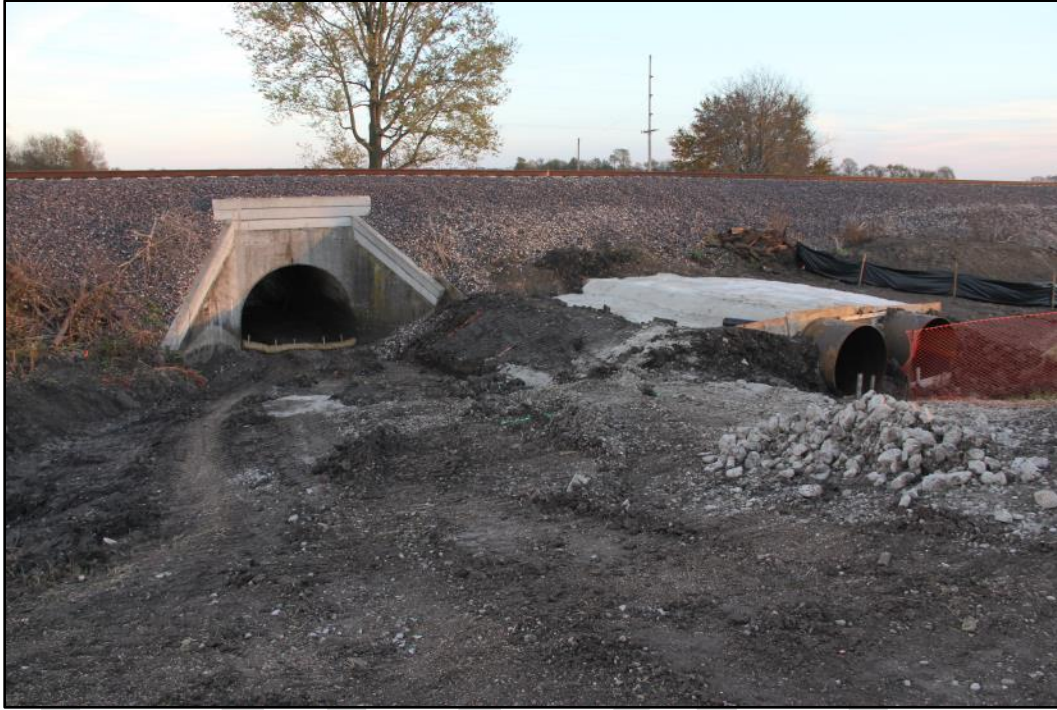
**Figure 22:** The west side of the culvert located at MP 163.60 was constructed of concrete, as often happened when a roadbed was being widened in the early twentieth century. A new, two-pipe culvert is presently being erected immediately to the southwest. Hopefully its construction does not mean that the original 1876 culvert will be removed (Photo 7097).

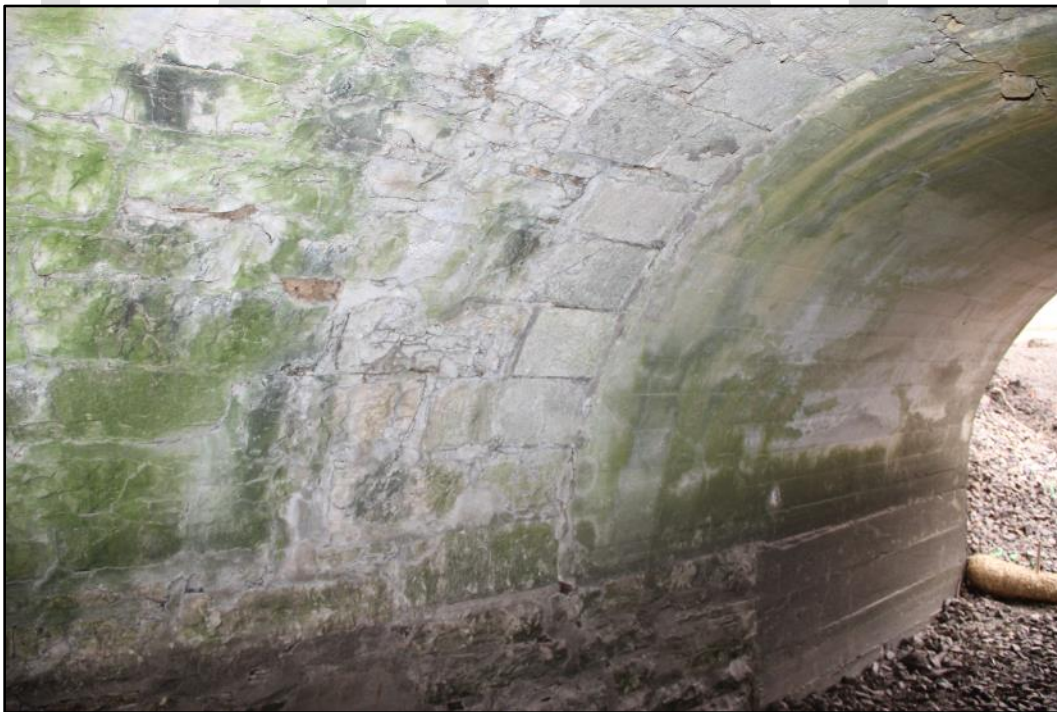
**Figure 23:** MP 163.60. Arch interior. Note the stone to concrete matching line (Photo 7130).

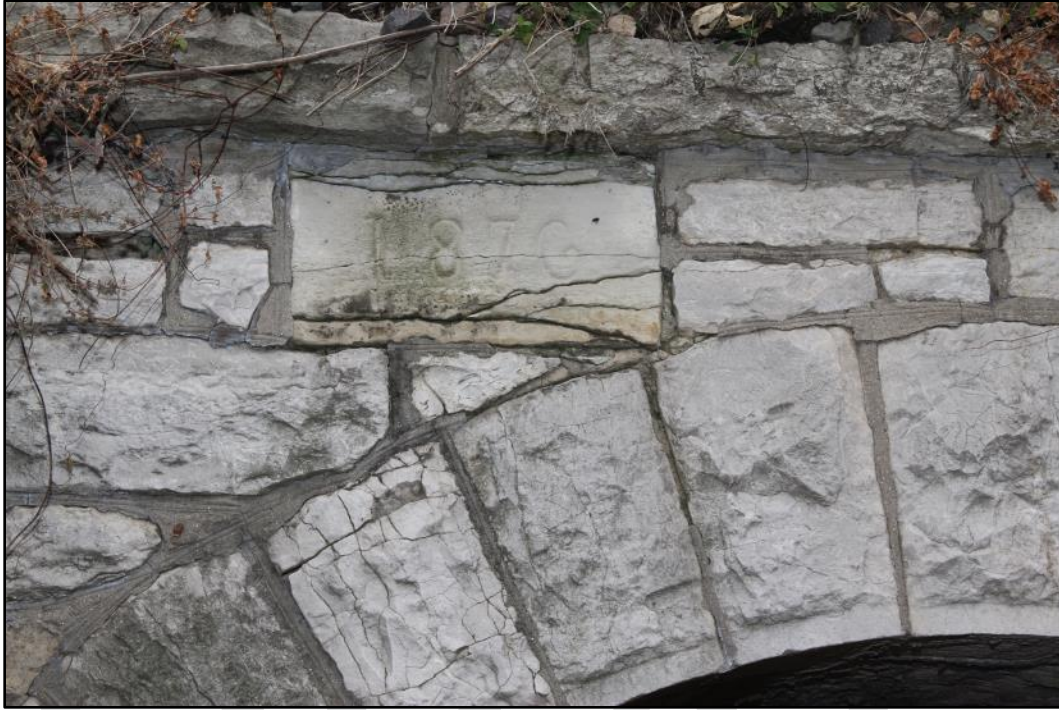
**Figure 24:** MP 163.60. 1876 date stone on the east side of the culvert (Photo 7126).

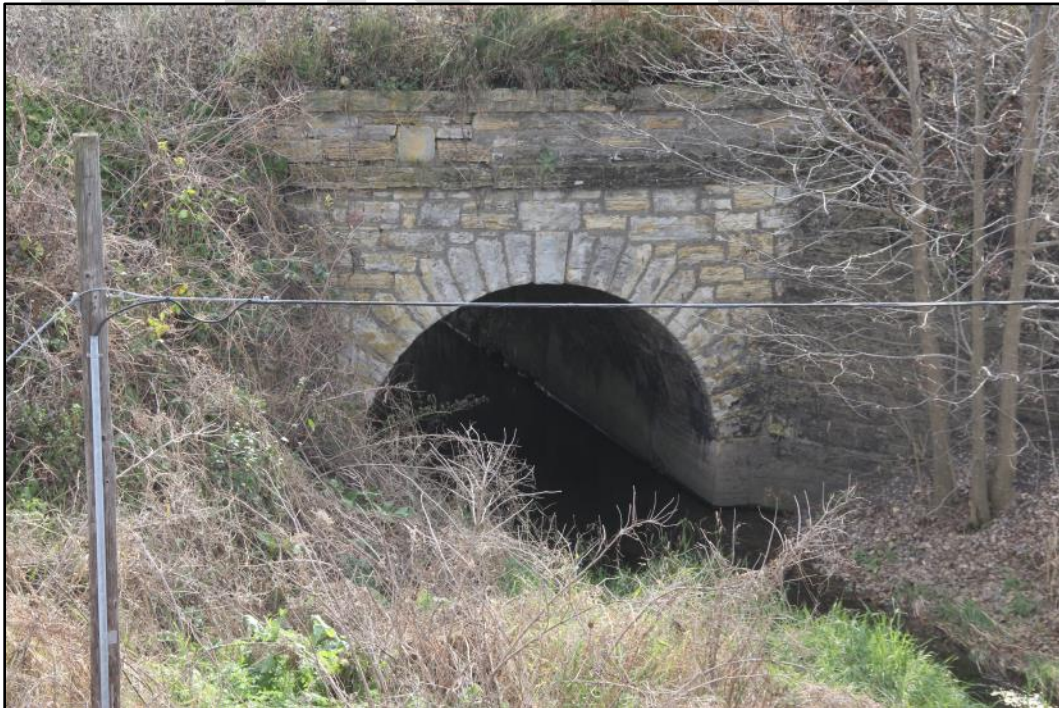
**Figure 25:** This is the west side of the stone culvert located at MP 112.20. This stonework is slightly different than that on the east side of the structure – which suggests it may be a bit newer. Nevertheless, this side of the structure exhibits significant character (Photo 7039).

111.20	Lexington	McLean	B	SL	P & B	Makin Rvr	--	Y	Y	Modern rehabilitation in progress – <a href="#">Photos 7034, 7035</a>
112.20	Money Ck	McLean	B	SN	Arch	Drainage	--	Y	Y	EXCEPTIONAL – <a href="#">Photos 7039, 7249</a>

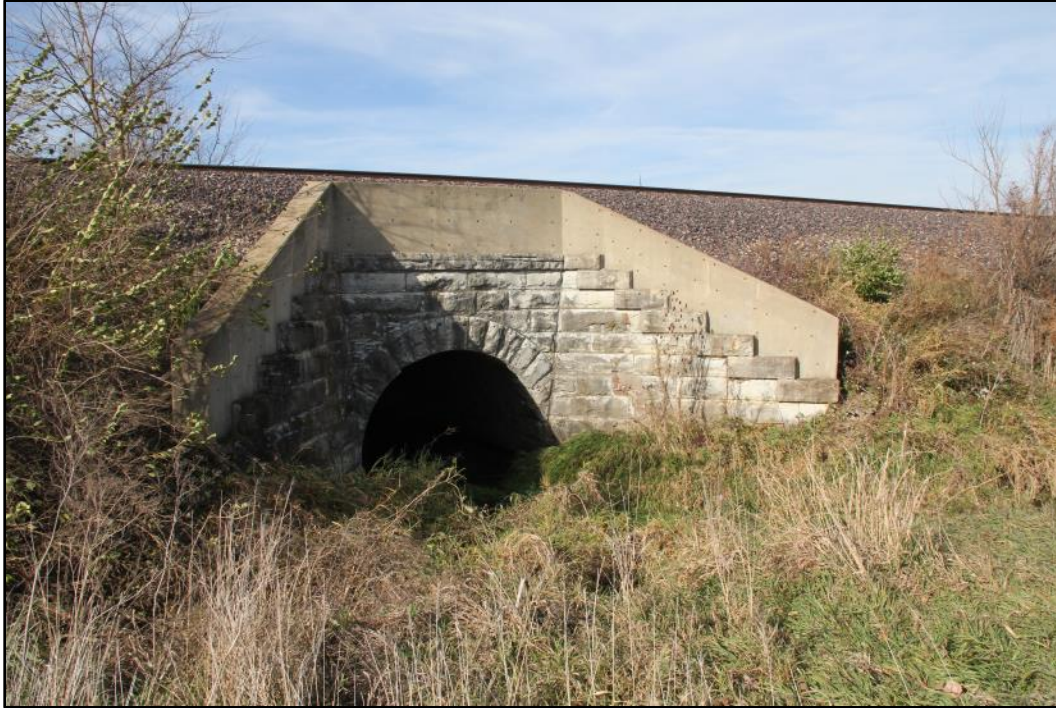
**Figure 26:** The east side of the culvert at MP 112.20 is likely the original. The segmental arch stones are finished and placed in a manner similar to the structure at MP 163.60. The retaining wall extension is a minor intrusion that is not thought to affect the overall integrity of the structure in a significant way (Photo 7249).

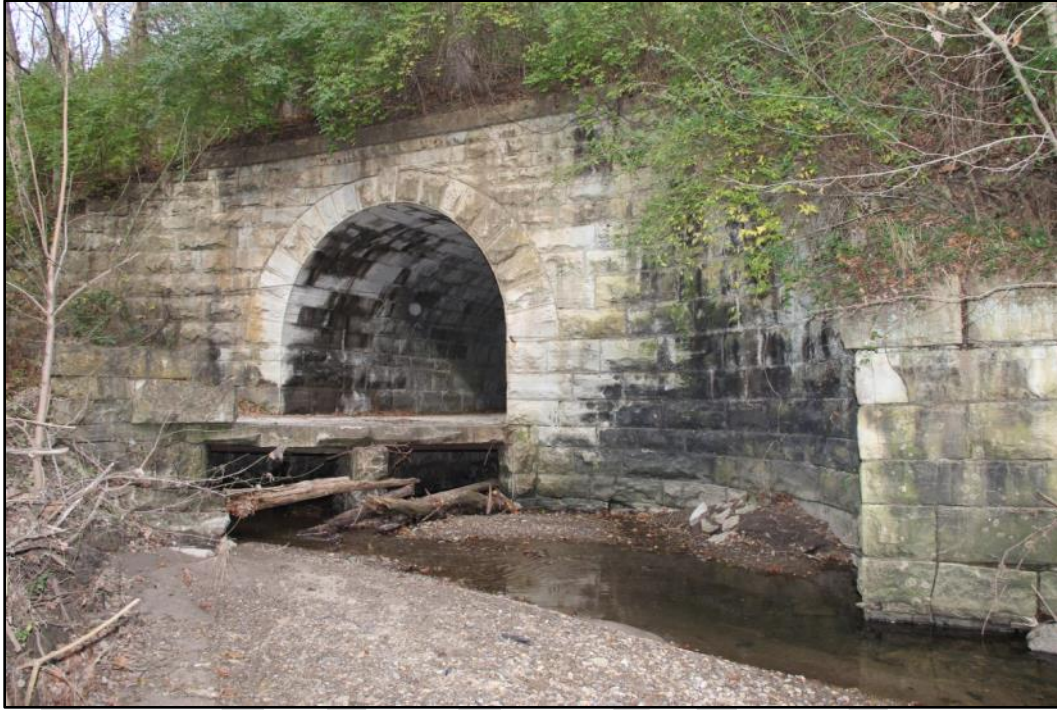
The stone culvert with what is likely the best integrity of all stone structures on the Chicago & Alton's line to St. Louis is that located at MP 254.30 and pictured in Figure 27. It is also monumental, when compared to any other stone arch on the route. This structure, in agreement with IHPA, is being documented for the IL HAER recordation program. What is interesting about this culvert is that it was constructed on a short, seven-mile segment of the Alton line that was built in 1881 to improve some grade-related problems, as well as to avoid the need for freight trains to pass through the City of Alton proper when it was otherwise not necessary (see the map in Figure 3, Page 20 for a delineation of this seven mile segment). At least three other, smaller culverts were also constructed on the Alton bypass route, one of which is illustrated in Figure 28 and located at MP 254.65. It is quite possible that the arch at MP 254.65, and upon inspection any other arches situated on the seven-mile bypass segment, as a discrete unit of the old Alton alignment, may also be eligible for the Register under Criterion A and/or C if they maintain their integrity.

**Figure 27:** This very impressive, stone culvert is located at MP 254.30. It is located on the seven mile, City of Alton bypass and was constructed in 1881. It is presently being documented for the IL HAER recordation collection (Photo 7220).

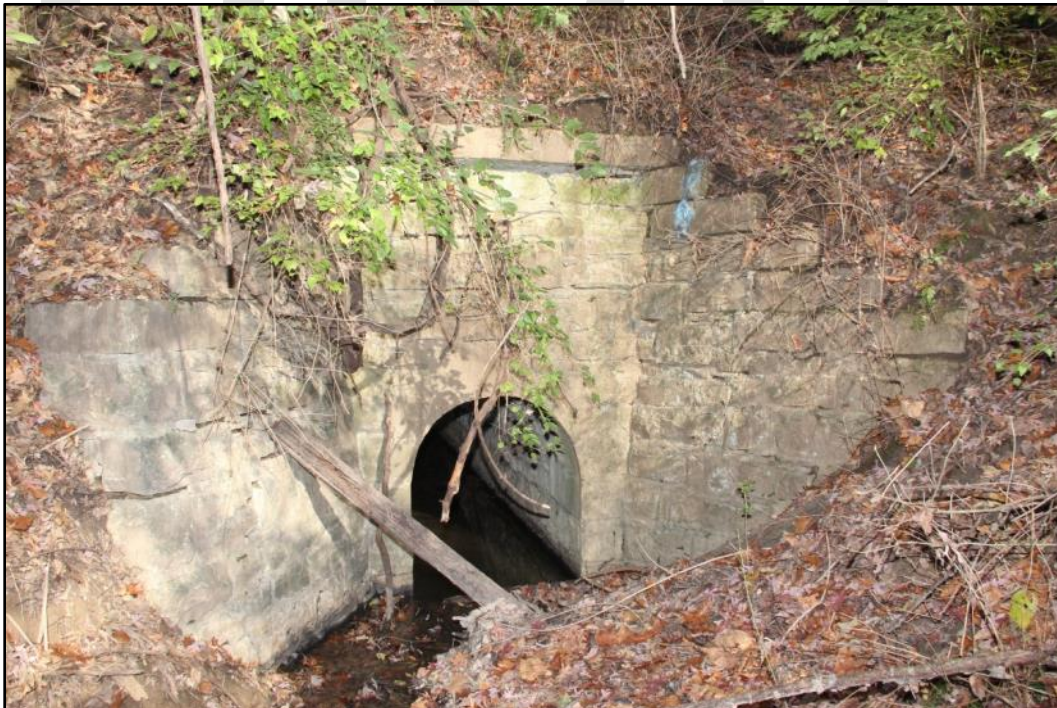
**Figure 28:** Located at MP 254.65, this stone culvert was constructed to facilitate drainage and the passage of water beneath the 1881 City of Alton bypass (Photo 7214).

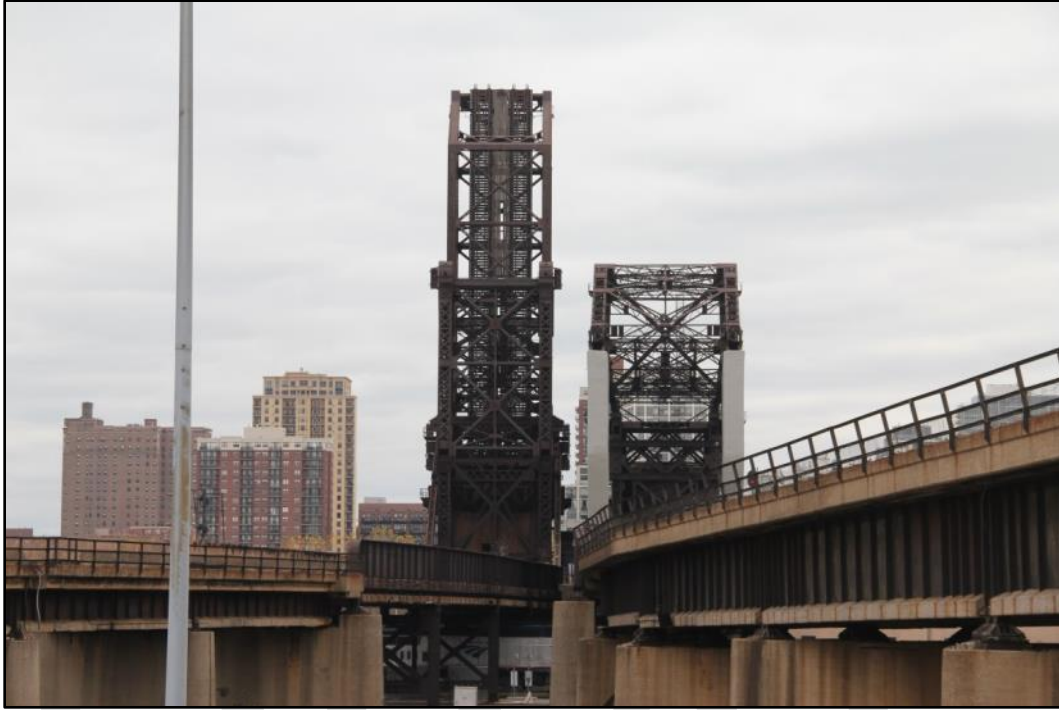
B0005 or B0010/Photo 6923: Resolve question of St. Charles Airline Bridge (HAER No. IL- 67). Which bridge is it?

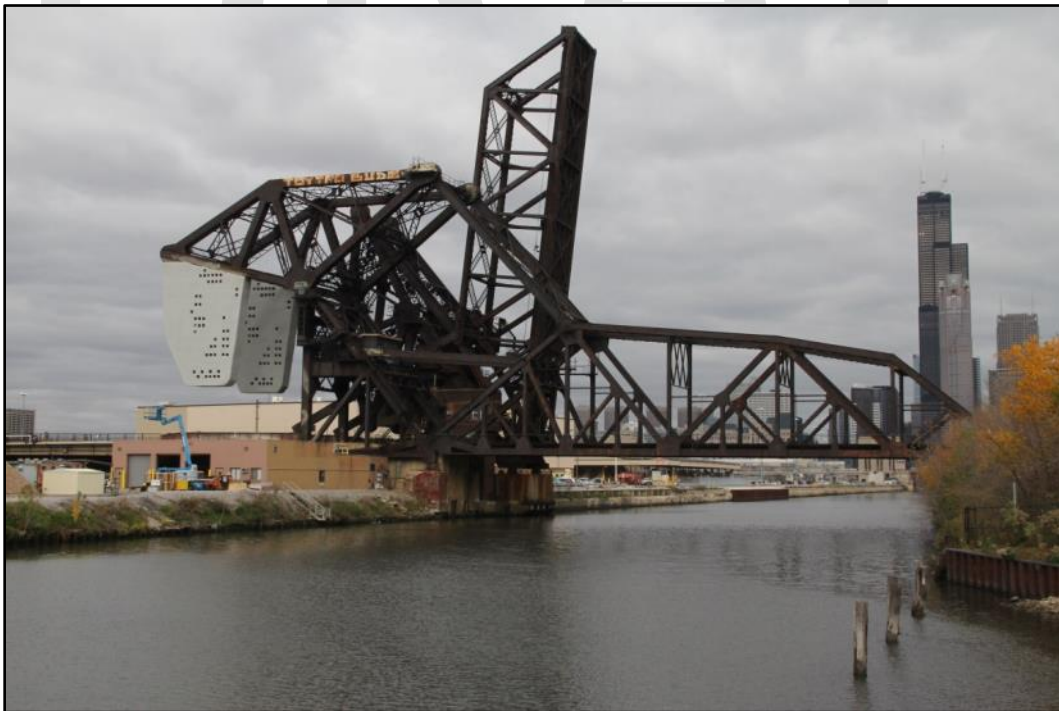
B0005 or B0010/Photo 6915: Resolve question of St. Charles Airline Bridge (HAER No. IL067). Which bridge is it?

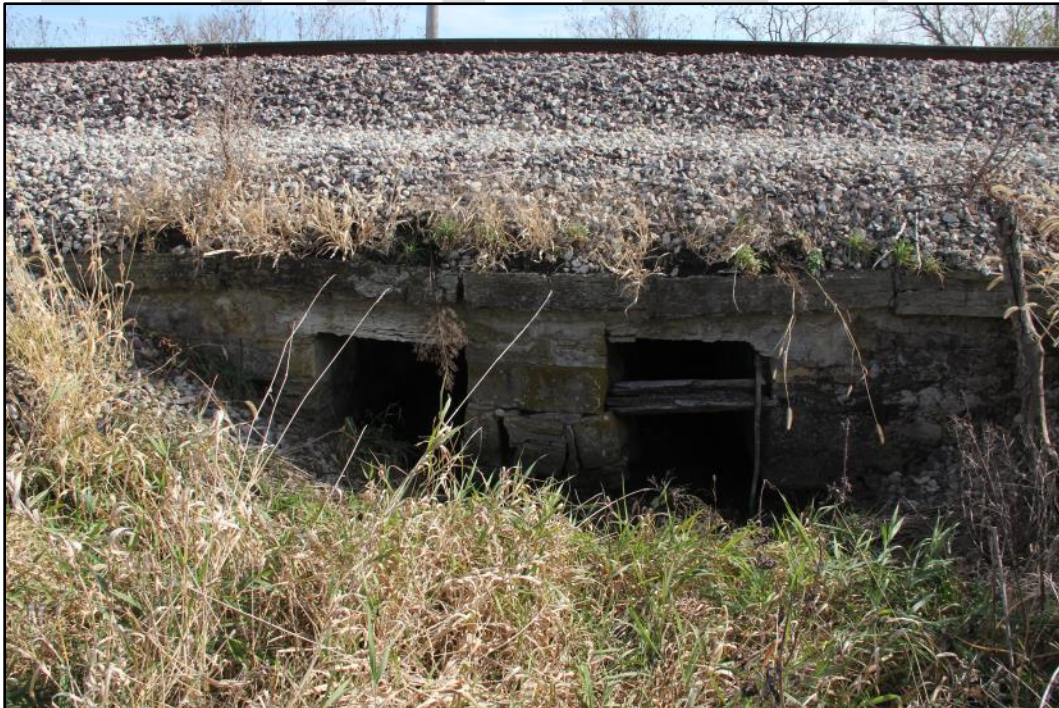
MP 046.95/Photo 6938

046.09	Joliet	Will	C	C/CI	Tube	Drainage	--	Y	N	Unremarkable
046.74	Joliet	Will	C	C	Pipe	Drainage	--	Y	N	Unremarkable/Modern
046.95	Joliet	Will	C	SN	Squared	Drainage	--	Y	Y	Unremarkable/Deteriorating -- Photos 6938, 6940

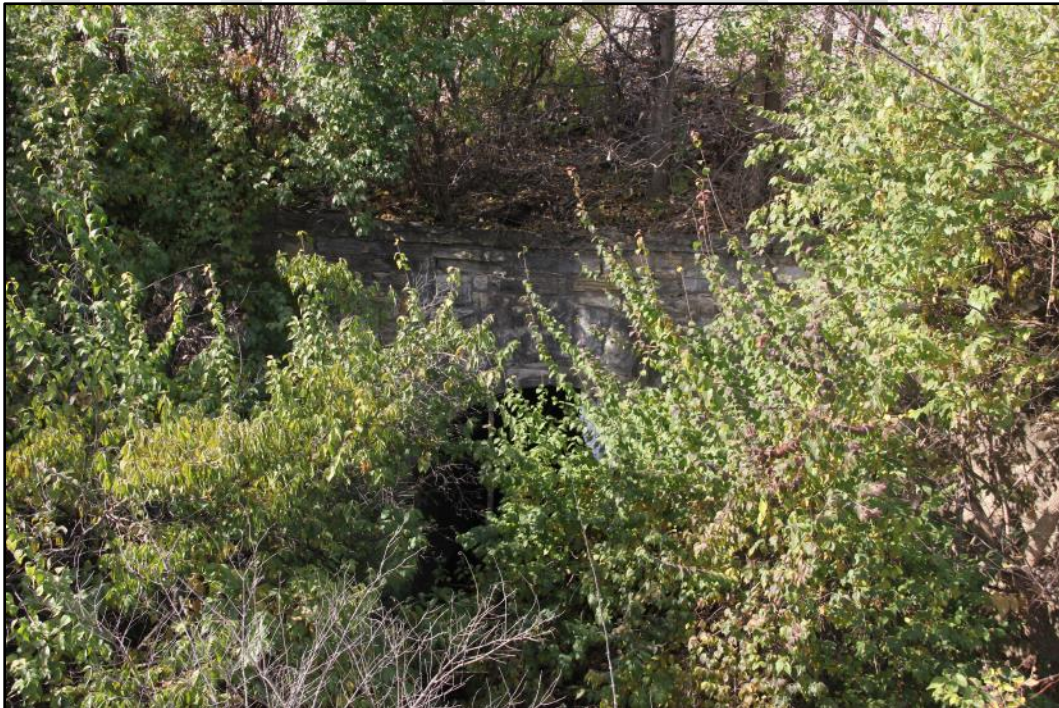
MP 047.30/Photo 6941

047.30	Joliet	Will	C	SN/C	Arch	Drainage	--	Y	Y	Unremarkable. Arch has a concrete lining -- Photo 6941
048.75	Wilmington	Will	C	C or CI	Tube	Drainage	--	Y	N	Unremarkable
