# Historic Railroad Structural Resources:

Chicago to St. Louis High Speed Rail

**IDOT Sequence #17337 & #17337A**

17 December 2014

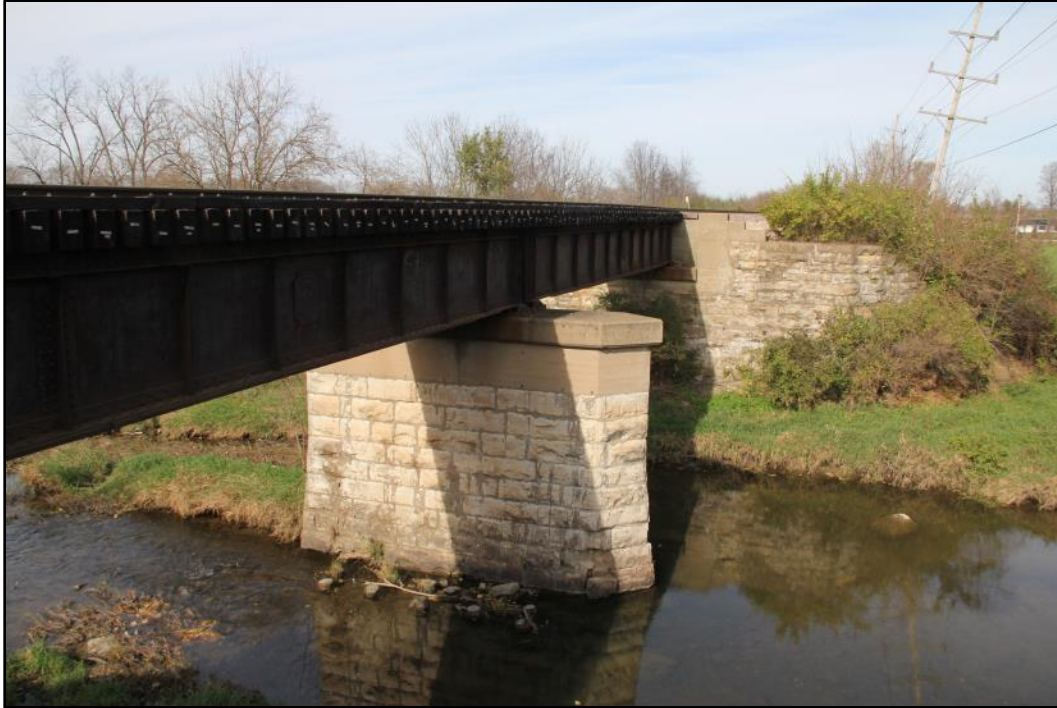
MP 049.52/Photo 6944

048.90	Wilmington	Will	C	CM	Tube	Drainage	--	Y	N	Unremarkable
049.20	Wilmington	Will	C	C/CI	Tube	Drainage	--	Y	N	Unremarkable/Overgrown
049.52	Wilmington	Will	B	C/SL	P & B (2 span)	Prairie Ck	1899	N	Y	(Lassig Bridge) Good Integrity -- Photos 6944, 6949

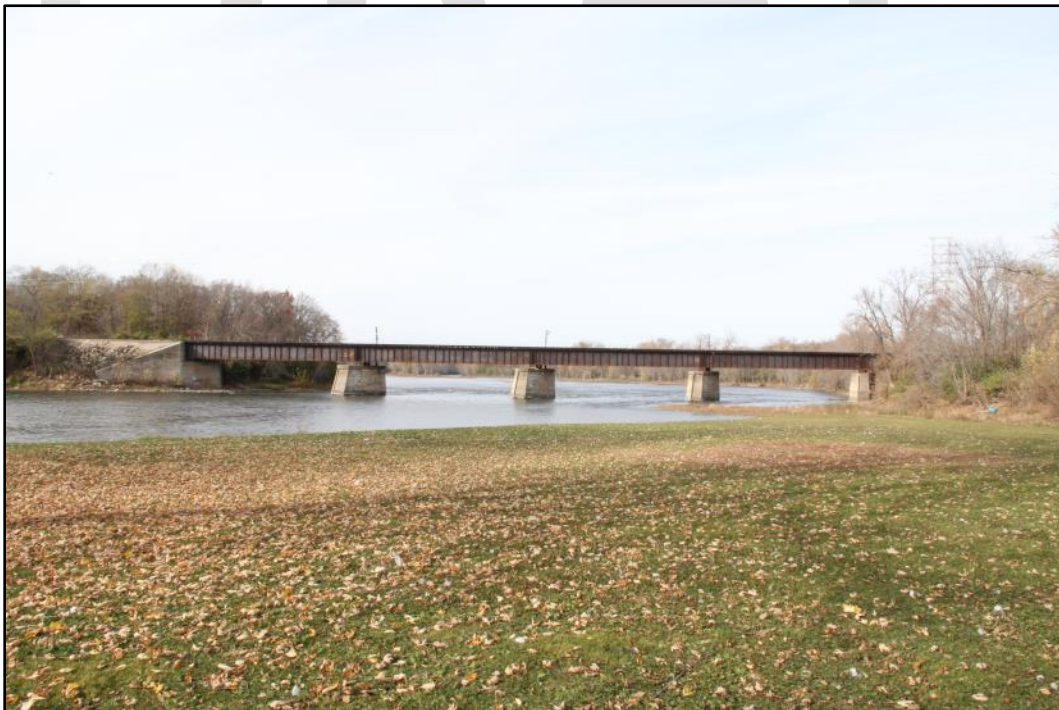
MP 052.70/Photo 6964

000.00	Wilmington	Will	B	SN/C/SL	P & B	Water St	--	N	Y	Unremarkable -- Photos 6971, 6972
052.70	Wilmington	Will	B	SN/C/SL	P & B	Kankakee Rvr	1930?	Y	Y	(American Bridge Co.?) Five Spans -- Photos 6964, 6965

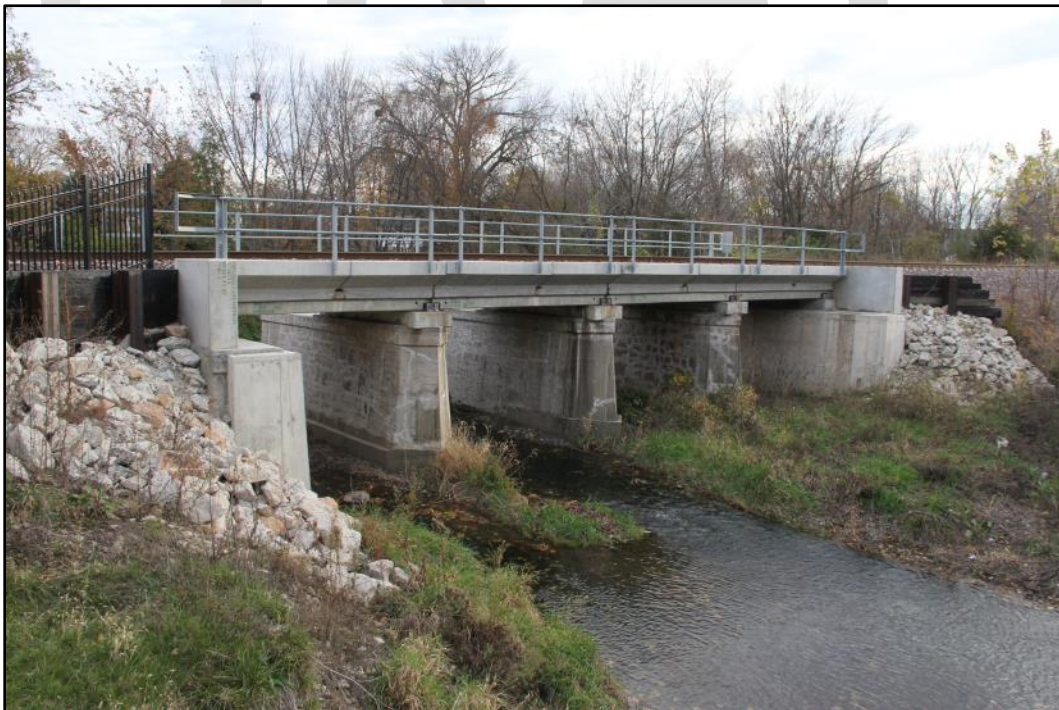
MP 073.26/Photo 6982

073.26	Dwight	Livingston	B	C	P & B	Gooseberry Ck	--	N	Y	Modern rehabilitation -- Photo 6982
075.90	Dwight	Livingston	C							No data received
077.41	Nevada	Livingston	C							No data received

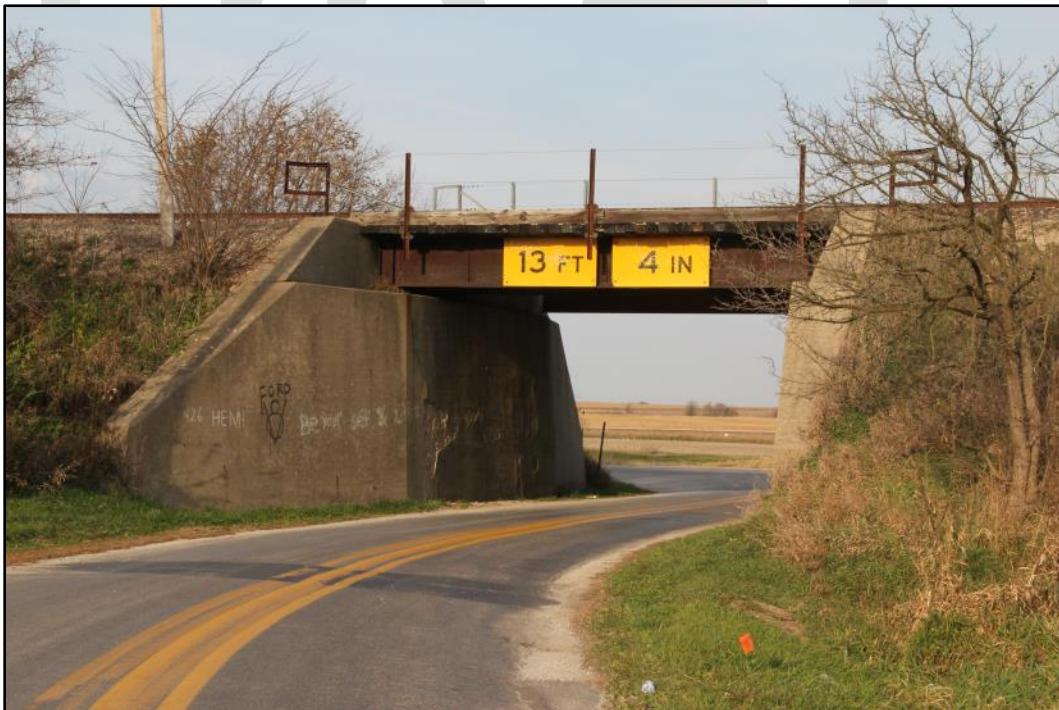
MP 084.75/Photo 7002

084.75	Odell	Livingston	C	CI	Tube	Drainage	1922	N	Y	Modern rehabilitation -- Photo 7002
085.73	Odell	Livingston	C	SL	Tube	Drainage	--	N	Y	Modern rehabilitation -- No Photo

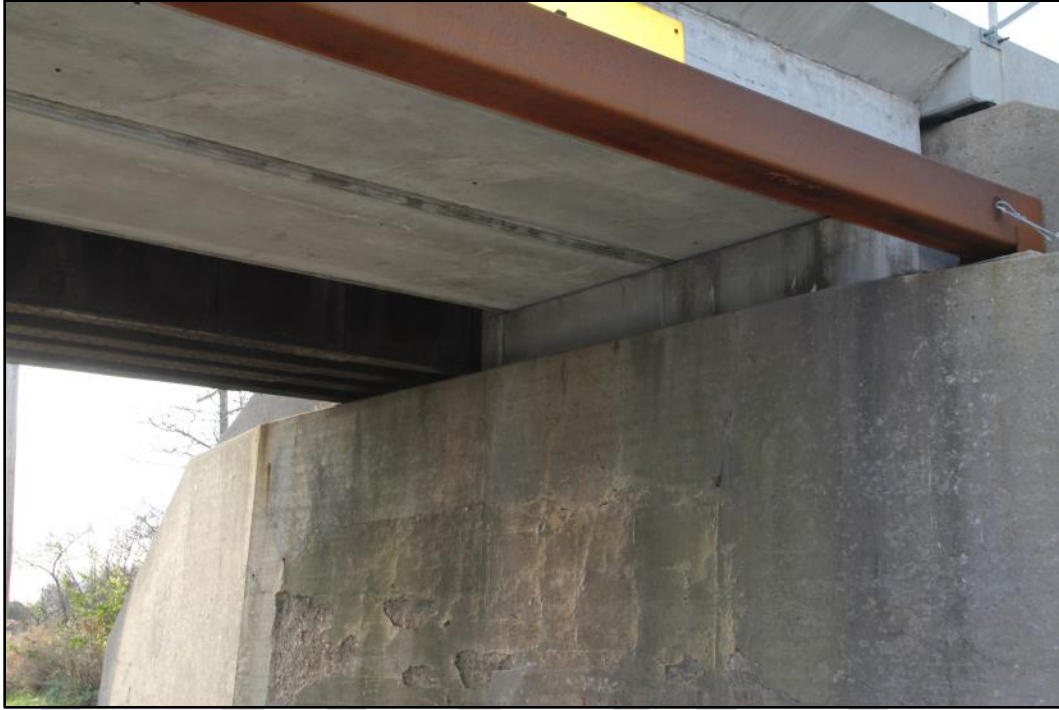
MP 000.00/Photo 7003

000.00	Odell	Livingston	B	C/SL	P & B	Roadway	--	N	Y	East side steel beam originals. West side new concrete deck -- Photos 7003, 7005
086.67	Odell	Livingston	B		P & B	Drainage	--	N	Y	Unremarkable -- Photo 7006

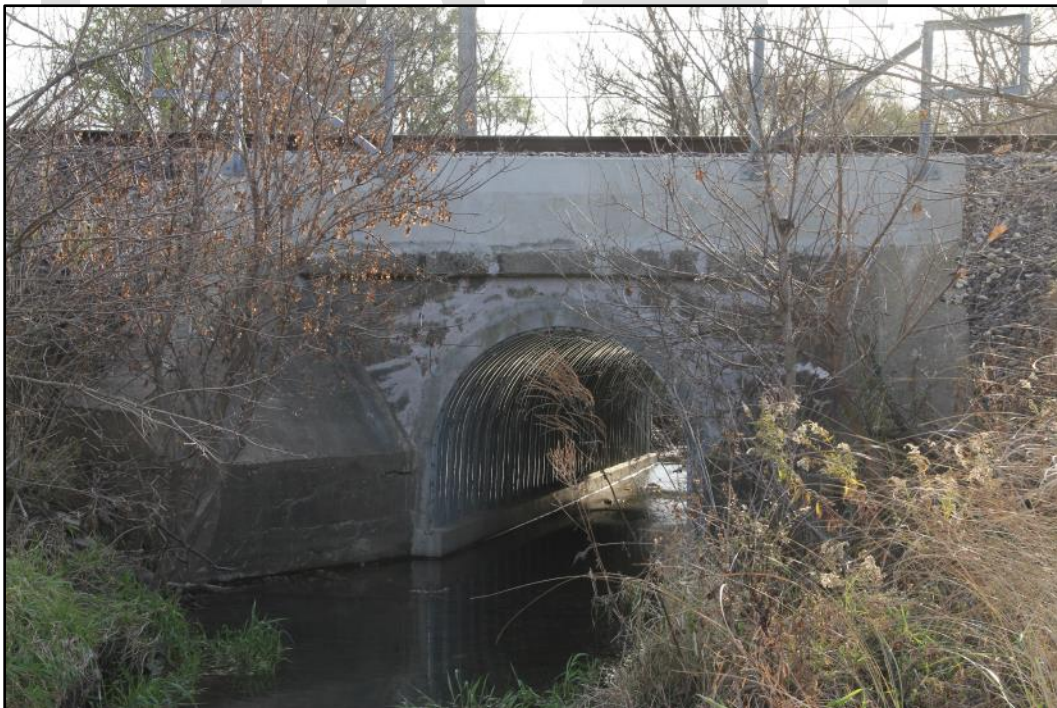
MP 087.09/Photo 7009

087.09	Odell	Livingston	C	CI	Tube	Drainage	--	N	Y	Modern rehabilitation -- Photo 7009
087.40	Pontiac	Livingston	C							No data received
088.64	Pontiac	Livingston	C		Tube/Arch	Drainage	--	N	Y	Modern rehabilitation -- Photo 7010

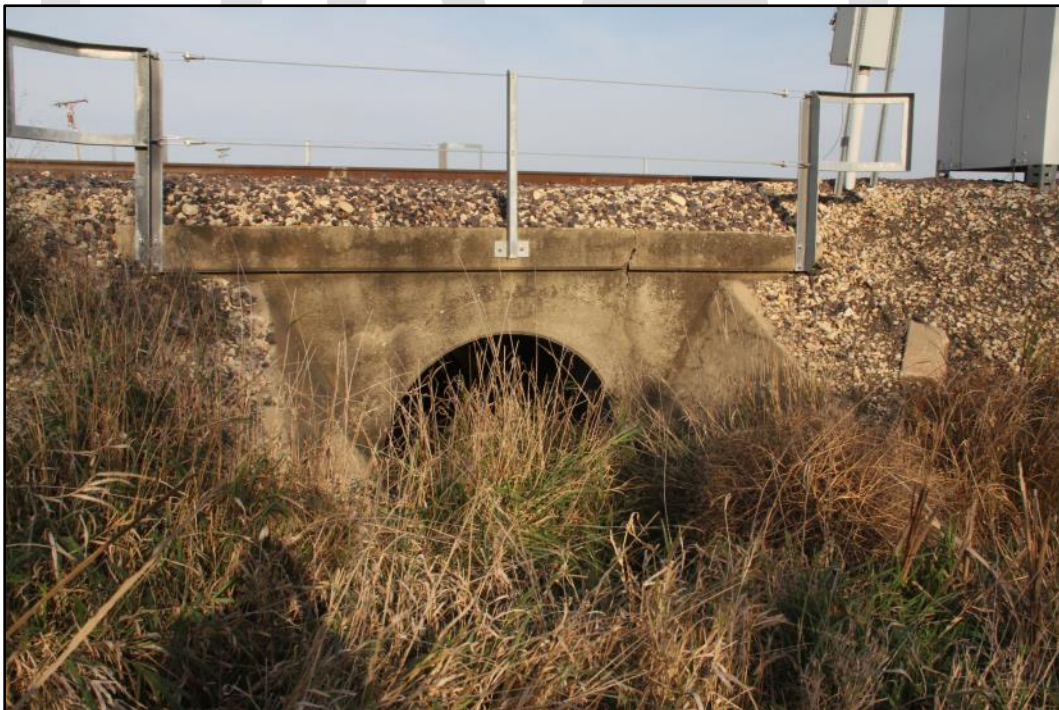
MP 088.83/Photo 7012

088.83	Pontiac	Livingston	C		Tube	Drainage	--	N	Y	Unremarkable -- Photos 7012, 7014
088.90	Pontiac	Livingston	C	SL	Tube	Drainage	--	N	Y	Modern replacement -- No Photo

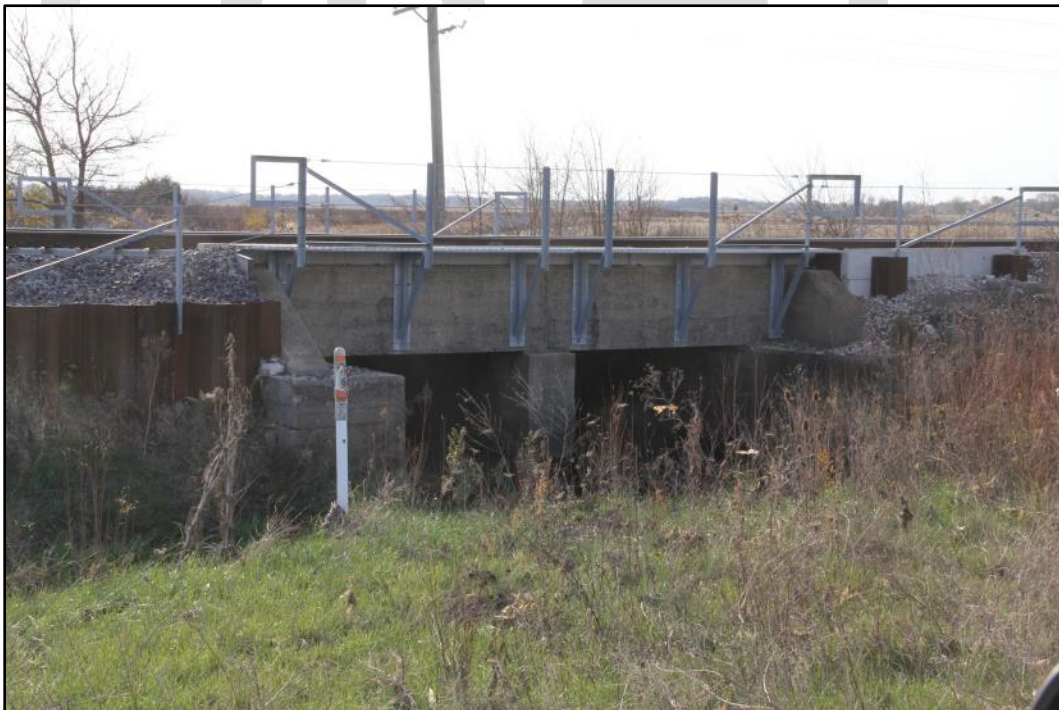
MP 089.24/Photo 7015

089.24	Pontiac	Livingston	C		Tube	Drainage	--	N	Y	Unremarkable/Rehabilitation -- Photo 7015

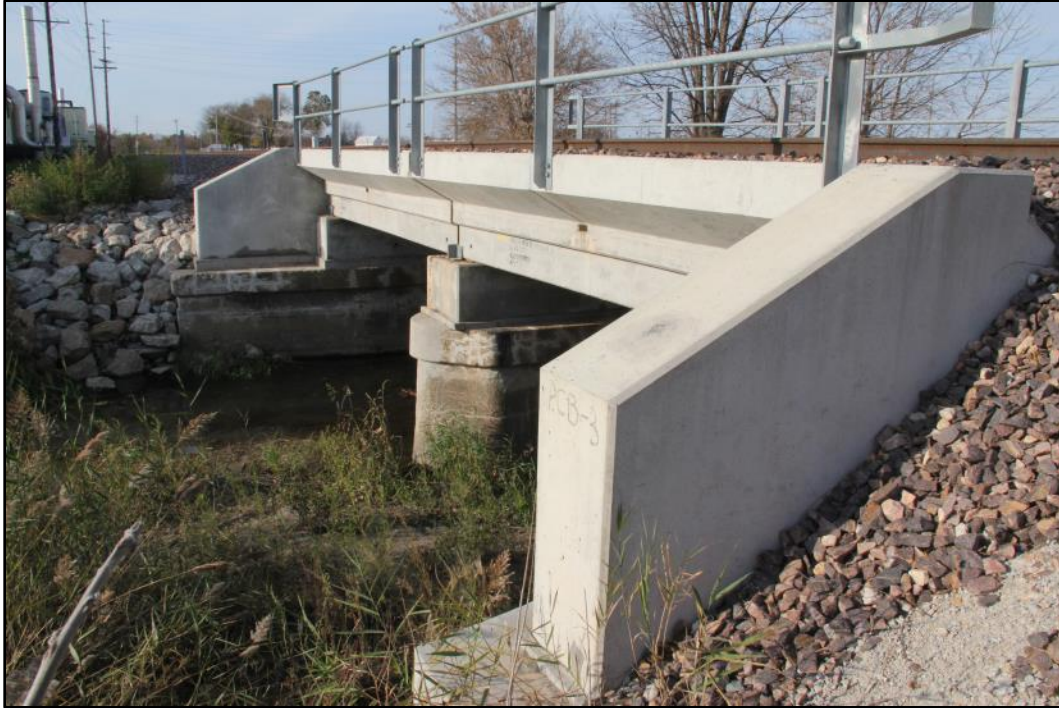
MP 089.83/Photo 7016

089.83	Pontiac	Livingston	B	C	P & B (2 span)	North Ck	--	N	Y	Unremarkable – <a href="#">Photo 7016</a>
090.13	Pontiac	Livingston	C	SL	Tube	Drainage	--	N	Y	<a href="#">Try to field review</a>

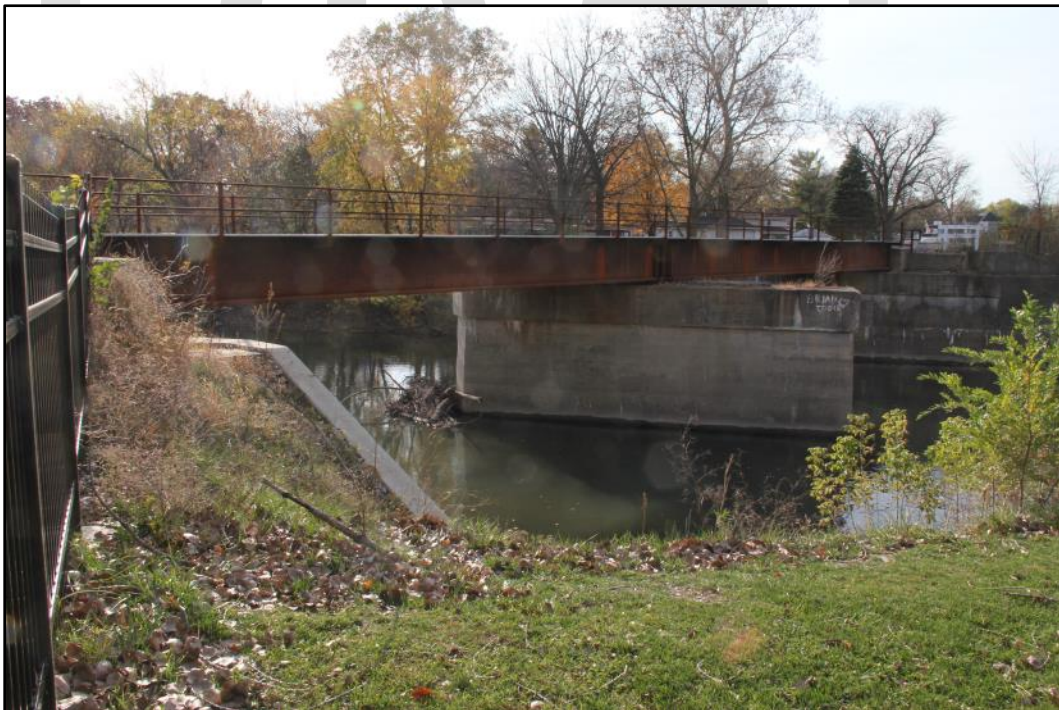
MP 090.91/Photo 7018

090.91	Pontiac	Livingston	B	C/SL	P & B (2)	North Ck	--	N	Y	Modern rehabilitation - <a href="#">Photo 7018</a>
092.12	Pontiac	Livingston	B	C/SL	P & B (2)	Vermillion Ck	--	N	Y	Modern rehabilitation - <a href="#">Photo 7020</a>

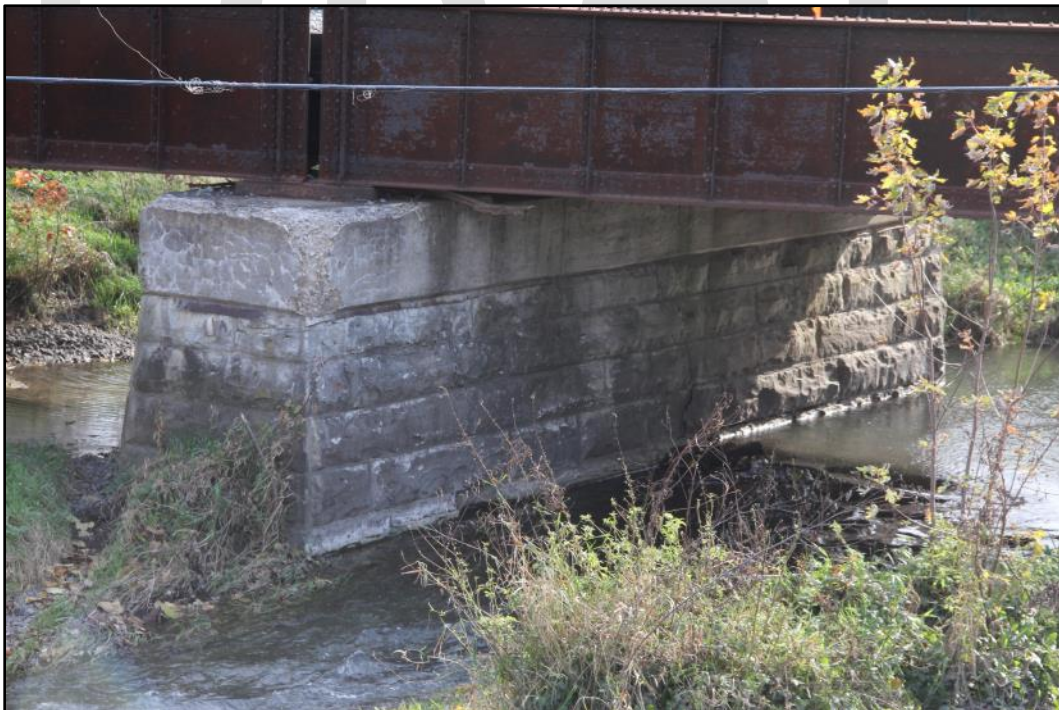
MP 097.00/Photo 7024

097.00	Eppards Pt	Livingston	B	SN/SL	P & B (2)	Rood Ck	--	N	Y	Unremarkable. Five Spans – <a href="#">Photos 7024, 7025</a>
098.20	Eppards Pt	Livingston	C							No data received

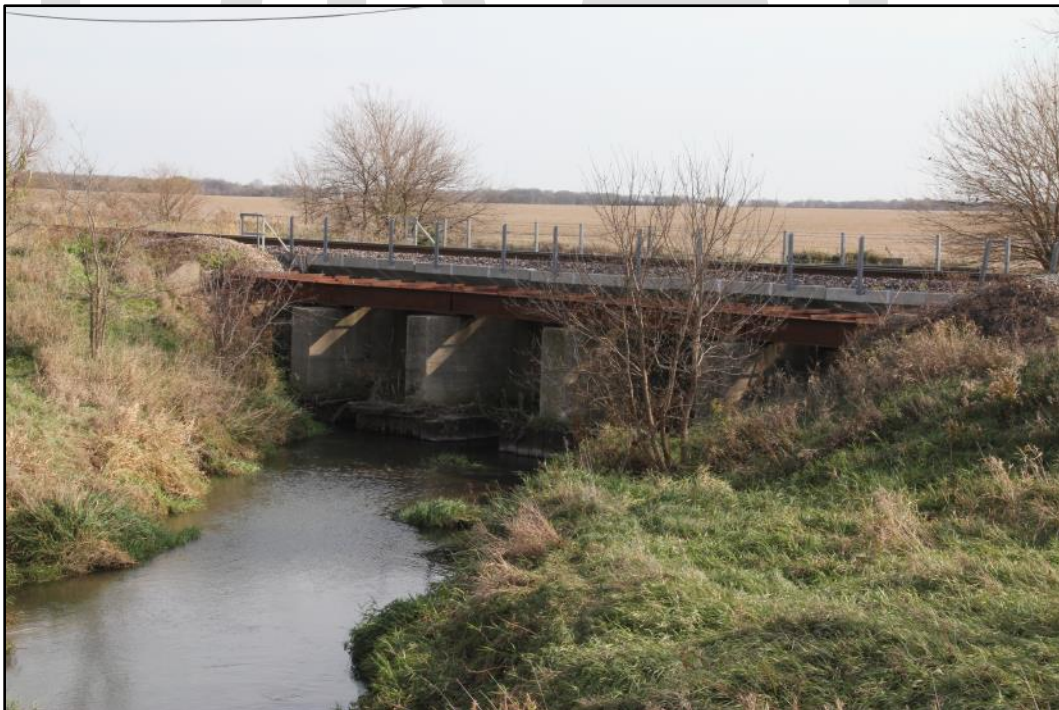
MP 098.98/Photo 7026

098.98	Eppards Pt	Livingston	C	C	Squared	Drainage	192?	Y	Y	Current rehabilitation – <a href="#">Photo 7026</a>
100.20	Pike	Livingston	B	C/SL	P & B	Root Ck	--	N	Y	Modern rehabilitation – <a href="#">Photo 7027</a>

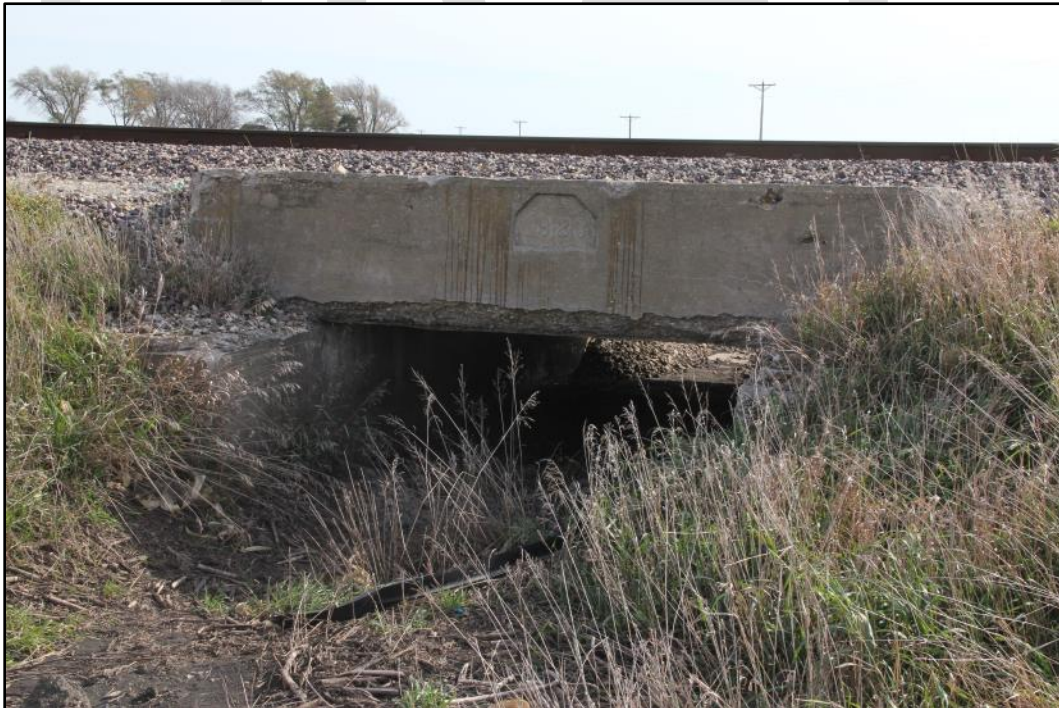
MP 100.85/Photo 7028

100.85	Pike	Livingston	B	C	P & B		1923	Y	Y	Modern rehabilitation (aka MP 100.90?) – <a href="#">Photos 7028, 7029</a>
102.70	Chenoa	Livingston	C							No data received

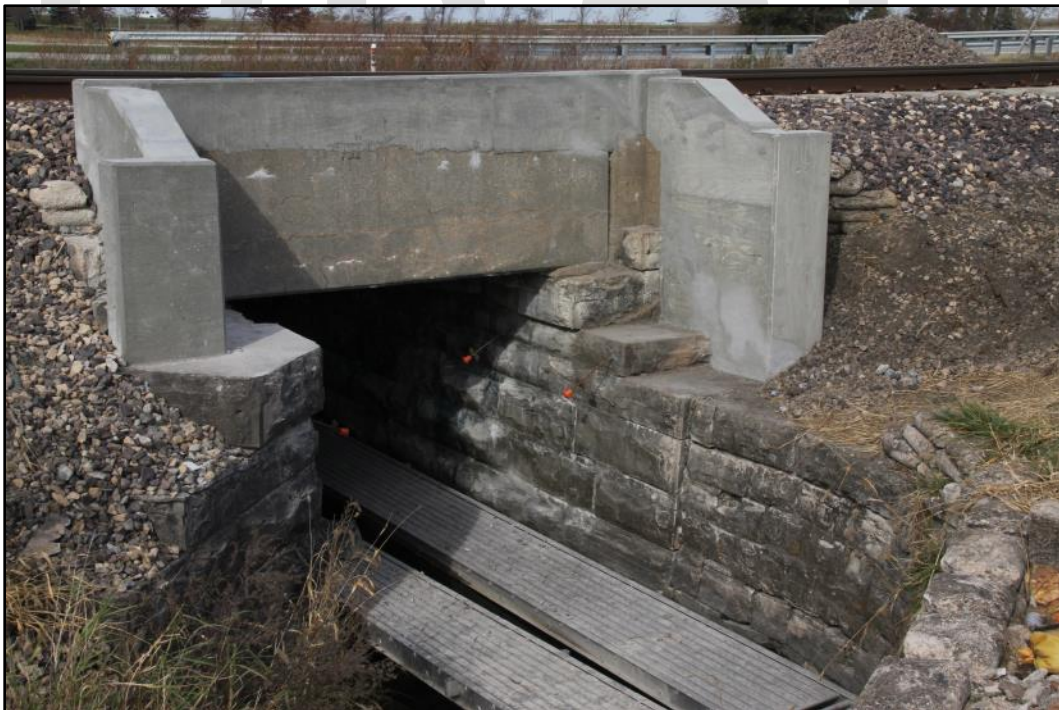
MP 108.50/Photo 7031

108.50	Lexington	McLean	B	C/SL	P & B	Turkey Ck	--	Y	Y	Modern rehabilitation in progress (aka MP 108.47?) – <a href="#">Photo 7031</a>
109.00	Lexington	McLean	C	C	P & B	Drainage	--	N	Y	Illustrates 1 period of stone construction and 2 periods of concrete construction – <a href="#">Photo 7032</a>

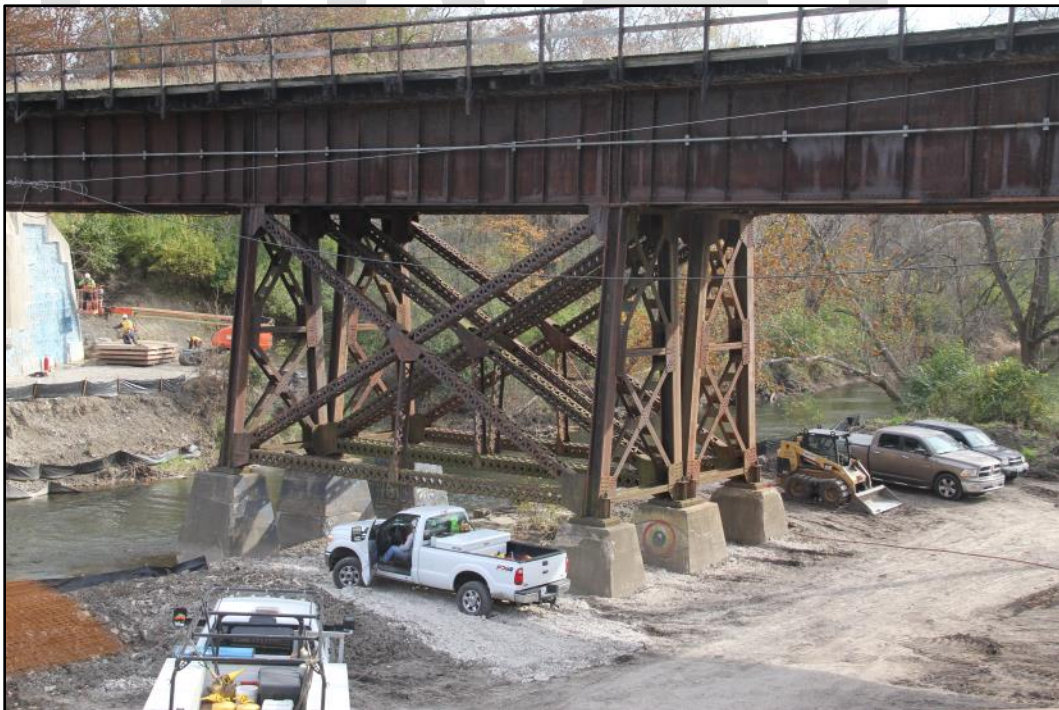
MP 111.20/Photo 7034

111.20	Lexington	McLean	B	SL	P & B	Makin Rvr	--	Y	Y	Modern rehabilitation in progress – <a href="#">Photos 7034, 7035</a>
112.20	Money Ck	McLean	B	SN	Arch	Drainage	--	Y	Y	EXCEPTIONAL – <a href="#">Photos 7039, 7249</a>

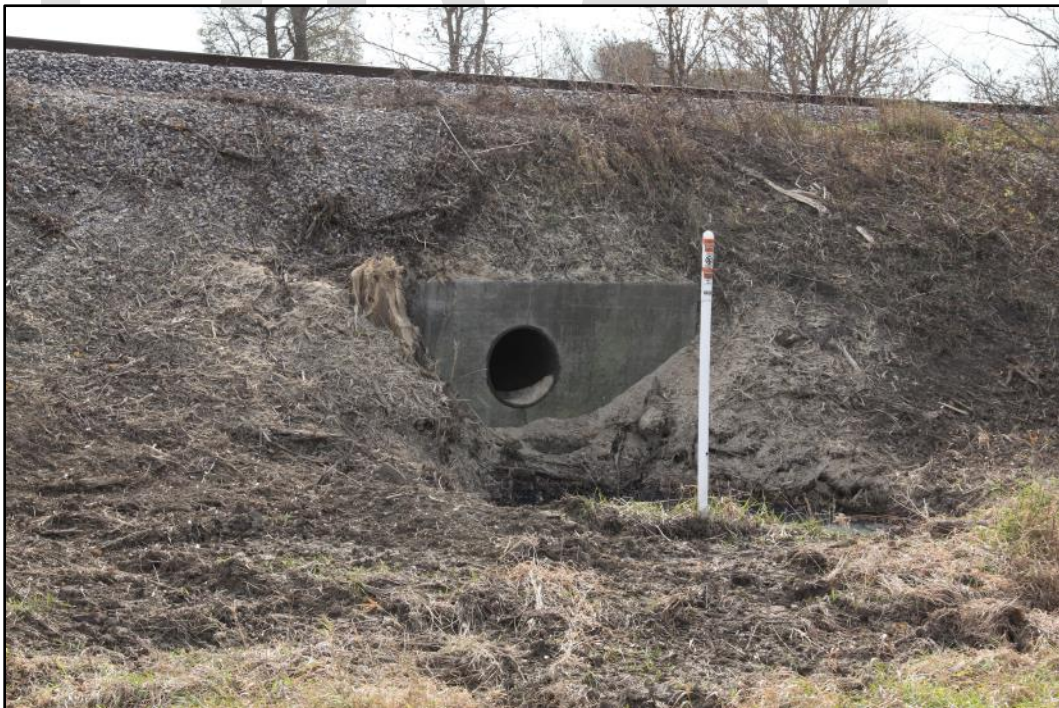
MP 114.40/Photo 7041

113.80	Money Ck	McLean	B	C/SL	P & B	Drainage	--	N	Y	Unremarkable – <a href="#">No Photo</a>
114.40	Money Ck	McLean	C	C	Arch	Drainage	--	N	Y	Unremarkable – <a href="#">Photo 7041</a>

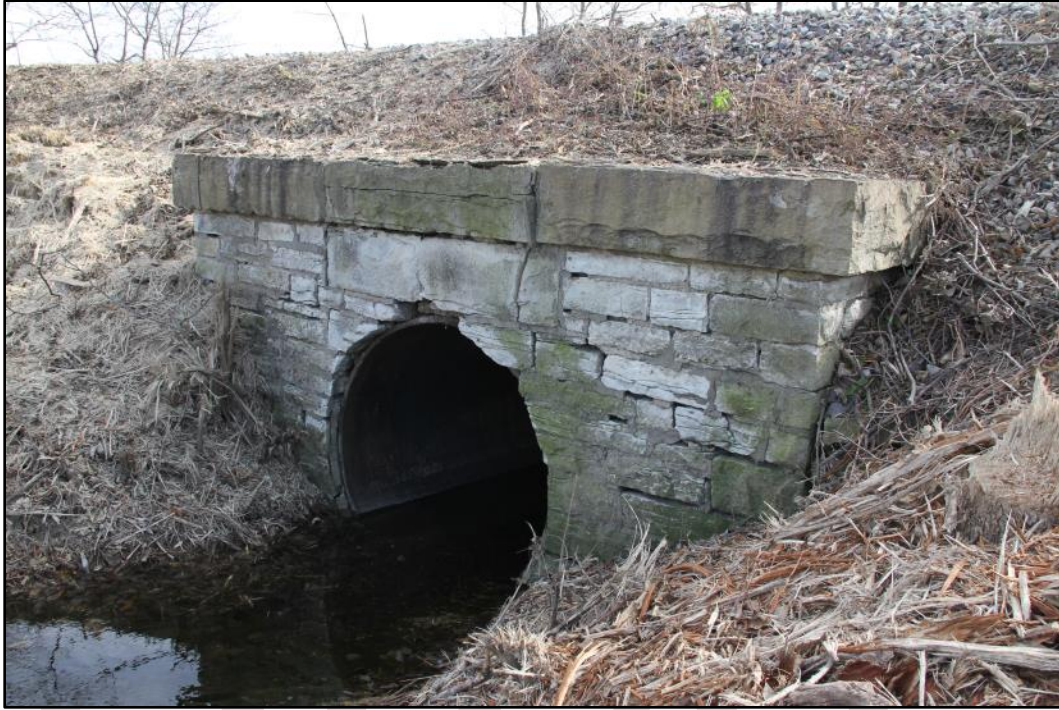
MP 116.10/Photo 7042

115.40	Money Ck	McLean	C	SN/CI	Tube	Drainage	--	Y	N	Unremarkable. Fair integrity
116.10	Money Ck	McLean	C	SN/CI	Tube	Drainage	--	Y	Y	Unremarkable – <a href="#">Photo 7042</a>

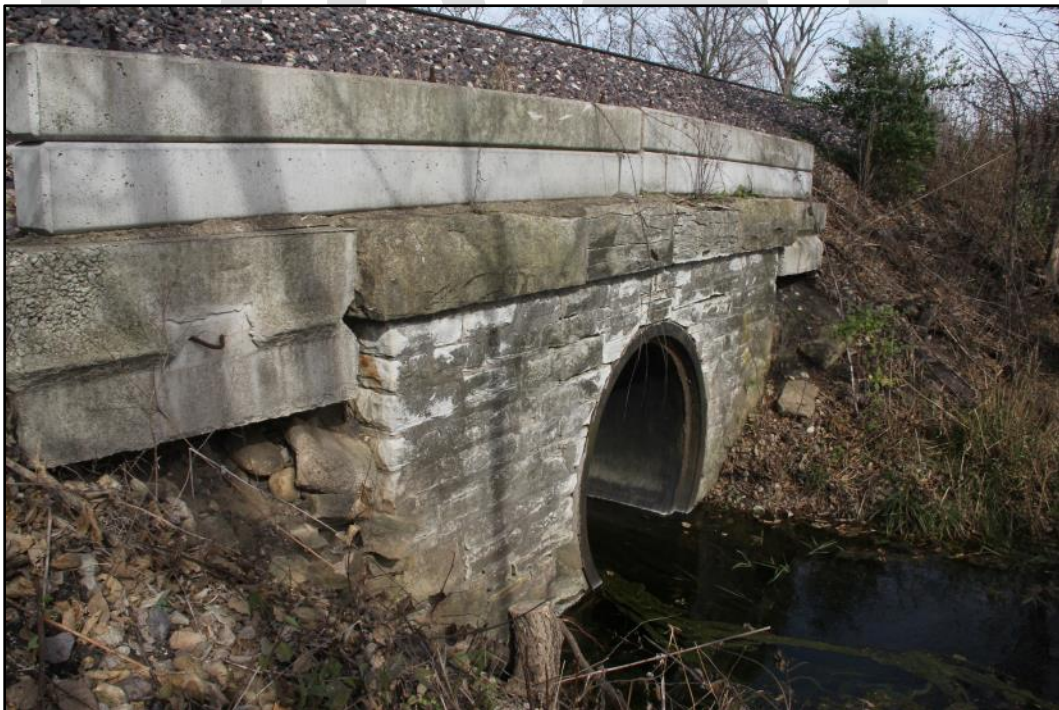
MP 116.99/Photo 7045

116.99	Money Ck	McLean	C	SN/CI	Tube	Drainage	--	Y	Y	Unremarkable – <a href="#">Photos 7045, 7046</a>
117.30	Towanda	McLean	B	SN/C	P & B (2 spans)	Money Ck	--	N	Y	Modern rehabilitation – <a href="#">Photo 7047</a>

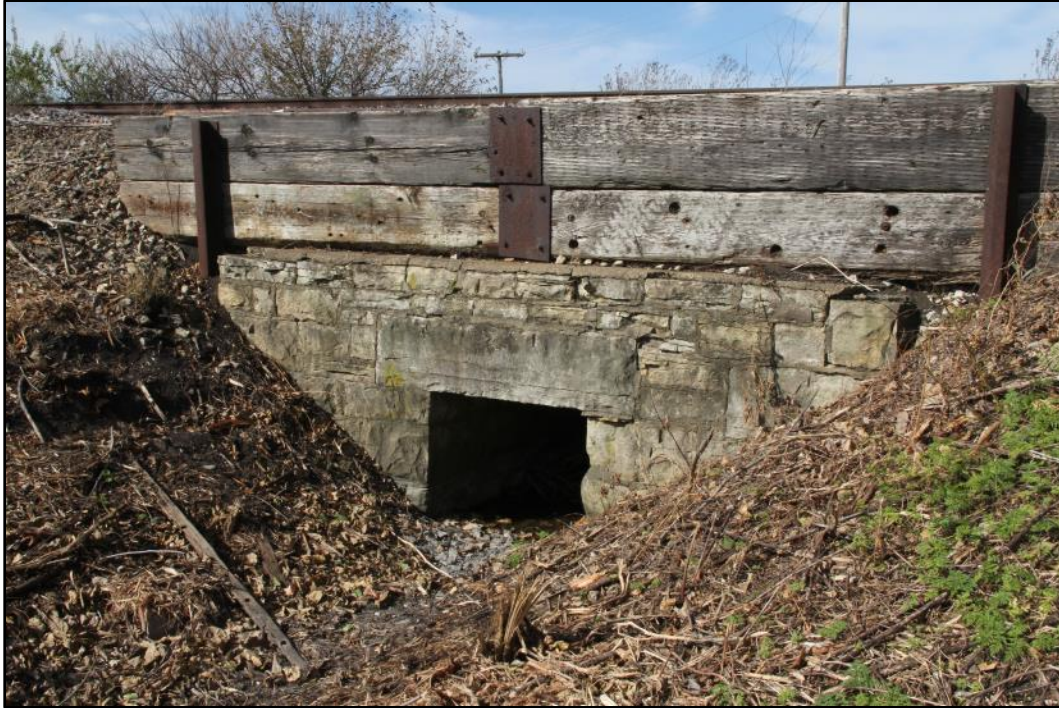
MP 118.60/Photo 7048

118.60	Towanda	McLean	C	SN	Squared	Drainage	--	Y	Y	Stonework on both sides differs. Good integrity – <a href="#">Photo 7048, 7049</a>
119.74	Towanda	McLean	C	SN/CI	Tube	Drainage	--	Y	N	Unremarkable. Overgrown.

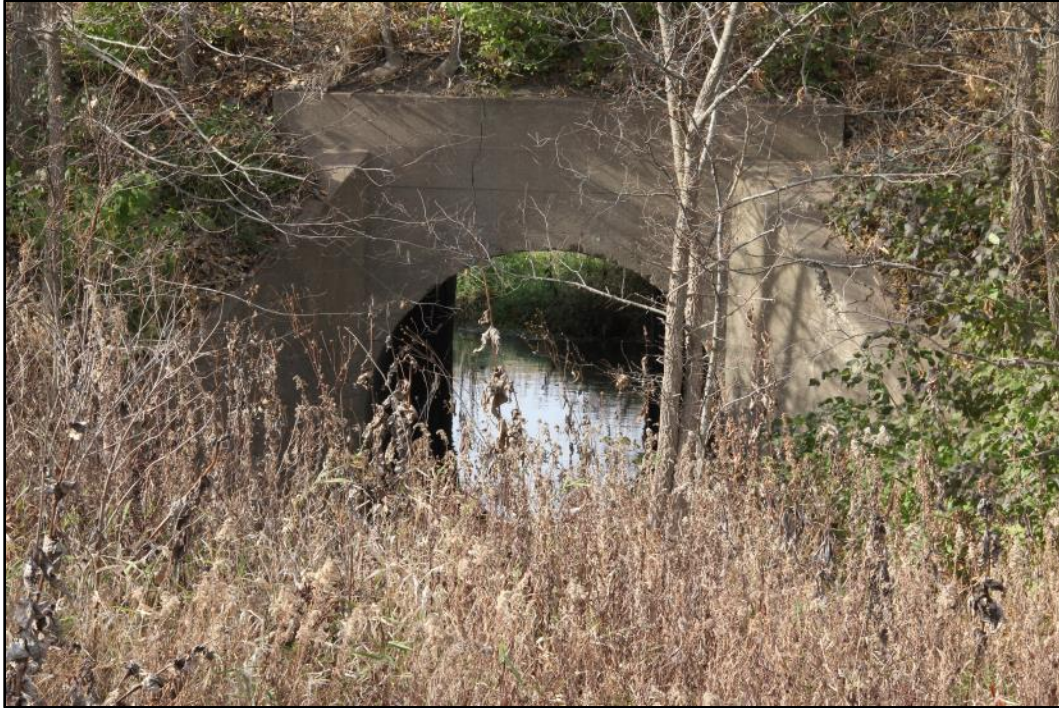
MP 134.60/Photo 7070

134.60	Funks Grove	McLean	C	C	Arch	Drainage	--	Y	Y	Unremarkable. Extension 1 side – Photos 7070, 7071
134.89	Funks Grove	McLean	C							No data received

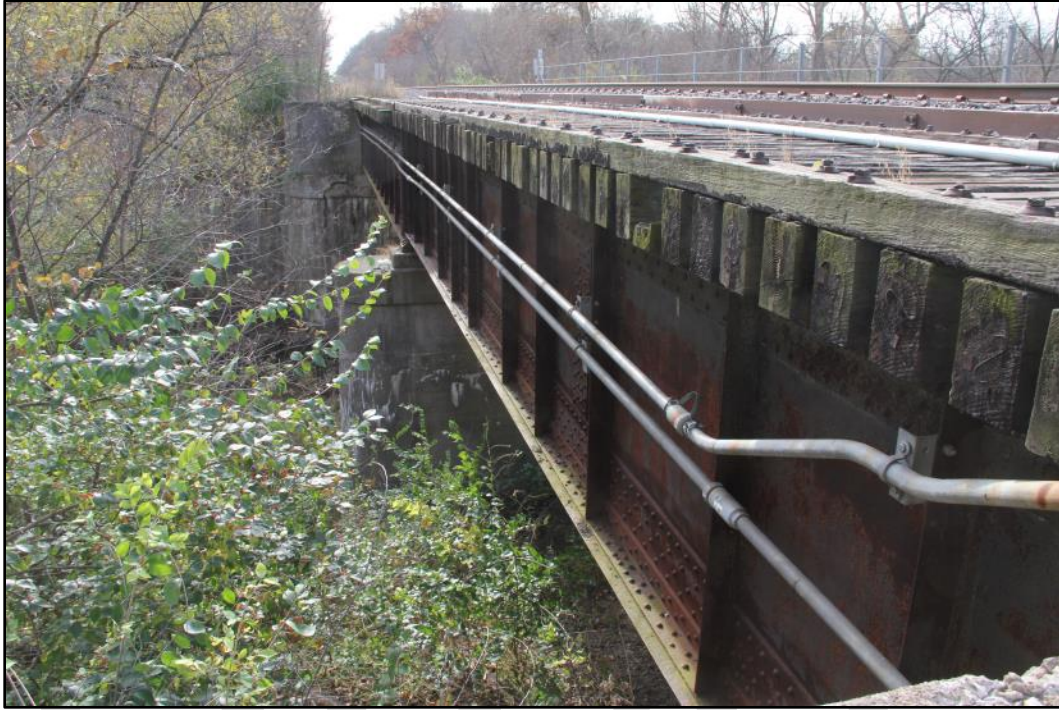
MP 136.50/Photo 7073

136.50	Funks Grove	McLean	B	C/SL	P & B	Timber Ck	--	N	Y	Unremarkable – Photos 7073, 7074
137.70	Funks Grove	McLean	C	C	Tube (?)	Drainage	--	Y	Y	Unremarkable – Photo 7077

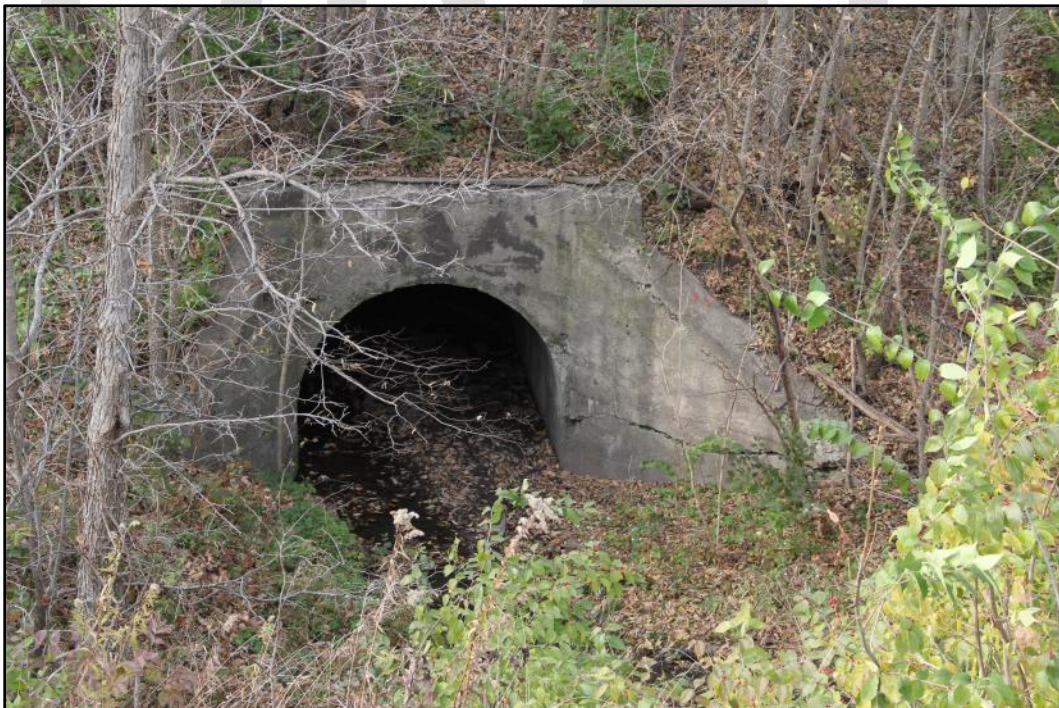
MP 137.90/Photo 7078

137.90	Funks Grove	McLean	C	C	Arch (?)	Drainage	--	Y	Y	Unremarkable – Photo 7078
138.50	Funks Grove	McLean	C							No data received
139.70	Mt Hope	McLean	C							No data received. Not found by PB

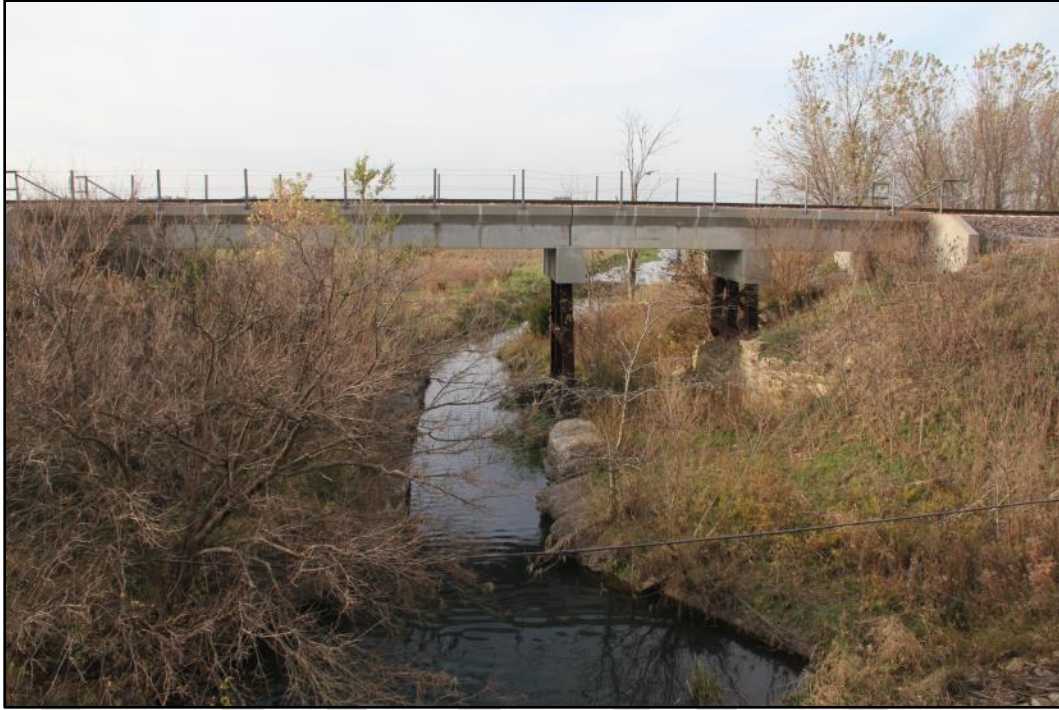
MP 144.10/Photo 7082

144.10	Mt Hope	McLean	B	SN/SL/C	P & B	Clear Ck	--	N	Y	Modern rehabilitation – Photo 7082
144.70	Atlanta	Logan	C							No data received
145.00	Atlanta	Logan	C	C/CI	Tube	Drainage	--	Y	N	Large retaining wall

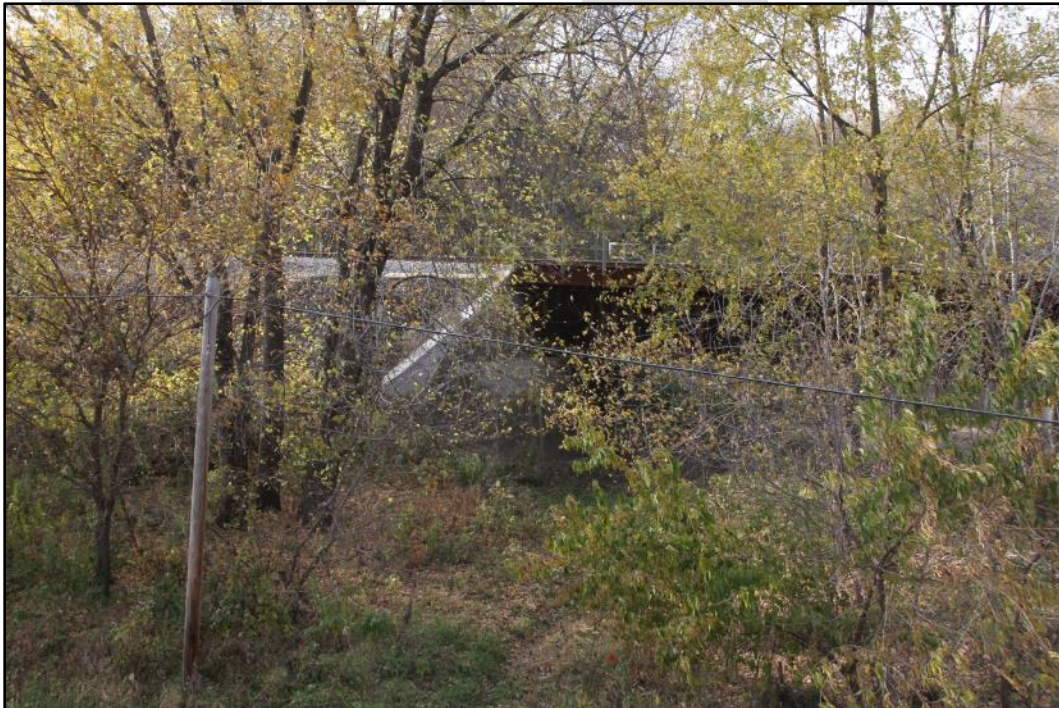
MP 149.50/Photo 7084

149.50	E Lincoln	Logan	B	C/SL	P & B (2)	Kickapoo Ck	--	N	Y	Modern rehabilitation – Photo 7084
149.90	E Lincoln	Logan	C	C	Arch	Drainage	--	Y	N	Unremarkable

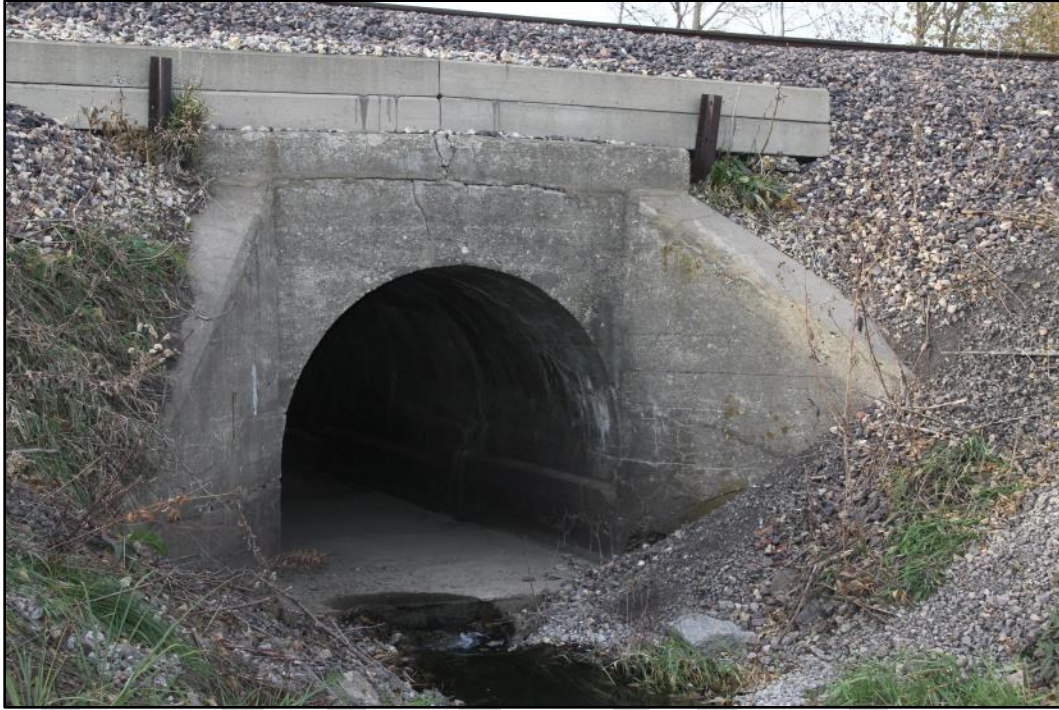
MP 152.70/Photo 7085

150.80	E Lincoln	Logan	C	C/CI	Tube	Drainage	--	Y	N	Unremarkable. Altered
151.50	E Lincoln	Logan	C	CI	Tube	Drainage	--	Y	N	Unremarkable
152.70	E Lincoln	Logan	C	C	Arch	Drainage	--	Y	Y	Unremarkable – Photos 7085, 7086

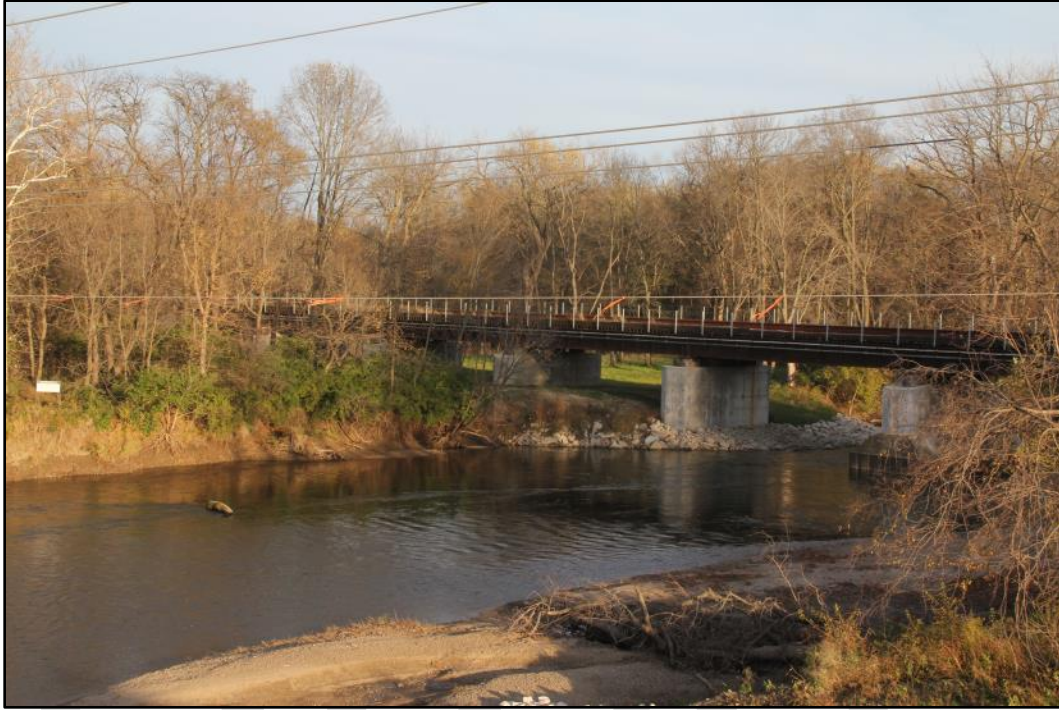
MP 158.10/Photo 7091

157.60	Broadwell	Logan	C	C	Tube	Drainage	--	Y	N	Unremarkable
157.70	Broadwell	Logan	B							No data received
158.10	Broadwell	Logan	B	C/SL	P & B	Salt Ck	--	N	Y	Modern rehabilitation – Photo 7091

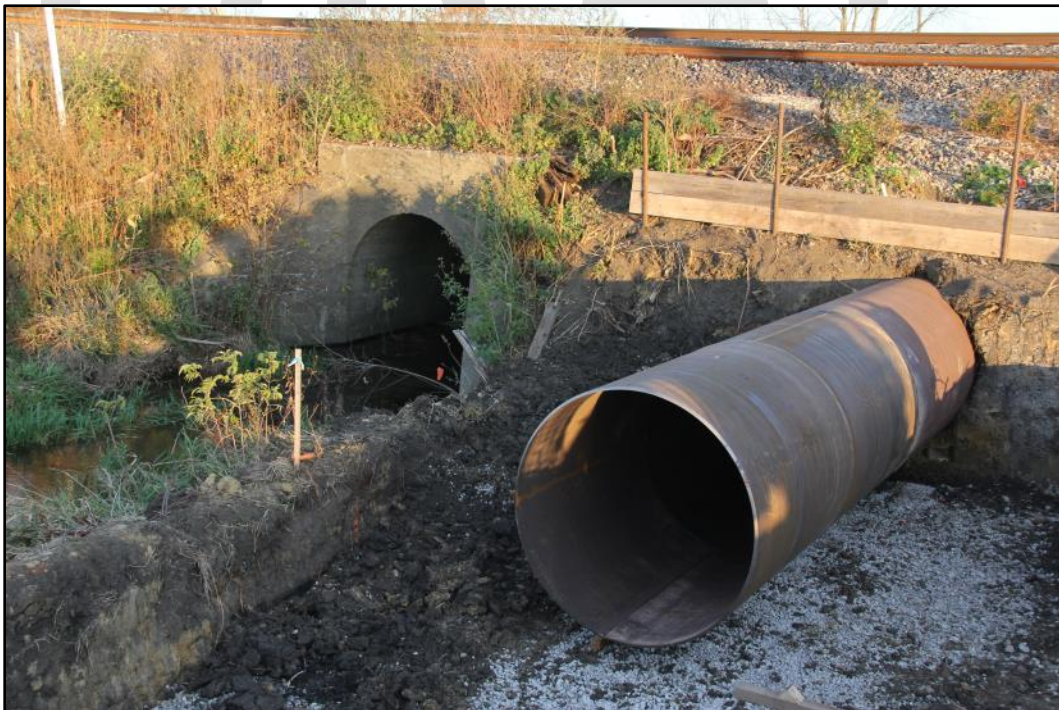
MP 162.70/Photo 7094

159.50	Broadwell	Logan	C	??	Tube	Drainage	--	Y	N	Unremarkable. Overgrown
159.90	Broadwell	Logan	C							No data received
162.70	Broadwell	Logan	C	C	Arch	Drainage	--	Y	Y	Unremarkable – Photos 7094, 7096

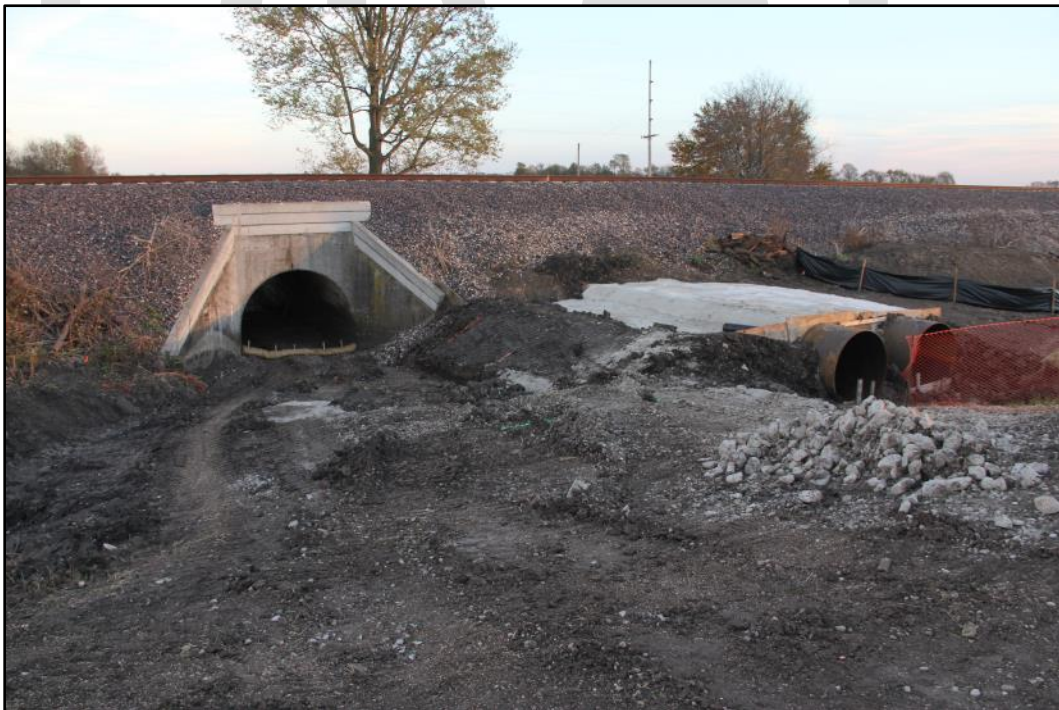
MP 163.60/Photo 7097

163.60	Broadwell	Logan	C	C/SN	Arch	Drainage	1876	Y	Y	VERY NICE. East side stone with 1876 date. West side concrete – Photos 7097, 7127
164.10	Broadwell	Logan	C	C/SN	Squared	Drainage	--	Y	N	1 side stone. 1 side concrete
