# Historic Railroad Structural Resources:

Chicago to St. Louis High Speed Rail

**IDOT Sequence #17337 & #17337A**

17 December 2014

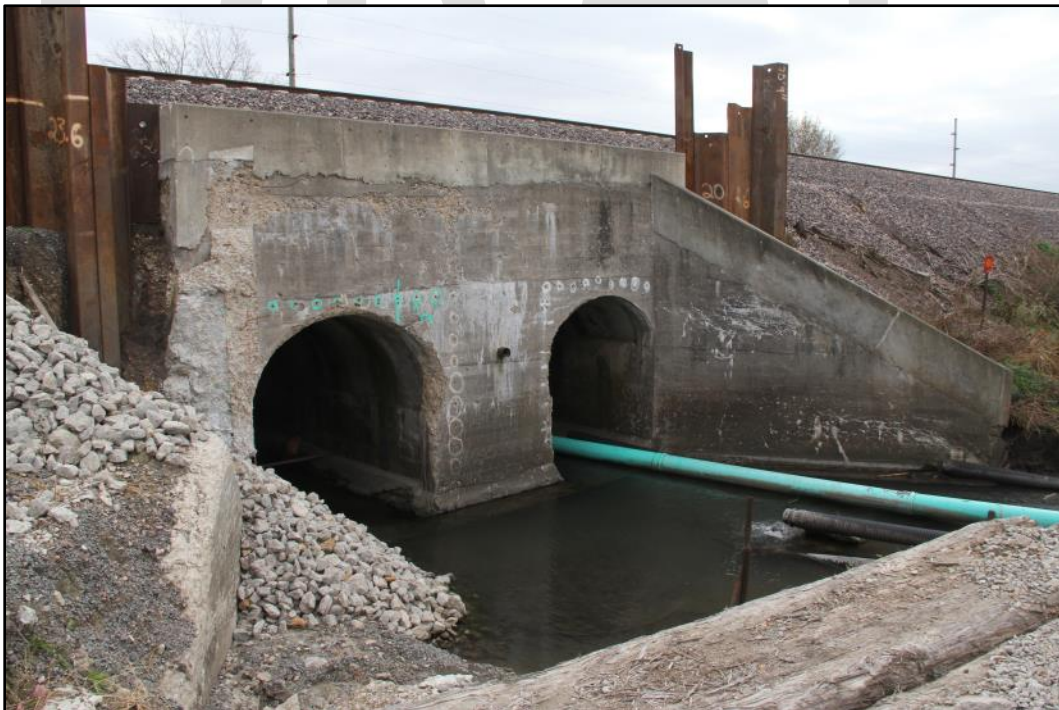
MP 165.20/Photo 7133

165.20	Broadwell	Logan	C	C	Arch (2)	Drainage	--	Y	Y	Current rehabilitation – Photo 7133
166.70	Elkhart	Logan	C	CI/CM	Tube	Drainage	--	Y	N	Unremarkable
167.25	Elkhart	Logan	C	CM/C	Tube	Drainage	--	Y	N	Unremarkable

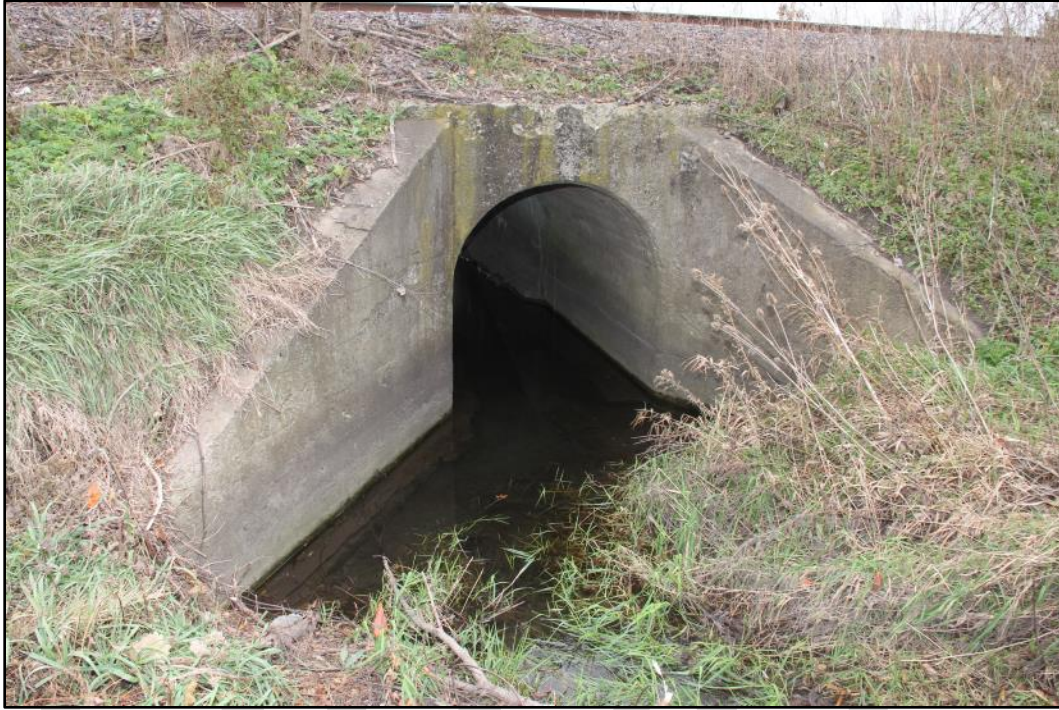
MP 172.10/Photo 7134

171.10	Williams	Sangamon	C	C/CM	Tube (2)	Drainage	--	Y	N	Unremarkable
172.10	Williams	Sangamon	C	SN/C	Arch	Drainage	--	Y	Y	Loss of integrity on stone side – Photo 7134, 7135

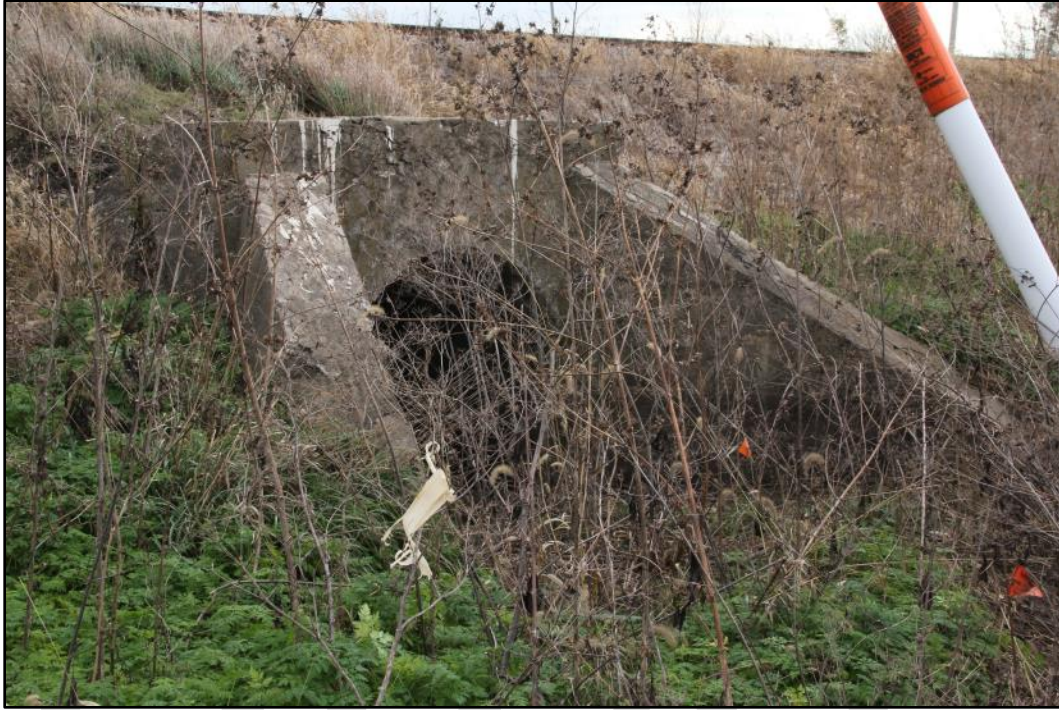
MP 172.40/Photo 7137

172.40	Williams	Sangamon	C	C	Arch	Drainage	--	Y	Y	Unremarkable – Photos 7137, 7138
175.80	Williams	Sangamon	C							No data received
176.20	Williams	Sangamon	C	C/SN	Squared	Drainage	--	Y	N	Unremarkable. Altered

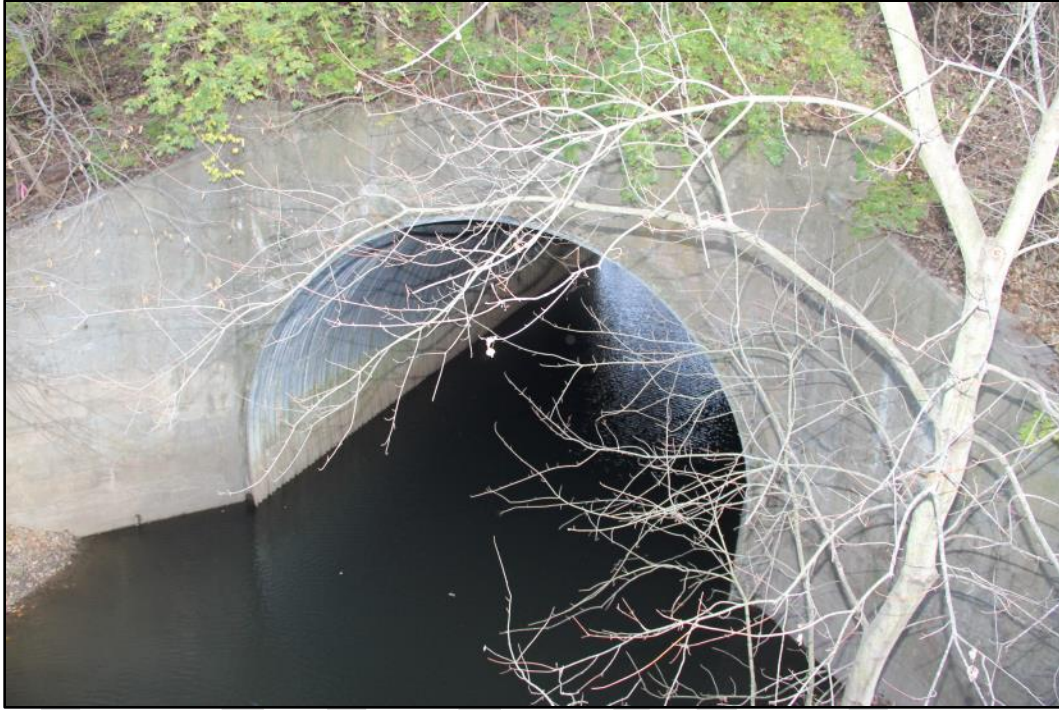
MP 176.40/Photo 7139

176.40	Williams	Sangamon	C	C/CM	Tube/Arch	Unnamed Ck	--	Y	Y	Unremarkable/Rehabilitated – Photo 7139
177.20	Williams	Sangamon	C	CI	Tube	Drainage	--	Y	N	Unremarkable. Obscured view

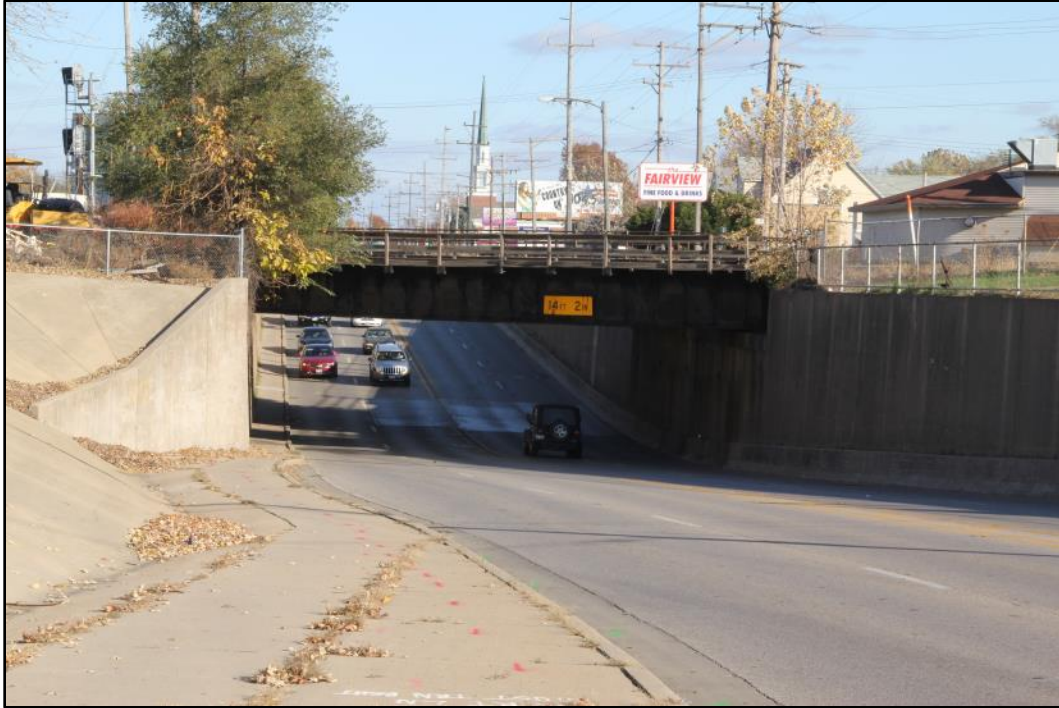
Sangamon Drive/Photo 7149

000.00	Springfield	Sangamon	B	C/SL	P & B	Sangamon Av	--	N	Y	Unremarkable – Photos 7149, 7150
000.00	Springfield	Sangamon	B	C/SL	P & B	9 <sup>th</sup> St	--	N	Y	(American Bridge Co.) Unremarkable – Photos 7152, 7155

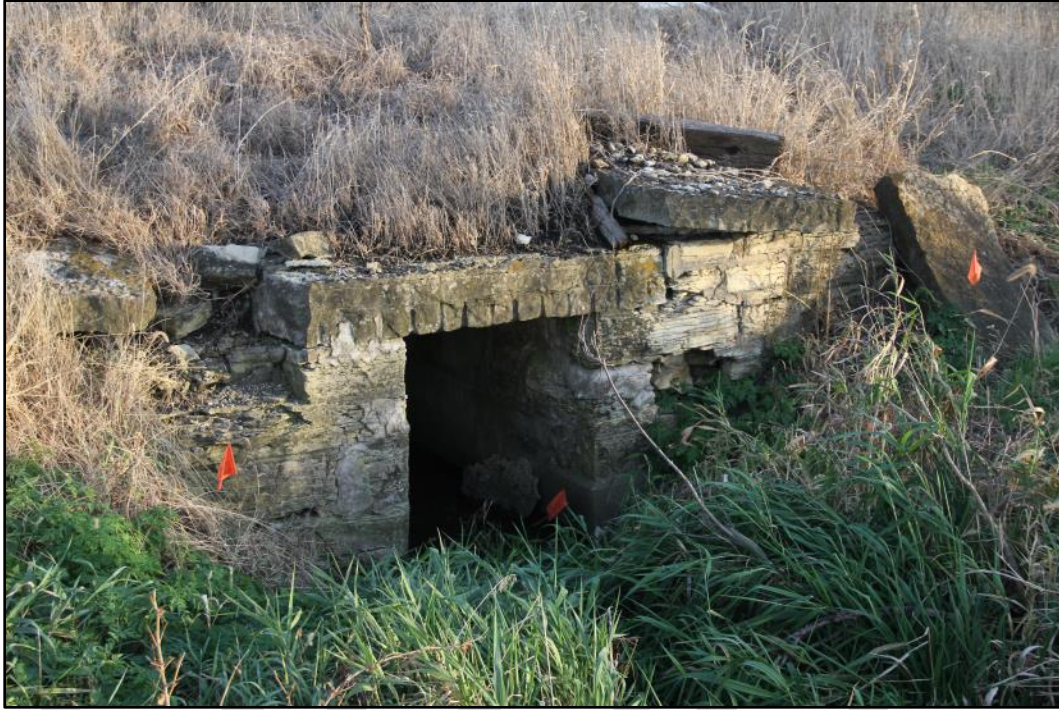
MP 191.65/Photo 7169

191.15	Woodside	Sangamon	C	C/CI/SN	Squared/Tube	Drainage	--	Y	N	Unremarkable. Amalgamation
191.65	Woodside	Sangamon	C	SN/C	Squared/Tube	Drainage	--	Y	Y	One side stone, one side concrete – Photos 7169, 7170

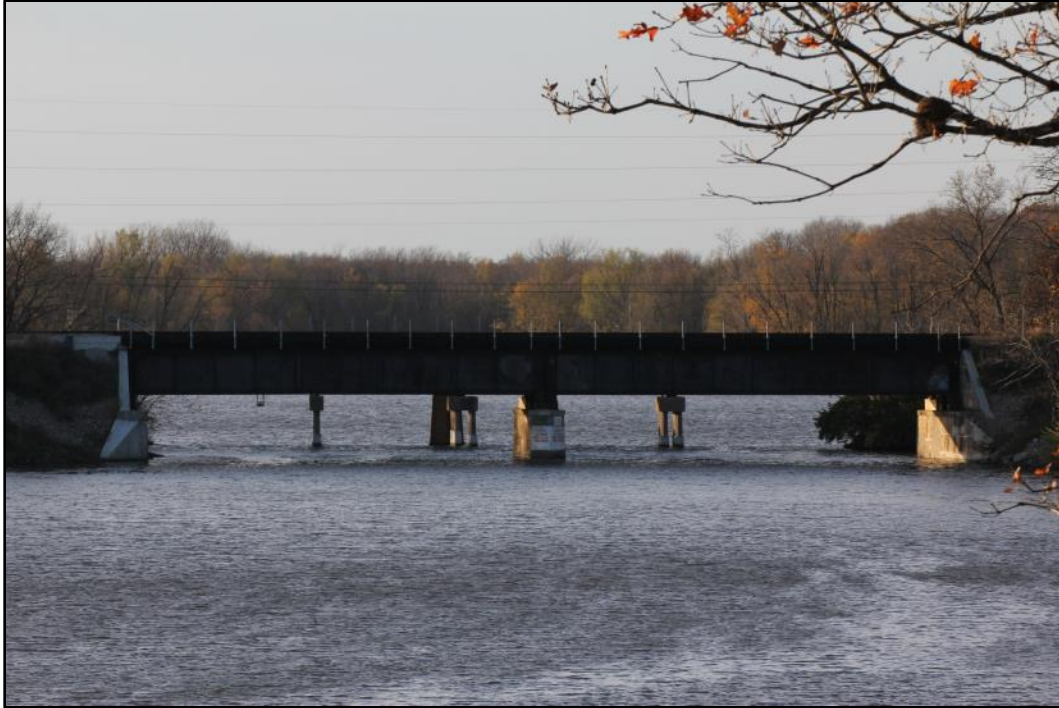
MP 192.10/Photo 7168

192.10	Woodside	Sangamon	B	C/SL	P & B (2 spans)	Springfield Lk			Y	Unremarkable – Photo 7168
192.90	Chatham	Sangamon	C							No data received
193.05	Chatham	Sangamon	C							No data received

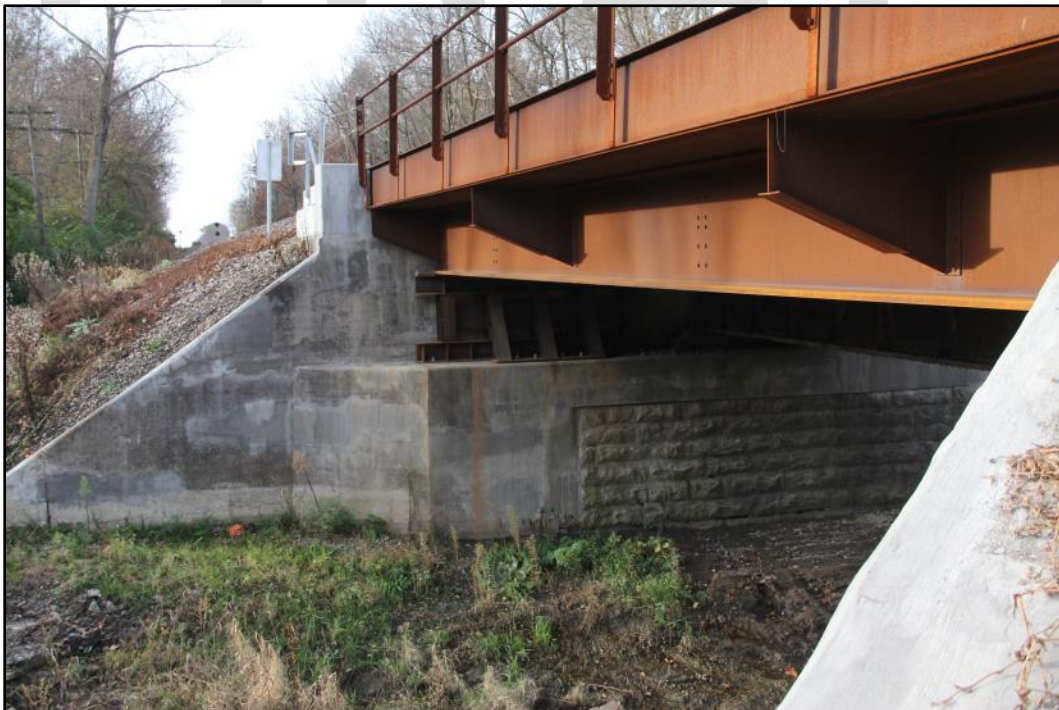
MP 197.72/Photo 7173

197.72	Chatham	Sangamon	B	SN/C/SL	P & B	Panther Ck	--	Y	Y	Distinct appearance of construction in 1870s, 1920s & 2010s – Photos 7173, 7174
199.20	Chatham	Sangamon	C	SN/CI	Tube	Drainage	--	Y	N	Unremarkable

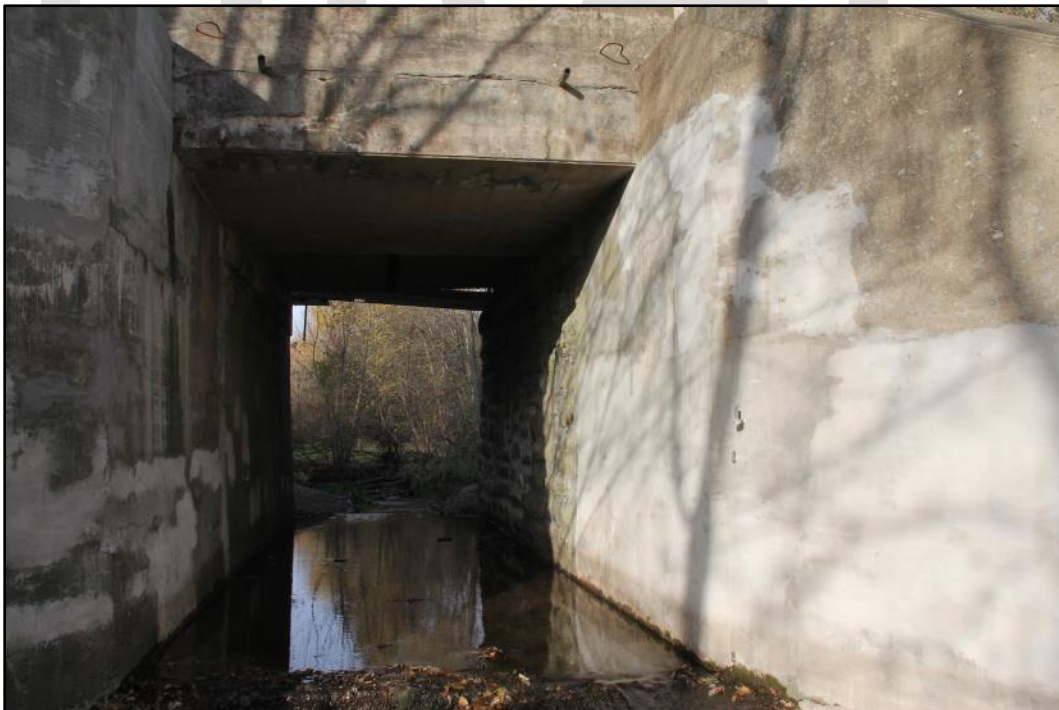
MP 201.64/Photo 7181

199.40	Auburn	Sangamon	C	SN/CI	Tube	Drainage	--	Y	N	Unremarkable
200.15	Auburn	Sangamon	C	SN/CI	Tube	Drainage	--	Y	N	Stone wall 1 side only
201.64	Auburn	Sangamon	B	SN/C	P & B	Sugar Ck	--	Y	Y	Under reconstruction/rehabilitation – Photos 7181, 7183

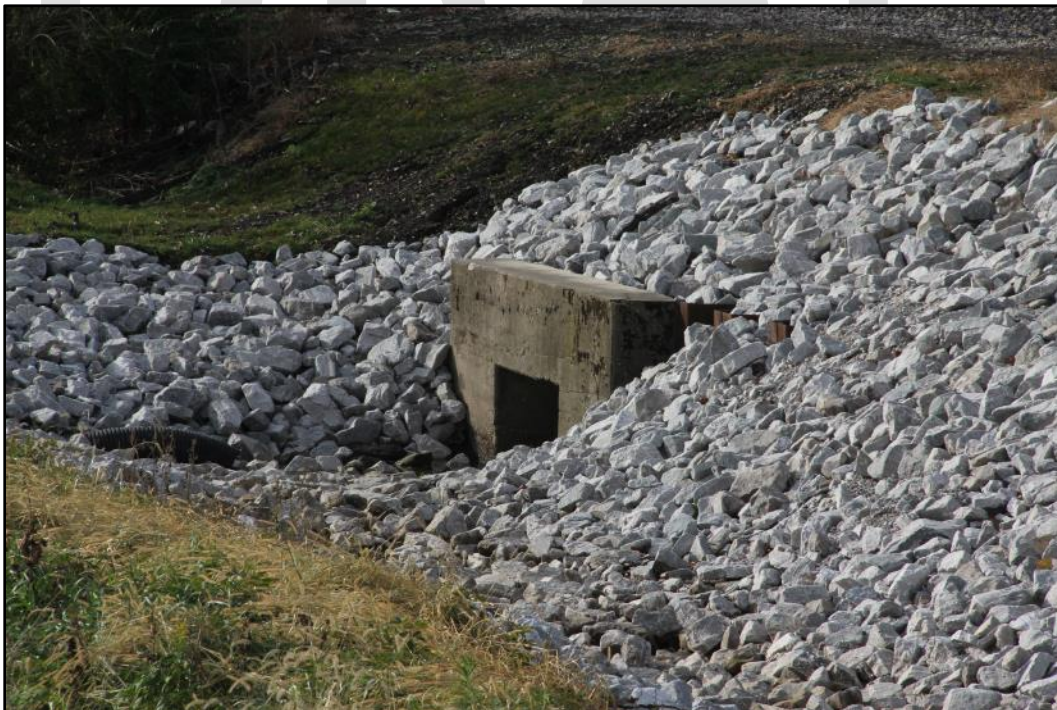
MP 204.43/Photo 7184

203.60	Auburn	Sangamon	C							No data received
203.91	Auburn	Sangamon	C							No data received
204.43	Auburn	Sangamon	C	C	Squared	Drainage	--	Y	Y	Unremarkable – Photos 7184, 7185

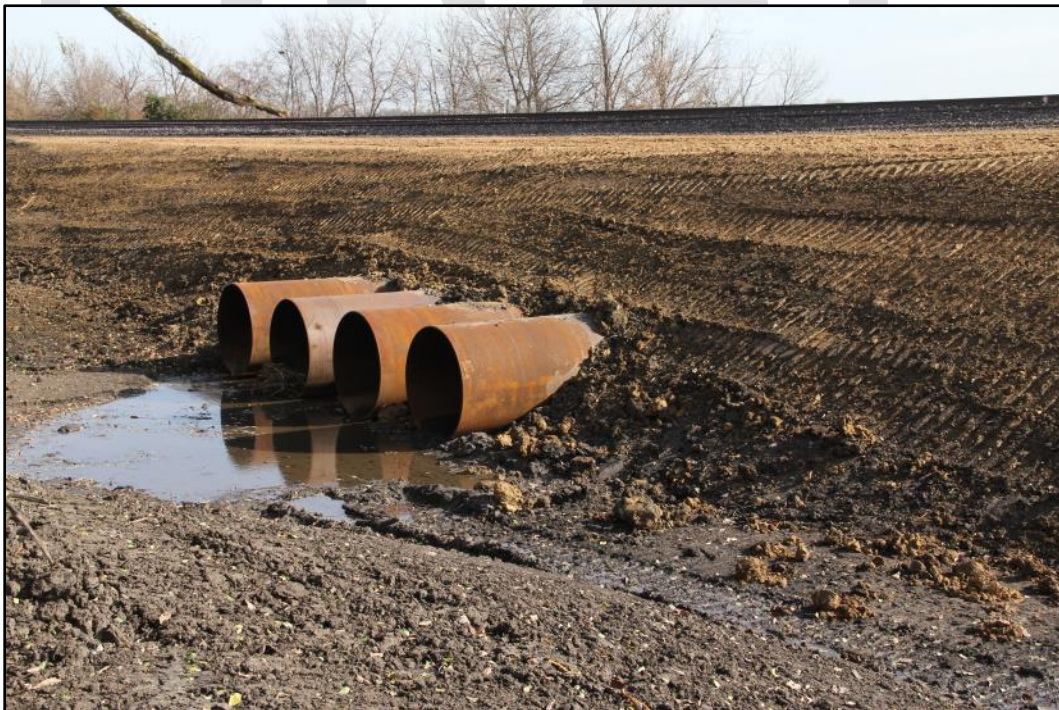
MP 214.00/Photo 7189

213.30	Nilwood	Macoupin	C	C	Arch	Drainage	--	Y	N	Unremarkable
214.00	Nilwood	Macoupin	C	C/SN	Arch	Drainage	2014	Y	Y	Arch now gone. 4 modern tubes – Photo 7189

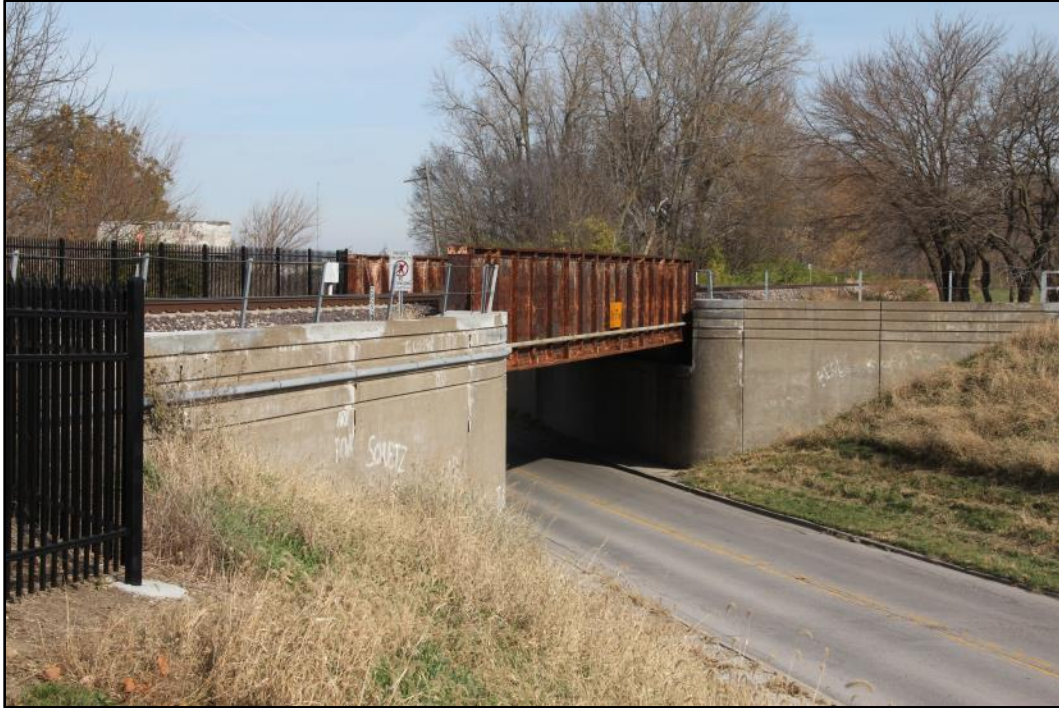
MP 222.53 (IL 4)/Photo 7190

221.89	Carlinville	Macoupin	C	C/CI	Tube	Drainage	--	Y	N	Unremarkable
222.53	Carlinville	Macoupin	B	C/SL	P & B	IL 4	--	N	Y	Unremarkable – Photo 7190
222.89	Carlinville	Macoupin	C	C/CI	Tube	Drainage	--	Y	N	Unremarkable

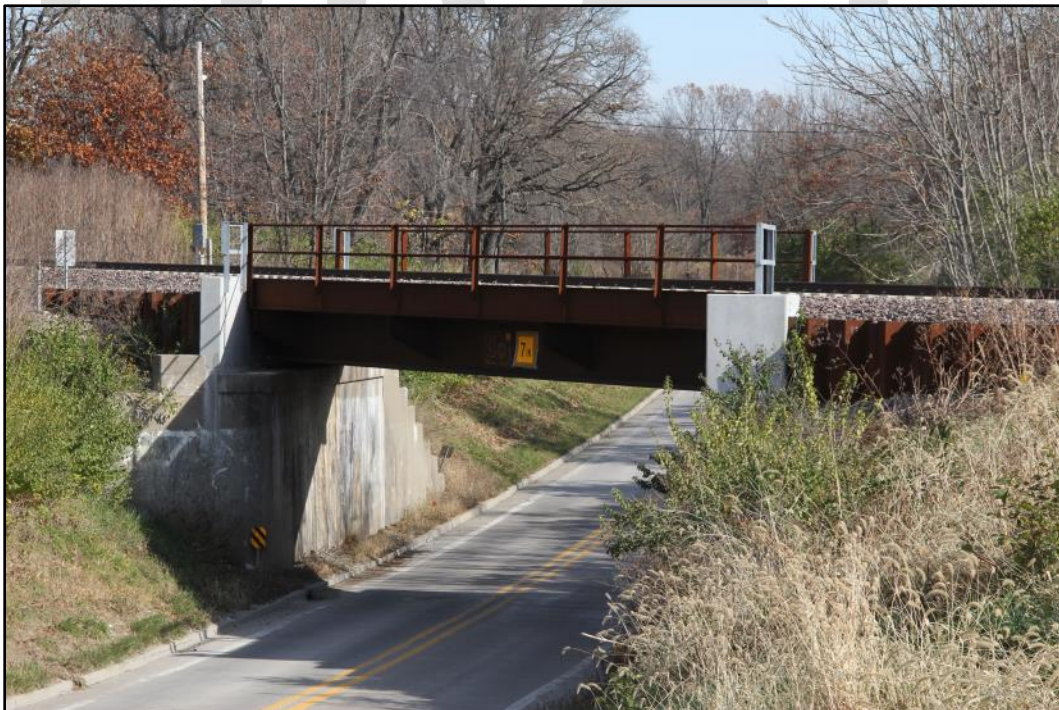
MP 227.30 (Alton Road)/Photo 7193

226.90	Polk	Macoupin	C	SN	Squared	Drainage	--	Y	N	Unremarkable. Partially buried
227.30	Polk	Macoupin	B	C/SL	P & B	Alton Rd	--	N	Y	Unremarkable. Rehabilitated – <a href="#">Photo 7193</a>

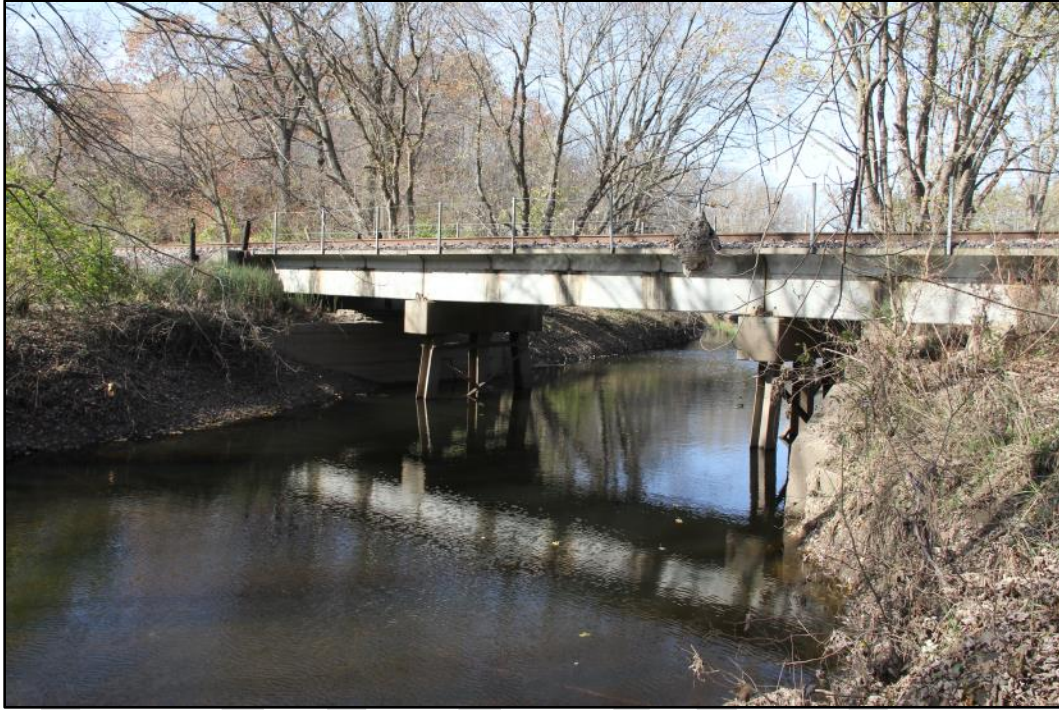
MP 229.41/Photo 7195

229.10	Polk	Macoupin	C							No data received
229.41	Polk	Macoupin	B	C/SL	P & B	Hurricane Ck	--	Y	Y	Modern rehabilitation – <a href="#">Photo 7195</a>
229.80	Polk	Macoupin	C							No data received

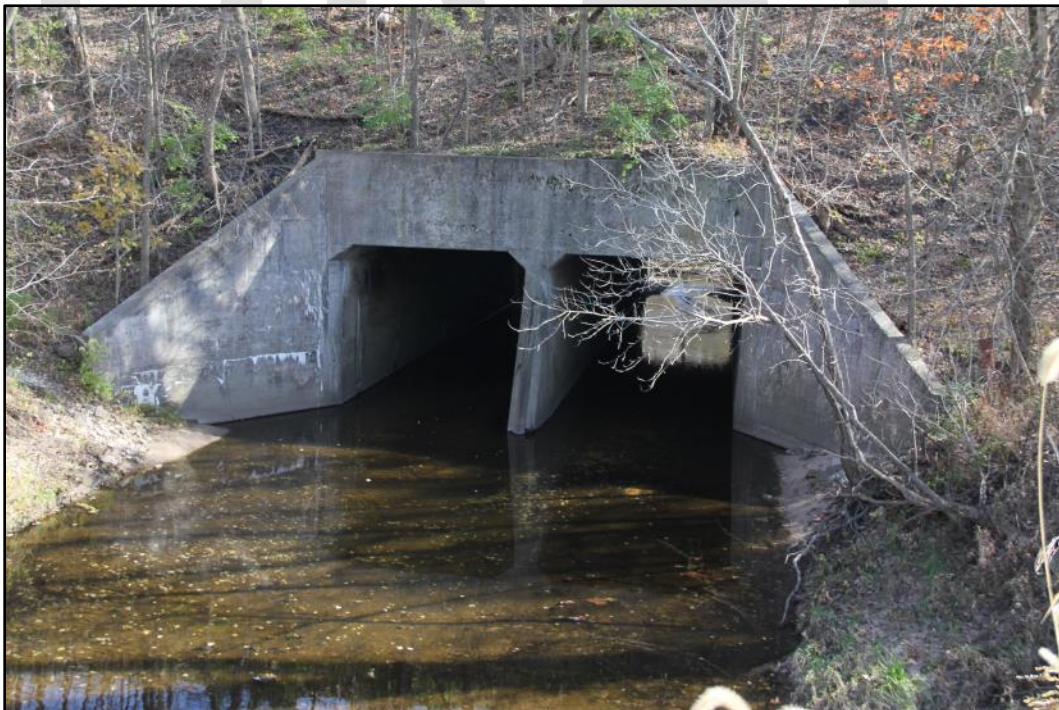
MP235.15/Photo 7198

235.15	Hillyard	Macoupin	C	C	Squared (2)	Drainage	---	Y	Y	Unremarkable – <a href="#">Photo 7198</a>
235.50	Hillyard	Macoupin	C	C	Tube	Drainage	---	Y	N	Unremarkable

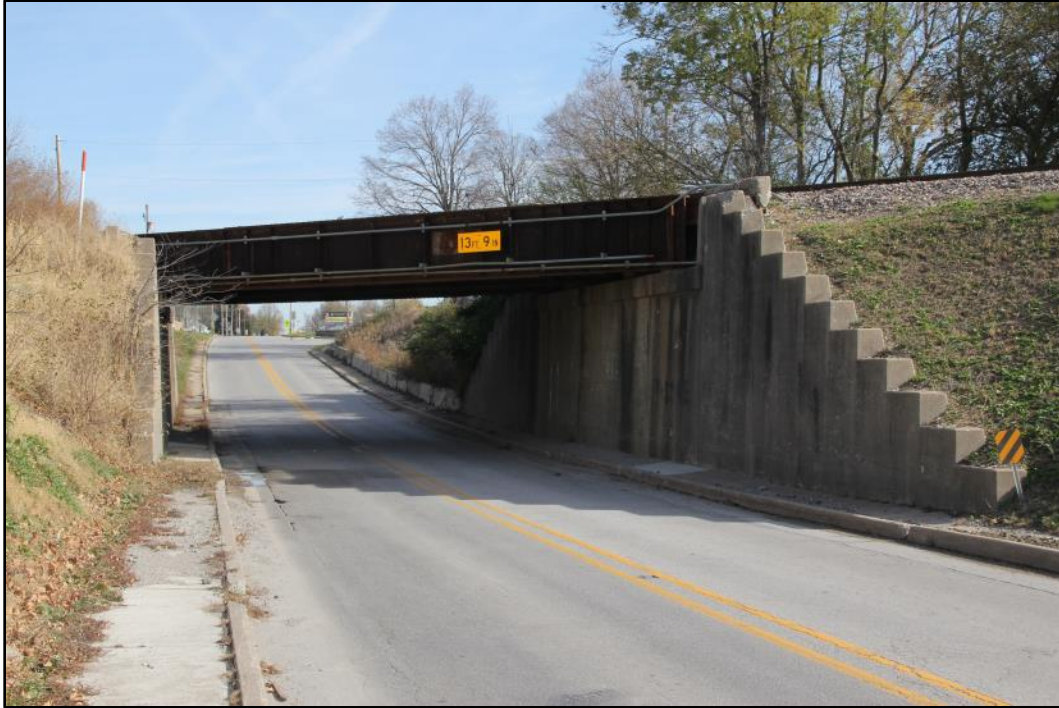
Railroad Street/Photo 7200

238.32	Shipman	Macoupin	C	C	Squared/Tube	Drainage	---	Y	N	Unremarkable
000.00	Shipman	Macoupin	B	C/SL	P & B	Railroad St	---	N	Y	Unremarkable – <a href="#">Photo 7200</a>

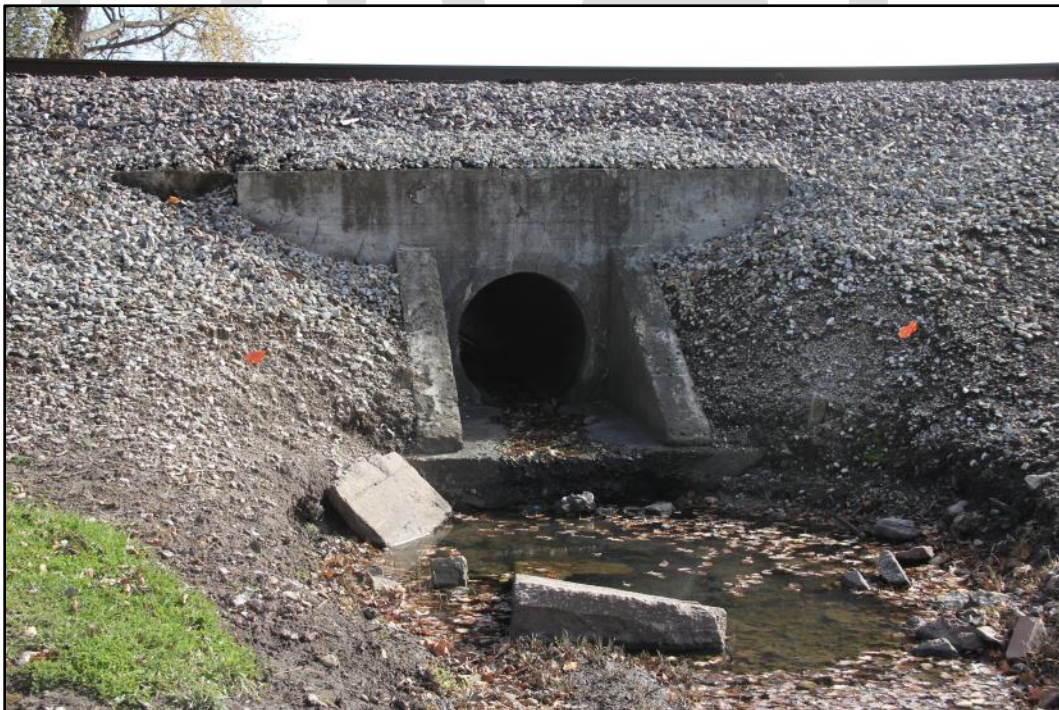
MP 238.75/Photo 7203

238.75	Shipman	Macoupin	C	C/CI	Tube	Drainage	---	Y	Y	Unremarkable – <a href="#">Photos 7203, 7204, 7205</a>
239.40	Shipman	Macoupin	C	C	Squared	Drainage	---	Y	N	Unremarkable

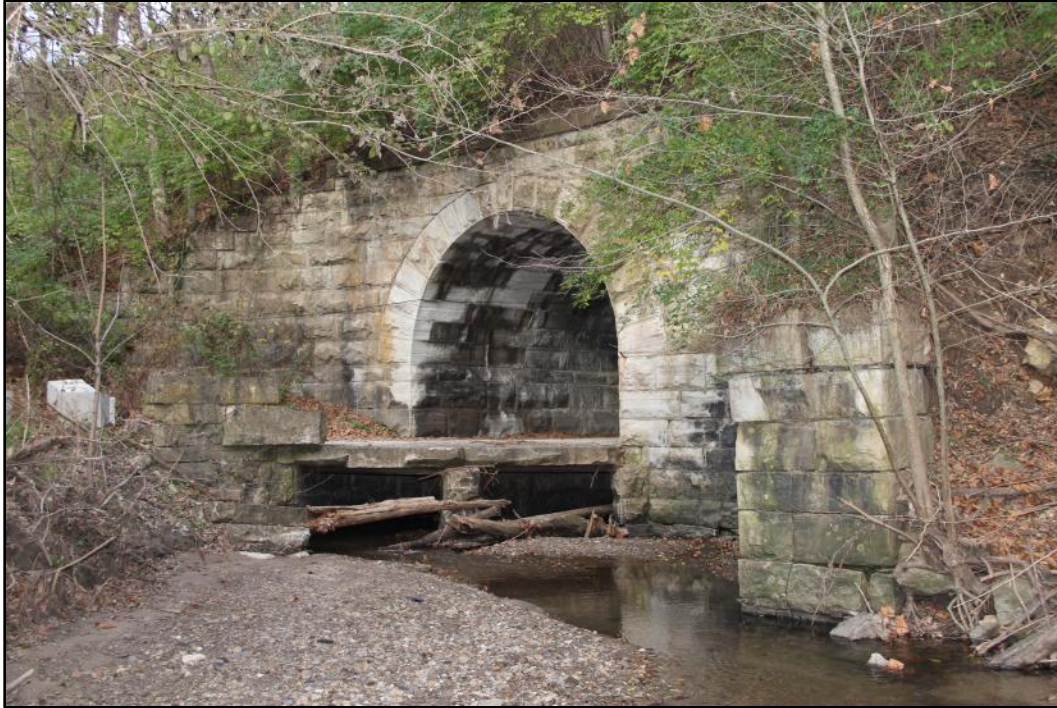
MP 254.30/Photo 7219

253.99	Godfrey	Madison	C	SN	Tube(?)	Drainage	---	Y	N	Flooded. Overgrown
254.30	Godfrey	Madison	C	SN	Arch	Black Ck	---	Y	Y	IL HAER Documentation - Photo 7219

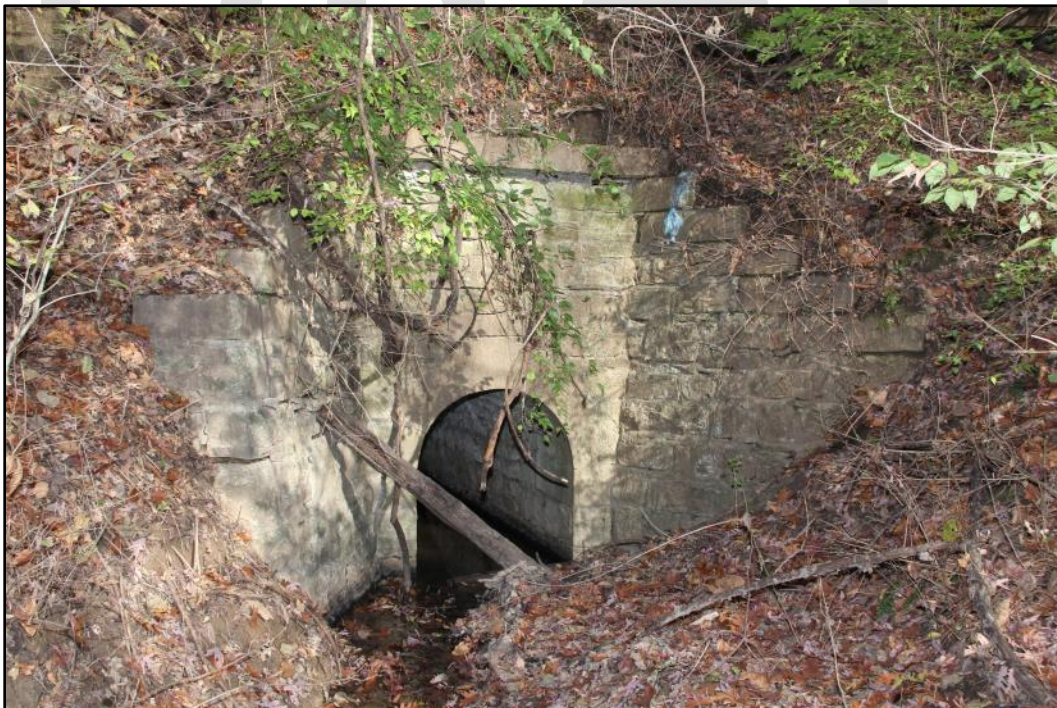
MP 254.65/Photo 7207

254.65	Alton	Madison	C	SN	Arch	Drainage	---	Y	Y	VERY NICE - Photos 7207, 7215
254.75	Alton	Madison	C	SN						No data received
254.95	Alton	Madison	C	SN	Squared	Drainage	---	Y	N	Unremarkable

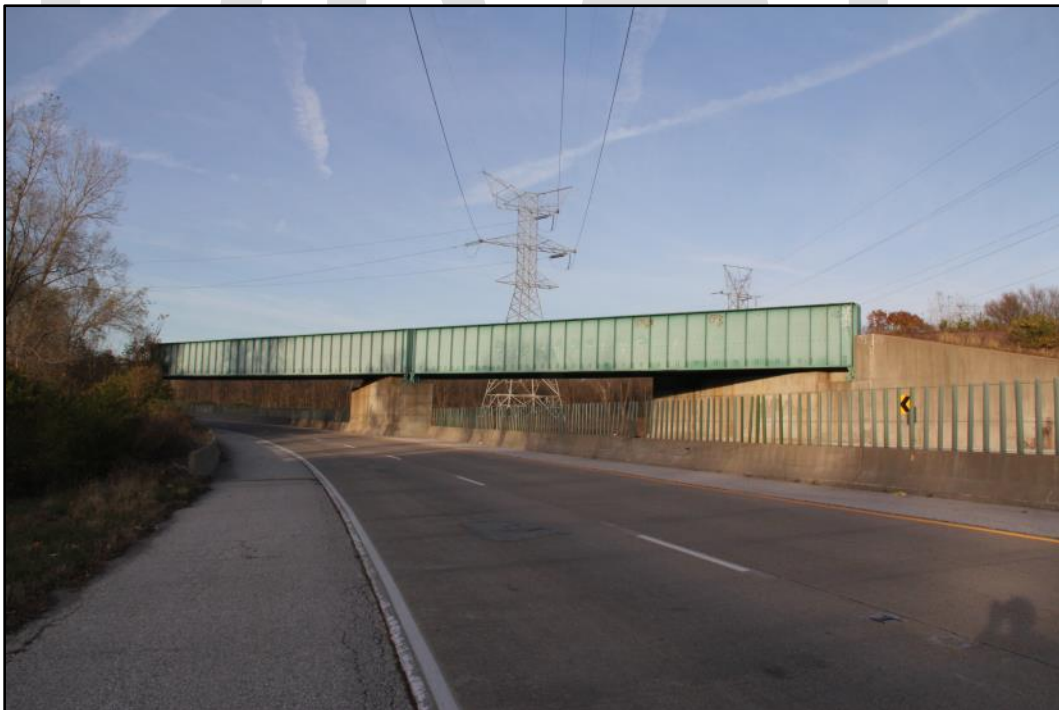
MP 258.12 (H. Adams Parkway)/Photo 7229

257.40	Alton	Madison	C	SN		Old RR Grade				No data received
258.12	Alton	Madison	B	C/SL	P & B	H Adams Pkwy	---	Y	Y	Unremarkable - Photo 7229
258.21	Alton	Madison	B	SN/SL	P & B	Wood Rvr	189?	Y	Y	(Lassig Bridge) VERY NICE - Photo 7231

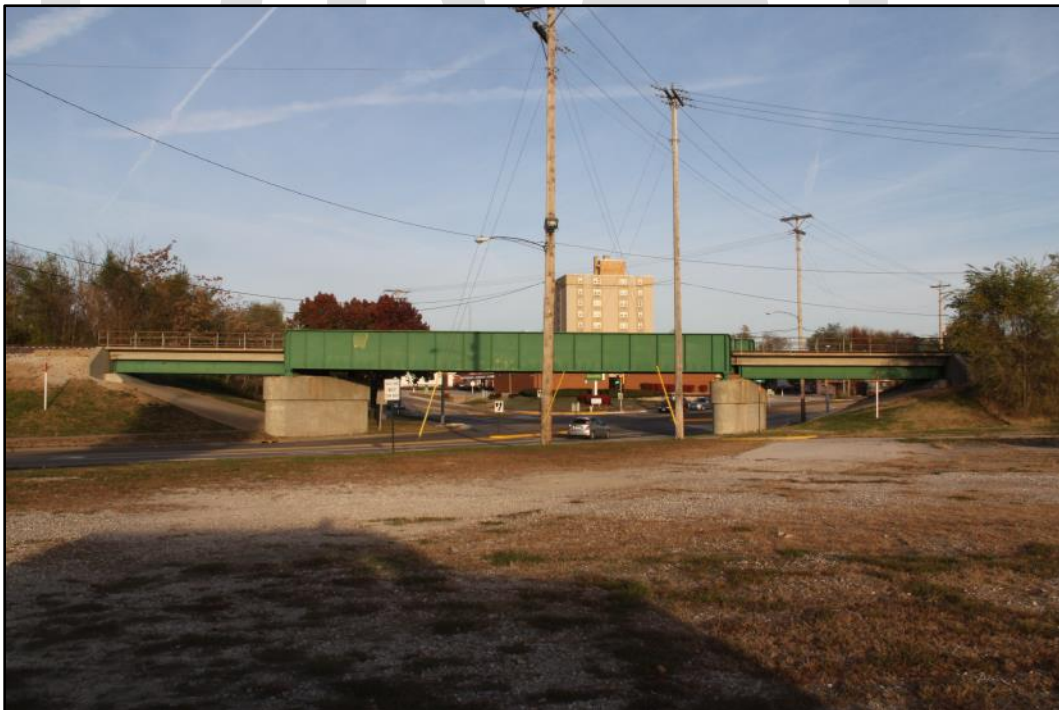
MP 258.78/Photo 7233

258.45	Alton	Madison	B	SL	P & B		---	Y	?	Try to field review
258.78	Alton	Madison	B	C/SL	P & B (3 spans)	W St. Louis Av	---	N	Y	Unremarkable - Photo 7233

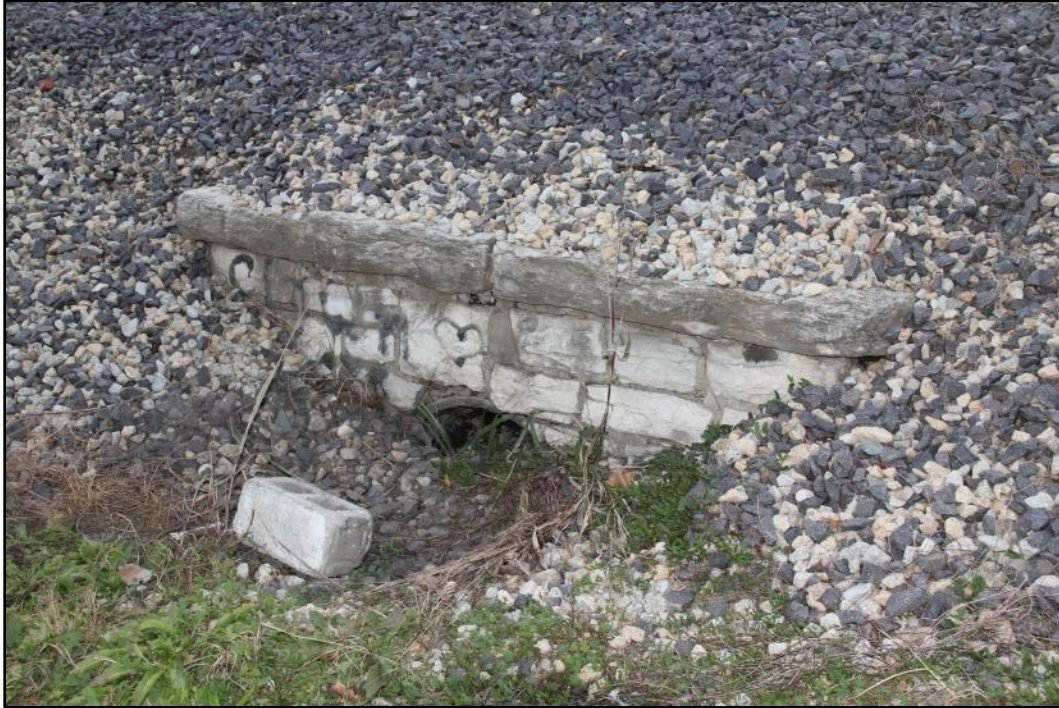
MP 259.35/Photo 7234

259.35	Alton	Madison	C	CI/SN	Tube	Drainage	---	Y	Y	Unremarkable - Photos 7234, 7235
262.05	Alton	Madison	C	CI	Tube	Drainage	---	Y	N	Unremarkable. Part buried

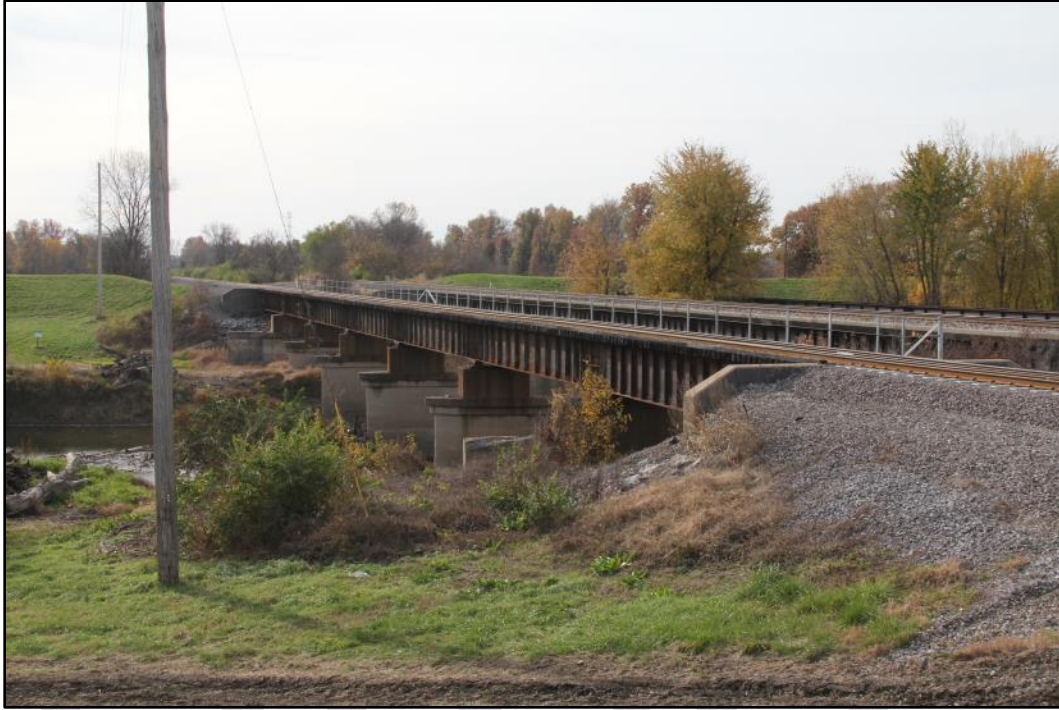
MP 266.75/Photo 7247

265.20	Alton	Madison	C	C	Tube		---	Y	N	Unremarkable. No walls
266.24	Chouteau	Madison	C	CM/CI	Tube		---	Y	N	Unremarkable. No walls
266.75	Chouteau	Madison	B	SL	P & B (7 spans)	Cahokia Ck	---	Y	Y	GOOD - Photo 7247
