Route 66 in Illinois:

(2012/13 Update and Expansion of the Original 1994/95 Survey)

IDOT Sequence #17337 & #17337A

22 December 2013

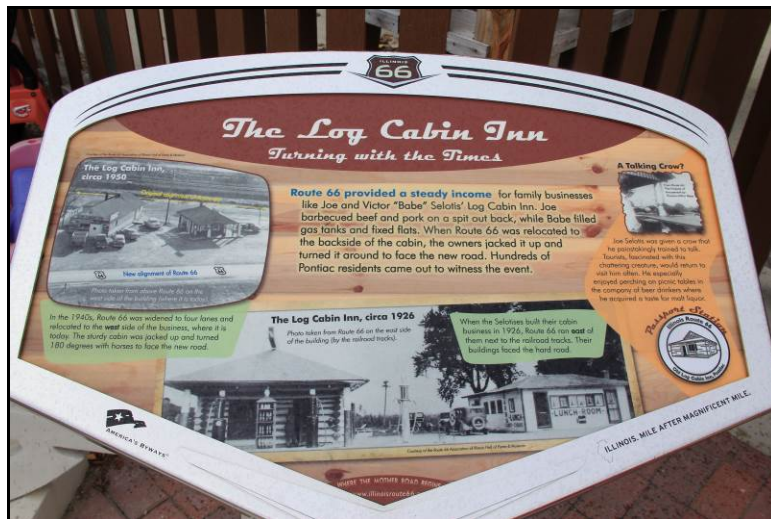
Figure 1 Interpretive sign at the Log Cabin Inn.

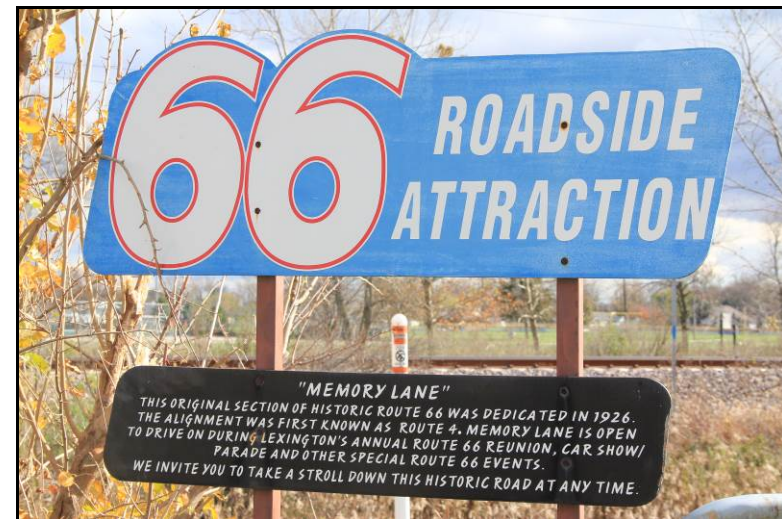
Figure 2: Another type of interpretive sign located along Route 66 in Illinois.

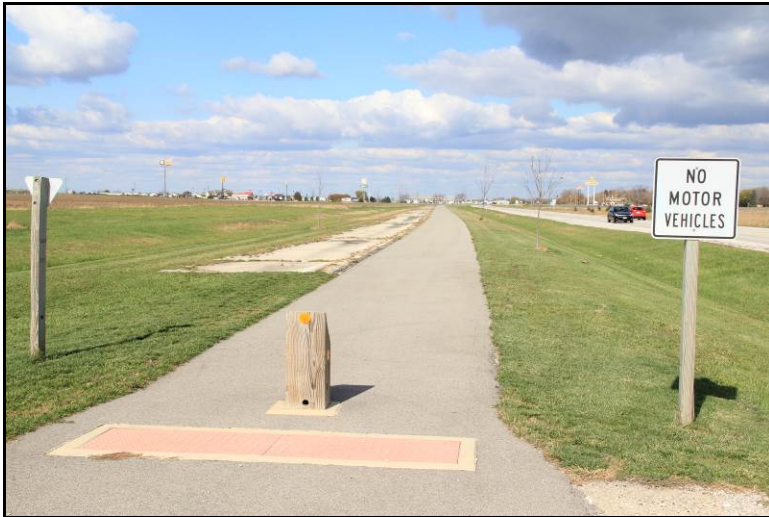
Figure 3: Abandoned Route 66 lanes near Chenoa are now a bike trail.

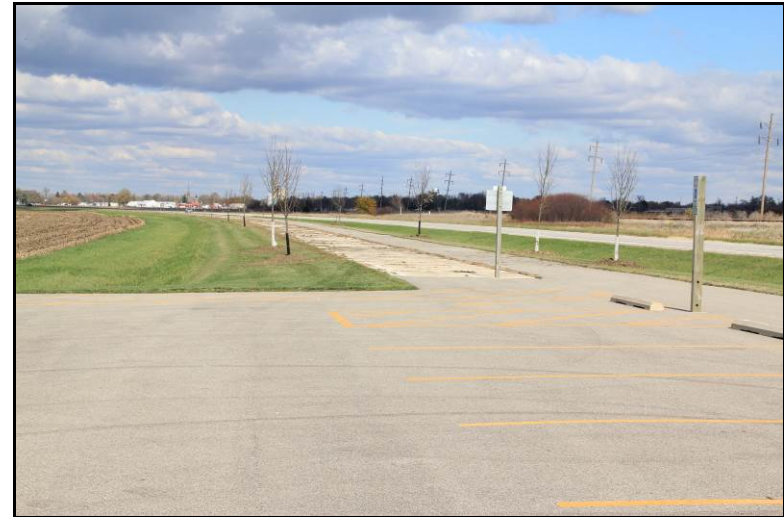
Figure 4: Another image of the Chenoa area trail with a parking lot.

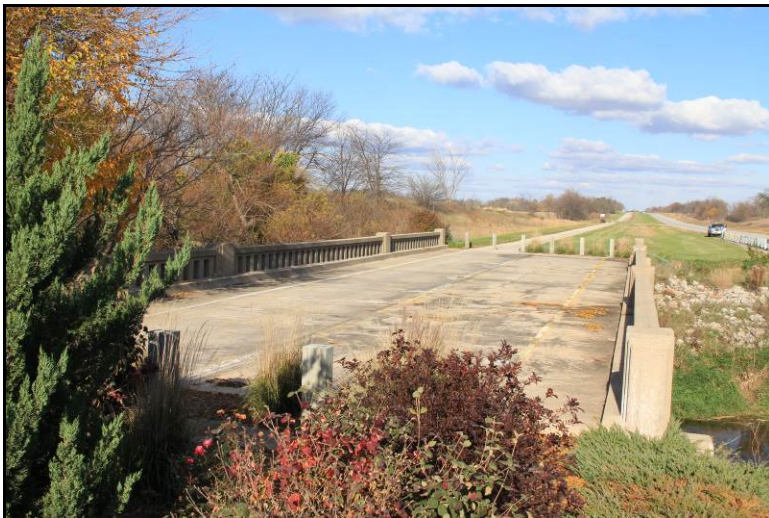
Figure 5: A bridge near Lexington that is now part of a bike trail.

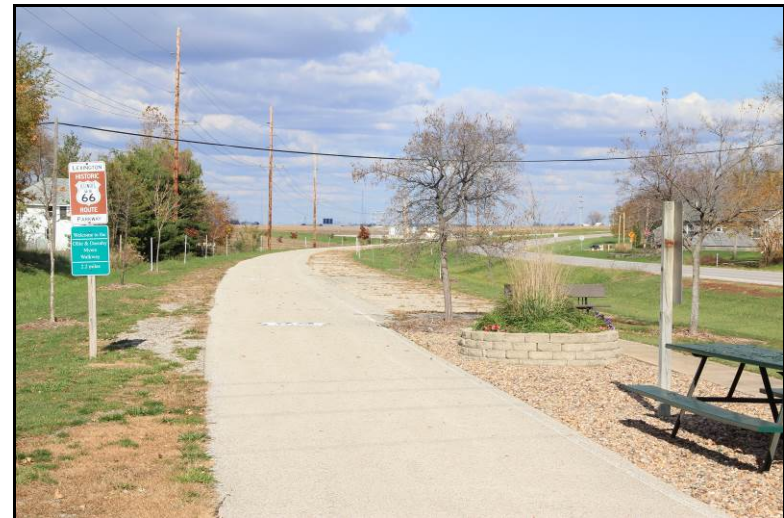
Figure 6: The Route 66 bike trail near Lexington.

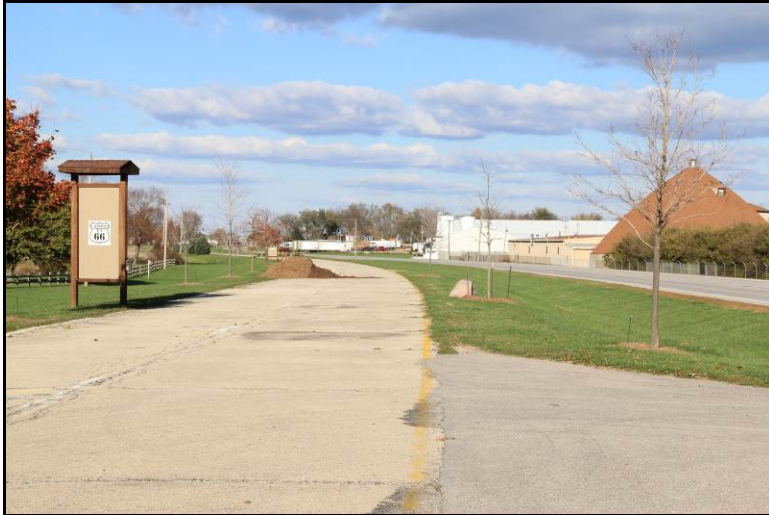
Figure 7: Interpretive display area in Towanda.

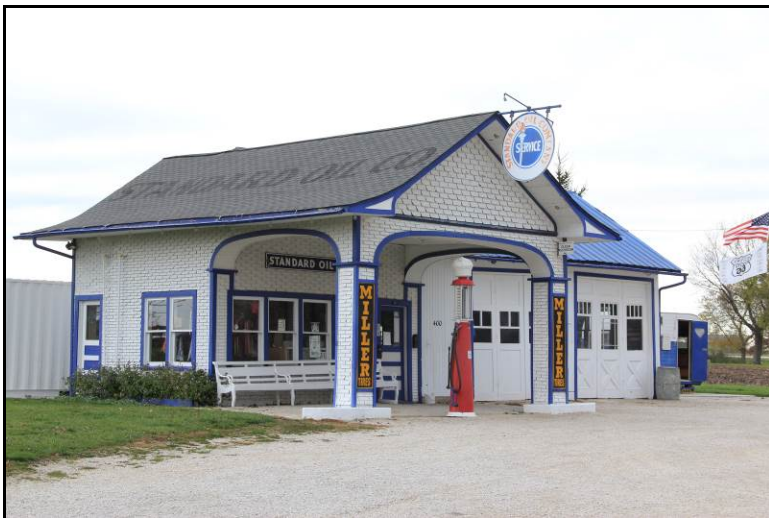
Figure 9: The Odell Standard Oil Station has been renovated.

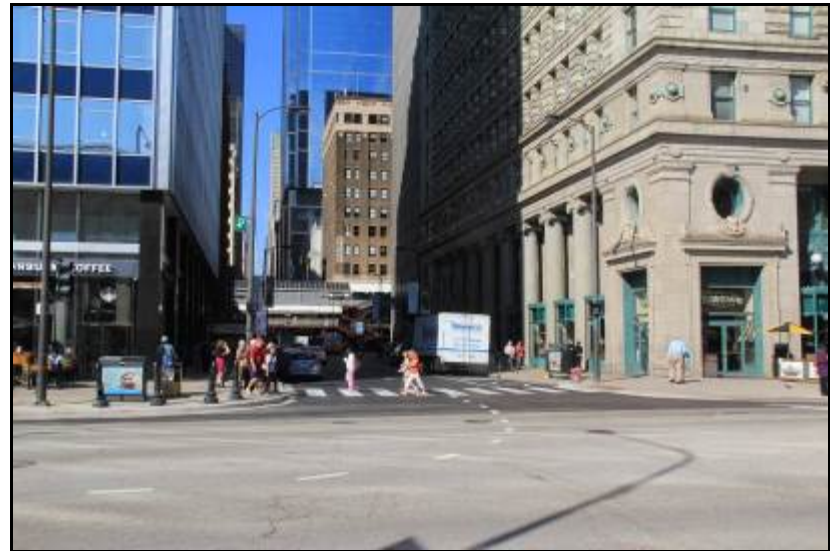
Sequence Number	Map Code	1994/95 Negative #	Address/Location	Type	Date Built	Historic Function	1994/95 Comments	2012/13 Comments and Photo Image #
A2	N/A	None	Adams St. & Michigan Ave.	1	Ca. 1990s	Historic RT 66 Sign	Not surveyed in 1994/5	This sign designates the beginning point of westbound RT 66 on Adams St., just W of Michigan Ave. IMG_3781

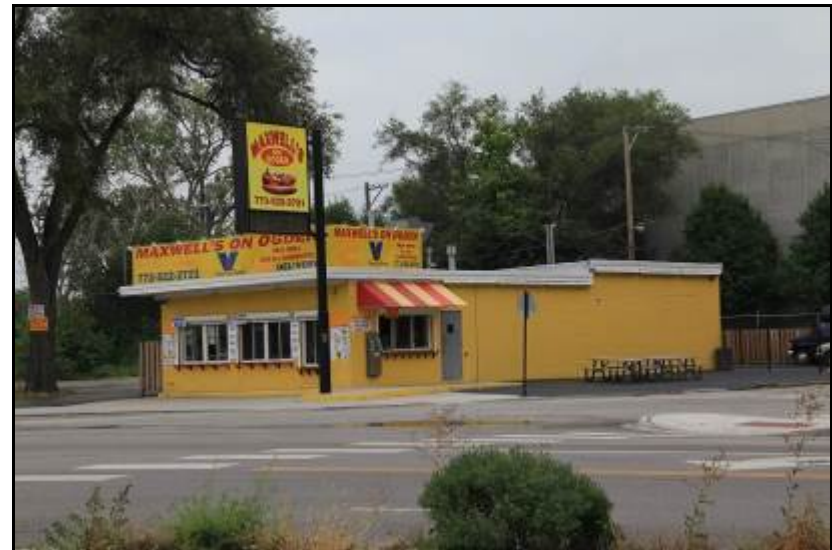
Sequence Number	Map Code	1994/95 Negative #	Address/Location	Type	Date Built	Historic Function	1994/95 Comments	2012/13 Comments and Photo Image #
A30	N/A	None	2600 W. Ogden	2	Ca. 1950s	Restaurant/ Diner	Not surveyed in 1994/5	"Maxwell's on Ogden" is a diner/restaurant that likely served many RT 66 travelers. IMG_3805

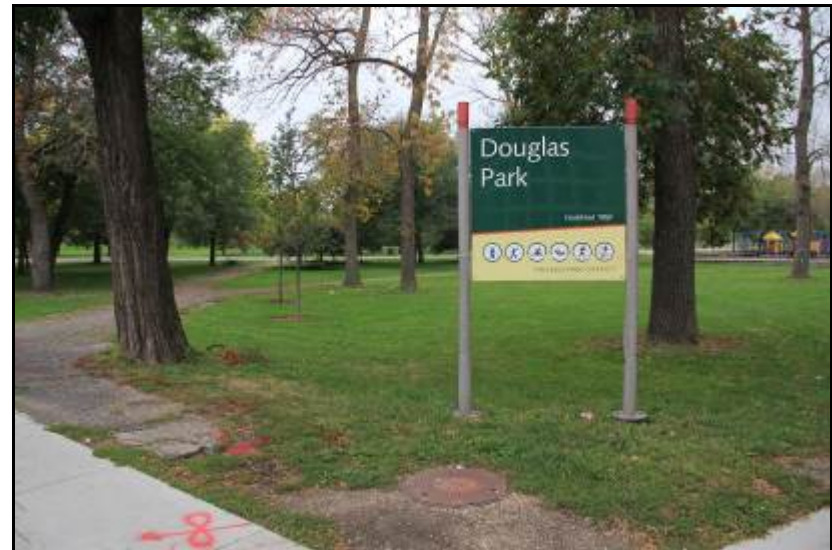
Sequence Number	Map Code	1994/95 Negative #	Address/Location	Type	Date Built	Historic Function	1994/95 Comments	2012/13 Comments and Photo Image #
A31	N/A	None	Ogden Ave. & California St.	3	Ca. 1860s	City Park	Not surveyed in 1994/5	“Douglas Park” was named for Stephan A. Douglas, prominent for his 1858 debates with Abraham Lincoln, shortly before the Civil War. IMG_3806

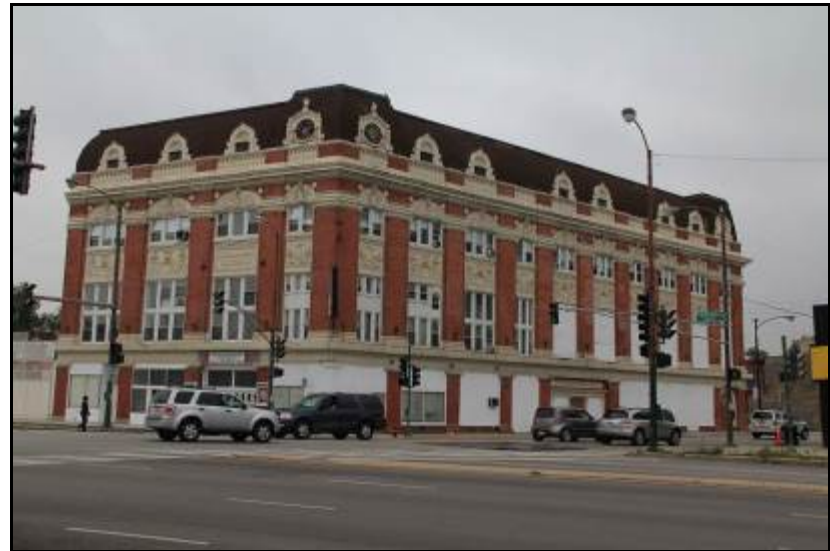
Sequence Number	Map Code	1994/95 Negative #	Address/Location	Type	Date Built	Historic Function	1994/95 Comments	2012/13 Comments and Photo Image #
A32	N/A	None	3202 W. Ogden Ave.	3	Ca. 1911	Auditorium	Not surveyed in 1994/5	The “Douglas Park Auditorium” was both a theater and a significant gathering place for the local Jewish community. IMG_3807

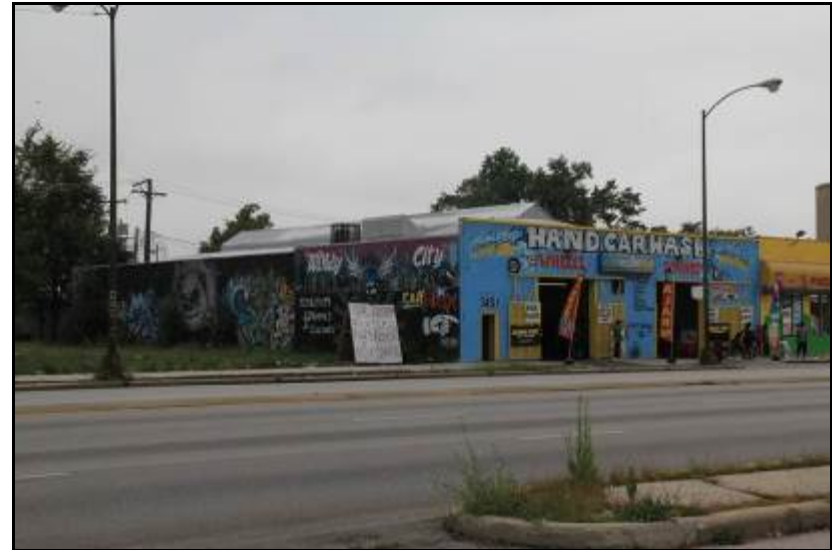
Sequence Number	Map Code	1994/95 Negative #	Address/Location	Type	Date Built	Historic Function	1994/95 Comments	2012/13 Comments and Photo Image #
A33	N/A	None	3451 Ogden Ave.	2	Ca. 1920s-30s	Garage	Not surveyed in 1994/5	An automotive care facility on RT 66. IMG_3808

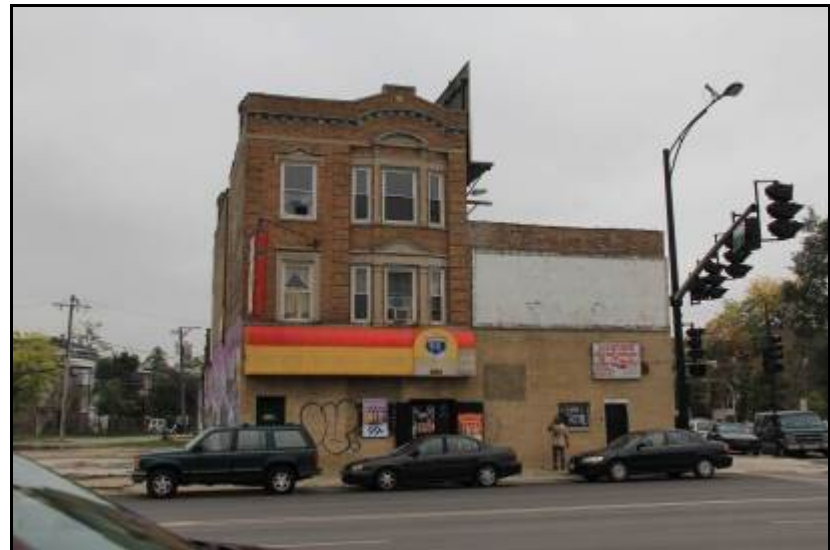
Sequence Number	Map Code	1994/95 Negative #	Address/Location	Type	Date Built	Historic Function	1994/95 Comments	2012/13 Comments and Photo Image #
A34	N/A	None	3661 Ogden Ave.	3	Ca. Early 20 th Century	Retail (?)	Not surveyed in 1994/5	This small residential/business building is now home to the "Route 66 Grocery." IMG_3809

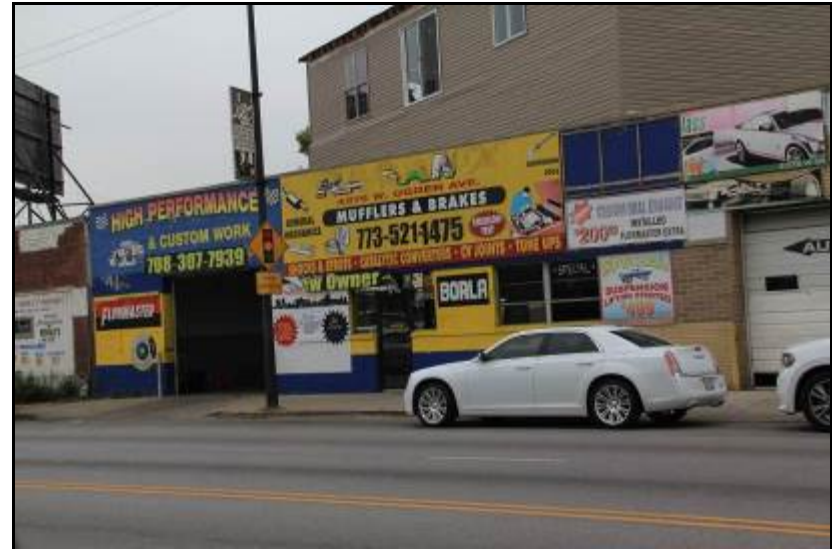
Sequence Number	Map Code	1994/95 Negative #	Address/Location	Type	Date Built	Historic Function	1994/95 Comments	2012/13 Comments and Photo Image #
A36	N/A	None	4376 Ogden Ave.	2	Ca. 1920s-30s	Garage	Not surveyed in 1994/5	An automotive care shop on RT 66. IMG_3811

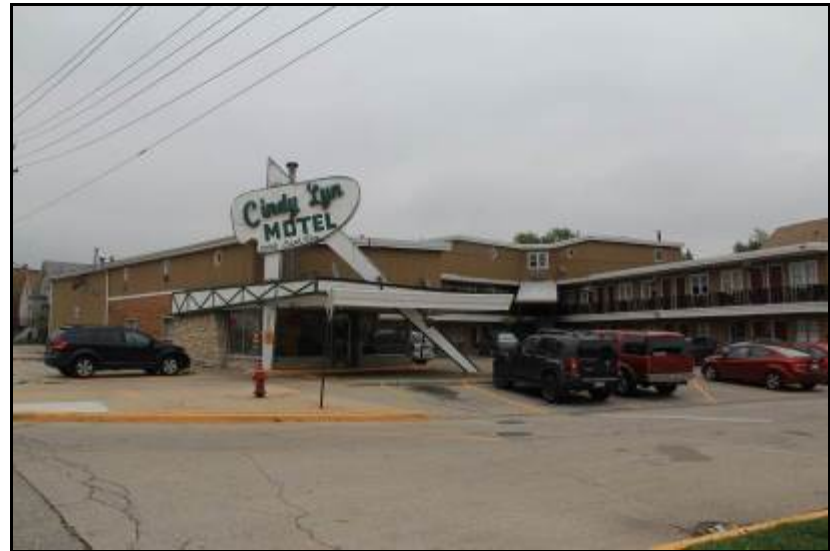
Sequence Number	Map Code	1994/95 Negative #	Address/Location	Type	Date Built	Historic Function	1994/95 Comments	2012/13 Comments and Photo Image #
A37	N/A	None	5291 Ogden Ave., CICERO	2	1960	Motel	Not surveyed in 1994/5	The “Cyndi Lynn Motel” originally had 18 rooms built to accommodate RT 66 travelers. It now has 65 rooms. IMG_3812

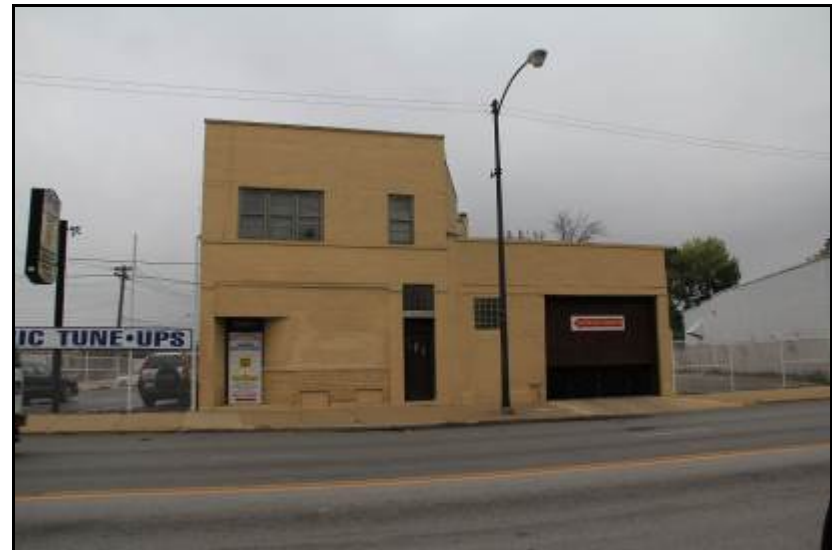
Sequence Number	Map Code	1994/95 Negative #	Address/Location	Type	Date Built	Historic Function	1994/95 Comments	2012/13 Comments and Photo Image #
A38	N/A	None	4418 Ogden Ave., CHICAGO	2	Unknown	Garage (?)	Not surveyed in 1994/5	The historical use of this building is uncertain. It is possible, given the garage door to the right, that the structure may have been an automotive care garage. IMG_3813

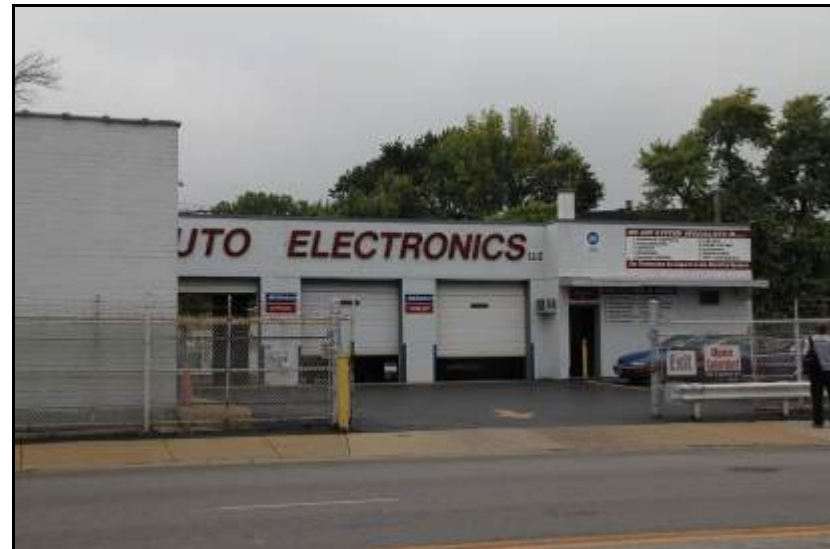
Sequence Number	Map Code	1994/95 Negative #	Address/Location	Type	Date Built	Historic Function	1994/95 Comments	2012/13 Comments and Photo Image #
A39	N/A	None	Ogden Ave. & S. Kostner, CICERO	2	Ca. 1940s- 50s	Garage (?)	Not surveyed in 1994/5	“Auto Electronics” is an automotive care facility located on RT 66. IMG_3814

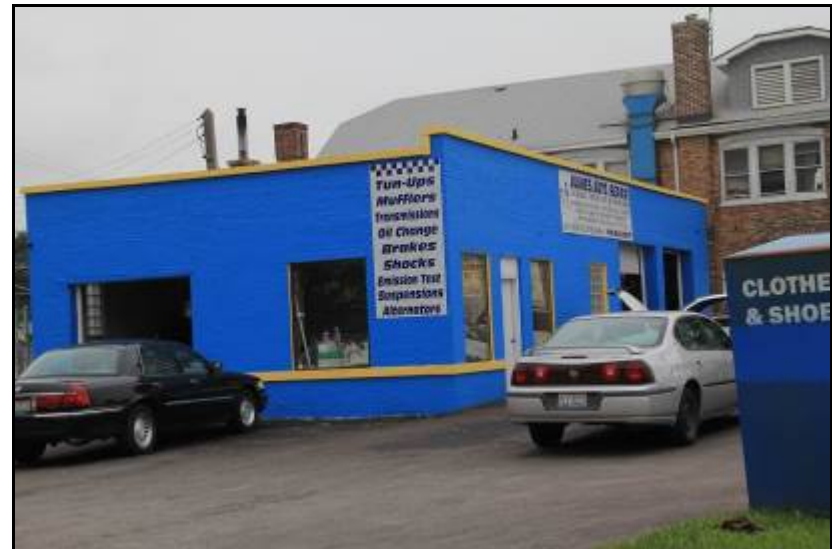
Sequence Number	Map Code	1994/95 Negative #	Address/Location	Type	Date Built	Historic Function	1994/95 Comments	2012/13 Comments and Photo Image #
A40	N/A	None	5301 Ogden Ave., CICERO	2	Ca. 1940s	Garage	Not surveyed in 1994/5	A very plain-looking gas station, now painted. "Juanes Auto Repair." IMG_3815

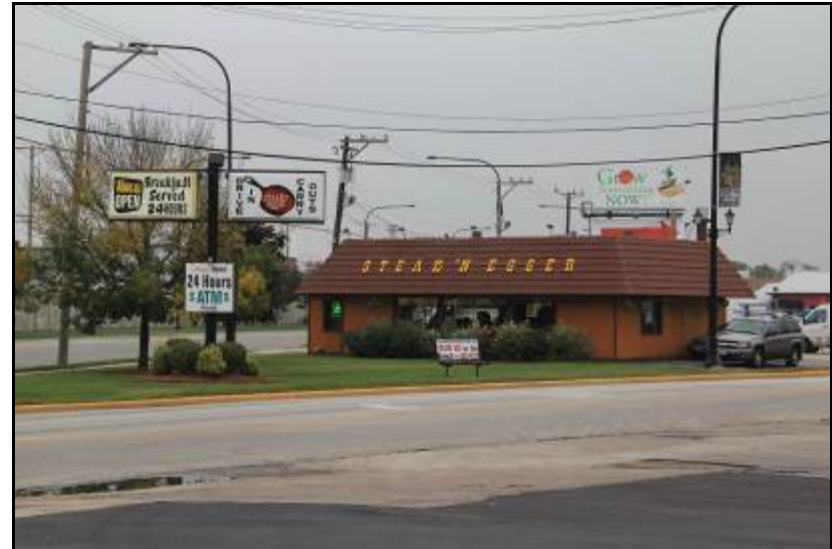
Sequence Number	Map Code	1994/95 Negative #	Address/Location	Type	Date Built	Historic Function	1994/95 Comments	2012/13 Comments and Photo Image #
A41	N/A	None	Ogden Ave. & 31 st St., CICERO	2	Ca. 1950s-60s	Restaurant	Not surveyed in 1994/5	The “Steak & Egger” Restaurant is adjacent to RT 66. IMG_3816

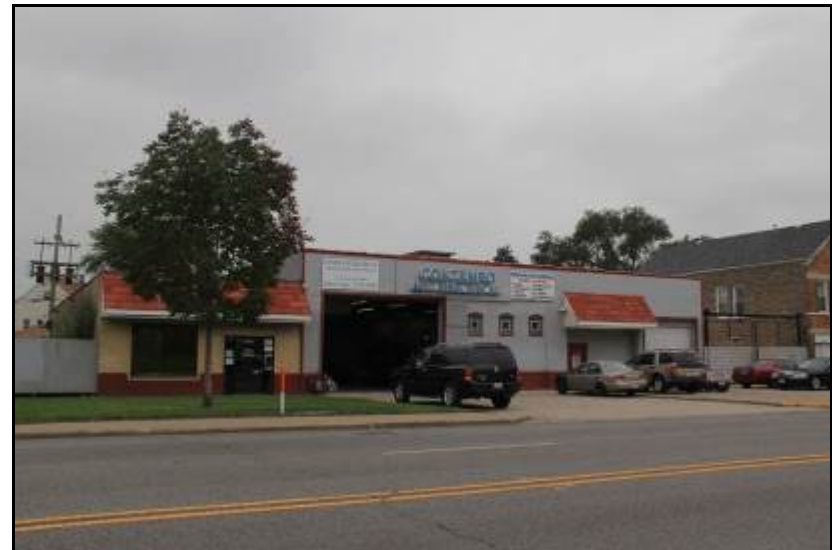
Sequence Number	Map Code	1994/95 Negative #	Address/Location	Type	Date Built	Historic Function	1994/95 Comments	2012/13 Comments and Photo Image #
A42	N/A	None	5119 Ogden Ave., CICERO	2	Ca. 1950s	Garage	Not surveyed in 1994/5	The “Contempo Auto Rebuilders” shop appears to date to the RT 66 period. IMG_3817

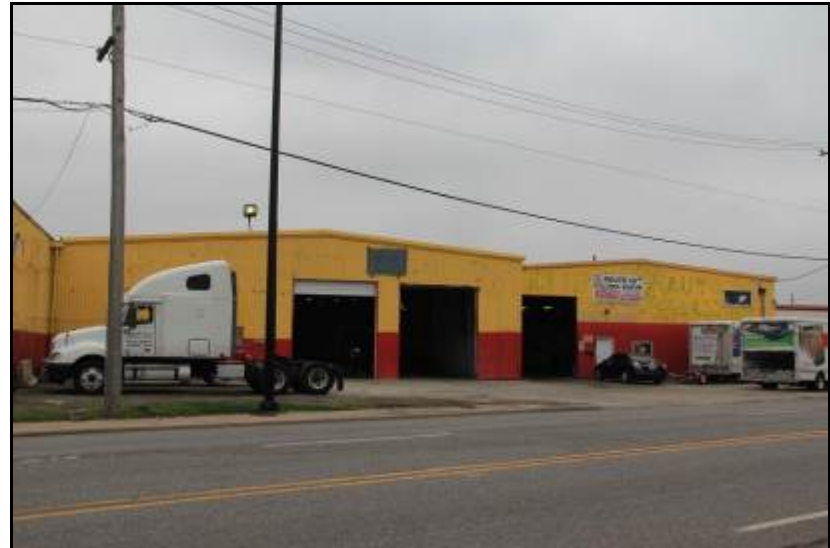
Sequence Number	Map Code	1994/95 Negative #	Address/Location	Type	Date Built	Historic Function	1994/95 Comments	2012/13 Comments and Photo Image #
A43	N/A	None	5827 Ogden Ave., CICERO	2	Ca. 1950s- 60s	Auto Repair	Not surveyed in 1994/5	"Route 66 Auto Glass" could have been a truck-repair facility/complex. IMG_3818

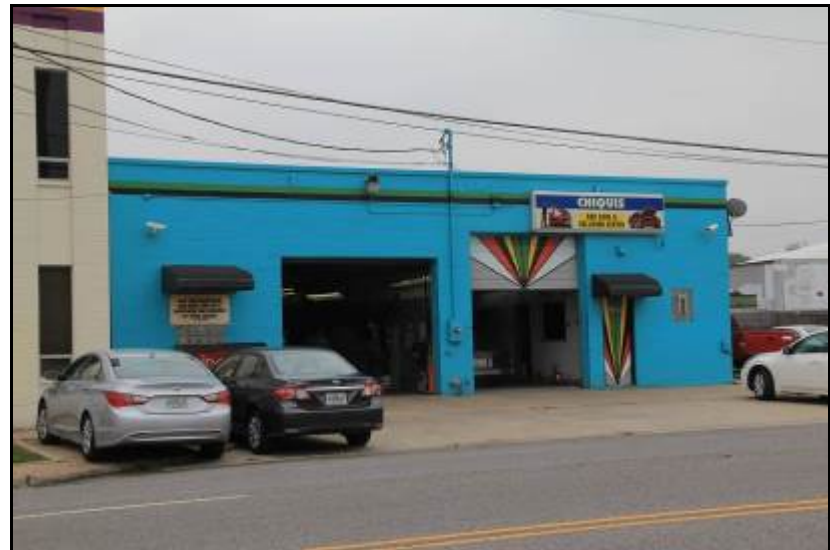
Sequence Number	Map Code	1994/95 Negative #	Address/Location	Type	Date Built	Historic Function	1994/95 Comments	2012/13 Comments and Photo Image #
A44	N/A	None	5841 Ogden Ave., CICERO	2	Ca. 1950s	Auto Repair	Not surveyed in 1994/5	“Chiquis Car Care” is a concrete block, auto service center. IMG_3819

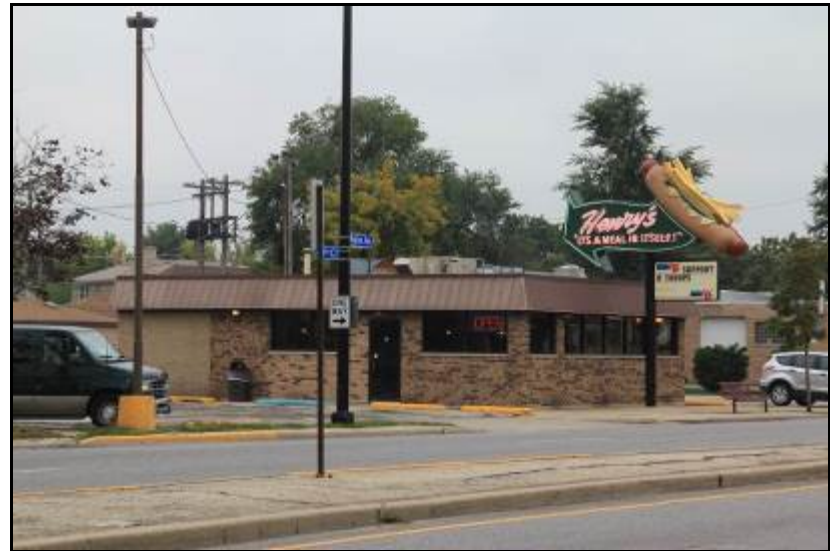
Sequence Number	Map Code	1994/95 Negative #	Address/Location	Type	Date Built	Historic Function	1994/95 Comments	2012/13 Comments and Photo Image #
A45	N/A	None	IMG_3820, CICERO	2	Ca. 1950s-60s	Drive-In	Not surveyed in 1994/5	Although in a newer building, "Henry's Drive-In" dates to the 1950s and served RT 66 travelers. IMG_3820

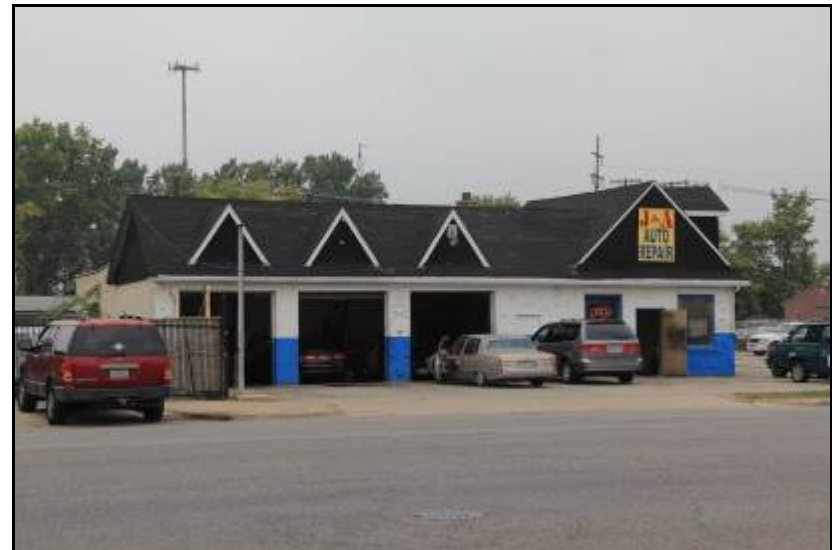
Sequence Number	Map Code	1994/95 Negative #	Address/Location	Type	Date Built	Historic Function	1994/95 Comments	2012/13 Comments and Photo Image #
A46	N/A	None	6100 Ogden Ave., CICERO	2	Ca. 1940s	Garage	Not surveyed in 1994/5	"J & A Auto Repair" is in a gas station/auto service building constructed of brick. IMG_3821

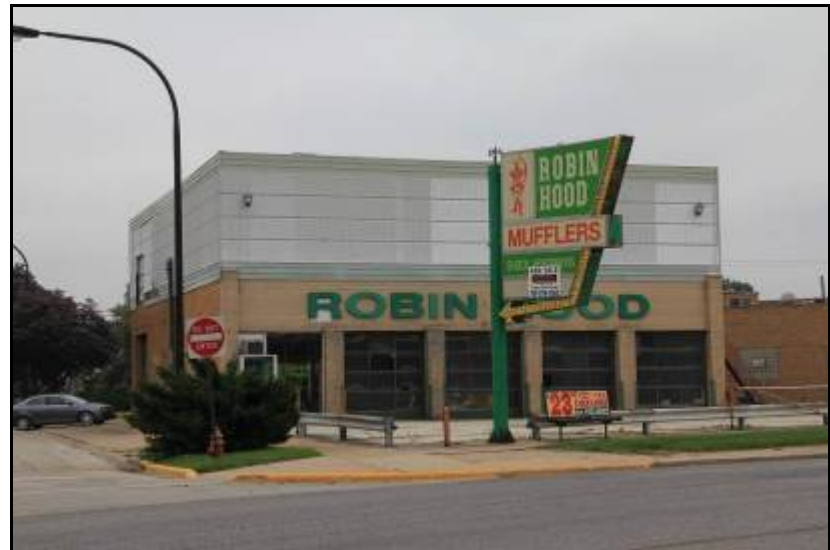
Sequence Number	Map Code	1994/95 Negative #	Address/Location	Type	Date Built	Historic Function	1994/95 Comments	2012/13 Comments and Photo Image #
A47	N/A	None	6131 Ogden Ave., CICERO	2	Ca. 1950s	Auto Service	Not surveyed in 1994/5	The vacant "Robin Hood Mufflers" auto service building. IMG_3822

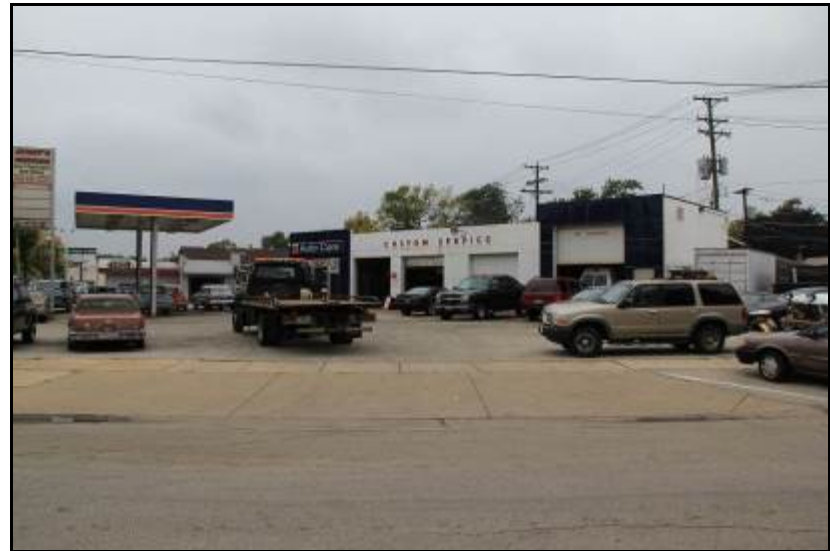
Sequence Number	Map Code	1994/95 Negative #	Address/Location	Type	Date Built	Historic Function	1994/95 Comments	2012/13 Comments and Photo Image #
A48	N/A	None	6229 Ogden Ave., BERWYN	2	Ca. 1950s	Gas/Service Station	Not surveyed in 1994/5	“Avrey’s Service” appears to be in an enameled panel building flanked with more recent additions. IMG_3823

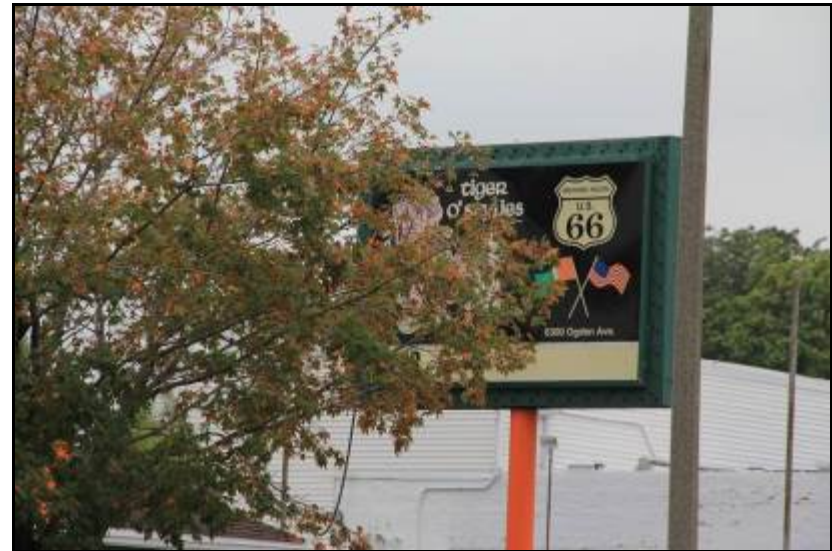
Sequence Number	Map Code	1994/95 Negative #	Address/Location	Type	Date Built	Historic Function	1994/95 Comments	2012/13 Comments and Photo Image #
A49	N/A	None	6300 Ogden Ave., BERWYN	2	Unknown	Restaurant	Not surveyed in 1994/5	“Tiger O’Styles” has a sign noting its location on RT 66. It is unknown if the facility postdated the highway. IMG_3825, 3824

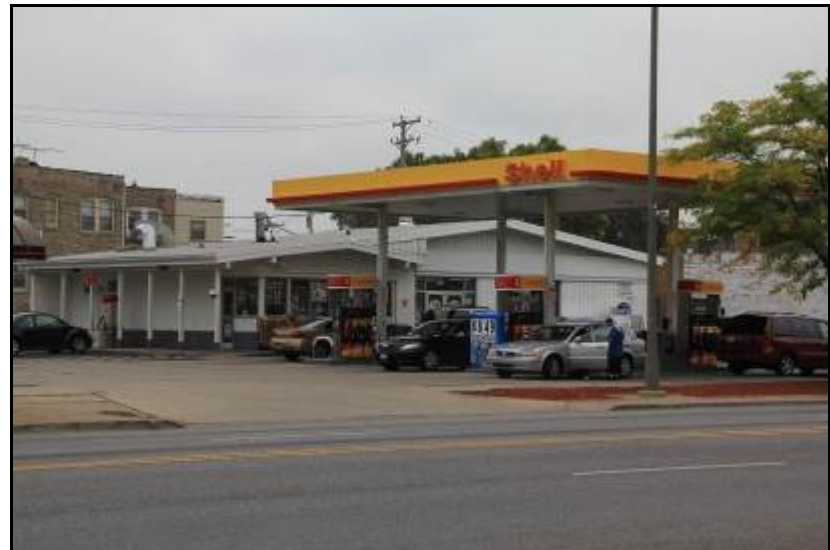
Sequence Number	Map Code	1994/95 Negative #	Address/Location	Type	Date Built	Historic Function	1994/95 Comments	2012/13 Comments and Photo Image #
A50	N/A	None	Ogden Ave. & Ridgeland Ave., BERWYN	2	Ca. 1960s	Gas Station	Not surveyed in 1994/5	The integrity of this ca. 1960s "Shell Oil" facility appears to be good. IMG_3826

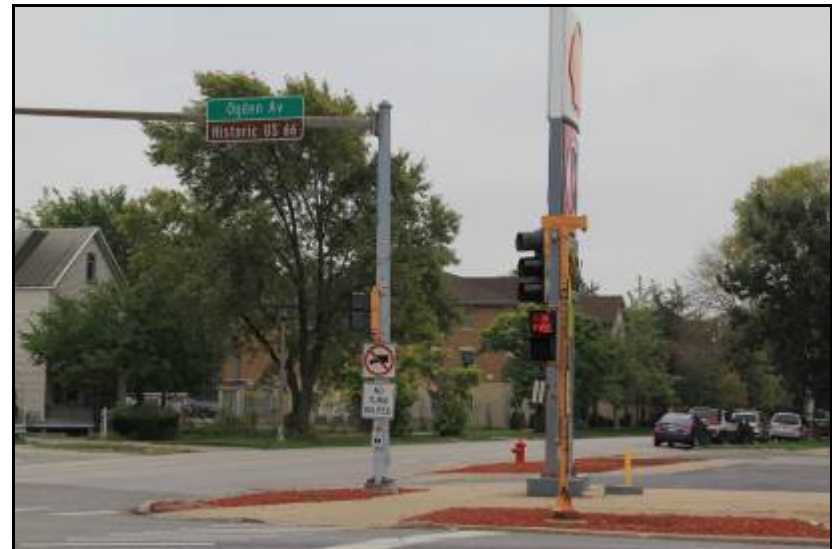
Sequence Number	Map Code	1994/95 Negative #	Address/Location	Type	Date Built	Historic Function	1994/95 Comments	2012/13 Comments and Photo Image #
A51	N/A	None	Ogden Ave. & Ridgeland Ave., BERWYN	1	Ca. 1990s	Historic RT 66 Sign	Not surveyed in 1994/5	A Historic RT 66 sign on Ogden Ave. IMG_3827

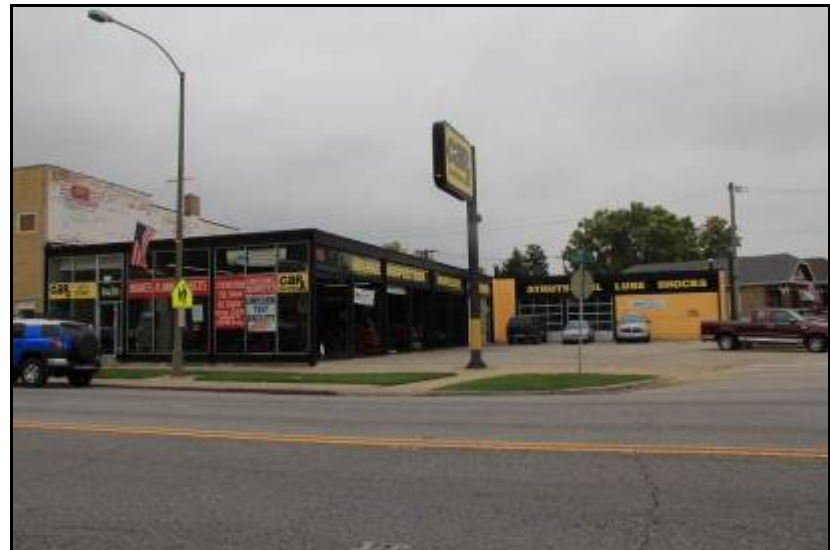
Sequence Number	Map Code	1994/95 Negative #	Address/Location	Type	Date Built	Historic Function	1994/95 Comments	2012/13 Comments and Photo Image #
A52	N/A	None	6420 Ogden Ave.	2	Ca. 1960s	Service Station	Not surveyed in 1994/5	"Car X Mufflers" now occupies a 1960s-looking auto care facility. IMG_3828

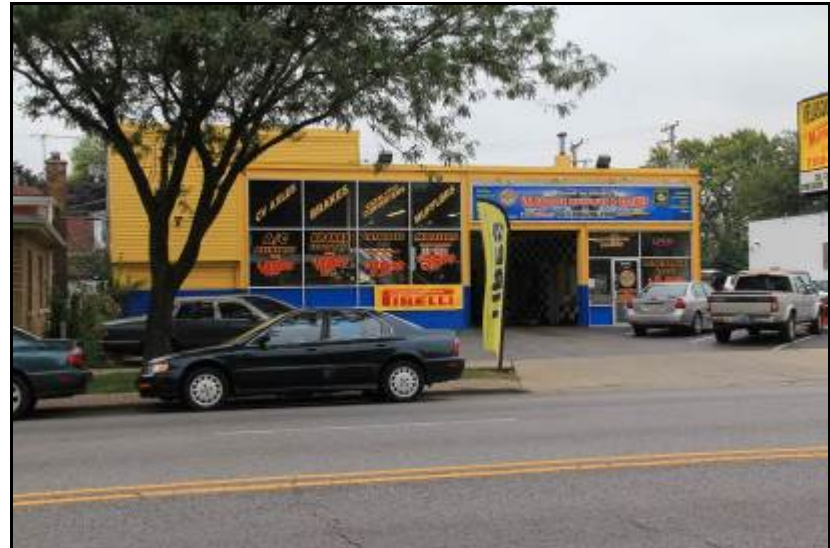
Sequence Number	Map Code	1994/95 Negative #	Address/Location	Type	Date Built	Historic Function	1994/95 Comments	2012/13 Comments and Photo Image #
A53	N/A	None	6440 Ogden Ave., BERWYN	2	Ca. 1950s-60s	Garage	Not surveyed in 1994/5	"Velasquez & Sons Auto Repair," a ca. late 1950s/early 1960s automobile care building. IMG_3829

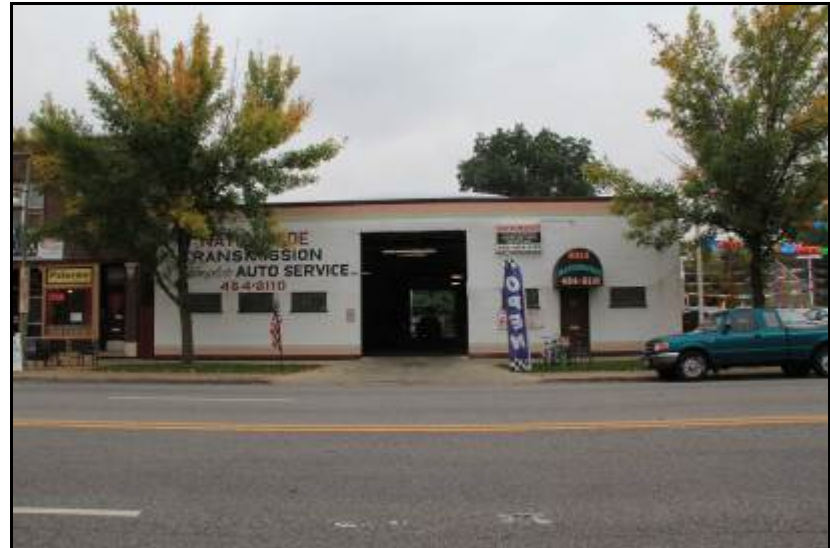
Sequence Number	Map Code	1994/95 Negative #	Address/Location	Type	Date Built	Historic Function	1994/95 Comments	2012/13 Comments and Photo Image #
A54	N/A	None	6512 Ogden Ave., BERWYN	2	Ca. 1960s- 70s	Garage	Not surveyed in 1994/5	"Nationwide Auto Repair" is in a building that MAY post-date RT 66. IMG_3830

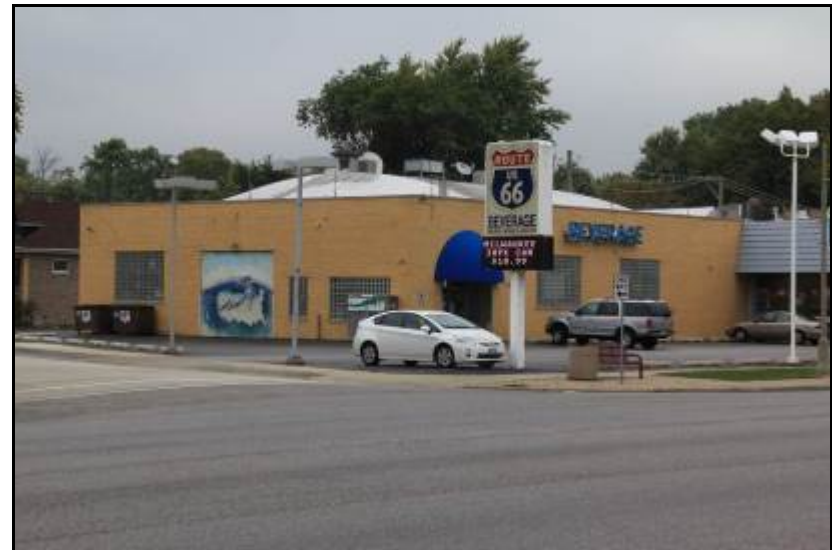
Sequence Number	Map Code	1994/95 Negative #	Address/Location	Type	Date Built	Historic Function	1994/95 Comments	2012/13 Comments and Photo Image #
A55	N/A	None	6847 Ogden Ave., BERWYN	3	Ca. 1950s	Retail	Not surveyed in 1994/5	"Route 66 Beverage" has a RT 66 map mural, as well as a neon RT 66 sign. IMG_3831, 3832, 3833, 3834

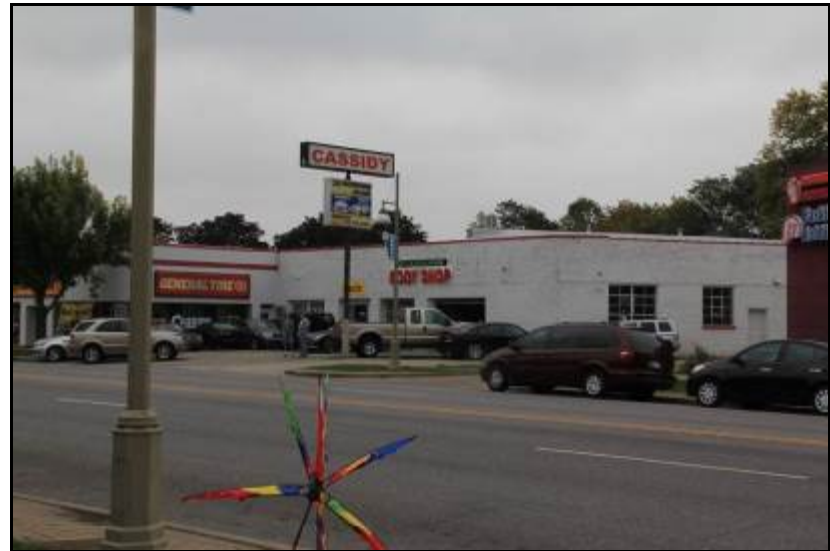
Sequence Number	Map Code	1994/95 Negative #	Address/Location	Type	Date Built	Historic Function	1994/95 Comments	2012/13 Comments and Photo Image #
A56	N/A	None	Ogden Ave. & Wenonah, BERWYN	2	Ca. 1950s-60s	Auto Dealer (?)	Not surveyed in 1994/5	“Cassidy Auto Body” is in a building that may have originally been a ca. 1960s auto dealership. IMG_3835

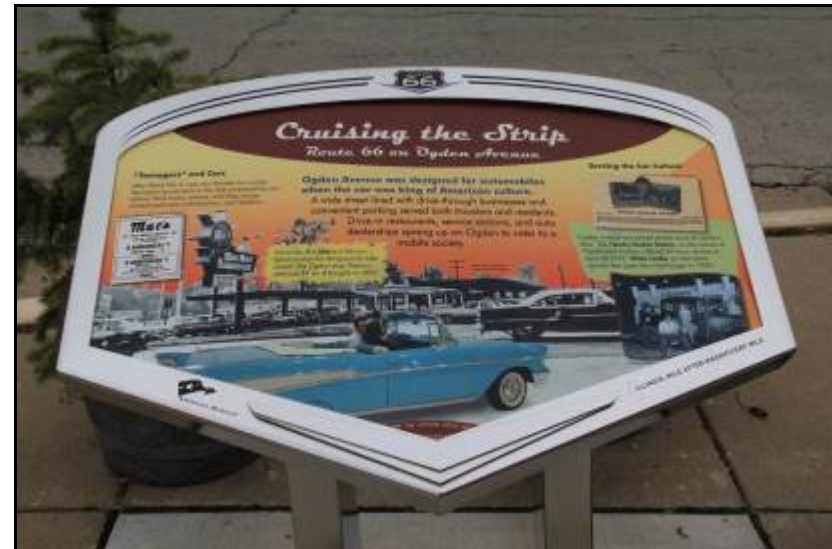
Sequence Number	Map Code	1994/95 Negative #	Address/Location	Type	Date Built	Historic Function	1994/95 Comments	2012/13 Comments and Photo Image #
A57	N/A	None	Ogden Ave. & Wenonah, BERWYN	2	Ca. 1990s-2000s	Interpretive Sign	Not surveyed in 1994/5	RT 66 Interpretive sign. IMG_3836

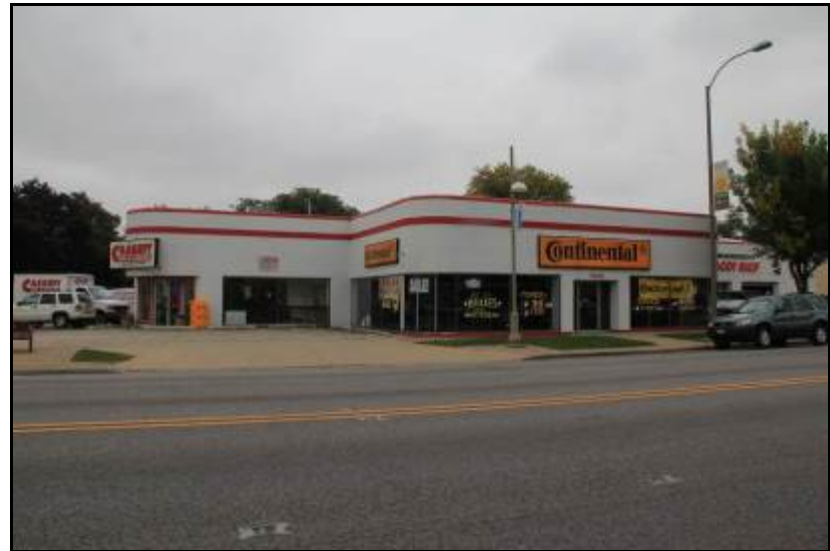
Sequence Number	Map Code	1994/95 Negative #	Address/Location	Type	Date Built	Historic Function	1994/95 Comments	2012/13 Comments and Photo Image #
A58	N/A	None	7000 Ogden Ave., BERWYN	2	Ca. 1960s-70s	Auto Dealer	Not surveyed in 1994/5	"Cassidy Tire & Service" occupies what was likely a former auto dealership on RT 66. Could post-date the highway. IMG_3837

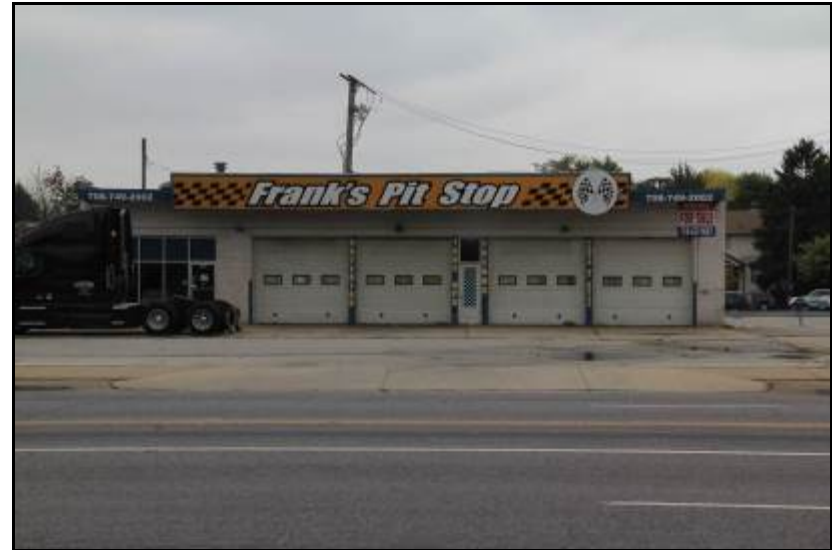
Sequence Number	Map Code	1994/95 Negative #	Address/Location	Type	Date Built	Historic Function	1994/95 Comments	2012/13 Comments and Photo Image #
A59	N/A	None	7144 Ogden Ave., BERWYN	2	Ca. 1950s-60s	Auto Service	Not surveyed in 1994/5	"Frank's Pit Stop" is vacant and for sale. IMG_3838

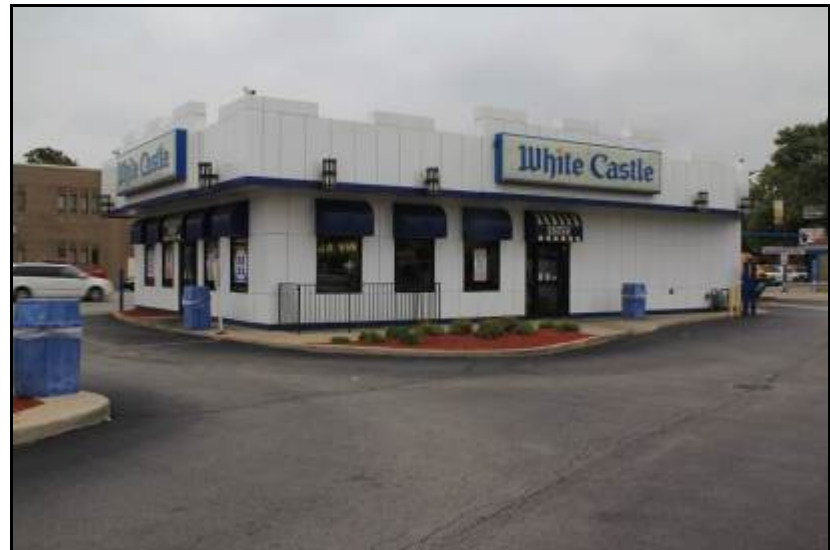
Sequence Number	Map Code	1994/95 Negative #	Address/Location	Type	Date Built	Historic Function	1994/95 Comments	2012/13 Comments and Photo Image #
A60	N/A	None	7155 Ogden Ave., BERWYN	2	Ca. 1950s- 60s	Restaurant	Not surveyed in 1994/5	“White Castle” is a hamburger chain with outlets around Chicago, including along RT 66. IMG_3839

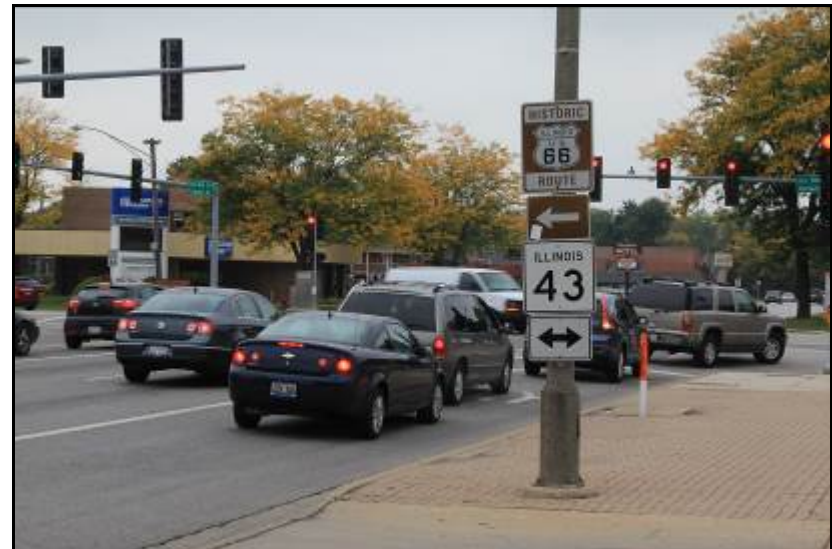
Sequence Number	Map Code	1994/95 Negative #	Address/Location	Type	Date Built	Historic Function	1994/95 Comments	2012/13 Comments and Photo Image #
A61	N/A	None	Ogden Ave. & Harlem Ave., BERQYN	1	Ca. 1990s	Historic RT 66 Sign	Not surveyed in 1994/5	Historic RT 66 signage that resulted from the 1990s project. IMG_3840

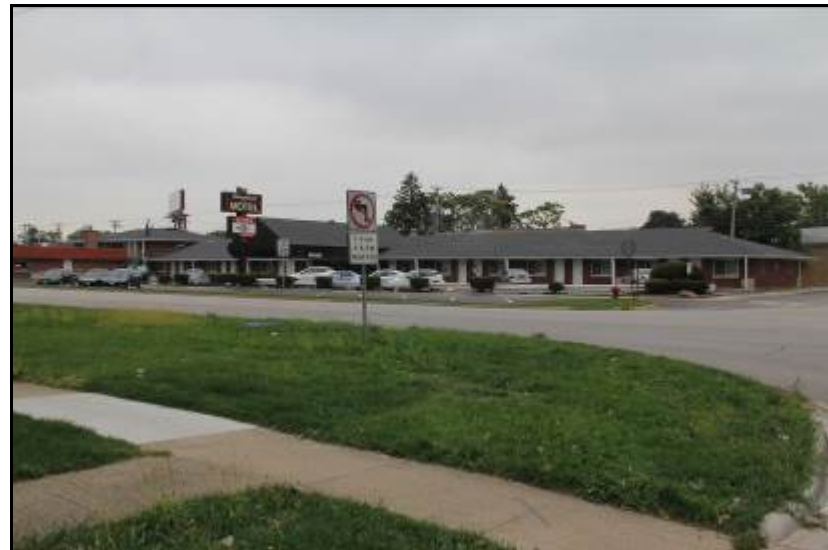
Sequence Number	Map Code	1994/95 Negative #	Address/Location	Type	Date Built	Historic Function	1994/95 Comments	2012/13 Comments and Photo Image #
A63	N/A	None	7307 Ogden Ave., LYONS	2	Ca. 1960s	Motel	Not surveyed in 1994/5	"Plank Road Inn" is adjacent to the Chicagoland Motel. IMG_3842

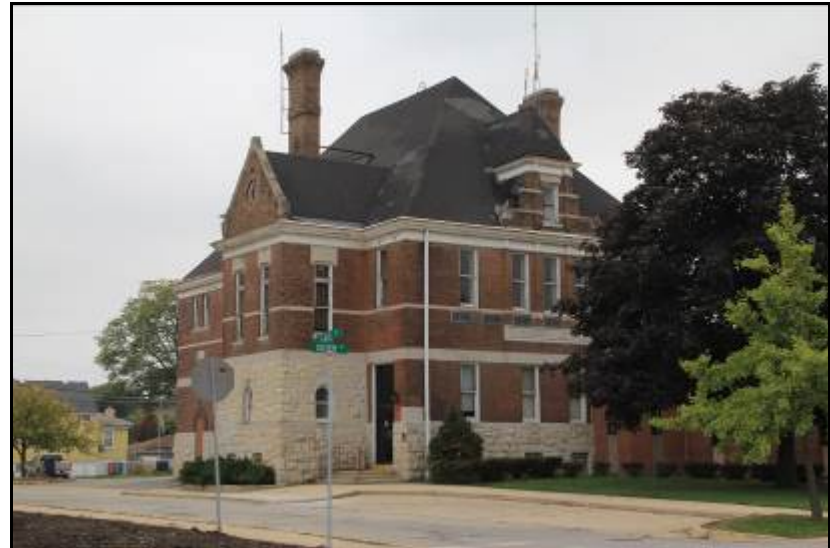
Sequence Number	Map Code	1994/95 Negative #	Address/Location	Type	Date Built	Historic Function	1994/95 Comments	2012/13 Comments and Photo Image #
A64	N/A	None	Ogden Ave. & Gage, LYONS	3	Ca. Late 19 th Century	City Hall	Not surveyed in 1994/5	Historic Lyons Village Hall. IMG_3843

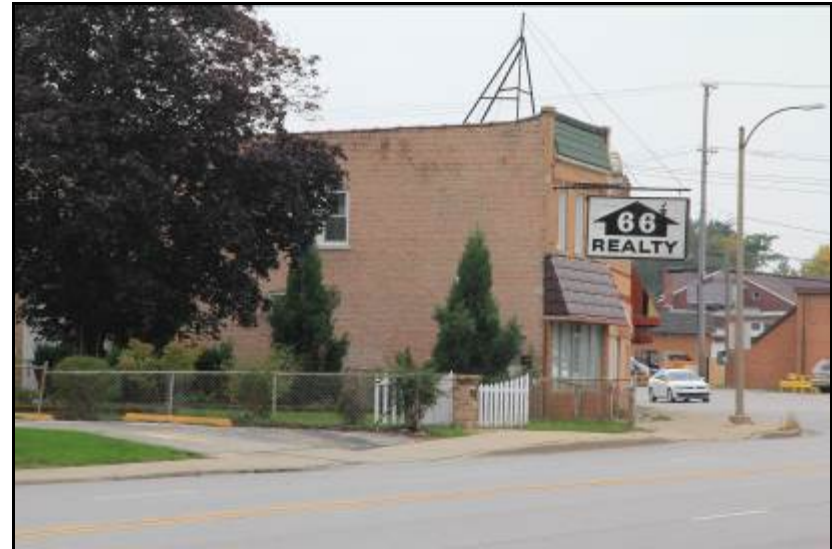
Sequence Number	Map Code	1994/95 Negative #	Address/Location	Type	Date Built	Historic Function	1994/95 Comments	2012/13 Comments and Photo Image #
A66	N/A	None	---- Joliet Rd., LYONS	3	Ca. 1920s- 30s	Office	Not surveyed in 1994/5	This modest, two story building housed "66 Realty." IMG_3848

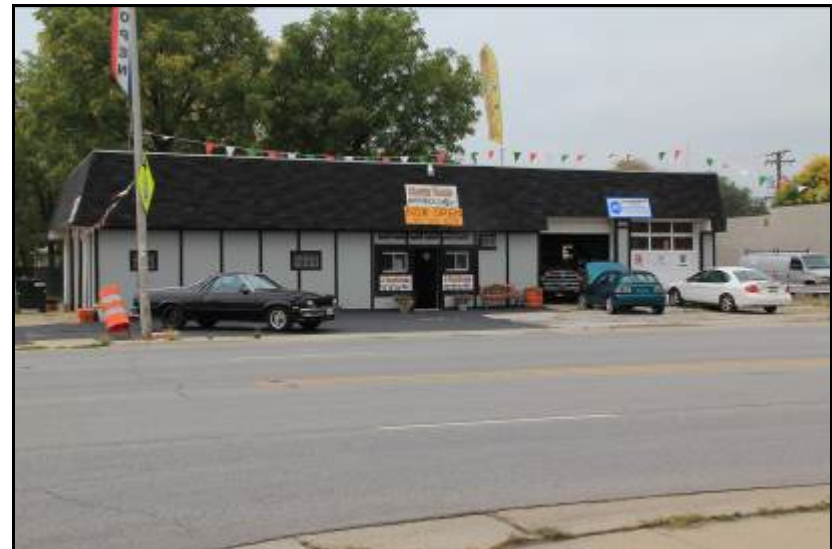
Sequence Number	Map Code	1994/95 Negative #	Address/Location	Type	Date Built	Historic Function	1994/95 Comments	2012/13 Comments and Photo Image #
A67	N/A	None	4558 Prescott Ave., LYONS	2	Ca. 1960s	Garage	Not surveyed in 1994/5	Stucco sheathed garage with two overhead doors to right (E). IMG_3849
