Route 66 in Illinois:

(2012/13 Update and Expansion of the Original 1994/95 Survey)

IDOT Sequence #17337 & #17337A

22 December 2013

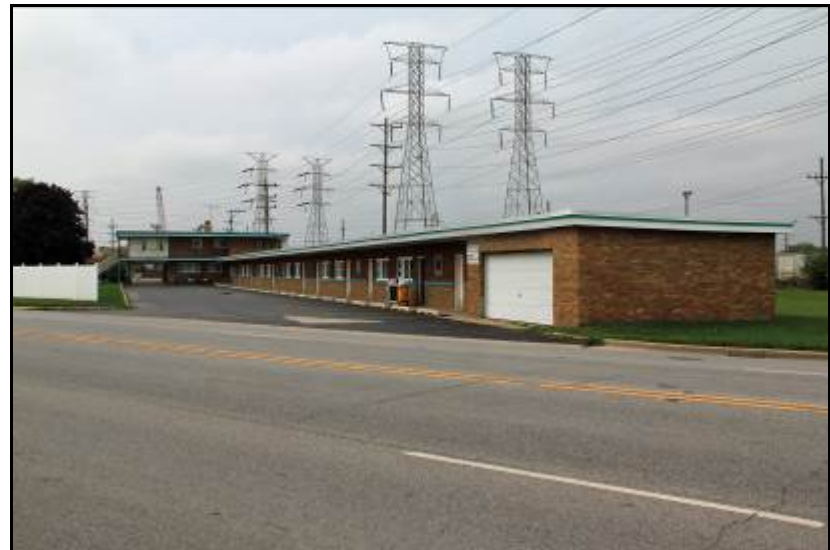
Sequence Number	Map Code	1994/95 Negative #	Address/Location	Type	Date Built	Historic Function	1994/95 Comments	2012/13 Comments and Photo Image #
A68	N/A	None	8136 Joliet Rd., McCOOK	2	Ca. 1950s-60s	Motel	Not surveyed in 1994/5	“Skyline Motel” is a single story, brick building with a two-story office and living quarters to the NW (distant left of photo) IMG_3850, 3851

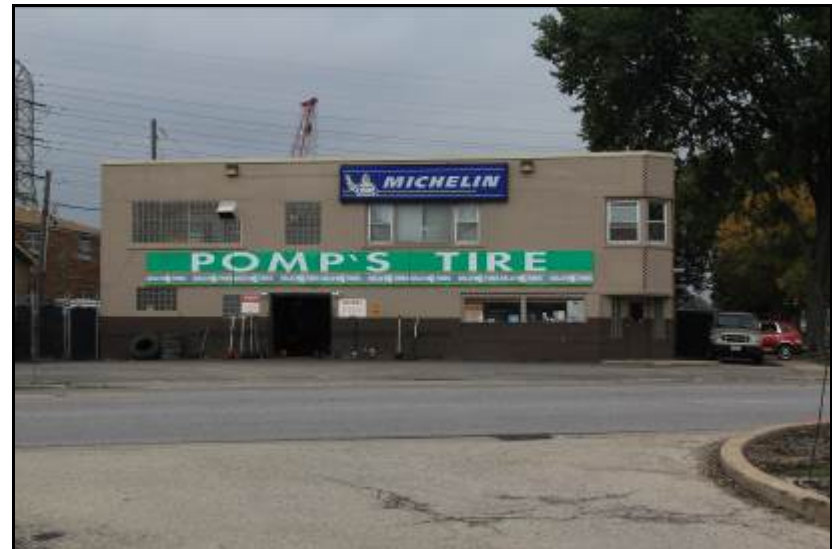
Sequence Number	Map Code	1994/95 Negative #	Address/Location	Type	Date Built	Historic Function	1994/95 Comments	2012/13 Comments and Photo Image #
A69	N/A	None	8240 Joliet Rd., McCOOK	2	Ca. 1950s	Garage (?)	Not surveyed in 1994/5	The building housing "Pomp's Tires" MAY once have been a truck care facility. IMG_3852

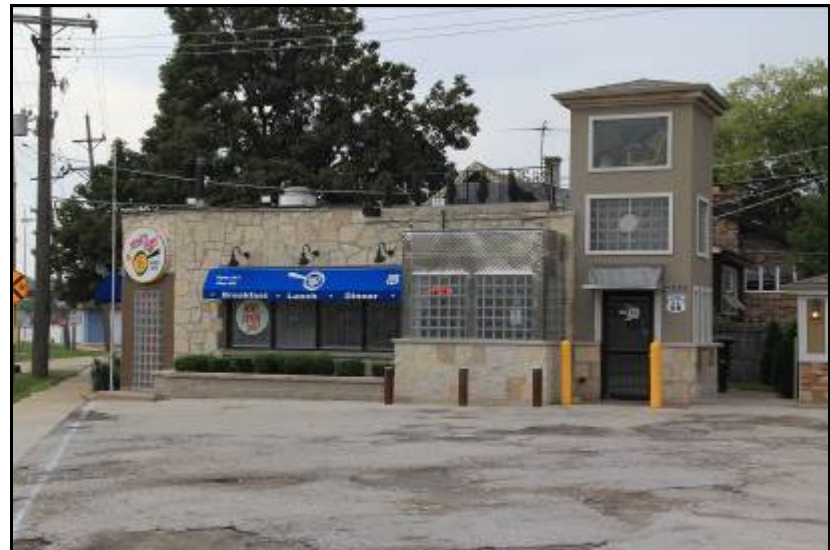
Sequence Number	Map Code	1994/95 Negative #	Address/Location	Type	Date Built	Historic Function	1994/95 Comments	2012/13 Comments and Photo Image #
A70	N/A	None	8408 Joliet Rd., McCOOK	2	Ca. 1970s (?)	Restaurant	Not surveyed in 1994/5	A “Steak & Egger” with RT 66 signs. This structure likely POST-DATES the highway. IMG_3853

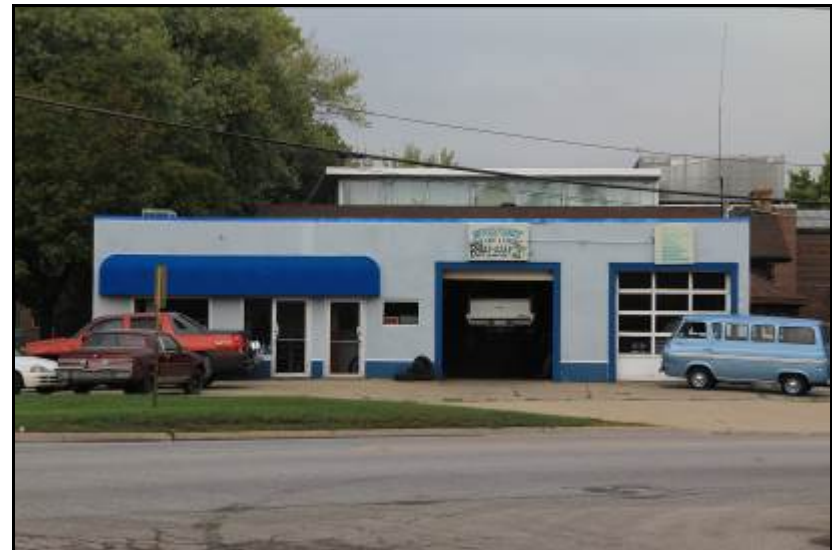
Sequence Number	Map Code	1994/95 Negative #	Address/Location	Type	Date Built	Historic Function	1994/95 Comments	2012/13 Comments and Photo Image #
A71	N/A	None	8418 Joliet Rd., McCOOK	2	Ca. 1950s- 60s	Garage	Not surveyed in 1994/5	"Riverfront Auto Care," an auto- mobile care garage with RT 66 signs. IMG_3854

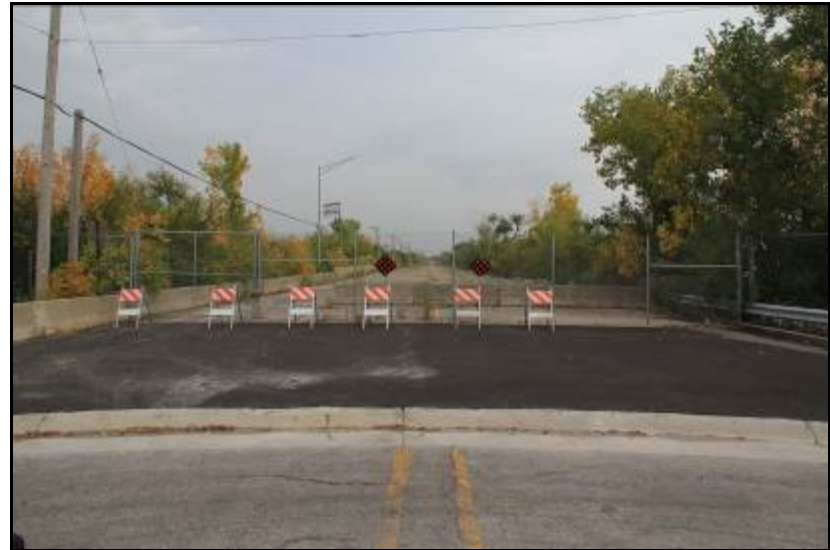
Sequence Number	Map Code	1994/95 Negative #	Address/Location	Type	Date Built	Historic Function	1994/95 Comments	2012/13 Comments and Photo Image #
A72	N/A	None	Joliet Rd., McCOOK	1	Unknown	RT 66	Not surveyed in 1994/5	The RT 66 roadway is closed between two quarries. IMG_3855

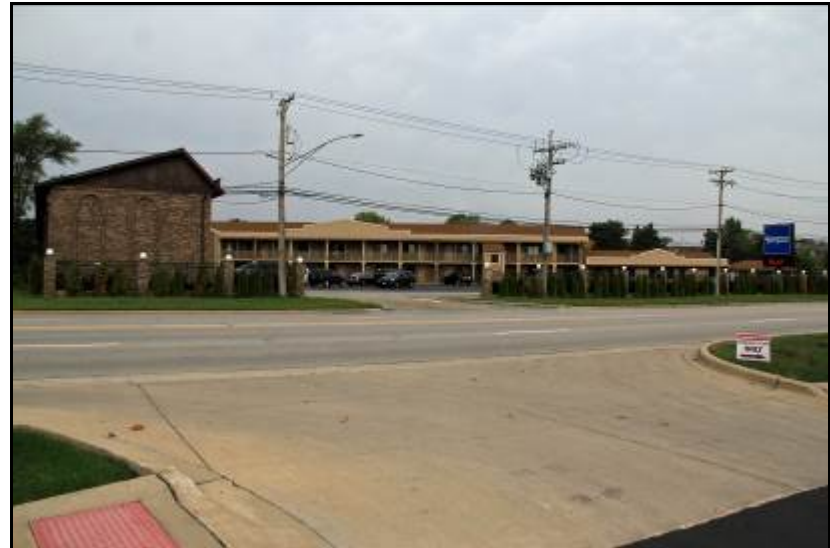
Sequence Number	Map Code	1994/95 Negative #	Address/Location	Type	Date Built	Historic Function	1994/95 Comments	2012/13 Comments and Photo Image #
A74	N/A	None	6401 Joliet Rd., LaGRANGE	2	Ca. 1960s-70s	Motel	Not surveyed in 1994/5	“Rodeway Inn & Suites” is a two-story, brick motel built in an “L” shape. IMG_3857

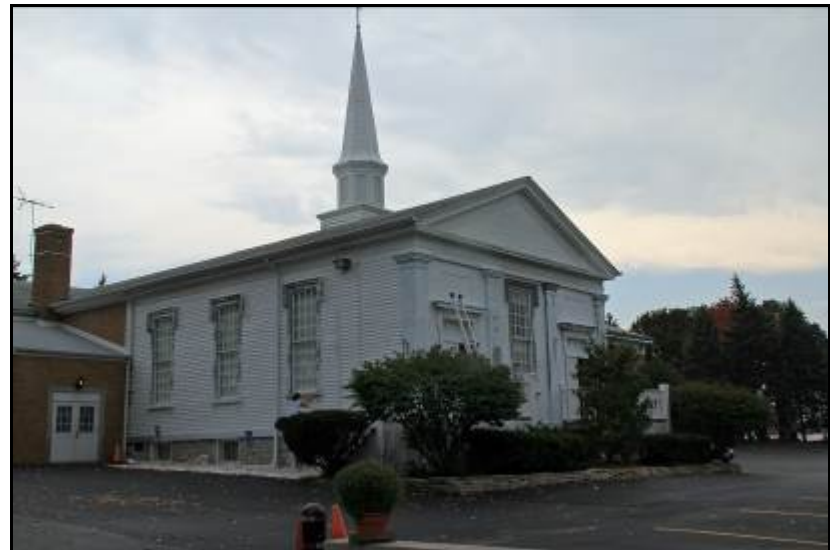
Sequence Number	Map Code	1994/95 Negative #	Address/Location	Type	Date Built	Historic Function	1994/95 Comments	2012/13 Comments and Photo Image #
A75	N/A	None	Joliet Rd. & Wolf Rd., INDIAN HEAD PARK	3	19 th Century	Church	Not surveyed in 1994/5	The historic front of this Greek Revival Church retains a significant amount of integrity. IMG_3858

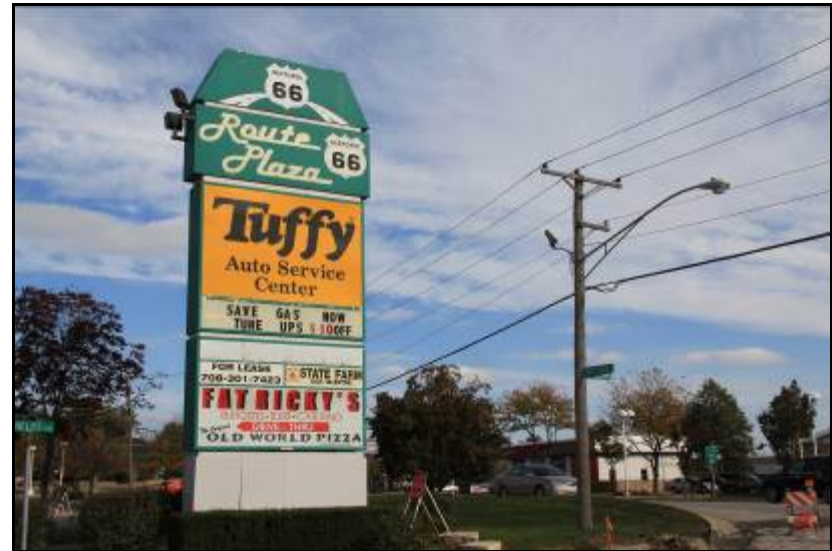
Sequence Number	Map Code	1994/95 Negative #	Address/Location	Type	Date Built	Historic Function	1994/95 Comments	2012/13 Comments and Photo Image #
A81	N/A	None	IL 53 & Norman-town Rd., ROMEOVILLE	3	Unknown	Retail	Not surveyed in 1994/5	“Route 66 Plaza” is an example of how the RT 66 name is tied to marketing along the roadway across the state. IMG_3929

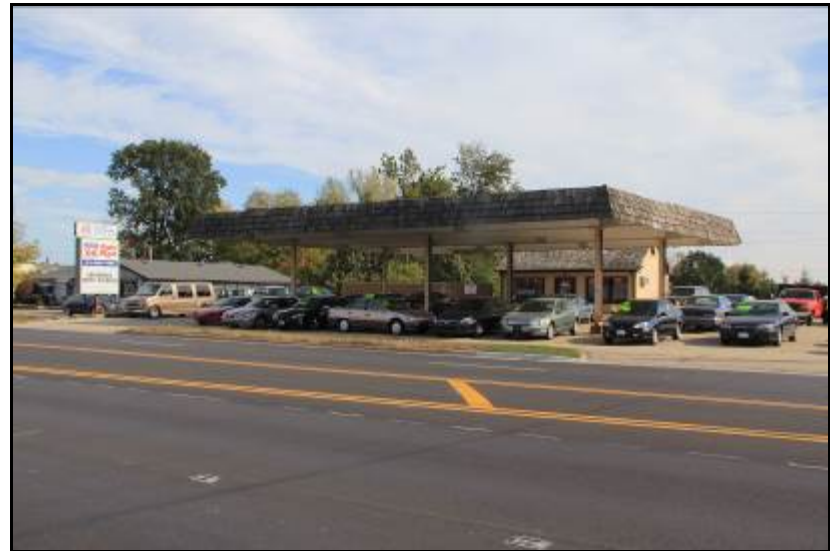
Sequence Number	Map Code	1994/95 Negative #	Address/Location	Type	Date Built	Historic Function	1994/95 Comments	2012/13 Comments and Photo Image #
A82	N/A	None	639 N. Independence Blvd., ROMEOVILLE	2	Ca. 1960s-70s	Gas Station	Not surveyed in 1994/5	This former gas station is now the "Route 66 Auto Mart." IMG_3930

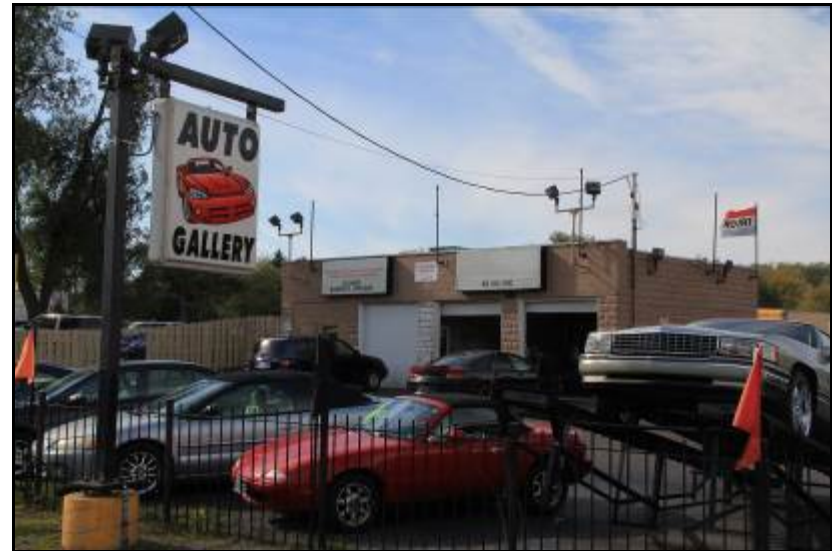
Sequence Number	Map Code	1994/95 Negative #	Address/Location	Type	Date Built	Historic Function	1994/95 Comments	2012/13 Comments and Photo Image #
A83	N/A	None	15050 S. Independence Blvd., ROMEDEVILLE	2	Ca. 1930s-40s	Gas/Service	Not surveyed in 1994/5	Now the "Auto Gallery," this is likely an old vehicular service facility. IMG_3931

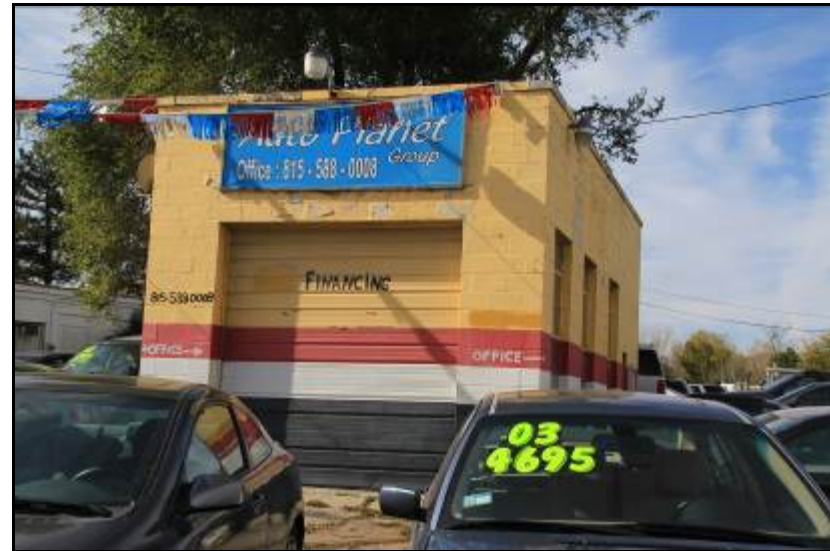
Sequence Number	Map Code	1994/95 Negative #	Address/Location	Type	Date Built	Historic Function	1994/95 Comments	2012/13 Comments and Photo Image #
A84	N/A	None	15056 S. Independence Blvd., ROMEDEVILLE	2	Ca. 1950s	Auto Service	Not surveyed in 1994/5	"Auto Planet" utilizes an old, concrete block service garage on RT 66. IMG_3933

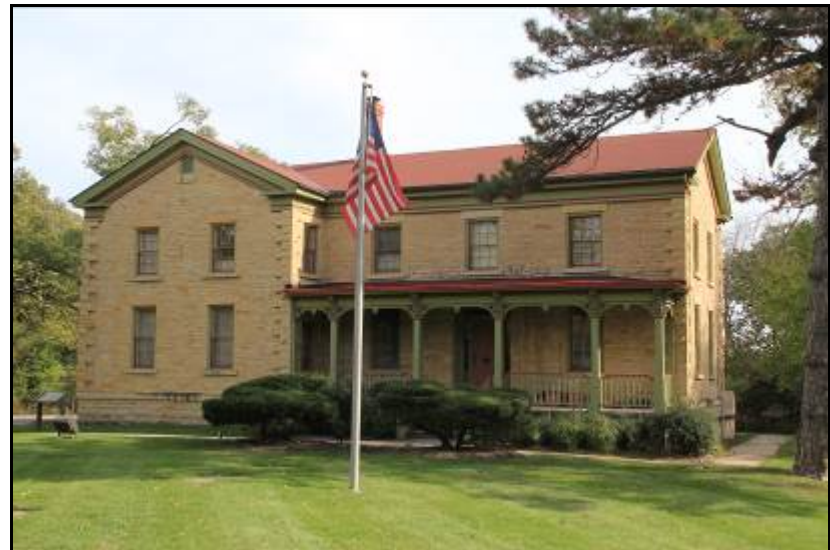
Sequence Number	Map Code	1994/95 Negative #	Address/Location	Type	Date Built	Historic Function	1994/95 Comments	2012/13 Comments and Photo Image #
A85	N/A	None	15701 S. Independence Blvd., ROMEDEVILLE	3	Ca. 1840s	House	Not surveyed in 1994/5	The "Historic Fitzpatrick House at Lewis University" is a prominent, two-story, gabled ell house with very pronounced corner quoins. IMG_3934, 3935, 3938

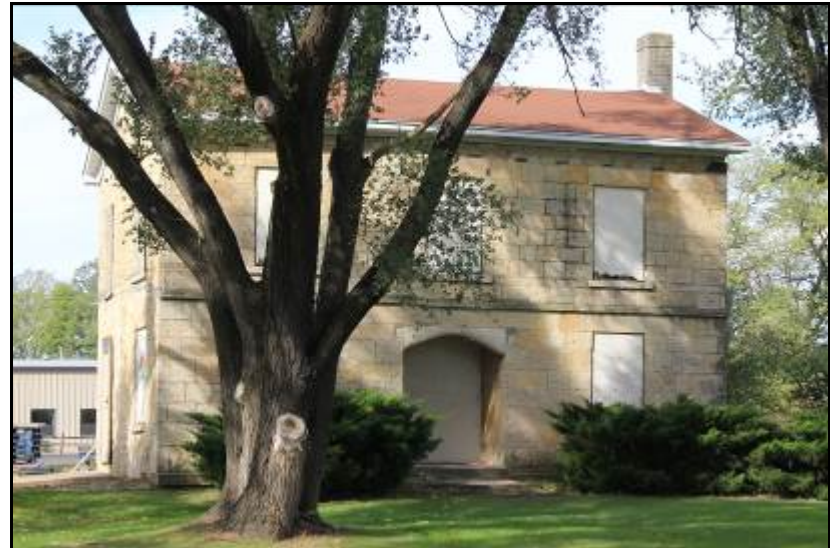
Sequence Number	Map Code	1994/95 Negative #	Address/Location	Type	Date Built	Historic Function	1994/95 Comments	2012/13 Comments and Photo Image #
A87	N/A	None	16210 S. Broadway, ROMEOVILLE	3	Ca. Mid-19 th Century	House	Not surveyed in 1994/5	Old stone house now associated with Park & Golf maintenance shops. IMG_3941

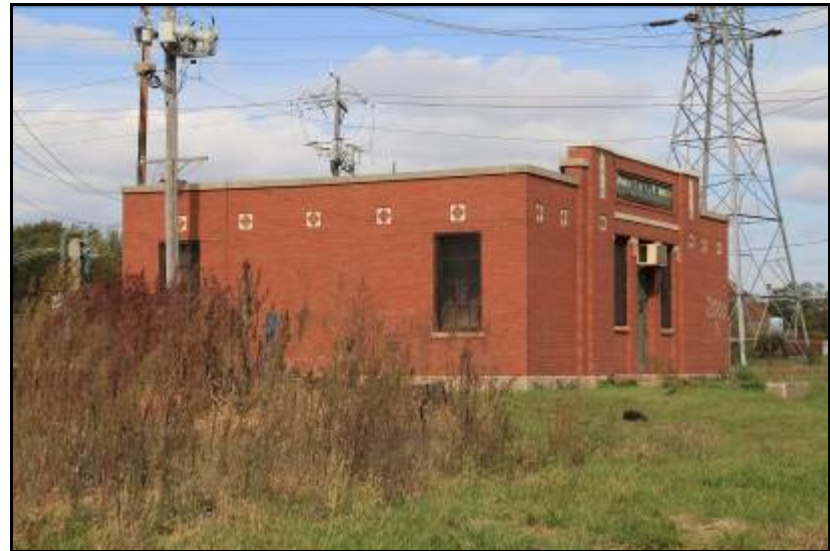
Sequence Number	Map Code	1994/95 Negative #	Address/Location	Type	Date Built	Historic Function	1994/95 Comments	2012/13 Comments and Photo Image #
A89	N/A	None	----- Broadway St., CREST HILL	3	Ca. 1920s	Utility Building	Not surveyed in 1994/5	This old "Public Service Company" building is constructed of brick and has a stepped parapet over the front door. IMG_3943

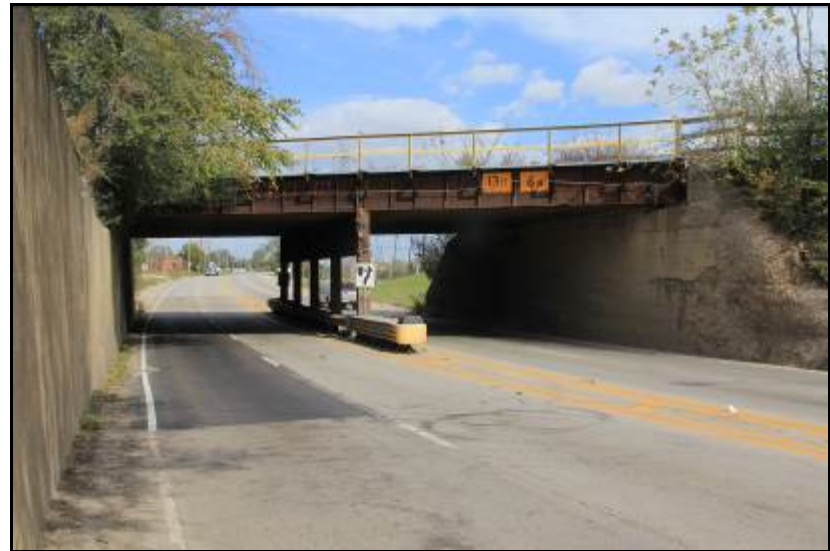
Sequence Number	Map Code	1994/95 Negative #	Address/Location	Type	Date Built	Historic Function	1994/95 Comments	2012/13 Comments and Photo Image #
A90	N/A	None	Broadway St. under Railroad Tracks, CREST HILL	2	Ca. 20 th Century	Bridge	Not surveyed in 1994/5	A simple post-and-beam bridge that carries railroad tracks over RT 66. IMG_3944

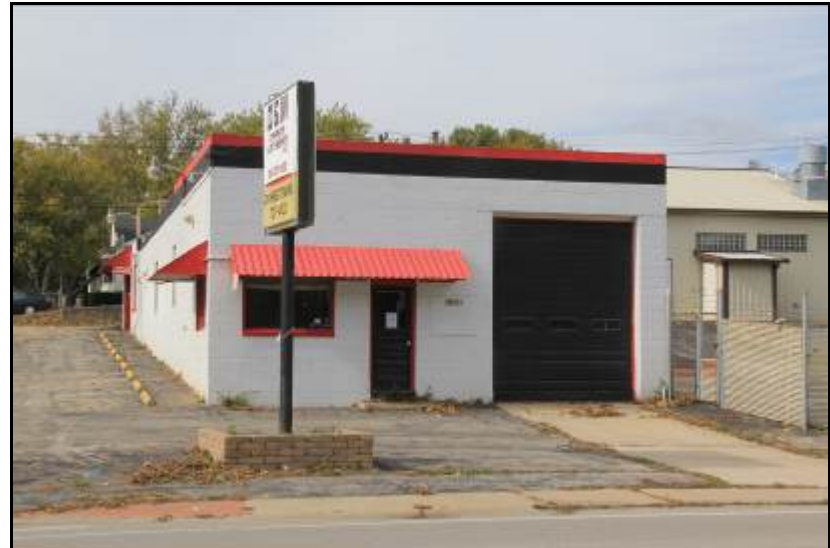
Sequence Number	Map Code	1994/95 Negative #	Address/Location	Type	Date Built	Historic Function	1994/95 Comments	2012/13 Comments and Photo Image #
A91	N/A	None	1901 Broadway St., CREST HILL	2	Ca. 1950s	Auto Service (?)	Not surveyed in 1994/5	A simple, concrete block building that may have offered auto repair services. IMG_3945

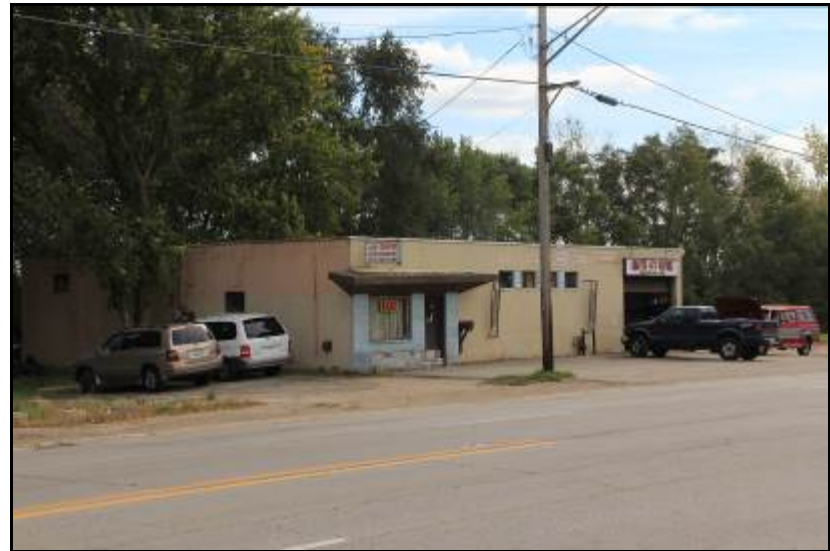
Sequence Number	Map Code	1994/95 Negative #	Address/Location	Type	Date Built	Historic Function	1994/95 Comments	2012/13 Comments and Photo Image #
A92	N/A	None	1820 Broadway St., CREST HILL	2	Ca. 1940s-50s	Auto Service (?)	Not surveyed in 1994/5	It is likely that this concrete block building was an auto repair operation – now “Chaves Auto Repair.” IMG_3947, 3946

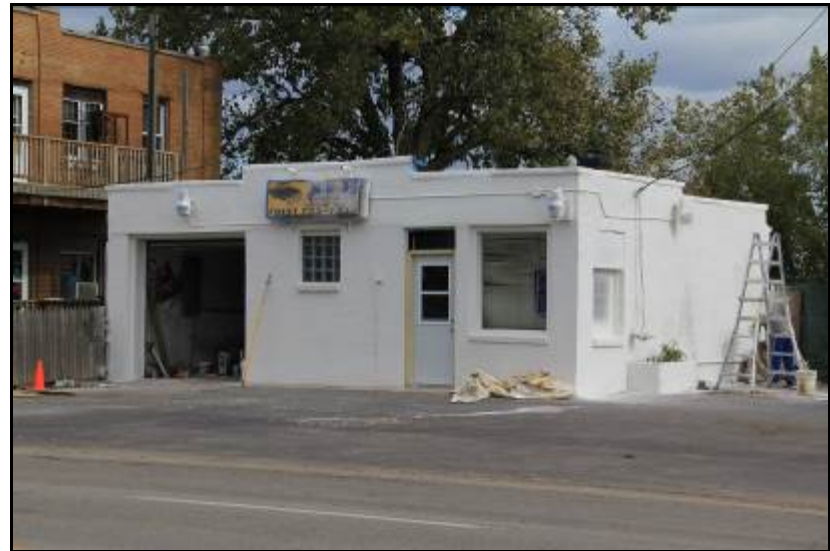
Sequence Number	Map Code	1994/95 Negative #	Address/Location	Type	Date Built	Historic Function	1994/95 Comments	2012/13 Comments and Photo Image #
A93	N/A	None	1714 Broadway St., CREST HILL	2	Ca. 1930s	Gas Station	Not surveyed in 1994/5	This stucco-sheathed building, now housing "J & H Auto" and being painted, appears to retain a good degree of integrity. IMG_3948

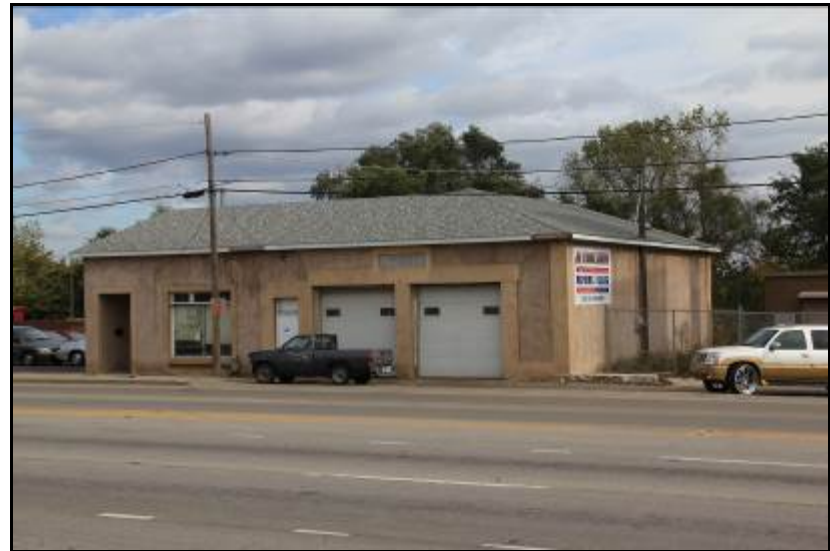
Sequence Number	Map Code	1994/95 Negative #	Address/Location	Type	Date Built	Historic Function	1994/95 Comments	2012/13 Comments and Photo Image #
A94	N/A	None	1600 Broadway St., CREST HILL	2	1927	Auto Repair & Service (?)	Not surveyed in 1994/5	"A1 Elite Automotive" appears to have been an auto repair facility on RT 66. Cornice inset "EGIZIO 1927." IMG_3949

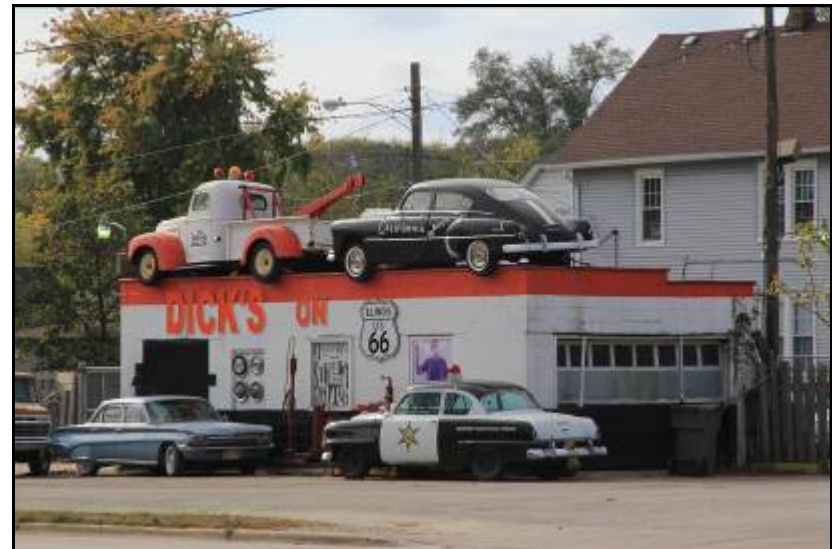
Sequence Number	Map Code	1994/95 Negative #	Address/Location	Type	Date Built	Historic Function	1994/95 Comments	2012/13 Comments and Photo Image #
A98	N/A	None	900 N. Broadway St., JOLIET	2	Ca. 1950s	Gas Station	Not surveyed in 1994/5	"Dick's on 66" is housed in an old concrete block accommodation. IMG_3958

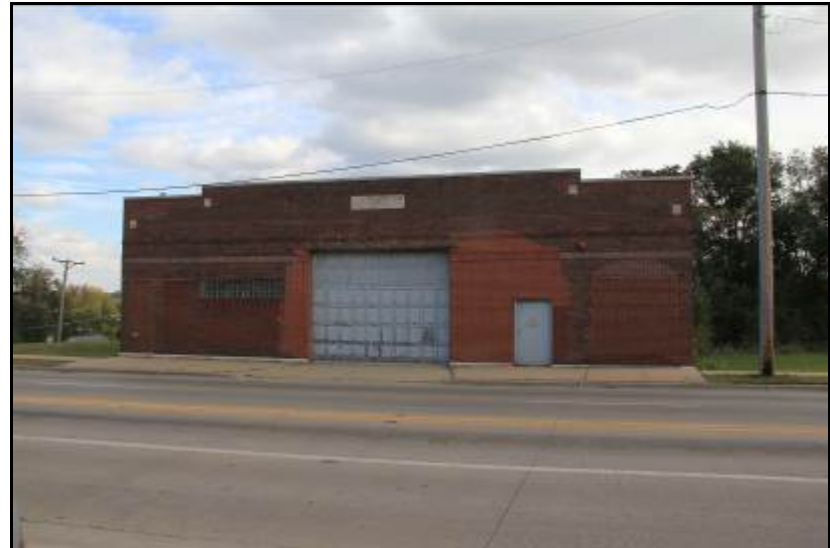
Sequence Number	Map Code	1994/95 Negative #	Address/Location	Type	Date Built	Historic Function	1994/95 Comments	2012/13 Comments and Photo Image #
A99	N/A	None	768 N. Broadway St., JOLIET	2	1930	Garage	Not surveyed in 1994/5	This MAY have been an old auto care facility. Cornice stone notes "H.M. Kochevar 1930." IMG_3959

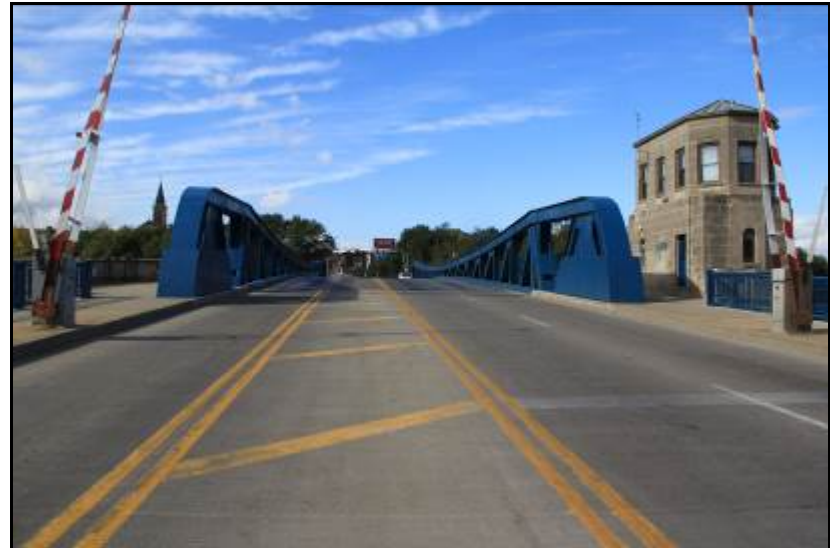
Sequence Number	Map Code	1994/95 Negative #	Address/Location	Type	Date Built	Historic Function	1994/95 Comments	2012/13 Comments and Photo Image #
A100	N/A	None	Ruby St. & Des Plaines River, JOLIET	1	1935	Bascule Bridge	Not surveyed in 1994/5	The Ruby St. bascule bridge carried RT 66 over the Des Plaines River. IMG_3961, 3962, 3963

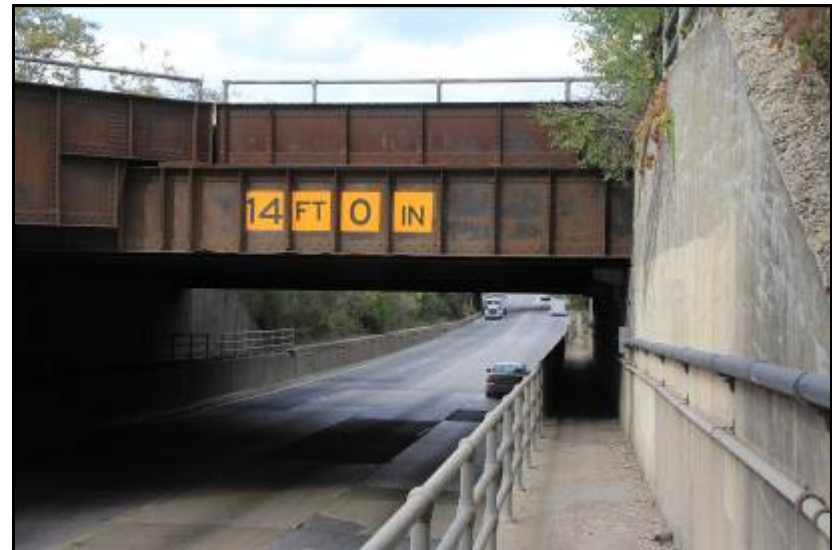
Sequence Number	Map Code	1994/95 Negative #	Address/Location	Type	Date Built	Historic Function	1994/95 Comments	2012/13 Comments and Photo Image #
A113	N/A	None	Chicago St., JOLIET	2	Unknown	Railroad Bridge	Not surveyed in 1994/5	A simple post-and-beam structural system carries the railroad over RT 66. S of IH-80. IMG_3982

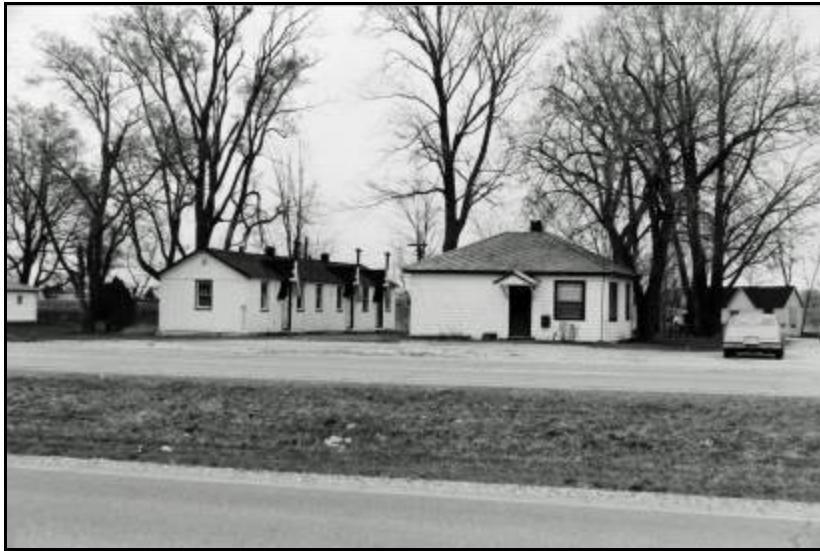
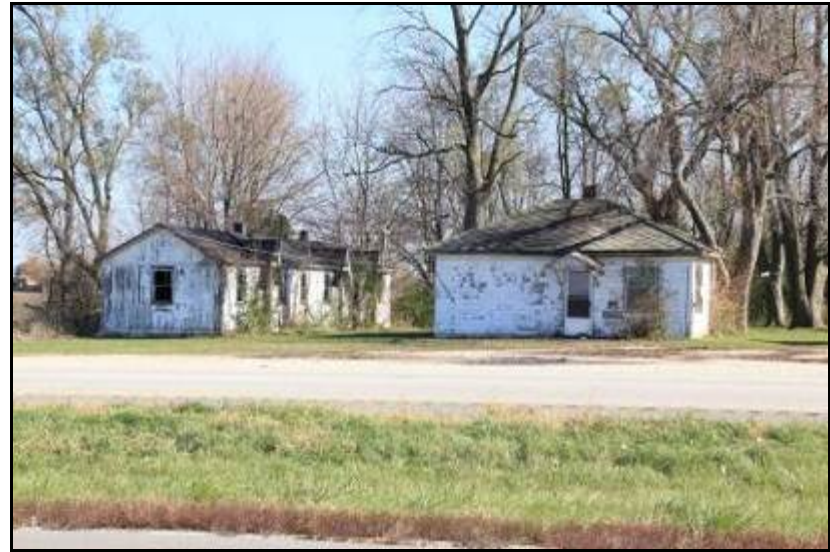
Sequence Number	Map Code	1994/95 Negative #	Address/Location	Type	Date Built	Historic Function	1994/95 Comments	2012/13 Comments and Photo Image #
1	06/01	06/01, IMG_1740	2428 IL 53 – S of Laraway Rd.	2	Ca. 1950s	Motel	Consists of a small office with clapboard siding, as well as long, narrow, gabled structures with small wall dormers over each room's door.	Motel remains. Now vacant and dilapidated. IMG_1220

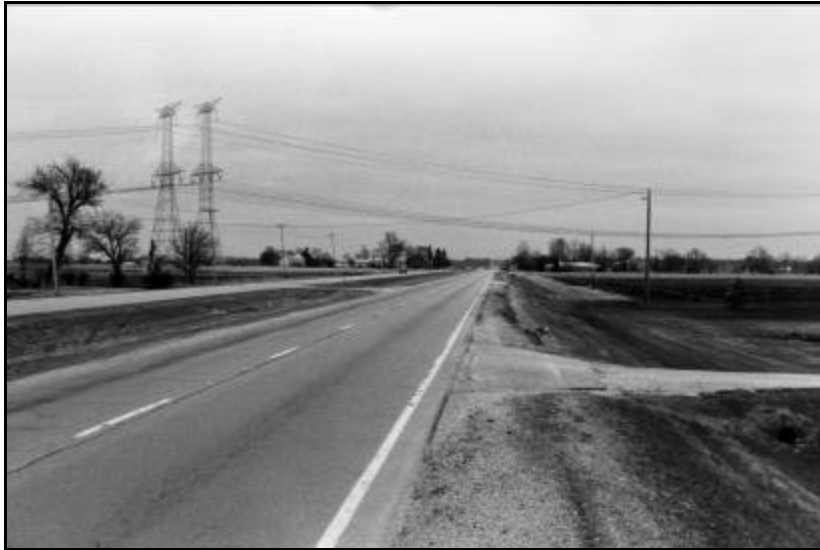
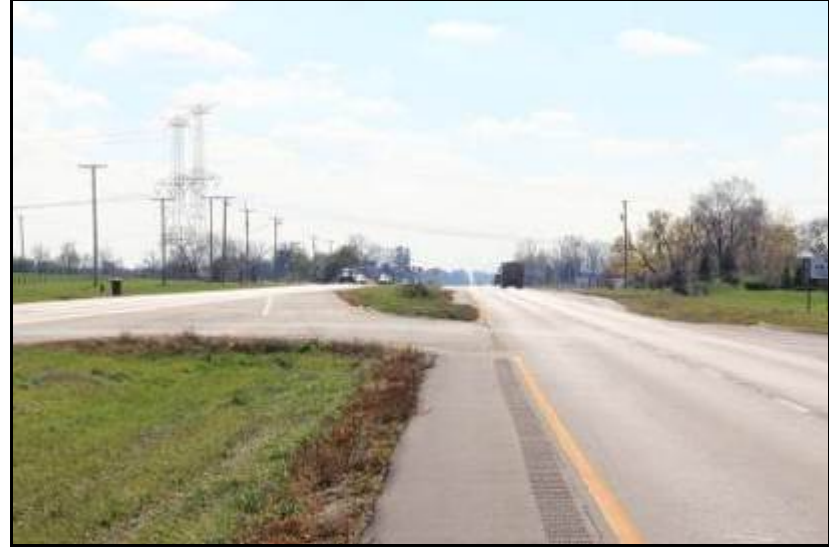
Sequence Number	Map Code	1994/95 Negative #	Address/Location	Type	Date Built	Historic Function	1994/95 Comments	2012/13 Comments and Photo Image #
3	06/03	06/03, IMG_1741	IL 53 & Sharp Rd.	1	Ca. Late 1940s	USH 66	Four-lane RT 66 (later Business route) between Joliet and Wilmington [view to S].	Recently re-paved (note impact on shoulders). IMG_1223

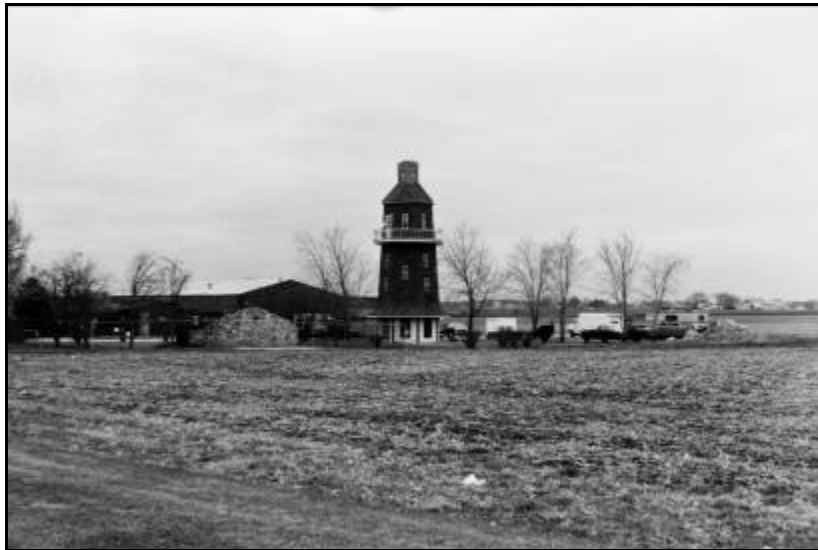
Sequence Number	Map Code	1994/95 Negative #	Address/Location	Type	Date Built	Historic Function	1994/95 Comments	2012/13 Comments and Photo Image #
4	06/04	06/04, IMG_1742	IL 53 – between Millsdale and Breen rds	3	Unknown	Unknown	Rather odd-looking structure that appears to be the base of a windmill.	Structure is gone.

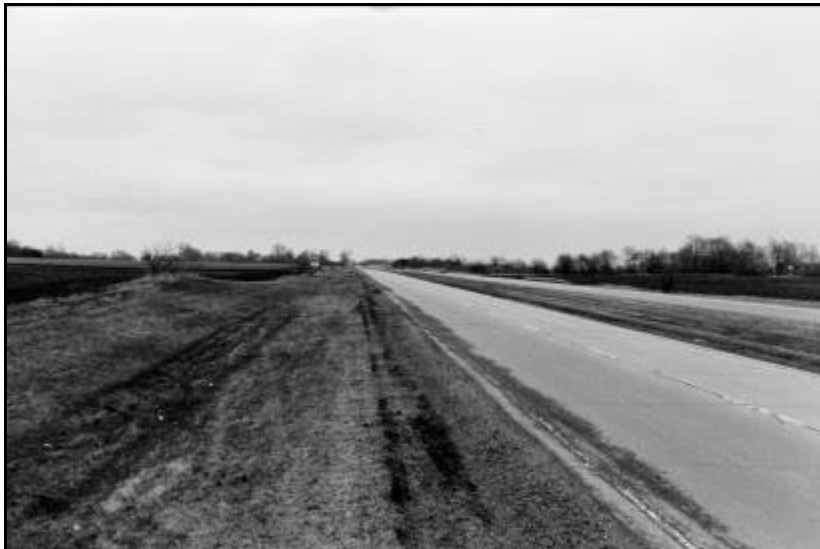
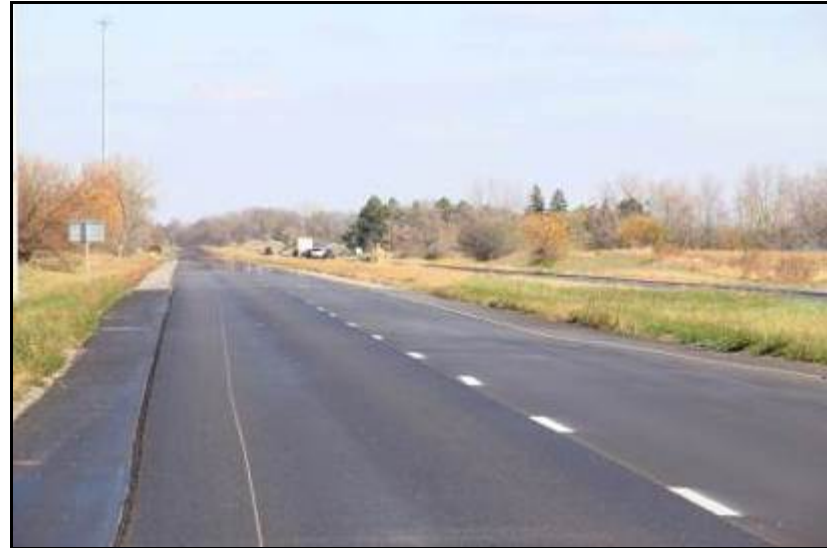
Sequence Number	Map Code	1994/95 Negative #	Address/Location	Type	Date Built	Historic Function	1994/95 Comments	2012/13 Comments and Photo Image #
6	06/07	07/07, IMG_1744	IL 53 & Mississippi Rd.	1	Ca. Late 1940s	USH 66	Four-lane RT 66 (later Business Route) between Joliet and Wilmington [view to N].	Currently being re-paved (note impact on shoulders). IMG_1225

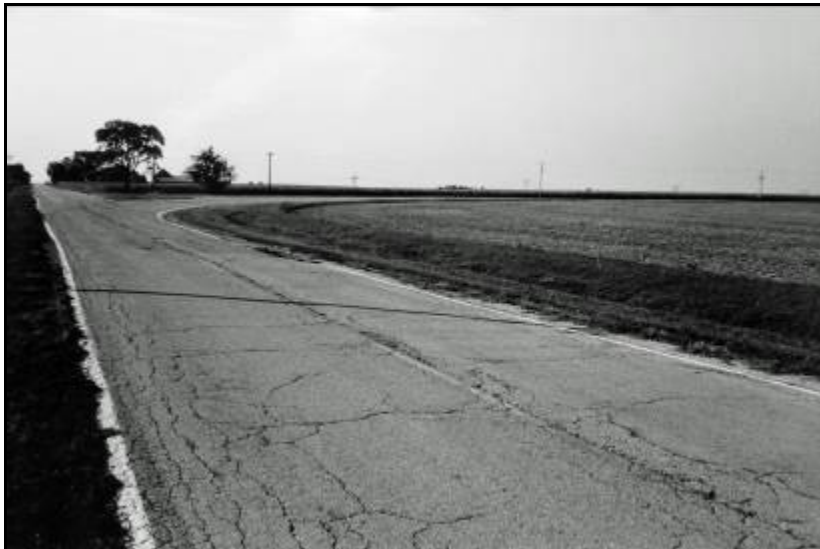
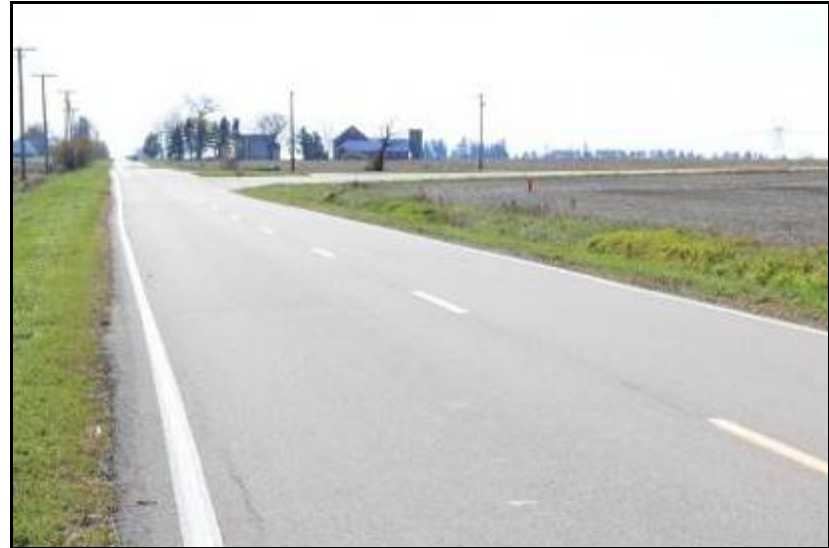
Sequence Number	Map Code	1994/95 Negative #	Address/Location	Type	Date Built	Historic Function	1994/95 Comments	2012/13 Comments and Photo Image #
7	20/00	20/00, IMG_1745	Old Chicago Rd. & Mississippi Rd.	1	Ca. 1930s	USH 66	Two-lane RT 66 with 9-foot lanes, ENE of Elwood – now used as local road.	Roadway has been repaved since 1994. IMG_1226

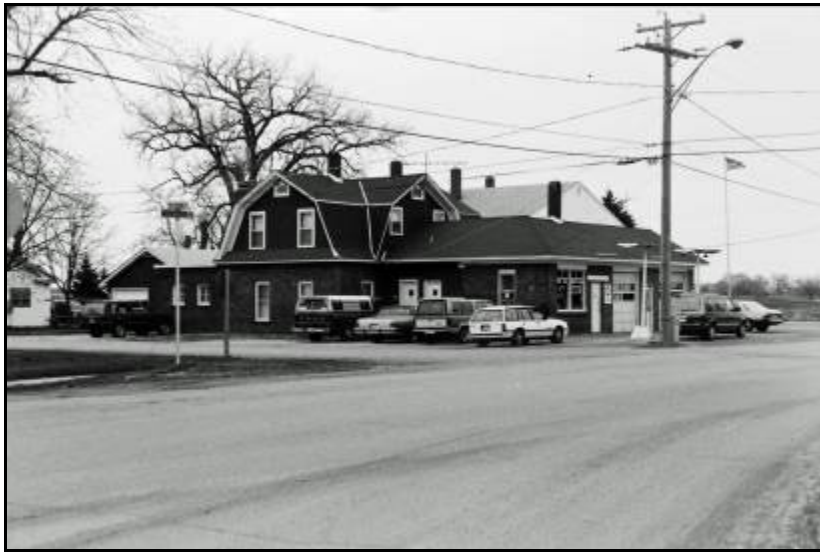
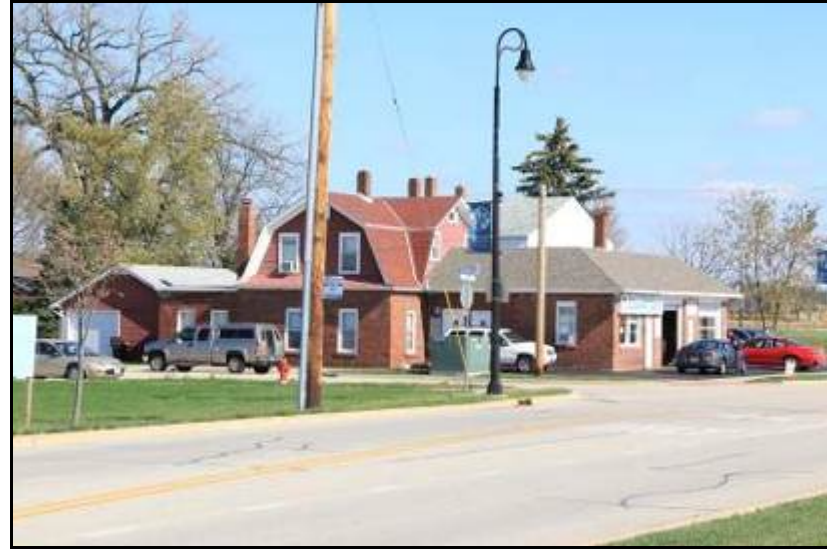
Sequence Number	Map Code	1994/95 Negative #	Address/Location	Type	Date Built	Historic Function	1994/95 Comments	2012/13 Comments and Photo Image #
8	06/08	06/08, IMG_1746	NE corner – Mississippi & Douglas, ELWOOD	2	Unknown	Gas/Service	Cross gable, gambrel roof house with a gas/service station addition built onto the front; could post-date the re-routing of 66 from the Mississippi to Douglas alignment through Elwood.	Few apparent changes. One garage door may have been closed and remodeled. IMG_1227

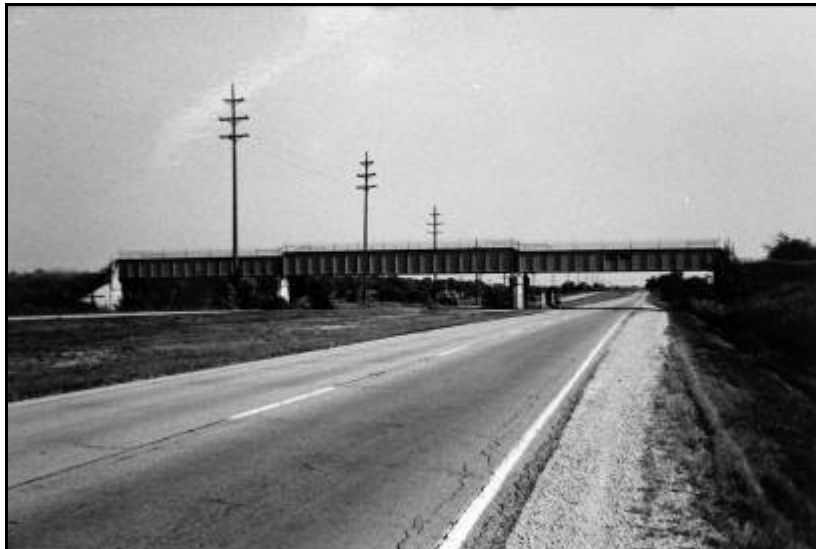
Sequence Number	Map Code	1994/95 Negative #	Address/Location	Type	Date Built	Historic Function	1994/95 Comments	2012/13 Comments and Photo Image #
10	20/01	20/01, IMG_1748	IL 53 under Juliet Munitions RR overpass	2	Ca. 1940s	RR Overpass	No bridge plate or IDOT bridge number, "T" beam construction.	No apparent changes on bridge. Note that roadway now has paved shoulders. IMG_1231

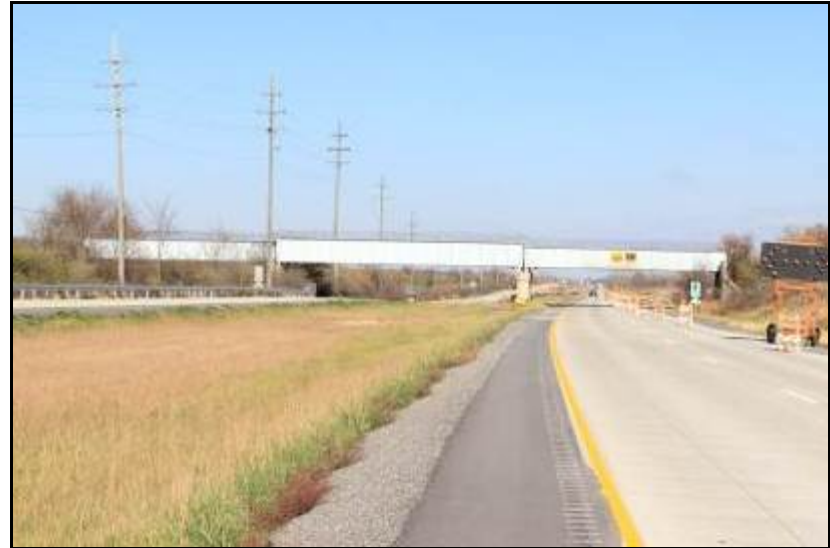
Sequence Number	Map Code	1994/95 Negative #	Address/Location	Type	Date Built	Historic Function	1994/95 Comments	2012/13 Comments and Photo Image #
11	06/10	06/10, 20/02, IMG_1749	IL 53 over Prairie Creek – S of Doyle Rd.	1	Ca. 1940s-50s	Bridge	One structure (for northbound lanes) remains: Bridge #099-0090 – no plate; three-span structure with five arched “T” beams that support a concrete deck.	This bridge was replaced in 2008.

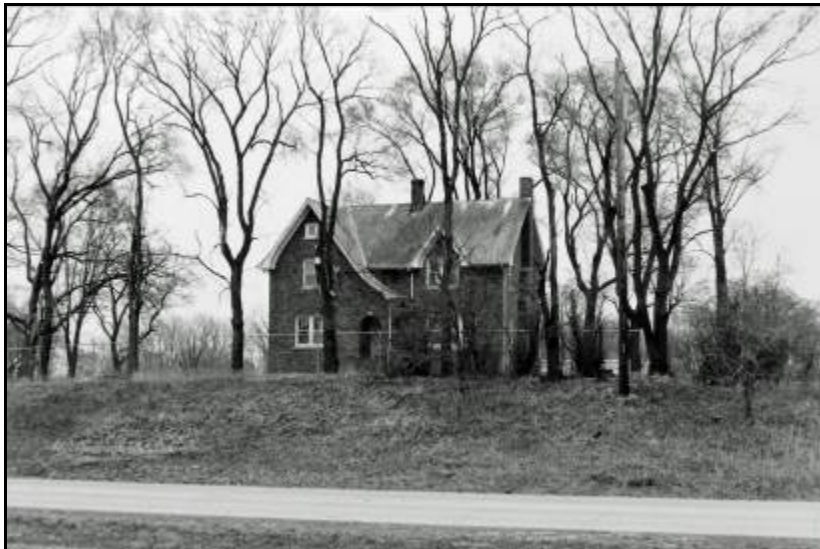
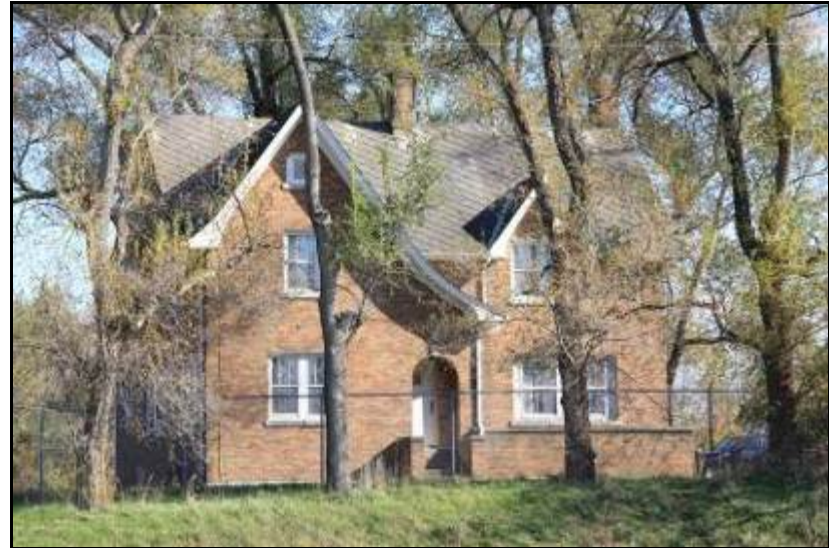
Sequence Number	Map Code	1994/95 Negative #	Address/Location	Type	Date Built	Historic Function	1994/95 Comments	2012/13 Comments and Photo Image #
12	06/11	06/11, IMG_1750	Il 53 & Webster Siding	3	Ca. 1920s-30s	Residential	Prominent, two-story, brick house on the grounds of the Joliet Munitions complex.	House is little changed. IMG_1234

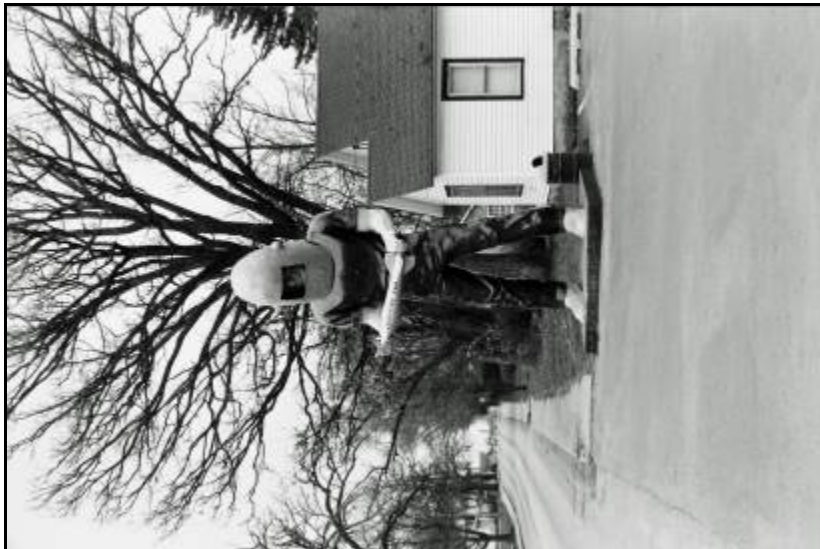
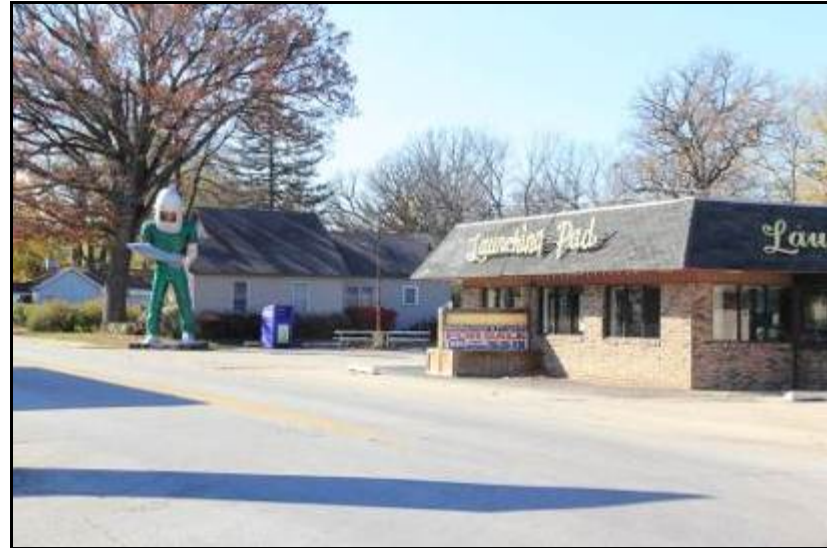
Sequence Number	Map Code	1994/95 Negative #	Address/Location	Type	Date Built	Historic Function	1994/95 Comments	2012/13 Comments and Photo Image #
13	06/12	06/12, IMG_1751	Baltimore & Daniels – E side of Wilmington	3	Ca. 1950s	Drive-In	Launching Pad Drive-In with large, road-side statue of astronaut.	Building and statue remain largely unchanged. Business is closed and building is for sale. IMG_ 1237

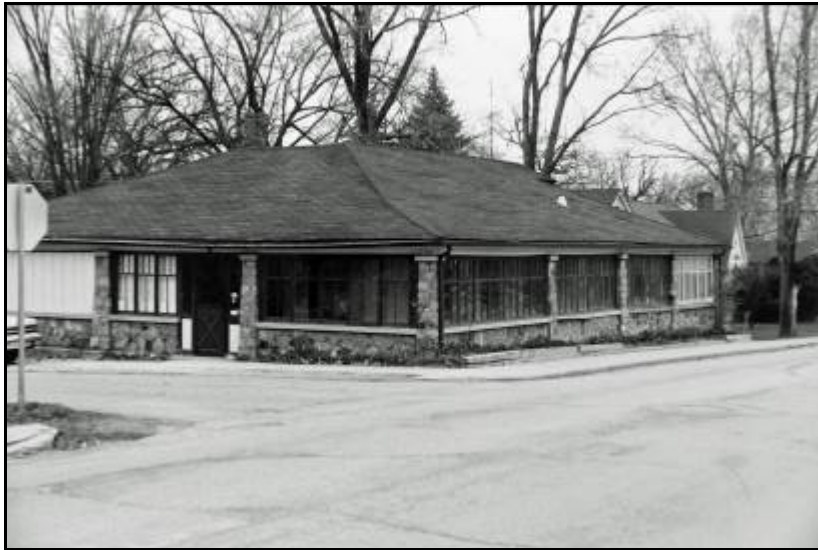
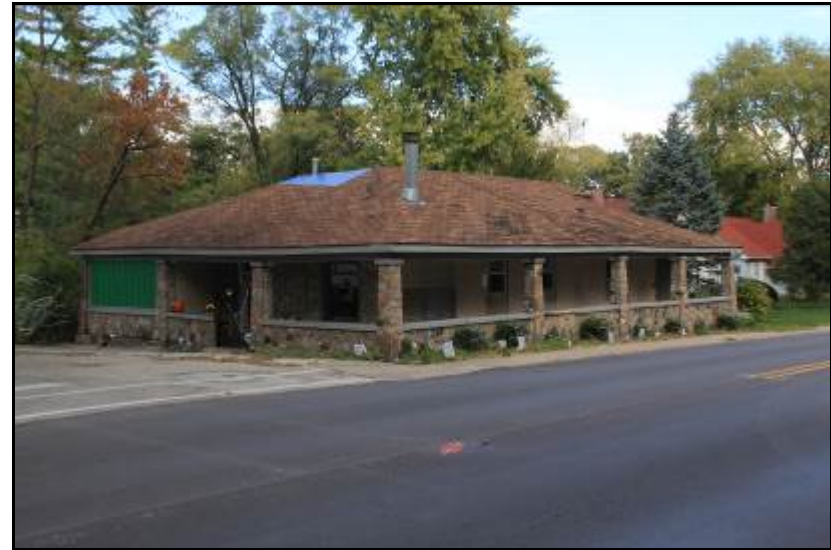
Sequence Number	Map Code	1994/95 Negative #	Address/Location	Type	Date Built	Historic Function	1994/95 Comments	2012/13 Comments and Photo Image #
14	06/13	06/13, IMG_4504	101 McIntyre	3	Ca. 1910s-20s	Residential	Large, low-lying, fieldstone structure that may have been used as a house.	This building has encountered some changes over the years, including the loss of the windows along McIntyre. IMG_3993
