Route 66 in Illinois:

(2012/13 Update and Expansion of the Original 1994/95 Survey)

IDOT Sequence #17337 & #17337A

22 December 2013

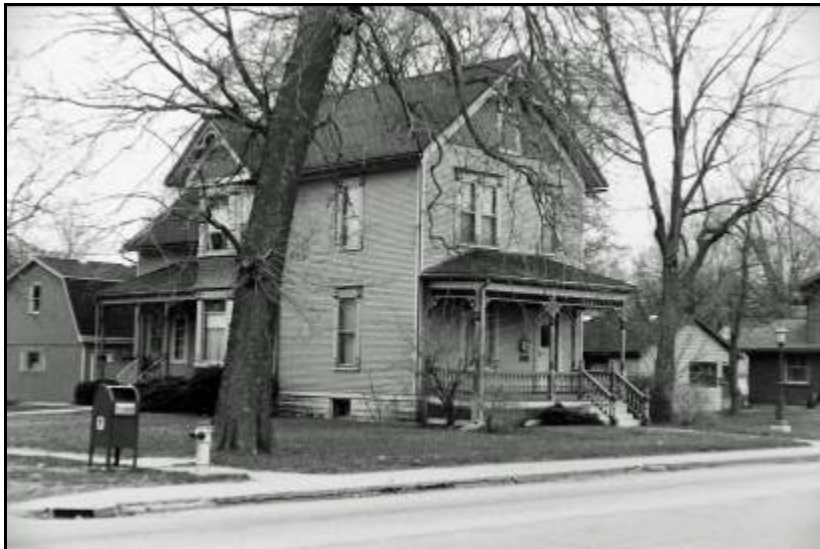
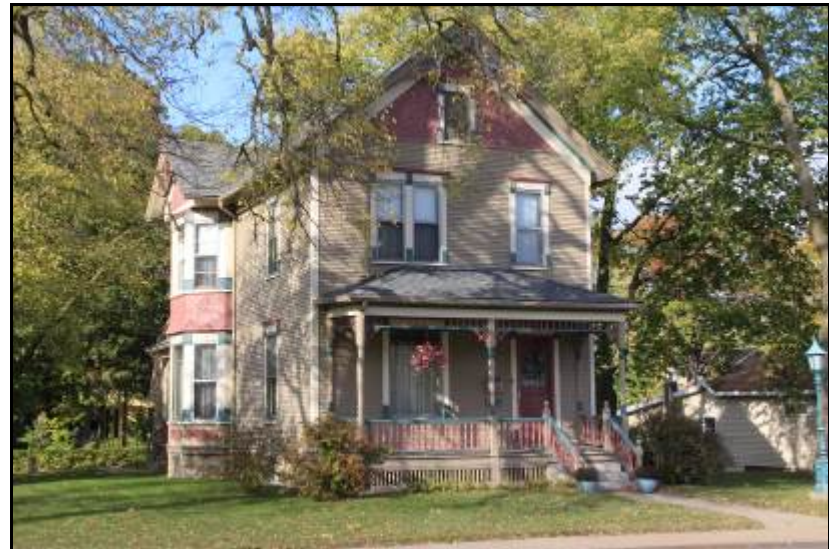
Sequence Number	Map Code	1994/95 Negative #	Address/Location	Type	Date Built	Historic Function	1994/95 Comments	2012/13 Comments and Photo Image #
15	06/14	06/14, IMG_4505	510 Baltimore	3	Ca. 1890s	Residential	Two-story, clapboard-sided, Queen Anne house with prominent ornamentation.	House is little changed. IMG_3994

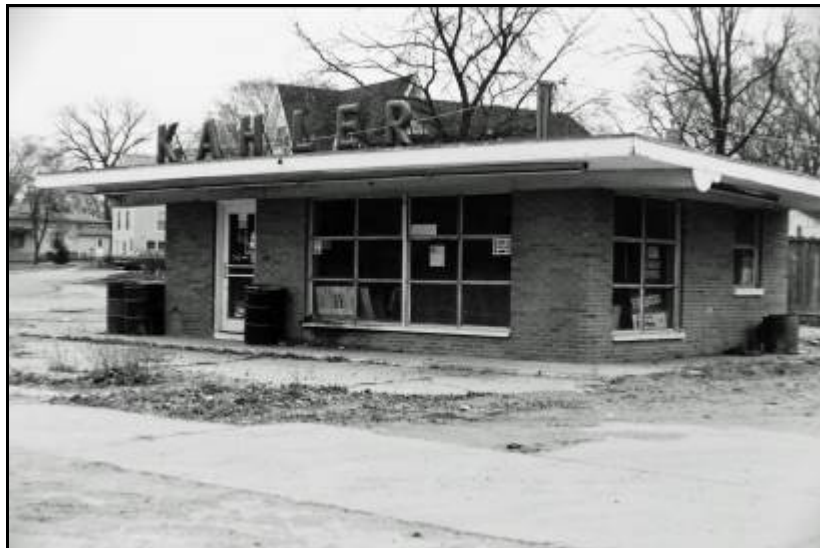
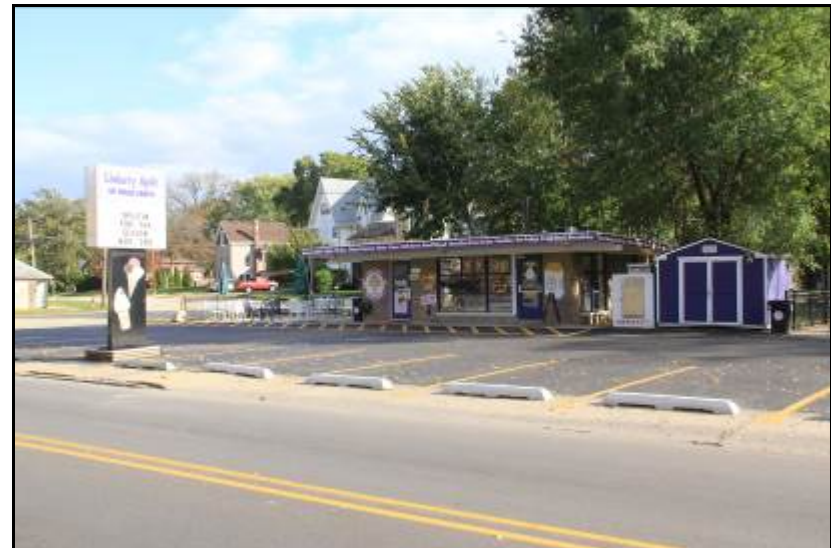
Sequence Number	Map Code	1994/95 Negative #	Address/Location	Type	Date Built	Historic Function	1994/95 Comments	2012/13 Comments and Photo Image #
16	06/15	06/15, IMG_4506	507 Baltimore	2	Ca. 1950s-60s	Gas Station	Functional-type gas station built of brick, with name of "Kahler" on it.	A significant change in use has occurred at this building. It is now a drive-in restaurant. IMG_3995

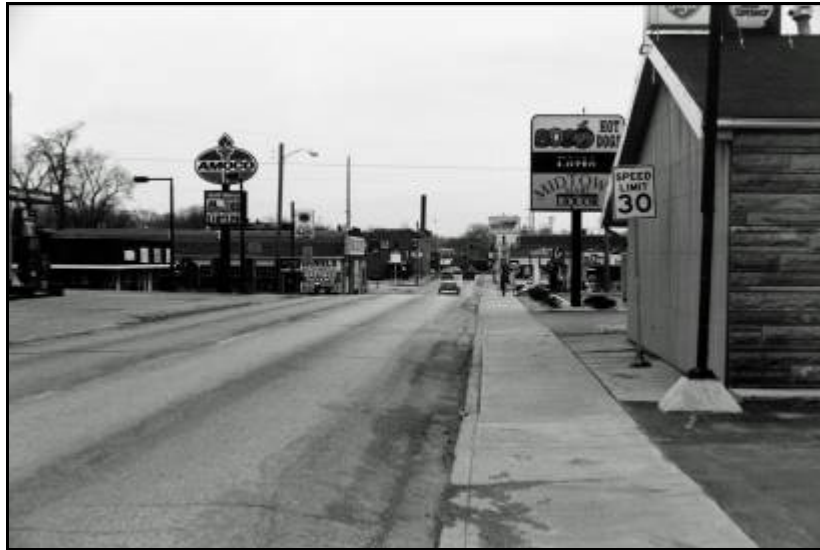
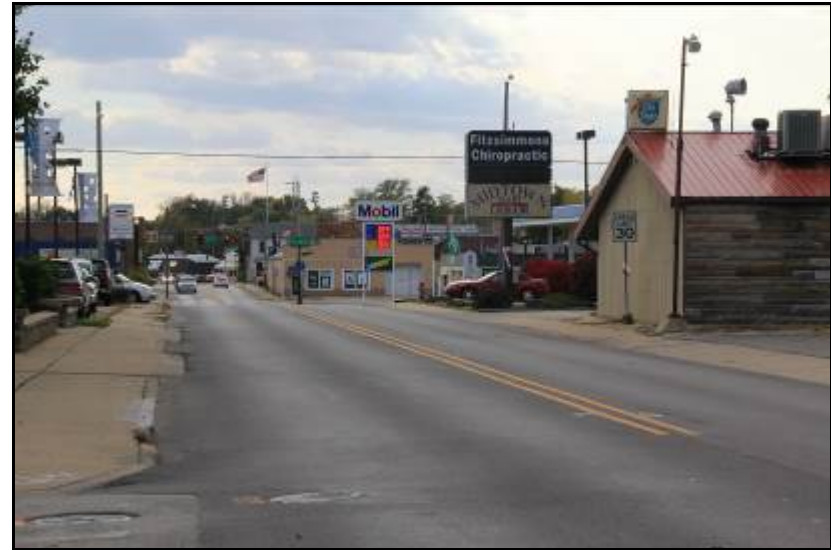
Sequence Number	Map Code	1994/95 Negative #	Address/Location	Type	Date Built	Historic Function	1994/95 Comments	2012/13 Comments and Photo Image #
17	06/29	06/29, IMG_4507	Baltimore & Joliet	1	Unknown	USH 66	Two-lane route through Wilmington [view to SW]	Perhaps the biggest change is in the signage along old RT 66. IMG_3998

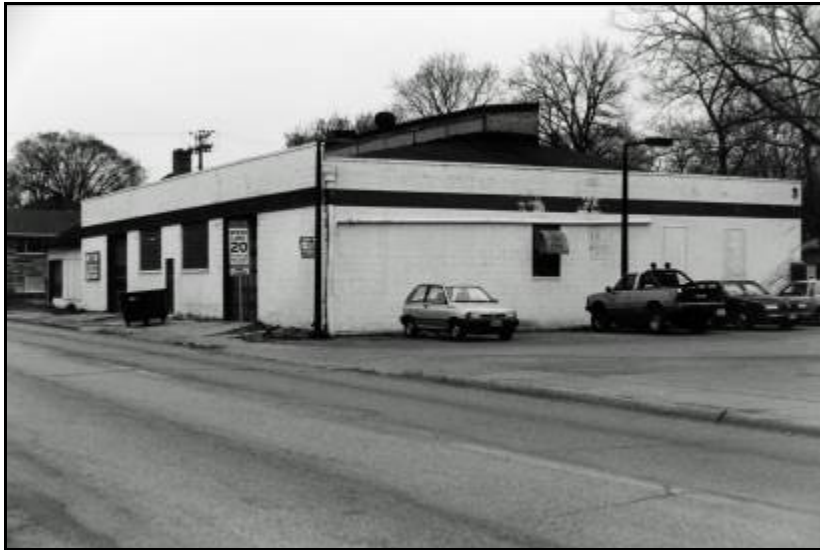
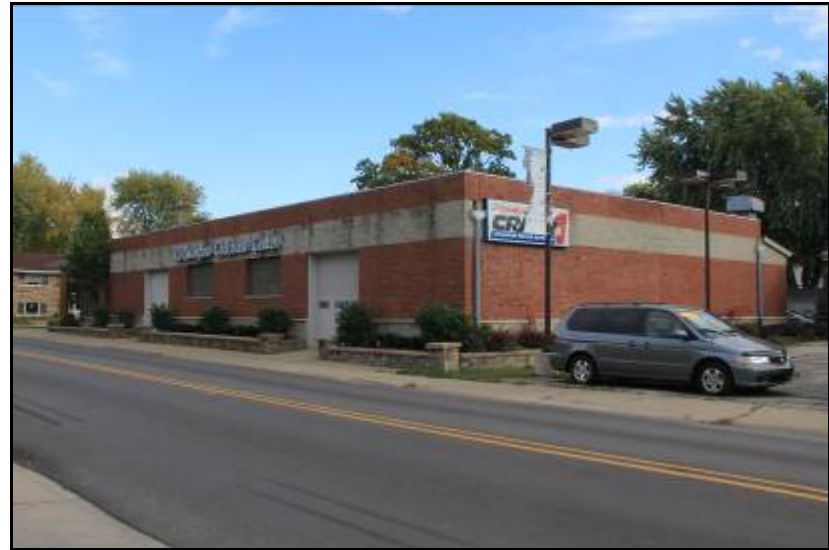
Sequence Number	Map Code	1994/95 Negative #	Address/Location	Type	Date Built	Historic Function	1994/95 Comments	2012/13 Comments and Photo Image #
18	06/16	06/16, IMG_4508	Baltimore & Joliet	2	Ca. 1940s-50s	Auto Service	Concrete block structure, may have been an automotive service-related building—now serves as “Lombardi Chevrolet Body Shop.”	This building, with some modifications, is now the “Wilmington Collision Center.” IMG_3999

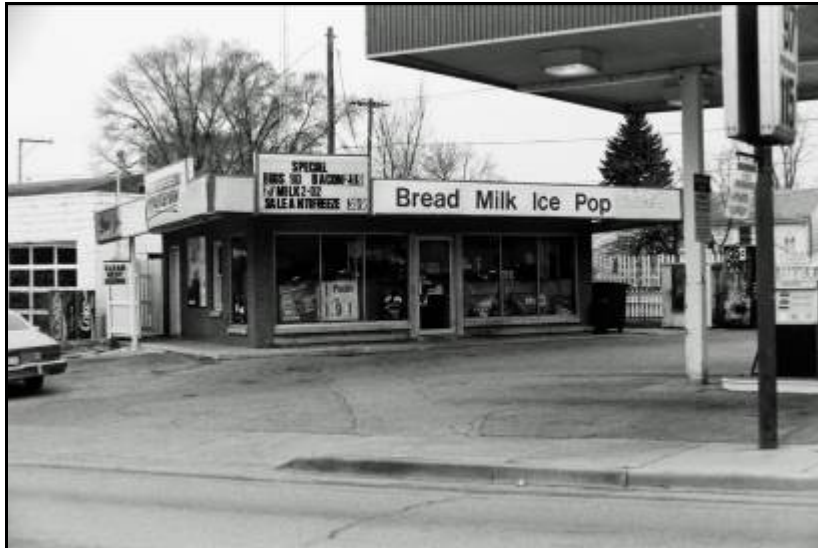
Sequence Number	Map Code	1994/95 Negative #	Address/Location	Type	Date Built	Historic Function	1994/95 Comments	2012/13 Comments and Photo Image #
19	06/28	06/28, IMG_4509	Baltimore & Kankakee	2	Ca. 1960s-70s	Gas Station	Brick and glass gas station/convenience store.	Replaced with modern facility.

No longer extant

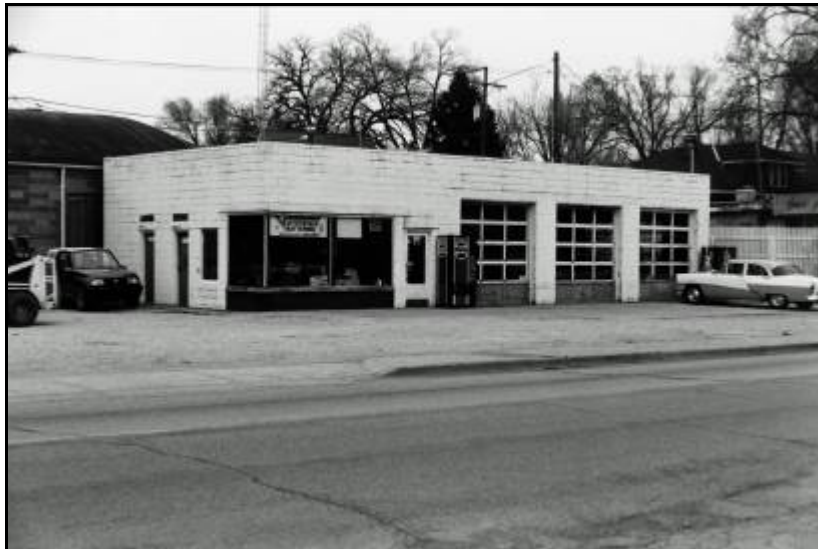
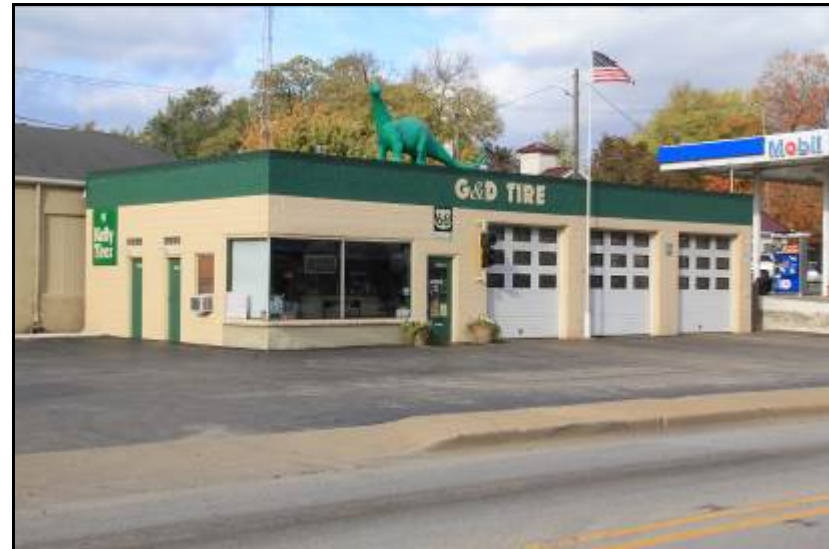
Sequence Number	Map Code	1994/95 Negative #	Address/Location	Type	Date Built	Historic Function	1994/95 Comments	2012/13 Comments and Photo Image #
20	06/27	06/27, IMG_4510	Baltimore & Main (NE corner)	2	Ca. 1950s/-60s	Gas/Service	Service station constructed of concrete blocks.	Cleaned up and painted, this structure (with its RT 66 sign) now houses "G&D Tire." IMG_4002

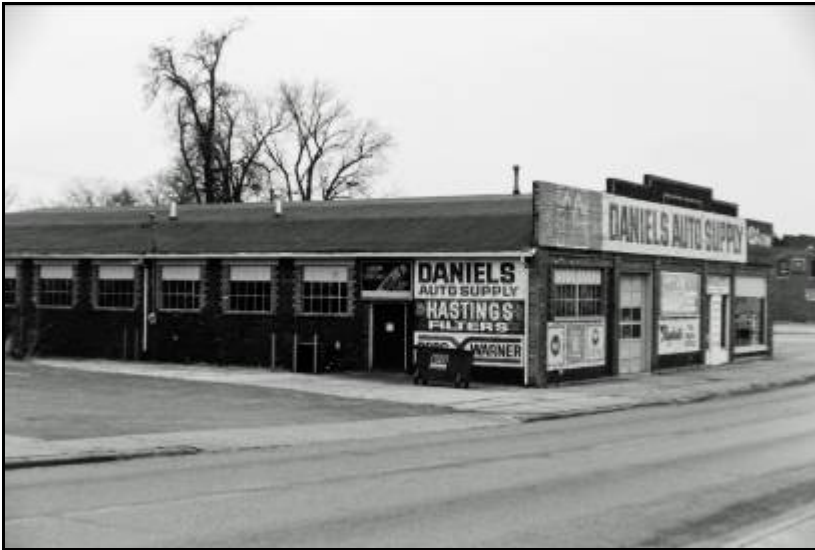
Sequence Number	Map Code	1994/95 Negative #	Address/Location	Type	Date Built	Historic Function	1994/95 Comments	2012/13 Comments and Photo Image #
21	06/17	06/17, IMG_4511	Baltimore & Main	2	Ca. 1930s	Auto Sales/Service	Now known as "Daniels Auto Supply," this structure well looks like it may have been a 1930s era auto sales and service business.	This building no longer remains.

No longer extant

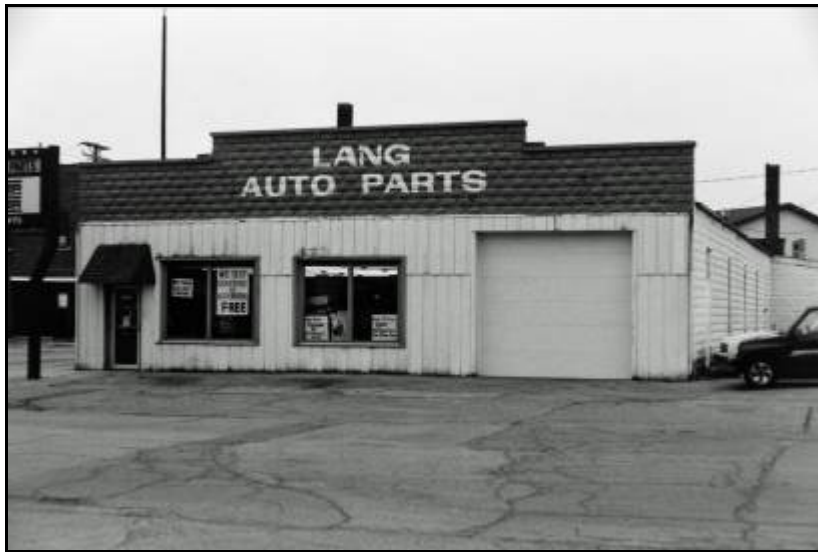
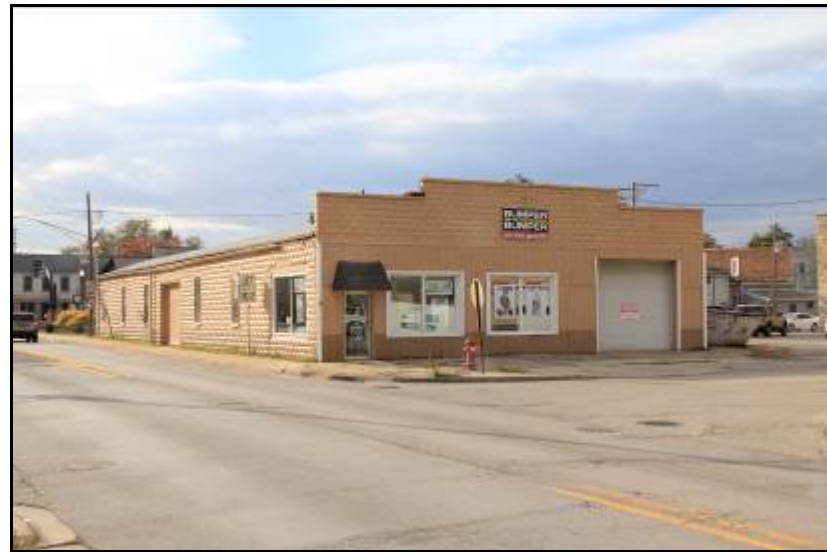
Sequence Number	Map Code	1994/95 Negative #	Address/Location	Type	Date Built	Historic Function	1994/95 Comments	2012/13 Comments and Photo Image #
22	06/19	06/19, IMG_4512	Baltimore & Main (NW corner)	2	Ca. 1920s-30s	Auto Service	This rock-faced, concrete block structure looks very much to have been an auto service business—now known as “Lang Auto Parts.”	Having been painted, this building now houses “Bumper to Bumper Auto Repair Specialists.” IMG_4004

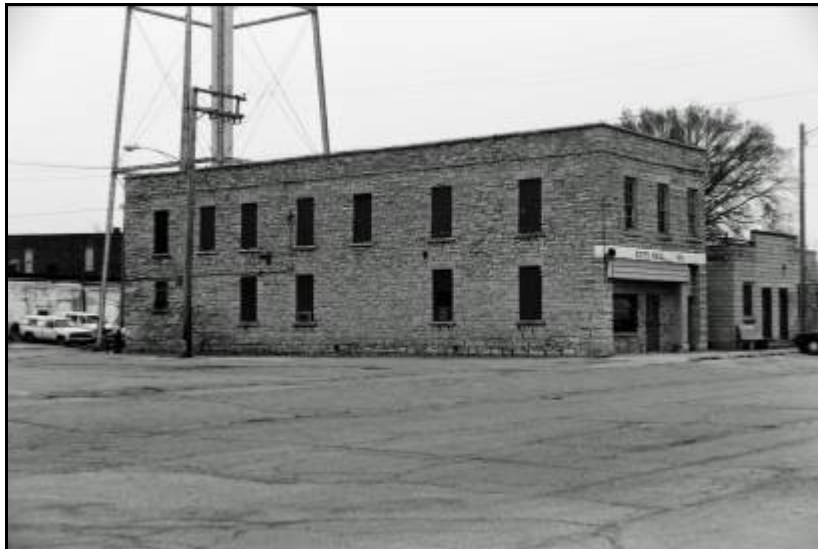
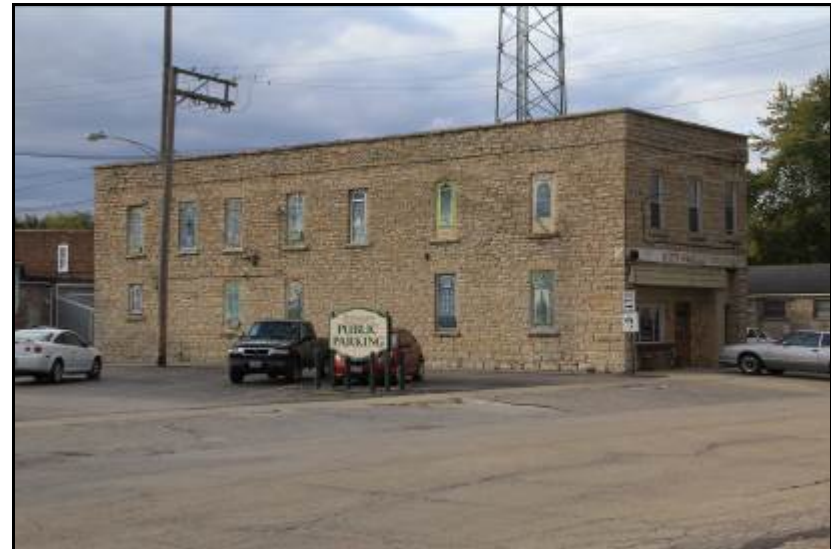
Sequence Number	Map Code	1994/95 Negative #	Address/Location	Type	Date Built	Historic Function	1994/95 Comments	2012/13 Comments and Photo Image #
23	06/18	06/18, IMG_4513	114 N. Main St.	3	1879	City Hall	Two-story, coursed, quarried stone structure—was the city hall—about a block N of Baltimore.	Few changes have occurred to the former city hall. IMG_4006

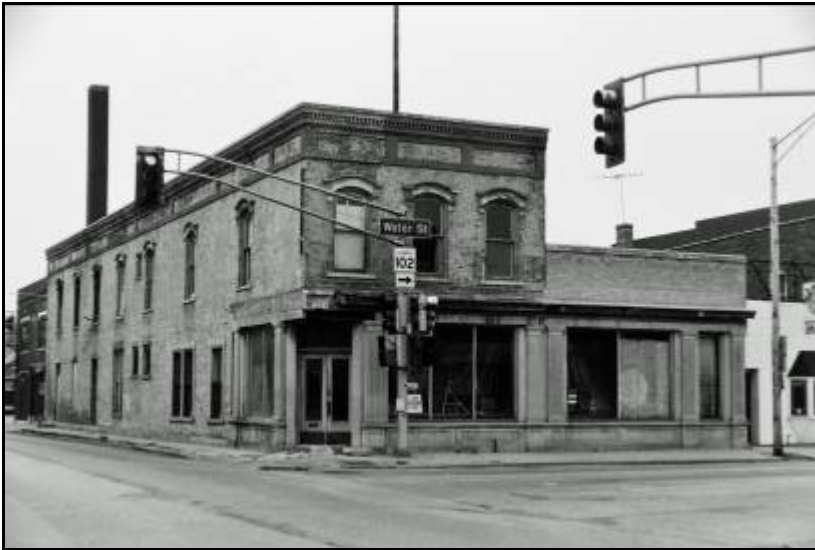
Sequence Number	Map Code	1994/95 Negative #	Address/Location	Type	Date Built	Historic Function	1994/95 Comments	2012/13 Comments and Photo Image #
24	06/24	06/24, IMG_4514	Baltimore & Water (SE corner)	3	Ca. 1870s-90s	Commercial	Although suffering from fire damage, this two-story, brick building has classical details, a prominent frieze and a commanding presence on the corner.	This building no longer remains.

No longer extant

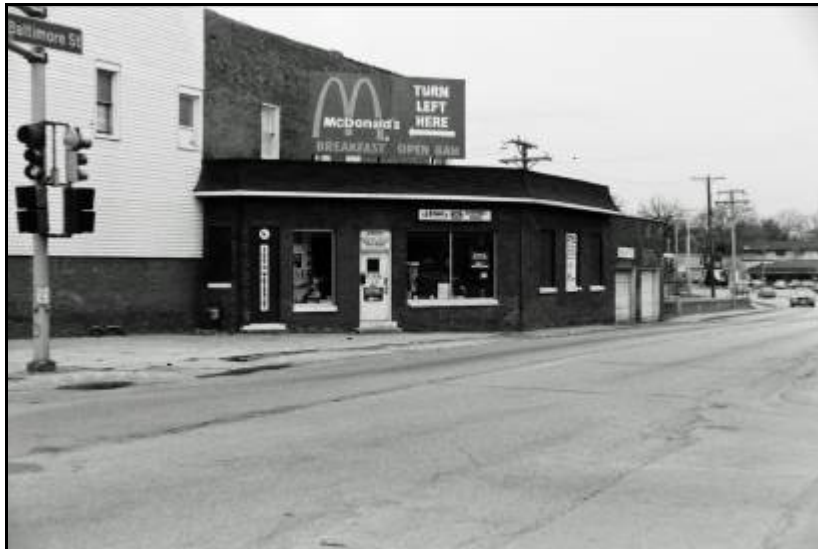
Sequence Number	Map Code	1994/95 Negative #	Address/Location	Type	Date Built	Historic Function	1994/95 Comments	2012/13 Comments and Photo Image #
25	06/20	06/20, IMG_4515	100 S. Water St.	2	Ca. 1930s	Gas/Service	Appears to be a brick, functional-type structure with a two-car service garage to the rear.	Structure is gone.

No longer extant

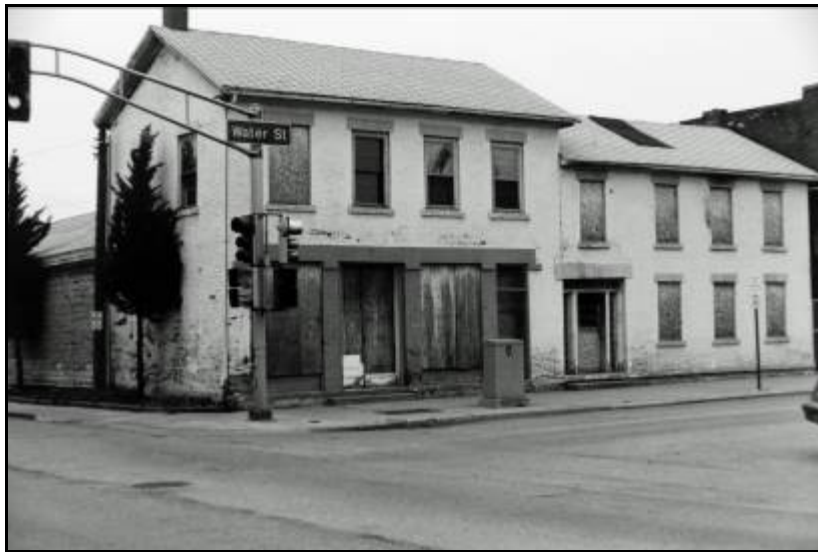
Sequence Number	Map Code	1994/95 Negative #	Address/Location	Type	Date Built	Historic Function	1994/95 Comments	2012/13 Comments and Photo Image #
26	06/23	06/23, 25-26, IMG_4516	Baltimore & Water (NW corner)	3	Ca. 1860s-90s	Commercial	Two-story, structure with shallow, gabled roof and stone lintels over windows; has a coursed stone addition to the rear and a brick addition to the N—three late 19 th century, brick retail buildings are to the N.	Changes over the years appear to include new windows and a new roof, although no use for this building is apparent. IMG_4009

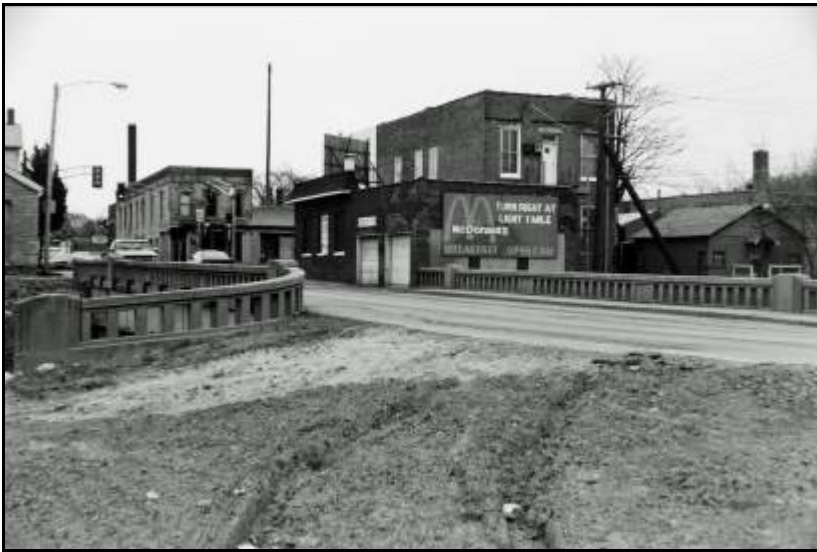
Sequence Number	Map Code	1994/95 Negative #	Address/Location	Type	Date Built	Historic Function	1994/95 Comments	2012/13 Comments and Photo Image #
27	06/22	06/22, 20/03, IMG_4517	Baltimore over Kankakee River	1	Ca. 1940s-50s	Bridge	Built as a two-lane structure; Bridge #099-0092 – no plate; single-span facility, the structural system of which is unknown due to massive concrete reinforcements.	Bridge was replaced in 1998.

No longer extant

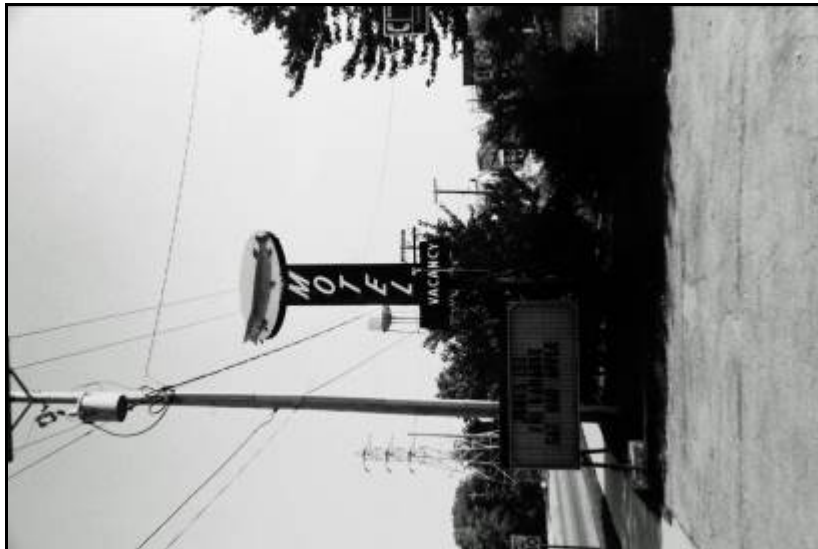
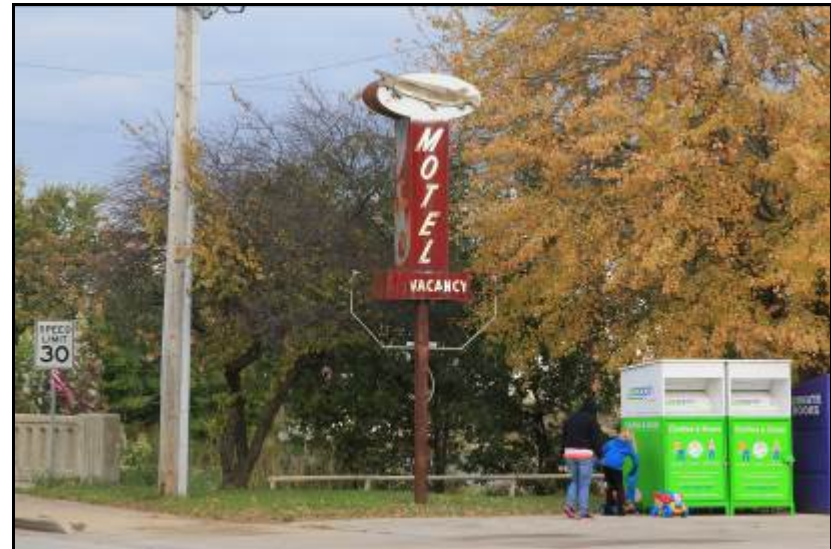
Sequence Number	Map Code	1994/95 Negative #	Address/Location	Type	Date Built	Historic Function	1994/95 Comments	2012/13 Comments and Photo Image #
28	20/04	20/04, IMG_4518	Baltimore & Kankakee River (SW corner)	2	Ca. 1950s	Motel Sign	Located adjacent to a modern motel, this sign, with its fish cut-out, likely dates to the 1950s or 60s.	There have been no apparent changes to this sign. IMG_4010

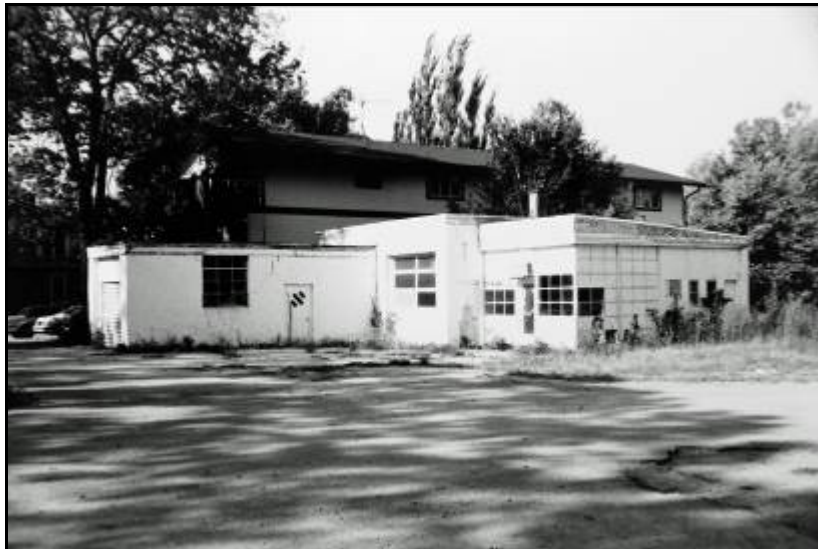
Sequence Number	Map Code	1994/95 Negative #	Address/Location	Type	Date Built	Historic Function	1994/95 Comments	2012/13 Comments and Photo Image #
29	20/05	20/05, IMG_4519	Baltimore & Park (NW corner)	2	Ca. 1960s	Gas/Service	Concrete block gas station with several additions and many glass panels—vacant.	Old service station replaced by a new structure.

No longer extant

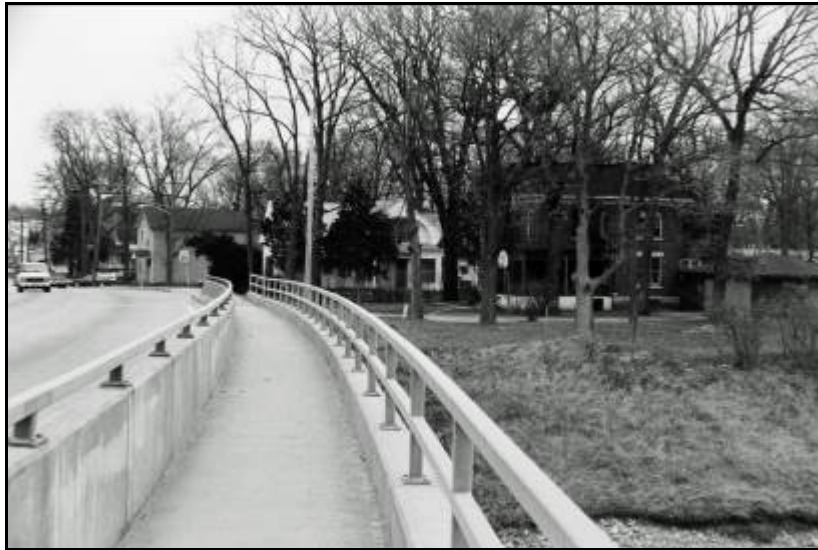
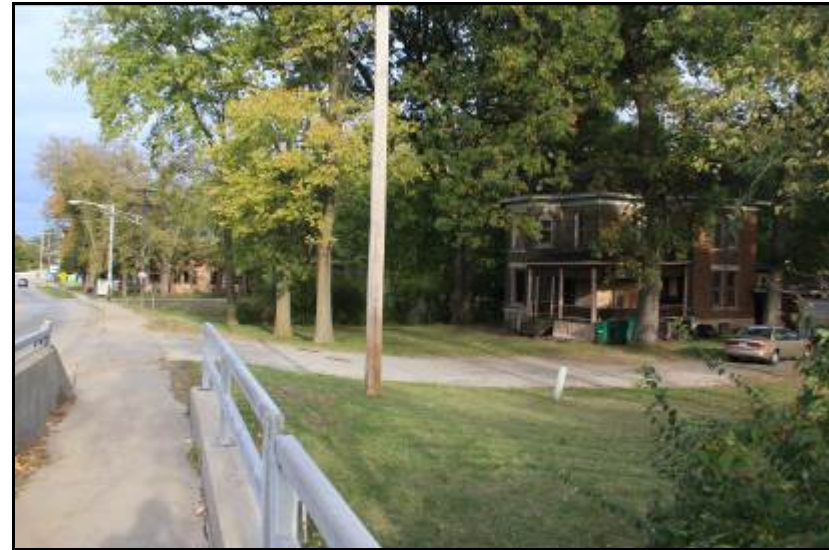
Sequence Number	Map Code	1994/95 Negative #	Address/Location	Type	Date Built	Historic Function	1994/95 Comments	2012/13 Comments and Photo Image #
30	06/30	06/30, IMG_4520	Baltimore and Kankakee River	3	Ca. Late 19 th /Early 20 th Century	Residential	Group of three, prominently viewed houses as eastbound USH 66 travelers entered Wilmington from the W.	Two of three historic period houses are now gone. Only the western-most building remains. IMG_4011

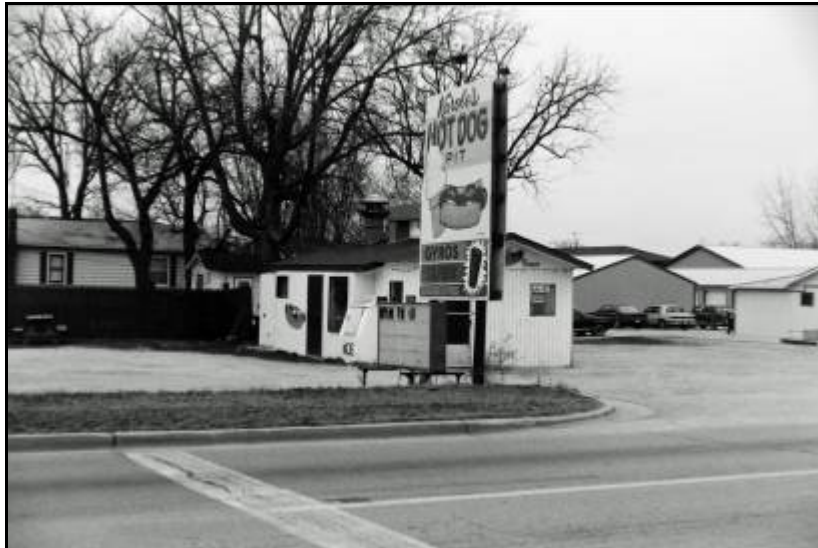
Sequence Number	Map Code	1994/95 Negative #	Address/Location	Type	Date Built	Historic Function	1994/95 Comments	2012/13 Comments and Photo Image #
31	06/31	06/31, IMG_4521	Baltimore & 1 st St.	2	Ca. 1960s	Drive-In	Small drive-in with vertical wood siding and little character.	Drive-in no longer exists. Replaced by a new professional building.

No longer extant

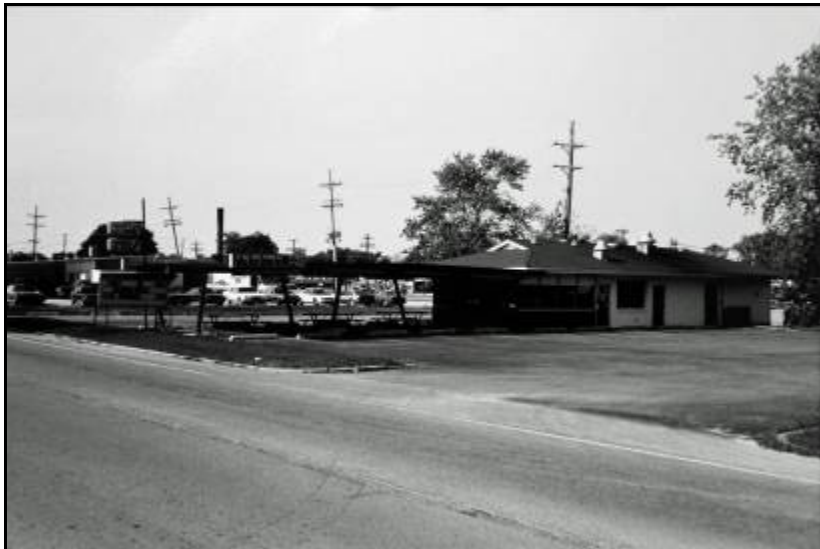
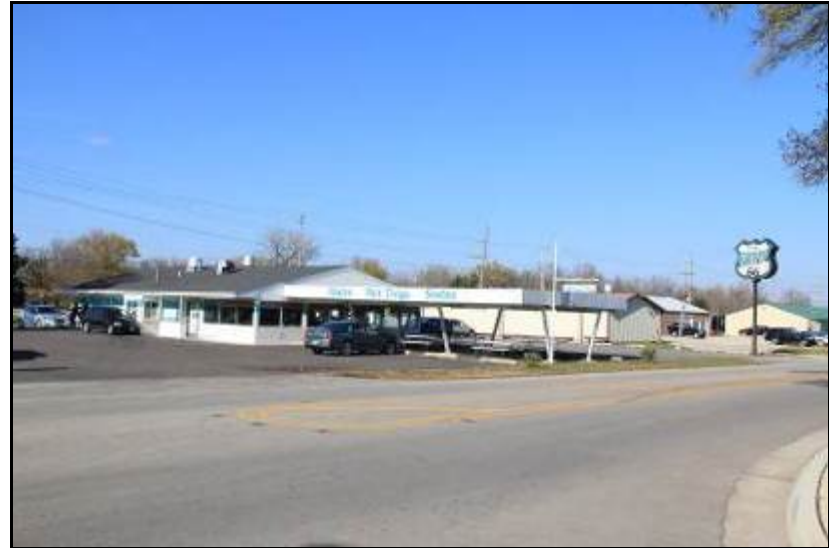
Sequence Number	Map Code	1994/95 Negative #	Address/Location	Type	Date Built	Historic Function	1994/95 Comments	2012/13 Comments and Photo Image #
32	20/6	20/6, IMG_1752	IL 53 & Oak (N Corner)	2	Ca. 1960a	Drive-In	Brick and concrete block drive-in with long, projecting canopy.	New paint scheme and sign out front. IMG_1240

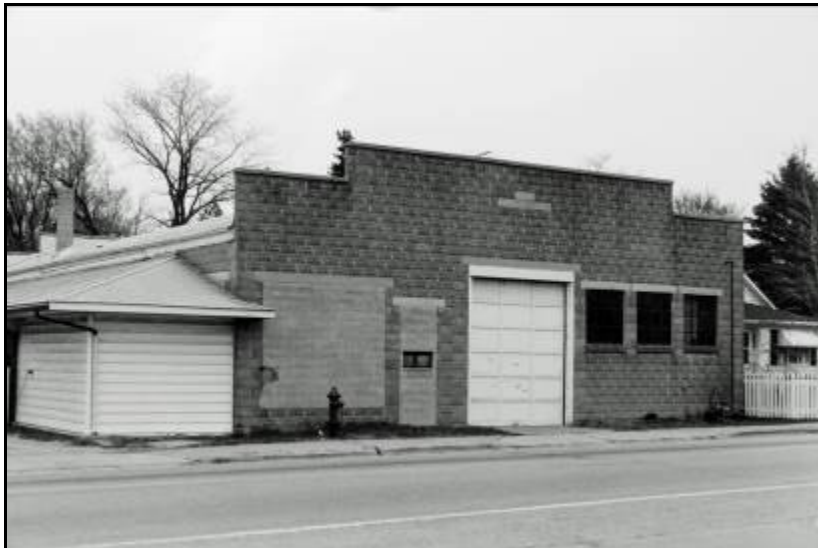
Sequence Number	Map Code	1994/95 Negative #	Address/Location	Type	Date Built	Historic Function	1994/95 Comments	2012/13 Comments and Photo Image #
33	06/35	06/35, IMG_1753	Front St. (IL 53) & Main, BRAIDWOOD	2	1928	Auto Service	Rock-faced, concrete block structure with stepped parapet façade – “Dan Danville, 1928” noted in parapet.	Garage is gone.

No longer extant

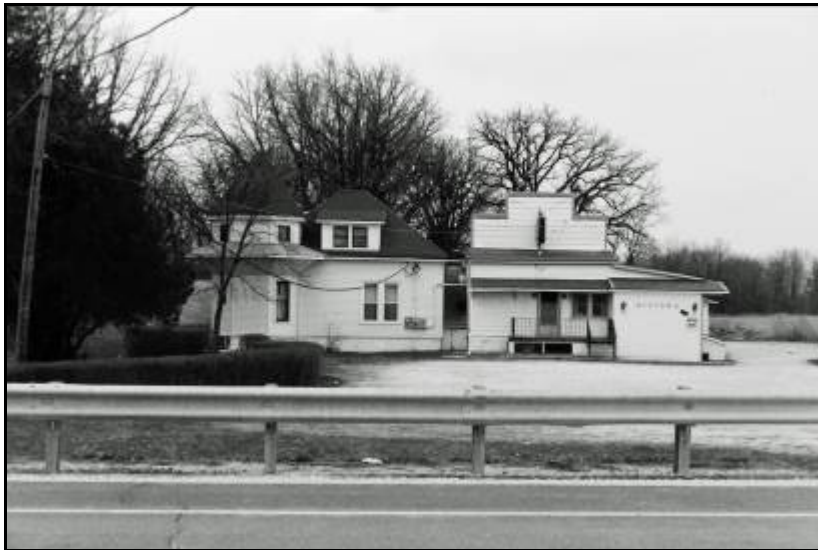
Sequence Number	Map Code	1994/95 Negative #	Address/Location	Type	Date Built	Historic Function	1994/95 Comments	2012/13 Comments and Photo Image #
34	07/03	07/03, IMG_1754	A 136 IL 53 (at Mazon River)	2	Ca. 1927	Restaurant	Historically known as the “Riviera,” this structure has several original windows that have been closed over and narrow, clapboard siding that has been replaced with wide (aluminum?) siding – recently inducted to Route 66 Hall of Fame, see Historic Illinois (v. 17, no. 2) for additional information.	The “Riviera” was destroyed by fire on 08 June 2010. Only the parking lot remains.

No longer extant

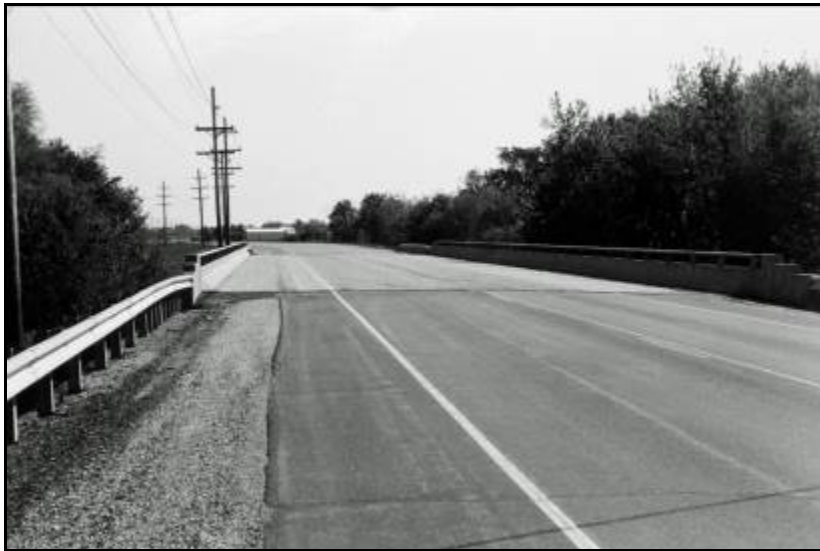
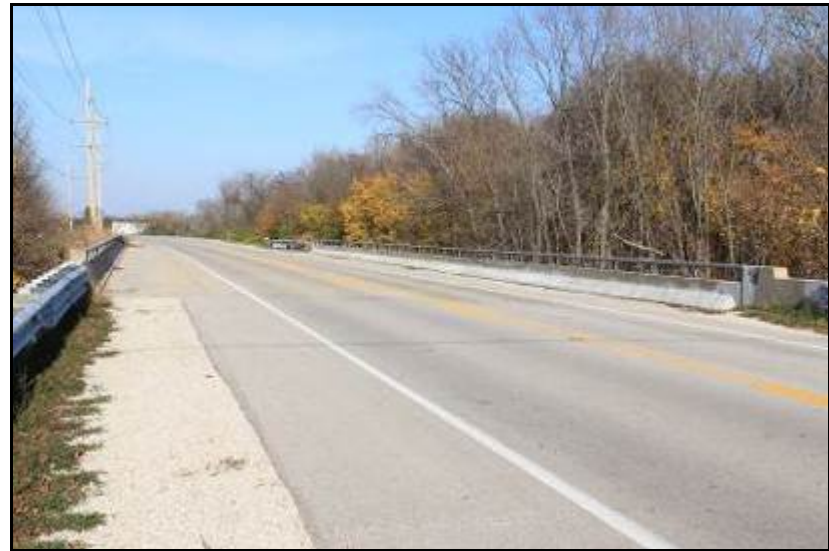
Sequence Number	Map Code	1994/95 Negative #	Address/Location	Type	Date Built	Historic Function	1994/95 Comments	2012/13 Comments and Photo Image #
35	11/07	11/07, IMG_1755	IL 53 over Mazon River	1	1969	Bridge	Bridge #0023 – plate notes: “Station 572+00.92, 1969, S.B.I RT 4 Sec. 6B-1, F.A. Project F-25 (43), Loading HS 20—a two-lane, “I” beam supported bridge with 2 abutments and 3 piers.	The 1969 bridge remains with little change. Situated immediately E of the location where the historic “Riviera” once stood.

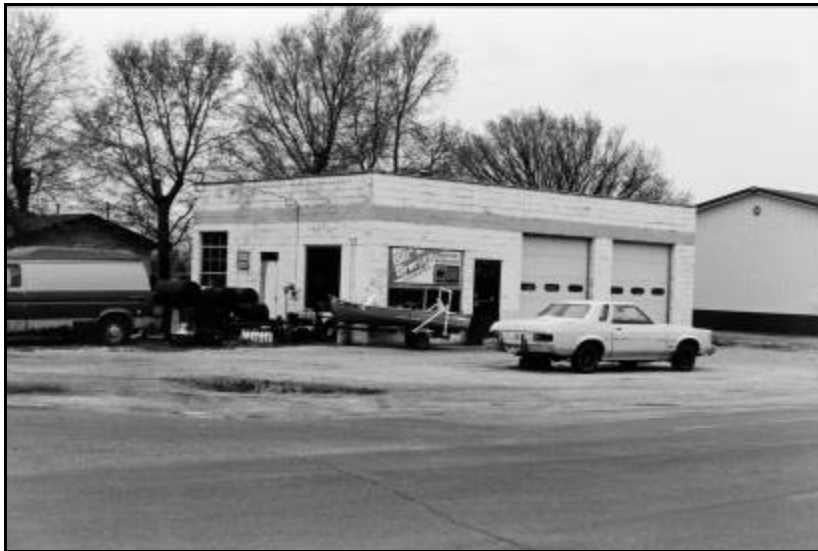
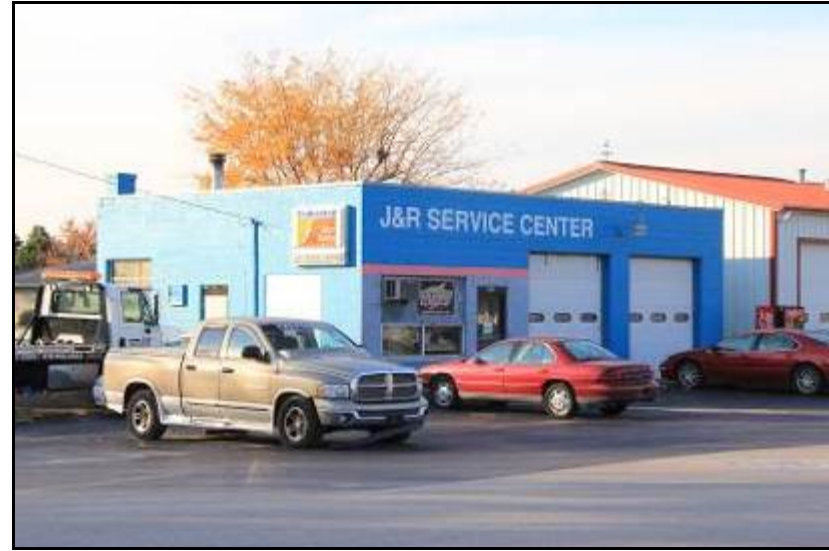
Sequence Number	Map Code	1994/95 Negative #	Address/Location	Type	Date Built	Historic Function	1994/95 Comments	2012/13 Comments and Photo Image #
36	07/04	07/04, IMG_1756	IL 53 & Washington (NW corner), GARDNER	2	Ca. 1950s-60s	Gas/Service	Concrete block service station – very plain.	This building has been repainted and remains in use as “J&R Service Center.” IMG_1245

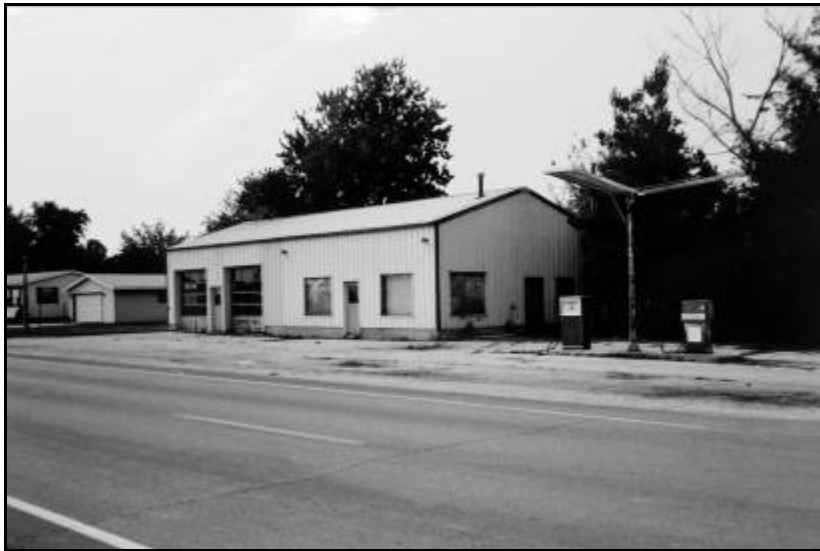
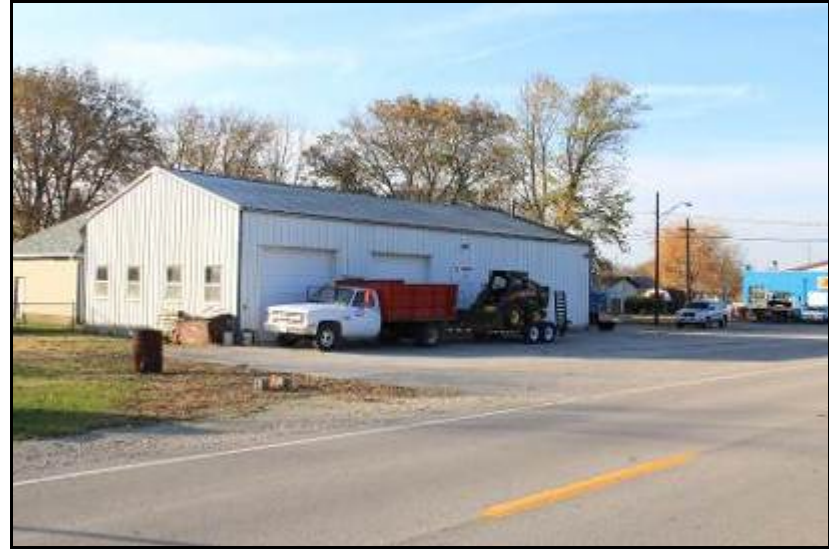
Sequence Number	Map Code	1994/95 Negative #	Address/Location	Type	Date Built	Historic Function	1994/95 Comments	2012/13 Comments and Photo Image #
37	20/07	20/07, IMG_1757	IL 53 & Washington (SW corner), GARDNER	2	Ca. 1960s	Gas/Service	Pole building-type structure on a concrete foundation.	While the building remains, there have been some changes to the garage doors and various windows. IMG_1249

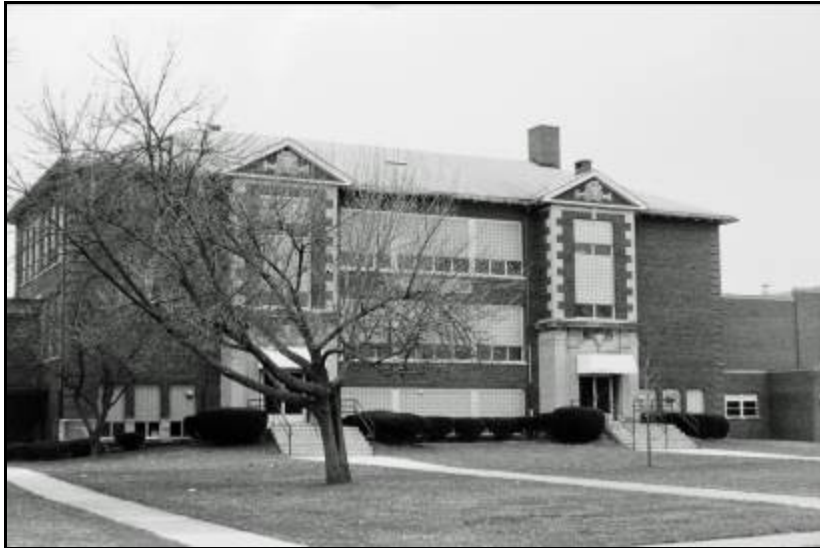
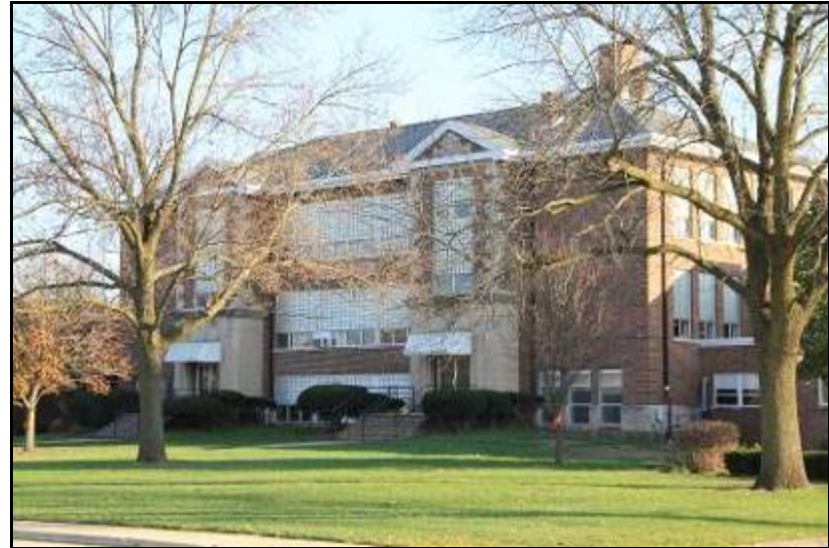
Sequence Number	Map Code	1994/95 Negative #	Address/Location	Type	Date Built	Historic Function	1994/95 Comments	2012/13 Comments and Photo Image #
38	07/05	07/05, IMG_1758	Main St., GARDNER	3	1920	3	Prominent, 2.5-story school – historically known as the “Gardner/S. Wilmington Township High School.	There are few apparent changes to the old school. IMG_1247

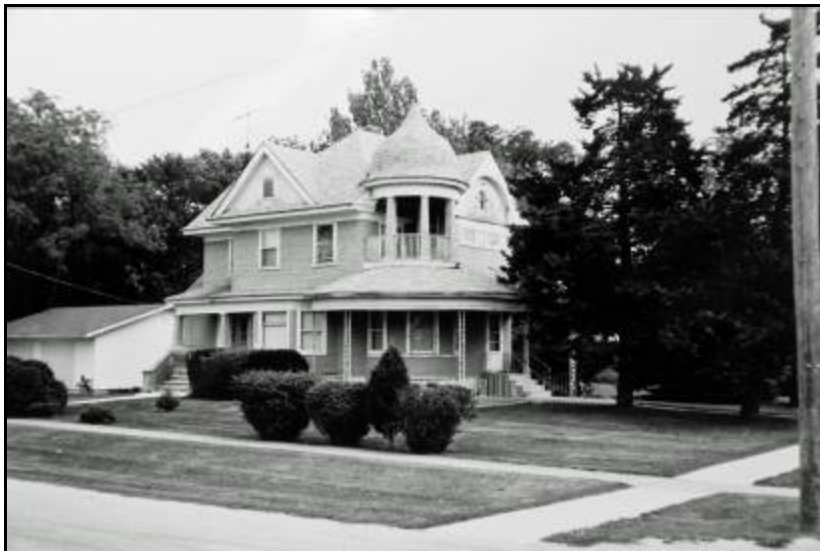
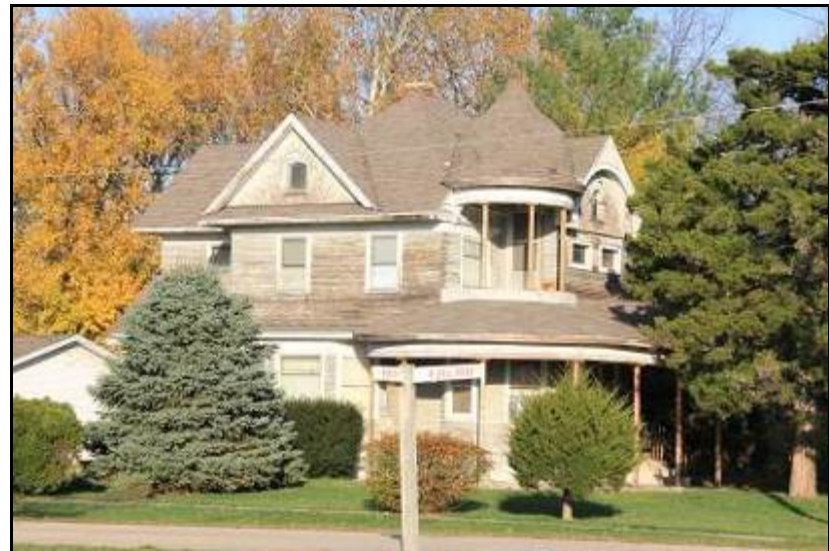
Sequence Number	Map Code	1994/95 Negative #	Address/Location	Type	Date Built	Historic Function	1994/95 Comments	2012/13 Comments and Photo Image #
39	20/08	20/08, IMG_1759	Main St. & RR (NE corner), GARDNER	3	Ca. 1890s-1910s	Residential	Queen Anne house with prominent, one-and-one-half side, wrap-around porch and prominent, second-floor, turret porch and clapboard siding.	House today very much resembles that of 1994. Note change in posts of turret balcony and front porch. IMG_1245

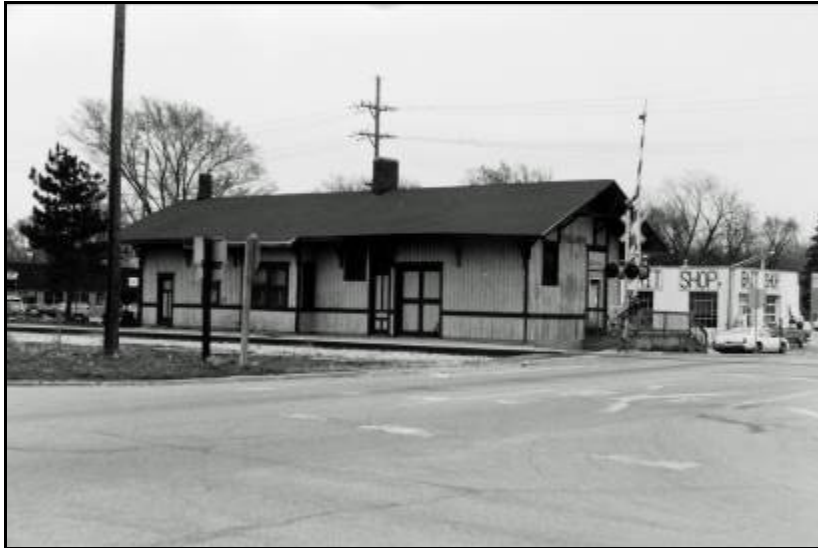
Sequence Number	Map Code	1994/95 Negative #	Address/Location	Type	Date Built	Historic Function	1994/95 Comments	2012/13 Comments and Photo Image #
40	06/32	06/32, IMG_1760	IL 129 & Main St., BRAIDWOOD	3	Ca. 1890s	RR Depot	A gable structure with board and batten siding and wide eaves with brackets.	Railroad depot is gone.

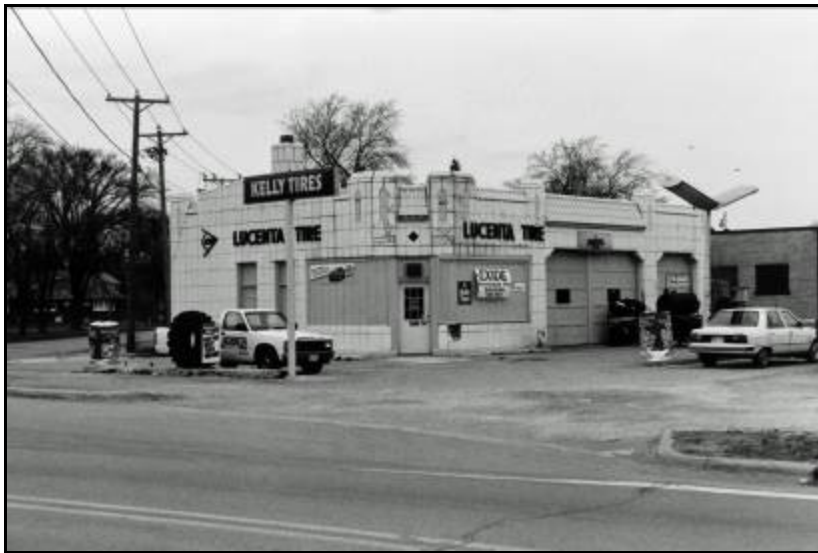
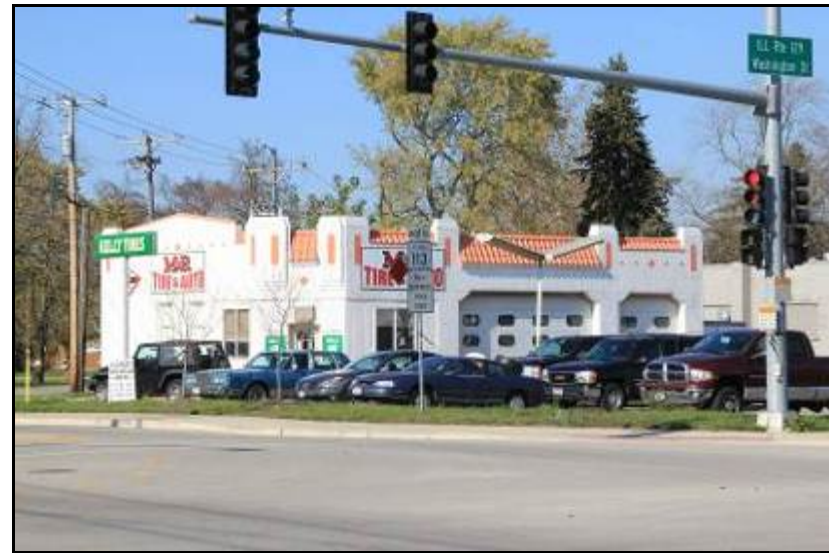
Sequence Number	Map Code	1994/95 Negative #	Address/Location	Type	Date Built	Historic Function	1994/95 Comments	2012/13 Comments and Photo Image #
41	06/33	06/33, IMG_1761	IL 129 & Mitchell St., BRAIDWOOD	2	Ca. 1930s-40s	Gas/Service	Respectable-type gas station with white enamel panels – offers some character, the closed-over windows notwithstanding.	Building remains with character generally intact. New garage doors and entrance to office (and adjacent windows). IMG_1238
