Route 66 in Illinois:

(2012/13 Update and Expansion of the Original 1994/95 Survey)

IDOT Sequence #17337 & #17337A

22 December 2013

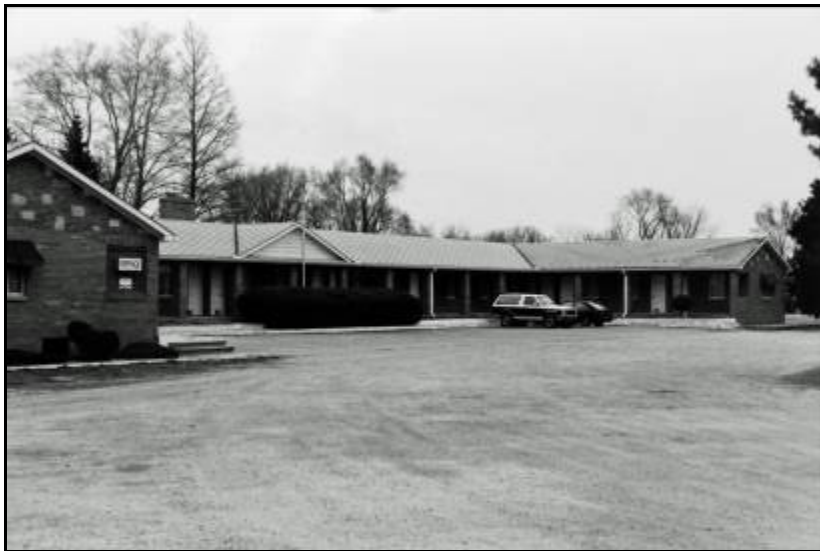
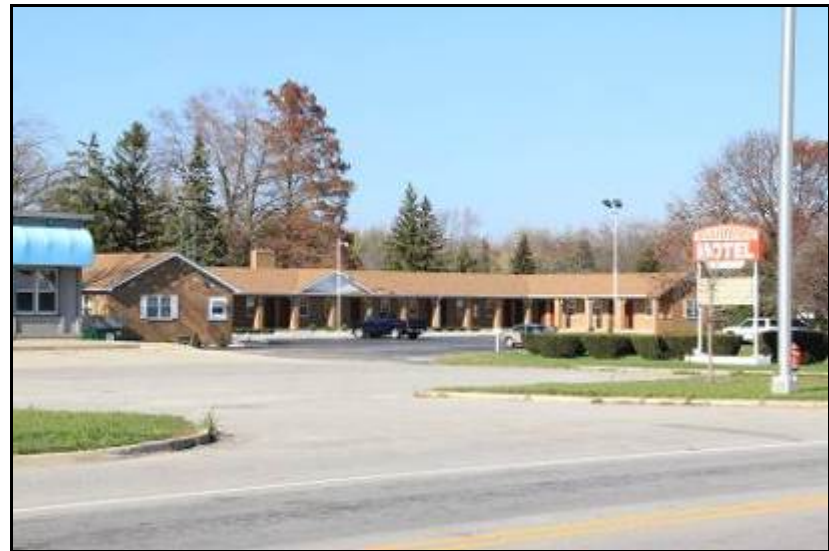
Sequence Number	Map Code	1994/95 Negative #	Address/Location	Type	Date Built	Historic Function	1994/95 Comments	2012/13 Comments and Photo Image #
42	06/34	06/34, IMG_1762	IL 129 & Mitchell St., BRAIDWOOD	2	Ca. 1960s	Motel	"Rossie's Motel," a "U" shaped, brick structure.	Motel remains largely unchanged. IMG_1239

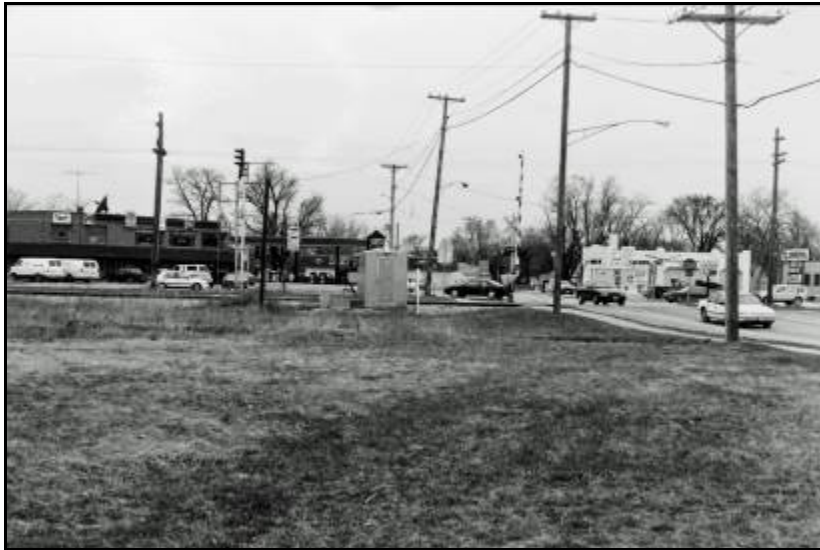
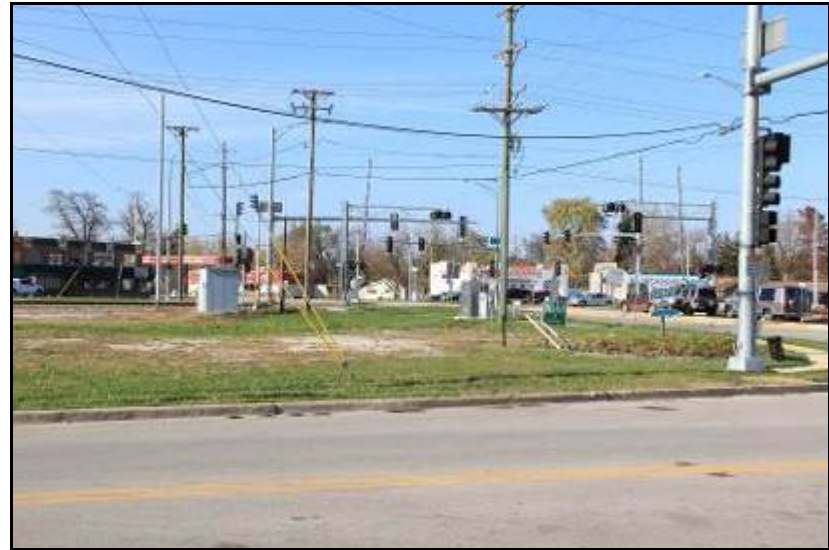
Sequence Number	Map Code	1994/95 Negative #	Address/Location	Type	Date Built	Historic Function	1994/95 Comments	2012/13 Comments and Photo Image #
43	06/36	06/36, IMG_1763	IL 129 & Mitchel St., BRAIDWOOD	3	Ca. 1940s	USH 66	USH 66, Joliet/Wilmington bypass through Braidwood.	General perspective view of Braidwood. Note new telephone poles and cantilevered railroad crossing signals. IMG_1241

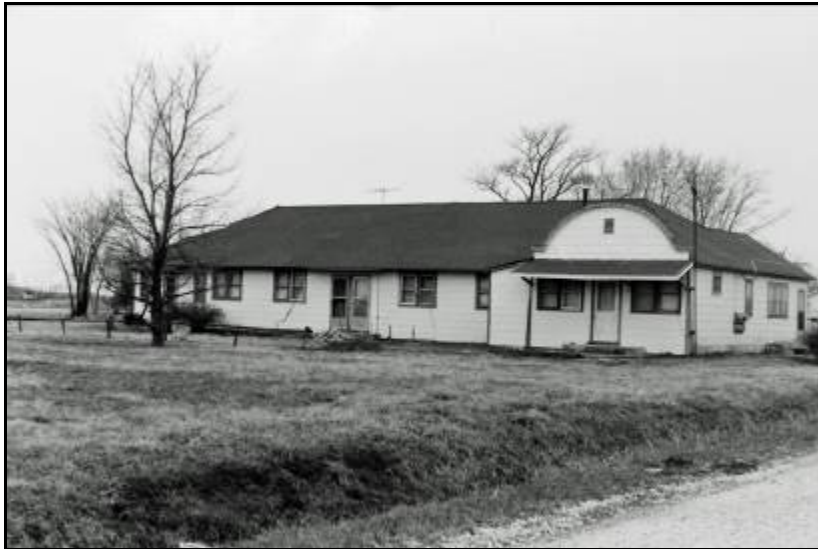
Sequence Number	Map Code	1994/95 Negative #	Address/Location	Type	Date Built	Historic Function	1994/95 Comments	2012/13 Comments and Photo Image #
44	07/01	07/01, IMG_1764	156 Division, BRACEVILLE	2	Ca. 1930s-40s	Tavern	Sheathed with wide, asbestos(?) siding – looks as if it could have been a bar, restaurant or dance hall.	Building is gone.

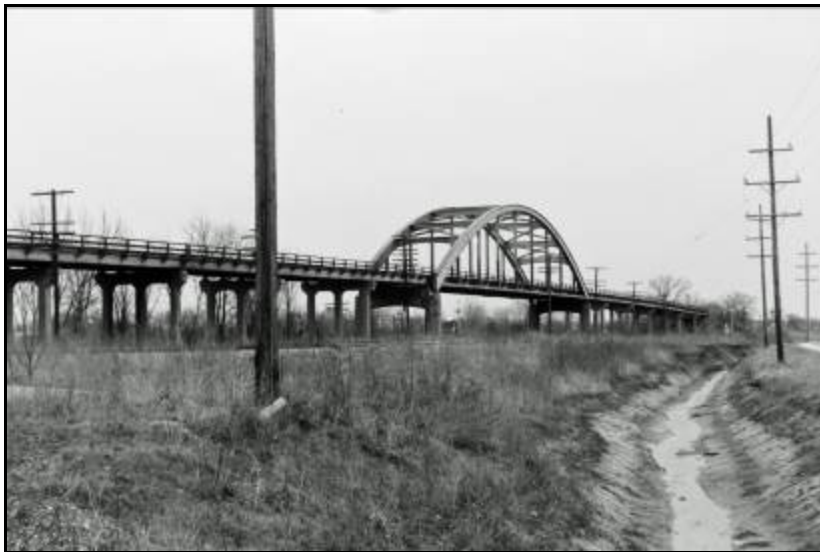
Sequence Number	Map Code	1994/95 Negative #	Address/Location	Type	Date Built	Historic Function	1994/95 Comments	2012/13 Comments and Photo Image #
45	07/02	07/02, 11/01-06, IMG_1765	IL 129 over Alton RR	1	1939	Bridge	Bridge #0062 – plate notes: “Alton RR Viaduct, Built 1939, Henry Horner – Governor, Federal Aid Route 77 Sec.91-v. Federal Aid Project 373-F; bridge utilizes rolled “T” beams for approaches and an arched, truss-like main span with a bottom chord, verticals, deck beams, stringers and riveted connections.	This prominent and visually intriguing bridge is now gone and the approach roads are closed.

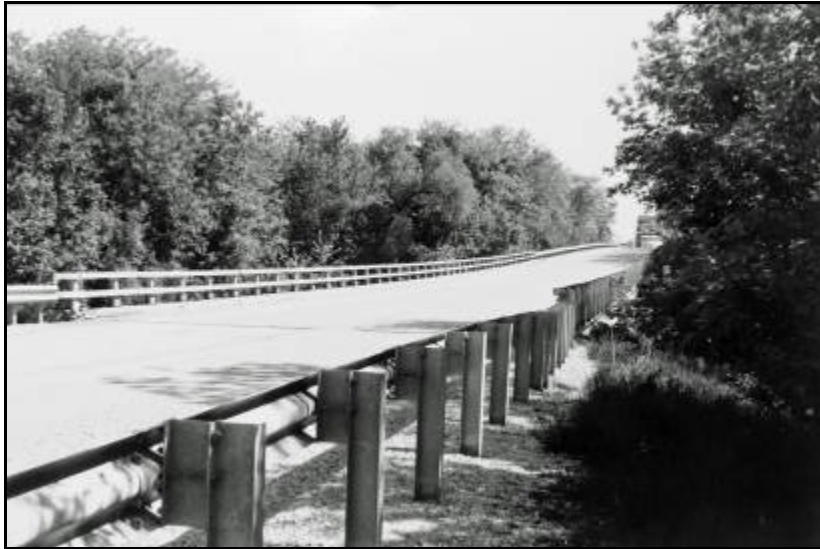
Sequence Number	Map Code	1994/95 Negative #	Address/Location	Type	Date Built	Historic Function	1994/95 Comments	2012/13 Comments and Photo Image #
46	11/08	11/08, IMG_1766	IL 129 over Mazon River	1	Ca. 1940s	Bridge	Bridge #0063 (no plate noted) – deck supported by 5 “I” beams, has 2 concrete piers and abutments.	The bridge W of the railroad viaduct is now gone. Taken out as part of viaduct removal effort.

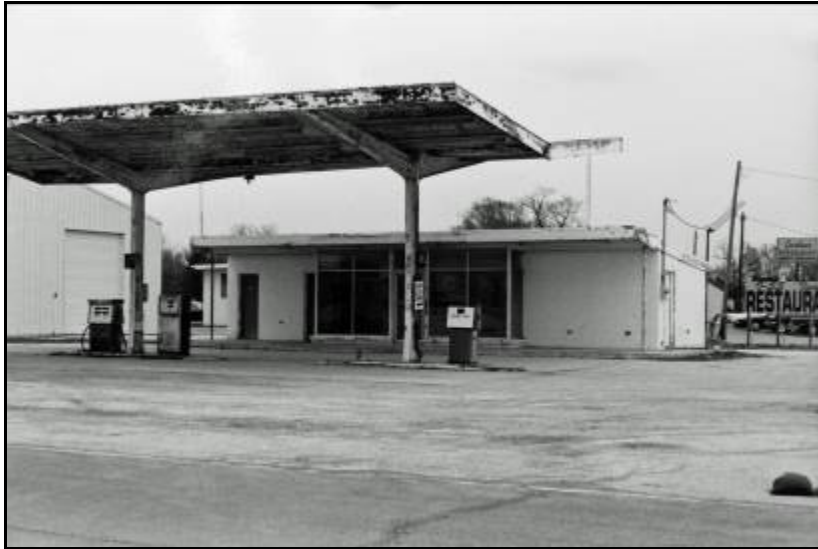
Sequence Number	Map Code	1994/95 Negative #	Address/Location	Type	Date Built	Historic Function	1994/95 Comments	2012/13 Comments and Photo Image #
47	07/06	07/06, IMG_1767	IL 53 & IL 129 (NE corner), GARDNER	2	Ca. 1960s	Gas Station	Concrete block structure with gently-pitched shed roof; large, separate canopy over pumps – vacant.	Structure now gone.

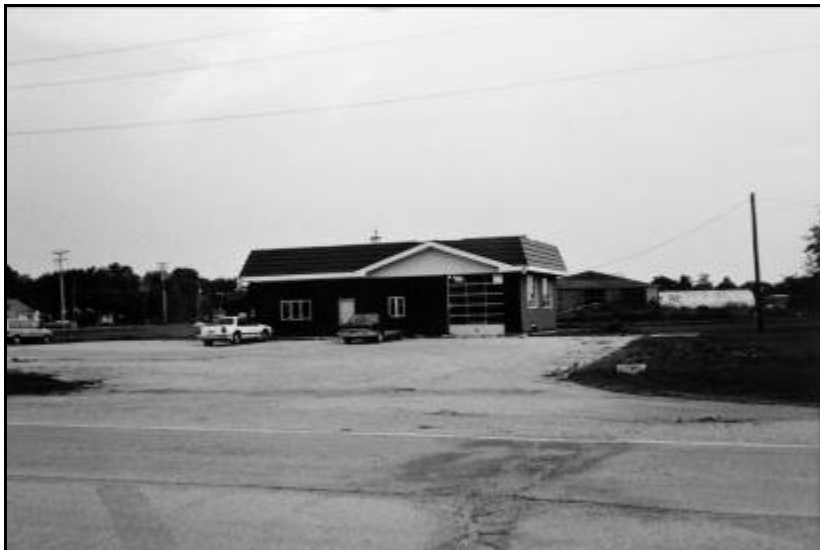
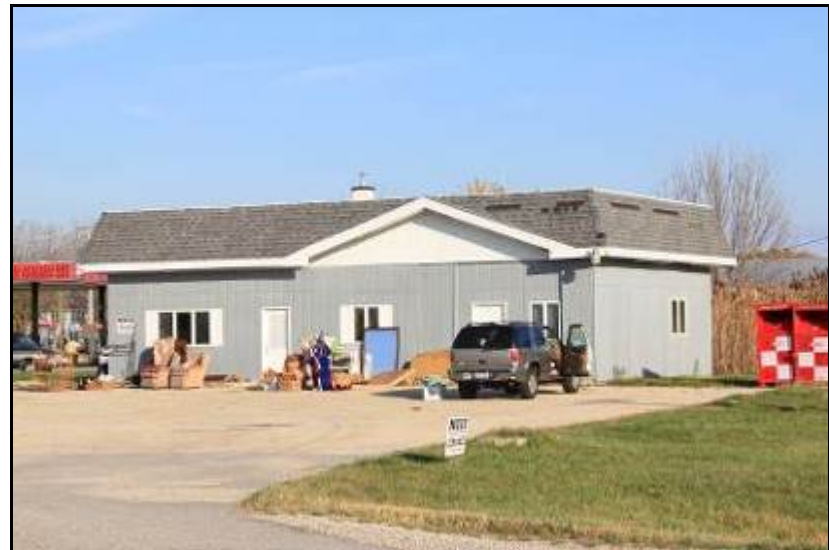
Sequence Number	Map Code	1994/95 Negative #	Address/Location	Type	Date Built	Historic Function	1994/95 Comments	2012/13 Comments and Photo Image #
48	20/09	20/09, IMG_1768	IL 53 & IL 129 (SE corner), GARDNER	2	Ca. 1960s-70s	Gas/Service	Brick, former Amoco station with some newer window treatments – may be vacant.	Garage door now covered over and replaced by a pedestrian door and casement window. IMG_1244

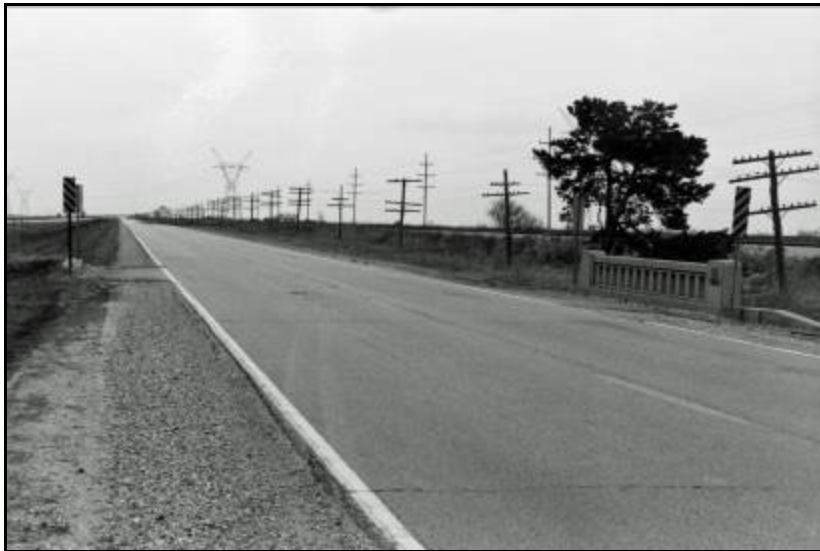
Sequence Number	Map Code	1994/95 Negative #	Address/Location	Type	Date Built	Historic Function	1994/95 Comments	2012/13 Comments and Photo Image #
49	07/07	07/07, 11/09, IMG_1769	Old 66 over Woods Creek	1	1954	Bridge	Only 1 of 2 original structures remains: Bridge #0003 – plate notes: “Station 277+84.76(2), 1954, State of Illinois, F.A. RTE 5 Sec. 7RB-1, F.A. Proj. I.N. 25(25), Loading H20-16; a single-span, concrete slab structure with railing on one side removed.	Woods Run Creek bridge gone. Replaced in 2004.

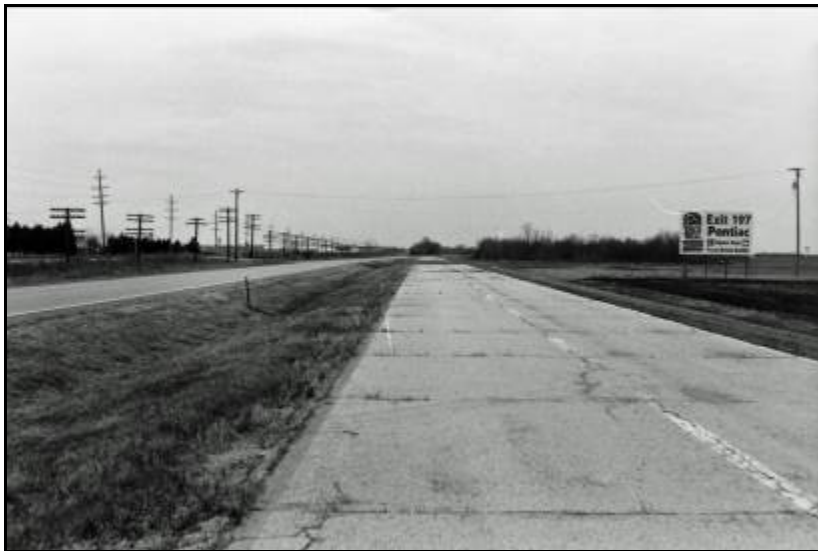
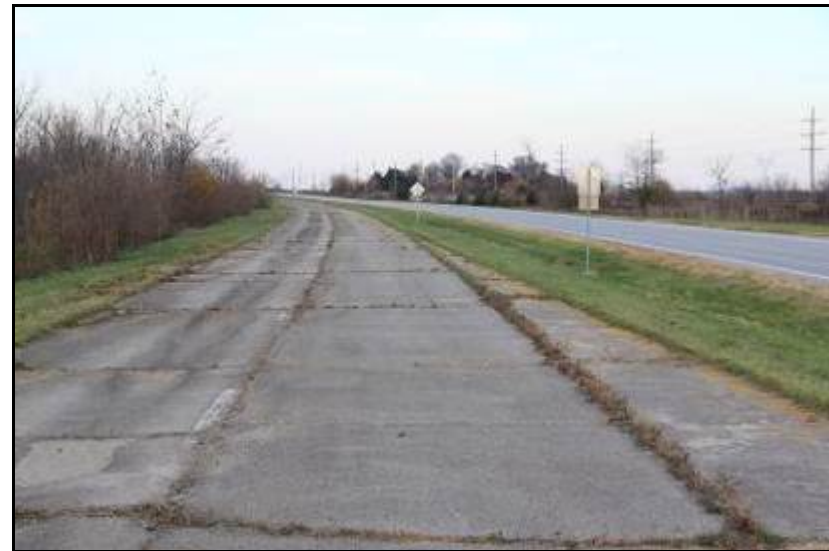
Sequence Number	Map Code	1994/95 Negative #	Address/Location	Type	Date Built	Historic Function	1994/95 Comments	2012/13 Comments and Photo Image #
50	07/08	07/08, IMG_1770	Old 66 & Mazon Rd.	1	Ca. 1954	USH 66	Four-lane segment N of Dwight, old south-bound lanes closed and being removed.	South-bound lanes remain but are closed. 2012 view to NE. IMG_1250

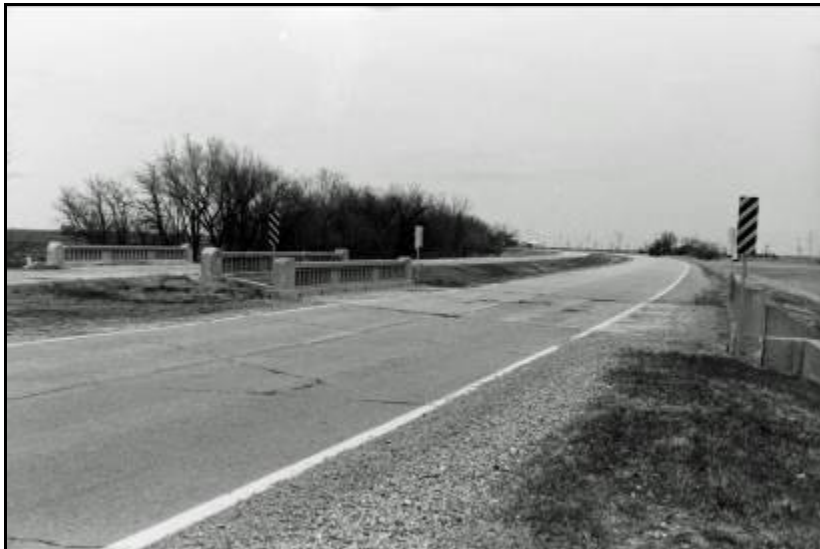
Sequence Number	Map Code	1994/95 Negative #	Address/Location	Type	Date Built	Historic Function	1994/95 Comments	2012/13 Comments and Photo Image #
51	07/09	07/09, 11/10-11, IMG_1771	Old 66 & Gooseberry Creek	1	1954	Bridges	Two original structures remain: Bridge #0001 (eastbound) and Bridge #0002 (westbound) – plate notes: “Station 378+75(2), 1954 by State of Illinois, F.A. RTE. 5 SEC .7x2B-1. F.A. Proj. I.N. 25(25), Loading H20 S16; single-span structures with straight, concrete “I” beams for deck support.	Historic bridges gone. Northbound lanes now have a new culvert built in 2000.

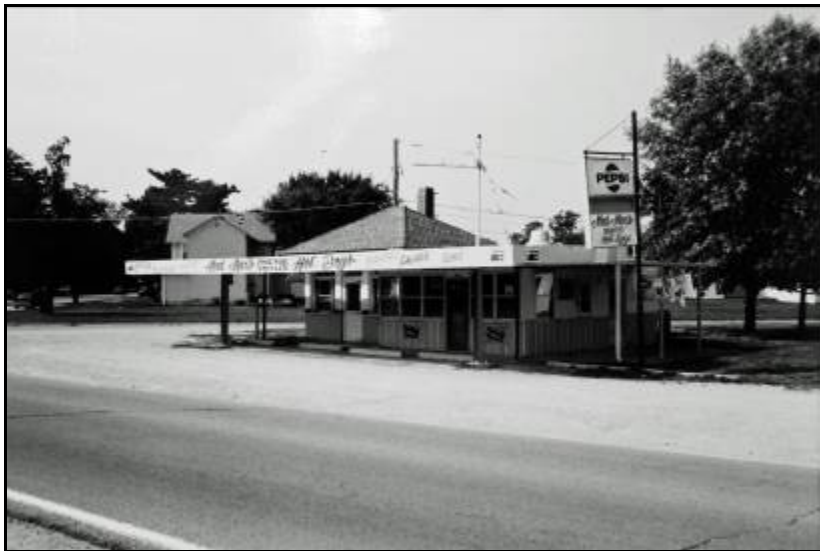
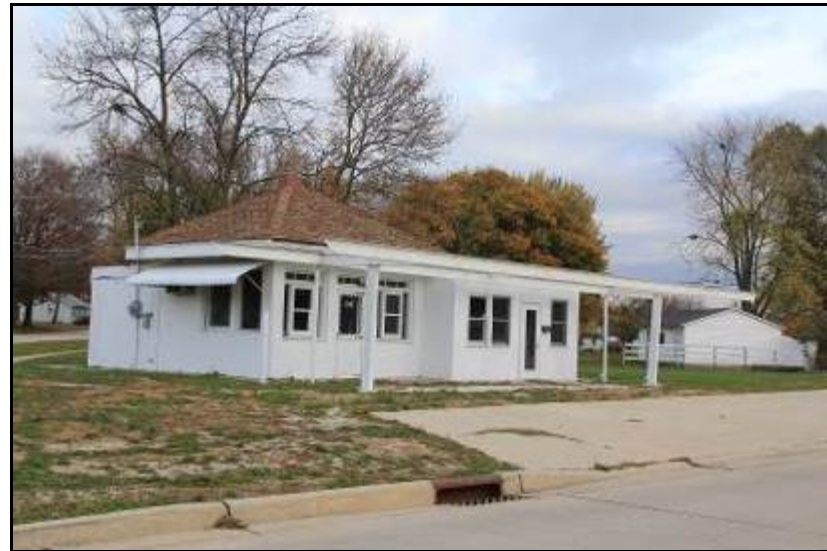
Sequence Number	Map Code	1994/95 Negative #	Address/Location	Type	Date Built	Historic Function	1994/95 Comments	2012/13 Comments and Photo Image #
52	20/10	20/10-11, IMG_1772	Wauponsie & Chicago (NE corner)	2	Ca. 1930s-60s	Gas/Drive-In	Hip roof structure of concrete looks to have originally been a gas station; subsequently developed into a drive-in with the addition of a small dining area and parking canopy – now Mad Max's Chicago Style Hot Dogs.	Former drive-in now closed and vacant. Note new concrete curb and change in the general setting. IMG_1263

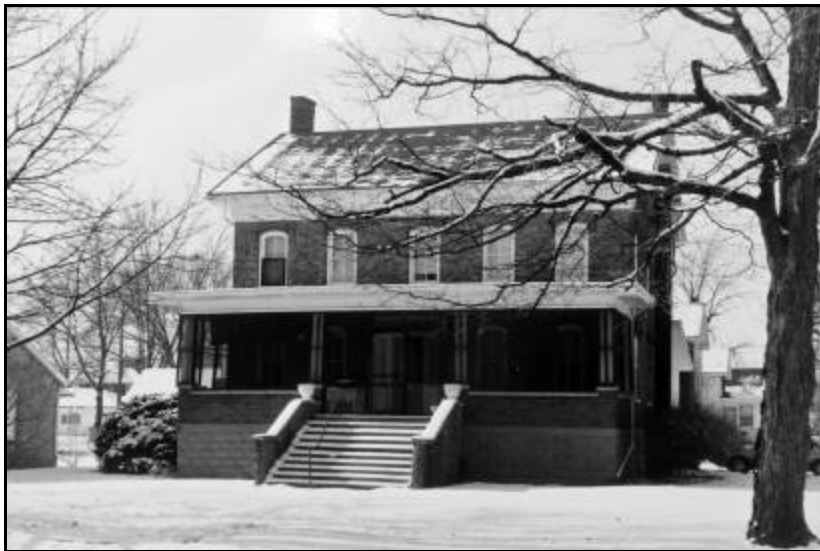
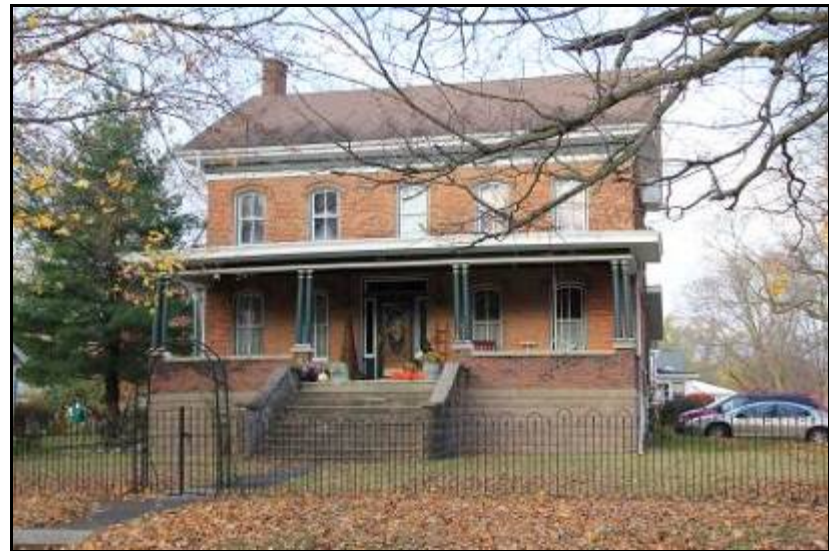
Sequence Number	Map Code	1994/95 Negative #	Address/Location	Type	Date Built	Historic Function	1994/95 Comments	2012/13 Comments and Photo Image #
53	01/03	01/03, IMG_1773	Wauponsie & Franklin (SW corner)	3	Ca. 1900-20s	Residential	Two-story, brick house with gabled roof and prominent porch rising from rock-faced, concrete block foundation; roof is supported by column clusters.	Prominent house remains with few changes. IMG_1261

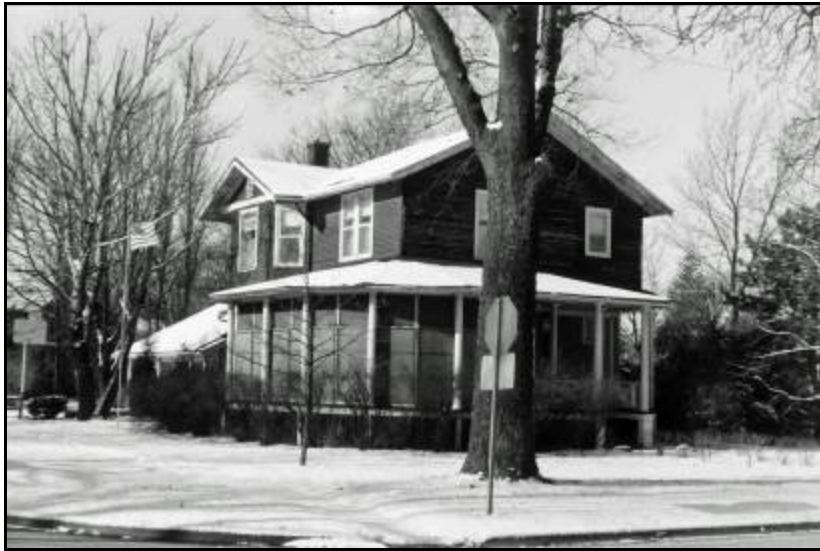
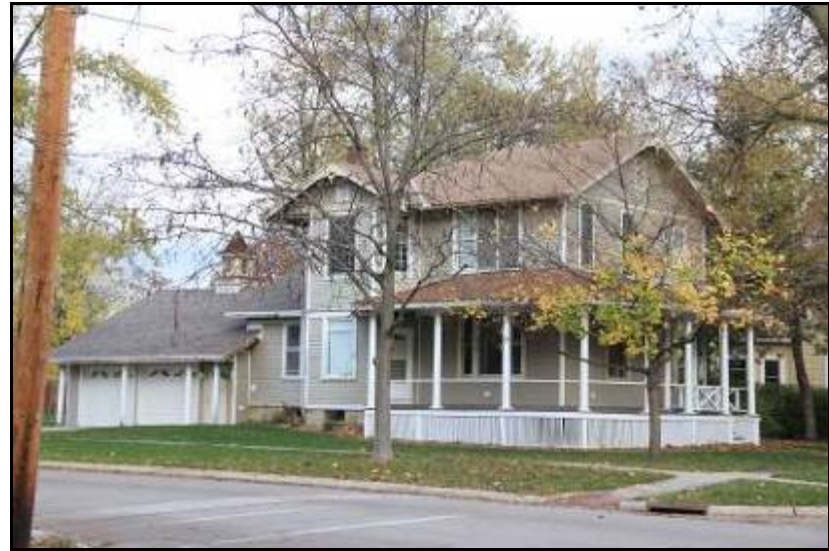
Sequence Number	Map Code	1994/95 Negative #	Address/Location	Type	Date Built	Historic Function	1994/95 Comments	2012/13 Comments and Photo Image #
54	01/04	01/04, IMG_1774	Wauponsie & Franklin (NW corner)	3	Ca. 1890s-1910s	Residential	Frame house of two stories, with clapboard siding and prominent, wrap-around porch.	House has been repainted and, possibly, rehabilitated (i.e., porch is no longer screened in). IMG_1262

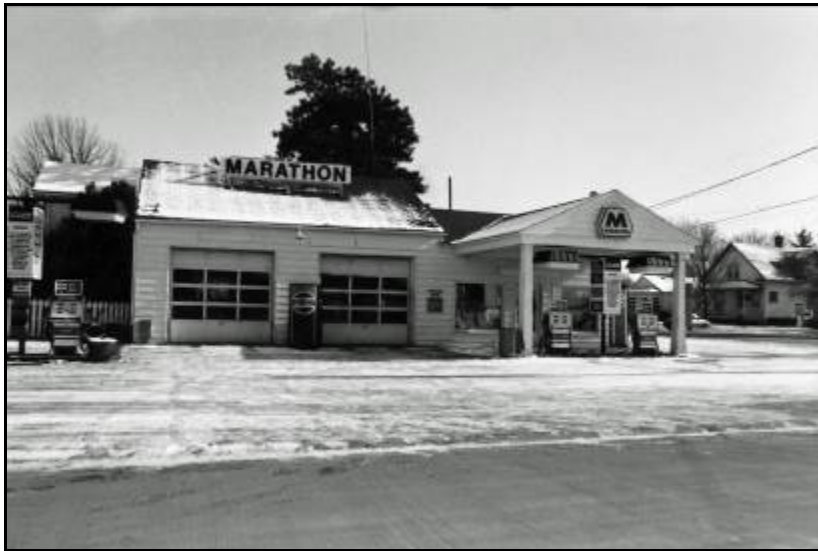
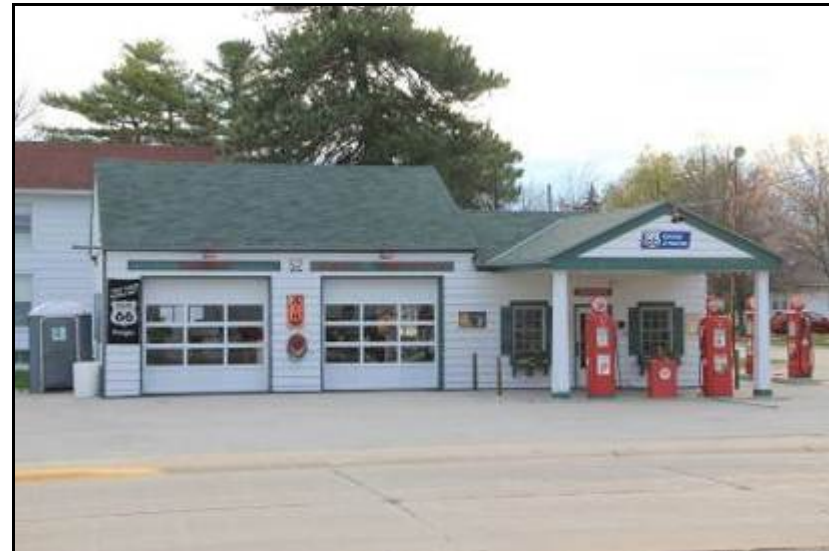
Sequence Number	Map Code	1994/95 Negative #	Address/Location	Type	Date Built	Historic Function	1994/95 Comments	2012/13 Comments and Photo Image #
55	01/05	01/05, IMG_1775	Old 66 & Mazon, DWIGHT	2	Ca. 1932	Gas/Service	Initially operated as a Texaco station, this present-day Marathon Oil Company station has a shallow, gabled roof and wide siding. See Waldmire Post Card for more information.	The station building remains and is now used as a RT 66 information center. IMG_1260

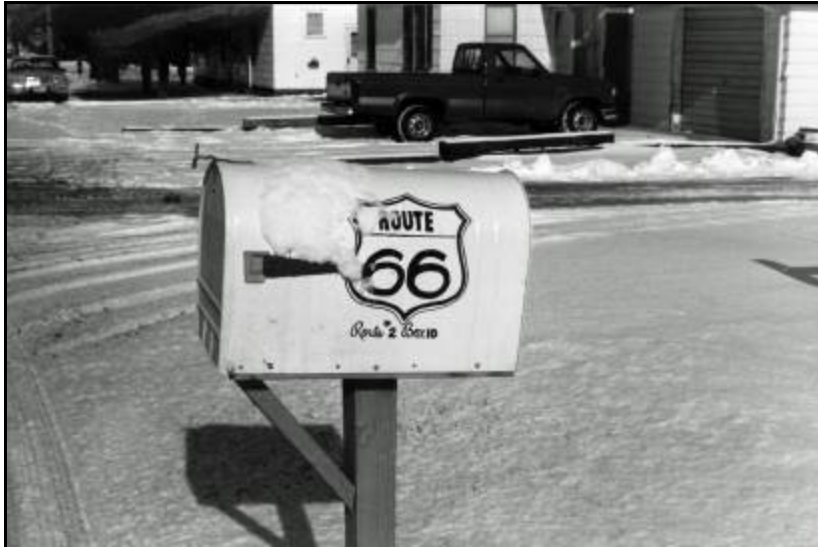
Sequence Number	Map Code	1994/95 Negative #	Address/Location	Type	Date Built	Historic Function	1994/95 Comments	2012/13 Comments and Photo Image #
56	01/06	01/06, IMG_1776	Old 66 between Delaware & Chippewa	3	Unknown	Mail Box	Mail box with prominent RT 66 insignia on side.	Mail box now gone.

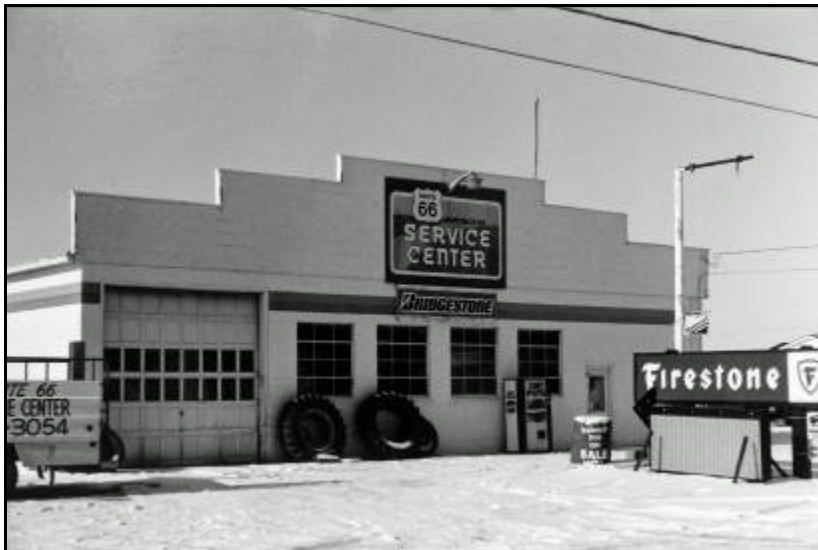
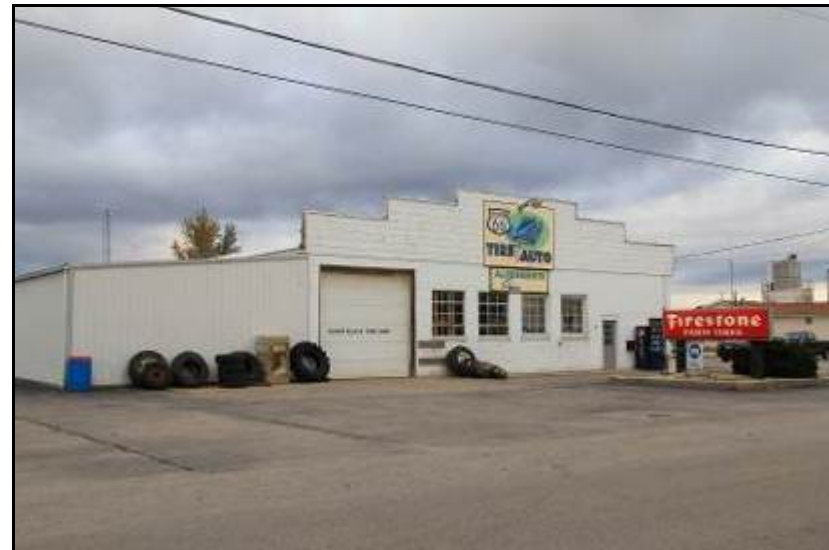
Sequence Number	Map Code	1994/95 Negative #	Address/Location	Type	Date Built	Historic Function	1994/95 Comments	2012/13 Comments and Photo Image #
57	01/07	01/07, IMG_1777	Old 66 between Chippewa & South (W side)	2	Ca. 1930s-40s	Gas/Service	This large, concrete block building is prominent for its three-step parapet – now Route 66 Service Center.	While the garage building remains, note the new, overhead garage door and the addition to the left. IMG_1258

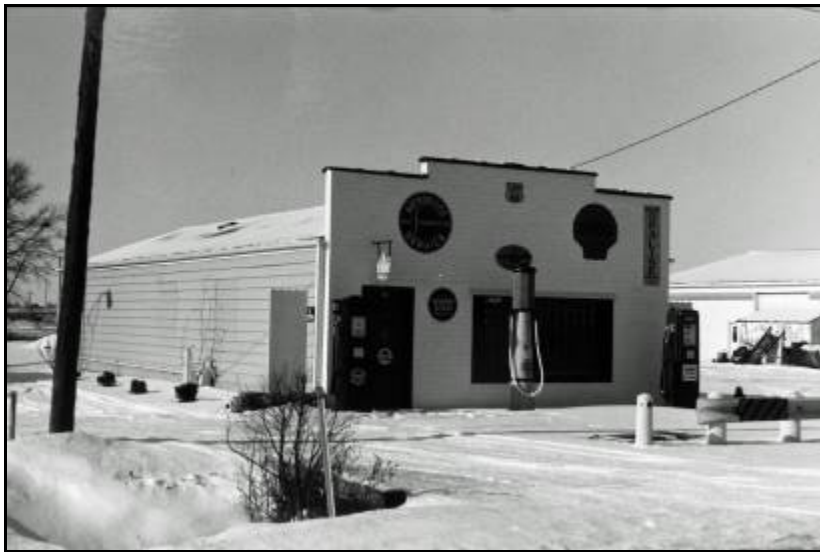
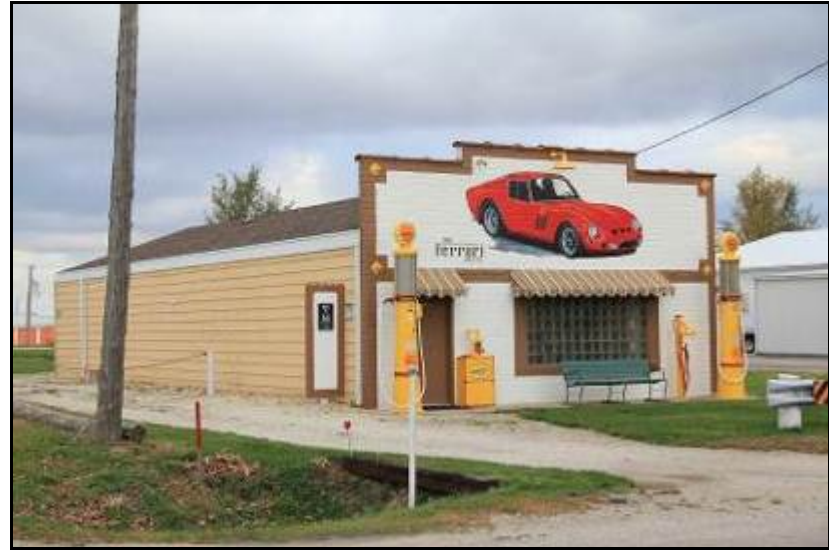
Sequence Number	Map Code	1994/95 Negative #	Address/Location	Type	Date Built	Historic Function	1994/95 Comments	2012/13 Comments and Photo Image #
58	01/08	01/08-09, IMG_1778	Old 66 between Chippewa & South (W side)	2	Ca. 1920s-30s	Unknown	Original use for this structure is unknown, although it may have been a service station at one time.	The building has been repainted and now has small awnings over the front window and door. IMG_1257

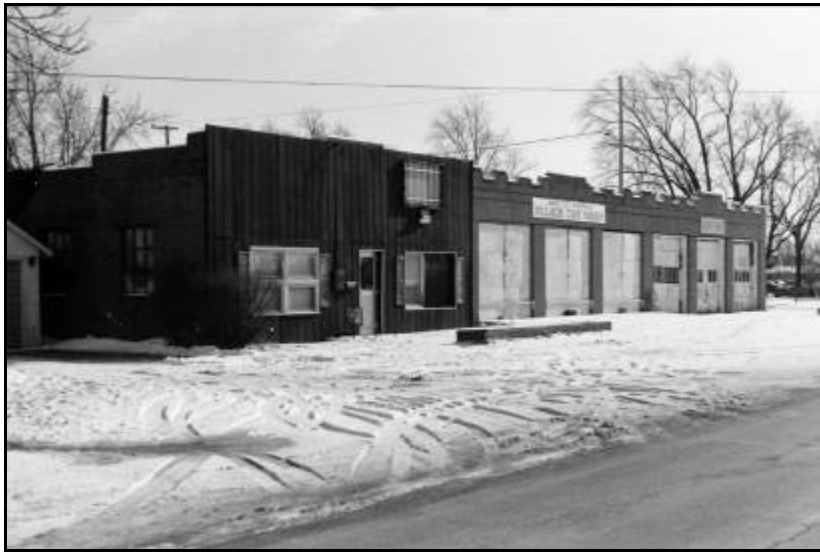
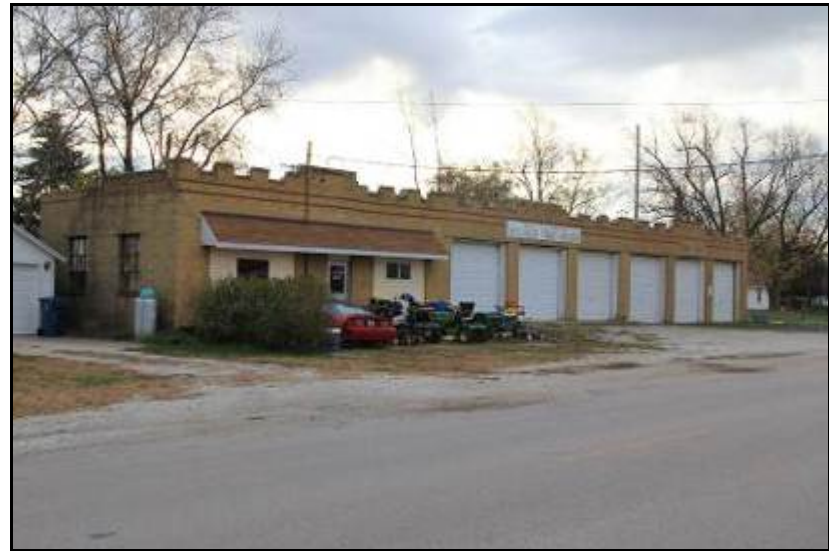
Sequence Number	Map Code	1994/95 Negative #	Address/Location	Type	Date Built	Historic Function	1994/95 Comments	2012/13 Comments and Photo Image #
59	01/10	01/10, IMG_1779	Old 66 between Chippewa & South (E side)	2	Ca. 1930s	Garage (?)	Built of brick, and with a prominent parapet with stone coping, this structure has many garage doors – specific use is unknown, but some type of garage seems logical.	Note that the wood paneling on the left side of the building has been removed, although a small awning has been constructed and windows have been infilled. IMG_1256

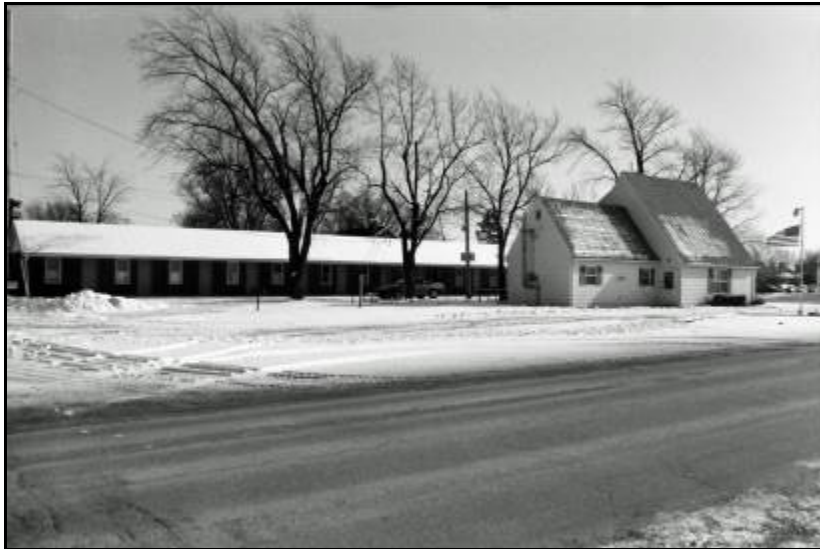
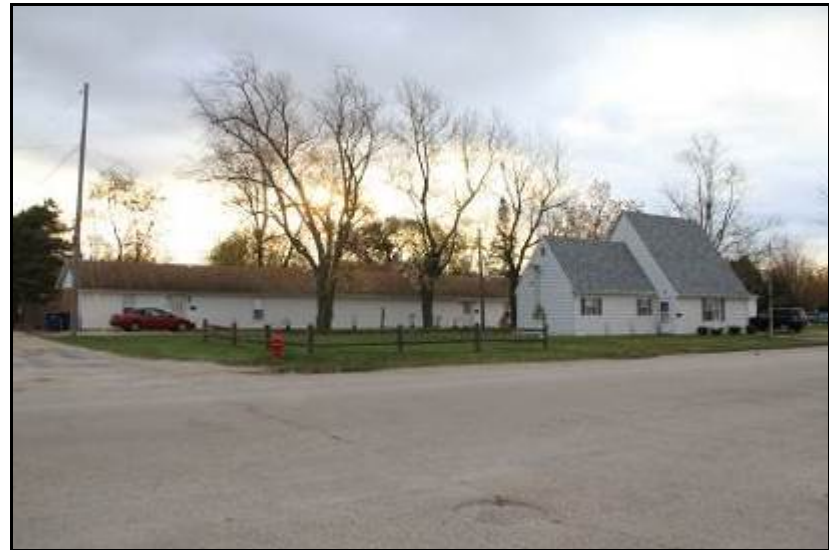
Sequence Number	Map Code	1994/95 Negative #	Address/Location	Type	Date Built	Historic Function	1994/95 Comments	2012/13 Comments and Photo Image #
60	01/18	01/18, IMG_1780	Old 66 between Chippewa & South (E side)	2	Ca. 1939	Motel	Originally Paulsen's Deluxe Motel, additions and changes have occurred. [Note that photos 01/11-17 are of Waldmire Post Cards for Dwight, as well as photos of old motel post cards and a Waldmire Post Card of original owner Metha Paulsen Jensen, a Rt. 66 Hall of Fame member in IL.]	Few changes to the former motel's residence since 1994. The windows and doorways in the motel portion itself have been largely removed and the space converted for other uses. IMG_1253

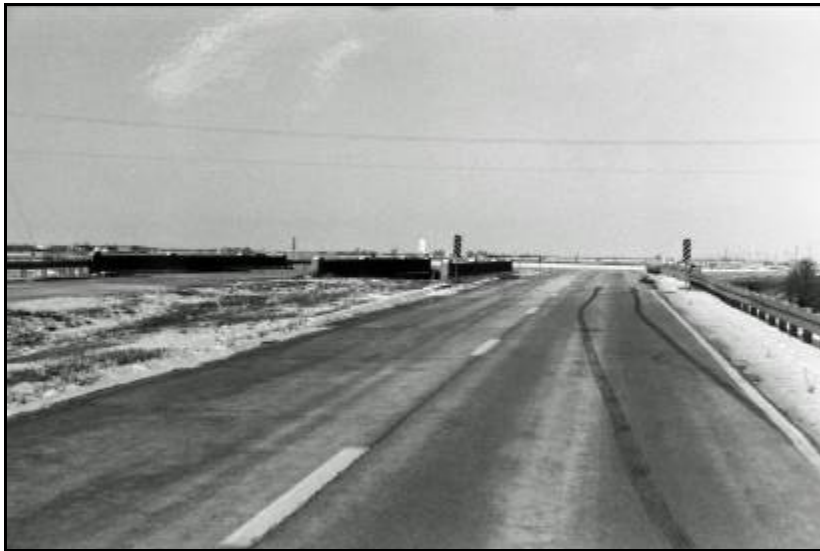
1994

Sequence Number	Map Code	1994/95 Negative #	Address/Location	Type	Date Built	Historic Function	1994/95 Comments	2012/13 Comments and Photo Image #
62	01/20	01/20, 07/10-11, 11/13-15, IMG_1782	Old 66 bypass over IL 17	1	1946/1954	Bridges	Two structures remain: Bridge #0016 (westbound) – plate notes: Station 498+54.05(1), Built 1946 by, State of Illinois, F.A. RT. 5 Sec. 7-X-2-H-B, Proj. F.I. 25(20), Loading H-20-S16 AND Bridge #0015 (eastbound) – plate notes: Station 498+54.05(2), Built 1954 by State of Illinois, F.A. RT5 Sec. 7X-2HB-1, F.A. Proj. I.N. 25(25), Loading H-20-S16; three-span structures with slightly arched, concrete “I” beams.	Historic period bridges and grade separation now gone. Replaced by an at-grade intersection.

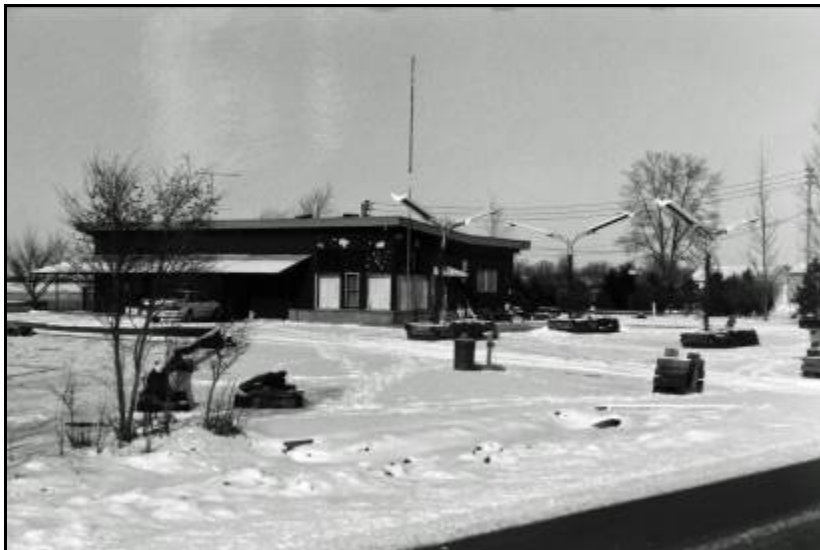
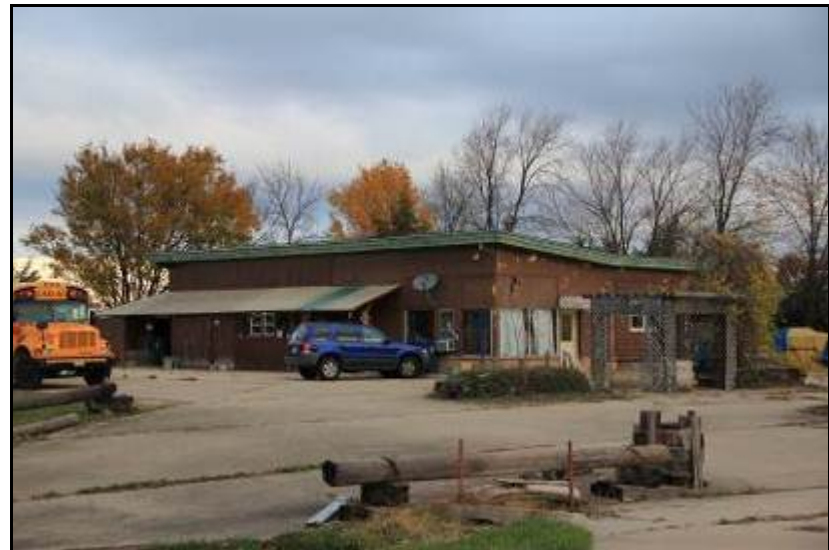
Sequence Number	Map Code	1994/95 Negative #	Address/Location	Type	Date Built	Historic Function	1994/95 Comments	2012/13 Comments and Photo Image #
63	01/21	01/21, IMG_1783	Old 66 & bypass	2	Ca. 1950s-60s	Gas/Service	Building has a combination flat and gently-sloped, shed roof, as well as several old, gas pump islands.	Gas station building remains with minor changes. The gas pump island lights extant in 1994 are now gone. IMG_1952

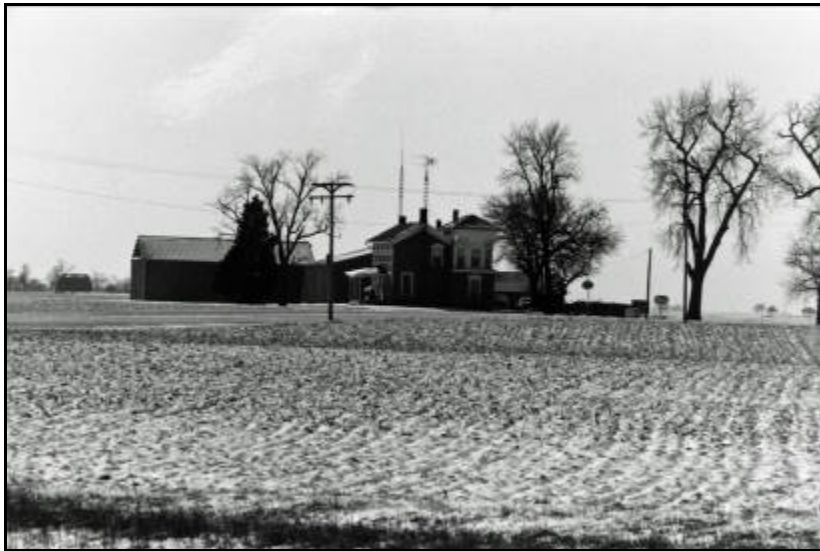
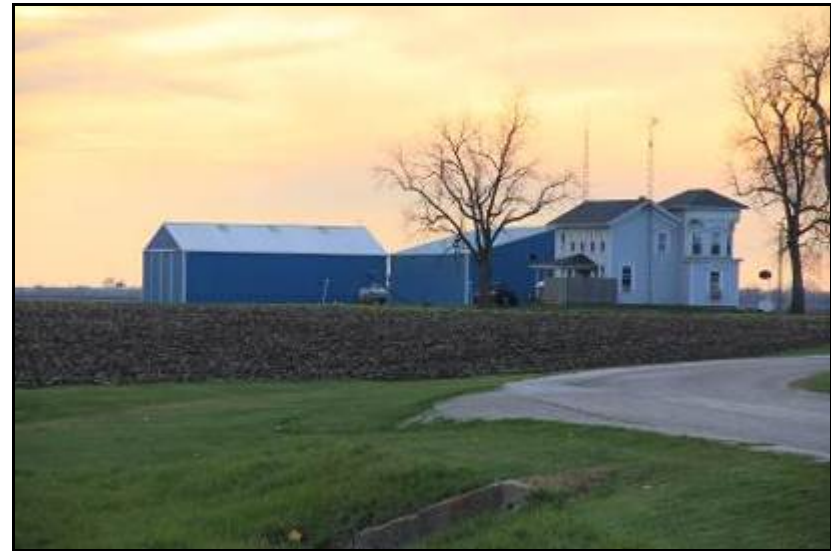
Sequence Number	Map Code	1994/95 Negative #	Address/Location	Type	Date Built	Historic Function	1994/95 Comments	2012/13 Comments and Photo Image #
64	01/22	01/22, IMG_1784	Old 66 & Rd. 3100N	3	Ca. 1890s-90s	Residential	Large, two-story, brick farmhouse with a gabled roof and a real sense of character.	House and farm remains, although the house may have been sided (it appears to be a bit sanitized). IMG_1251

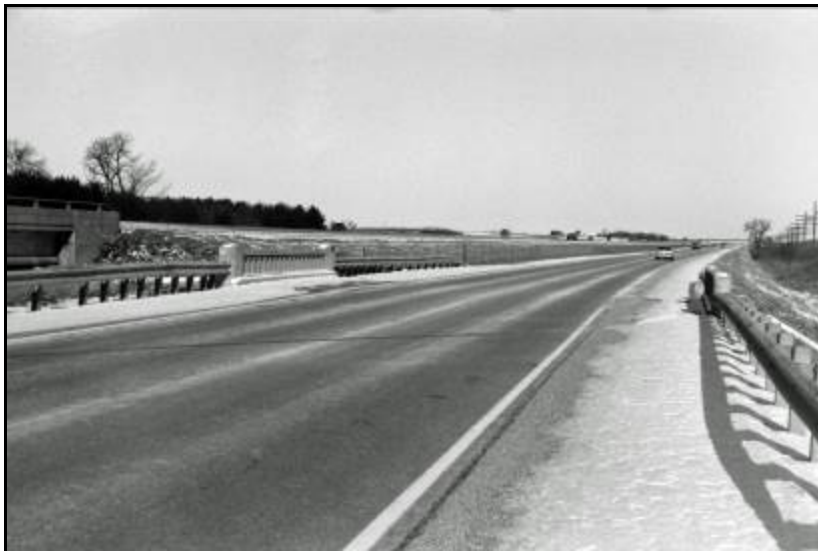
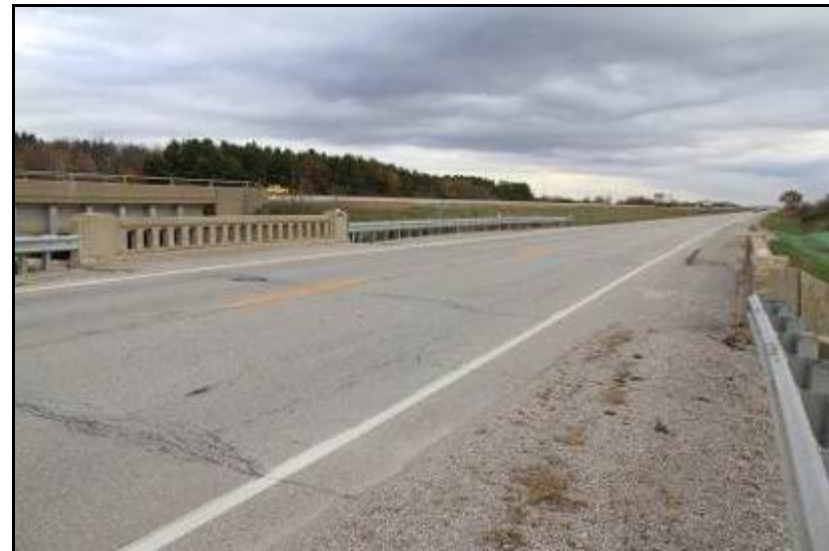
Sequence Number	Map Code	1994/95 Negative #	Address/Location	Type	Date Built	Historic Function	1994/95 Comments	2012/13 Comments and Photo Image #
65	01/23	01/23, 11/16-17, IMG_1785	Old 66 over branch of W Fork Mazon River	1	1954	Bridge	One structure remains: Bridge #0013 – plate notes: Station 699+64(2), Built 1954 by, State of Illinois, F.A. Route 5 Section 8 RB-1, F.A. Proj. F 1-25 (24), Loading H20-S16; single-span structure with concrete “T” beams.	No apparent changes to the one bridge remaining in 1994. IMG_1268

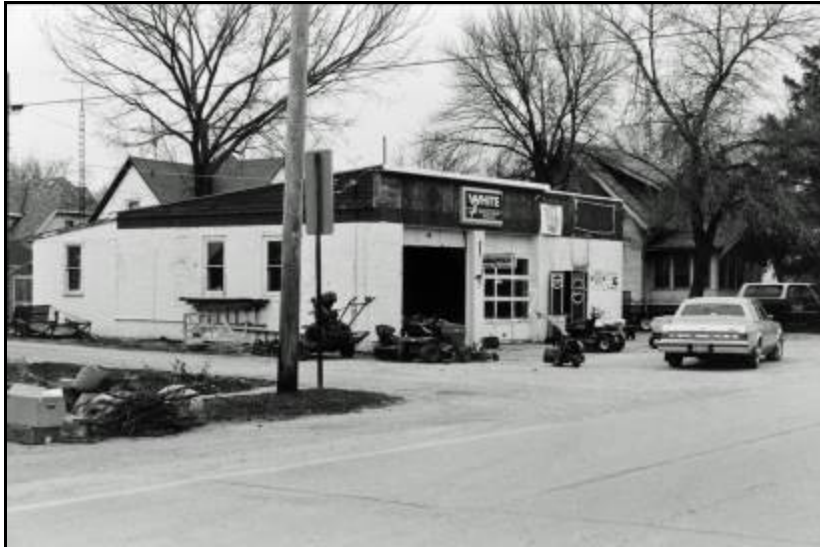
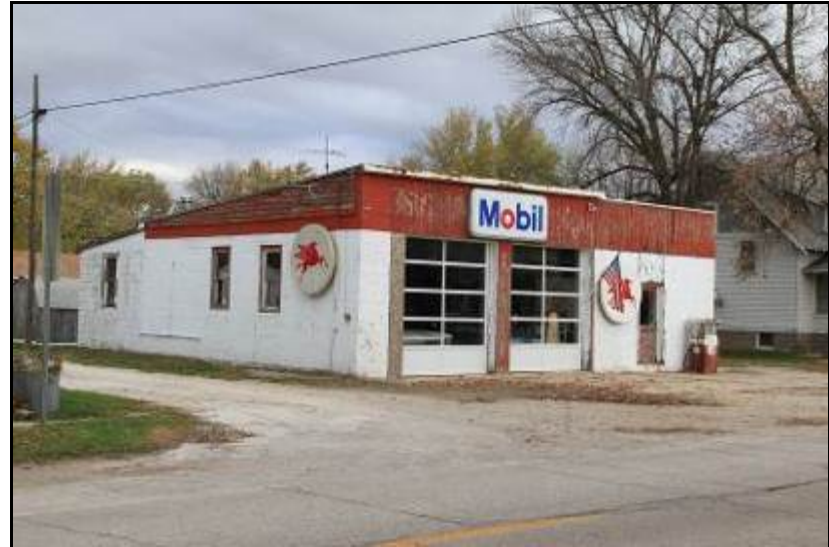
Sequence Number	Map Code	1994/95 Negative #	Address/Location	Type	Date Built	Historic Function	1994/95 Comments	2012/13 Comments and Photo Image #
66	07/12	07/12, IMG_1786	102 West Ave., ODELL	2	Ca. 1950s	Gas/Service	Concrete block structure with shed roof.	Signage at this service station has changed, as have the garage doors. IMG_1269

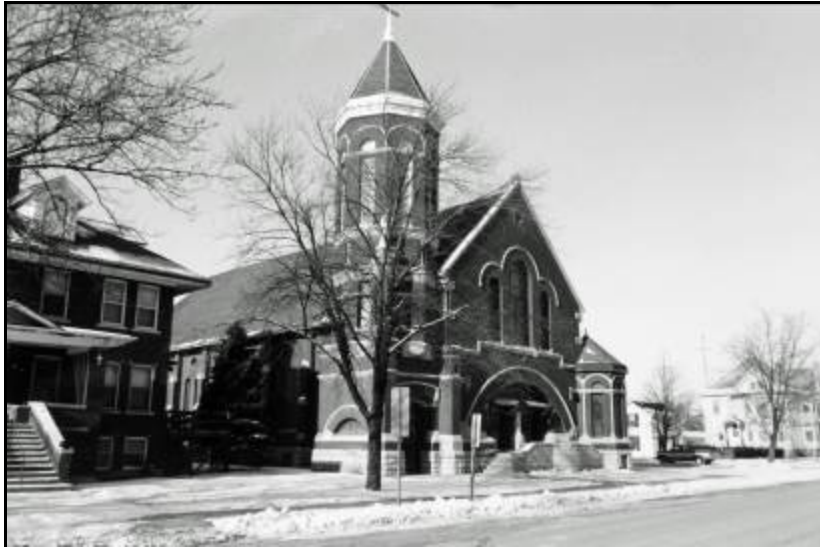
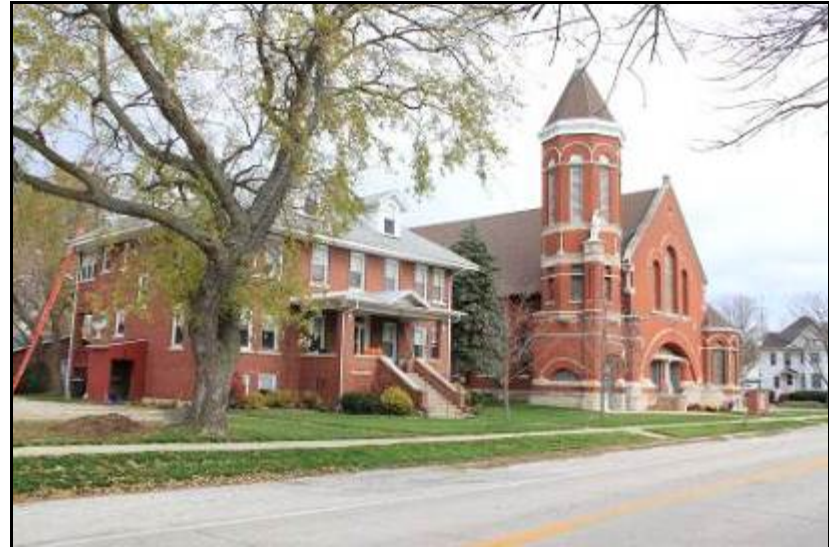
Sequence Number	Map Code	1994/95 Negative #	Address/Location	Type	Date Built	Historic Function	1994/95 Comments	2012/13 Comments and Photo Image #
67	01/24	01/24, IMG_1787	West Ave. & Hamilton, ODELL	3	1901	Church	Large, brick, Romanesque structure built in 1901 – “St. Paul’s Parish.”	No readily apparent changes to the church noted. IMG_1270

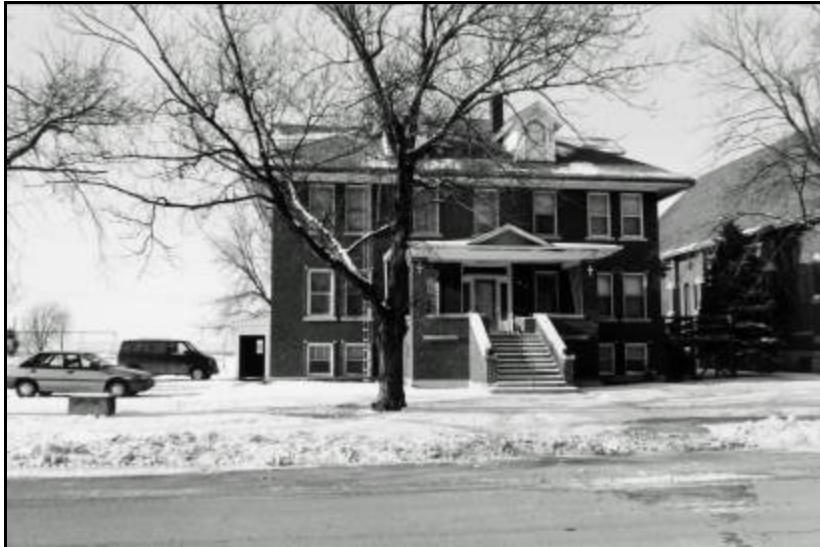
1994

Sequence Number	Map Code	1994/95 Negative #	Address/Location	Type	Date Built	Historic Function	1994/95 Comments	2012/13 Comments and Photo Image #
68	01/25	01/25, IMG_1788	202 West Ave., ODELL	3	1895	Church-related	Brick, 2.5 story school or rectory associated with "St. Paul's Parish."	No apparent changes to the parish rectory observed. IMG_1270
