Route 66 in Illinois:

(2012/13 Update and Expansion of the Original 1994/95 Survey)

IDOT Sequence #17337 & #17337A

22 December 2013

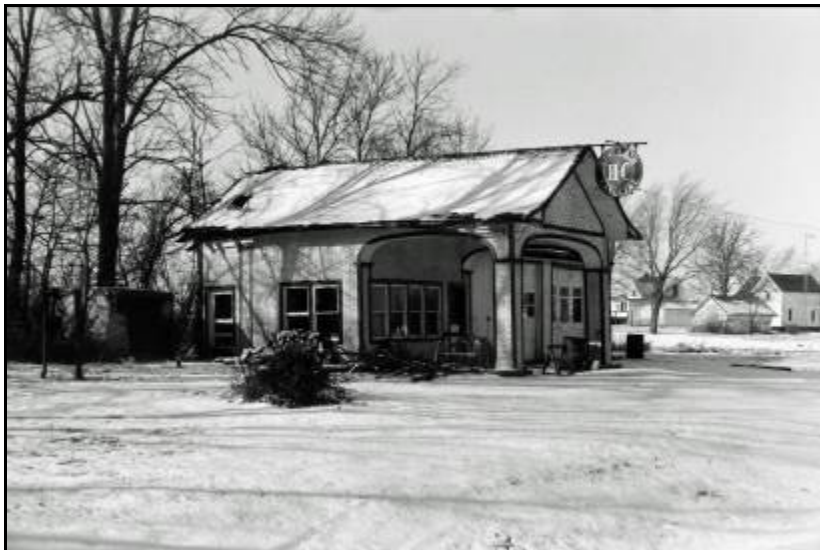
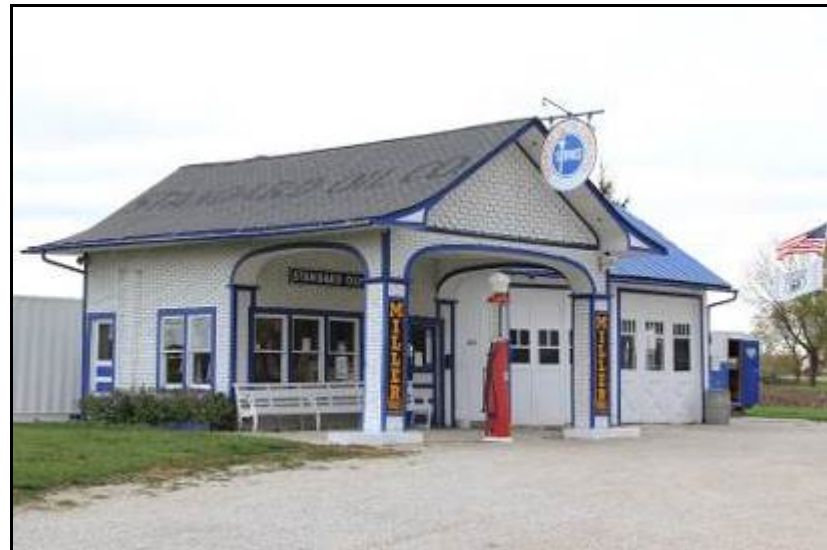
Sequence Number	Map Code	1994/95 Negative #	Address/Location	Type	Date Built	Historic Function	1994/95 Comments	2012/13 Comments and Photo Image #
69	01/26	01/26-29, 07/13-18, IMG_1789	West Ave. & Deer St., ODELL	2	Ca. 1930s	Gas/Service	Served as both a "Sinclair" and a "Standard Oil" gas station; reflects Domestic-type of gas station and is sheathed with wooden shingles.	The old service station received a grant from "Hampton Inns" and has been rehabilitated. It is now a RT 66 information center. IMG_1271

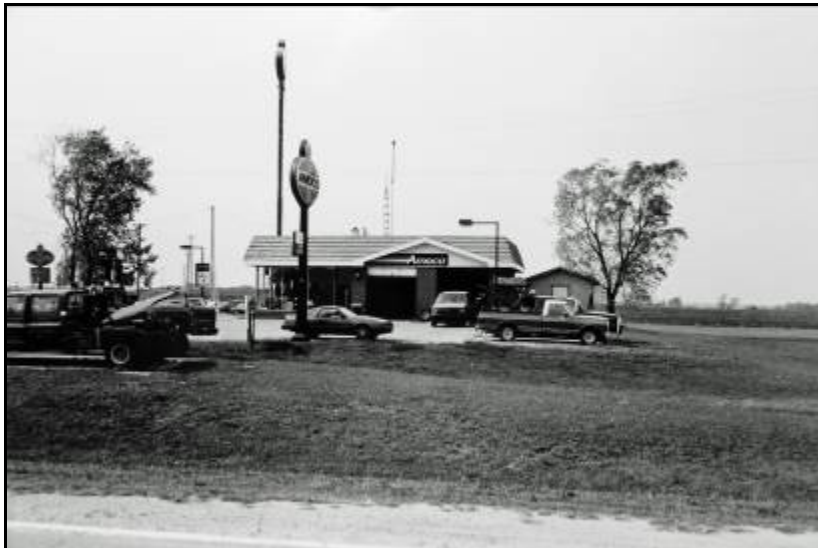
Sequence Number	Map Code	1994/95 Negative #	Address/Location	Type	Date Built	Historic Function	1994/95 Comments	2012/13 Comments and Photo Image #
70	20/13	20/13, IMG_1790	Old 66 bypass & Main (NW corner), ODELL	2	Ca. 1960s-70s	Gas/Service	Amoco station of brick with fiberglass or plastic shingles; could well have been built to serve both USH 66 and I-55.	Structure now gone. The current facility is new construction.

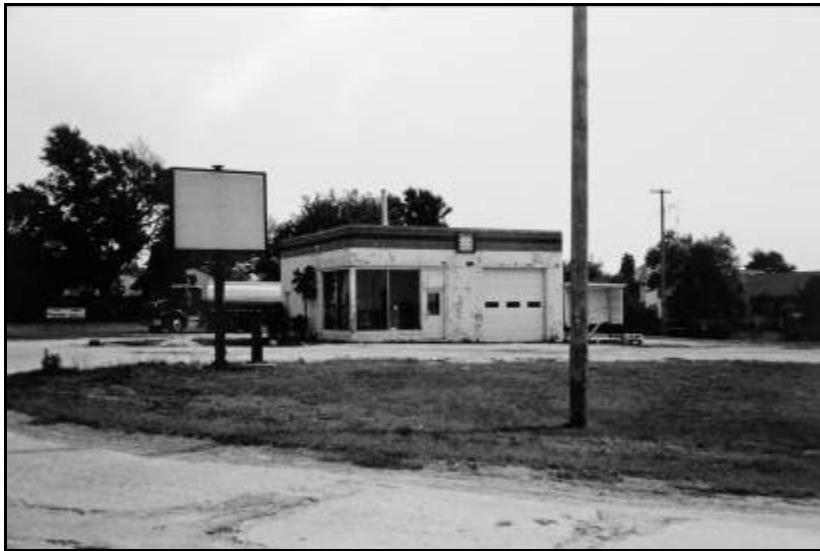
1994

Sequence Number	Map Code	1994/95 Negative #	Address/Location	Type	Date Built	Historic Function	1994/95 Comments	2012/13 Comments and Photo Image #
71	20/12	20/12, IMG_1791	Old 66 bypass & Main (SW corner), ODELL	2	Ca. 1950s	Gas/Service	Old, concrete block gas station – vacant.	Building is gone.

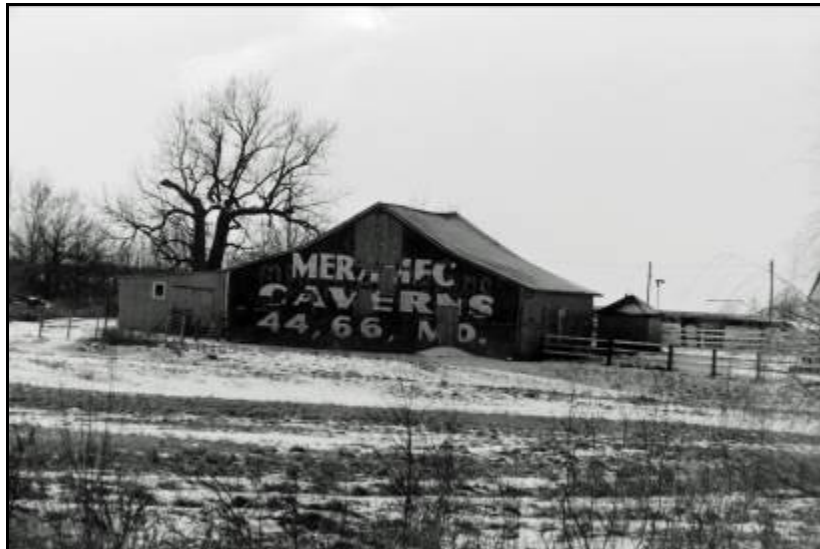
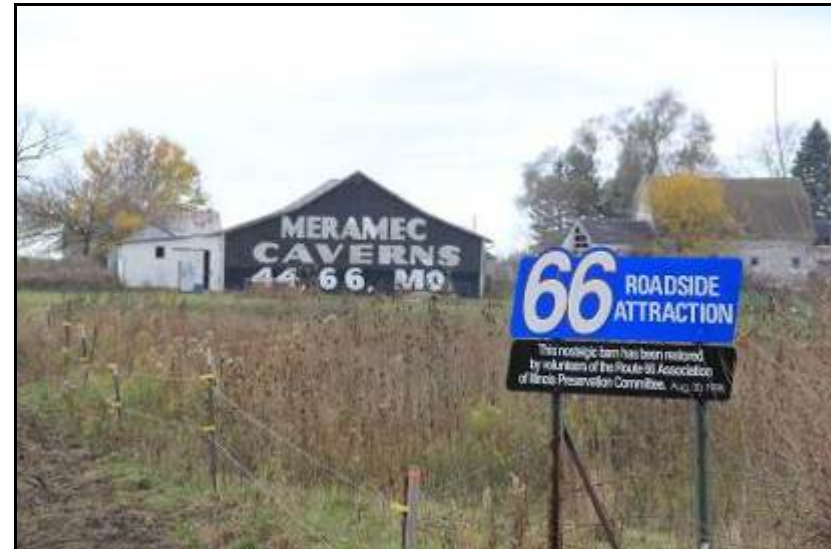
Sequence Number	Map Code	1994/95 Negative #	Address/Location	Type	Date Built	Historic Function	1994/95 Comments	2012/13 Comments and Photo Image #
72	01/30	01/30-31, IMG_1792	Old 66 at CAYUGA	2	Unknown	Advertising	Meramec Caverns sign on side of a barn.	Sign has been repainted and a RT 66 attraction sign added. IMG_1273

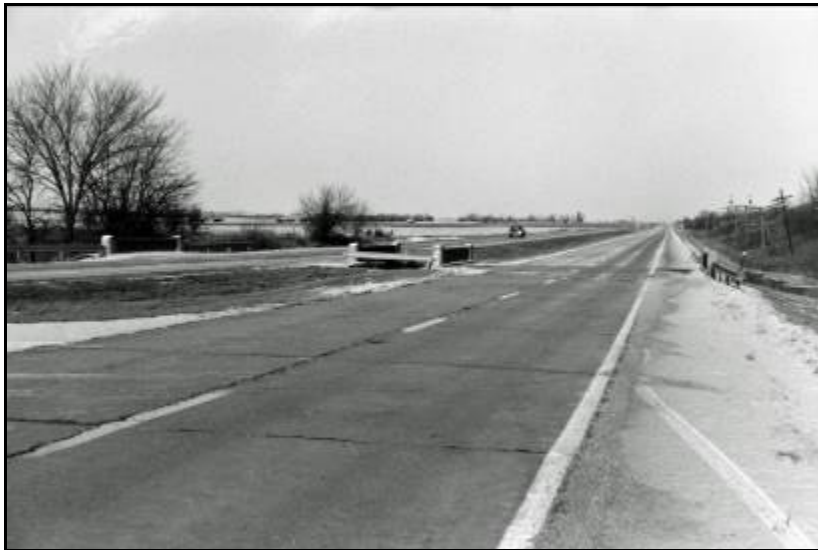
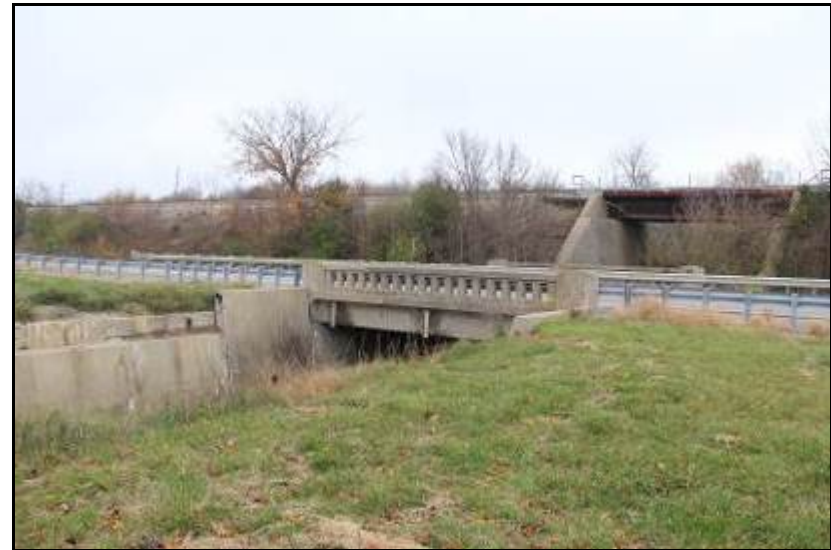
Sequence Number	Map Code	1994/95 Negative #	Address/Location	Type	Date Built	Historic Function	1994/95 Comments	2012/13 Comments and Photo Image #
73	01/32	01/32, 11/19-20, IMG_1793	Old 66 over Wolf Creek, CAYUGA	1	1955	Bridges	Two structures remain: Bridge #0011 (eastbound) and #0012 (westbound) – plate notes: Station 1180+22(2), Built 1955 by, State of Illinois, S.B.I. RT. 4 Sec. 10-R-B-1, F.A. Proj. F.I. 25 (24), Loading H20-S16; one-span bridges with concrete “T” beams.	Westbound lanes and bridge removed. Eastbound bridge remains. IMG_1274

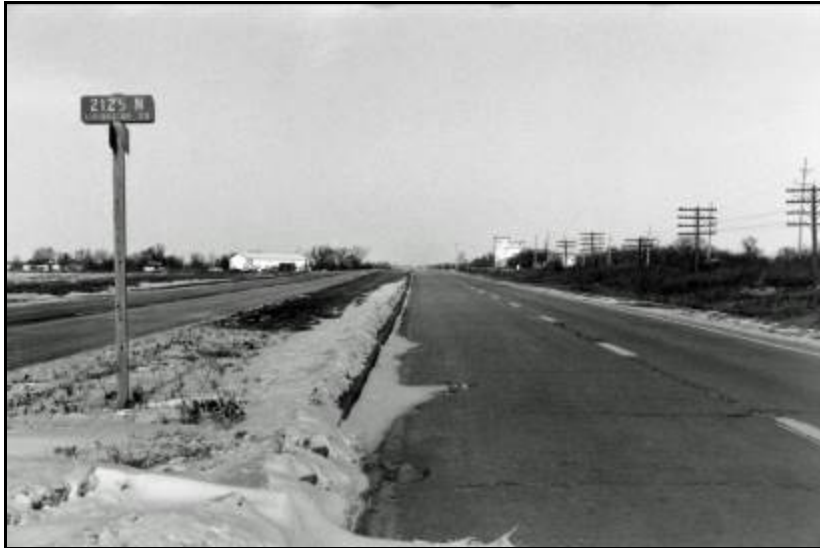
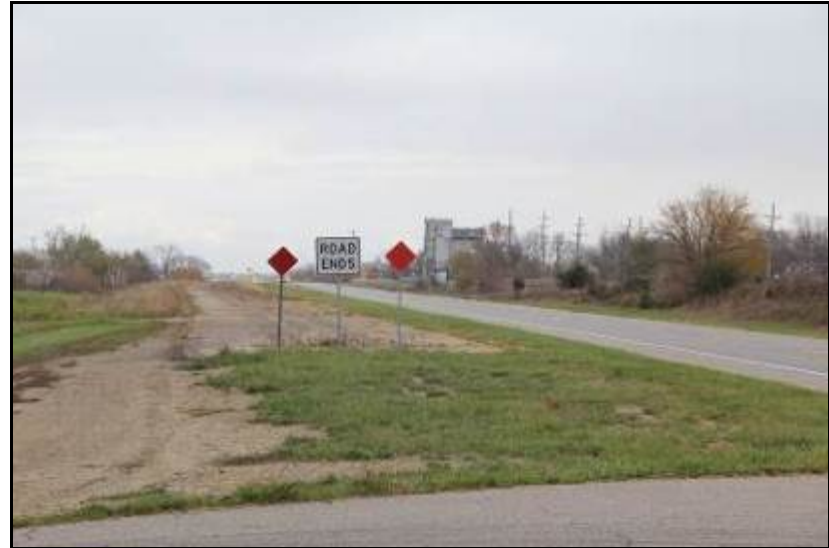
Sequence Number	Map Code	1994/95 Negative #	Address/Location	Type	Date Built	Historic Function	1994/95 Comments	2012/13 Comments and Photo Image #
74	01/33	01/33 IMG_1794	Old 66 at CAYUGA	1	Ca. 1955	USH 66	Four-lane 66 at Cayuga [view to NE].	The westbound lanes are now closed, although they remain. IMG_1276

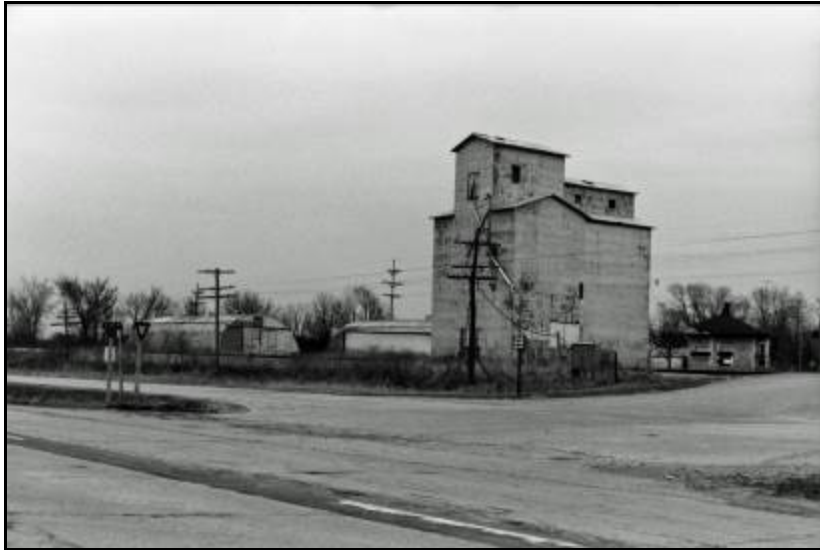
1994

Sequence Number	Map Code	1994/95 Negative #	Address/Location	Type	Date Built	Historic Function	1994/95 Comments	2012/13 Comments and Photo Image #
75	07/19	07/19, IMG_1795	Old 66 at CAYUGA	3	Ca. 1890s-1910s	Grain Elevator	Cayuga grain elevator with corrugated metal siding.	The grain elevator remains. IMG_0000

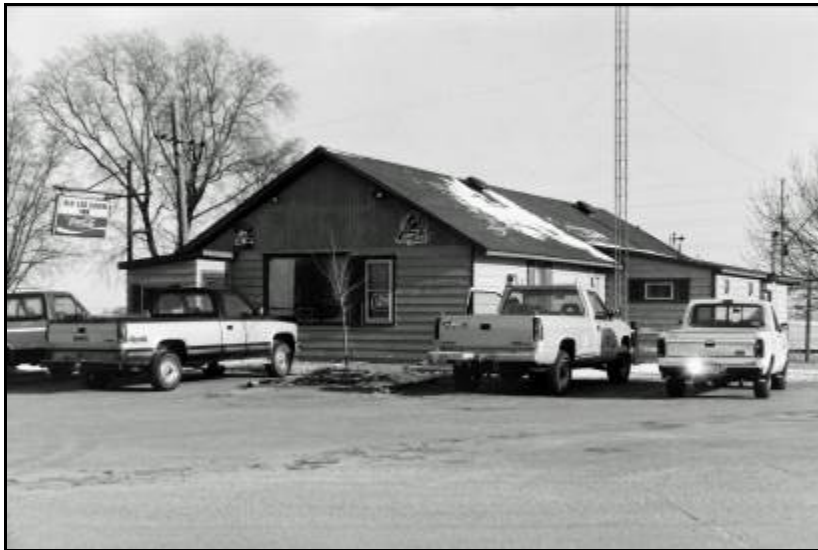
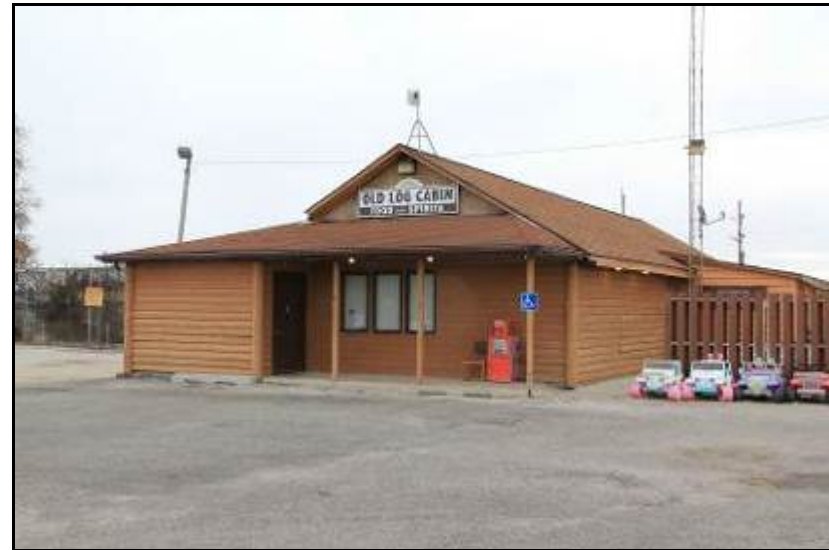
Sequence Number	Map Code	1994/95 Negative #	Address/Location	Type	Date Built	Historic Function	1994/95 Comments	2012/13 Comments and Photo Image #
76	01/34	01/34-35, IMG_1796	Old 66 & Pontiac Rd., N OF PONTIAC	2	Ca. 1920s	Café	“Old Log Cabin Inn” has relatively modern-looking, wide siding; see Waldmire Post Card for more information – also note that photos 03/03 and 03/04 show the original log cabin-type nature of the structure, and that photos 03/05 & 03/06 show the café and adjacent gas station, ca 1940s or 1950s.	The restaurant has been resheathed. A new, hip roof porch and entrance have been constructed. IMG_1277

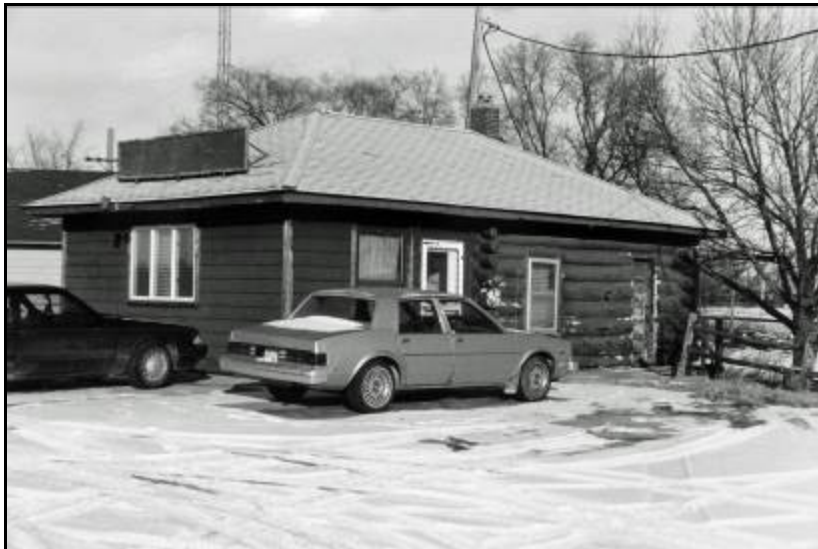
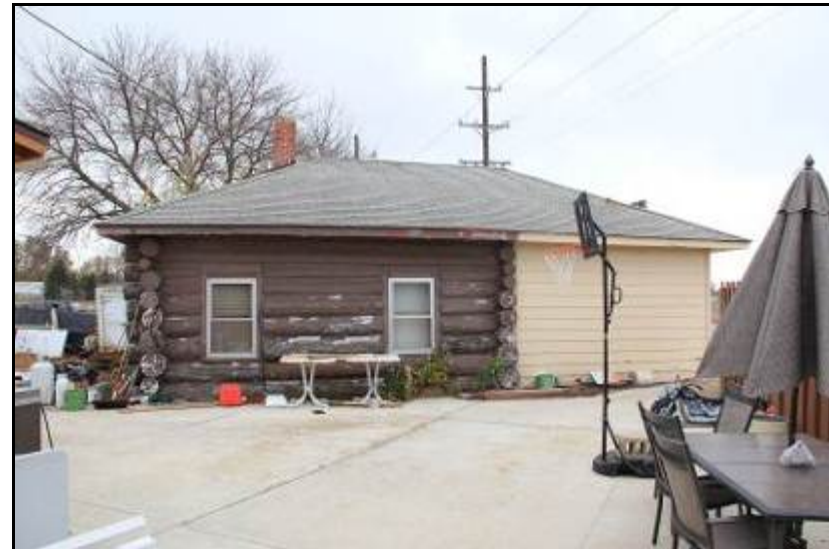
Sequence Number	Map Code	1994/95 Negative #	Address/Location	Type	Date Built	Historic Function	1994/95 Comments	2012/13 Comments and Photo Image #
77	01/36	01/36, IMG_1797	Old 66 & Pontiac Rd., N OF PONTIAC	2	Ca. 1930s	Gas Station	Adjacent to the "Old Log Cabin Inn," the log cabin-type construction of this building is seen in its back half; served as Texaco Station, front drive-through now enclosed – note photos 03/01, 03/04 & 03/07-09 are historic views of the gas station, and that photos 03/05-06 are historic pictures of the gas station and café together.	That part of the gas station where the pumps had been, which was enclosed in 1994, appears to have been resheathed. IMG_1278

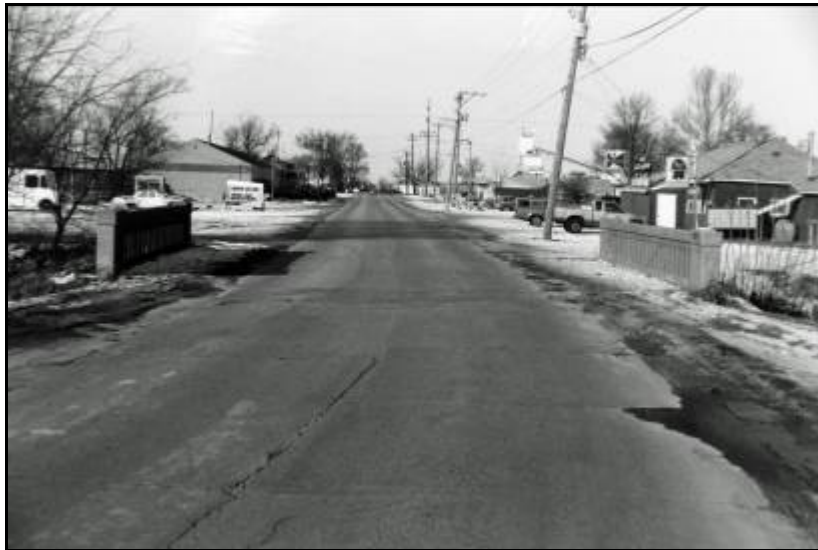
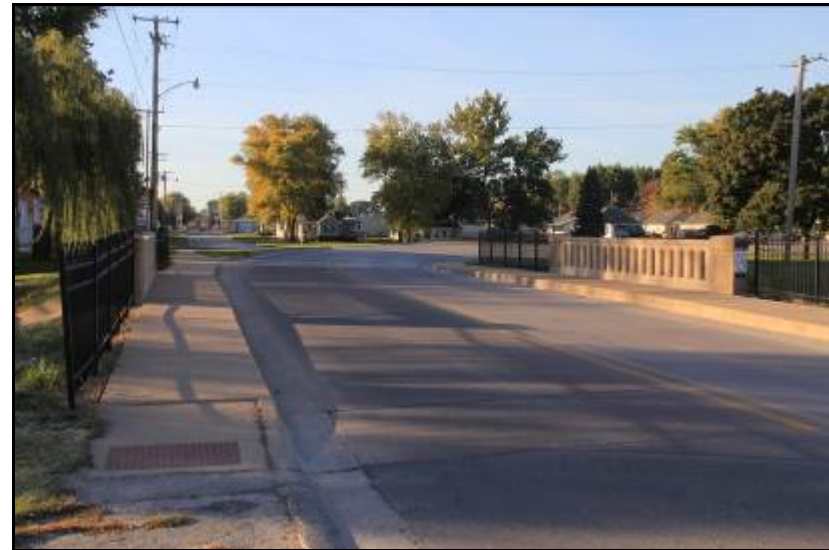
Sequence Number	Map Code	1994/95 Negative #	Address/Location	Type	Date Built	Historic Function	1994/95 Comments	2012/13 Comments and Photo Image #
78	02/03	02/03-06, 20/14, IMG_4522	Division St. over North Creek	1	1926	Bridge	A two-lane structure on IL 4; Bridge #0073 – plate notes: “Station 47+00, Built 1926 by, State of Illinois, Bond Issue Rt 4, (illegible) 11-BX;” single span structure with concrete deck supported by five concrete “T” beams—note that photos 02/09-02/15 are pictures of the bridge plate and the old IL 4 designation painted on the end of the bridge railing (a rare find).	Although the historic endposts of the bridge remain, it was otherwise reconstructed—with what appears to be a slightly higher railing—in 2005. Several new interpretive signs exist at this location. IMG_4012-4016

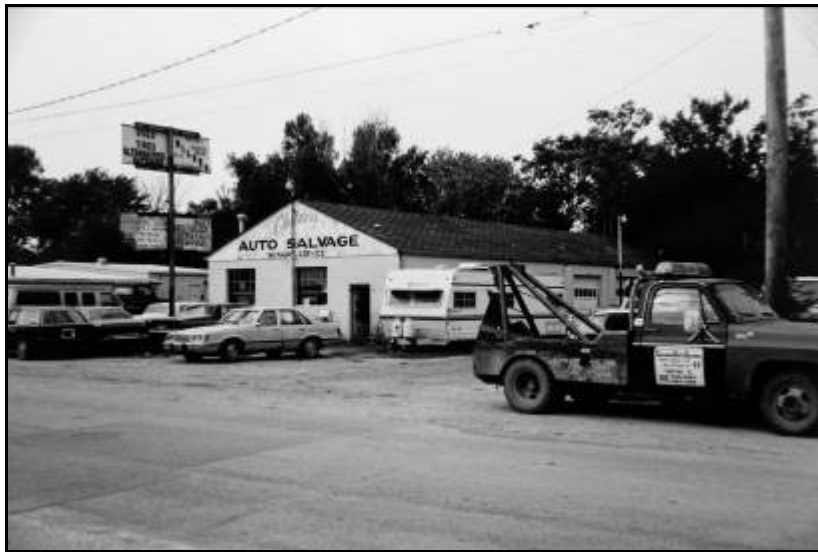
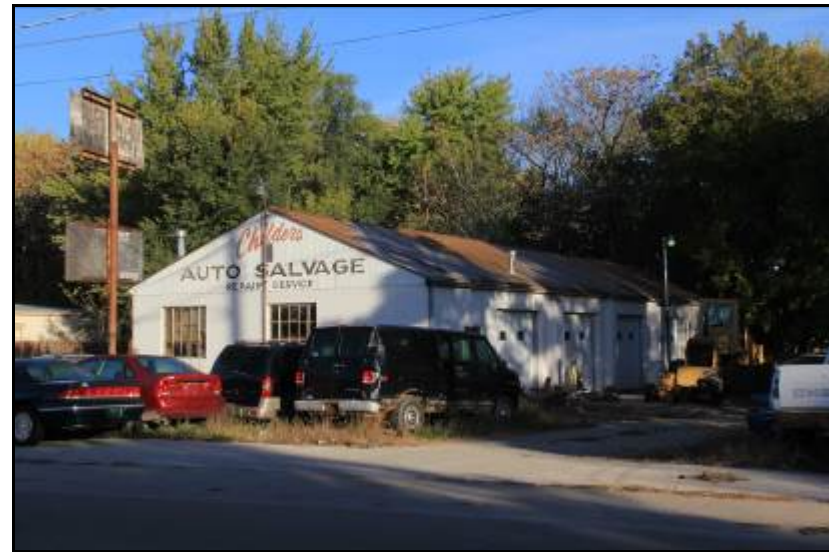
Sequence Number	Map Code	1994/95 Negative #	Address/Location	Type	Date Built	Historic Function	1994/95 Comments	2012/13 Comments and Photo Image #
79	20/17	20/17, IMG_4523	Lincoln Ave. & Vermillion (NW corner)	2	Ca. 1940s-50s	Auto Service (?)	Concrete block structure with gabled roof, has garage doors to rear; <u>may</u> have been an auto service business – now “Childers Auto Salvage.”	Few changes appear to have been made at this location. IMG_4017

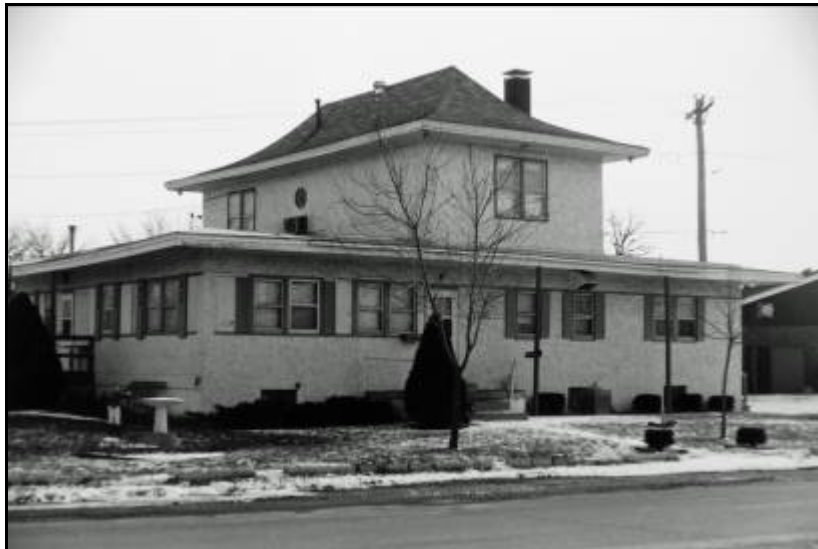
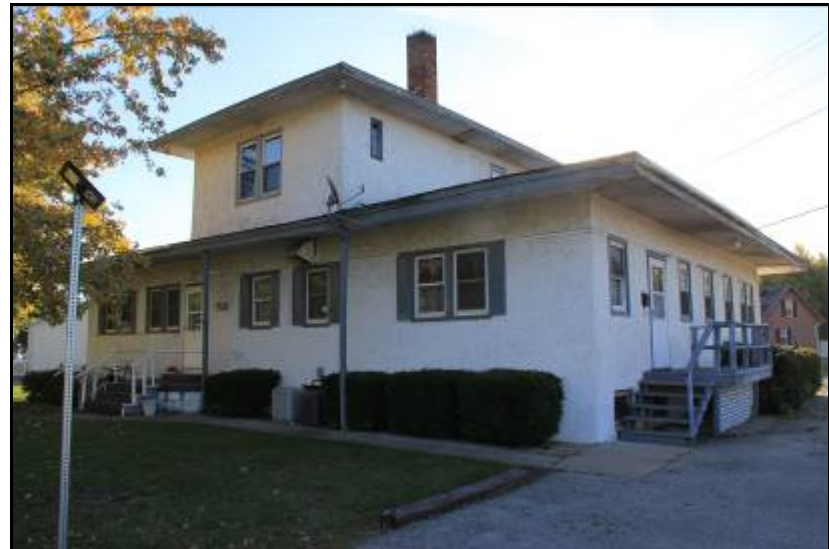
Sequence Number	Map Code	1994/95 Negative #	Address/Location	Type	Date Built	Historic Function	1994/95 Comments	2012/13 Comments and Photo Image #
80	02/16	02/16, IMG_4524	720 Lincoln Ave.	3	Ca. 1920s-30s	Residential	Large, stucco-sheathed house with a flat roof and a partial second floor with an interesting, flared, hipped roof.	This house is largely unchanged. IMG_4019

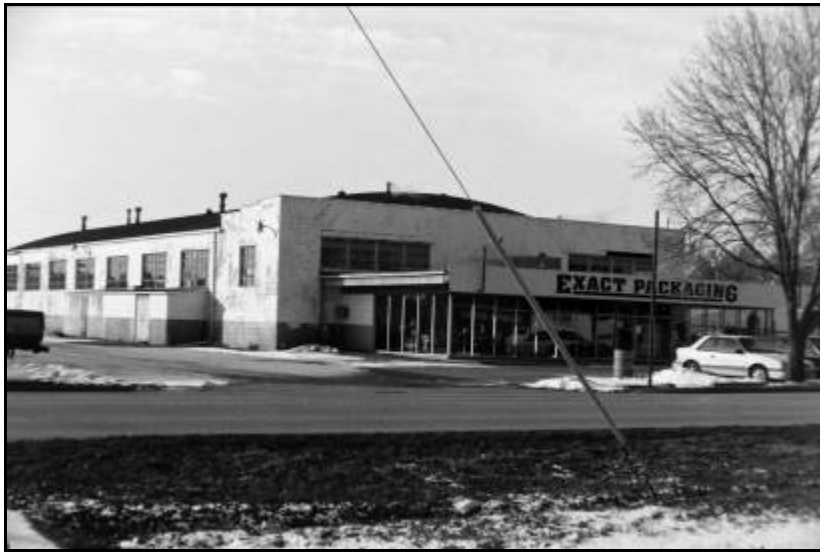
1994/5

Sequence Number	Map Code	1994/95 Negative #	Address/Location	Type	Date Built	Historic Function	1994/95 Comments	2012/13 Comments and Photo Image #
81	02/17	02/17, IMG_4525	825 Ladd St.	2	Ca. 1950s	Auto Dealer	Large, concrete block structure with a prominent, glass show room in front; now known as "Exact Packaging," this looks very much like it was an auto dealer.	It is unclear if this building is presently used. The display windows, and several others behind the display area, have been boarded over. IMG_4021

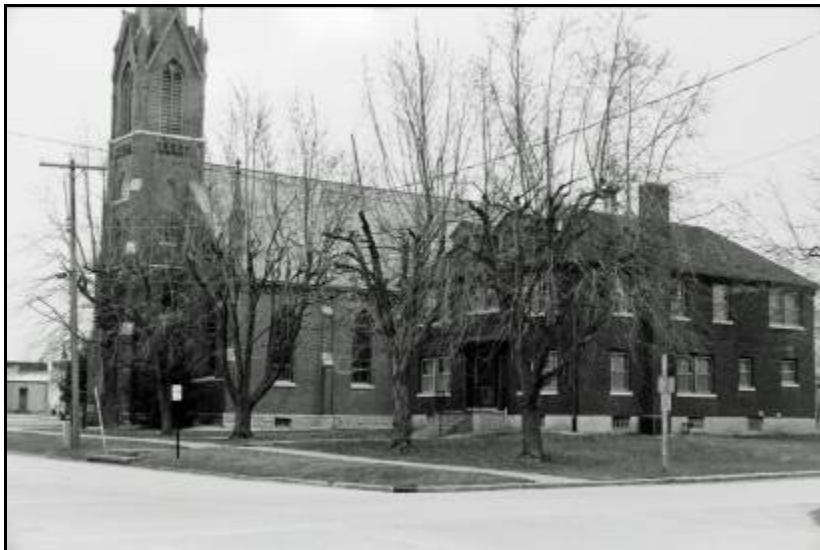
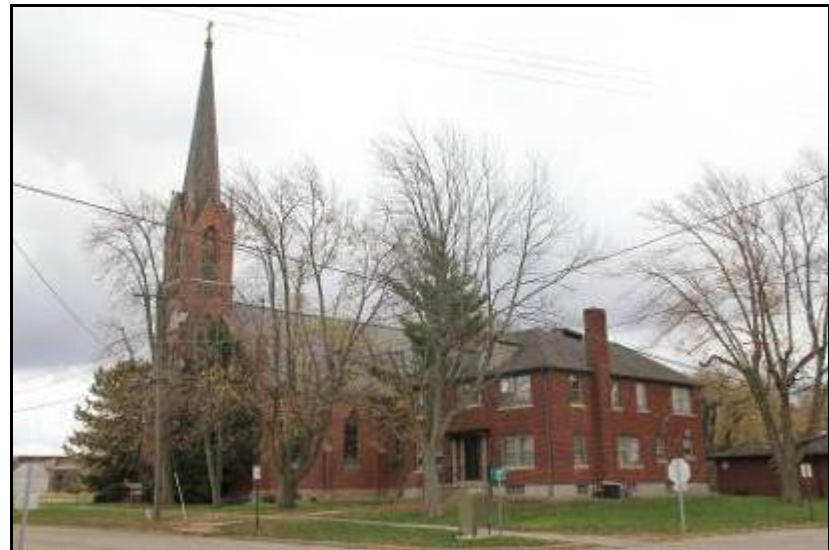
Sequence Number	Map Code	1994/95 Negative #	Address/Location	Type	Date Built	Historic Function	1994/95 Comments	2012/13 Comments and Photo Image #
96	07/32	07/32, IMG_1810	Morehead between Franklin & Crittenden (W side)	2	Ca. 1930s	Auto Dealer	Structure built of glazed brick and has three-step parapet – “Kubiak Chevrolet;” completely resheathed, summer 1994.	Front of former auto dealership is resheathed with wood, although the three-step parapet remains evident. A fence has also been built around the front. IMG_1301

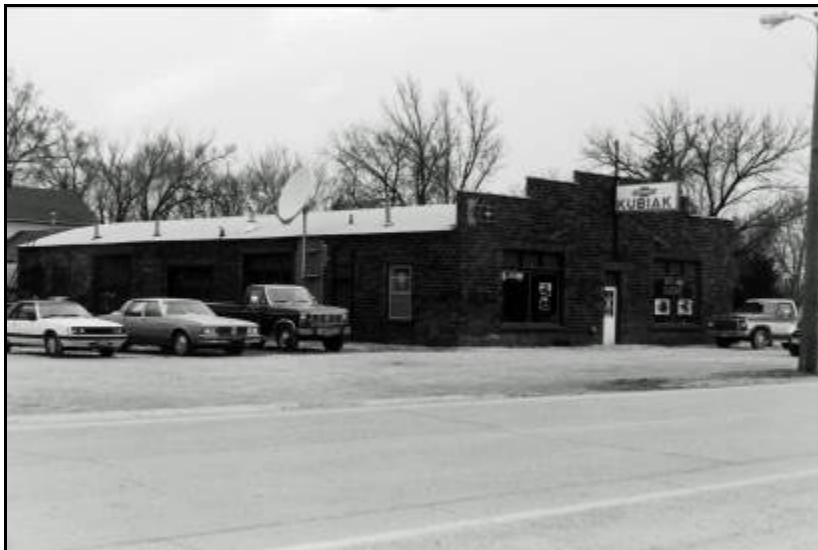
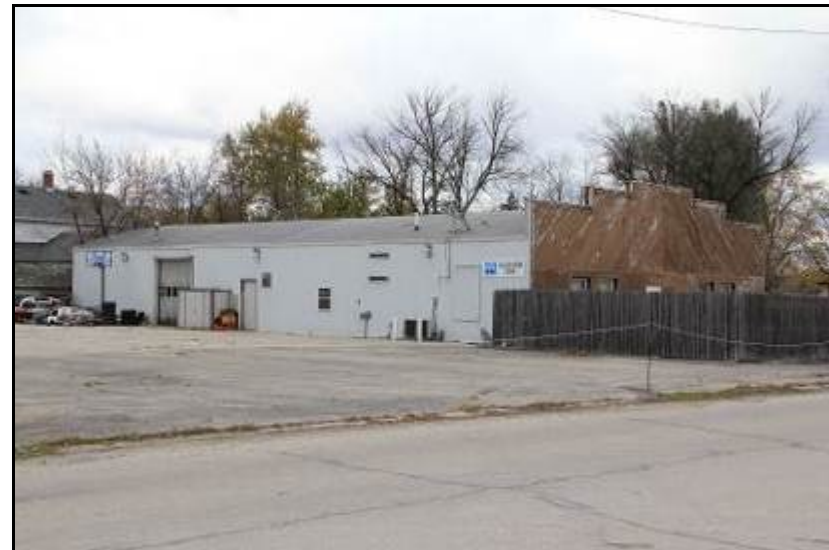
Sequence Number	Map Code	1994/95 Negative #	Address/Location	Type	Date Built	Historic Function	1994/95 Comments	2012/13 Comments and Photo Image #
97	20/21	20/21, IMG_1811	Morehead & Franklin (NE corner)	2	1918	Café	“Wahl’s Bros. Café/Steve’s Café” – see Waldmire Post Card for further information; frame structure with some clapboard and board and batten siding remodeled into auto dealer sales, summer 1994.	The historic restaurant has been long closed, with an overhead garage door constructed in the left portion of the building. IMG_1302

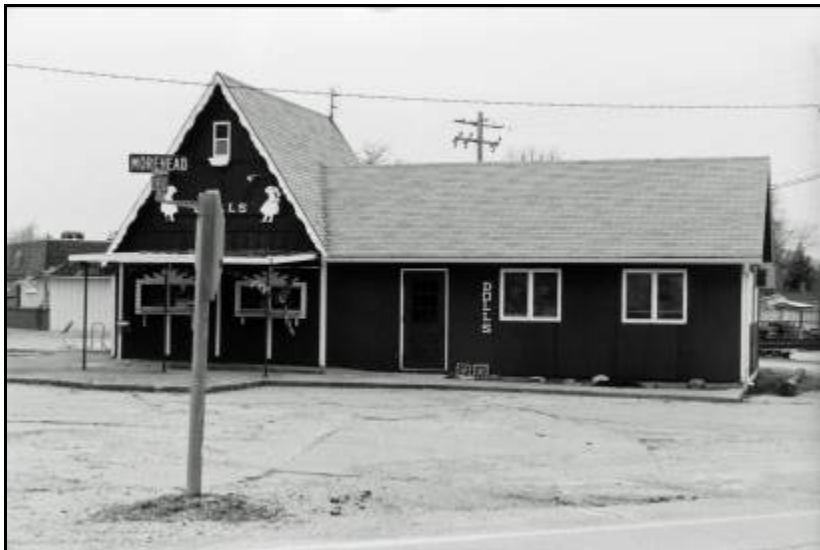
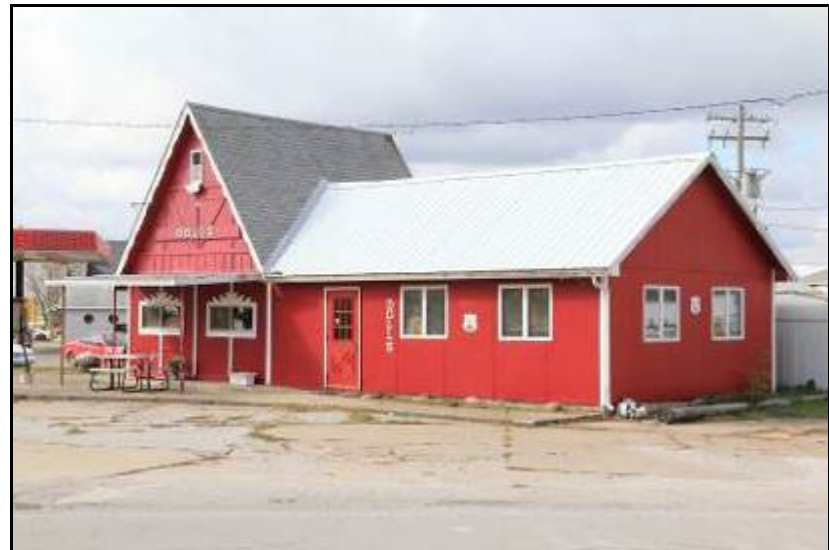
Sequence Number	Map Code	1994/95 Negative #	Address/Location	Type	Date Built	Historic Function	1994/95 Comments	2012/13 Comments and Photo Image #
100	07/30	07/30, IMG_1814	Morehead St. & Cemetery Ave. (NE corner)	3	Ca. 1940s-60s	Gas Station/ Grain Elevators	Contextual view that would have been noted by a driver going N on the through-town route; note gas station and grain elevators.	RT 66-related gas station now removed from the context. IMG_1304

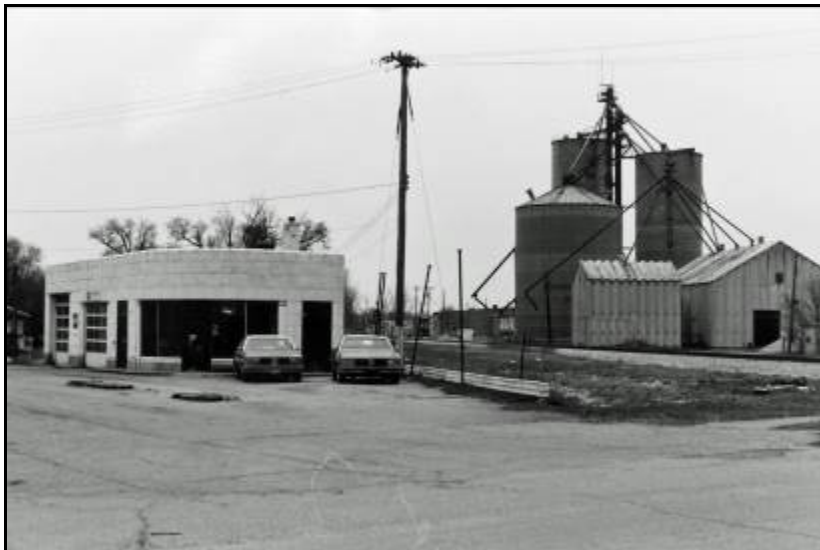
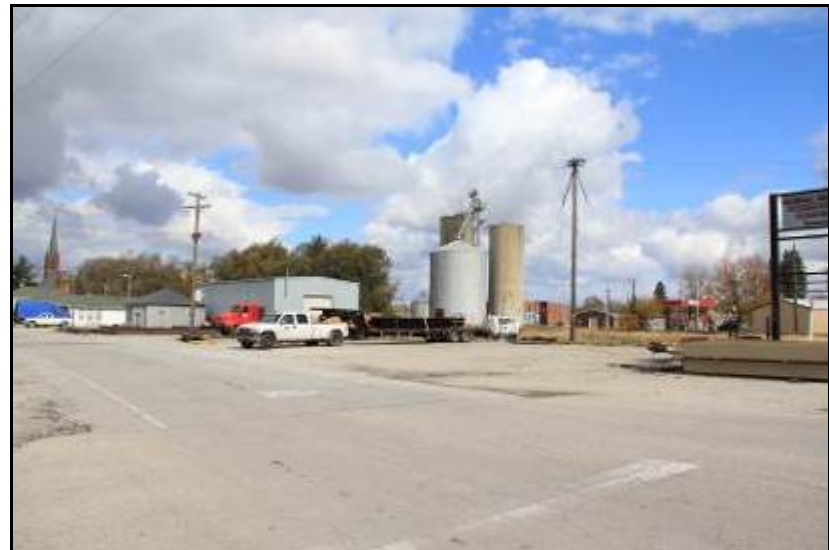
Sequence Number	Map Code	1994/95 Negative #	Address/Location	Type	Date Built	Historic Function	1994/95 Comments	2012/13 Comments and Photo Image #
101	07/31	07/31. IMG_1815	Cemetery Ave. & RR Tracks	2	Ca. 1930s-40s	Auto Service	Built of rock-faced, concrete blocks and adjacent to old 66; possibly a 66-period auto service center.	Significant changes to this service center include the closing and paneling over of several overhead doors. IMG_1305

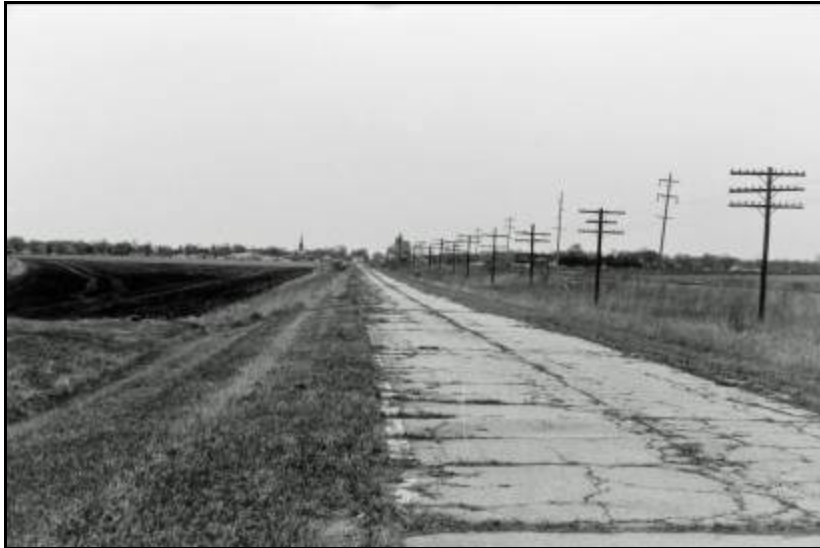
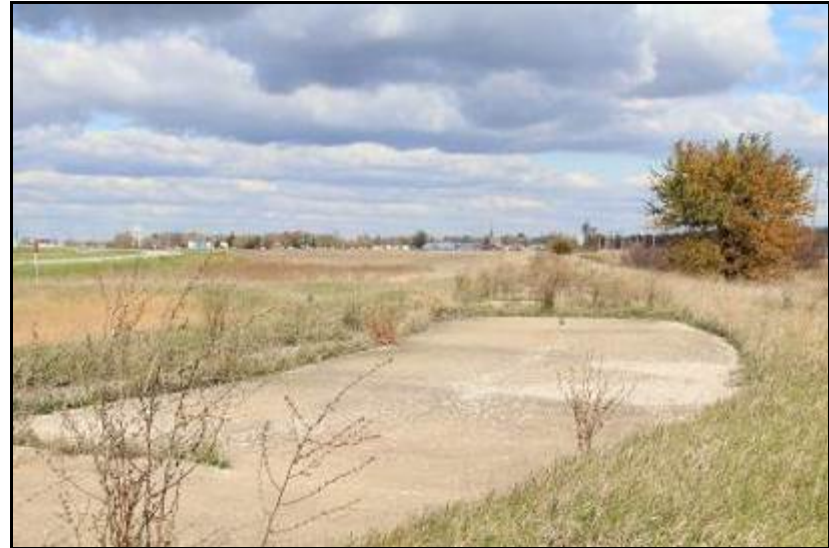
Sequence Number	Map Code	1994/95 Negative #	Address/Location	Type	Date Built	Historic Function	1994/95 Comments	2012/13 Comments and Photo Image #
103	20/22	20/22, IMG_1817	Old 66 Bypass & CR 19 (SE corner)	2	Ca. 1950s	Gas/Service	Now used for auto sales, this building has enamel panel sheathing and a prominent, projecting canopy.	The former gas station continues as an auto sales facility. IMG_1306

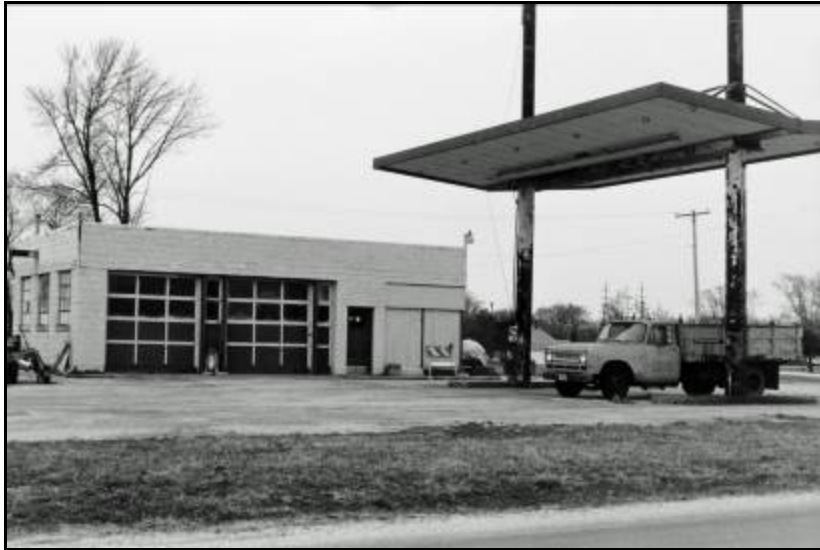
Sequence Number	Map Code	1994/95 Negative #	Address/Location	Type	Date Built	Historic Function	1994/95 Comments	2012/13 Comments and Photo Image #
104	07/34	07/34, IMG_1818	Old 66 Bypass & Morehead	2	Ca. 1950s	Gas/Service	Concrete block gas station, vacant, with detached, large, metal canopy over pump islands.	Former gas station now gone.

No longer extant

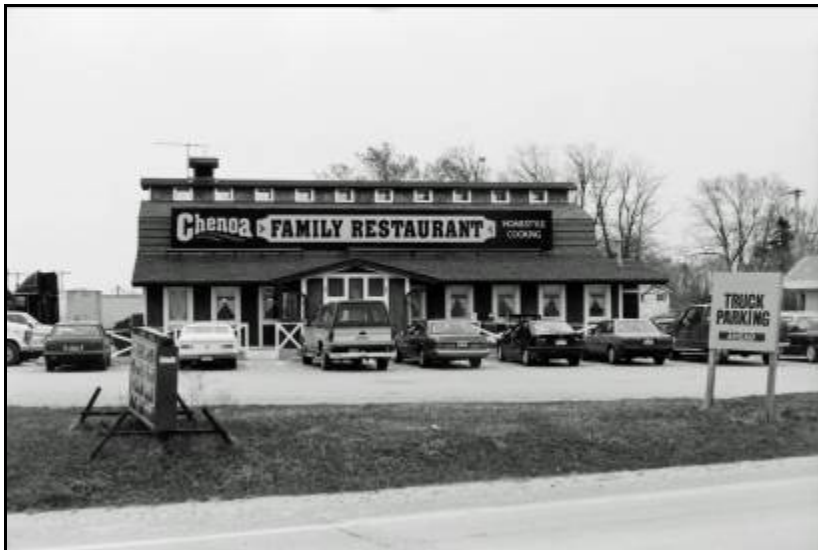
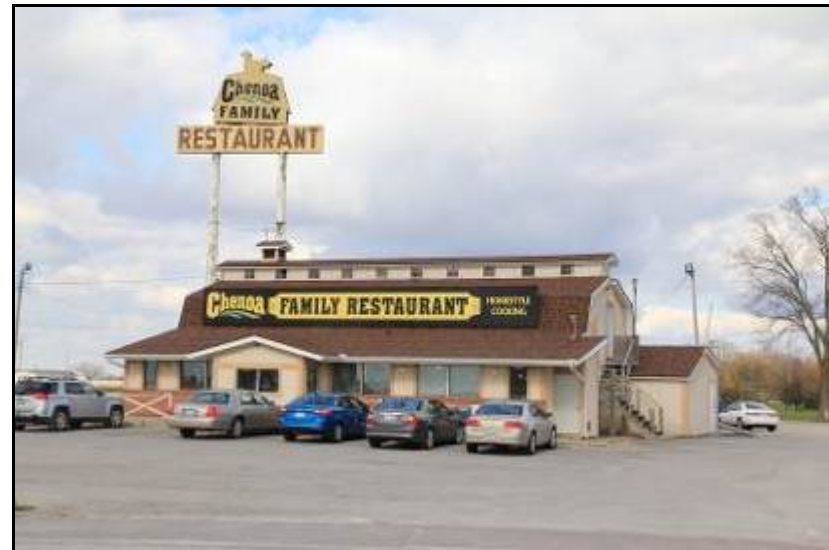
Sequence Number	Map Code	1994/95 Negative #	Address/Location	Type	Date Built	Historic Function	1994/95 Comments	2012/13 Comments and Photo Image #
105	07/27	07/27, IMG_1819	Old 66 Bypass & USH 24	2	Ca. 1960s	Restaurant	Late period, roadside eatery – “Chenoa Family Restaurant.”	In addition to a tall, new sign, changes have been made to entryway and windows. IMG_1307

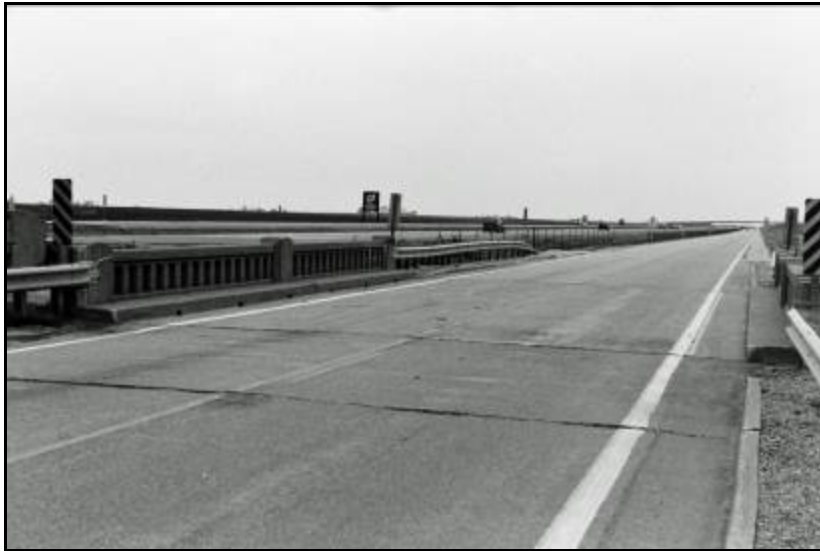
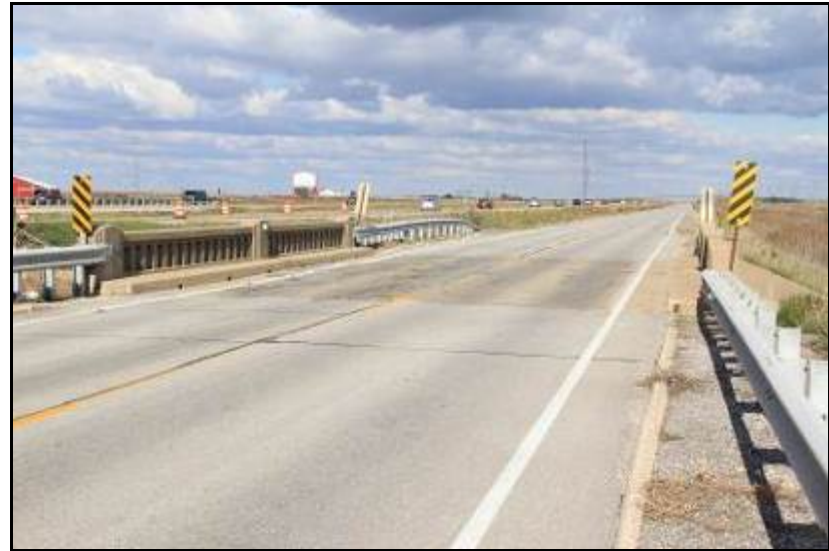
Sequence Number	Map Code	1994/95 Negative #	Address/Location	Type	Date Built	Historic Function	1994/95 Comments	2012/13 Comments and Photo Image #
107	08/02	08/02, 11/28-29, IMG_1821	Old 66 over Turkey Creek	1	1954	Bridge	One structure remains: Bridge #0039 – plate notes: Station 2349+10, Built 1954 by, State of Illinois, F.A. Rt. F Sec. 14 RB-1, F.A. Project F1 25 (22), Loading H20-S16; two-span structure with concrete slab deck.	Eastbound bridge remains largely as it was in 1994. IMG_1311

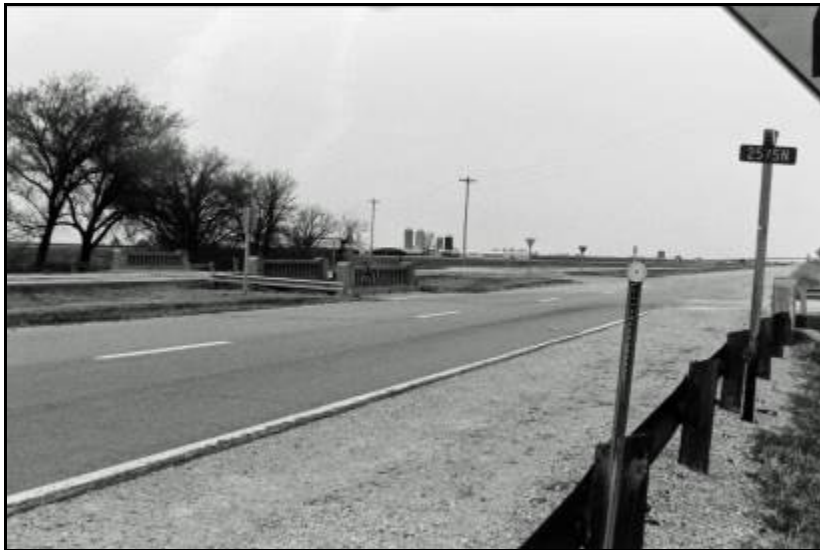
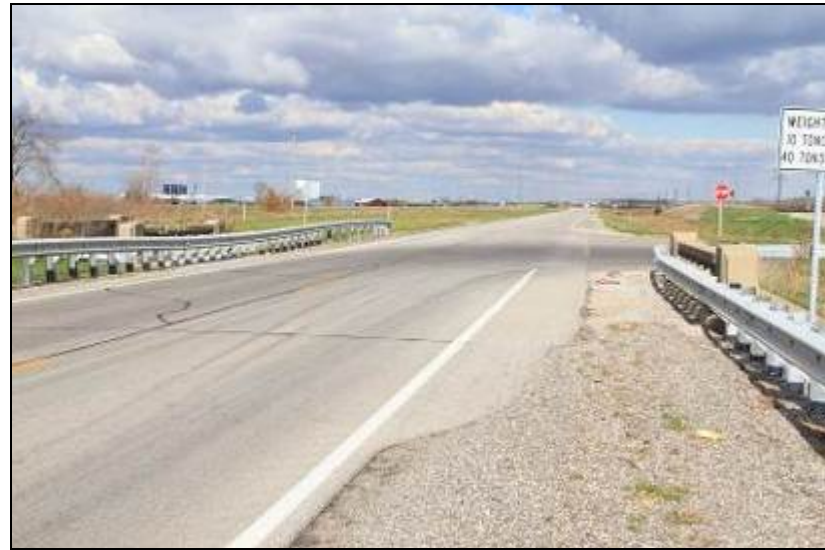
Sequence Number	Map Code	1994/95 Negative #	Address/Location	Type	Date Built	Historic Function	1994/95 Comments	2012/13 Comments and Photo Image #
108	08/03	08/03, 11/30-31, IMG_1822	Old 66 over unnamed branch of Turkey Creek	1	1954	Bridges	Two structures remain: Bridge #0037 (eastbound) and #0038 (westbound) – plate notes: Station 2369+55, Built 1954 by, State of Illinois, F.A.Rt. 5 Sec. 14 RB-1, R.A. Project F1 25(22), Loading H20-S16; one-span, concrete slab structures.	Both bridges remain, albeit with beam-guard lining on the eastbound lanes. The westbound lanes have been closed. IMG_1314

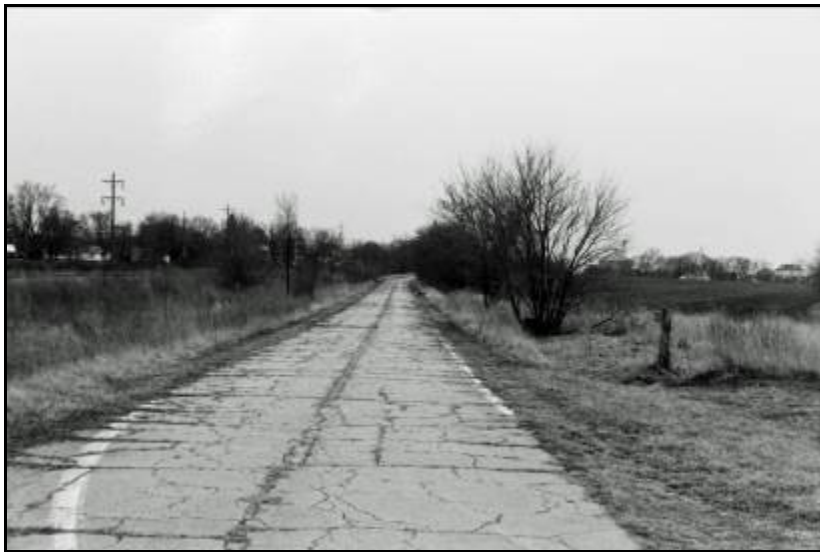
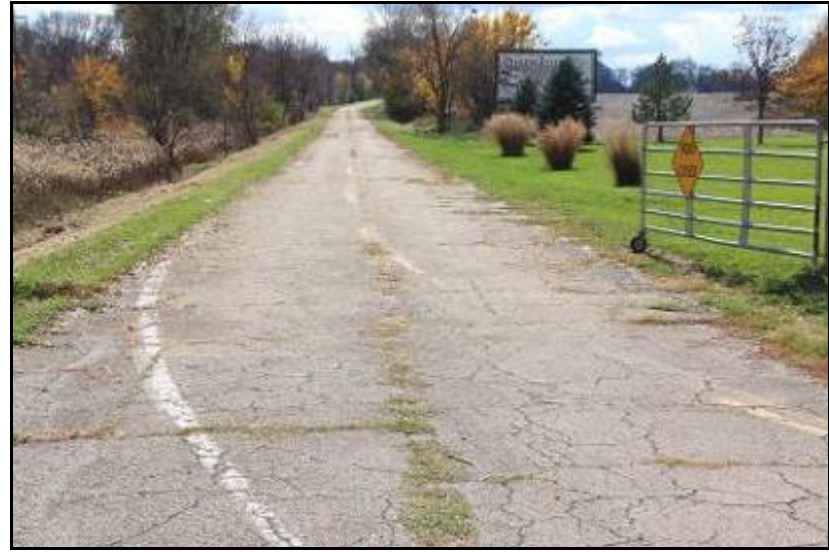
Sequence Number	Map Code	1994/95 Negative #	Address/Location	Type	Date Built	Historic Function	1994/95 Comments	2012/13 Comments and Photo Image #
109	08/04	08/04, 03/12-13, IMG_1823	Old 66 & 66 Bypass, N of LEXINGTON	1	Ca. 1920s	USH 66	Part of original alignment into Lexington from N (view to S in images 03/12 & 08/04 and to N in 03/13).	Note landscaping differences to the right of the historic roadway. Otherwise, few changes. IMG_1324

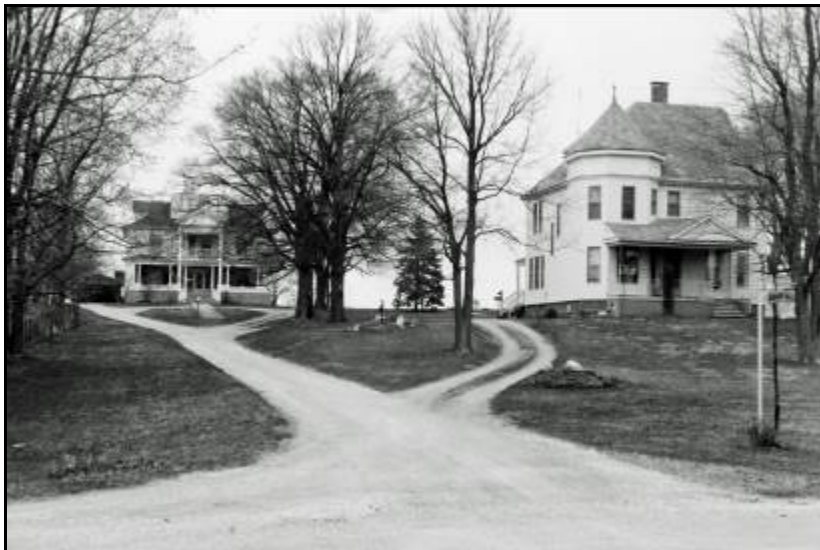
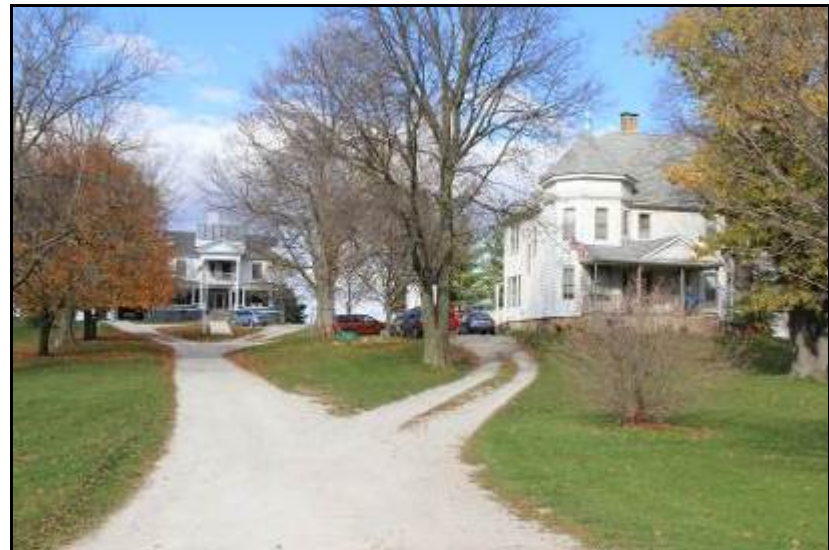
Sequence Number	Map Code	1994/95 Negative #	Address/Location	Type	Date Built	Historic Function	1994/95 Comments	2012/13 Comments and Photo Image #
110	08/08	08/08-09, IMG_1824	Old 66 & Serogin Hill, LEXINGTON	3	Ca. Late 19 th , Early 20 th Century	Residential	Three large, turn-of-the-century houses set atop Serogin Hill, the most visible of which has a two-story turret.	Few changes observed. IMG_1327
