Route 66 in Illinois:

(2012/13 Update and Expansion of the Original 1994/95 Survey)

IDOT Sequence #17337 & #17337A

22 December 2013

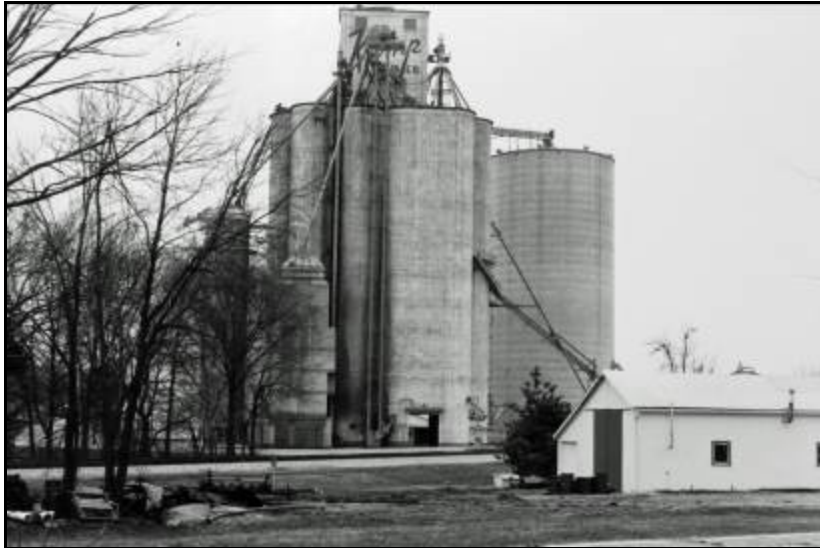
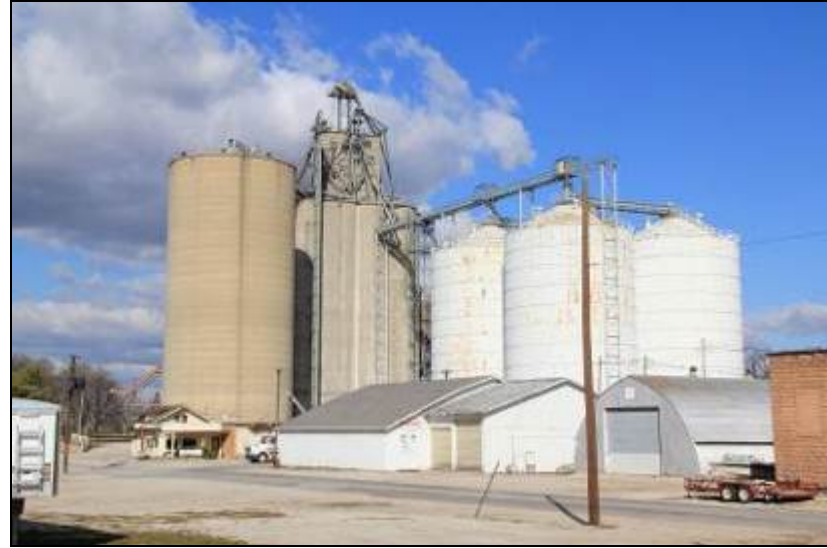
Sequence Number	Map Code	1994/95 Negative #	Address/Location	Type	Date Built	Historic Function	1994/95 Comments	2012/13 Comments and Photo Image #
111	08/07	08/07, IMG_1825	Old 66 & Sergoin Hill, LEXINGTON	3	Ca. 1950s-60s	Grain Elevator	Reinforced concrete grain elevators.	Some elevators have been added since 1994. IMG_1330

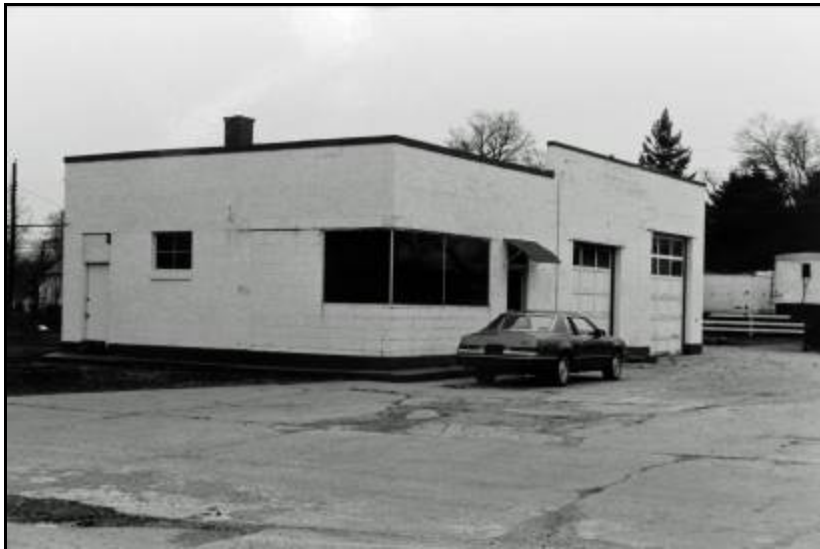
Sequence Number	Map Code	1994/95 Negative #	Address/Location	Type	Date Built	Historic Function	1994/95 Comments	2012/13 Comments and Photo Image #
112	08/06	08/06, IMG_1826	Grove & Main, LEXINGTON	2	Ca. 1950s-60s	Gas/Service	Vacant, concrete block gas station.	Former station is now occupied and has new garage doors. IMG_1333

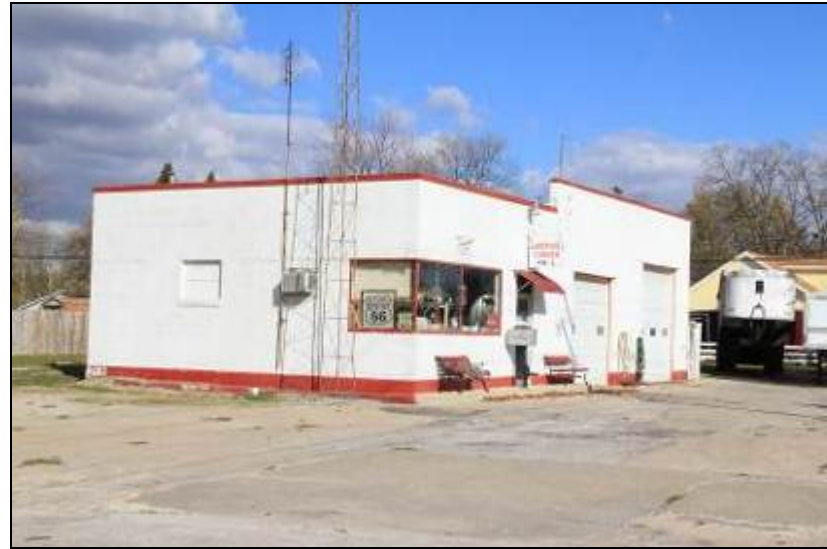
Sequence Number	Map Code	1994/95 Negative #	Address/Location	Type	Date Built	Historic Function	1994/95 Comments	2012/13 Comments and Photo Image #
113	08/05	08/05, IMG_1827	Old 66 & 66 Bypass, S of LEXINGTON	2	Ca. 1950s-60s	Drive-In	Old drive-in with frame kitchen and detached, metal canopy for customers; vacant and used for storage – “Oasis Drive-In.”	Old drive-in remains, although in a generally dilapidated condition. IMG_1332

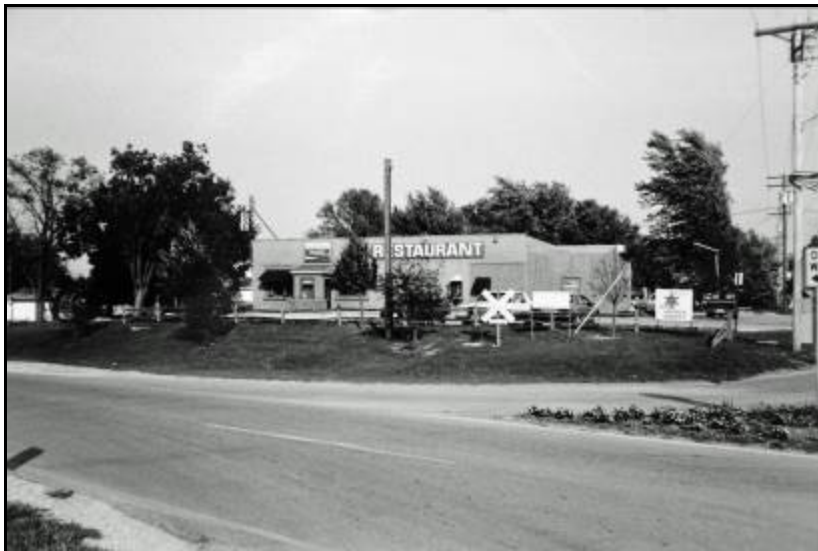
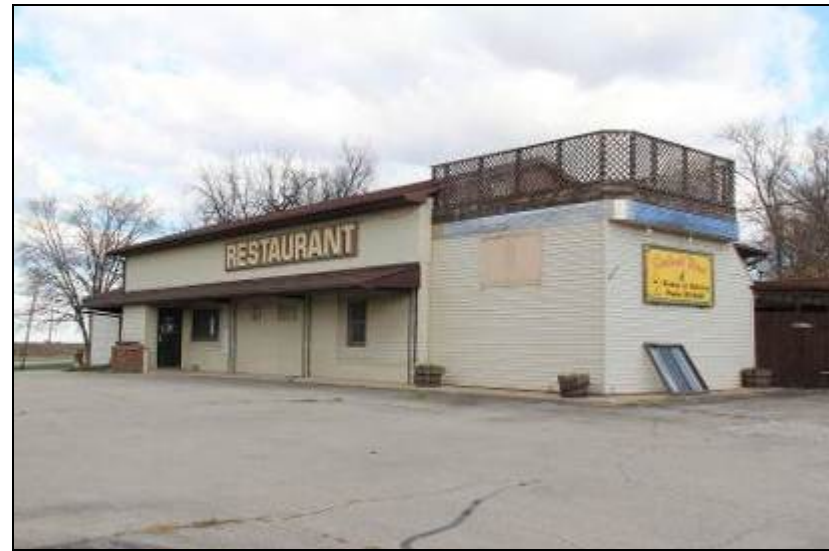
Sequence Number	Map Code	1994/95 Negative #	Address/Location	Type	Date Built	Historic Function	1994/95 Comments	2012/13 Comments and Photo Image #
114	20/24	20/24, IMG_1828	Old 66 Bypass & Main (NE corner), LEXINGTON	2	Ca. 1940s-50s	Gas/Service	Now the "Filling Station Restaurant," this structure looks to have a concrete veneer finish and what was a canopy with a chrome border area beneath the canopy has since been enclosed, but chrome is still visible.	A couple of changes have been made to this now closed restaurant, including the addition of a shed-roofed porch and a shallow, gabled roof. IMG_1335

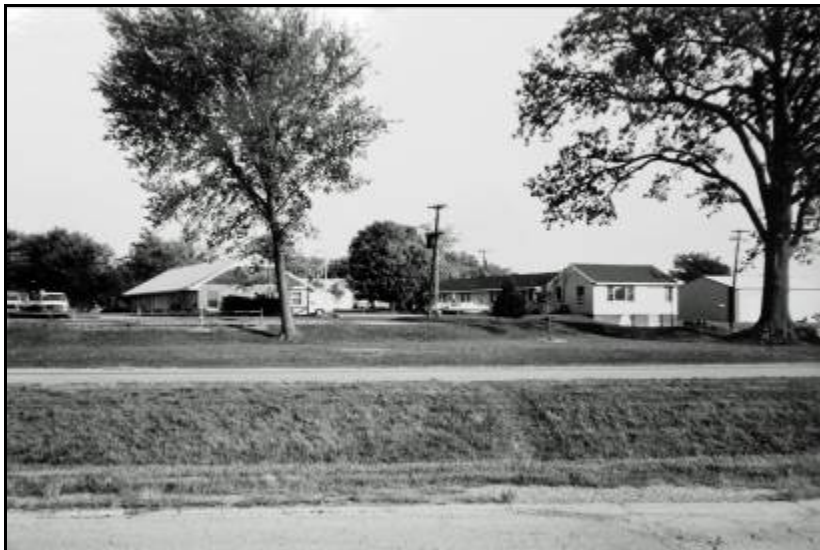
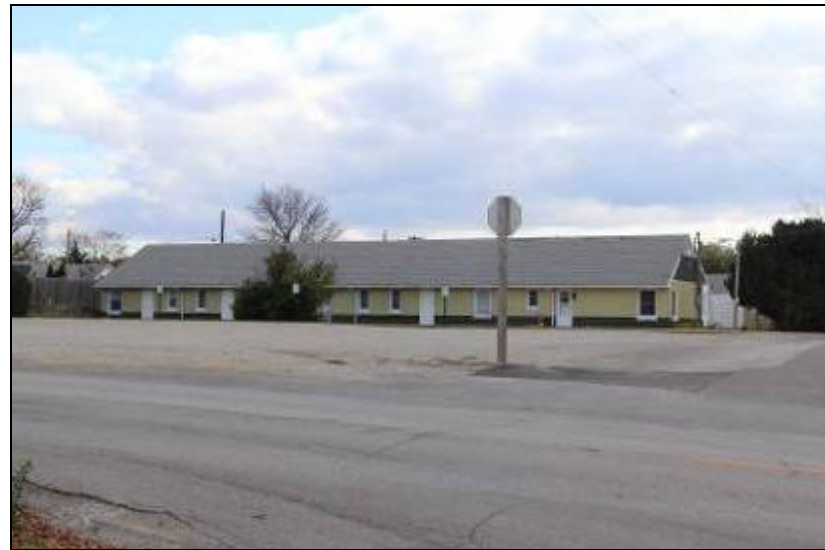
Sequence Number	Map Code	1994/95 Negative #	Address/Location	Type	Date Built	Historic Function	1994/95 Comments	2012/13 Comments and Photo Image #
115	20/23	20/23, IMG_1829	Old 66 Bypass & Main (NE corner), LEXINGTON	2	Ca. 1950s	Motel	Single level motel with gabled roofs and glazed (?) brick sheathing; was the "Lexington Motel," now converted to apartments.	Few, if any, changes of consequence appear to have been made to this former motel. IMG_1334

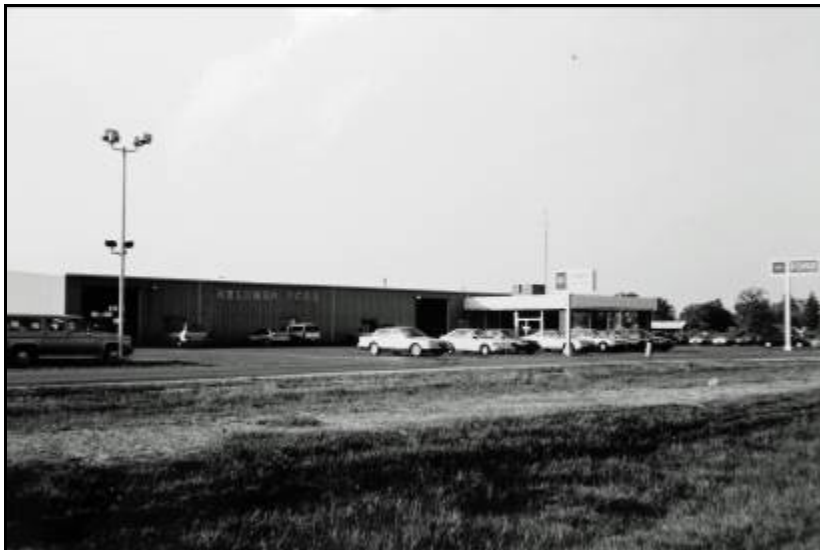
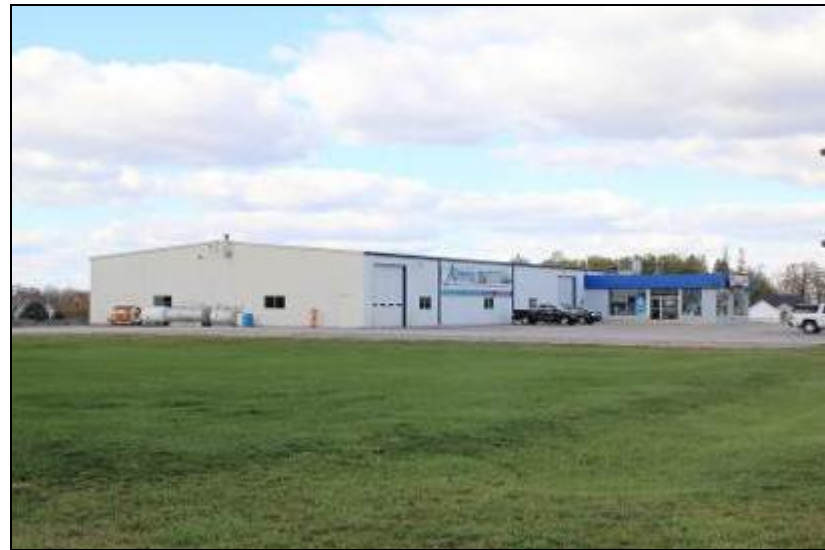
Sequence Number	Map Code	1994/95 Negative #	Address/Location	Type	Date Built	Historic Function	1994/95 Comments	2012/13 Comments and Photo Image #
116	20/25	20/25, IMG_1830	Old 66 Bypass (S of Main on W side), LEXINGTON	2	Ca. 1970s	Auto Dealer	Brick and glass showroom attached to large, pole barn-type shop area – “Neldner Ford.”	This former auto dealership is now a NAPA store. IMG_1336

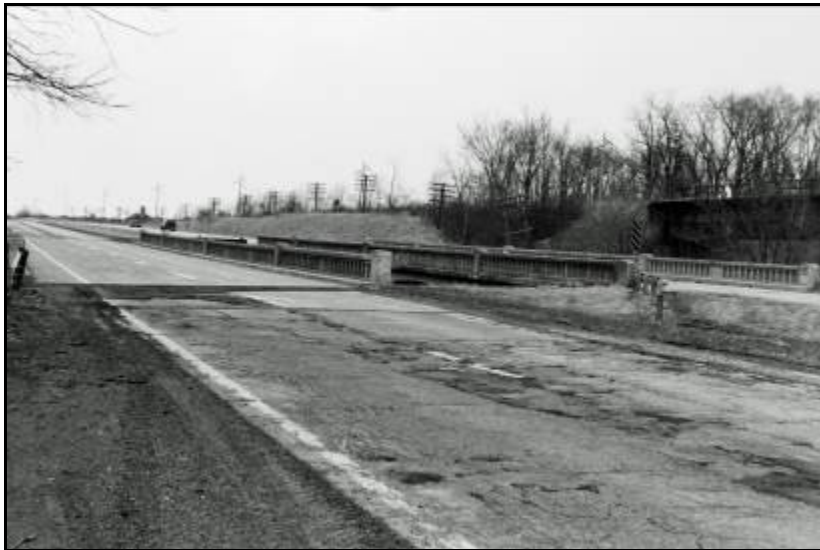
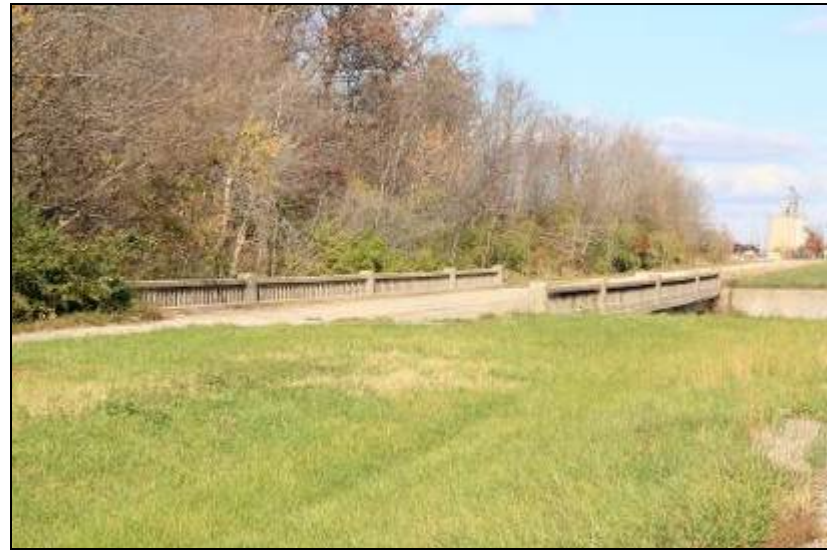
Sequence Number	Map Code	1994/95 Negative #	Address/Location	Type	Date Built	Historic Function	1994/95 Comments	2012/13 Comments and Photo Image #
117	08/10	08/10, 11/32-33, IMG_1831	Old 66 over Mackinaw River	1	1954	Bridges	Two structures remain: Bridge #0035 (eastbound) and #0036 (westbound) – plate notes: Station 2490+58.7(2), Built 1954 by, State of Illinois, F.A. Rt. 5 Sec. 14-RB 1, F.A. Proj. F1-25(22), Loading H20-S16; four-span structures with arched, concrete beams.	The westbound bridge remains, albeit for lanes now closed. The eastbound bridge was reconstructed in 2000. IMG_1337

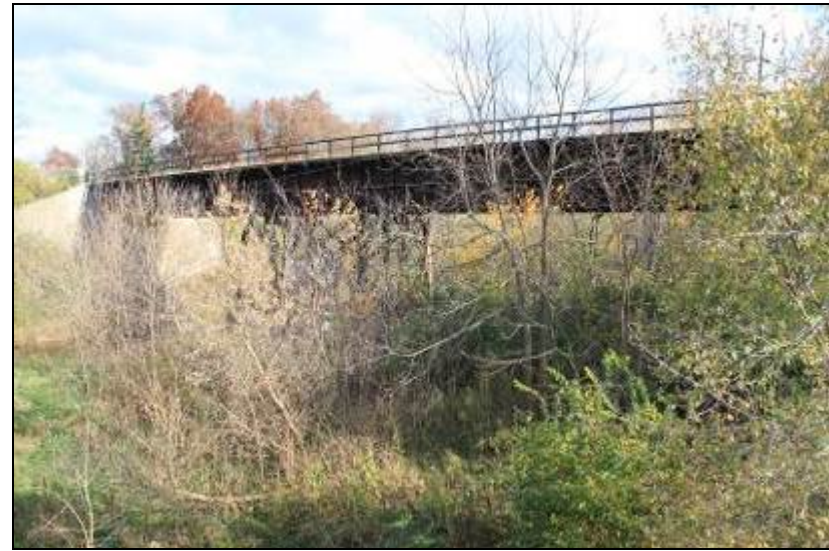
Sequence Number	Map Code	1994/95 Negative #	Address/Location	Type	Date Built	Historic Function	1994/95 Comments	2012/13 Comments and Photo Image #
119	08/12	08/12, 11/34, IMG_1833	Old 66 over Unnamed Creek	1	1954	Bridge	One structure remains: Bridge #0033 – plate notes: Station 2628+24(2), Built 1954 by, State of Illinois, F.A. Rt. 5 Sec. 14-RB-1, F.A. Proj. F1-25(22), Loading H20-S16; one-span structure with concrete slab deck.	The one structure found in 1994 remains today. Note the addition of beam-guard in front of the concrete bridge, however. IMG_1341

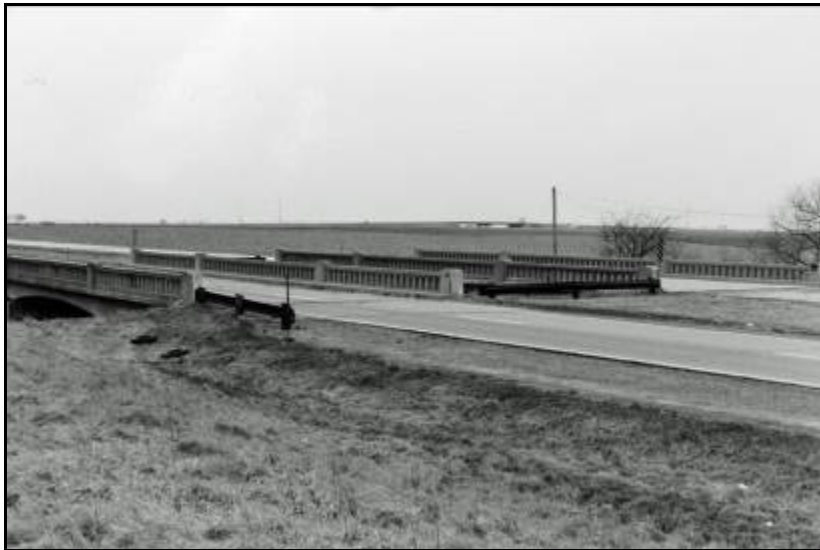
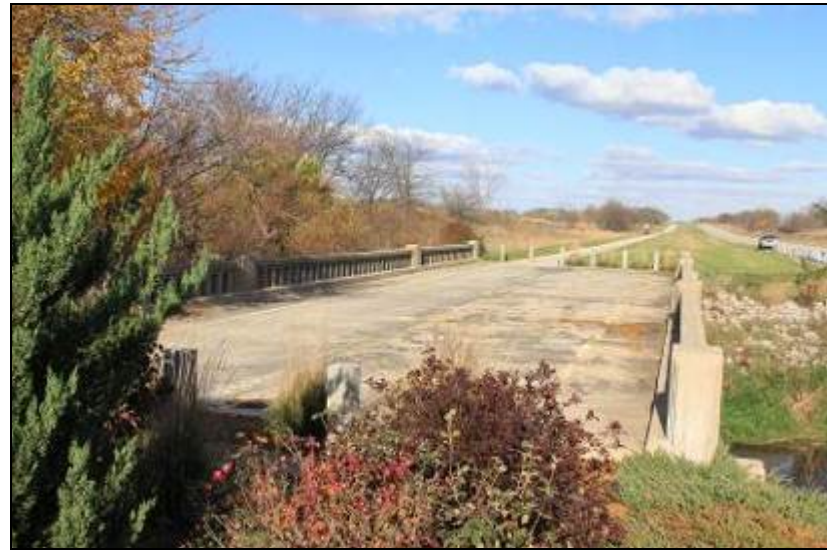
Sequence Number	Map Code	1994/95 Negative #	Address/Location	Type	Date Built	Historic Function	1994/95 Comments	2012/13 Comments and Photo Image #
120	08/13	08/13, 11/35-37, IMG_1834	Old 66 over Money Creek	1	1954	Bridges	Two structures remain: Bridge #0031 (eastbound) and #0032 (westbound) – plate notes: Station 2812+20(2), Built 1954 by, State of Illinois, F.A. Rt. 5 Sec. 15-RB-1, F.A. Proj. F.I. 25(22), Loading H20-S16; three-span structures with arched, concrete beams.	The eastbound bridge was reconstructed in 1999 utilizing a railing that mimics that of 1954. Westbound lanes remain, although now closed and used for an adjacent bike trail. IMG_1343

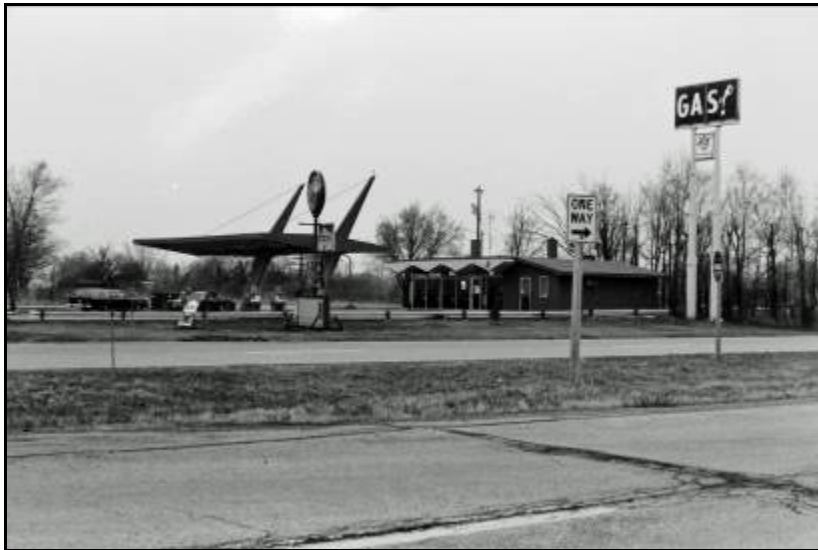
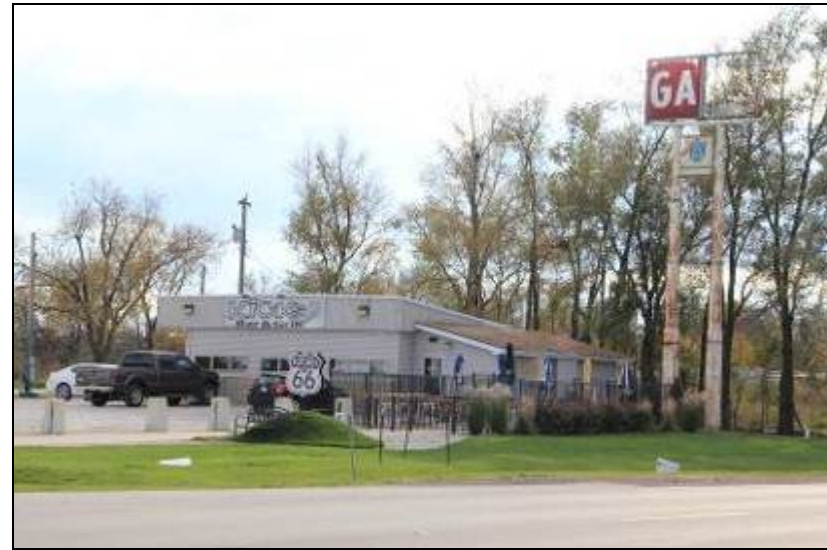
Sequence Number	Map Code	1994/95 Negative #	Address/Location	Type	Date Built	Historic Function	1994/95 Comments	2012/13 Comments and Photo Image #
121	08/14	08/14, IMG_1835	Old 66 & Old 66 Bypass, N of TOWANDA	2	Ca. 1950s	Gas Station	Simple brick (?) and glass gas station with a futuristic, "Jetson-like," detached canopy.	The former gas station remains, though substantially remodeled and now used as a restaurant. Part of the old gas sign also remains, though the modernistic canopy that had been over the pumps is now gone. IMG_1347

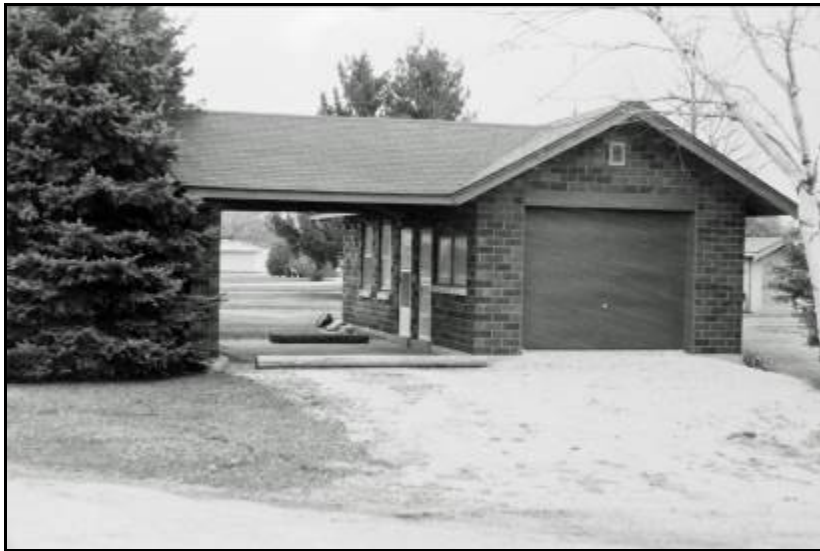
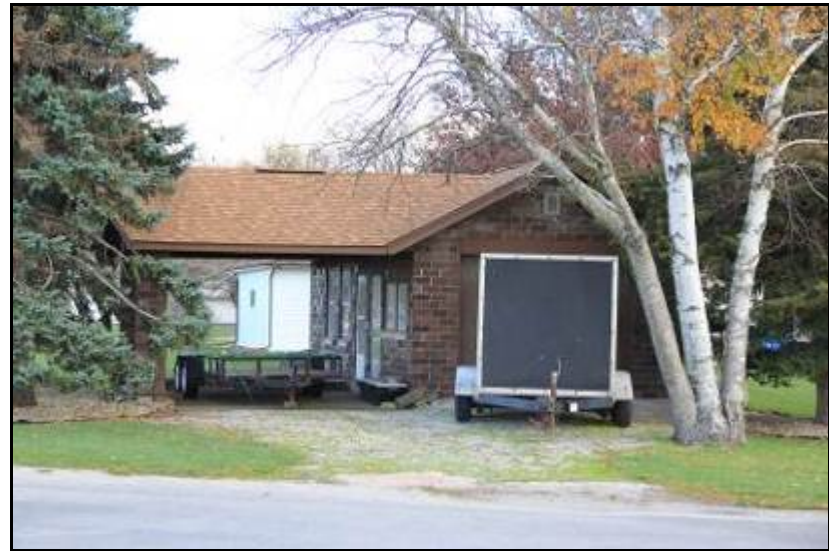
Sequence Number	Map Code	1994/95 Negative #	Address/Location	Type	Date Built	Historic Function	1994/95 Comments	2012/13 Comments and Photo Image #
122	08/15	08/15-16, IMG_1836	Jackson & Madison, TOWANDA	2	Ca. 1930s-40s	Gas Station	Glazed brick gas station with attached canopy, converted to residential use with new garage door cut into S endwall; gas pump island seen in photo 08/16.	Few changes noted to this old facility. IMG_1348

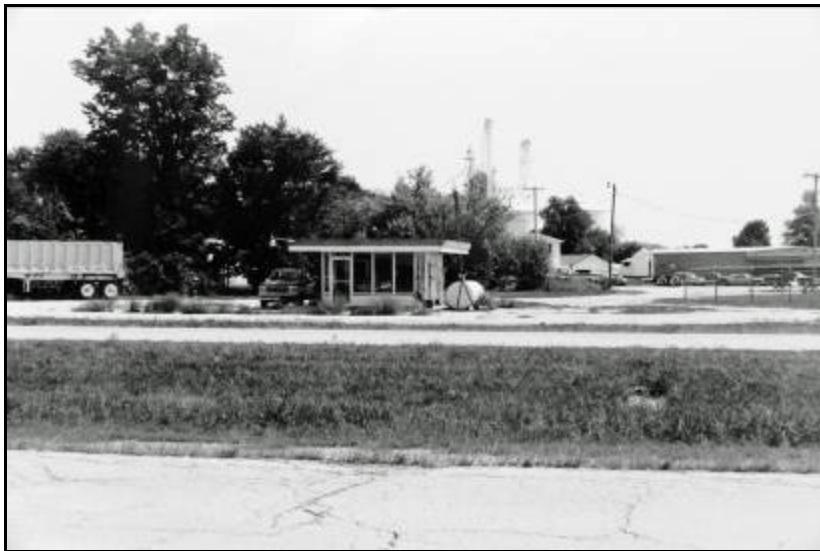
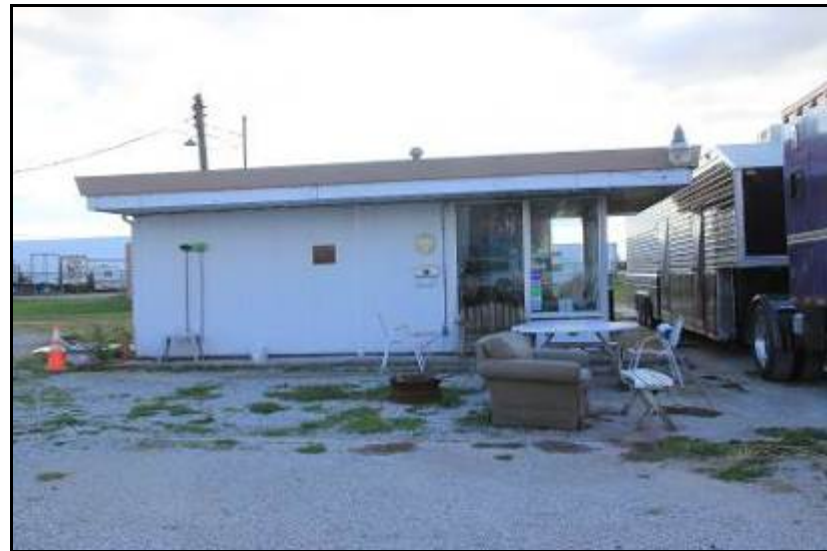
Sequence Number	Map Code	1994/95 Negative #	Address/Location	Type	Date Built	Historic Function	1994/95 Comments	2012/13 Comments and Photo Image #
123	17/34	17/34, IMG_1837	Old 66 Bypass, S of TOWANDA	2	Ca. 1950s-60s	Gas Station	Small, brick and glass structure with flat roof – could well have been a gas station.	This possible, former gas station appears little changed, although a number of large tractor/trailers were parked in front of it. IMG_1349

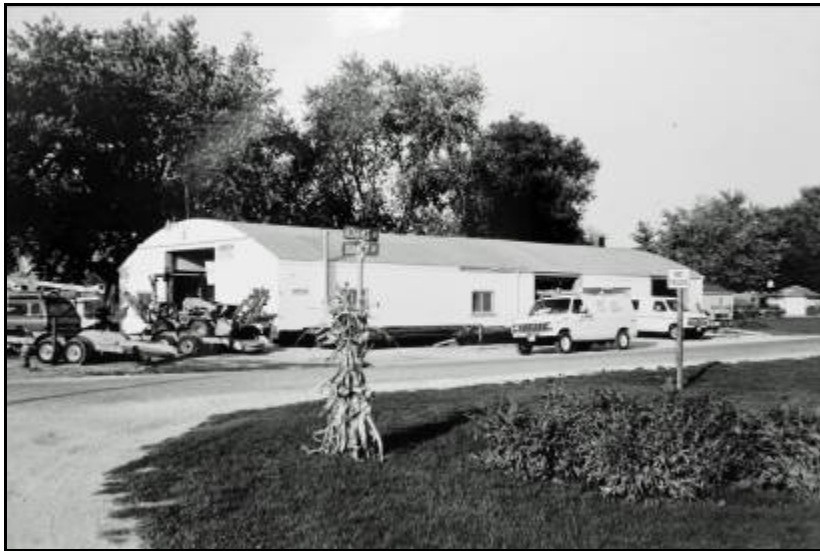
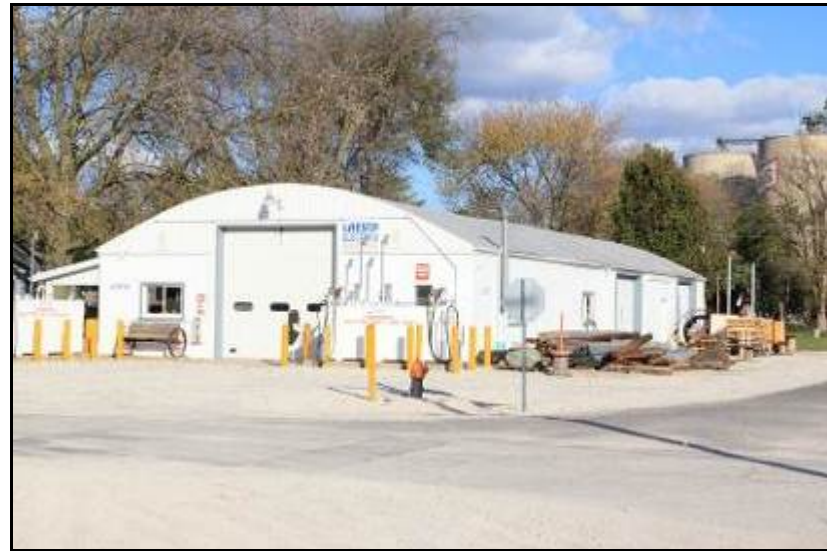
Sequence Number	Map Code	1994/95 Negative #	Address/Location	Type	Date Built	Historic Function	1994/95 Comments	2012/13 Comments and Photo Image #
124	20/26	20/26, IMG_1838	Quincy (1930s 66) & Adams (NE corner), TOWANDA	2	Ca. 1940s-50s	Service Garage (?)	Concrete block structure with an arched roof – <u>could</u> have been a service garage at one time, although it may post-date designation of Quincy as USH 66.	Few apparent changes were observed on this structure. IMG_1352

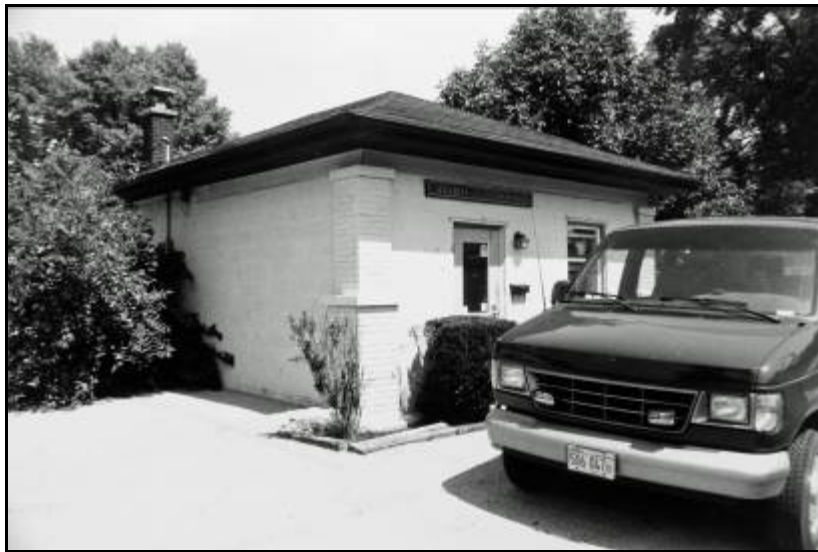
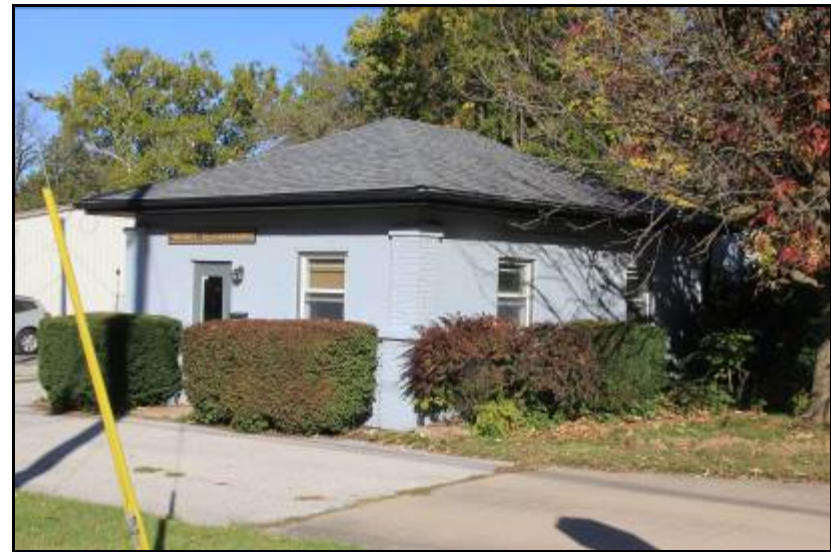
Sequence Number	Map Code	1994/95 Negative #	Address/Location	Type	Date Built	Historic Function	1994/95 Comments	2012/13 Comments and Photo Image #
125	17/33	17/33, IMG_4528	310 Pine St., NORMAL	2	Ca. 1930s-40s	Gas Station	Small, brick structure with hip roof, the front part of which provided a drive-through and was supported by two, brick columns; rear of building served as office; drive-through now enclosed – “Security Locksmiths.”	No significant changes were noted at “Security Locksmiths.” IMG_4024

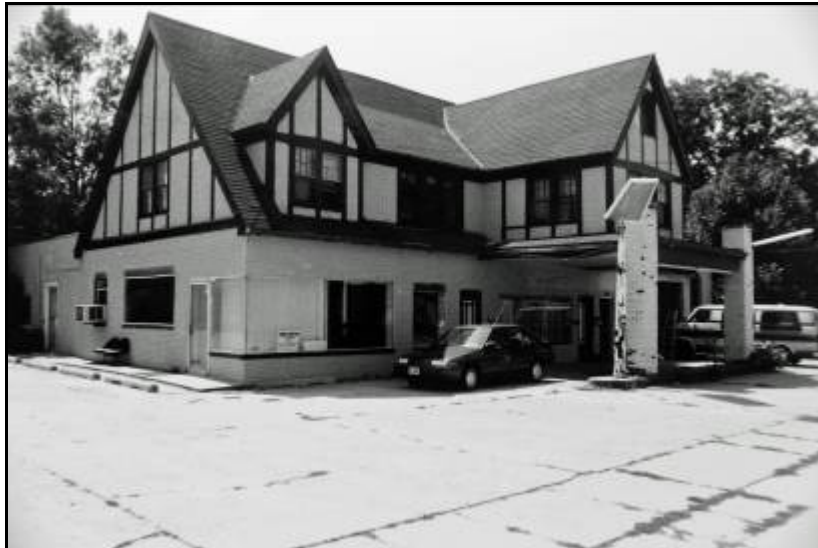
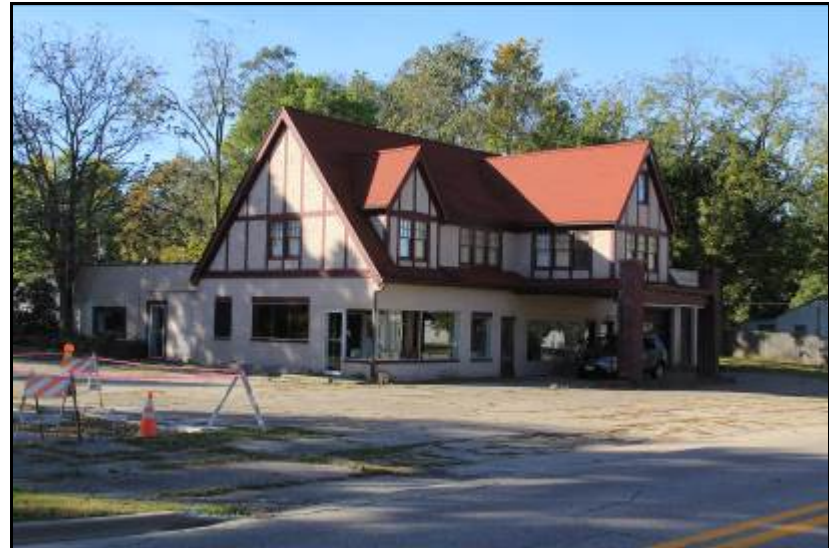
Sequence Number	Map Code	1994/95 Negative #	Address/Location	Type	Date Built	Historic Function	1994/95 Comments	2012/13 Comments and Photo Image #
126	17/31	17/31-32, IMG_4529	305 Pine St., NORMAL	2	Ca. 1940s	Café/Gas	Large, two-story structure with steeply-pitched, gabled roof, gabled dormers, half-timber-like sheathing in the gables and dormers; first floor of brick – present use uncertain – perhaps the largest gas station/restaurant noted in the survey corridor.	Few changes appear to have occurred at this former RT 66-related facility. IMG_4025

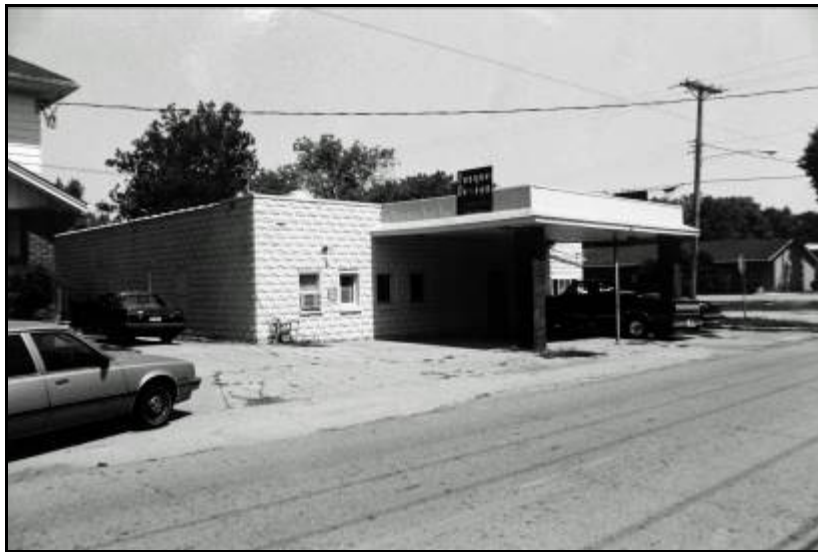
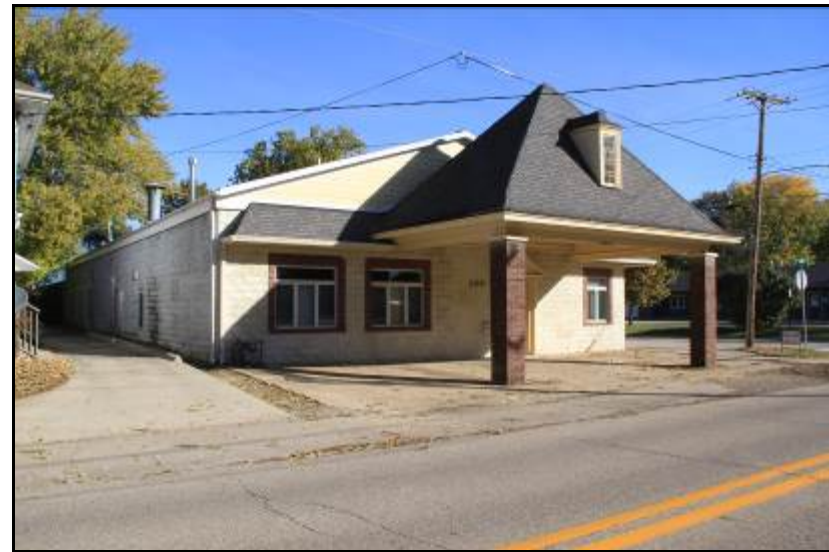
Sequence Number	Map Code	1994/95 Negative #	Address/Location	Type	Date Built	Historic Function	1994/95 Comments	2012/13 Comments and Photo Image #
127	17/30	17/30, IMG_4530	208 Pine St., NORMAL	2	Ca. 1930s-40s	Gas/Service	Rock-faced, concrete block structure with projecting canopy supported by two, large, brick columns.	A pyramidal roof has been constructed on the drive through canopy, as has a gabled roof been erected over the balance of the structure to the N. New windows have also been installed. IMG_4027

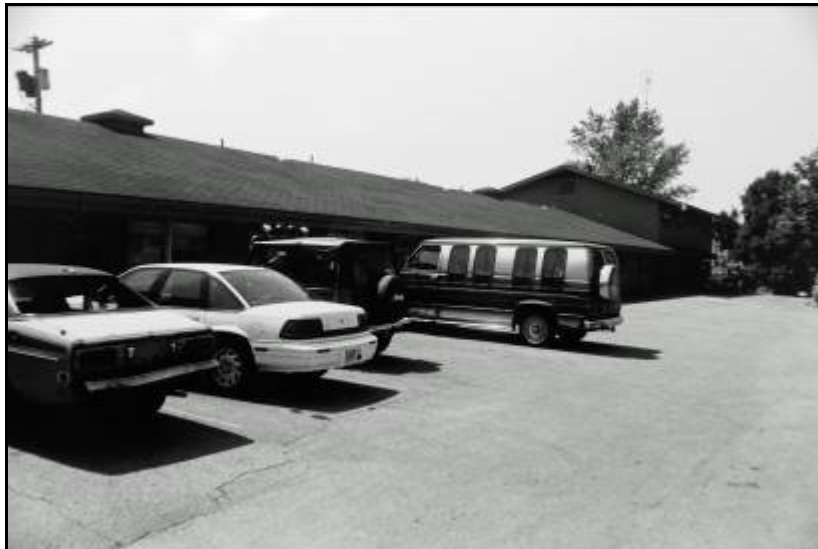
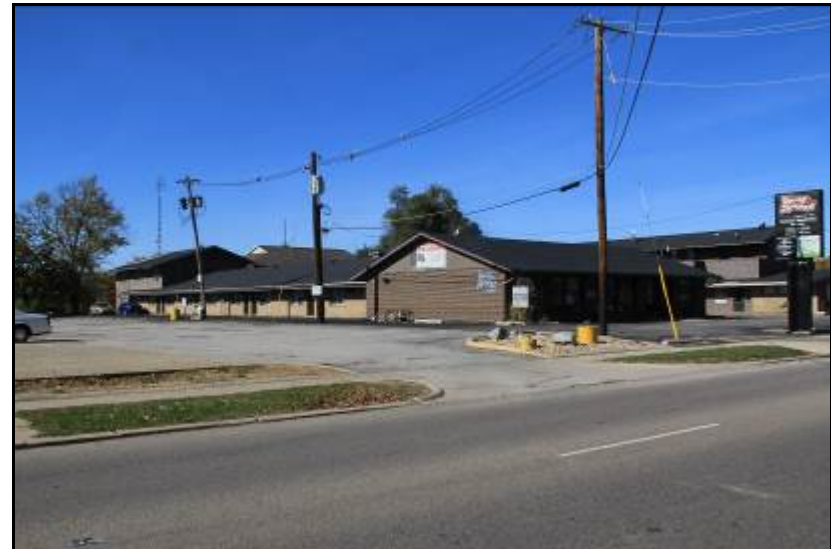
Sequence Number	Map Code	1994/95 Negative #	Address/Location	Type	Date Built	Historic Function	1994/95 Comments	2012/13 Comments and Photo Image #
128	17/28	17/28-29, IMG_4531	309 N. Main St., NORMAL	2	Ca. 1960s	Motel	Single-level, brick motel with two-story, frame office/living quarters at W end; converted to student housing.	There has been little noticeable change to this building. IMG_4054

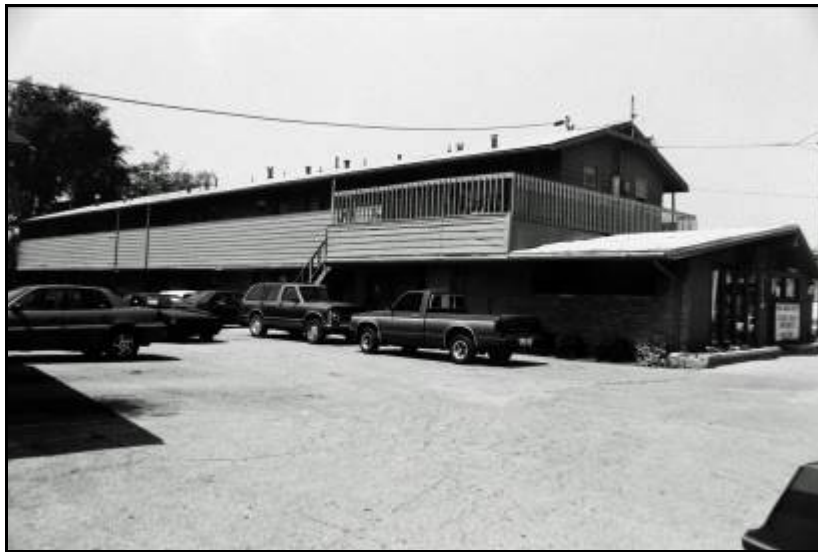
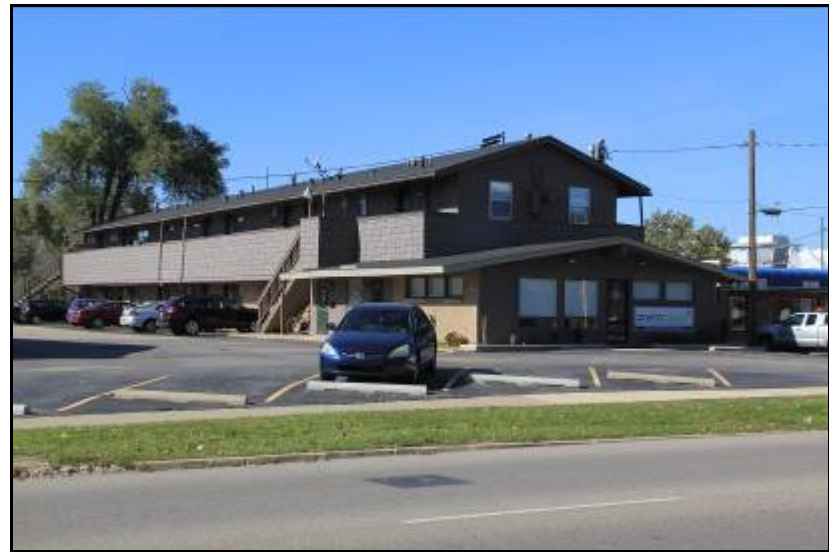
Sequence Number	Map Code	1994/95 Negative #	Address/Location	Type	Date Built	Historic Function	1994/95 Comments	2012/13 Comments and Photo Image #
129	17/27	17/27, IMG_4532	311 N. Main St., NORMAL	2	Ca. 1960s	Motel	Two-story, frame and brick motel with single-story office at E end; converted to student housing.	There have been some changes to the second floor railing of this former motel, as well as to the front (first floor) windows. IMG_4055

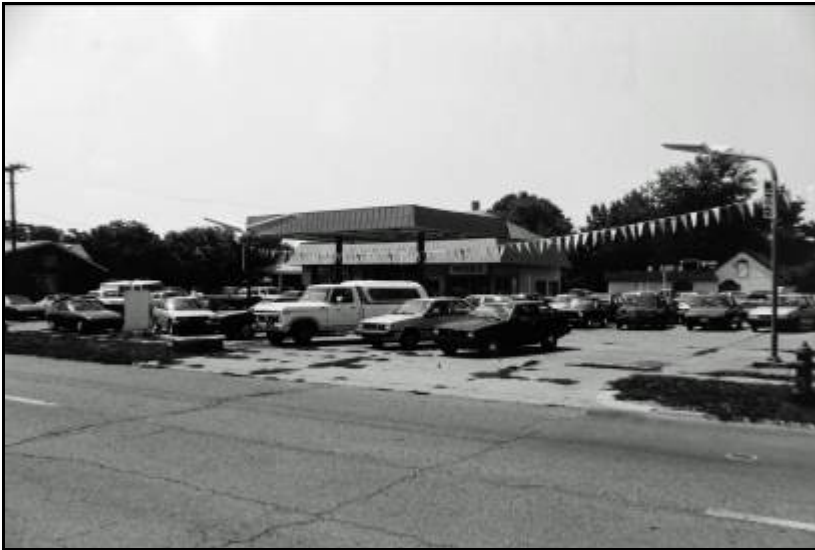
Sequence Number	Map Code	1994/95 Negative #	Address/Location	Type	Date Built	Historic Function	1994/95 Comments	2012/13 Comments and Photo Image #
130	17/26	17/26, IMG_4533	N. Main St. & Osage (SW corner), NORMAL	2	Ca. 1960s (?)	Gas Station	“Sunoco” station.	This building no longer remains.

No longer extant

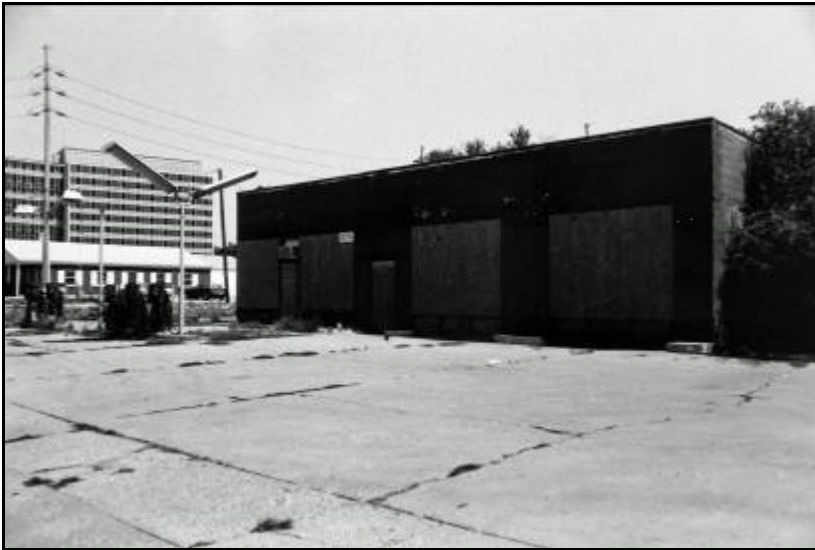
Sequence Number	Map Code	1994/95 Negative #	Address/Location	Type	Date Built	Historic Function	1994/95 Comments	2012/13 Comments and Photo Image #
131	17/25	17/25, IMG_4534	N. Main St. & Osage (SE corner), NORMAL	2	Ca. 1960s	Gas/Service	Abandoned, concrete block gas station with pumps still in front.	Structure is now gone.

No longer extant

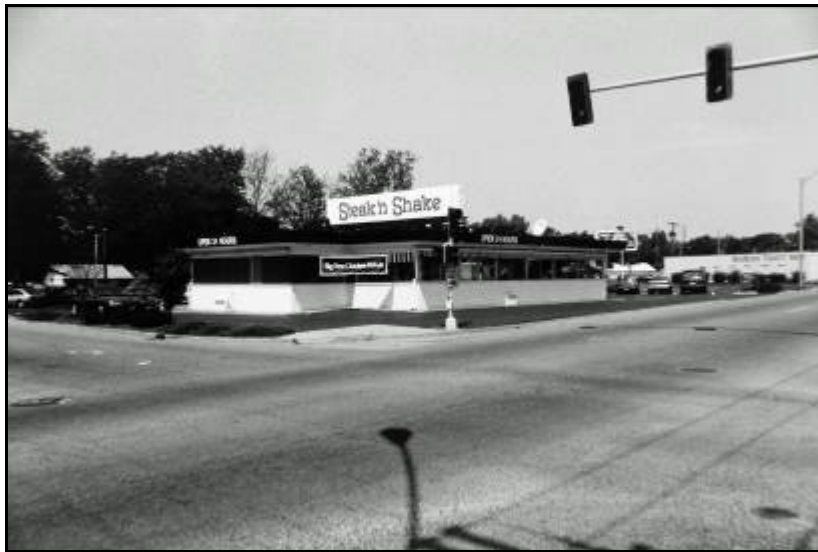
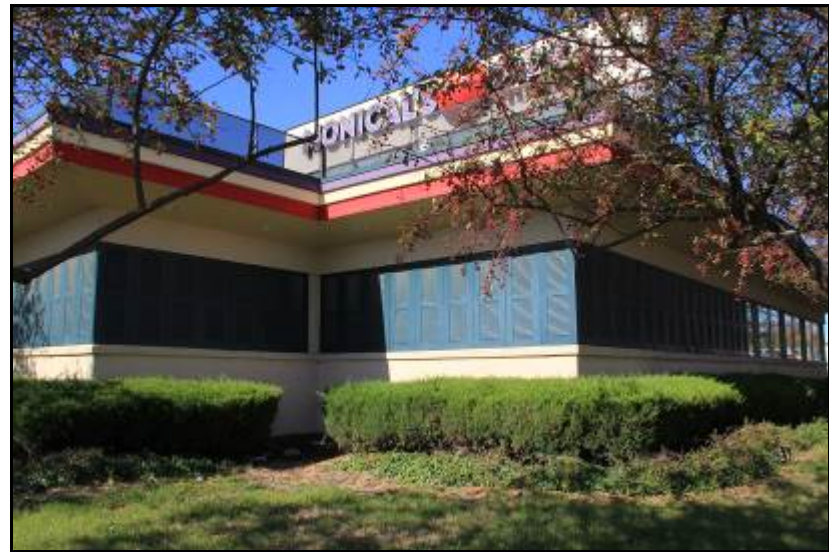
Sequence Number	Map Code	1994/95 Negative #	Address/Location	Type	Date Built	Historic Function	1994/95 Comments	2012/13 Comments and Photo Image #
132	17/24	17/24, IMG_4535	219 S. Main St., NORMAL	2	Ca. 1930s	Restaurant	Brick and glass structure with a flat roof; Route 66 Association of Illinois publication notes this as the first "Shake & Bake" – opened in 1934.	This significant "Shake & Bake" location is now a Monicle's Pizza outlet. IMG_4053

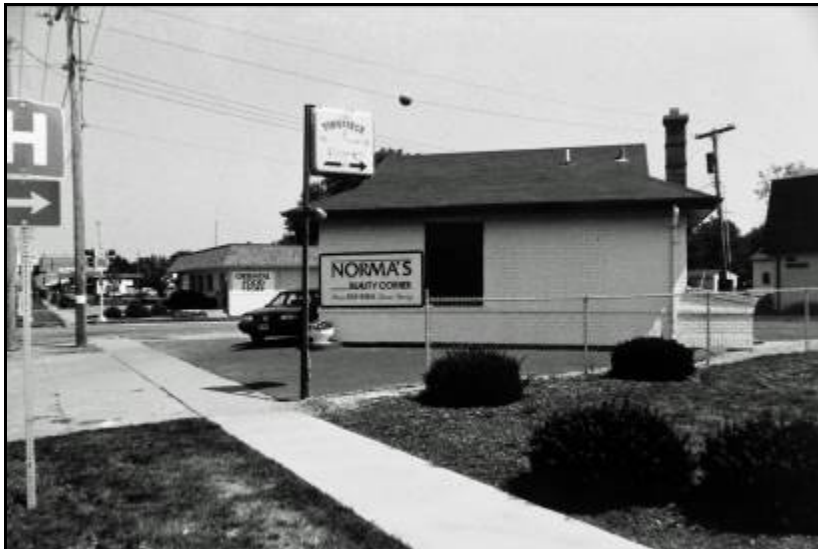
Sequence Number	Map Code	1994/95 Negative #	Address/Location	Type	Date Built	Historic Function	1994/95 Comments	2012/13 Comments and Photo Image #
133	17/23	17/23, IMG_4536	1302 N. Main St., BLOOMINGTON	2	Ca. 1960s (?)	Gas Station (?)	Small, brick structure – <u>may</u> have been a gas station.	The building is gone. The area now appears to be a parking lot for the adjacent hospital.

No longer extant

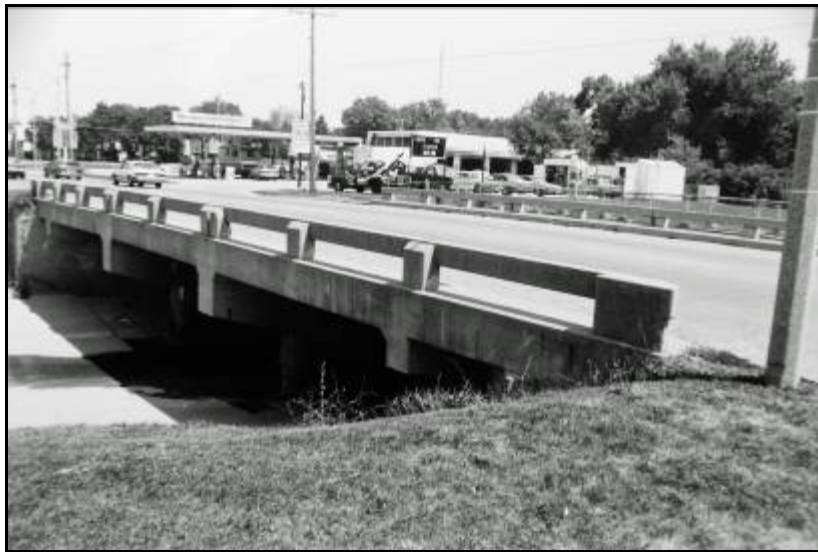
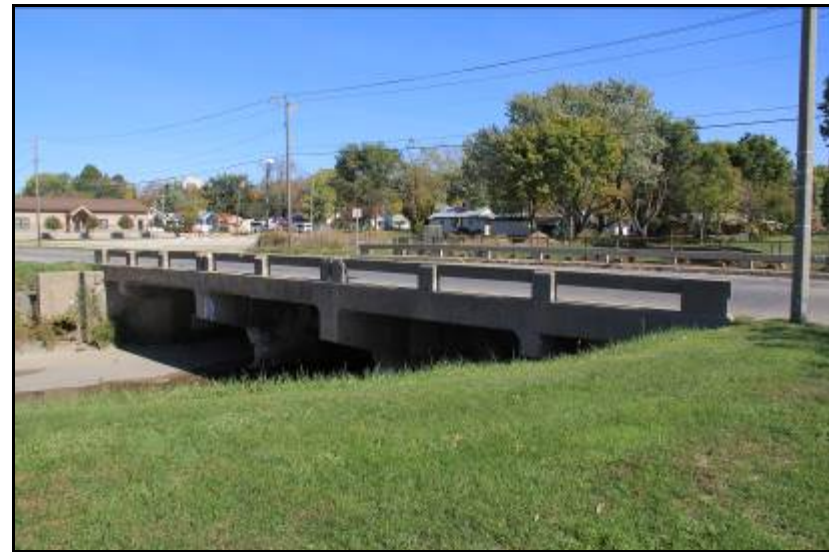
Sequence Number	Map Code	1994/95 Negative #	Address/Location	Type	Date Built	Historic Function	1994/95 Comments	2012/13 Comments and Photo Image #
134	17/21	17/21, IMG_4537	Main St. over Sugar Creek, NORMAL	1	1954	Bridge	Single, two-lane structure: Bridge #0054 – plate notes: “Station 12+45.70, Built 1954 by, State of Illinois, S.B.J. Rt. 2-Sec 62-2B, Loading H20-S16; three span structure with a slab deck.	While appearing to be little changed, the concrete on this bridge seems to be deteriorating. IMG_4050

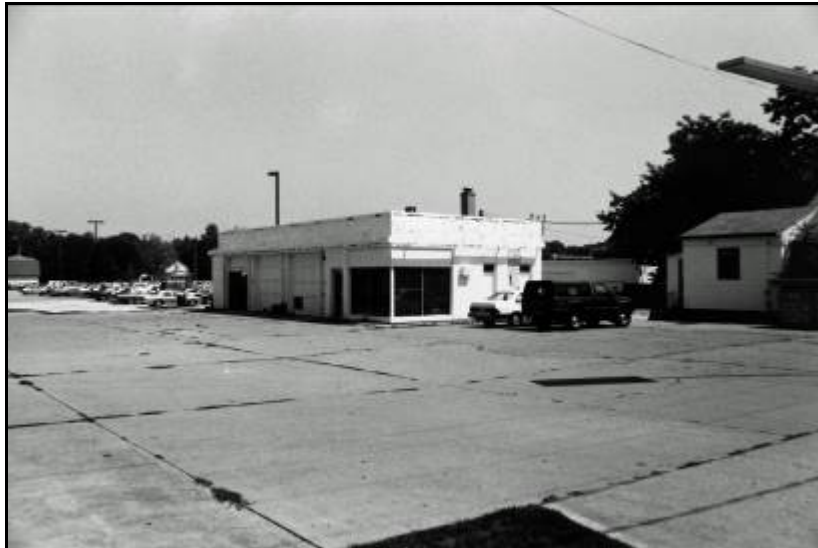
Sequence Number	Map Code	1994/95 Negative #	Address/Location	Type	Date Built	Historic Function	1994/95 Comments	2012/13 Comments and Photo Image #
135	17/20	17/20, IMG_4538	1322 N. Main St., BLOOMINGTON	2	Ca. 1960s	Gas/Service	Vacant gas station built of brick or concrete blocks.	This building no longer remains.

No longer extant

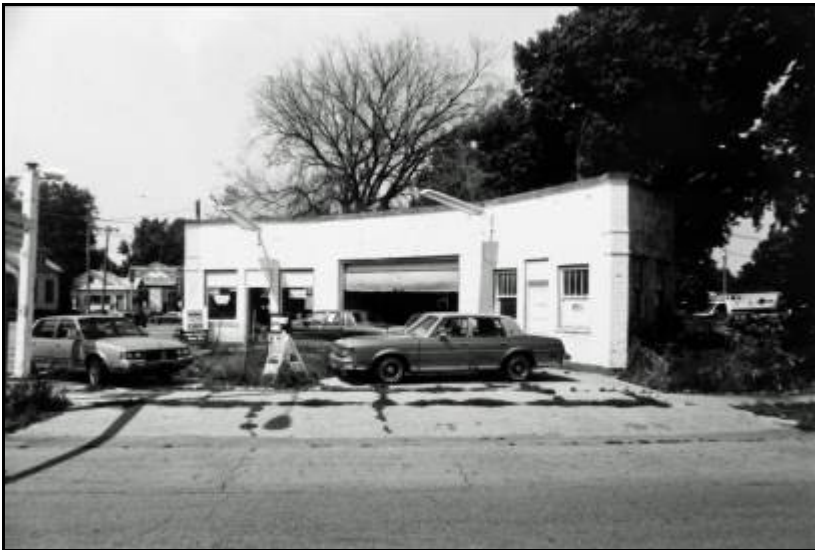
Sequence Number	Map Code	1994/95 Negative #	Address/Location	Type	Date Built	Historic Function	1994/95 Comments	2012/13 Comments and Photo Image #
136	17/19	17/19, IMG_4539	N. Main St. & Empire, BLOOMINGTON	2	Ca. 1930s	Gas Station	Respectable-type gas station built of brick in a generally triangular form; garage door centered in front, office doors and windows symmetrically placed on either side.	Structure is now gone.

No longer extant
