Route 66 in Illinois:

(2012/13 Update and Expansion of the Original 1994/95 Survey)

IDOT Sequence #17337 & #17337A

22 December 2013

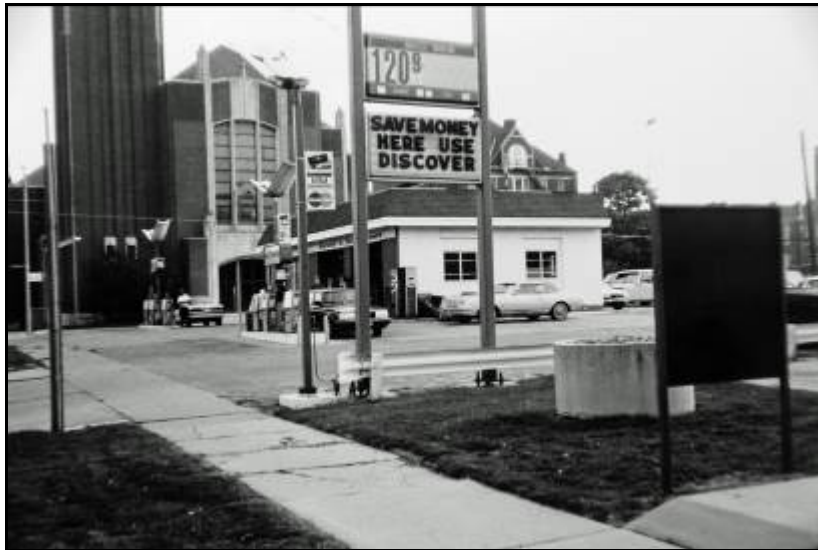
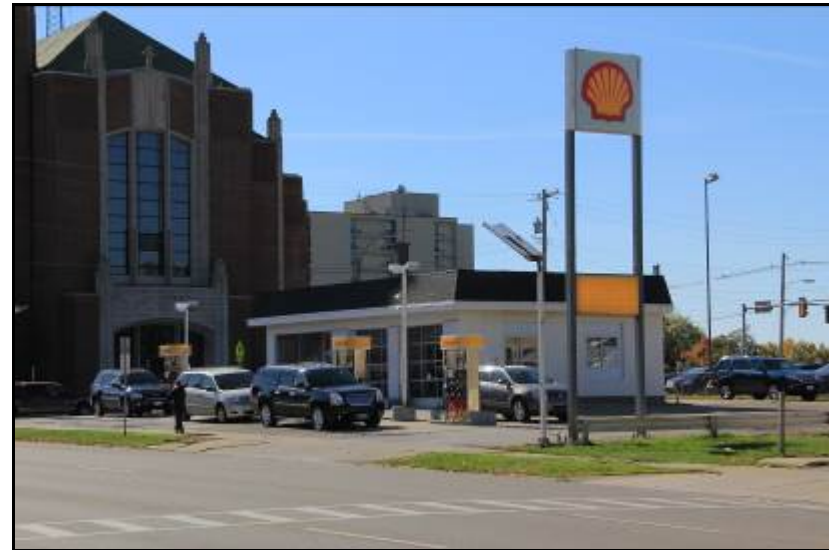
Sequence Number	Map Code	1994/95 Negative #	Address/Location	Type	Date Built	Historic Function	1994/95 Comments	2012/13 Comments and Photo Image #
137	20/30	20/30 IMG_4540	N. Main & Chestnut (NW corner), BLOOMINGTON	2	Ca. 1950s-60s	Gas/Service	“Shell” station with brick façade and dentilled cornice (attempt at Colonial Revival?); possible enamel paneled sidewalls may suggest original construction in 1950s.	The “Shell” gas station remains, although with a new sign. IMG_4049

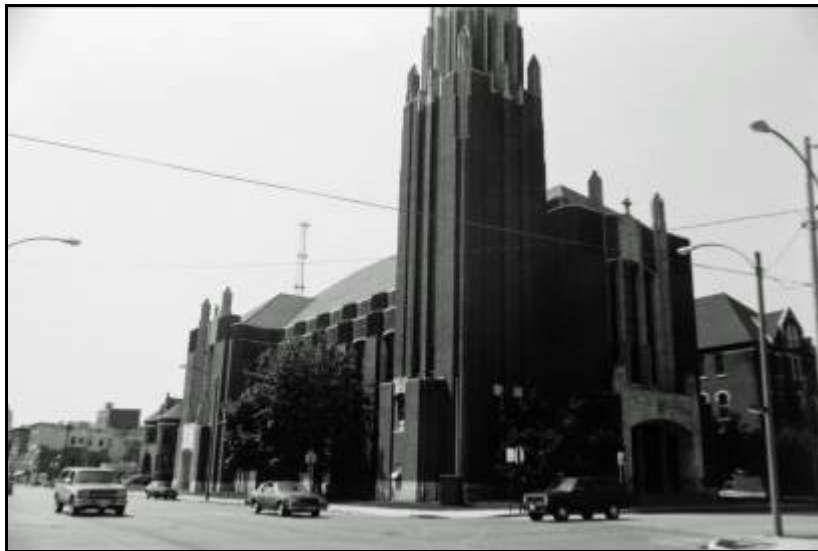
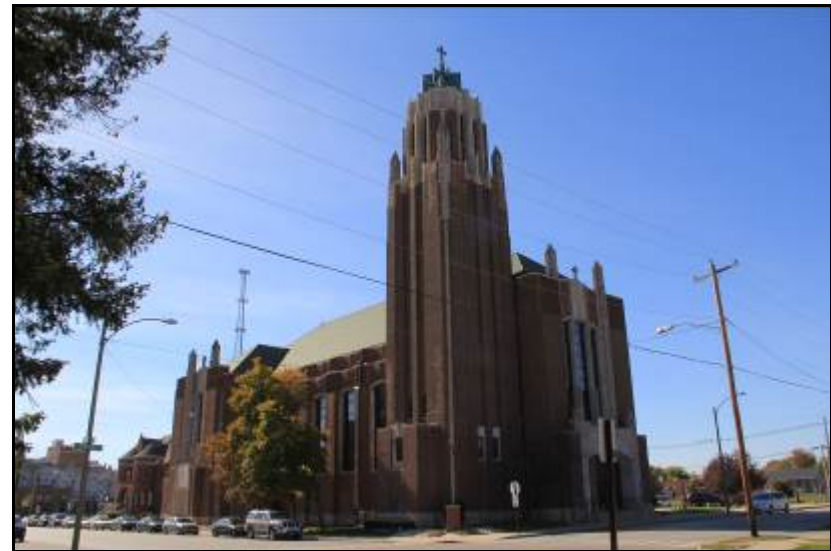
Sequence Number	Map Code	1994/95 Negative #	Address/Location	Type	Date Built	Historic Function	1994/95 Comments	2012/13 Comments and Photo Image #
139	17/17	17/17, IMG_4542	711 N. Main St., BLOOMINGTON	3	1932	Church	Massive, Art Deco church – “Holy Trinity Catholic Church.”	No significant changes have been made to this church. The building immediately to the W—perhaps church related (rectory, offices)—has been removed. IMG_4047

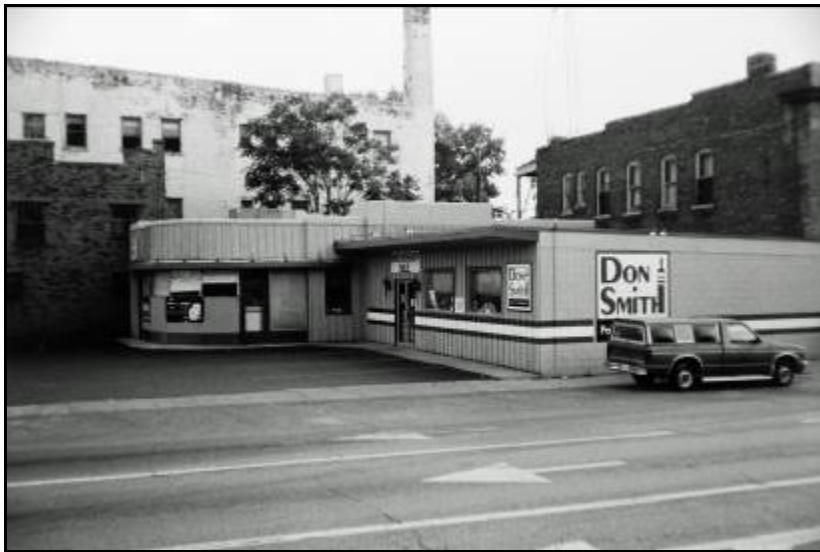
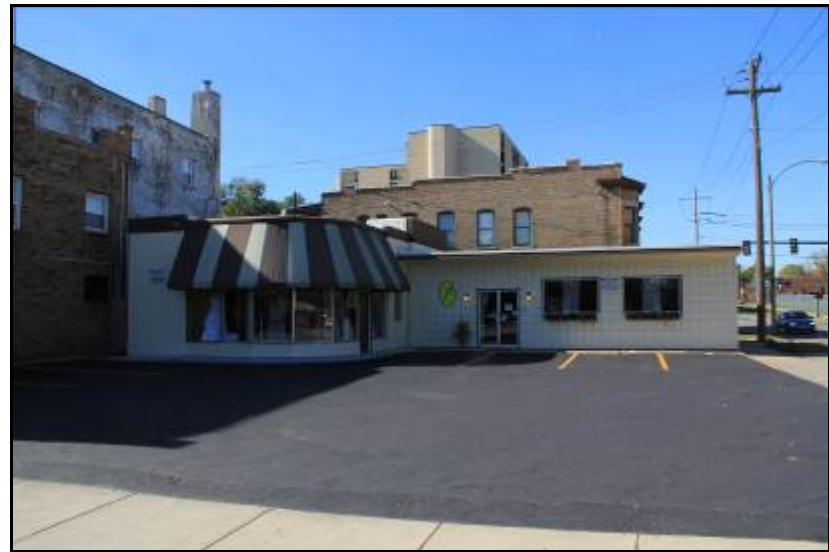
Sequence Number	Map Code	1994/95 Negative #	Address/Location	Type	Date Built	Historic Function	1994/95 Comments	2012/13 Comments and Photo Image #
140	20/29	20/29, IMG_4543	626 N. Main St., BLOOMINGTON	2	Ca. 1940s	Gas/Service	Substantially remodeled with large addition, but seeping, curved corner and parapet clearly suggest a Moderne gas station.	This structure, with some stylistic changes, is now used as a retail shop. IMG_4042

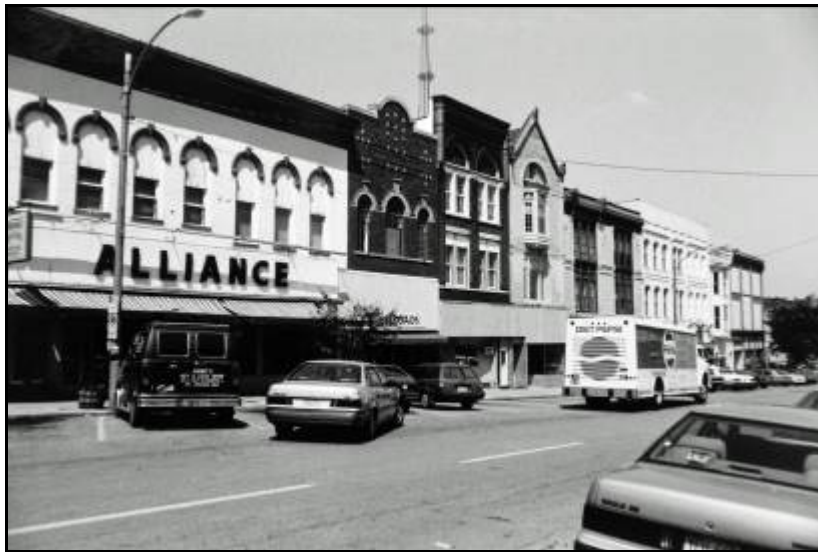
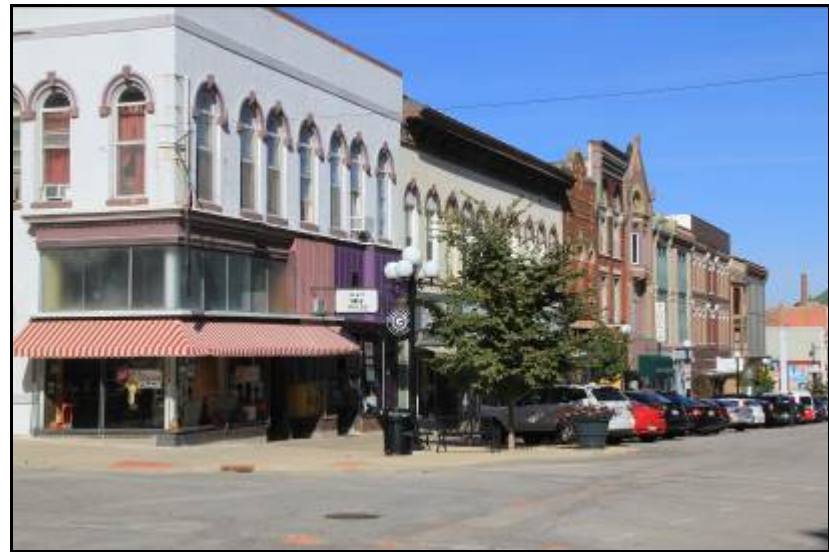
Sequence Number	Map Code	1994/95 Negative #	Address/Location	Type	Date Built	Historic Function	1994/95 Comments	2012/13 Comments and Photo Image #
141	17/16	17/16, IMG_4544	Block of 400 N. Main St., BLOOMINGTON	3	Ca. Late 19 th , Early 20 th Century	Commerce	Entire business block with wide variety of brick and tone, commercial vernacular structures (W side of street).	No significant changes have been made to this business block. IMG_4041

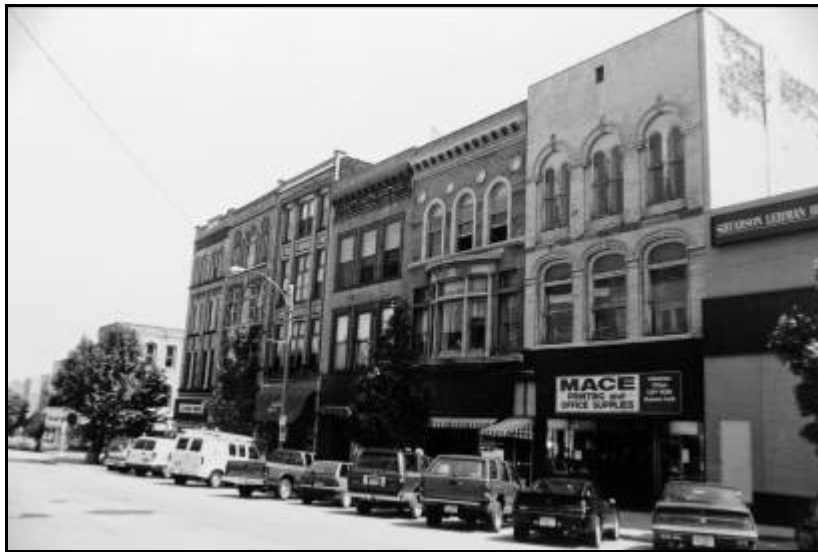
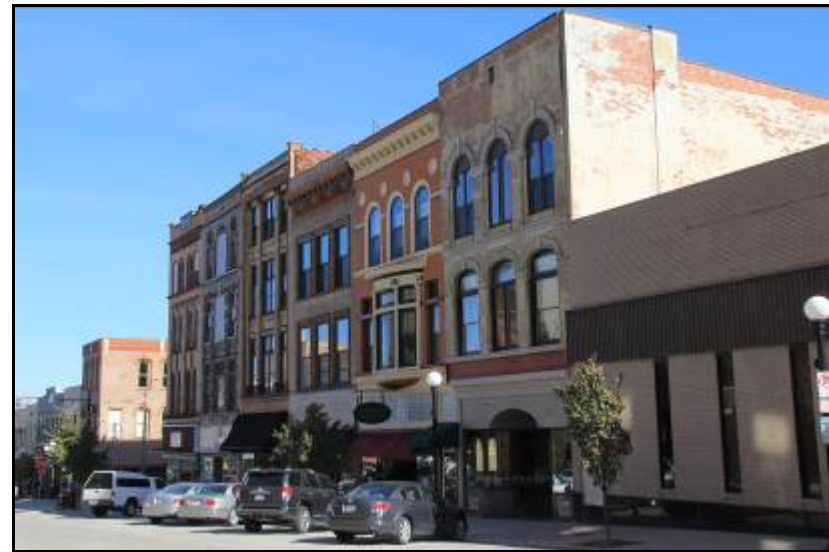
Sequence Number	Map Code	1994/95 Negative #	Address/Location	Type	Date Built	Historic Function	1994/95 Comments	2012/13 Comments and Photo Image #
142	17/15	17/15, IMG_4545	Block of 300 N. Main St., BLOOMINGTON	3	Ca. Late 19 th , Early 20 th Century	Commerce	Entire business block with wide variety of two and three-story, brick and stone, vernacular structures, several with prominent cornices.	No significant or detrimental changes have been made to this block. IMG_4040

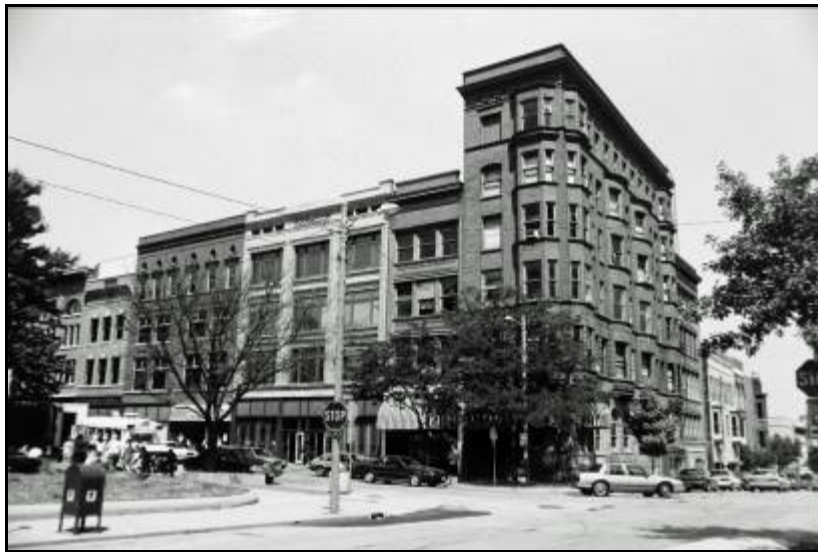
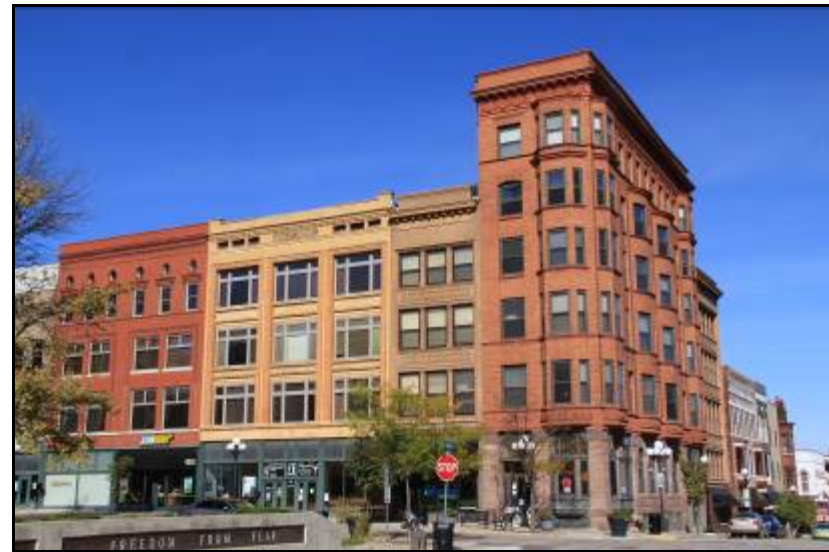
Sequence Number	Map Code	1994/95 Negative #	Address/Location	Type	Date Built	Historic Function	1994/95 Comments	2012/13 Comments and Photo Image #
143	17/14	17/14, IMG_4546	306 N. Main St., BLOOMINGTON	3	Ca. Late 19 th , Early 20 th Century	Commerce	Business block with largely four-story, brick, commercial vernacular structures with subtle cornices; building at corner is six stories, built of brick and has projecting bays and prominent cornice.	No significant changes have been made to this prominent collection of buildings. IMG_4039

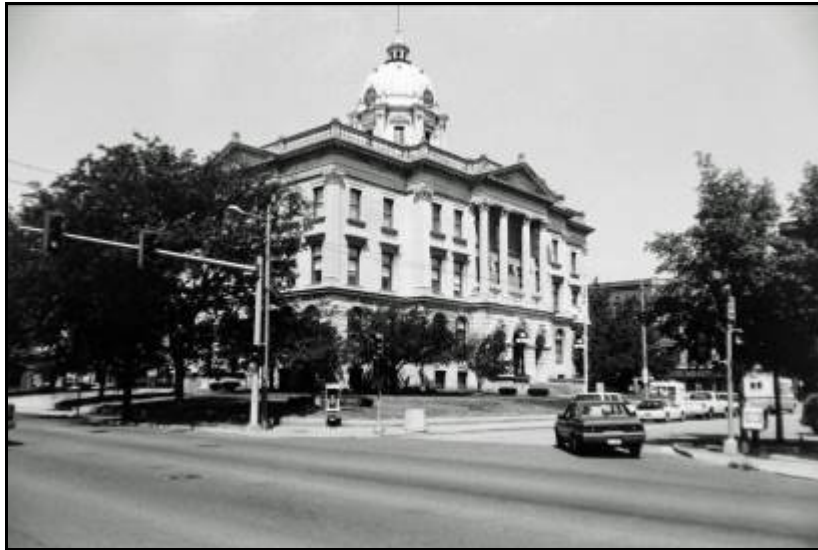
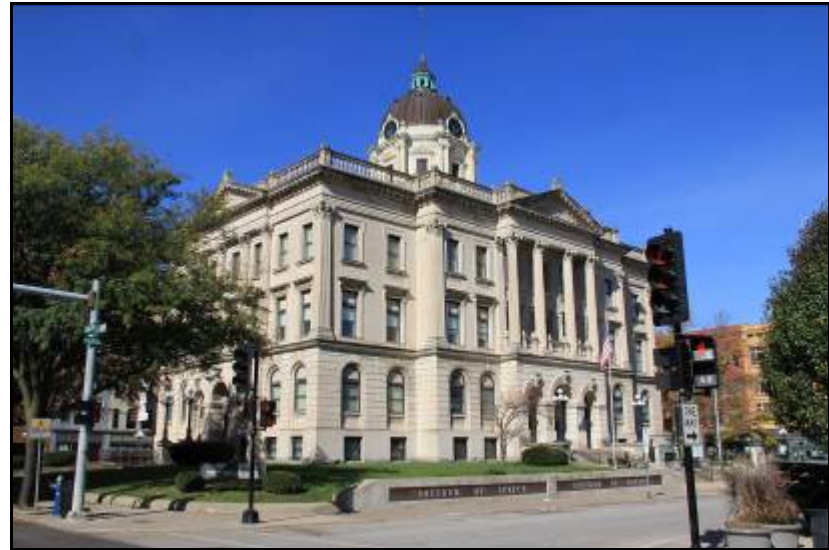
Sequence Number	Map Code	1994/95 Negative #	Address/Location	Type	Date Built	Historic Function	1994/95 Comments	2012/13 Comments and Photo Image #
144	17/13	17/13, IMG_4547	N. Main St. & Washington (NW corner)	3	1903	Government	Large, Classical Revival structure, possibly a former county courthouse – now local museum and library.	McLean County offices moved out of the courthouse in 1991, when the “McLean County Historical Society” moved in. IMG_4038

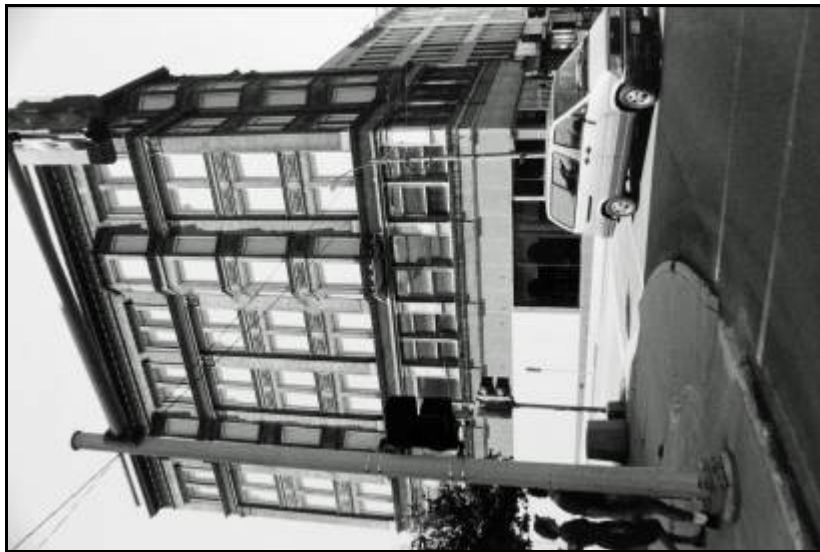
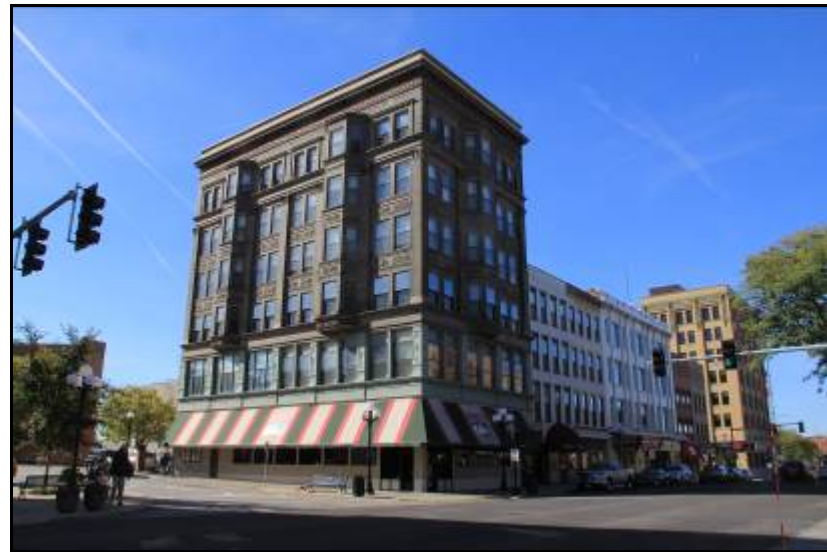
Sequence Number	Map Code	1994/95 Negative #	Address/Location	Type	Date Built	Historic Function	1994/95 Comments	2012/13 Comments and Photo Image #
145	17/12	17/12, IMG_4548	104 W. Washington, BLOOMINGTON	3	Ca. Late 19 th , Early 20 th Century	Commerce	Six-story, brick building with projecting bays, decorative panels between windows on each floor and prominent cornice.	Other than the addition of the first floor awing, there appear to be few changes to this structure. IMG_4037

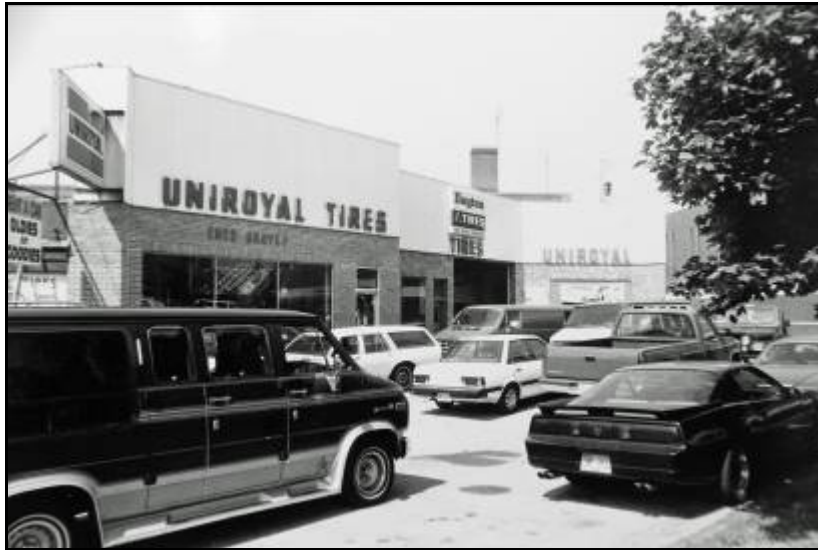
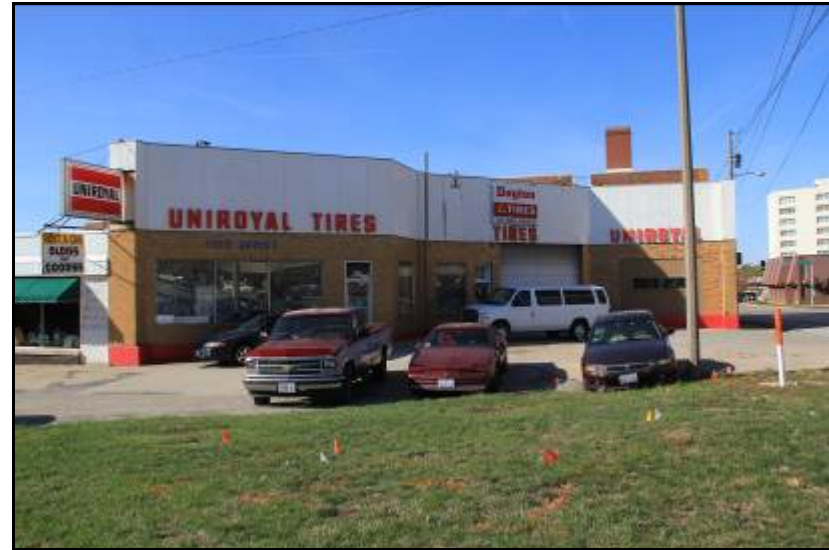
Sequence Number	Map Code	1994/95 Negative #	Address/Location	Type	Date Built	Historic Function	1994/95 Comments	2012/13 Comments and Photo Image #
146	17/11	17/11, IMG_4549	303 S. Main St., BLOOMINGTON	2	Ca. 1940s-50s	Auto Dealer	Brick "Uniroyal Tires" structure – <u>may</u> have been an auto dealer at one time.	No changes of significance have affected this building. IMG_40236

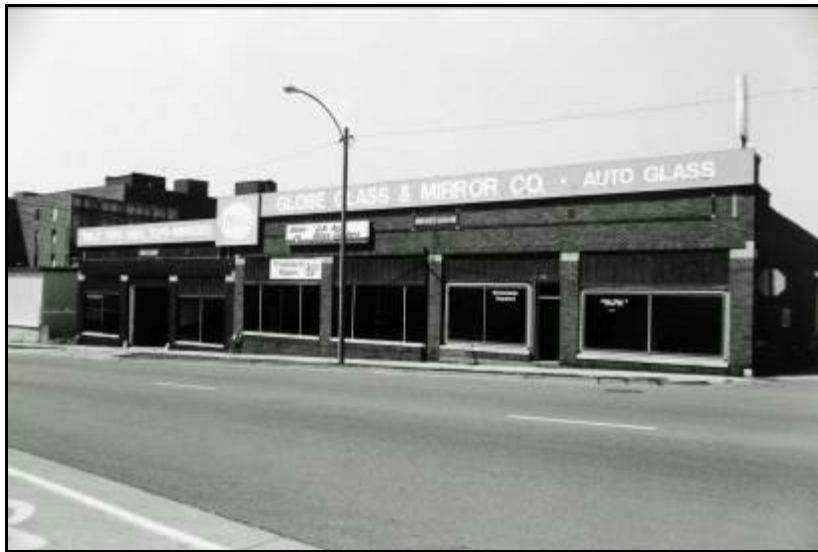
Sequence Number	Map Code	1994/95 Negative #	Address/Location	Type	Date Built	Historic Function	1994/95 Comments	2012/13 Comments and Photo Image #
147	17/10	17/10, IMG_4550	321 S. Main St., BLOOMINGTON	2	1928/1926	Auto Dealer	Brick structure with prominent parapet obscured by modern sign, reduced-size display windows and two distinct portions – left (S) part dated 1928 while right (N) part dated 1926.	There have been some nominal changes to this building, most significantly the removal of the signs on the building's parapet—thus revealing some nice architectural features. IMG_4035

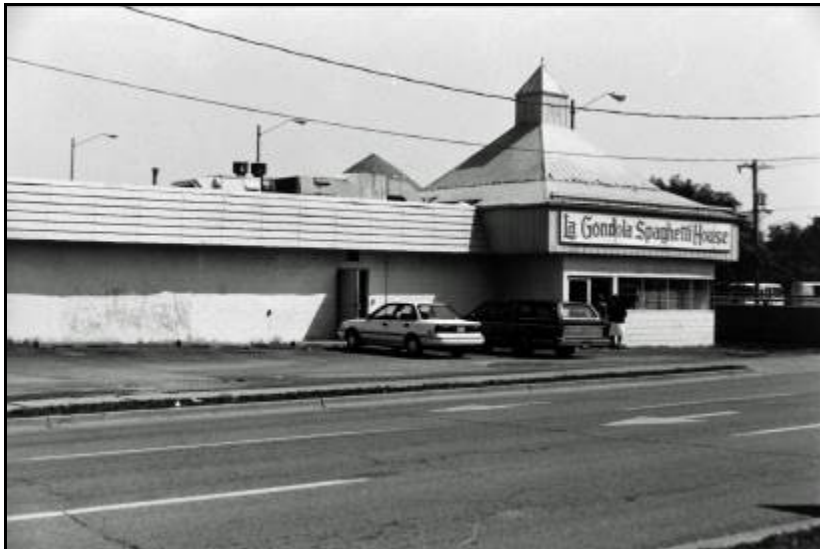
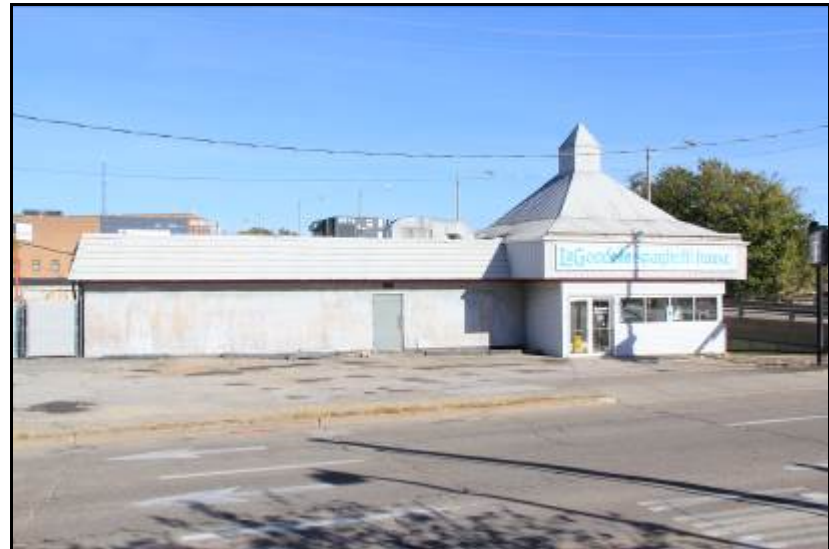
Sequence Number	Map Code	1994/95 Negative #	Address/Location	Type	Date Built	Historic Function	1994/95 Comments	2012/13 Comments and Photo Image #
148	17/09	17/09, IMG_4551	509 Oakland, BLOOMINGTON	2	Ca. 1960s	Restaurant	Looks to be an old “Kentucky Fried Chicken” building – now “Gondola Spaghetti House.”	No significant changes have occurred to this building. IMG_4034

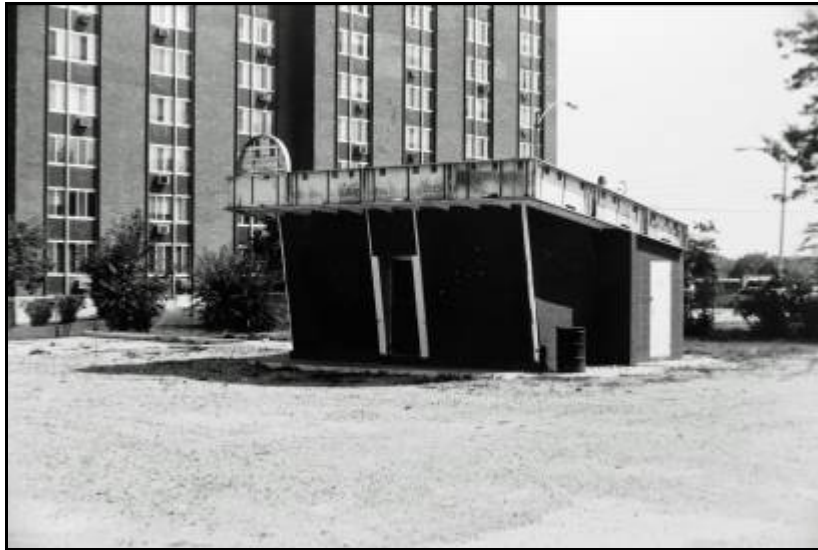
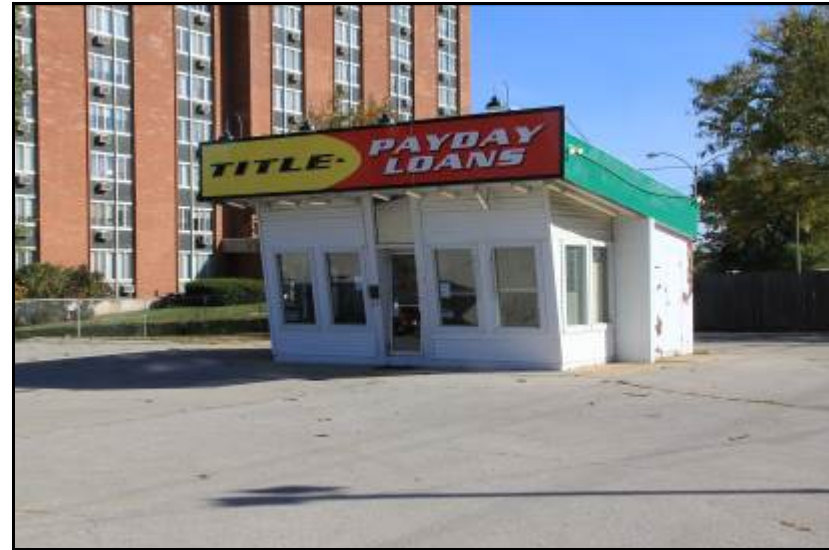
Sequence Number	Map Code	1994/95 Negative #	Address/Location	Type	Date Built	Historic Function	1994/95 Comments	2012/13 Comments and Photo Image #
149	17/08	17/08, IMG_4552	806 S. Main St., BLOOMINGTON	2	Ca. 1960s	Gas Station	Classical, 1960s era "Clark" gas station with shed roof – vacant.	This former gas station, with its new windows and sheathing, has been adaptively reused and is now a payday loan facility. IMG_4033

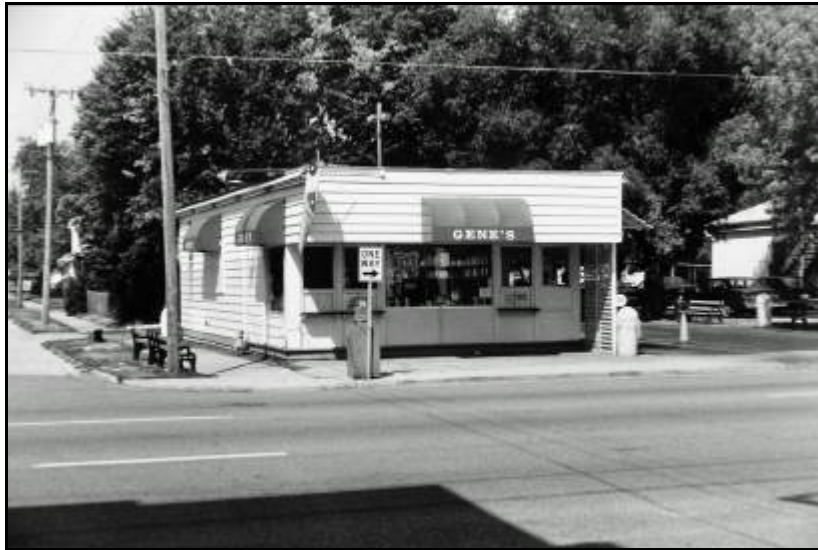
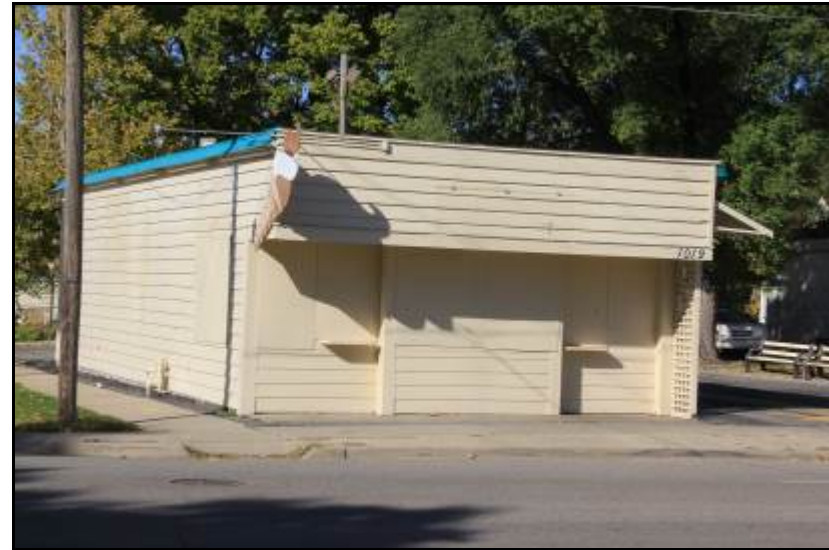
Sequence Number	Map Code	1994/95 Negative #	Address/Location	Type	Date Built	Historic Function	1994/95 Comments	2012/13 Comments and Photo Image #
150	17/07	17/07, IMG_4553	1019 S. Main St., BLOOMINGTON	2	Ca. 1950s-60s	Drive-In	Small, clapboard-sheathed drive-in – “Gene’s.”	There appear to be few changes to this drive-in, which, hopefully, is only closed for the winter. IMG_4032

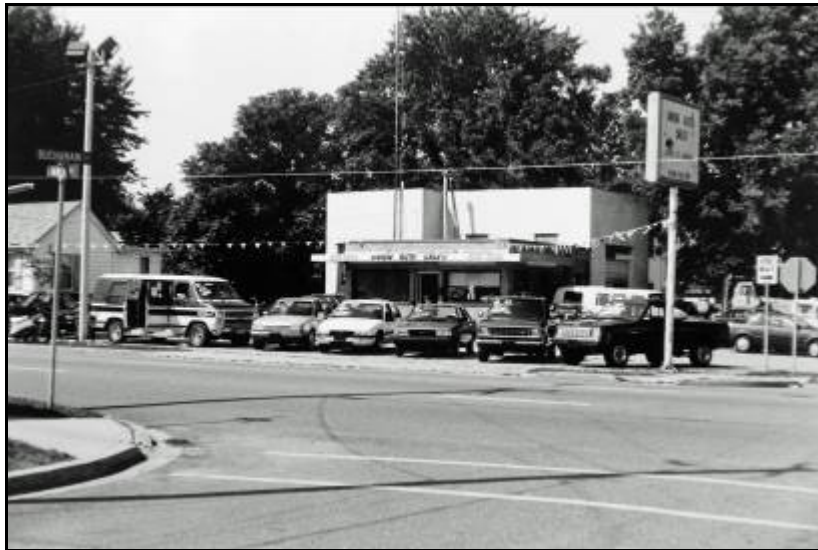
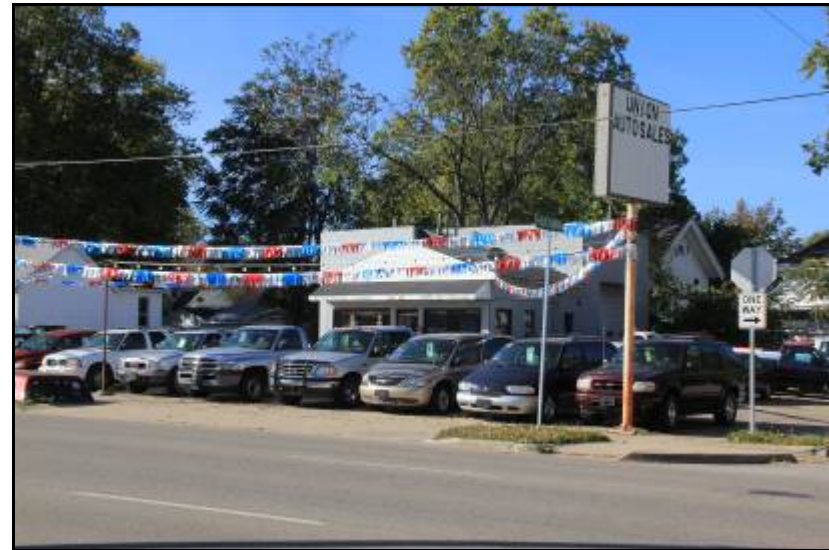
Sequence Number	Map Code	1994/95 Negative #	Address/Location	Type	Date Built	Historic Function	1994/95 Comments	2012/13 Comments and Photo Image #
151	17/06	17/06, IMG_4554	1201 (?) S. Main St., BLOOMINGTON	2	Ca. 1950s-60s	Auto Dealer	Concrete block garage with a small showroom appears to be an old auto sales operation – “Union Auto Sales.”	A new gabled roof over the office/show room portion of this building appears to be the biggest change that has occurred over the years. IMG_4031

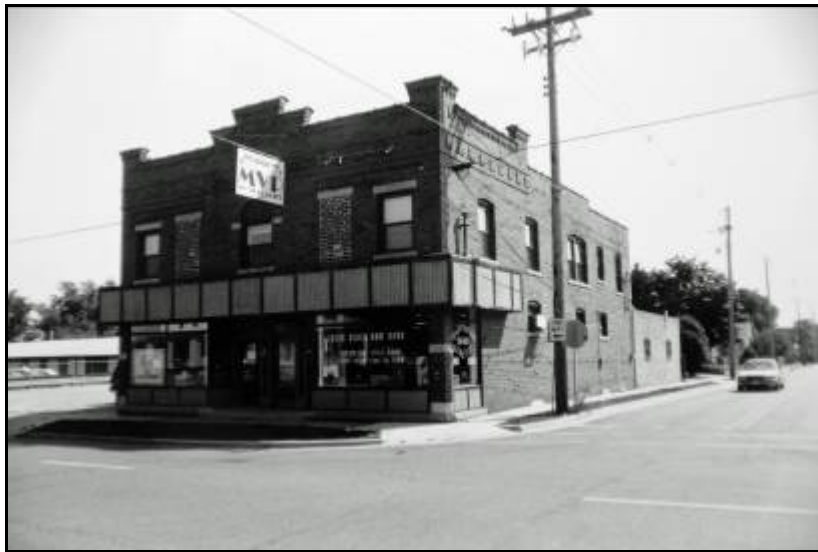
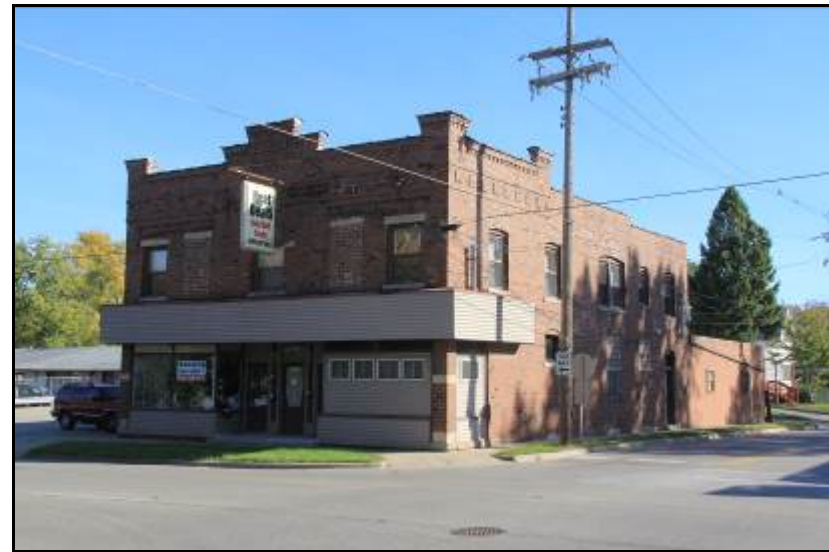
Sequence Number	Map Code	1994/95 Negative #	Address/Location	Type	Date Built	Historic Function	1994/95 Comments	2012/13 Comments and Photo Image #
152	17/05	17/05, IMG_4555	1312 S. Main St., BLOOMINGTON	3	Ca. Late 19 th , Early 20 th Century	Commerce	Two-story, brick, retail building with some second floor windows in-filled and prominent parapet with decorative cornice.	Changes to this building include modifications to the first floor, display windows. Otherwise the historic form remains. IMG_4030

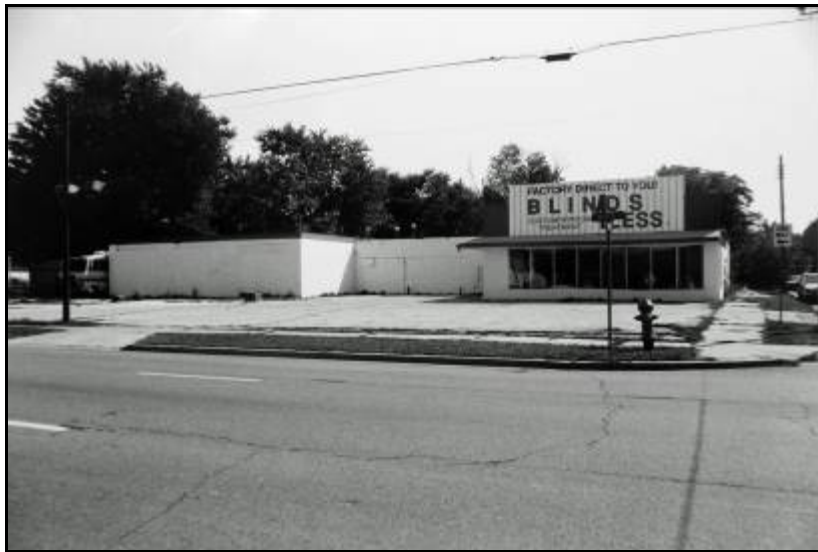
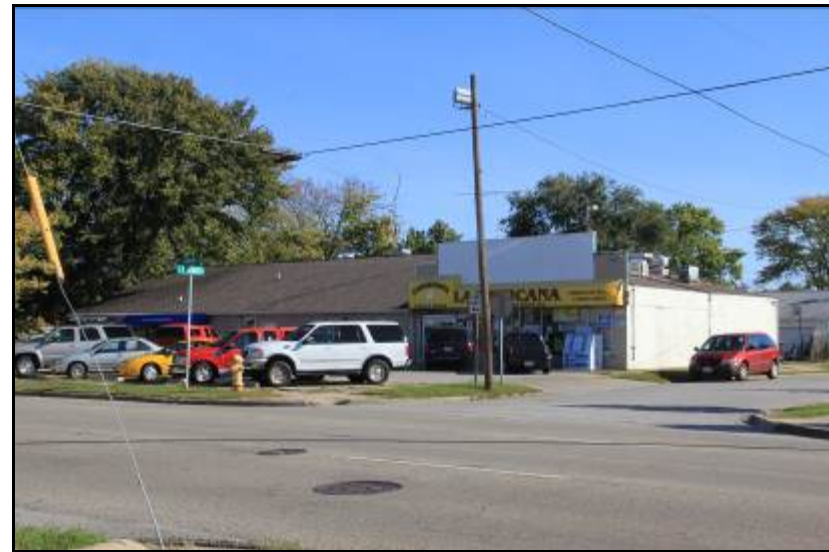
Sequence Number	Map Code	1994/95 Negative #	Address/Location	Type	Date Built	Historic Function	1994/95 Comments	2012/13 Comments and Photo Image #
153	17/04	17/04, IMG_4556	1416 S. Main St., BLOOMINGTON	2	Ca. 1960s	Auto Dealer (?)	Concrete block structure looks as if it could have been an auto dealer operation.	Prominent alterations to this building since the mid-1990s include window changes, the construction of a gabled roof over much of the structure and new signage. IMG_4029

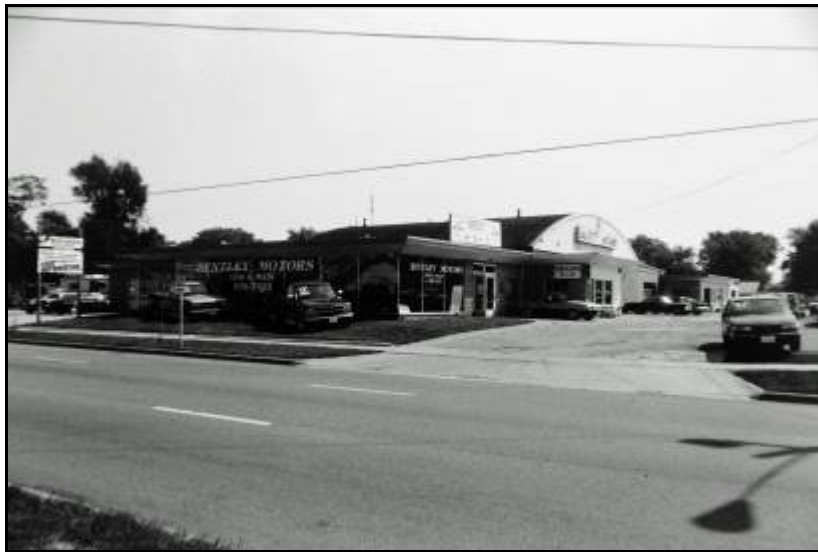
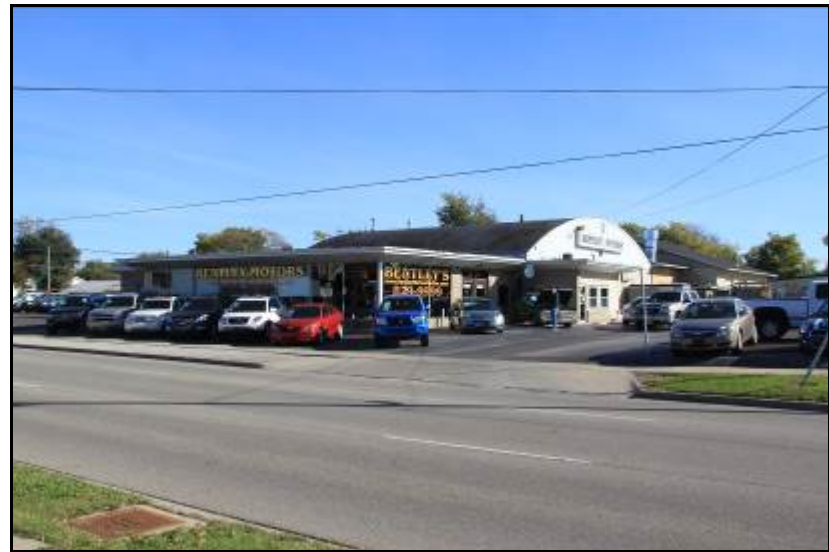
Sequence Number	Map Code	1994/95 Negative #	Address/Location	Type	Date Built	Historic Function	1994/95 Comments	2012/13 Comments and Photo Image #
154	17/03	17/03, IMG_4557	1508 S. Main St., BLOOMINGTON	2	Ca. 1940s-50s	Auto Dealer	Original part of building has an arched roof; subsequent brick and glass additions – “Bentley Motor Sales.”	Minor changes to the signage notwithstanding, this auto dealership appears to be little altered. IMG_4028

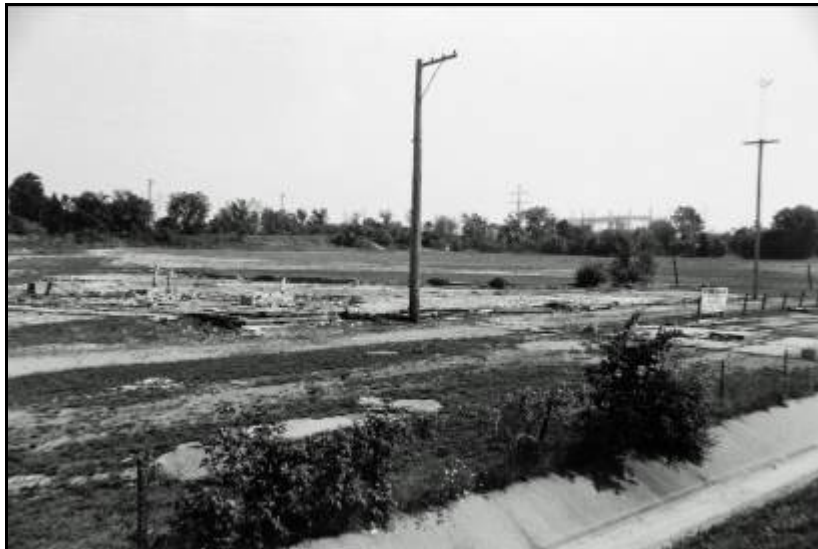
Sequence Number	Map Code	1994/95 Negative #	Address/Location	Type	Date Built	Historic Function	1994/95 Comments	2012/13 Comments and Photo Image #
155	17/01	17/01, IMG_4558	S. Main St. & RT 66 Bypass	2	Ca. 1940s-50s	Drive-In Movie	Remains of old drive-in movie theater; vacant land now for sale.	No evidence of the old drive-in theater was observed. The area appears to be all redeveloped.

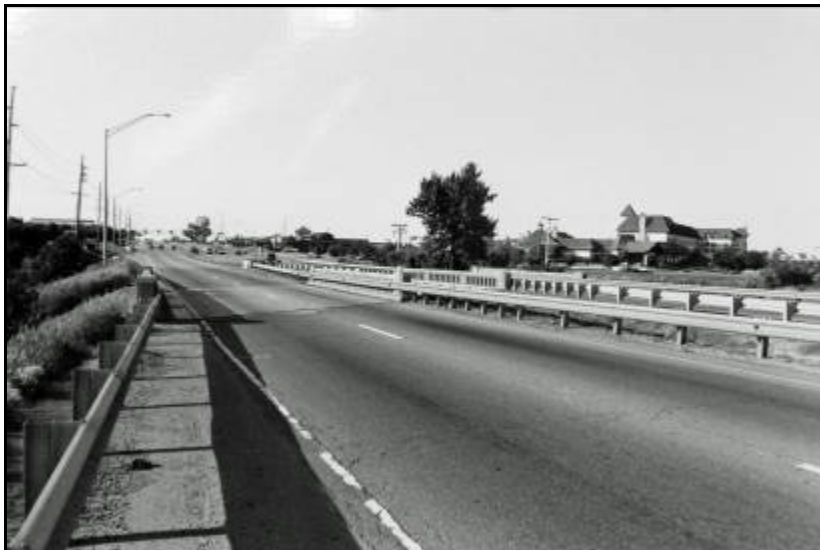
Sequence Number	Map Code	1994/95 Negative #	Address/Location	Type	Date Built	Historic Function	1994/95 Comments	2012/13 Comments and Photo Image #
156	13/02	13/02-04, IMG_1839	Business 1-55 over Sugar Creek, NORMAL	1	Ca. 1940-55	Bridges	Two structures: Bridge #0067 (southbound) and #0068 (northbound) – no plate; single-span with five “I” beams to support concrete decks.	The bridge was replaced in 1999.

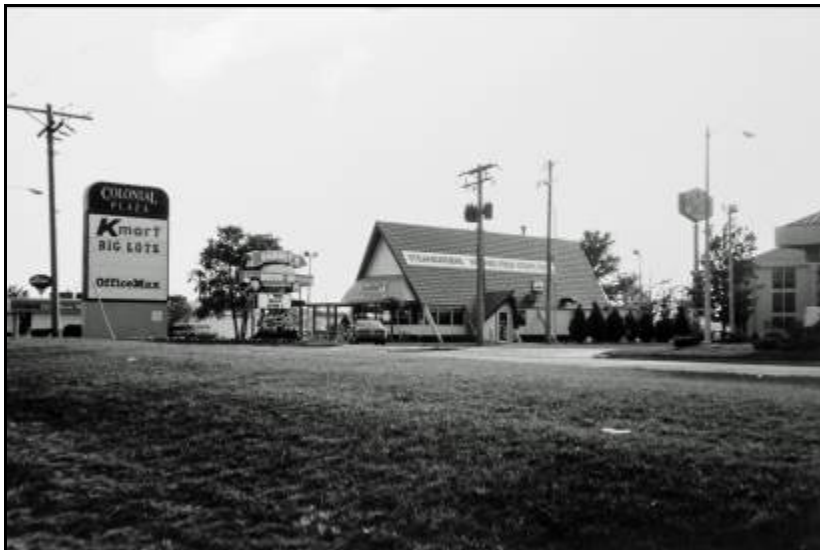
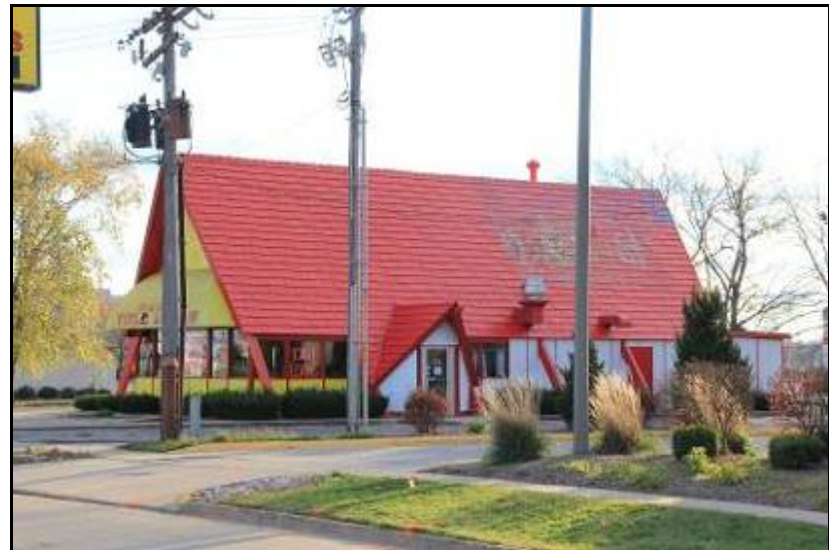
Sequence Number	Map Code	1994/95 Negative #	Address/Location	Type	Date Built	Historic Function	1994/95 Comments	2012/13 Comments and Photo Image #
157	20/27	20/27, IMG_1840	Business I-55 & STH 9 (NW corner), BLOOMINGTON	2	Ca. 1960s-70s	Drive-In	Modern-looking, "A" frame; likely post-dates USH 66 – "Dabney's Drive-In."	Former restaurant now used as an instant loan store. Could postdate RT 66. IMG_1353

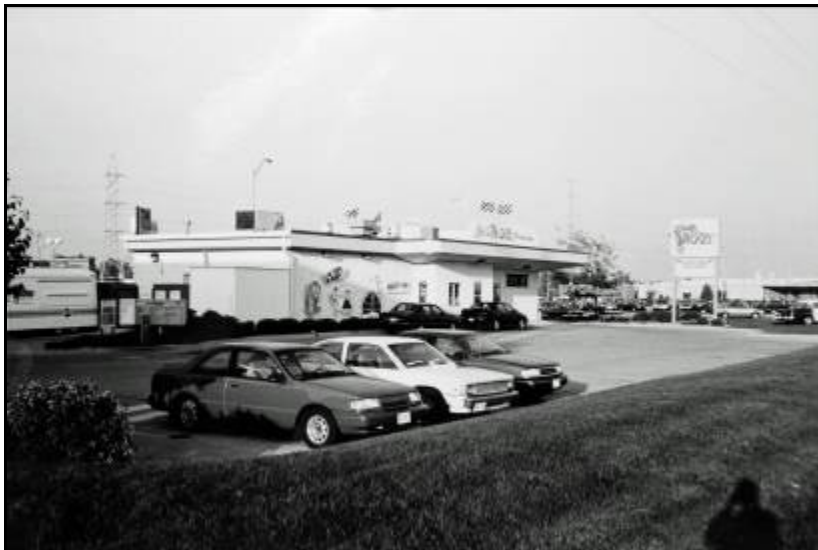
Sequence Number	Map Code	1994/95 Negative #	Address/Location	Type	Date Built	Historic Function	1994/95 Comments	2012/13 Comments and Photo Image #
158	20/28	20/28, IMG_1841	Business I-55 & IL 150 (NW corner), BLOOMINGTON	2	Ca. 1970s-80s	Drive-In	Looks to be a new construction (or a reconstruction?); contemporary building has a drive-through – “Double Nickel Drive-In.”	Structure now gone.

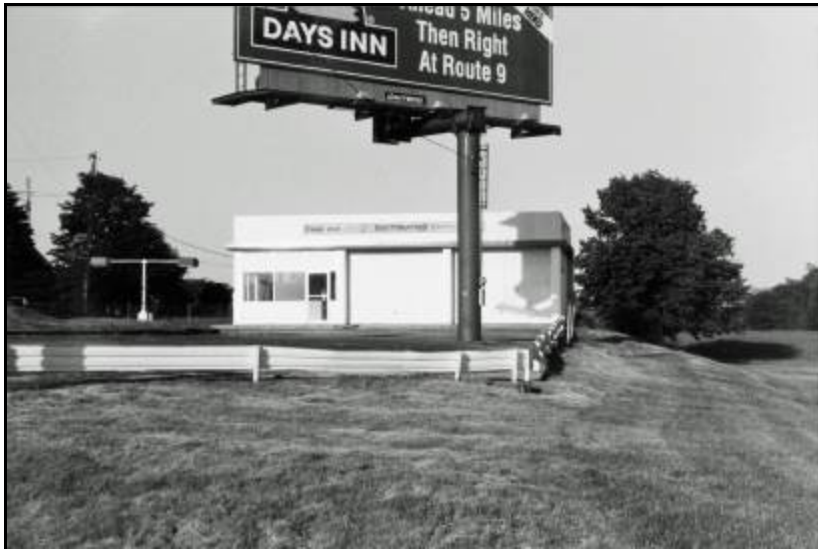
Sequence Number	Map Code	1994/95 Negative #	Address/Location	Type	Date Built	Historic Function	1994/95 Comments	2012/13 Comments and Photo Image #
159	13/05	13/05, IMG_1842	Old 66 & Cabintown Rd., BLOOMINGTON	2	Ca. 1960s	Gas/Service	Very plain-looking gas station with two garage doors – vacant.	This building no longer remains.

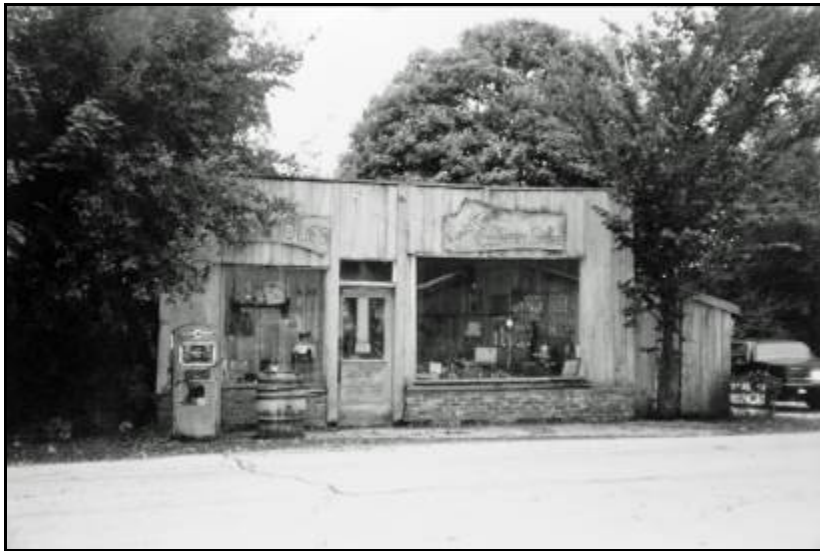
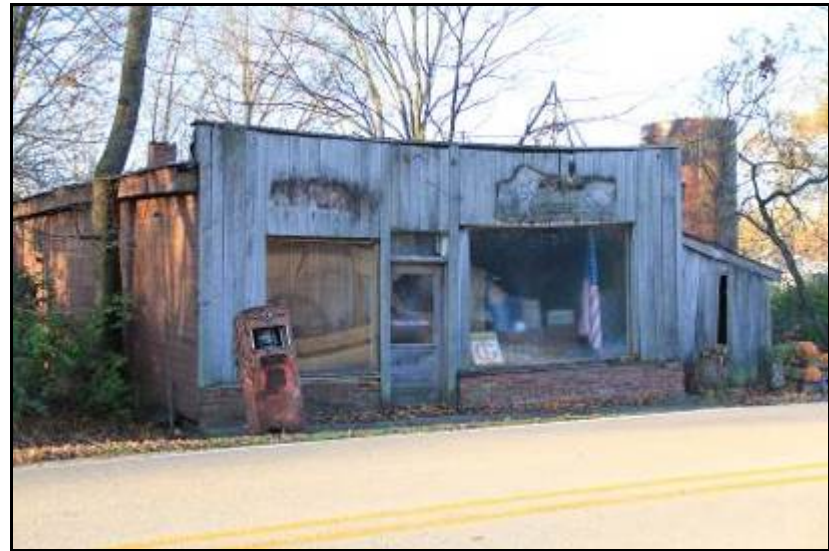
Sequence Number	Map Code	1994/95 Negative #	Address/Location	Type	Date Built	Historic Function	1994/95 Comments	2012/13 Comments and Photo Image #
160	21/10	21/10, IMG_1843	Rd. 550N & RR, FUNK'S GROVE	2	Ca. 1940s (?)	Gas Station	Structure has brick foundation, vertical board siding that is not original and a very nice door (likely original) with ornamental inset panels – “Funk’s Grove Country Store.”	While there have been some changes to this structure and its setting, it very much retains its 1994 character. IMG_1354

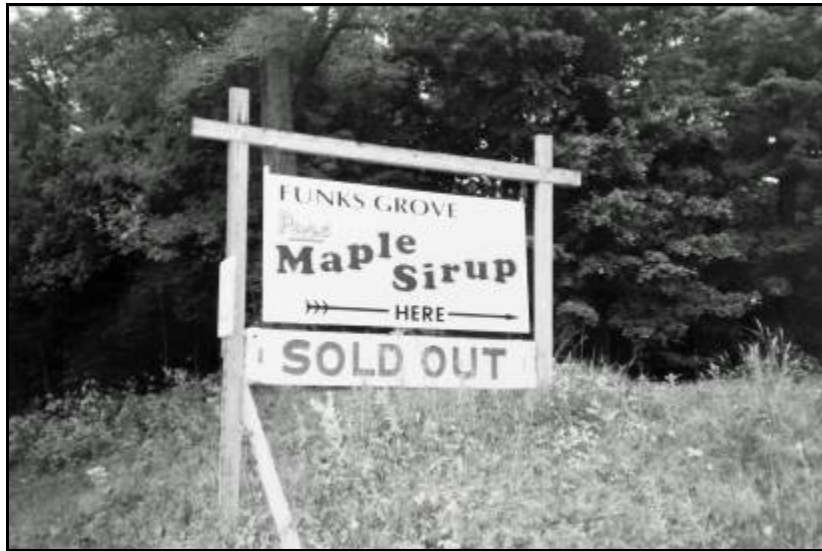
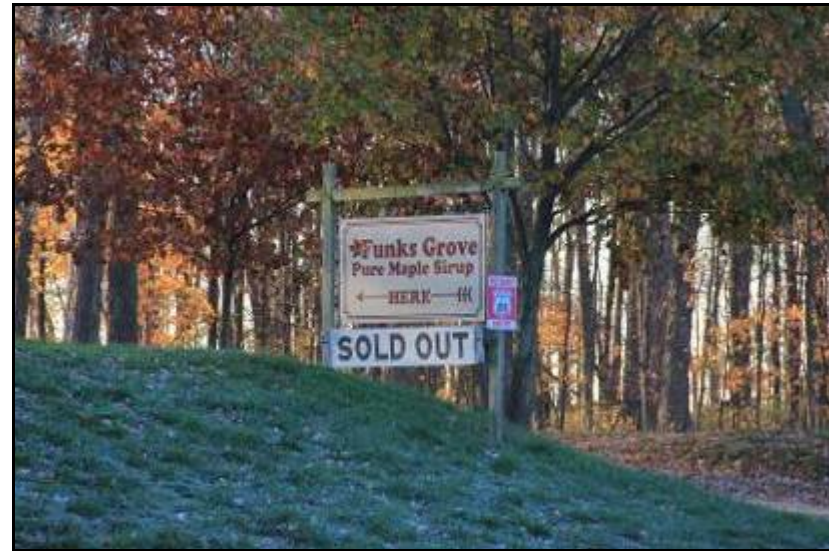
Sequence Number	Map Code	1994/95 Negative #	Address/Location	Type	Date Built	Historic Function	1994/95 Comments	2012/13 Comments and Photo Image #
161	21/11	21/11, IMG_1844	Old 66, FUNK'S GROVE	3	Ca. 19 th & 20 th Centuries	Maple Tree Grove	"Funk's Grove Pure Maple Sirup" trees and production facilities – see Waldmire Post Card for further information.	While a new sign identifies it, the "Funks Grove Pure Maple Sirup" operation remains adjacent to RT 66. IMG_1357
