Route 66 in Illinois:

(2012/13 Update and Expansion of the Original 1994/95 Survey)

IDOT Sequence #17337 & #17337A

22 December 2013

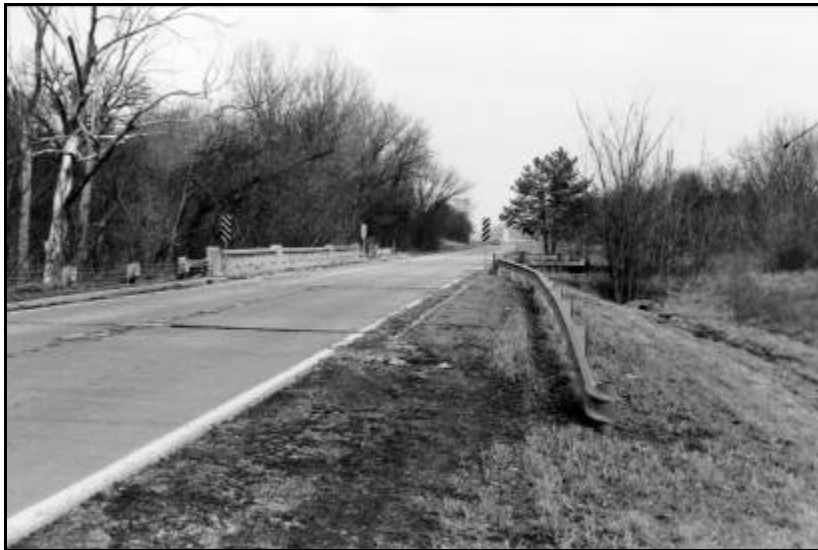
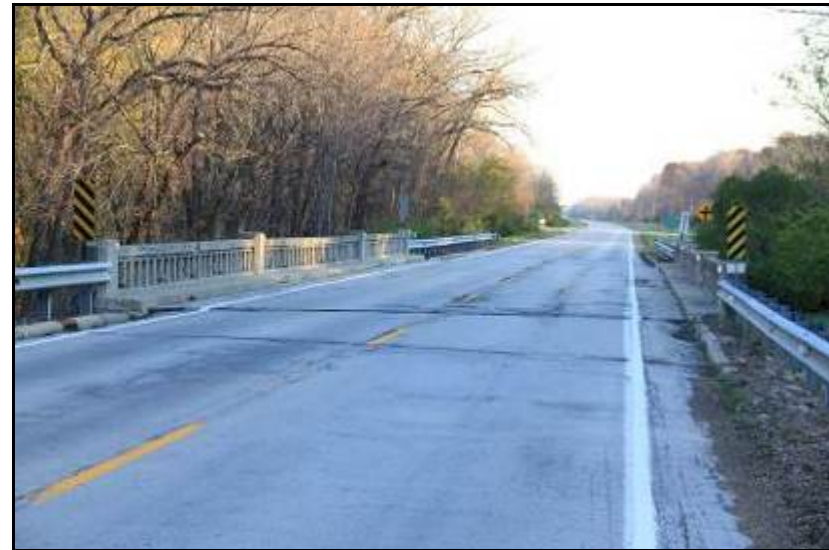
Sequence Number	Map Code	1994/95 Negative #	Address/Location	Type	Date Built	Historic Function	1994/95 Comments	2012/13 Comments and Photo Image #
162	03/14	03/14, 12/02-04, IMG_1845	Old 66 over Timber Creek	1	1954	Bridge	One structure remains: Bridge #0003 (westbound) – plate notes: Station 159+89.8, Built 1954 by, State of Illinois, F.A. Rt. 5 Sec. 17 RB-2 F.A. Proj. F.I. – 26(48), Loading H20-S16; three-span structure with arched, concrete beams.	The 1954, westbound bridge remains, largely unchanged. IMG_1355

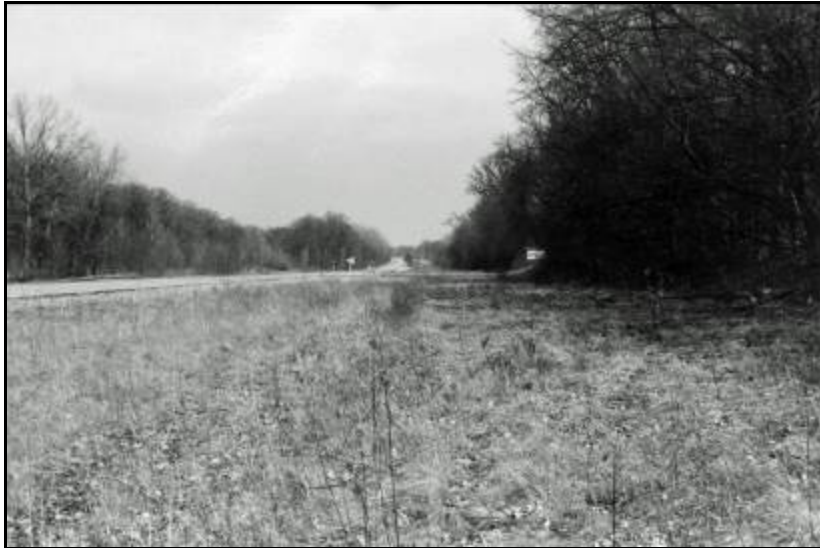
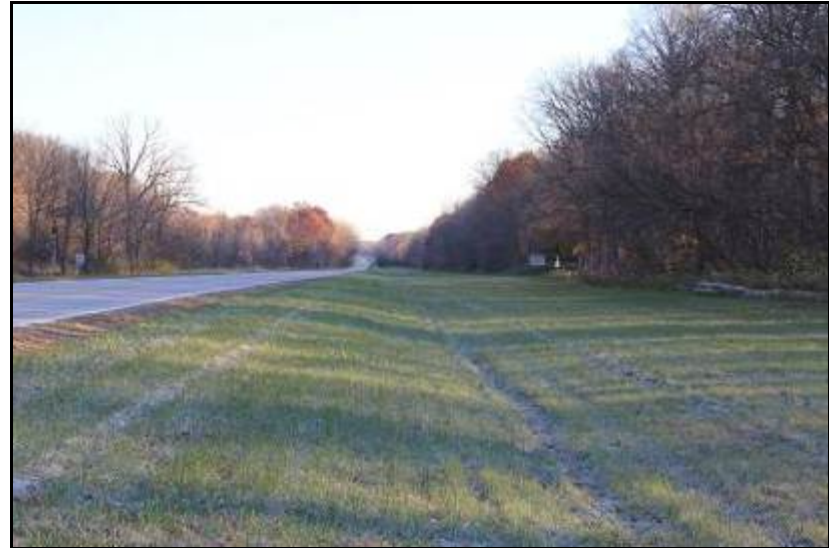
Sequence Number	Map Code	1994/95 Negative #	Address/Location	Type	Date Built	Historic Function	1994/95 Comments	2012/13 Comments and Photo Image #
163	03/15	03/15, IMG_1846	Old 66 at FUNK'S GROVE	1	1954	USH 66	Four-lane 66 at Funk's Grove with two eastbound lanes removed (view to NE).	The 1994 view is largely unchanged. IMG_1359

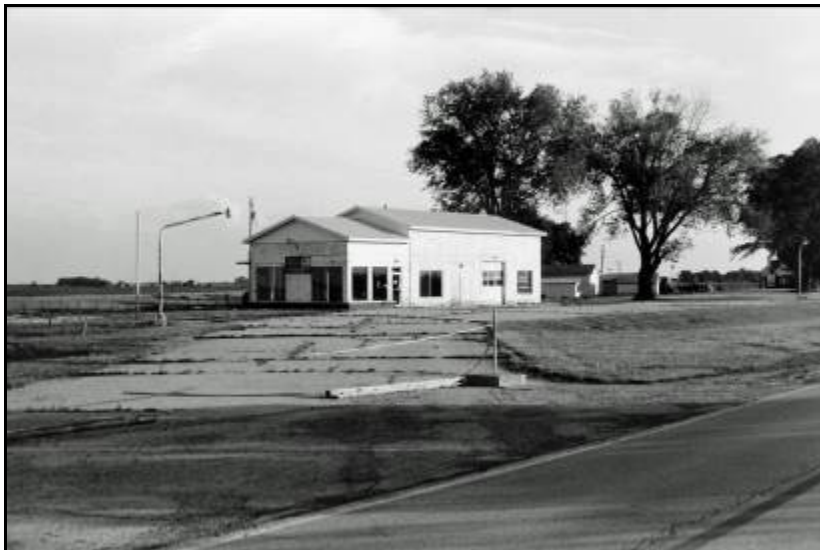
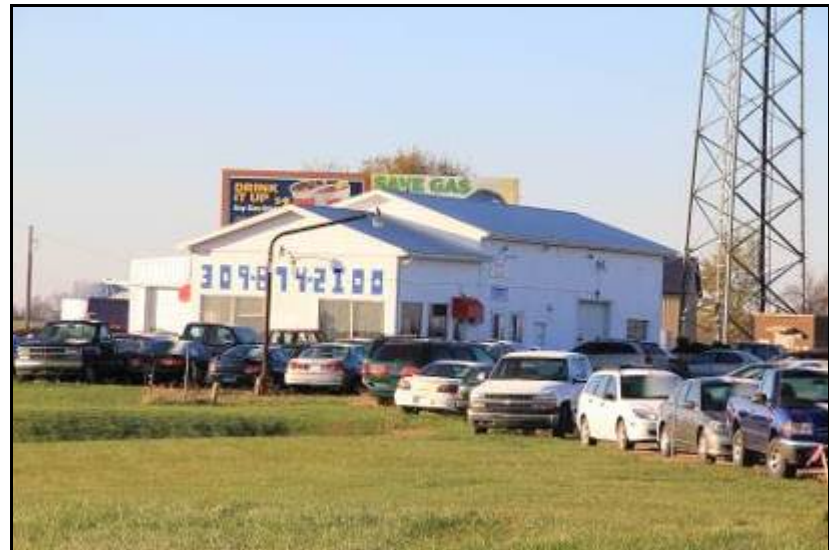
Sequence Number	Map Code	1994/95 Negative #	Address/Location	Type	Date Built	Historic Function	1994/95 Comments	2012/13 Comments and Photo Image #
164	13/06	13/06, IMG_1847	Old 66 at Rd. 300N	2	Ca. 1950s	Gas/Service	Concrete block gas/service station – vacant.	The old service station now facilitates the sale of used cars. IMG_1360

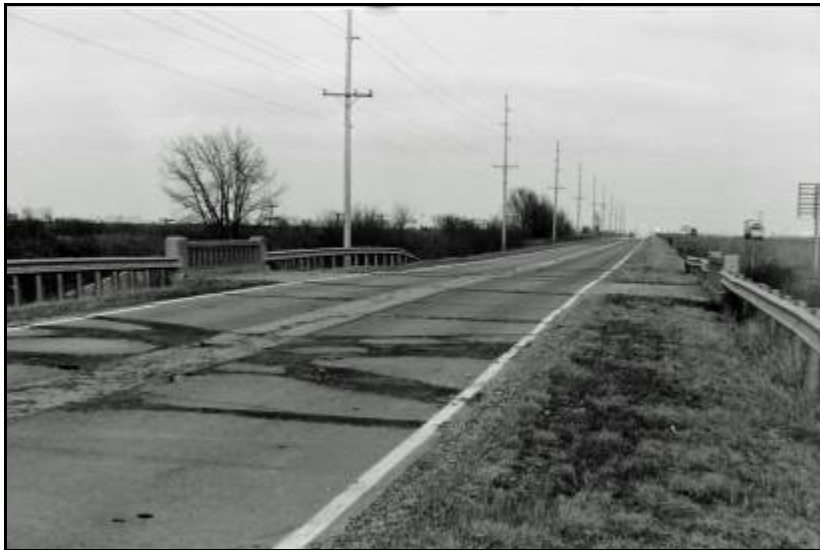
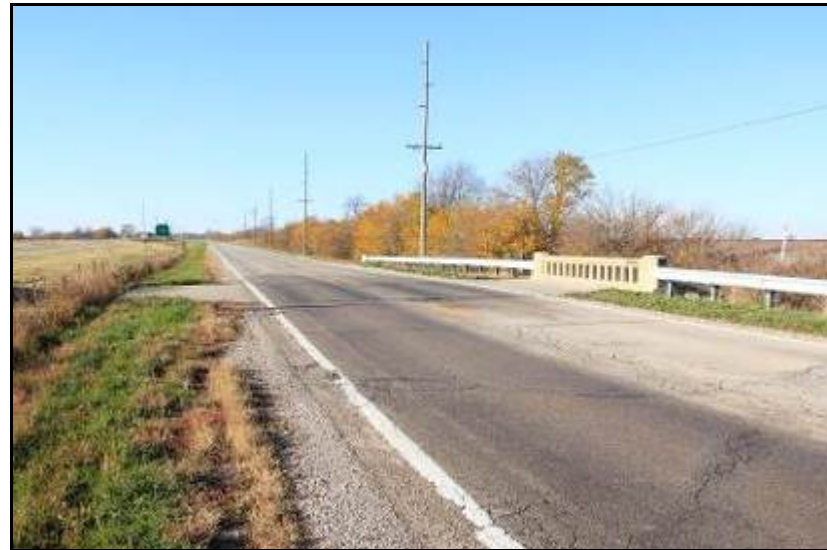
Sequence Number	Map Code	1994/95 Negative #	Address/Location	Type	Date Built	Historic Function	1994/95 Comments	2012/13 Comments and Photo Image #
165	03/16	03/16, 12/05, IMG_1848	Old 66 over Clear Creek	1	1954	Bridge	One structure remains: Bridge #054-0004 (westbound) – plate notes: Station 572+29(2), Built 1954 by, State of Illinois, F.A. Rt. 5 Sec 20-RB-2, F.A. Proj. F.I. 26(48), Loading H20-S16; single-span structure with concrete slab deck.	While the structure remains today, the railing adjacent to I-55 has been removed (2012 view to SW). IMG_1361

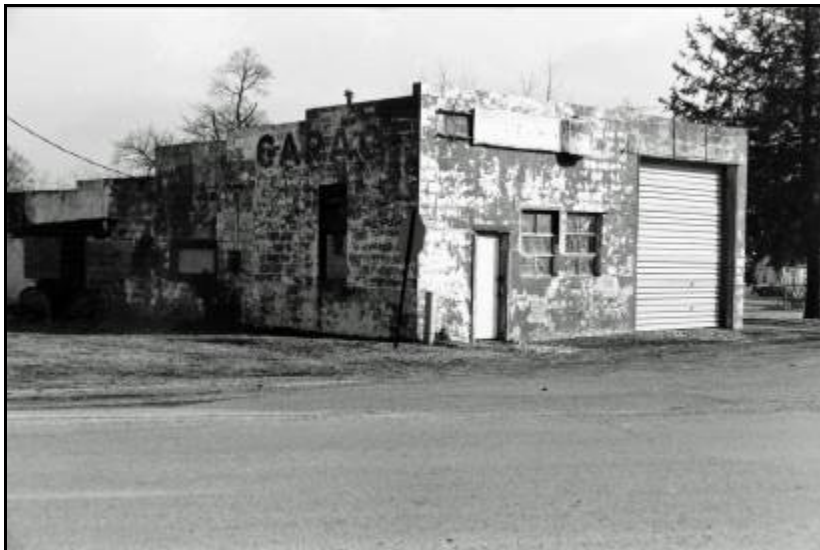
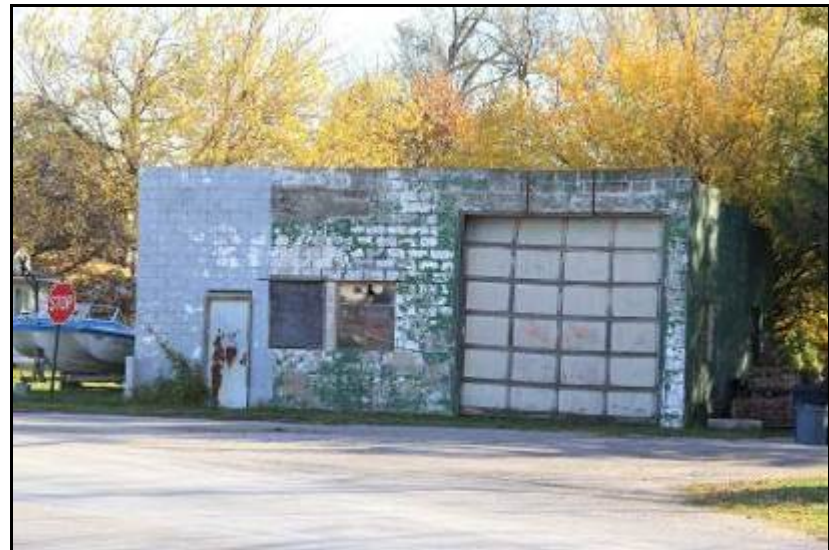
Sequence Number	Map Code	1994/95 Negative #	Address/Location	Type	Date Built	Historic Function	1994/95 Comments	2012/13 Comments and Photo Image #
166	03/17	03/17, IMG_1849	Arch St. & Montgomery (NE corner), ATLANTA	2	Ca. 1940s	Gas/Service	Concrete block structure – likely once served as a gas and service station.	Dilapidated in 1994, the structure remains today with a different, overhead garage door. IMG_1363

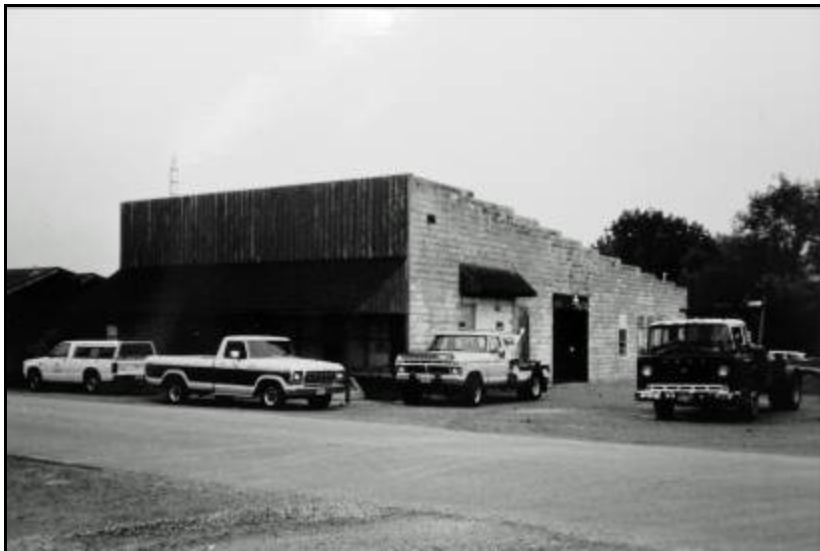
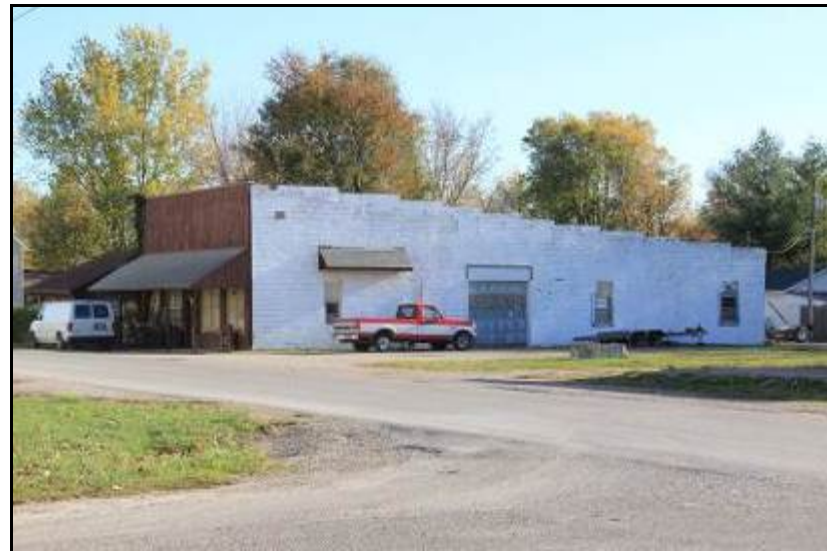
Sequence Number	Map Code	1994/95 Negative #	Address/Location	Type	Date Built	Historic Function	1994/95 Comments	2012/13 Comments and Photo Image #
167	21/12	21/12, IMG_1850	203 Arch St., ATLANTA	2	Ca. 1930s-40s	Auto Service	Despite modern wood siding and shed roof porch on front, this is a concrete block structure with an overhead, garage door on the side; looks as if it could have been an auto service building.	Structure remains little changed. IMG_1364

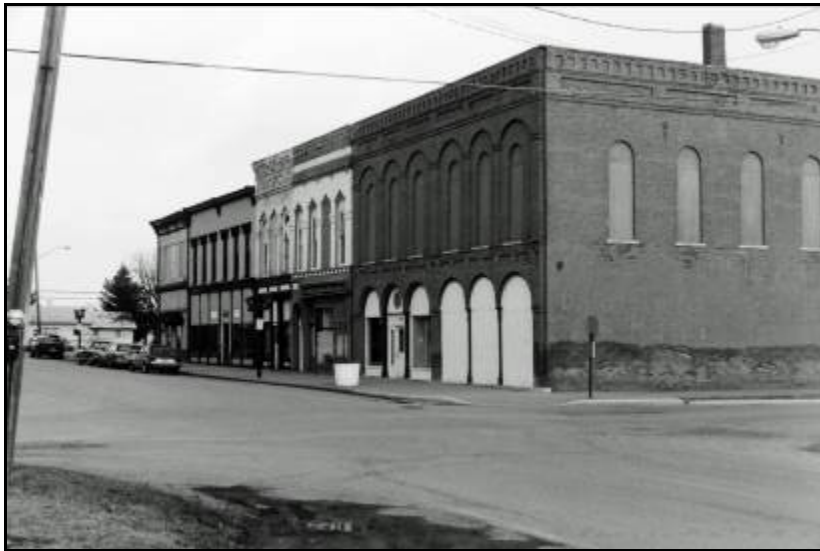
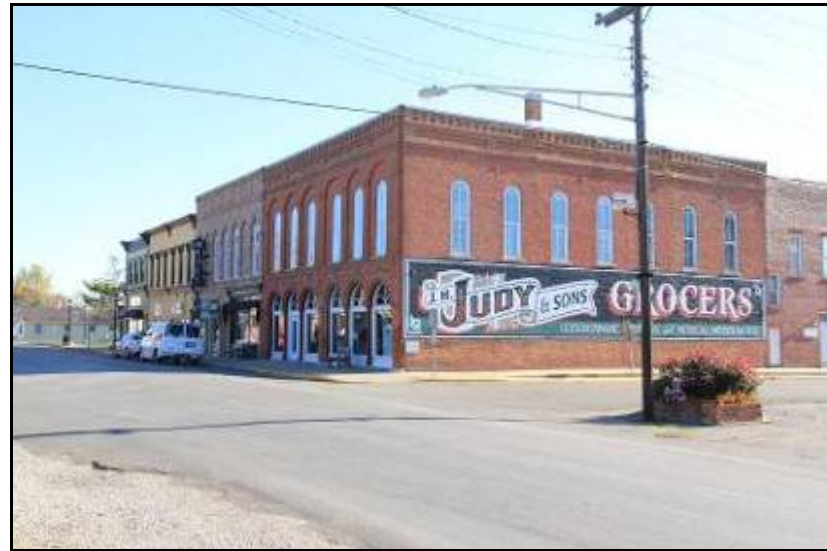
Sequence Number	Map Code	1994/95 Negative #	Address/Location	Type	Date Built	Historic Function	1994/95 Comments	2012/13 Comments and Photo Image #
168	03/18	03/18, IMG_1851	110 Arch St., ATLANTA	3	Ca. Late 19 th , Early 20 th Century	Commercial	Entire business block with commercial vernacular structures, several of which have prominent cornices.	Several buildings have been rehabilitated, one of which includes Atlanta's RT 66 museum. IMG_1365

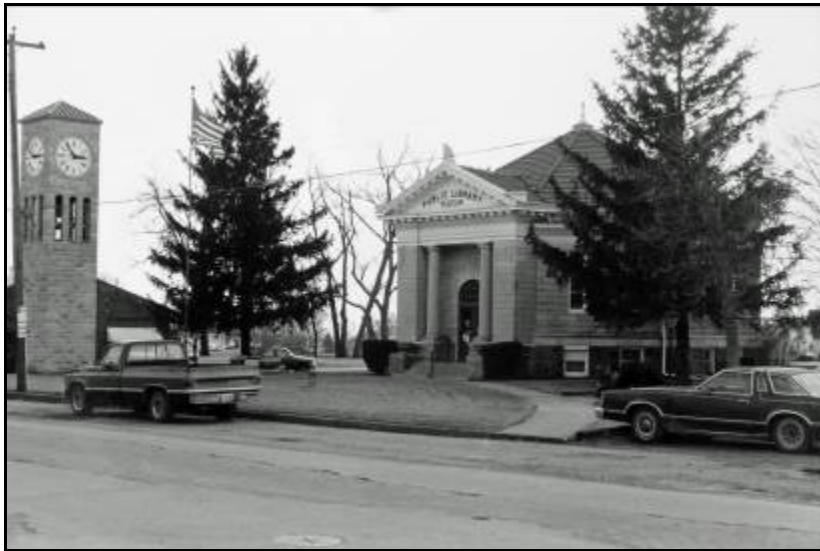
Sequence Number	Map Code	1994/95 Negative #	Address/Location	Type	Date Built	Historic Function	1994/95 Comments	2012/13 Comments and Photo Image #
169	03/19	03/19, 21, IMG_1852	Arch St. & Race (W corner), ATLANTA	3	Ca. 1910	Library	Octagonal library built of dressed/quarried stone with classical, fully pedimented entrance; see Waldmire Post Card for more information.	The library remains and is little changed. IMG_1366

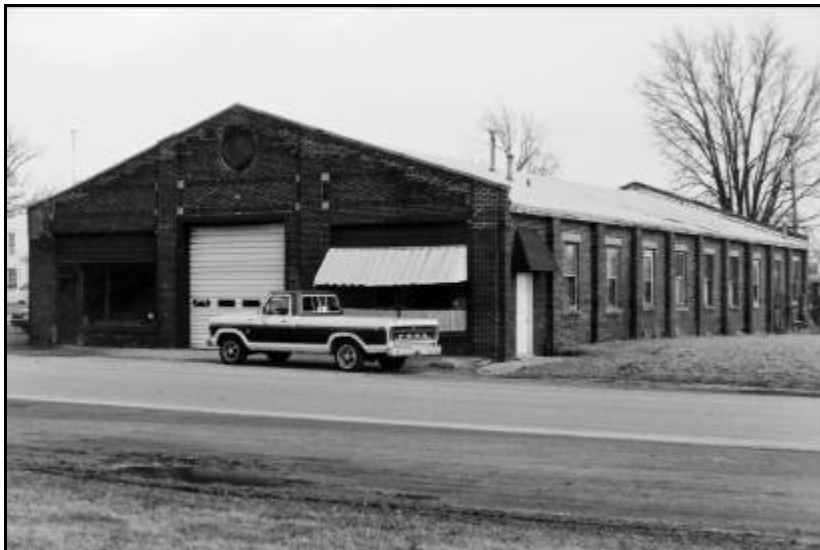
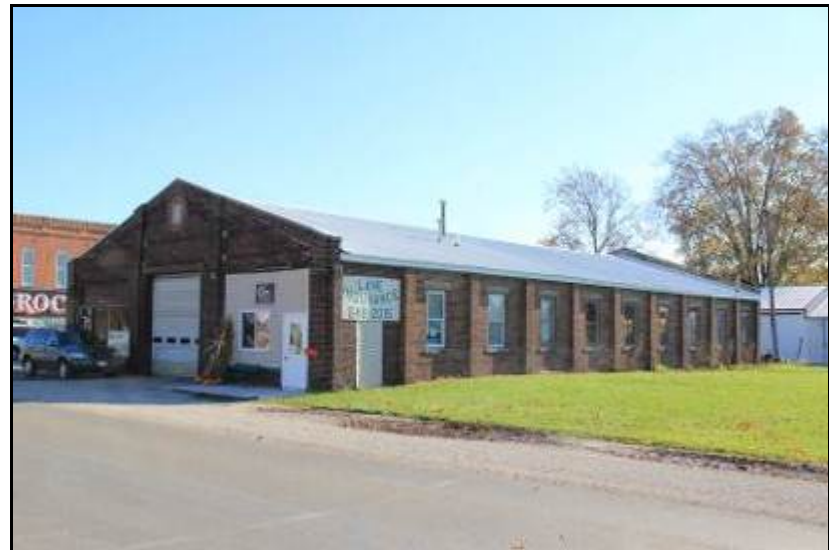
Sequence Number	Map Code	1994/95 Negative #	Address/Location	Type	Date Built	Historic Function	1994/95 Comments	2012/13 Comments and Photo Image #
170	03/20	03/20, IMG_1853	Arch St. & Race (S corner), ATLANTA	2	Ca. 1920s-30s	Auto Garage	Brick structure with shallow, gabled roof and parapets with what appears to be concrete coping.	Some changes have occurred to this structure, including the infilling of the right, front window. IMG_1371

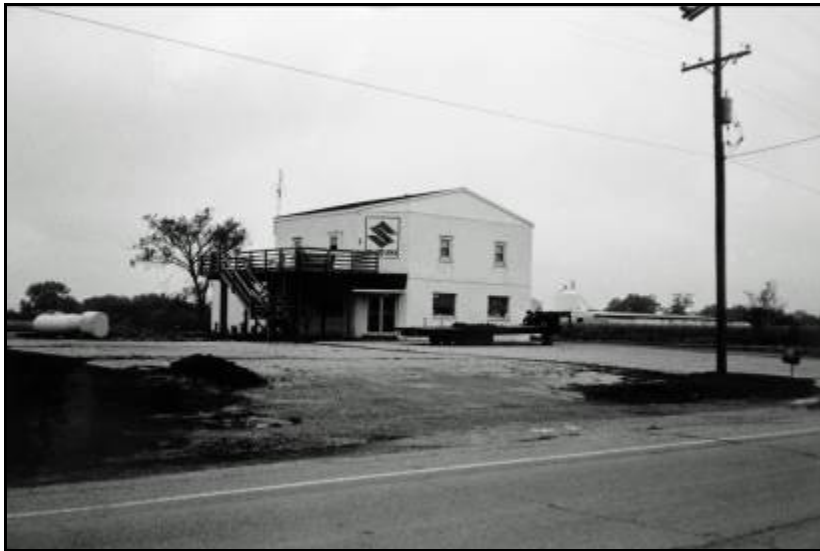
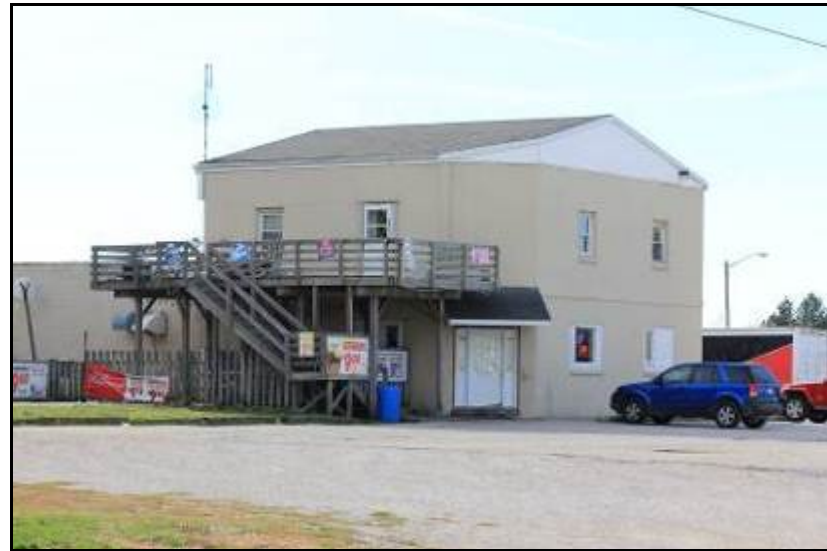
Sequence Number	Map Code	1994/95 Negative #	Address/Location	Type	Date Built	Historic Function	1994/95 Comments	2012/13 Comments and Photo Image #
171	21/13	21/13, IMG_1854	Bypass 66 & Atlanta Rd. (SW corner), ATLANTA	2	Ca. 1950s	Gas/Diesel Truck Stop (?)	Possible old gas and/or diesel (truck) stop of concrete blocks with two stories and (add-on?) shallow, gabled roof – large, concrete apron remains around building.	Minor changes have been made to this building since 1994, including the installation of a new door in the canted corner. Subsequently found to be a former RT 66-related restaurant. IMG_1469

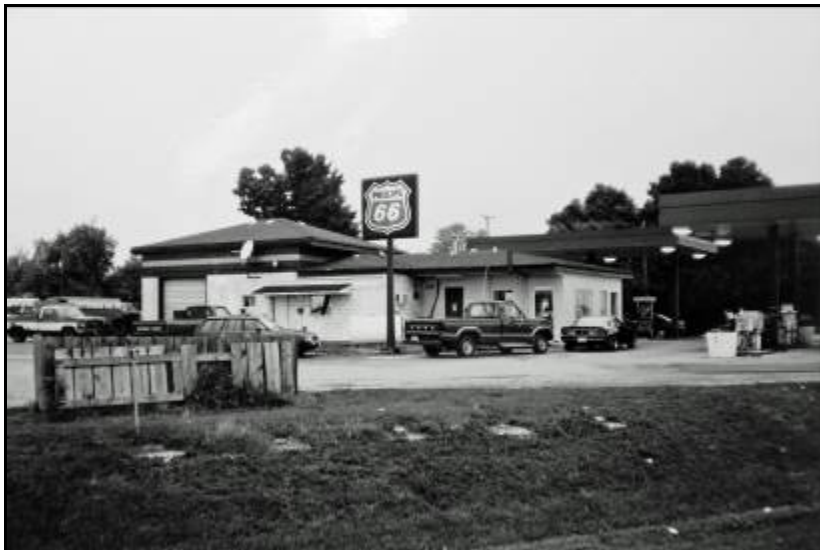
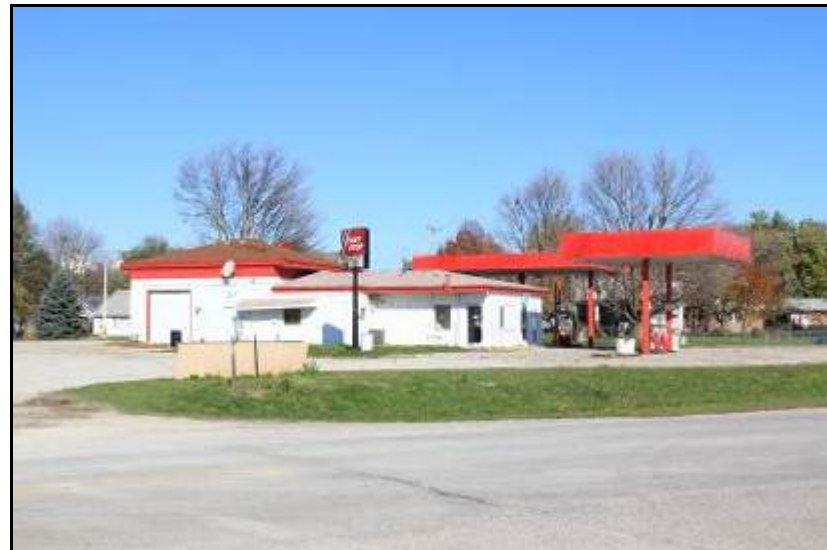
Sequence Number	Map Code	1994/95 Negative #	Address/Location	Type	Date Built	Historic Function	1994/95 Comments	2012/13 Comments and Photo Image #
172	21/14	21/14, IMG_1855	Bypass 66 & CR 6 (SW corner), ATLANTA	2	Ca. 1950s	Gas/Service	Despite modern updates, this concrete block, hip roof structure looks like it may originally date to 1950s or 60s – “Phillips 66” station.	Nominal changes have been made to this station, including the covering of at least one window, which is now closed. IMG_1372

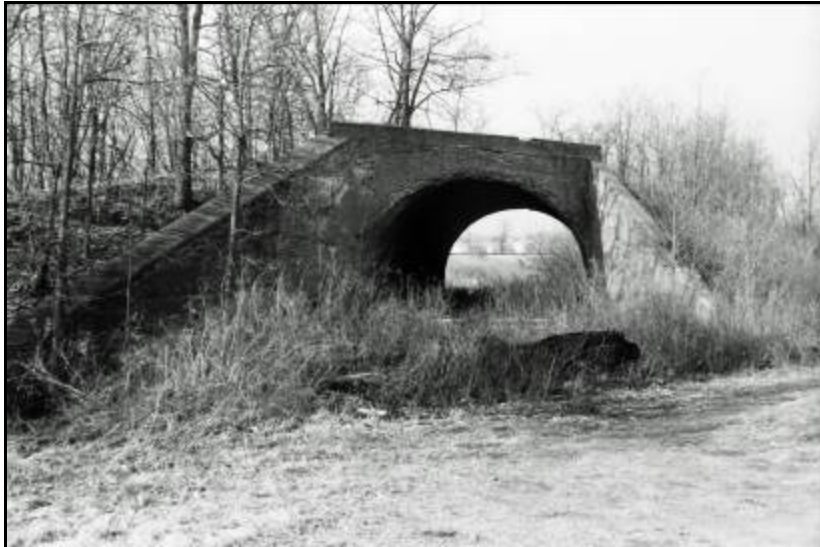
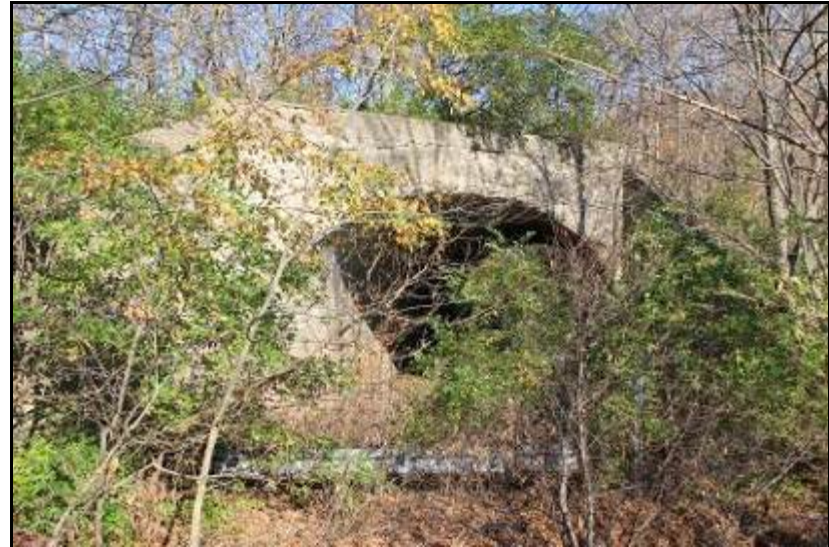
Sequence Number	Map Code	1994/95 Negative #	Address/Location	Type	Date Built	Historic Function	1994/95 Comments	2012/13 Comments and Photo Image #
173	03/22	03/22, IMG_1856	Old 66 & Rd. 2250N	3	Unknown	RR Overpass	Old, round-arched, concrete railroad overpass – abandoned.	The old railroad facility is a bit more overgrown. IMG_1373

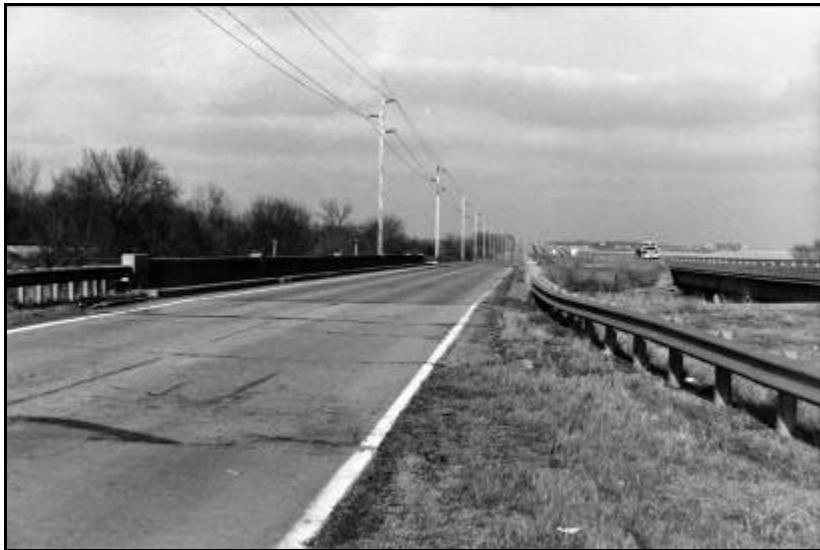
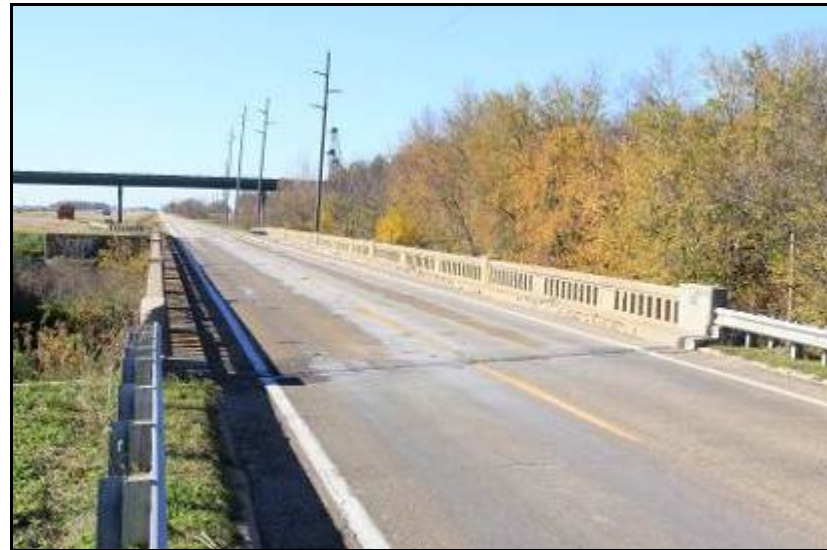
Sequence Number	Map Code	1994/95 Negative #	Address/Location	Type	Date Built	Historic Function	1994/95 Comments	2012/13 Comments and Photo Image #
174	03/23	03/23-25, 12/06-07, IMG_1857	Old 66 over Kickapoo Creek	1	1954	Bridge	One structure remains; no bridge # noted – plate states: Station 281+96.09(2), Built 1954 by, State of Illinois, F.A. Rt. 5 Sec. 21 R.B.2, F.A. Proje. F1026(48), loading H20-S16; five-span structure with arched, concrete beams.	The bridge remains and is little changed (2012 view is to the SW). IMG_1374

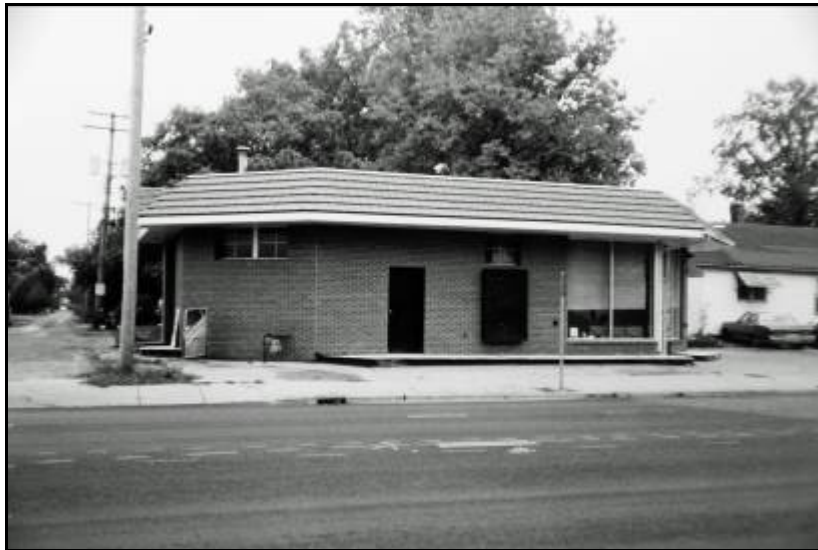
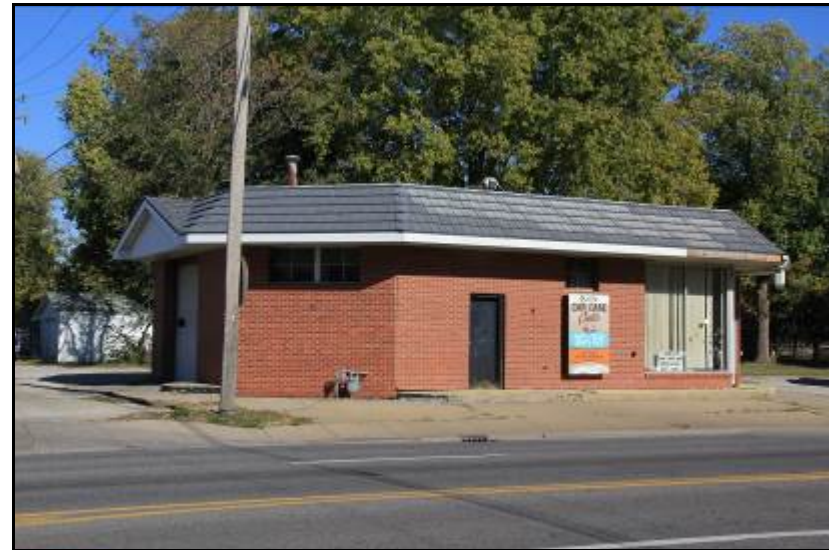
Sequence Number	Map Code	1994/95 Negative #	Address/Location	Type	Date Built	Historic Function	1994/95 Comments	2012/13 Comments and Photo Image #
175	21/15	21/15, IMG_4559	Kickapoo St. & Keokuk St. (N corner)	2	Ca. 1960s-70s	Gas/Service	Brick gas station with plastic/fiberglass shingles.	Few consequential changes appear to have been made to this circa 1960s/70s gas station, which now houses a car care service. IMG_4056

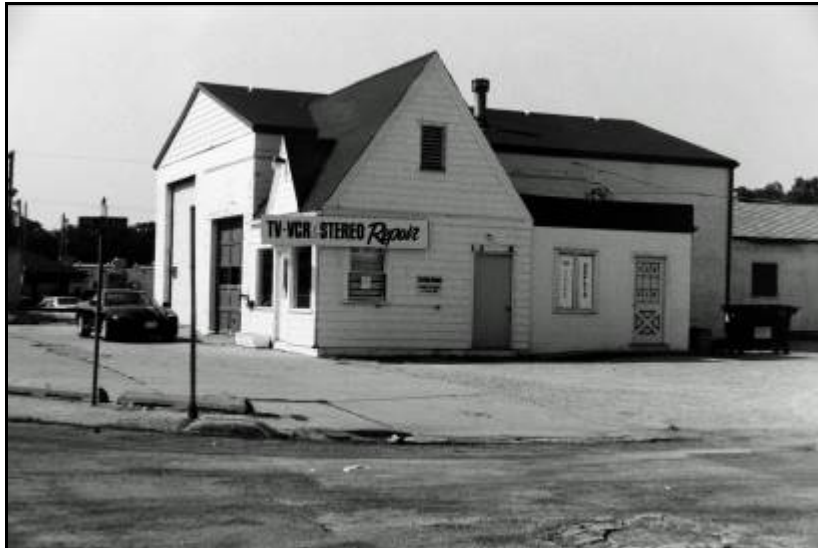
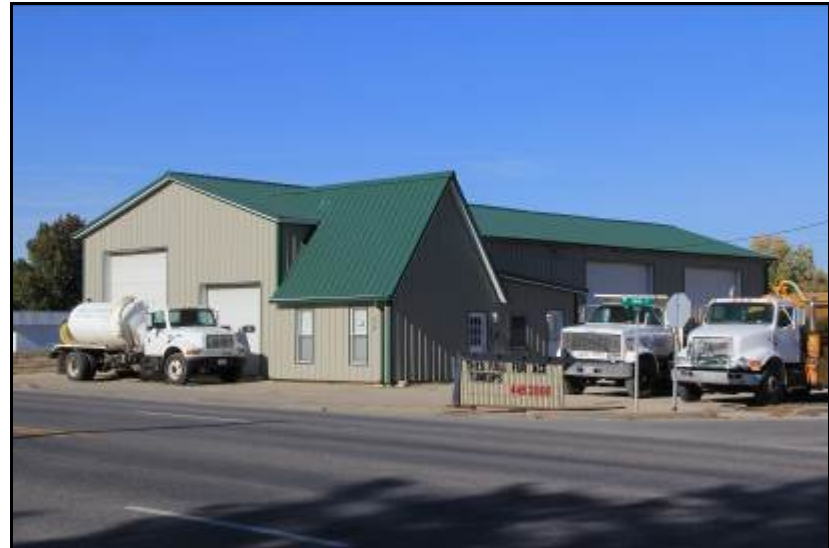
Sequence Number	Map Code	1994/95 Negative #	Address/Location	Type	Date Built	Historic Function	1994/95 Comments	2012/13 Comments and Photo Image #
176	17/35	17/35-36, IMG_4560	620 Keokuk St.	2	Ca. 1930s-40s	Gas/Service	Domestic-type gas station with wide, (aluminum?) siding and service garage additions.	Dramatic changes to this historic-period gas station/garage building include a complete resheathing with metal siding and the loss of the gable dormer over the gas station entry-way, as well as the loss of the doorway itself. IMG_4057

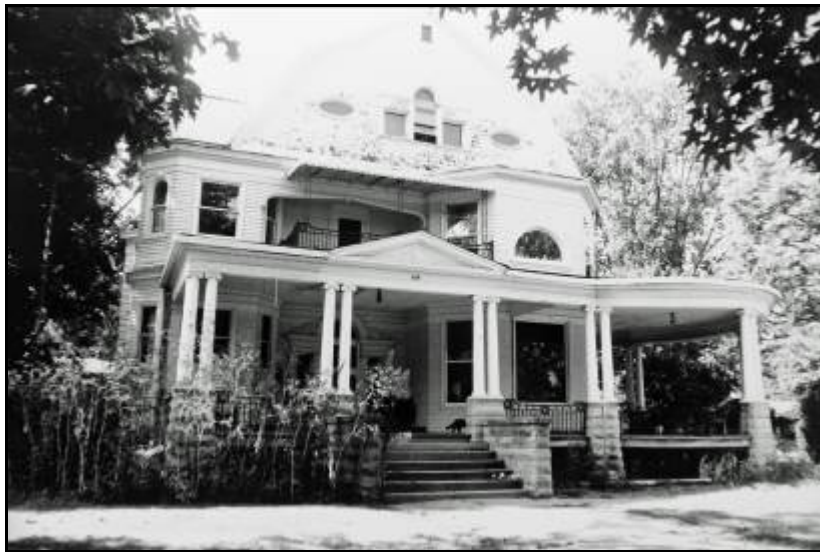
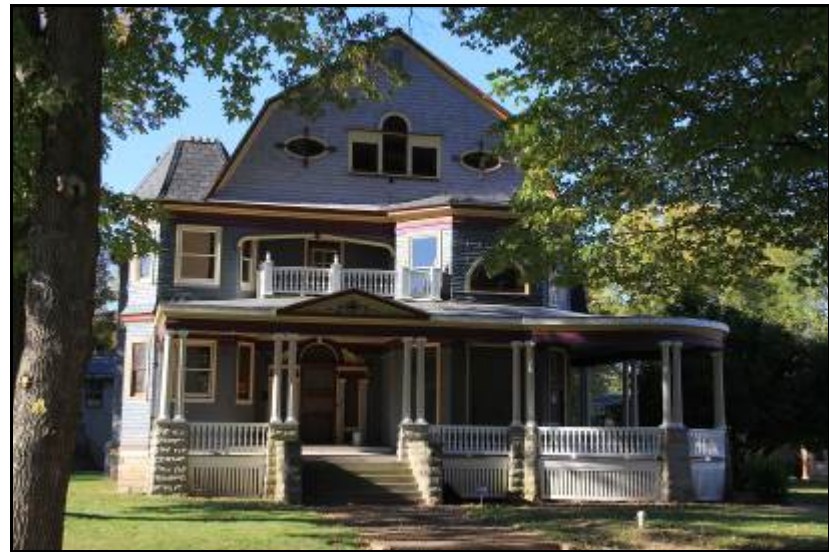
Sequence Number	Map Code	1994/95 Negative #	Address/Location	Type	Date Built	Historic Function	1994/95 Comments	2012/13 Comments and Photo Image #
177	18/01	18/01, IMG_4561	325 Logan St.	3	Ca. Late 19 th , Early 20 th Century	Residential	Queen Anne house, 2.5 stories with impressive, wrap-around porch with dentilled frieze.	This prominent Queen Anne house appears to be well maintained and cared for. IMG_4058

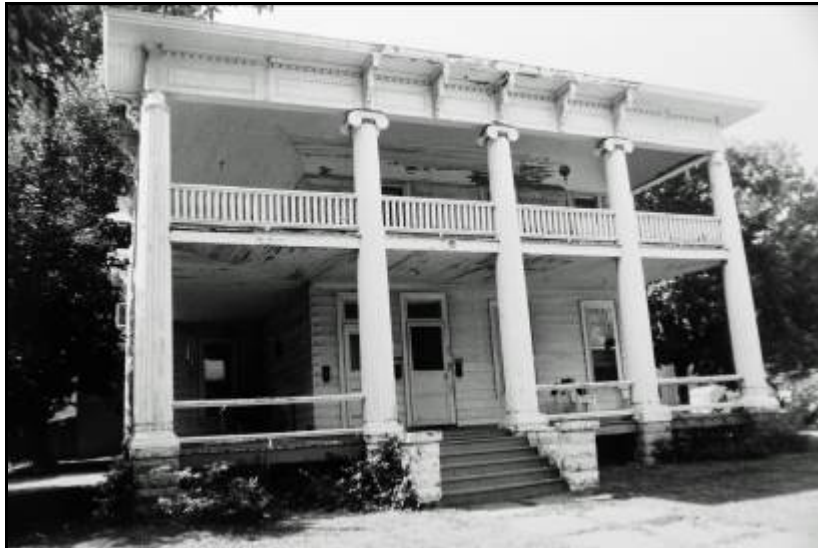
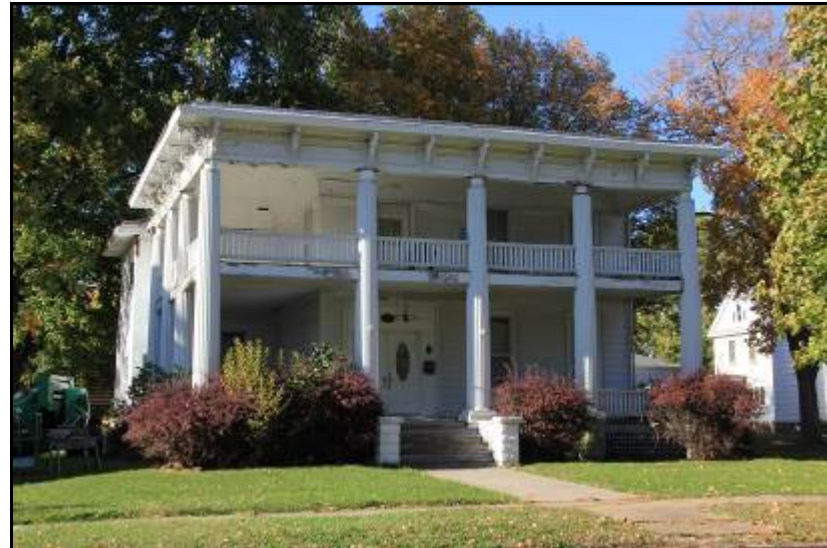
Sequence Number	Map Code	1994/95 Negative #	Address/Location	Type	Date Built	Historic Function	1994/95 Comments	2012/13 Comments and Photo Image #
178	18/02	18/02, IMG_4562	229 Logan St.	3	Ca. Late 19 th , Early 20 th Century	Residential	Classical Revival with prominent, two-level, open porch supported by five fluted columns, also has eave brackets and wide, dentilled frieze.	Although a new, main entryway door has been installed since the 1990s, and despite the loss of the Ionic Order column capitals, this prominent, Classical Revival house appears to be rather well maintained. IMG_4059

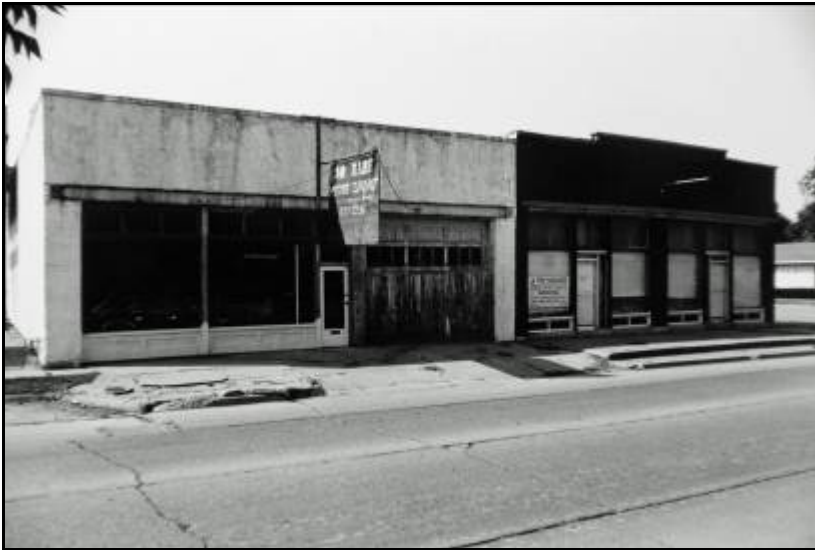
Sequence Number	Map Code	1994/95 Negative #	Address/Location	Type	Date Built	Historic Function	1994/95 Comments	2012/13 Comments and Photo Image #
179	18/03	18/03, IMG_4563	115 Logan St.	2	Ca. 1930s-40s	Auto Service	This combination concrete veneer/brick-sheathed structure could well have been an auto service garage at one time.	This building combination appears to have been removed.

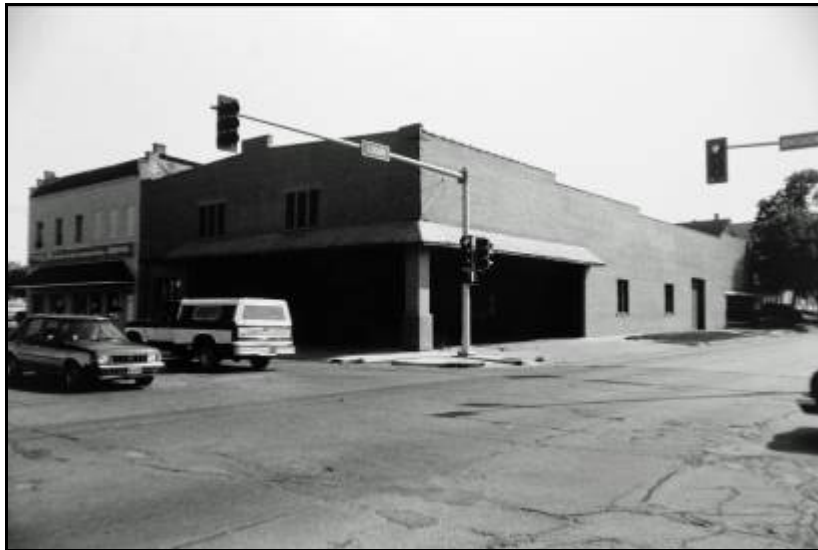
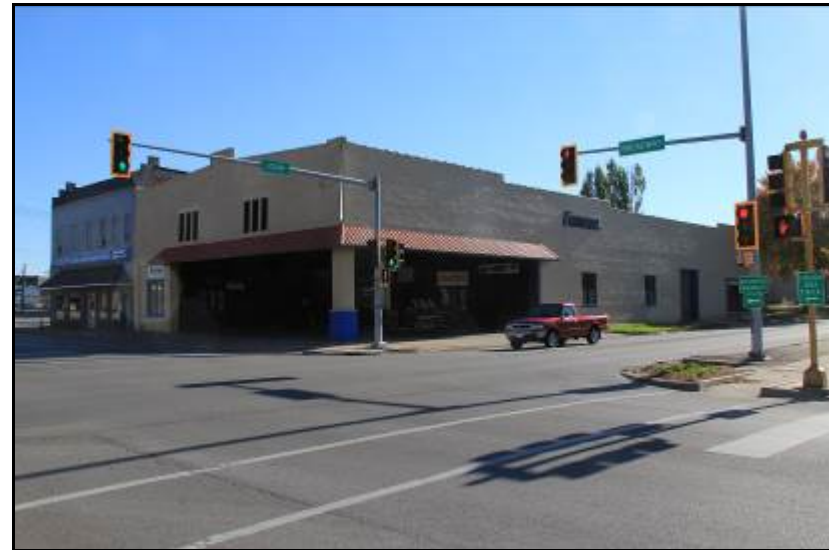
Sequence Number	Map Code	1994/95 Negative #	Address/Location	Type	Date Built	Historic Function	1994/95 Comments	2012/13 Comments and Photo Image #
180	18/04	18/04, IMG_4564	401 Broadway St.	2	Ca. 1930s-40s	Auto Dealer (?)	Two-story, brick structure with parapets and recessed, angular drive-through on the ground level; likely once served as a gas and service station or a car dealer.	The old automobile-related building remains with few apparent changes. IMG_4060

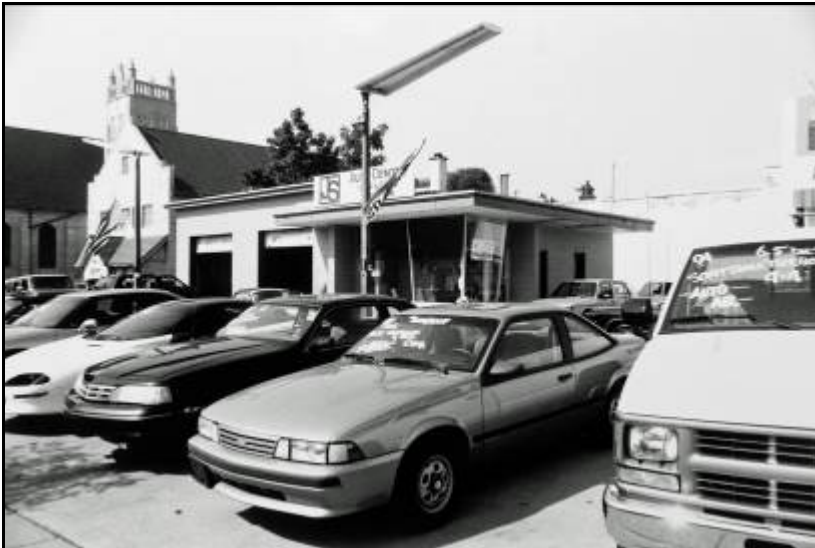
Sequence Number	Map Code	1994/95 Negative #	Address/Location	Type	Date Built	Historic Function	1994/95 Comments	2012/13 Comments and Photo Image #
181	18/05	18/05, IMG_4565	Broadway St. & Logan St.	2	Ca. 1960s	Gas/Service	Concrete block gas station and service garage.	Used for auto sales in the 1990s, this building has been removed.

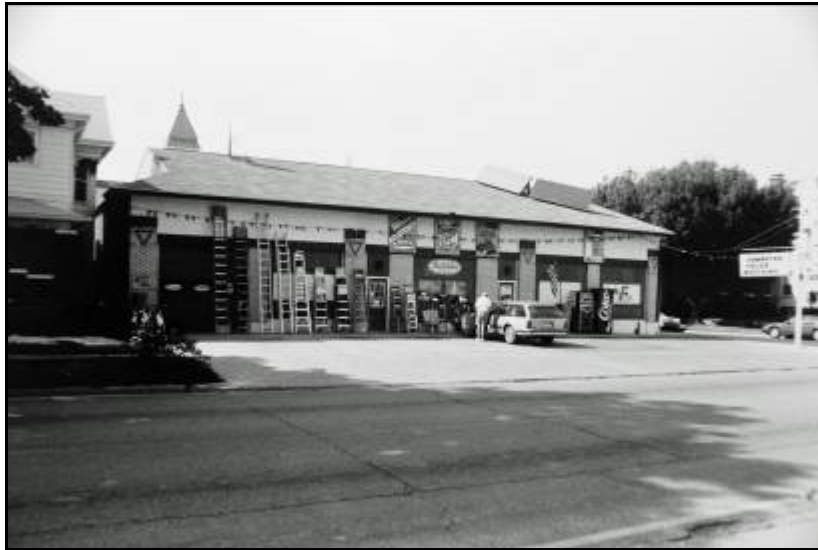
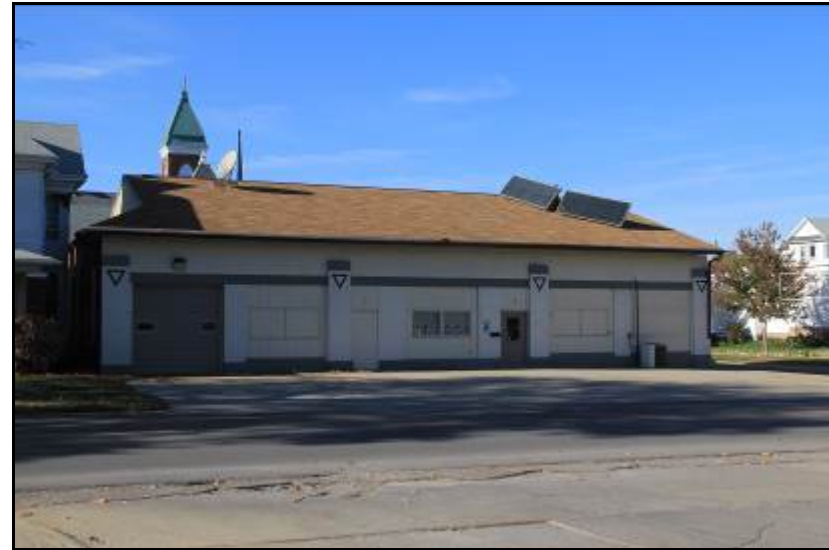
Sequence Number	Map Code	1994/95 Negative #	Address/Location	Type	Date Built	Historic Function	1994/95 Comments	2012/13 Comments and Photo Image #
182	18/06	18/06, IMG_4566	Logan St. & Pulaski St.	2	Unknown	Gas/Service (?)	This brick structure <u>may</u> have once served as a gas and service station.	The current use of this former auto service building is unclear. Some doors have been replaced and windows covered. IMG_4061

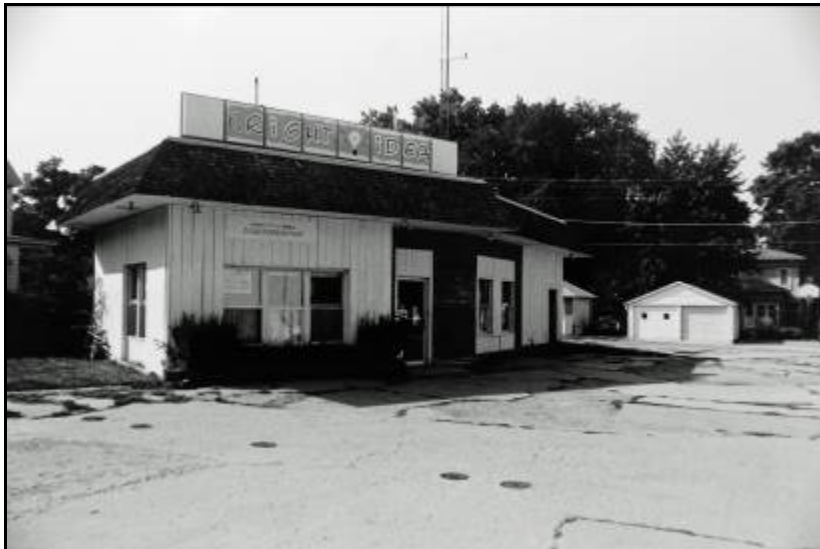
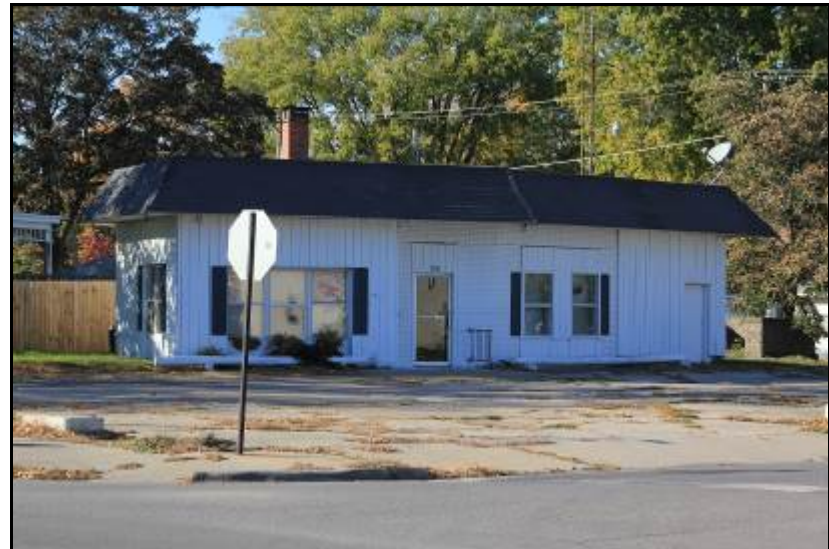
Sequence Number	Map Code	1994/95 Negative #	Address/Location	Type	Date Built	Historic Function	1994/95 Comments	2012/13 Comments and Photo Image #
183	18/07	18/07, IMG_4567	106 S. Union St.	2	Ca. 1960s	Gas/Service	Brick and frame structure — looks as if it may once have been a gas station.	Perhaps a former gas station, this building appears to be vacant. IMG_4062

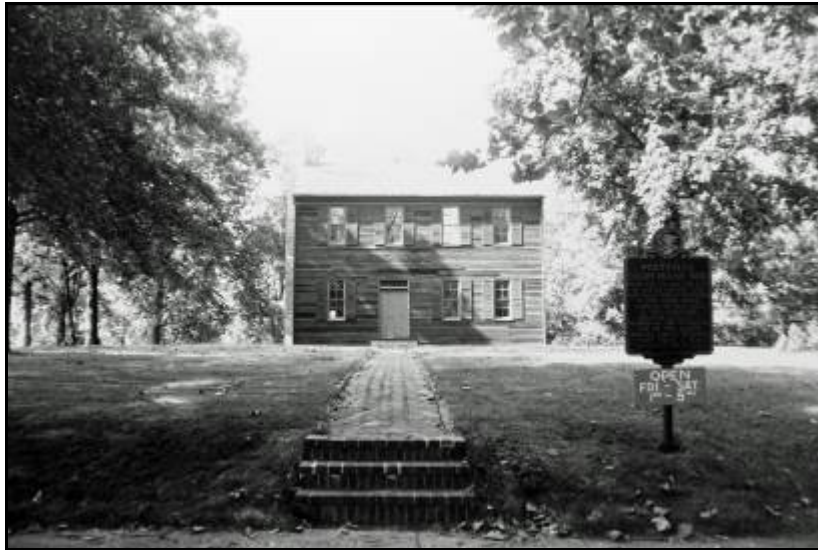
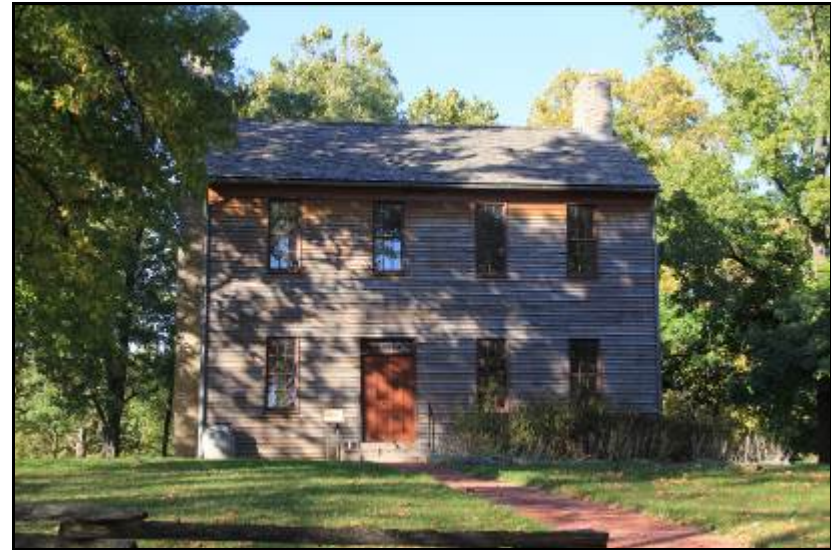
Sequence Number	Map Code	1994/95 Negative #	Address/Location	Type	Date Built	Historic Function	1994/95 Comments	2012/13 Comments and Photo Image #
184	18/08	18/08, IMG_4568	5 th St. & Madison St.	3	Unknown	Museum	Reconstruction of the “Postville Court House,” a State Historic Site – “Deskins Tavern” Historic Marker immediately across Fifth St.	This building appears to be largely unchanged. IMG_4063

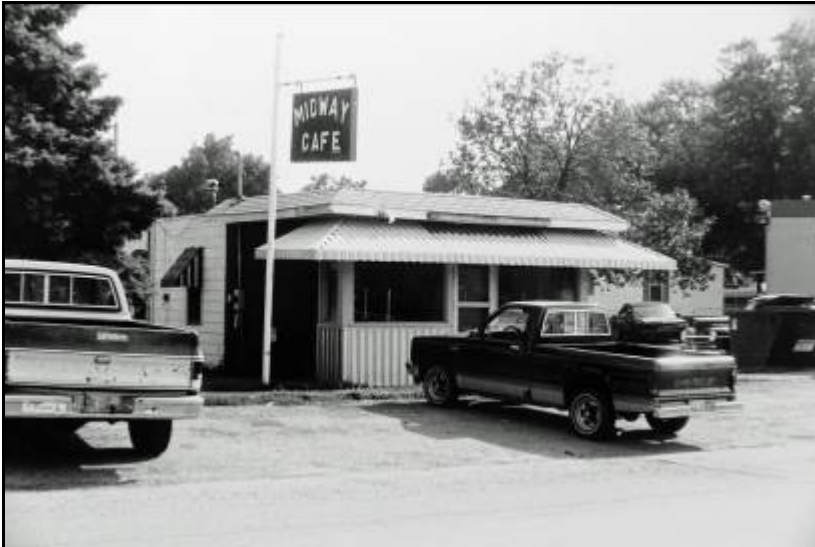
Sequence Number	Map Code	1994/95 Negative #	Address/Location	Type	Date Built	Historic Function	1994/95 Comments	2012/13 Comments and Photo Image #
185	18/09	18/09, IMG_4569	5 th St. & Jefferson St.	2	Ca. 1940s-50s	Café	Small café with mixture of siding materials – “Midway Café.”	This diner has been removed.
