Route 66 in Illinois:

(2012/13 Update and Expansion of the Original 1994/95 Survey)

IDOT Sequence #17337 & #17337A

22 December 2013

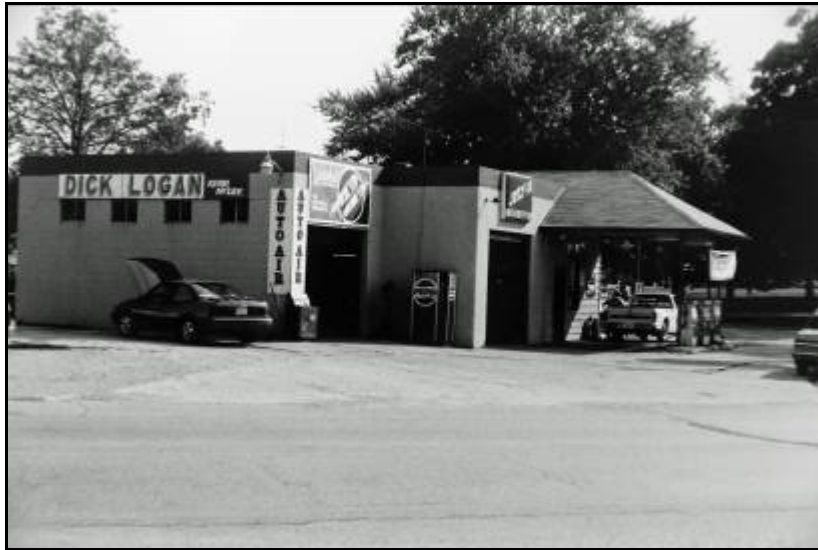
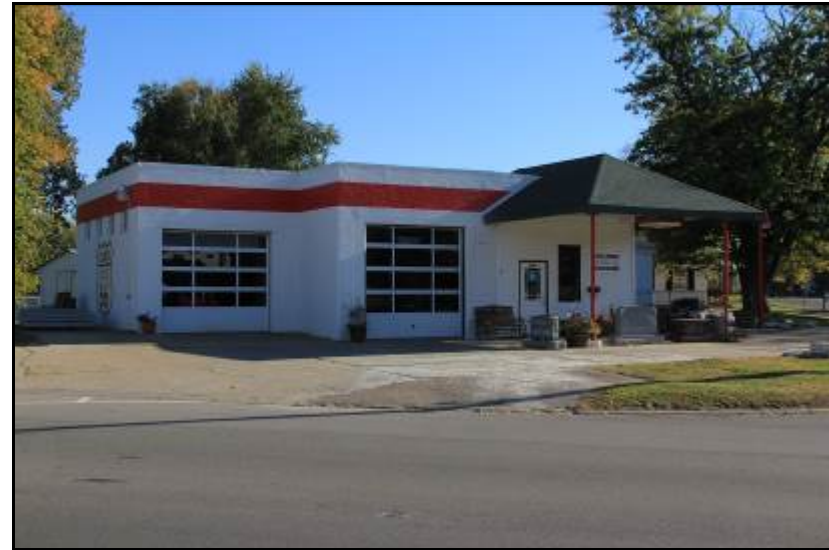
Sequence Number	Map Code	1994/95 Negative #	Address/Location	Type	Date Built	Historic Function	1994/95 Comments	2012/13 Comments and Photo Image #
186	18/10	18/10, IMG_4570	5 th St. & Washington St.	2	Ca. 1950s-60s	Gas/Service	Combination concrete block and frame gas station.	Although painted, this former gas station appears to now be used as a memorial monument shop venue. IMG_4065

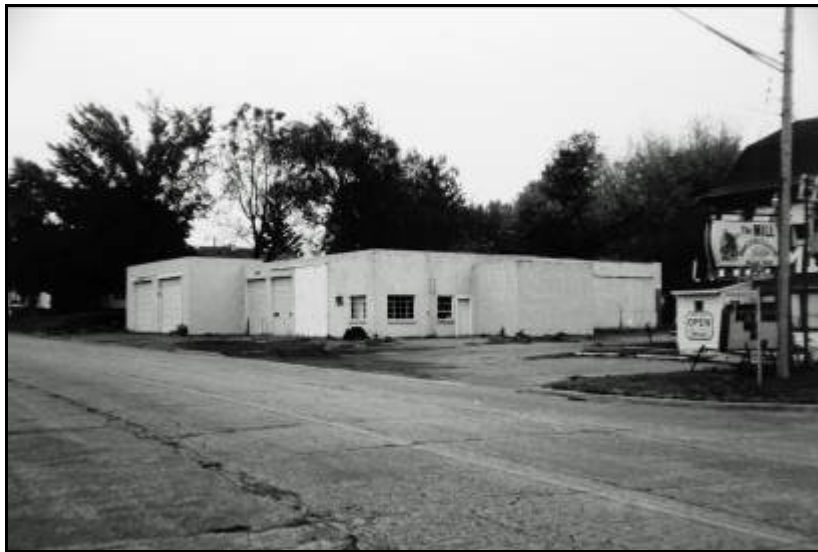
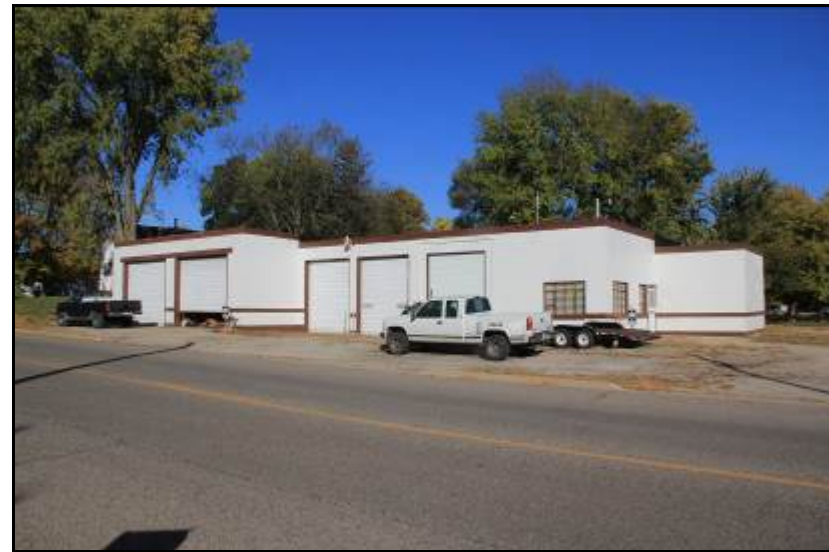
Sequence Number	Map Code	1994/95 Negative #	Address/Location	Type	Date Built	Historic Function	1994/95 Comments	2012/13 Comments and Photo Image #
187	21/17	21/17, IMG_4571	Washington St. & 2 nd St. (SE corner)	2	Ca. 1950s	Auto Service (?)	Concrete block garage – may have been an auto repair business, or perhaps some type of unrelated, corporate garage.	Aside from being cleaned up and painted, there appear to be few, if any, changes of consequence to this garage complex. IMG_4067

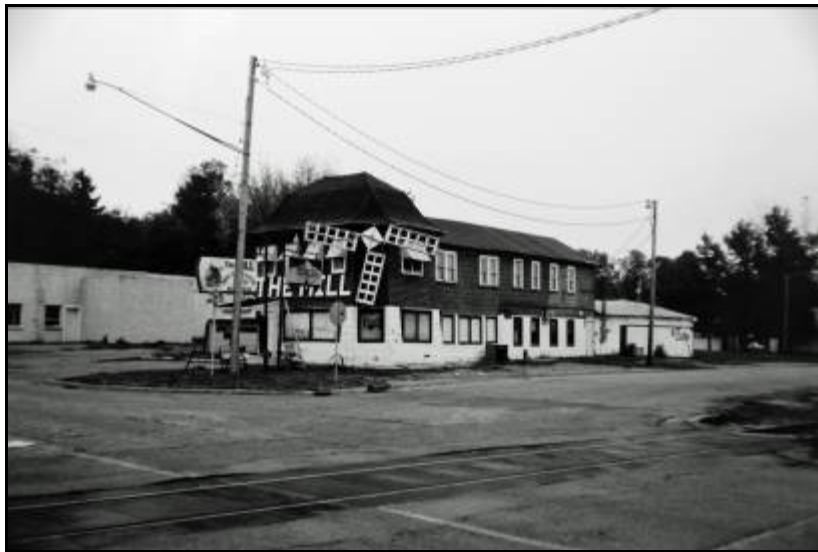
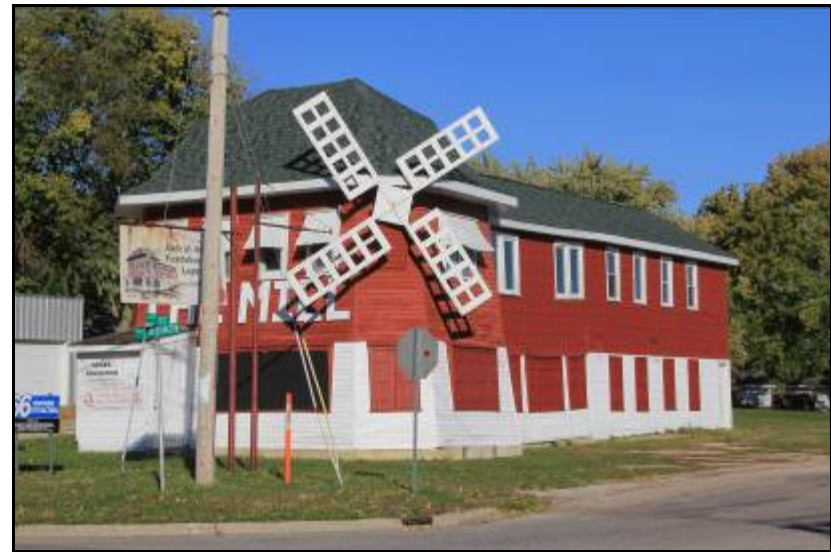
Sequence Number	Map Code	1994/95 Negative #	Address/Location	Type	Date Built	Historic Function	1994/95 Comments	2012/13 Comments and Photo Image #
188	21/16	21/16, IMG_4572	Washington St. & 1 st St. (NE corner)	2	Ca. 1930s	Restaurant	Two-story building with windmill front, with combination asbestos and clapboard siding.	The windmill remains today, little changed – although some windows have been (temporarily?) covered. There are apparent attempts being made to raise money for restoration. IMG_4068

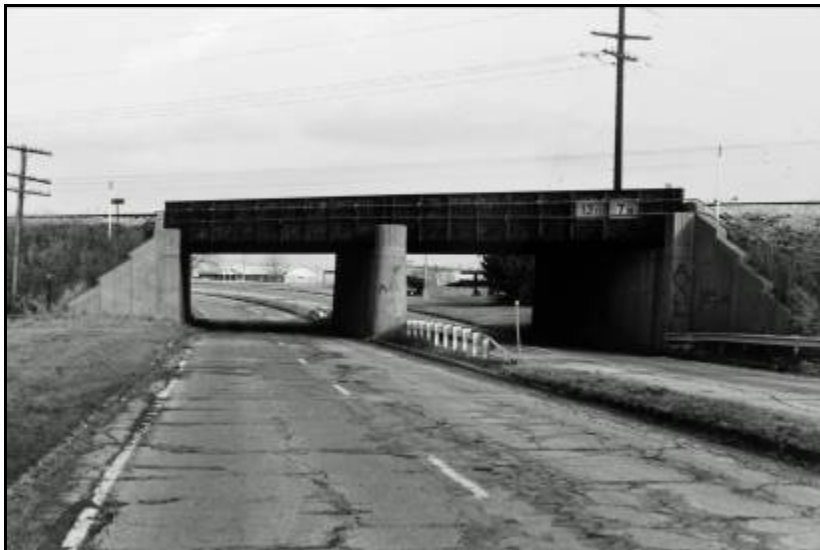
Sequence Number	Map Code	1994/95 Negative #	Address/Location	Type	Date Built	Historic Function	1994/95 Comments	2012/13 Comments and Photo Image #
189	04/01	04/01-02, 12/08, IMG_1858	Old 66 & RR tracks (N side of town)	2	Unknown	RR Overpass	Two abutment, one pier structure; no date or plate available.	No changes appear to have been made to this structure. IMG_1376

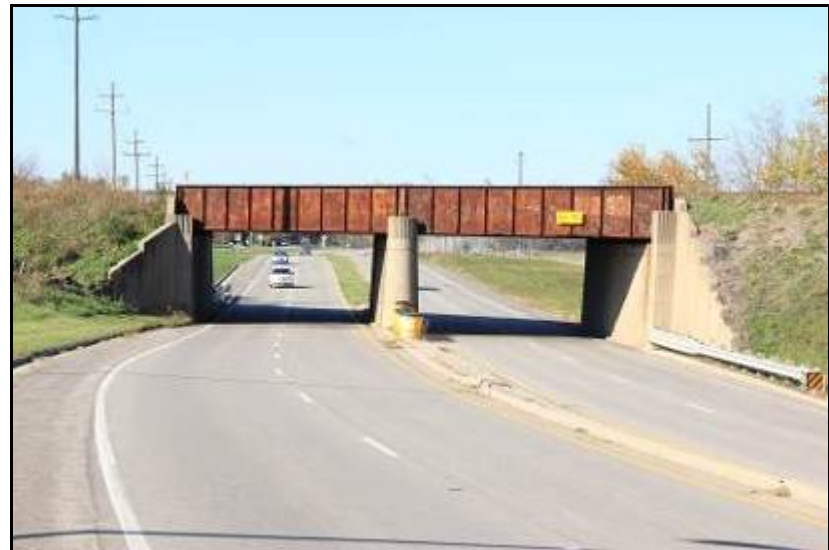
Sequence Number	Map Code	1994/95 Negative #	Address/Location	Type	Date Built	Historic Function	1994/95 Comments	2012/13 Comments and Photo Image #
190	04/03	04/03, 12/09-10, IMG_1859	Old 66 & RR tracks	1	Unknown	Bridge	Built as one structure: Bridge #054-0006 – no plate noted; four-lane, five-span structure with “T” beam-supported deck.	Bridge replaced in 1997.

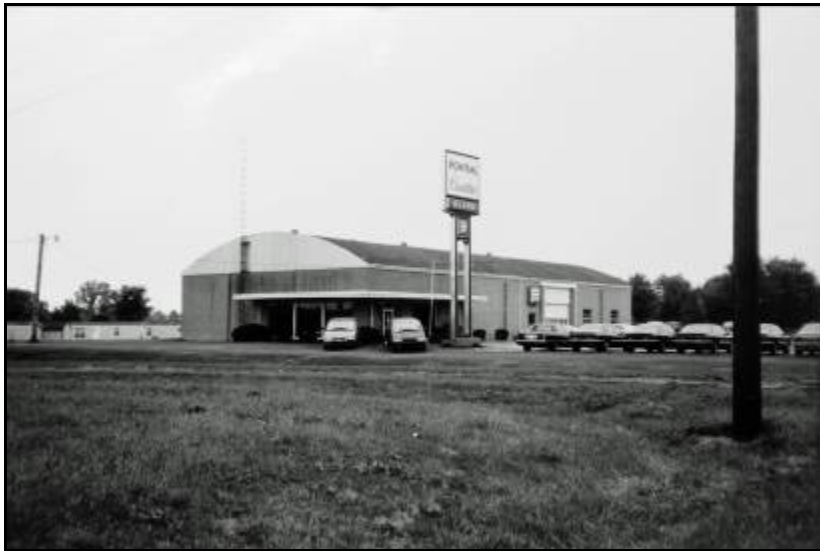
Sequence Number	Map Code	1994/95 Negative #	Address/Location	Type	Date Built	Historic Function	1994/95 Comments	2012/13 Comments and Photo Image #
191	21/18	21/18, IMG_1860	Old 66 & Postville Rd.	2	Ca. 1950s	Auto Dealer	Concrete block and brick auto dealership with arched roof.	This old "Pontiac" dealership is now home to a paramedic operation. Note the new front windows in arched gable, and the three, garage door addition to the rear. IMG_1378

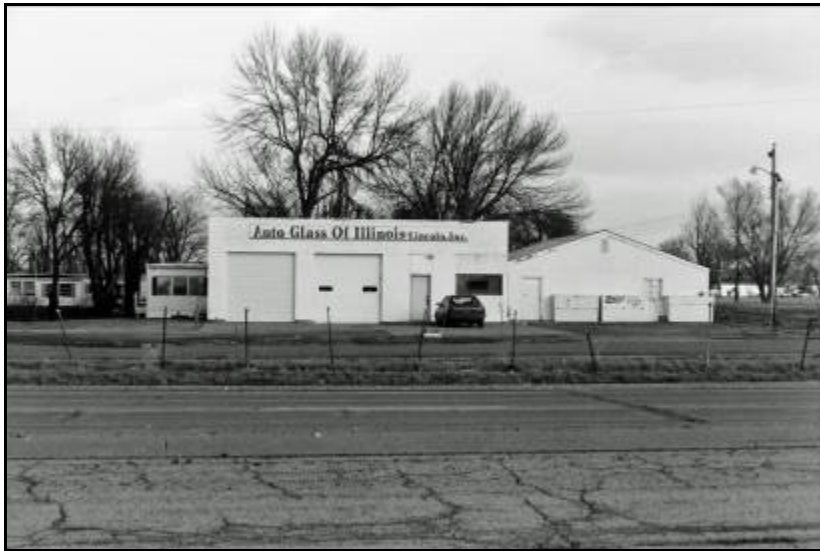
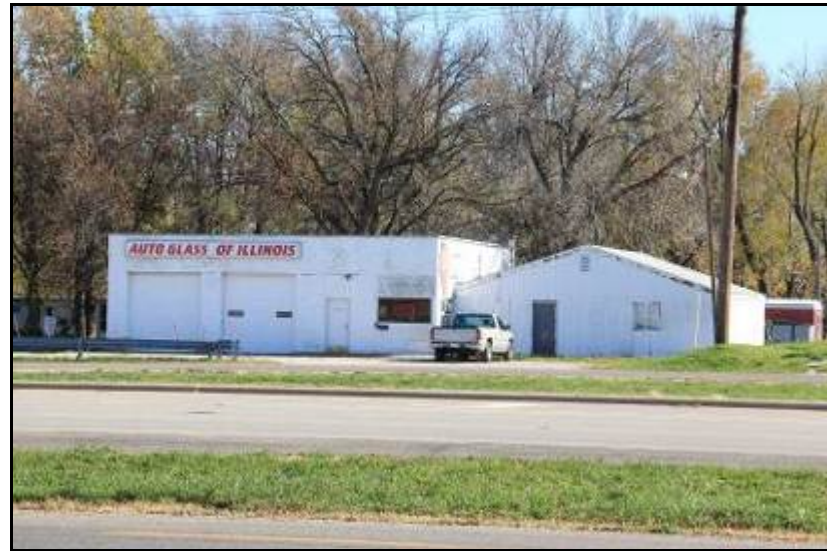
Sequence Number	Map Code	1994/95 Negative #	Address/Location	Type	Date Built	Historic Function	1994/95 Comments	2012/13 Comments and Photo Image #
192	04/04	04/04, IMG_1861	Old 66 & Postville Rd.	2	Ca. 1950s	Gas/Service	Very plain, concrete block gas station.	Other than the change in signage, there are no readily observable alterations to this building. IMG_1379

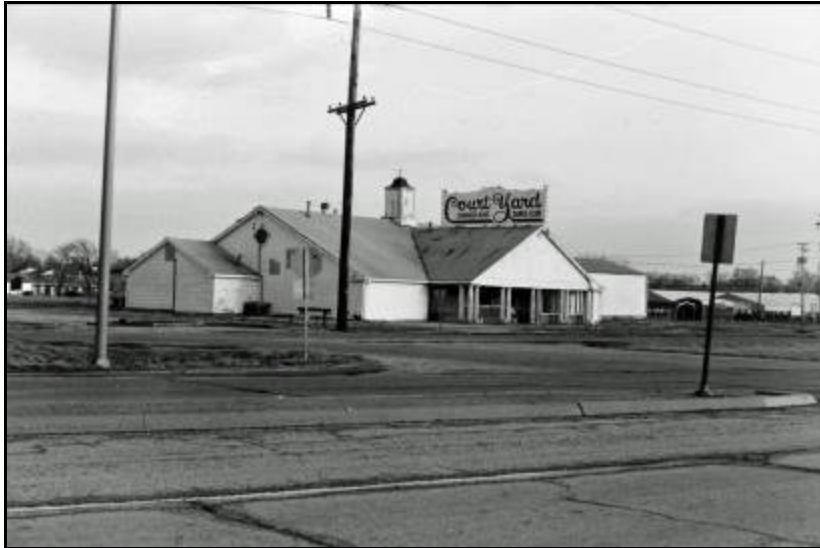
Sequence Number	Map Code	1994/95 Negative #	Address/Location	Type	Date Built	Historic Function	1994/95 Comments	2012/13 Comments and Photo Image #
193	04/05	04/05, IMG_1862	Old 66 & Postville Rd.	2	Ca. 1950s (?)	Ballroom	Large, generally brick structure with gabled roof; could well date to the RT 66 period – “Court Yard Dinner and Dance Club.”	Structure is now gone.

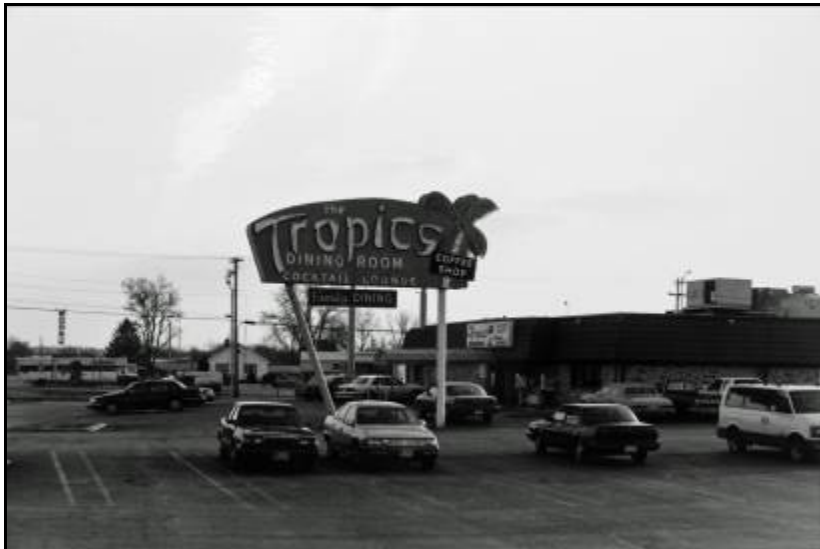
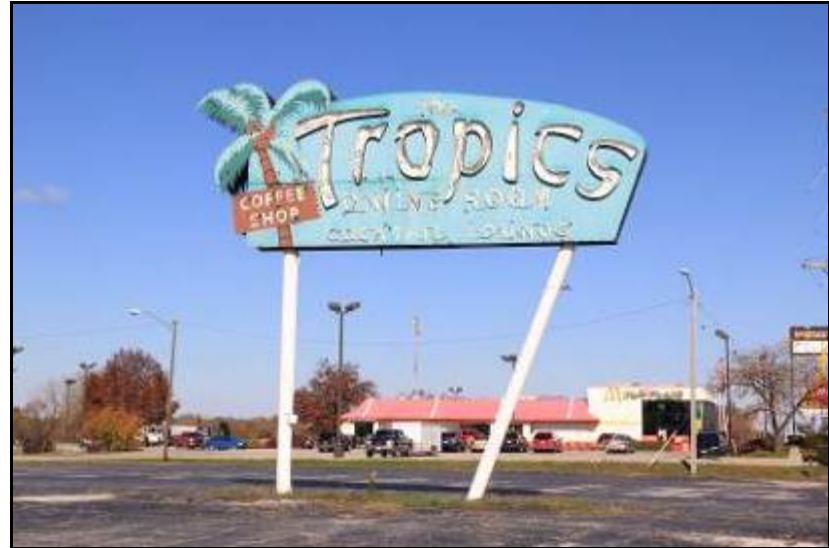
Sequence Number	Map Code	1994/95 Negative #	Address/Location	Type	Date Built	Historic Function	1994/95 Comments	2012/13 Comments and Photo Image #
194	04/06	04/06, IMG_1863	Old 66 & IL 10 (NW corner)	2	Ca. 1950s	Restaurant	"Tropics" restaurant building is a new structure, but the neon sign dates to the 1950s.	The restaurant is now closed and vacant. The prominent "Tropics" sign, however, remains. IMG_1380

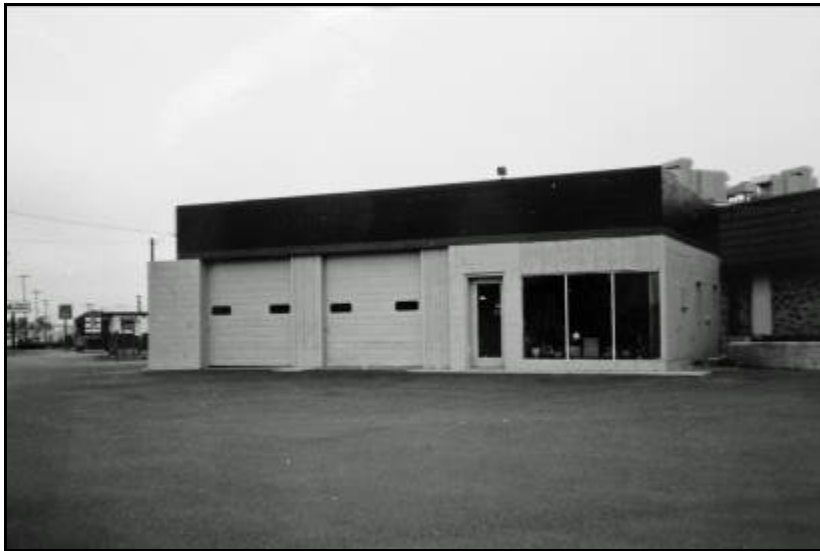
Sequence Number	Map Code	1994/95 Negative #	Address/Location	Type	Date Built	Historic Function	1994/95 Comments	2012/13 Comments and Photo Image #
195	21/19	21/19, IMG_1864	Old 66 & Woodlawn Dr. (NW corner)	2	Ca. 1960s	Gas/Service	Simple, concrete block station with some vertical board siding – vacant.	Structure now gone. Replaced by a new, cell telephone store.

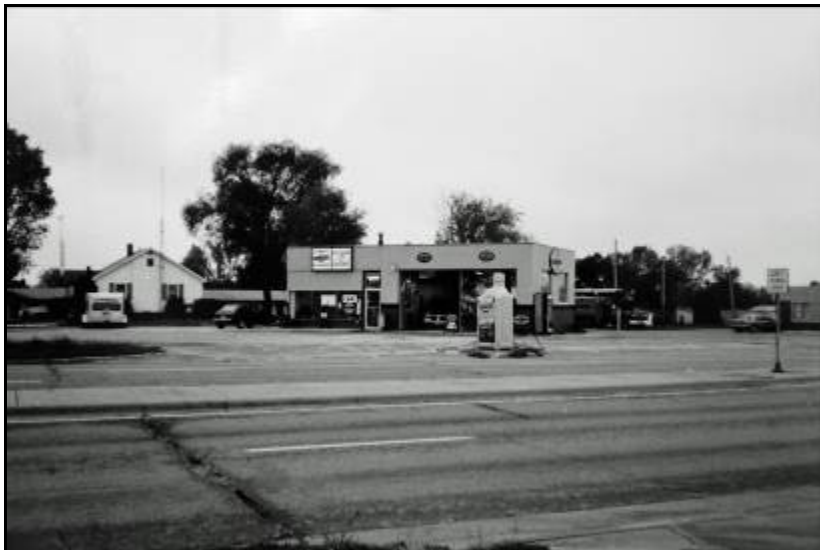
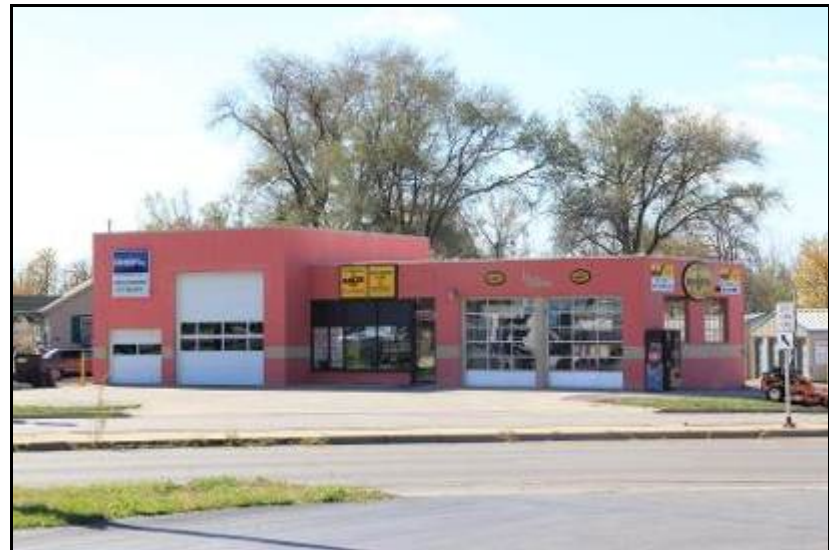
Sequence Number	Map Code	1994/95 Negative #	Address/Location	Type	Date Built	Historic Function	1994/95 Comments	2012/13 Comments and Photo Image #
196	21/20	21/20, IMG_1865	Old 66 & Woodlawn Dr. (SW corner)	2	Ca. 1950s	Gas/Service	Concrete veneer building with somewhat rounded corners (vague reference to Moderne style?)	In addition to a new paint scheme, an addition with two overhead garage doors has been built to the left. IMG_1381

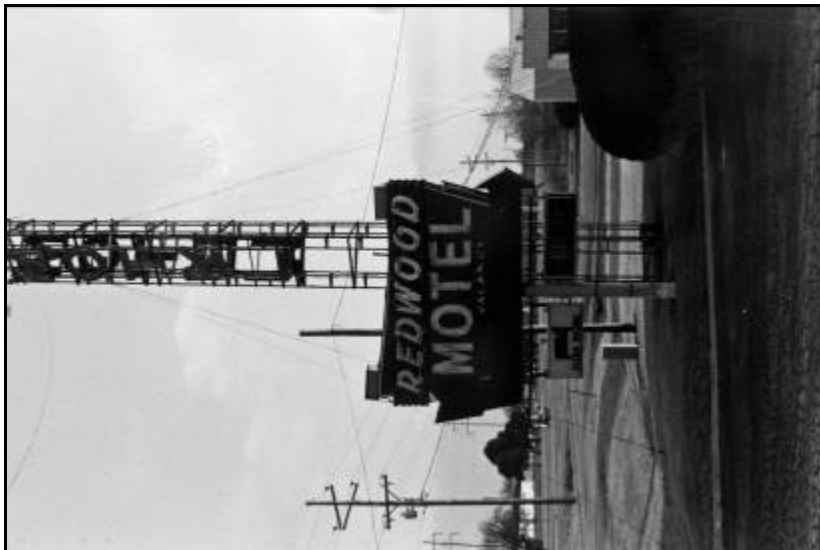
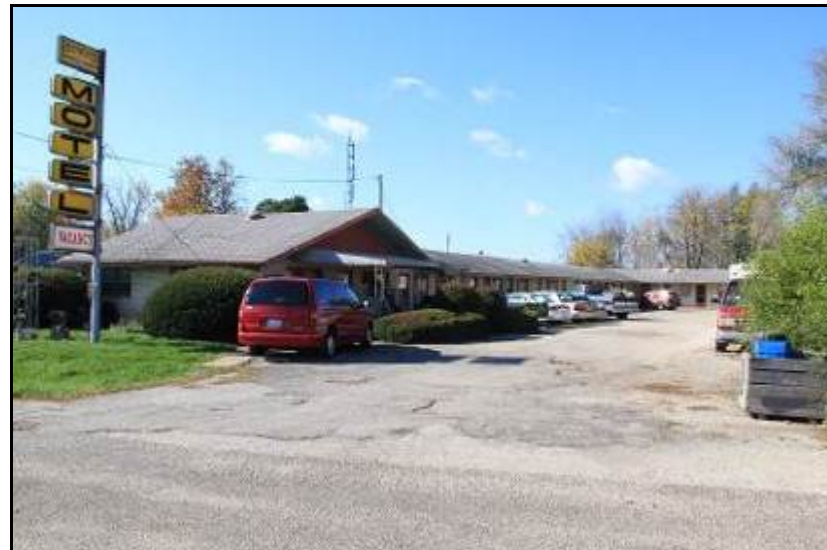
Sequence Number	Map Code	1994/95 Negative #	Address/Location	Type	Date Built	Historic Function	1994/95 Comments	2012/13 Comments and Photo Image #
197	04/07	04/07, 21/21, IMG_1866	Old 66 & IL 20 (SW corner)	2	Ca. 1956	Motel	Single-story, brick motel with shallow gables and "L" shape – note "Redwood Motel" sign.	The "Redwood Motel" remains today, though with a new sign on the street. IMG_1382

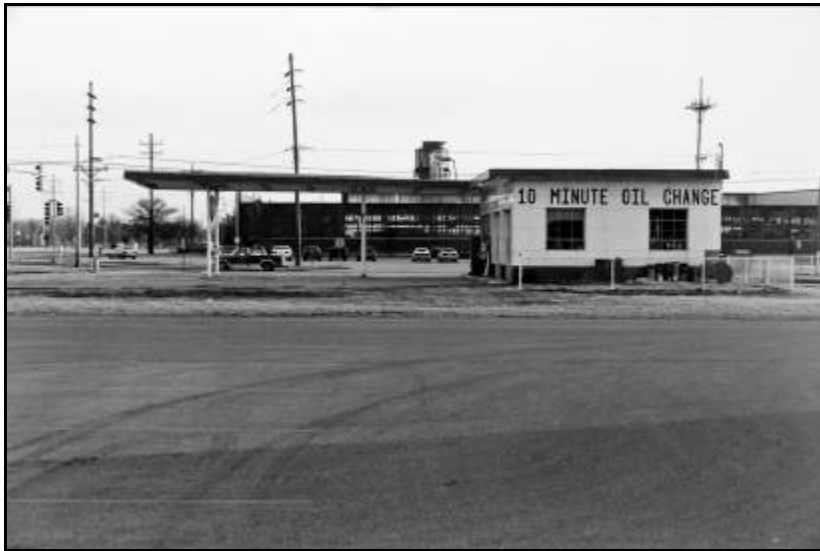
Sequence Number	Map Code	1994/95 Negative #	Address/Location	Type	Date Built	Historic Function	1994/95 Comments	2012/13 Comments and Photo Image #
198	04/08	04/08, IMG_1867	Old 66 & IL 20 (S of intersection)	2	Ca. 1950s	Gas/Service	Gas station sheathed with enamel panels with prominent, attached canopy.	Structure now gone.

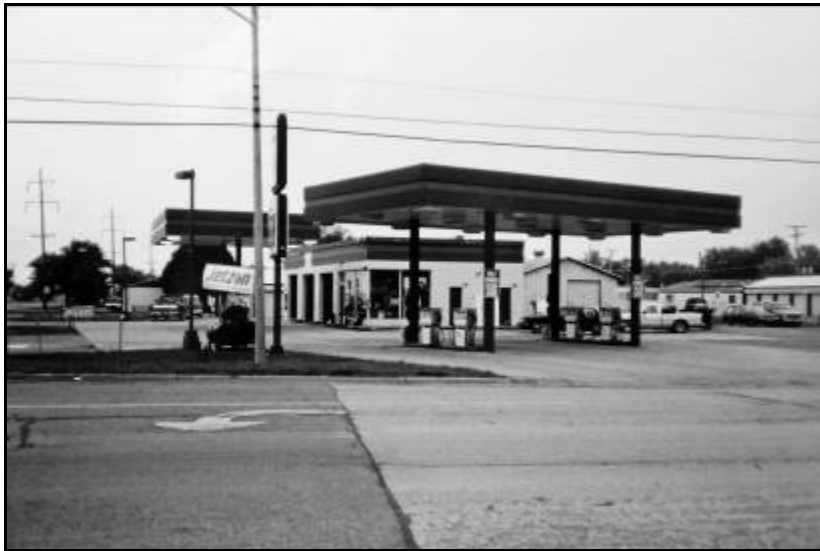
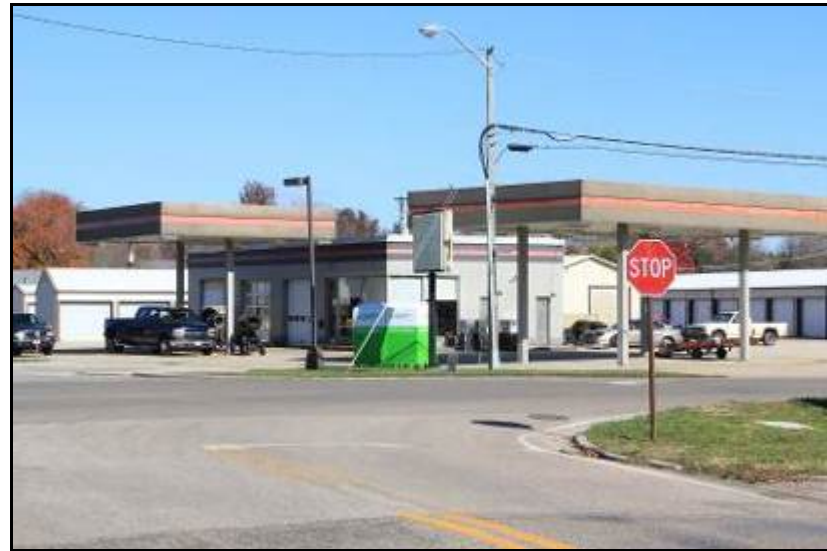
Sequence Number	Map Code	1994/95 Negative #	Address/Location	Type	Date Built	Historic Function	1994/95 Comments	2012/13 Comments and Photo Image #
199	21/22	21/22, IMG_1868	Old 66 & 5 th St. (NE corner)	2	Ca. 1950s	Gas/Service	Gas station sheathed with enamel panels (?), concrete block addition and modern canopies.	The station remains with some changes, including the removal of gas pumps. IMG_1383

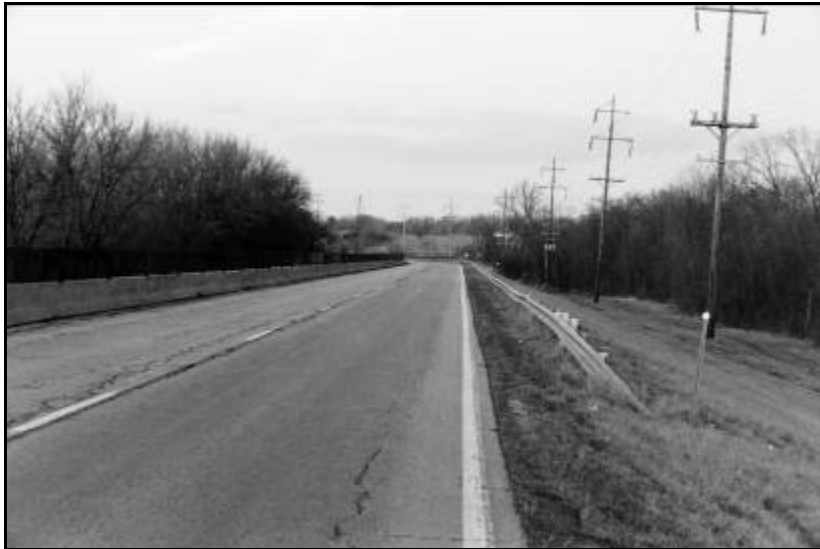
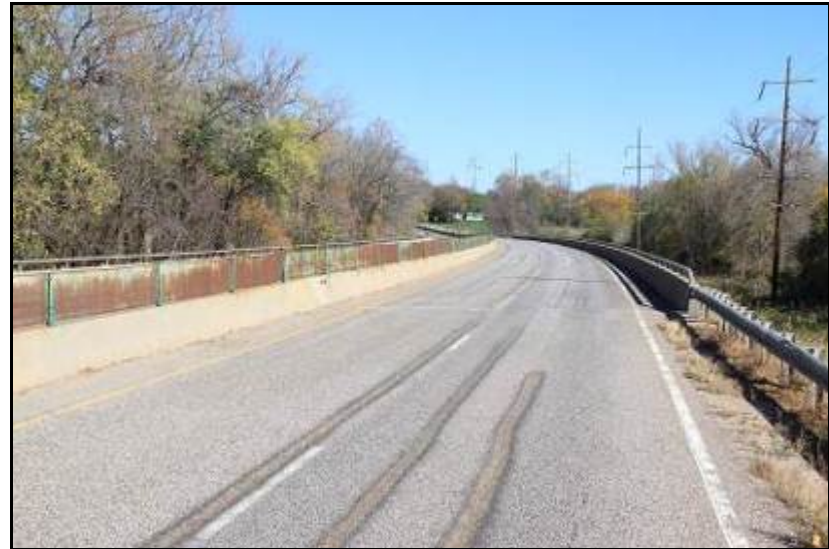
Sequence Number	Map Code	1994/95 Negative #	Address/Location	Type	Date Built	Historic Function	1994/95 Comments	2012/13 Comments and Photo Image #
200	04/09	04/09, IMG_1869	Old 66 over Salt Creek	1	1975	Bridge	Built as one structure: Bridge #054/0005 – plate notes: Station 99+46.00, Rebuilt 1975 by, State of Illinois, F.A. Rt. 5 Sec. 23 BR, Loading HS-20; multiple-span structure carries four lanes and has a modern “T” beam-supported deck.	This bridge remains with few, if any, changes. IMG_1384

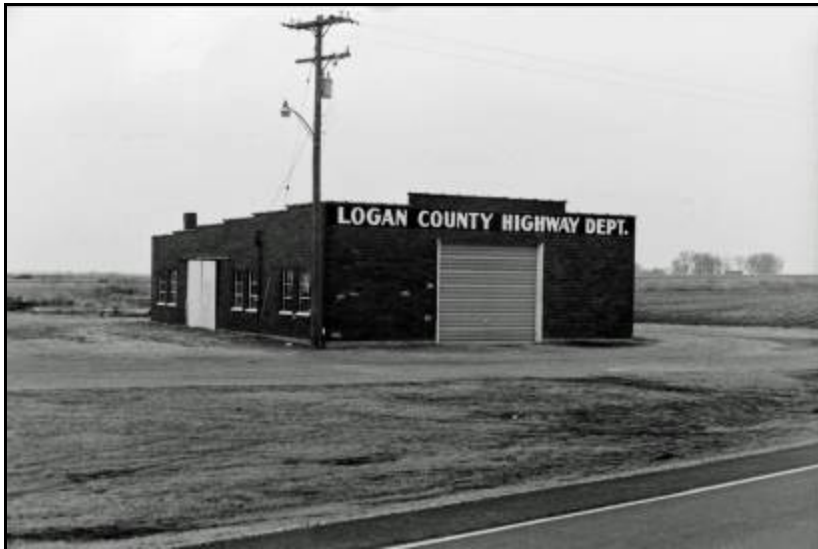
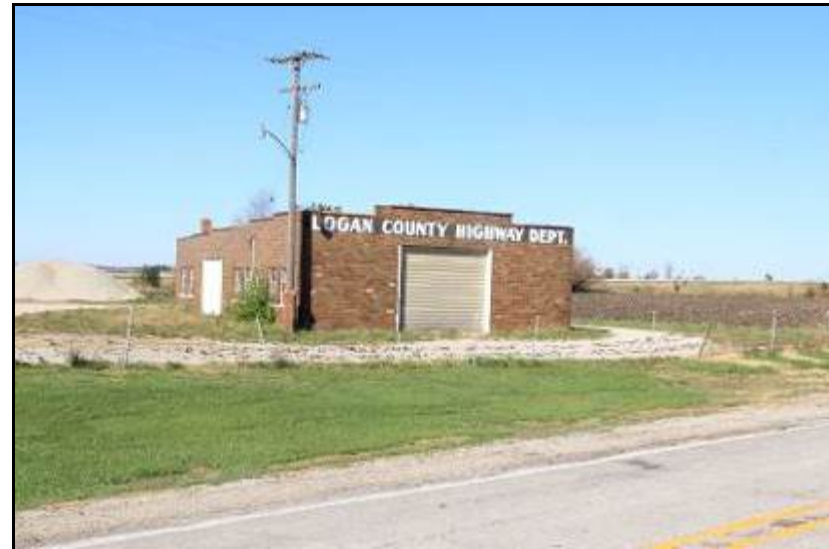
Sequence Number	Map Code	1994/95 Negative #	Address/Location	Type	Date Built	Historic Function	1994/95 Comments	2012/13 Comments and Photo Image #
201	05/11	05/11, IMG_1870	Old 66 & Rd. 800E (N end of BROADWELL)	2	Ca. 1930s-40s	Highway Service	Brick structure with stepped parapets with rounded coping – “Logan County Highway Dept.”	Structure remains with no apparent changes. IMG_1386

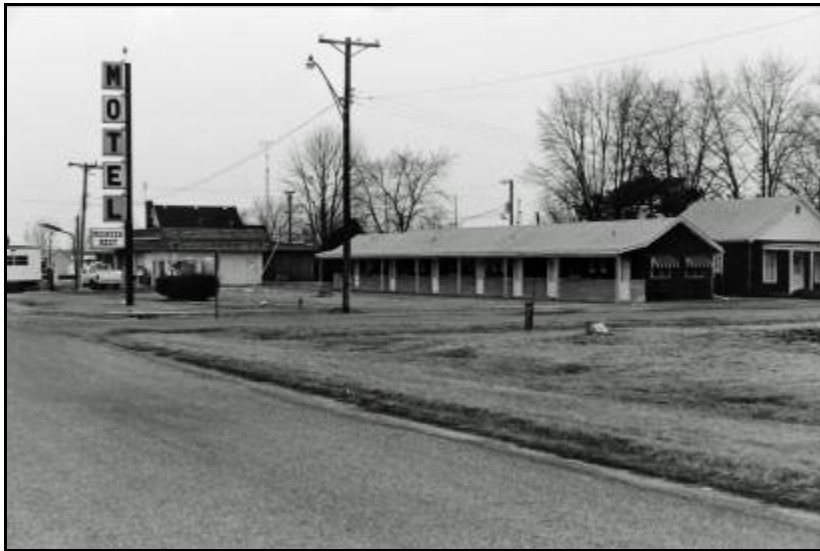
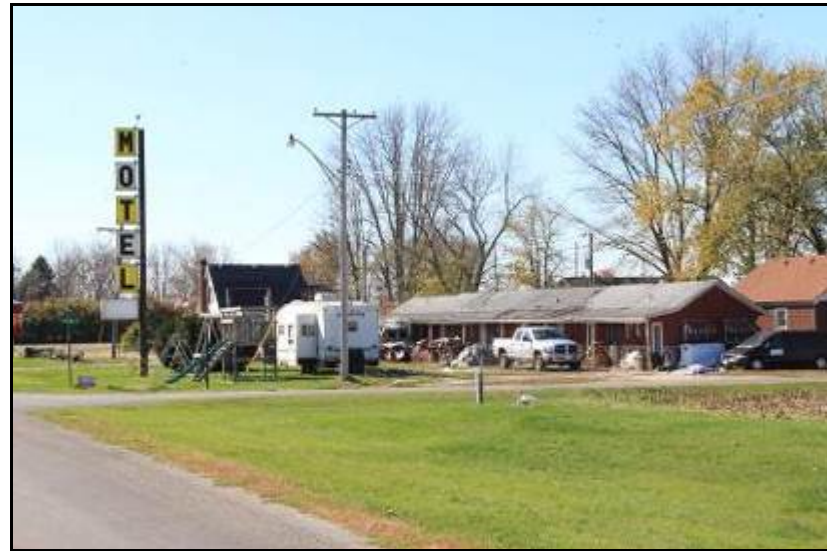
Sequence Number	Map Code	1994/95 Negative #	Address/Location	Type	Date Built	Historic Function	1994/95 Comments	2012/13 Comments and Photo Image #
202	05/10	05/10, IMG_1871	Old 66 at BROADWELL	2	Ca. 1950s	Motel	Small motel with seven rooms and gabled roof; adjacent to "Pig Hip" restaurant which has the same stone veneer/redwood sheathing as the motel.	The motel building remains, though its present use is unknown/not apparent. IMG_1387

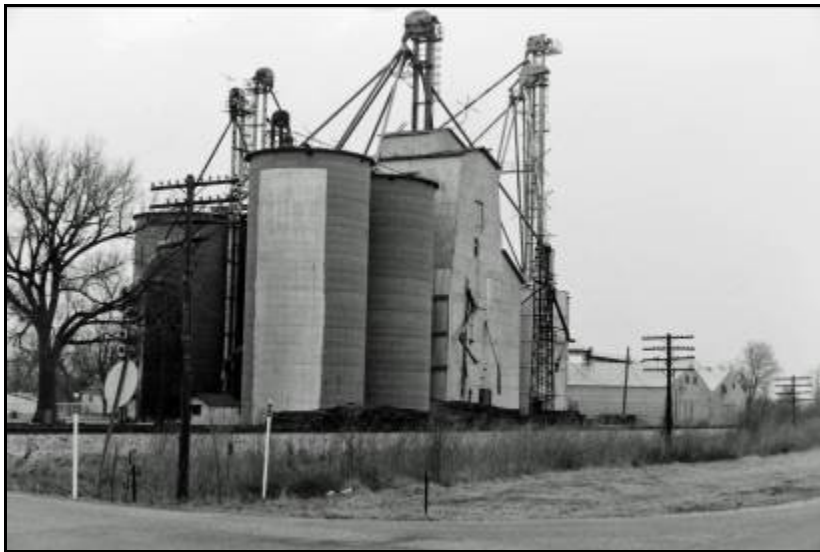
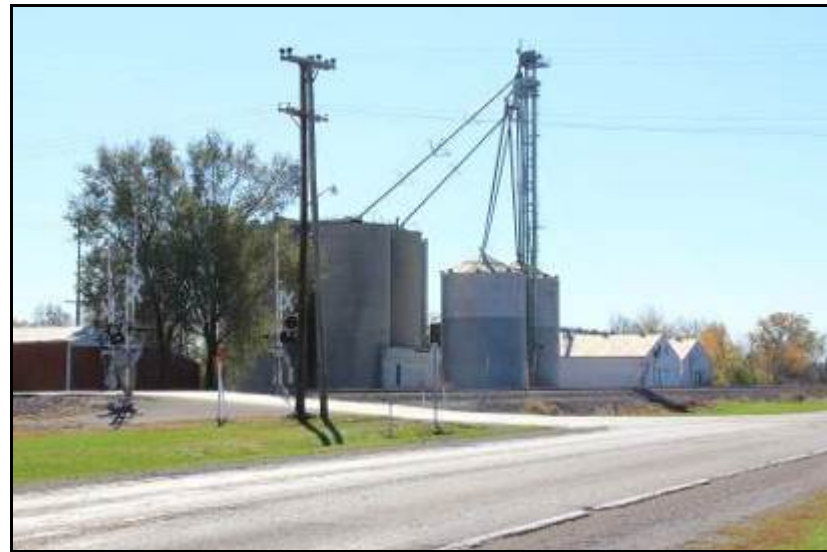
Sequence Number	Map Code	1994/95 Negative #	Address/Location	Type	Date Built	Historic Function	1994/95 Comments	2012/13 Comments and Photo Image #
203	05/09	05/09, IMG_1872	Old 66 at BROADWELL	3	Ca. 1930s-50s	Grain Elevator	Collection of cylindrical, reinforced concrete grain elevators.	Although there have been some changes to the elevators and their arrangement, including the loss of the historic period, frame elevator, the facility is still visually prominent on RT 66. IMG_1388

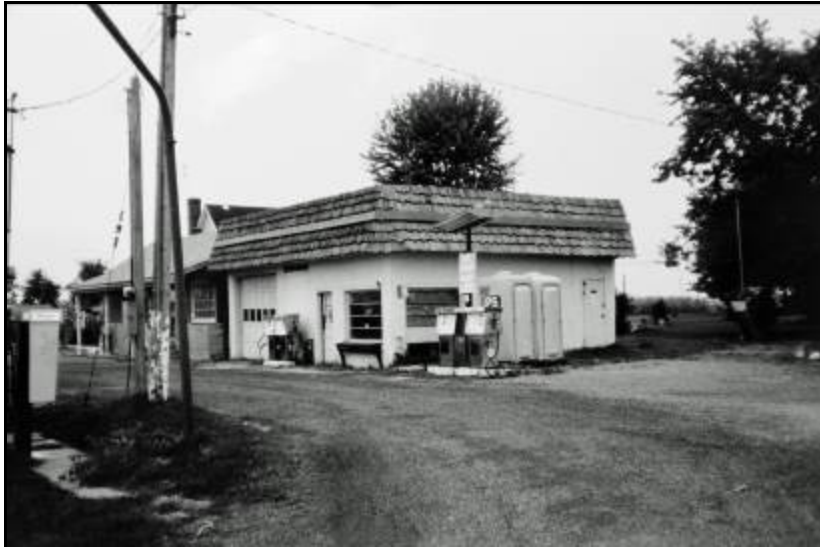
Sequence Number	Map Code	1994/95 Negative #	Address/Location	Type	Date Built	Historic Function	1994/95 Comments	2012/13 Comments and Photo Image #
204	21/23	21/23, IMG_1873	Old 66 at BROADWELL	2	Ca. 1950s-60s	Gas/Service	Concrete block gas station between "Pioneer Motel" and "Pig Hip" restaurant; out of business.	Structure now gone.

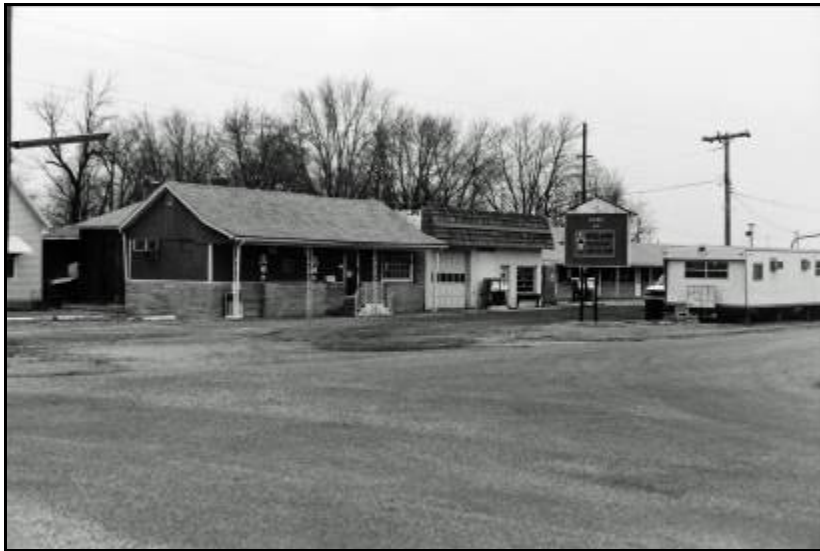
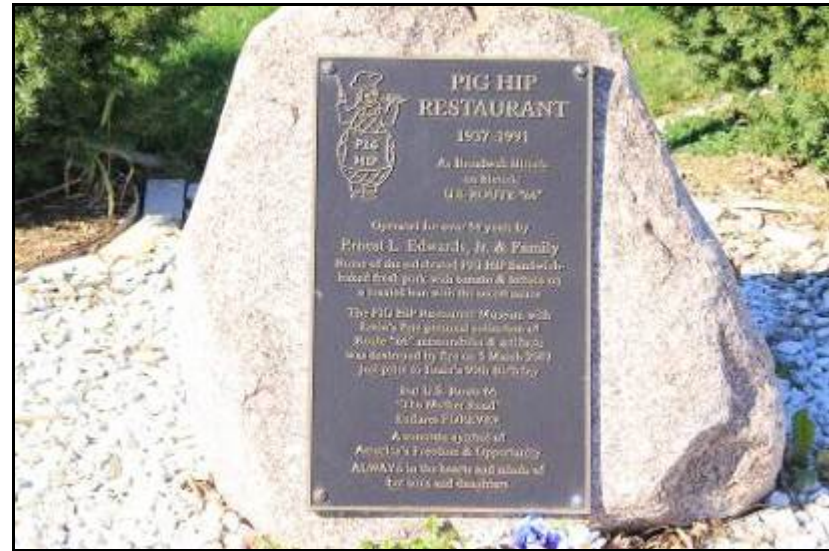
Sequence Number	Map Code	1994/95 Negative #	Address/Location	Type	Date Built	Historic Function	1994/95 Comments	2012/13 Comments and Photo Image #
205	05/08	05/08, IMG_1874	Old 66 at BROADWELL	2	Ca. 1937	Restaurant	"Pig Hip" restaurant, opened in 1937; small gabled structure with combination stone veneer/redwood sheathing – see Waldmire Post Card for additional information.	Structure is now gone. The "Pig Hip" burned down in 2007. IMG_1390

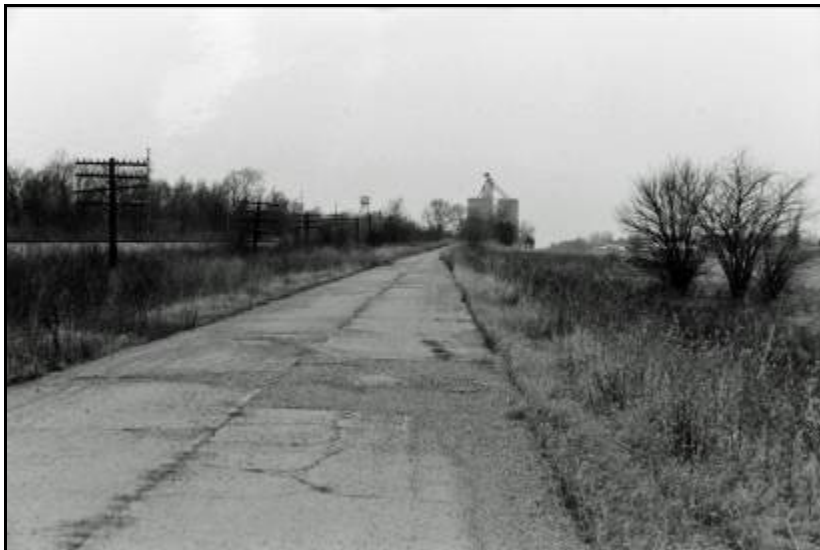
Sequence Number	Map Code	1994/95 Negative #	Address/Location	Type	Date Built	Historic Function	1994/95 Comments	2012/13 Comments and Photo Image #
206	05/06	05/06-7, IMG_1875	Old 66, N of ELKHART	1	Ca. 1920S	IL 4/USH 66	Archaeological segment of original alignment N of Elkhart (view to SW, toward the town).	The abandoned segment of RT 66 N of Elkhart remains, though a bit more overgrown. IMG_1393

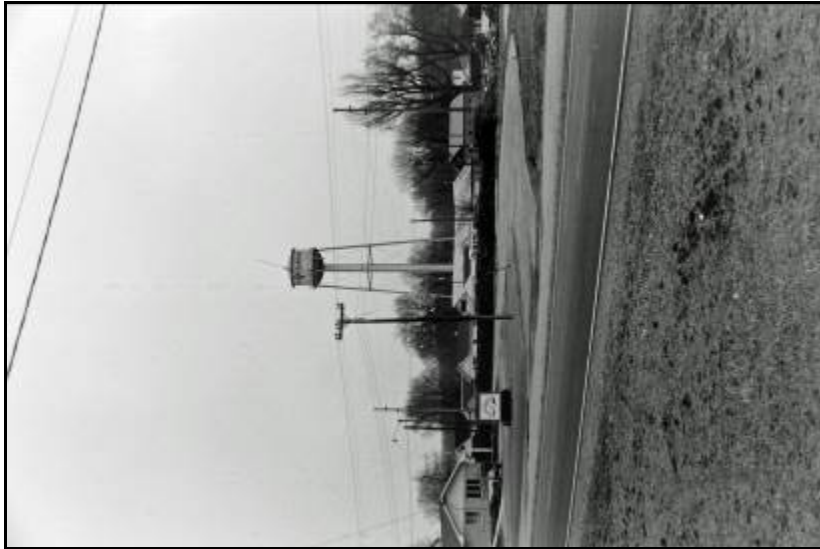
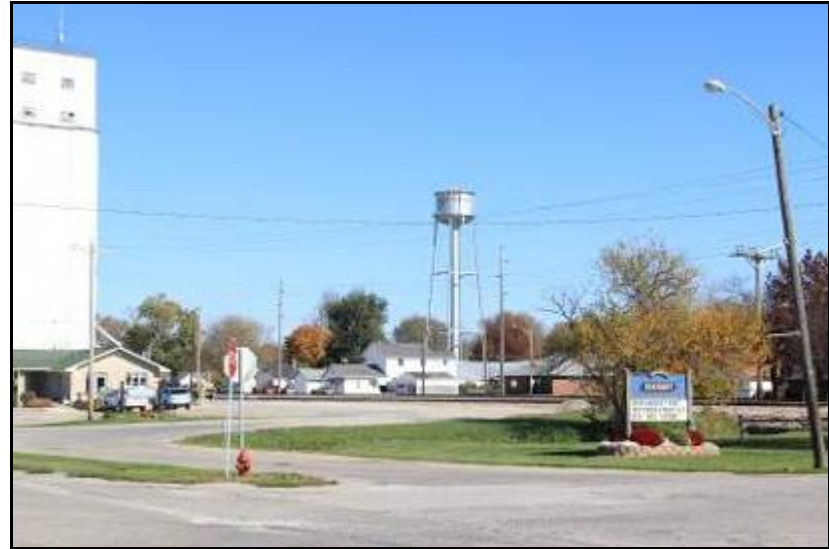
Sequence Number	Map Code	1994/95 Negative #	Address/Location	Type	Date Built	Historic Function	1994/95 Comments	2012/13 Comments and Photo Image #
207	05/05	05/05, IMG_1876	Old 66 at ELKHART	3	Unknown	Water Tower	General view from alignment to NE, note prominently visible water tower.	Only minor changes to this general view of Elkhart. IMG_1400

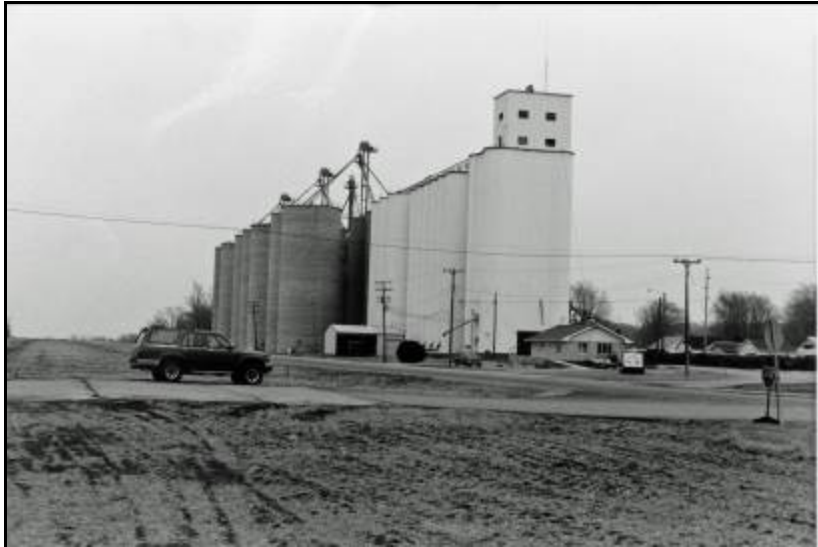
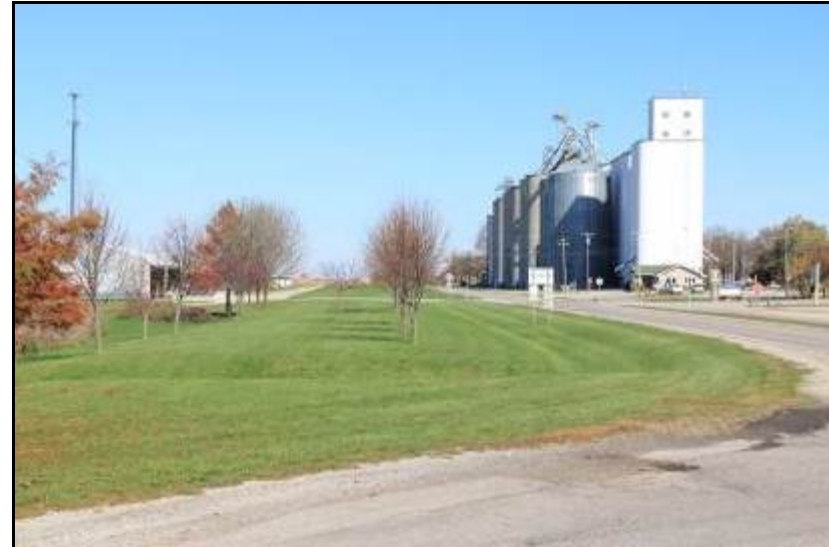
Sequence Number	Map Code	1994/95 Negative #	Address/Location	Type	Date Built	Historic Function	1994/95 Comments	2012/13 Comments and Photo Image #
208	05/04	05/04, IMG_1877	Old 66 at ELKHART	3	Ca. 1950s-60s	Grain Elevators	Impressive complex of reinforced, concrete grain elevators immediately across the RR tracks from 66.	The elevators remain, as does the old RT 66 westbound alignment, now with grass and trees. IMG_1398

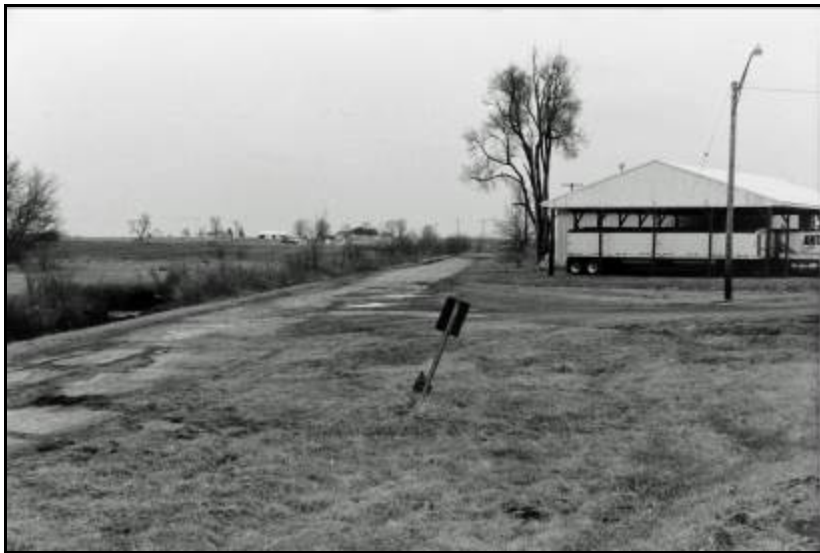
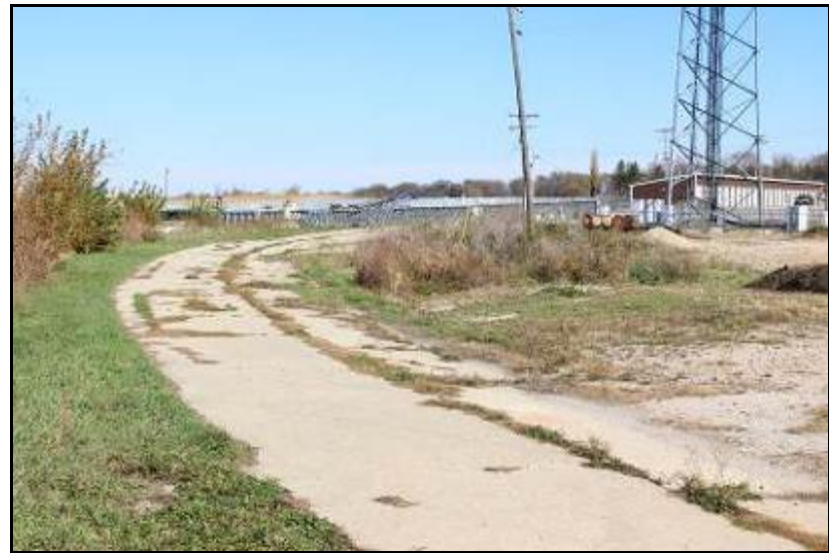
Sequence Number	Map Code	1994/95 Negative #	Address/Location	Type	Date Built	Historic Function	1994/95 Comments	2012/13 Comments and Photo Image #
209	05/03	05/03, IMG_1878	Old 66 at ELKHART	1	Ca. 1920s	IL 4/USH 66	Possible segment of RT 66 immediately NW of Elkhart.	Although not the exact same location as the 1994 picture, this image illustrates another portion of that small section of RT 66 immediately NW of Elkhart. IMG_1399

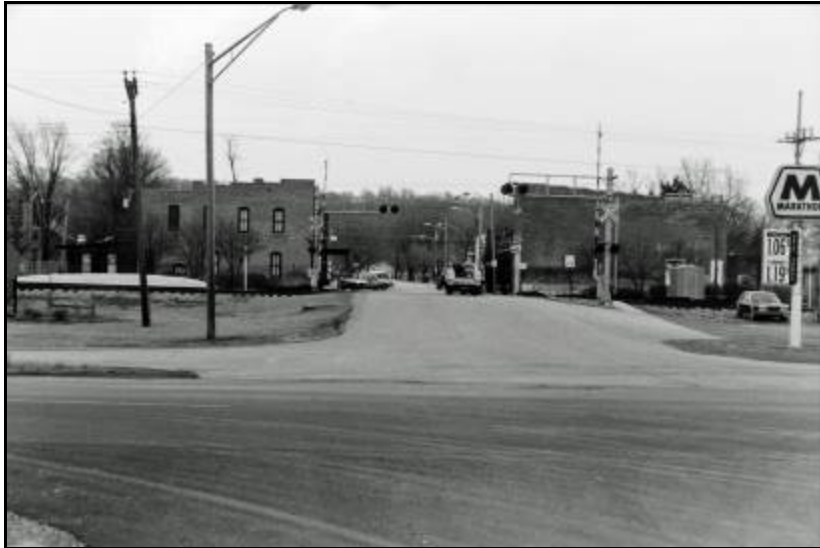
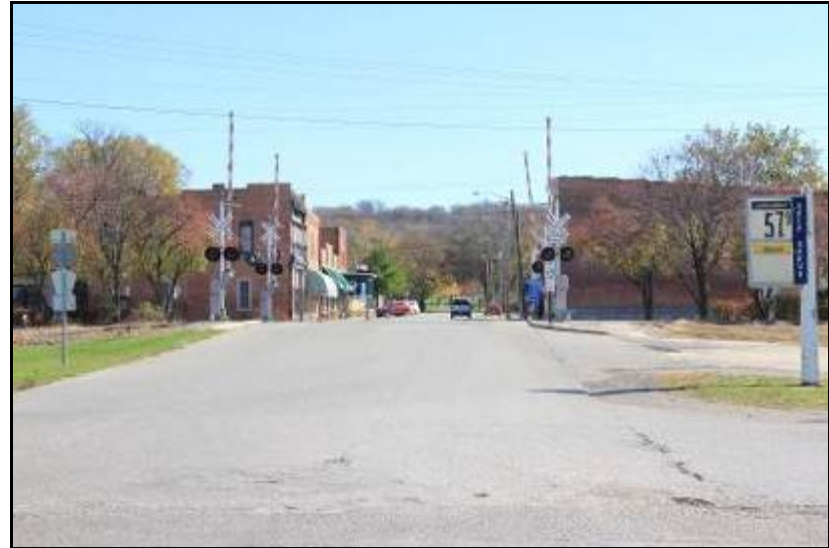
Sequence Number	Map Code	1994/95 Negative #	Address/Location	Type	Date Built	Historic Function	1994/95 Comments	2012/13 Comments and Photo Image #
211	05/01	05/01, IMG_1880	Old 66 at ELKHART	3	Unknown	Town adjacent to RT 66	View of Elkhart downtown from Main Street intersection with RT 66.	View is largely unchanged. The cantilevered railroad lights are now gone. IMG_1397

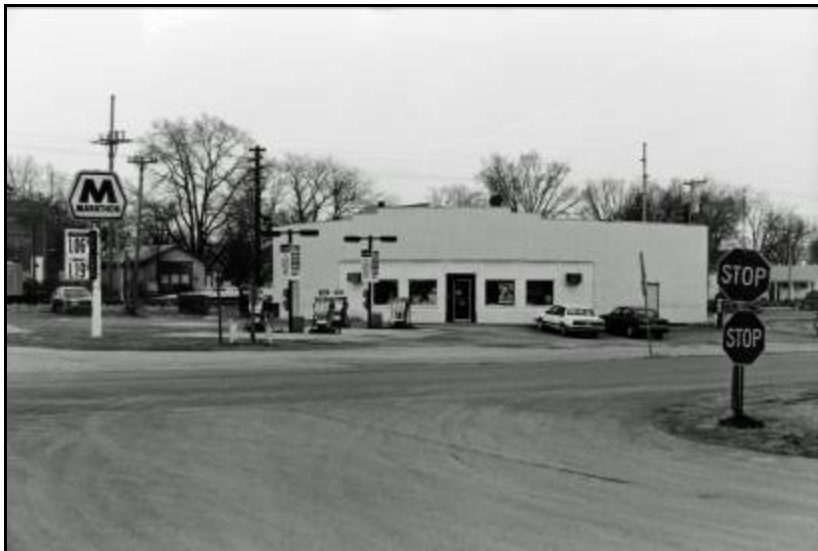
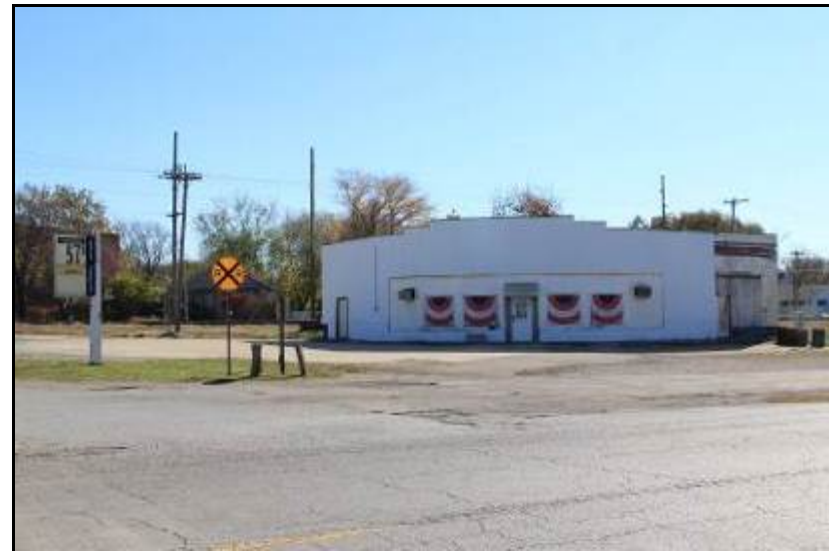
Sequence Number	Map Code	1994/95 Negative #	Address/Location	Type	Date Built	Historic Function	1994/95 Comments	2012/13 Comments and Photo Image #
212	04/23	04/23-24, IMG_1881	Old 66 at ELKHART	2	Ca. 1940s	Gas/Service	Originally sheathed with glazed brick, structure has metal siding; also has prominent, rounded corner typical of 1940s or 50s era streamline movement – “Marathon Oil;” see Waldmire Post Card for more information on Elkhart.	This is no longer an operating service station. Note that the modern sheathing has been removed from the building in the far right of the illustration, thus revealing the structure’s original construction material. IMG_1396
