Route 66 in Illinois:

(2012/13 Update and Expansion of the Original 1994/95 Survey)

IDOT Sequence #17337 & #17337A

22 December 2013

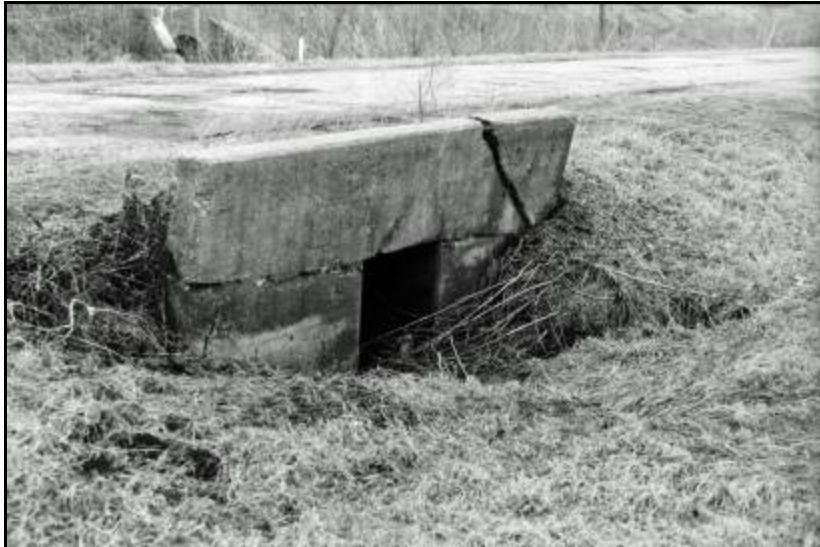
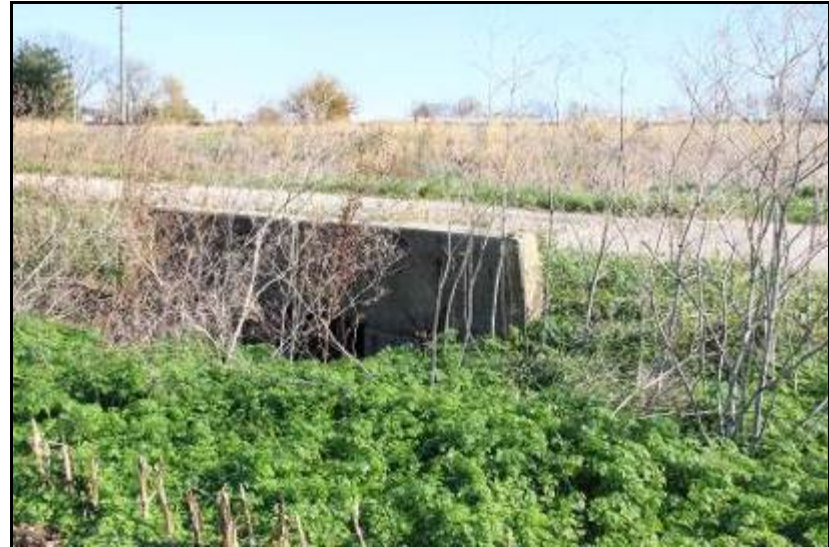
Sequence Number	Map Code	1994/95 Negative #	Address/Location	Type	Date Built	Historic Function	1994/95 Comments	2012/13 Comments and Photo Image #
213	04/22	04/22, IMG_1882	Old 66, N of WILLIAMSVILLE	1	Ca. 1920s	Culvert	Small, concrete culvert typical of several noted along the alignment – nothing distinctive or unique.	The small concrete culvert remains. IMG_1402

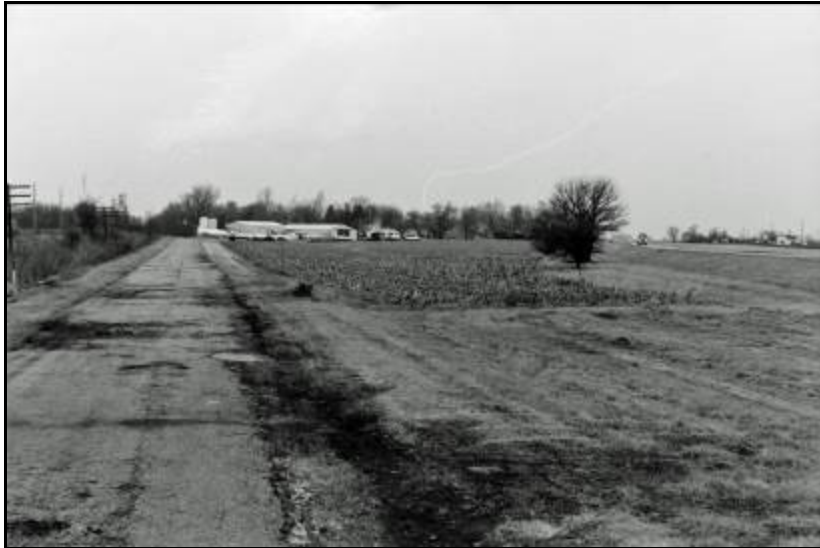
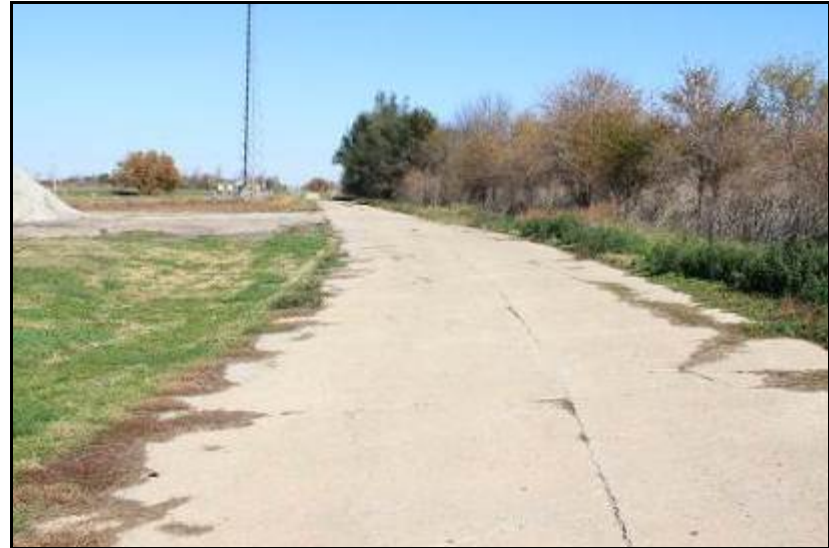
Sequence Number	Map Code	1994/95 Negative #	Address/Location	Type	Date Built	Historic Function	1994/95 Comments	2012/13 Comments and Photo Image #
214	04/21	04/21, IMG_1883	Old 66, N of WILLIAMSVILLE	1	Ca. 1920s	IL 4/USH 66	Segment of original 66 as it enters Williamsville from N (view to SW).	RT 66 N of Williamsville viewed to the NE, as opposed to SW as illustrated in 1994. IMG_1402

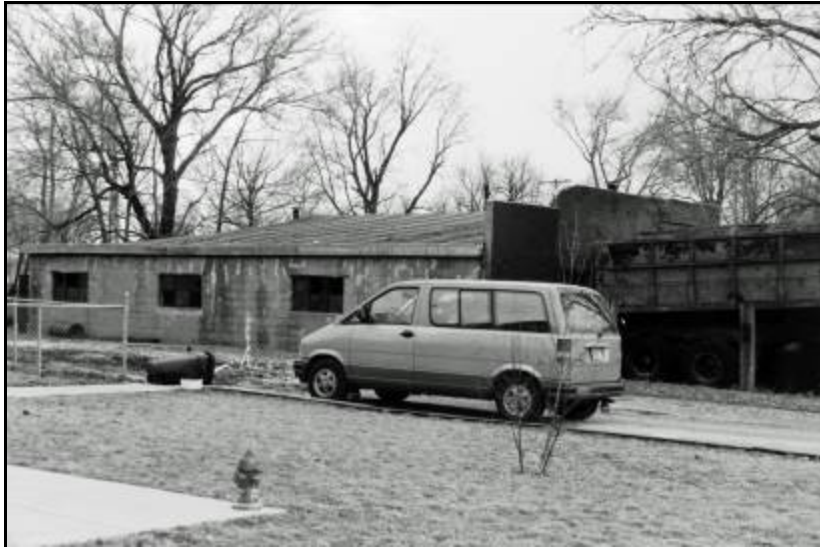
Sequence Number	Map Code	1994/95 Negative #	Address/Location	Type	Date Built	Historic Function	1994/95 Comments	2012/13 Comments and Photo Image #
215	04/20	04/20, IMG_1884	Taylor St. & Pine, WILLIAMSVILLE	2	Ca. 1920s-30s (?)	Auto Service	Many trucks and trailers obscure view of building; looks as if it could have been a service station at one time.	Structure now gone.

No longer extant

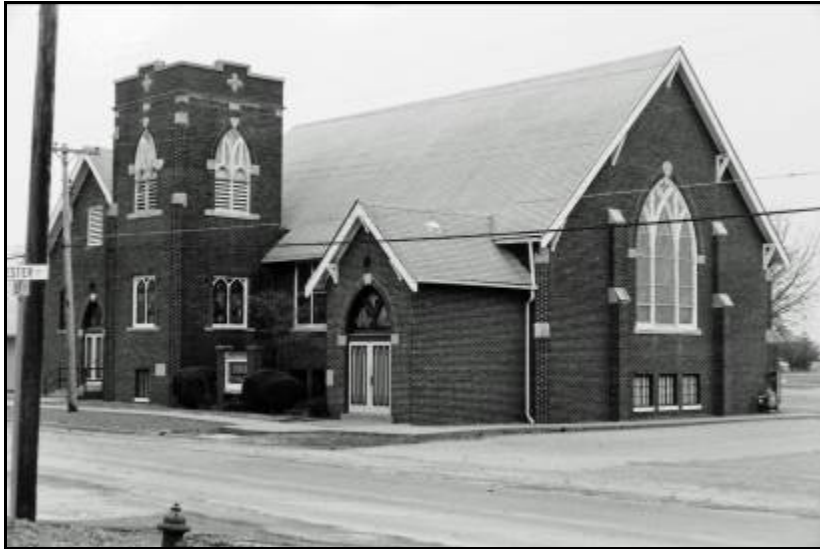
Sequence Number	Map Code	1994/95 Negative #	Address/Location	Type	Date Built	Historic Function	1994/95 Comments	2012/13 Comments and Photo Image #
216	04/19	04/19, IMG_1885	Elm St. & Lester, WILLIAMSVILLE	3	Ca. 1920s-30s	Church	Modestly-sized, brick church with Gothic Revival influences.	This building no longer remains.

No longer extant

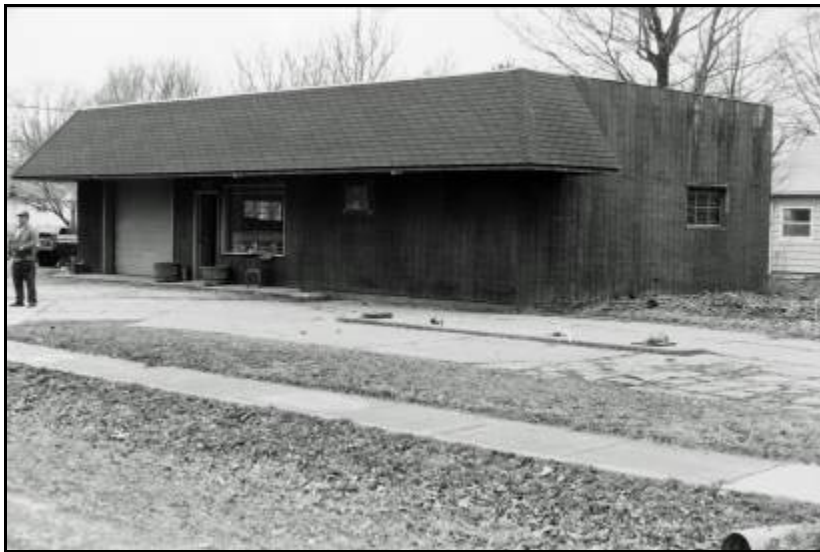
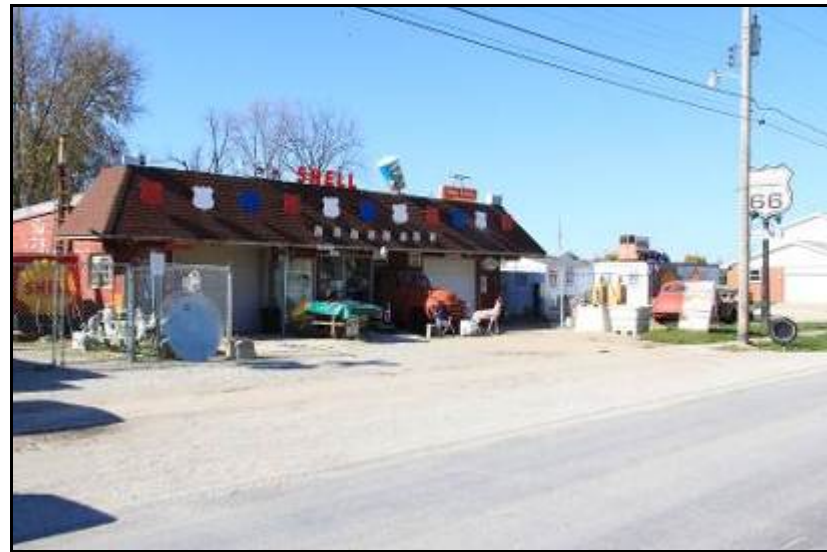
Sequence Number	Map Code	1994/95 Negative #	Address/Location	Type	Date Built	Historic Function	1994/95 Comments	2012/13 Comments and Photo Image #
217	04/18	04/18, IMG_1886	117 Elm St., WILLIAMSVILLE	2	Ca. 1950s (?)	Gas/Service	Building has been completely resheathed, thus hard to really know much about it; gas pump islands clearly visible in front of structure.	Another overhead garage door appears to have been installed in this structure, which is now a RT 66 shrine. IMG_1403

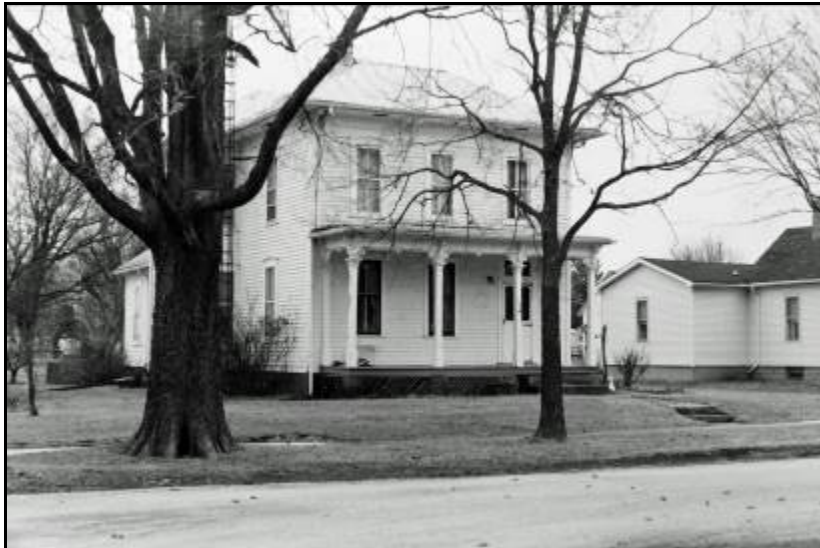
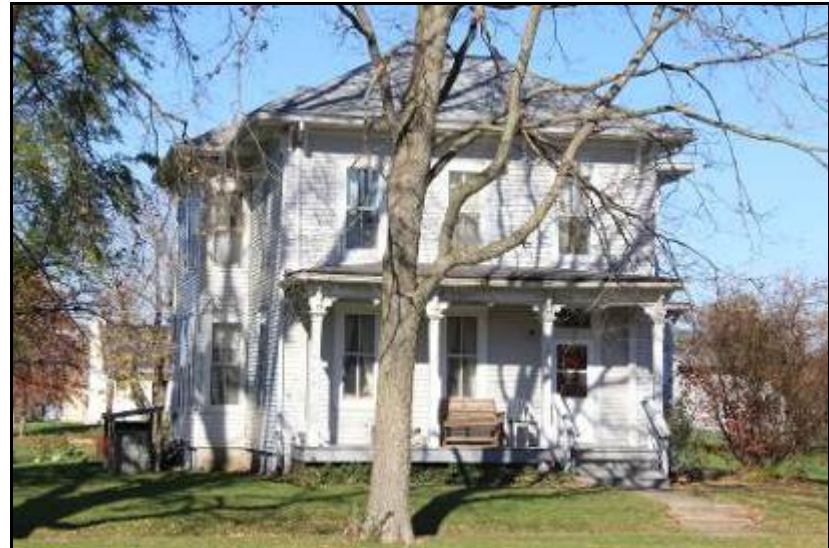
Sequence Number	Map Code	1994/95 Negative #	Address/Location	Type	Date Built	Historic Function	1994/95 Comments	2012/13 Comments and Photo Image #
218	04/17	04/17, IMG_1887	129 Flagg St., WILLIAMSVILLE	3	Ca. Late 19 th , Early 20 th Century	Residential	Clapboard-sheathed, two-story house has porch with ornate frieze and post brackets; also standing seam, metal roof and dentilled frieze on house.	Little has changed on this nice, modest Italianate house. IMG_1404

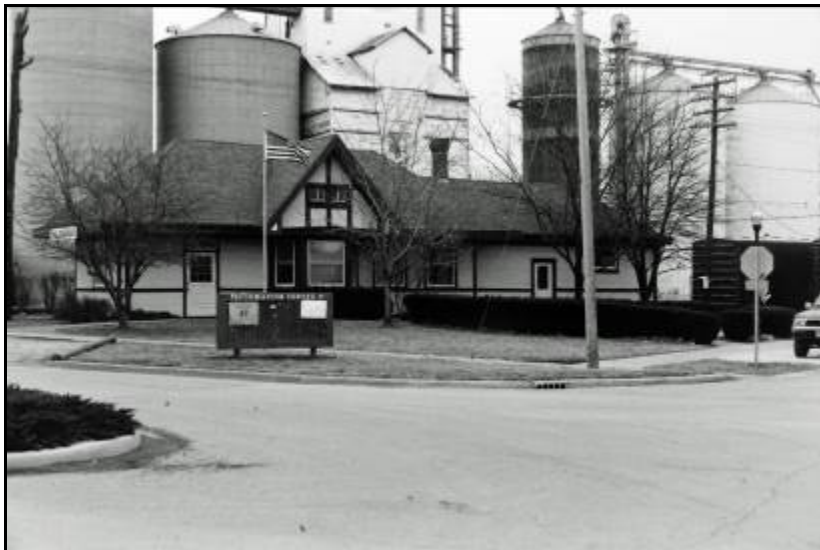
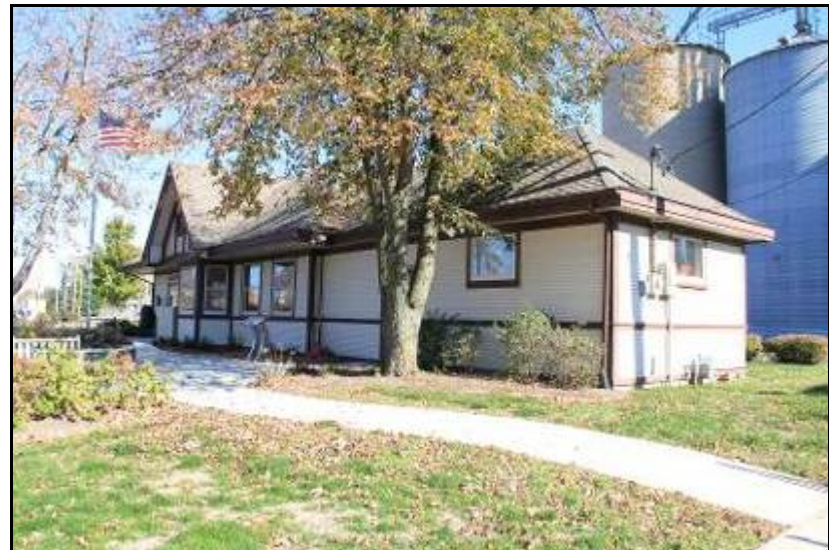
Sequence Number	Map Code	1994/95 Negative #	Address/Location	Type	Date Built	Historic Function	1994/95 Comments	2012/13 Comments and Photo Image #
219	04/15	04/15-16, IMG_1888	Elm St. & Main St, WILLIAMSVILLE	3	Ca. Early 20 th Century	RR Depot	Hip roof structure with clapboard sheathing.	There appear to have been few changes to the old Williamsville railroad station. IMG_1405

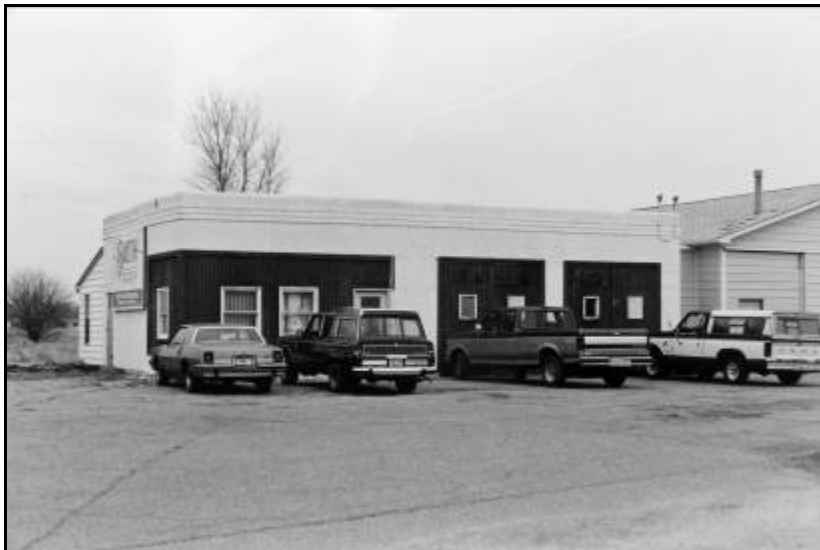
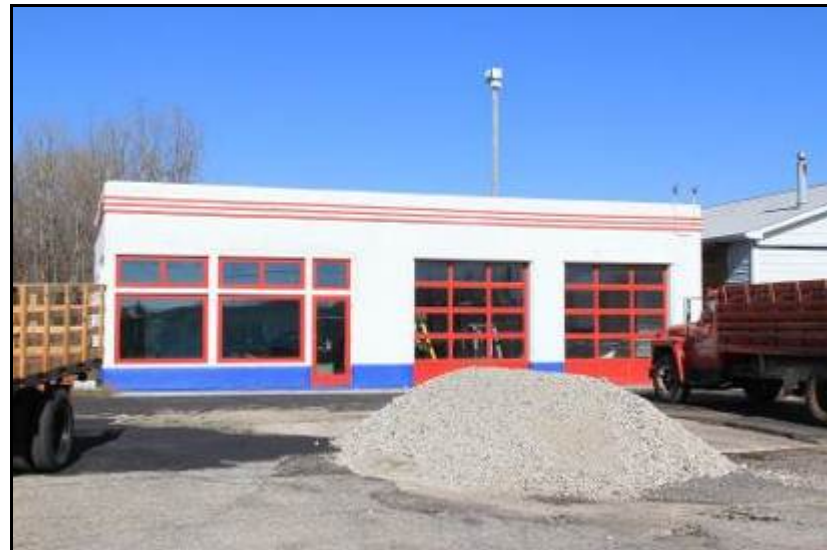
Sequence Number	Map Code	1994/95 Negative #	Address/Location	Type	Date Built	Historic Function	1994/95 Comments	2012/13 Comments and Photo Image #
220	04/14	04/14, IMG_1889	Old 66 & Old Bypass 66, S side of Williamsville	2	Ca. 1950s	Gas/Service	Old gas station adaptively reused; garage doors and retail area very unsympathetically in-filled – a 1950s Functional-type gas station.	This former service station has been nicely restored since 1994. IMG_1407

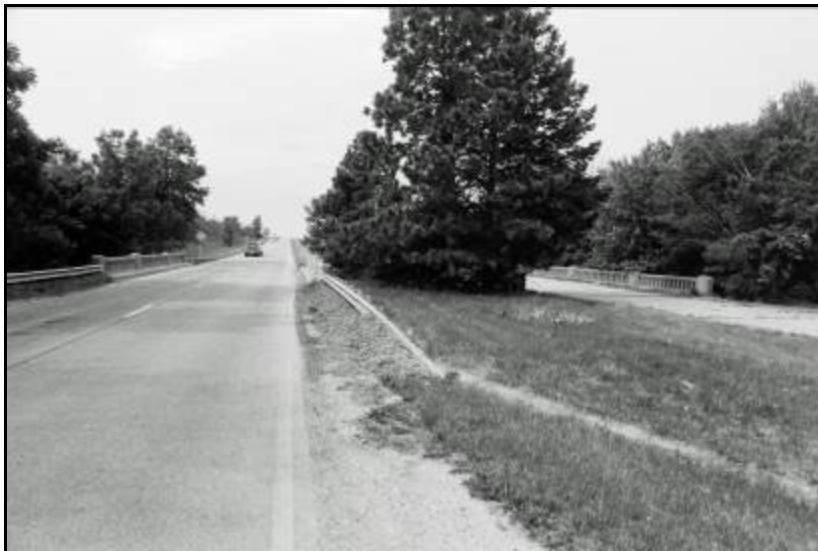
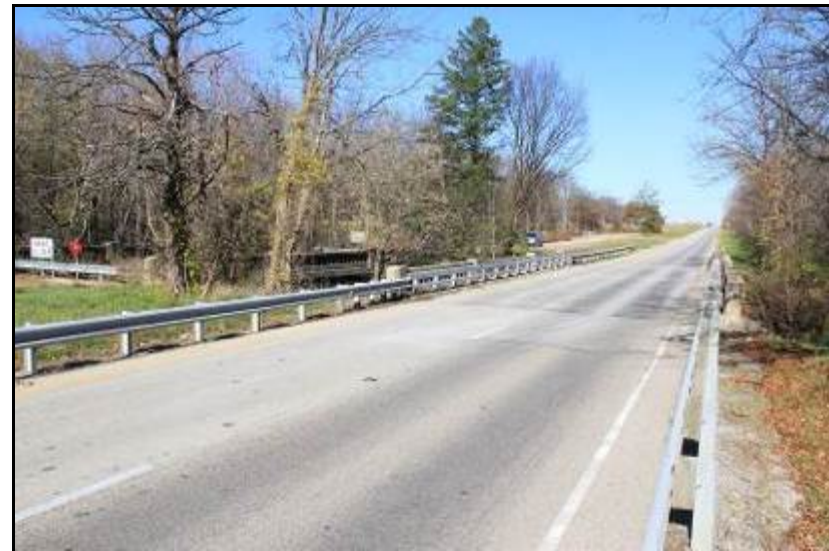
Sequence Number	Map Code	1994/95 Negative #	Address/Location	Type	Date Built	Historic Function	1994/95 Comments	2012/13 Comments and Photo Image #
221	13/07	13/07-08, IMG_1890	Old 66 over Fancy Creek, N of SHERMAN	1	1953	Bridges	Two structures remain; Bridge #084-0031 – plate notes: Station 351+08(2), Built 1953 by, State of Illinois, F.A. Rt. 5 Sec. 25R-2B, Project I-26(44), Loading H-20-S16; three-span structure with concrete slab deck.	Both east and westbound lanes remain, though those westbound are closed. IMG_1408

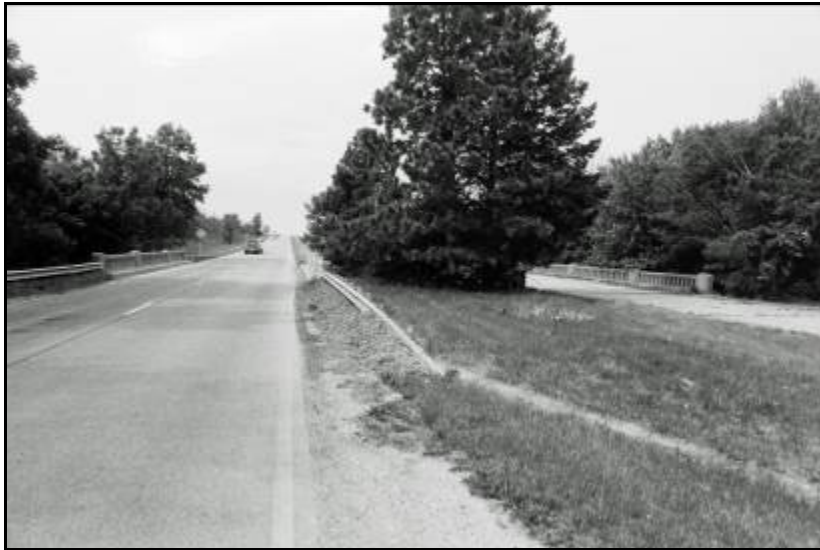
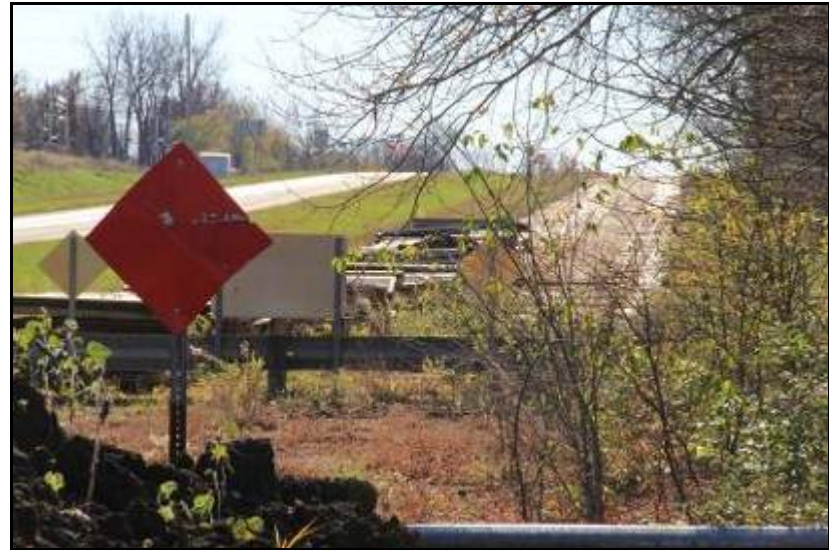
Sequence Number	Map Code	1994/95 Negative #	Address/Location	Type	Date Built	Historic Function	1994/95 Comments	2012/13 Comments and Photo Image #
222	13/09	13/09, IMG_1891	Old 66 at Fancy Creek, N of SHERMAN	1	Ca. 1953	USH 66	Four-lane 66 NE of Springfield; only two lanes open to traffic, although all four remain (view to SW).	Westbound lanes are closed in 2012, as they were in 1994. The illustration is taken from the closed bridge with a view to the SW. IMG_1411

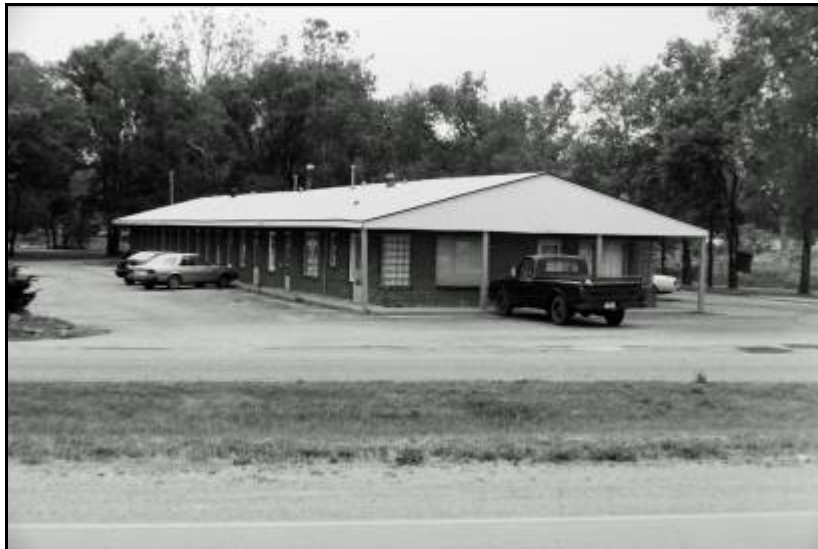
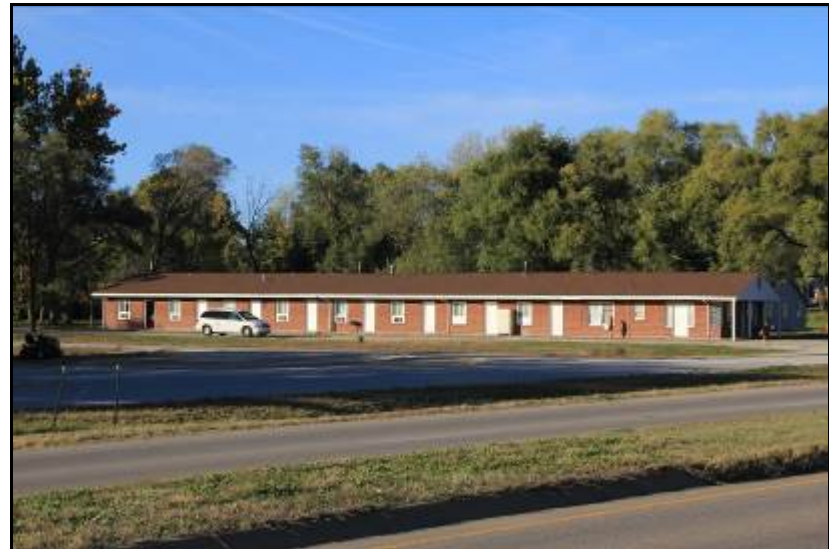
Sequence Number	Map Code	1994/95 Negative #	Address/Location	Type	Date Built	Historic Function	1994/95 Comments	2012/13 Comments and Photo Image #
223	13/10	13/10, IMG_4573	4333 Peoria Rd.	2	Ca. 1950s-60s	Motel	Brick motel with several distinctive glass block windows; now appears to be apartments.	No consequential changes appear to have affected this structure. IMG_4071

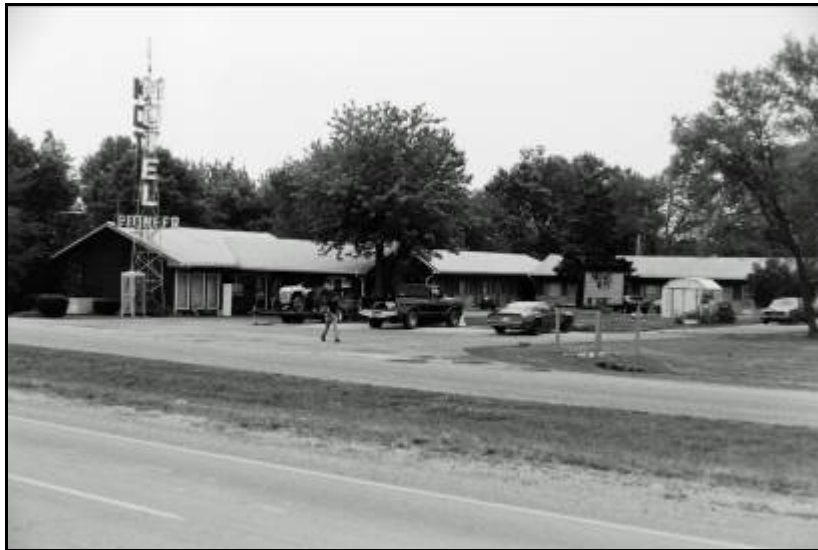
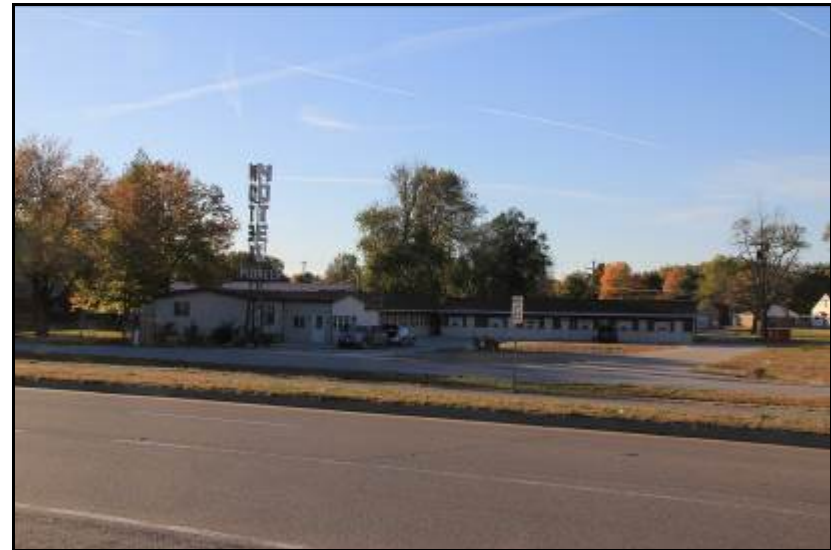
Sequence Number	Map Code	1994/95 Negative #	Address/Location	Type	Date Built	Historic Function	1994/95 Comments	2012/13 Comments and Photo Image #
224	13/11	13/11, IMG_4574	4321 Peoria Rd.	2	Ca. 1950s-60s	Motel	Wood and brick-sheathed motel – “Motel Pioneer.”	The motel’s neon sign remains. The entrance to the office, as well as the windows of the entrance and office, appear to have been modified. IMG_4072

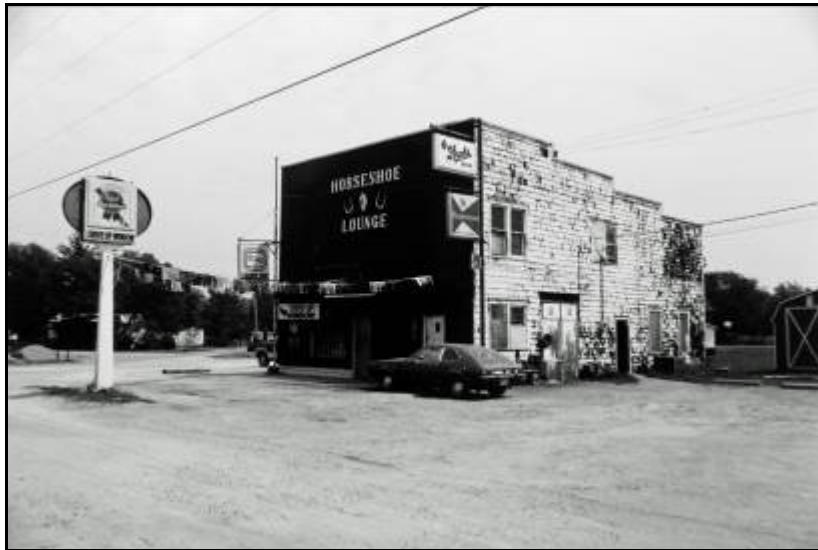
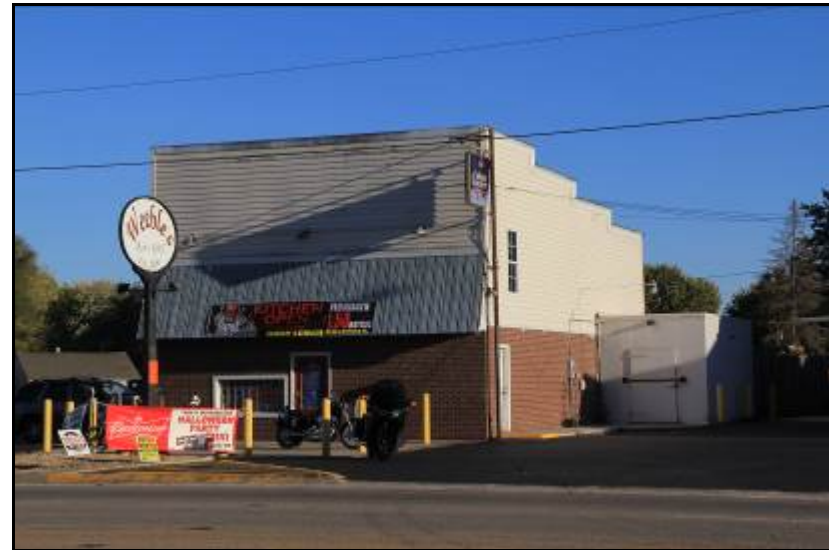
Sequence Number	Map Code	1994/95 Negative #	Address/Location	Type	Date Built	Historic Function	1994/95 Comments	2012/13 Comments and Photo Image #
225	19/22	19/22, IMG_4575	4136 Peoria Rd.	2	Ca. 1920s	Gas/Roadhouse	Rising from rock-faced, concrete block foundation, two-story structure has wood and wood shingle siding; old oil company sign out front – could well have been old gas/food stop.	Many windows in this building have been sheathed over or modified. The exterior fabric of the structure has also been prominently altered. IMG_4073

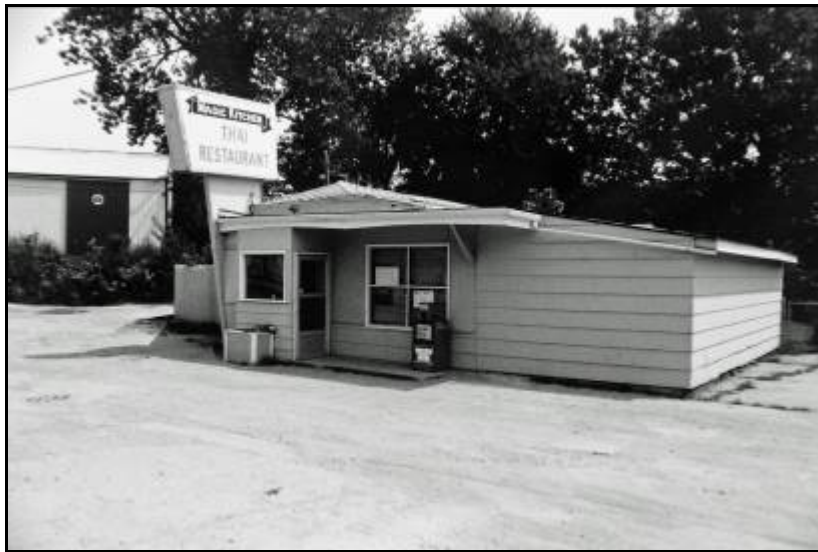
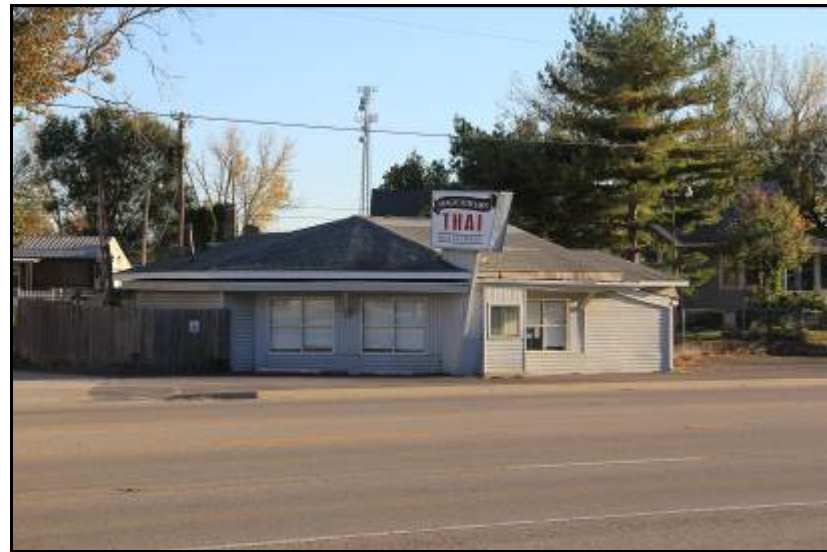
Sequence Number	Map Code	1994/95 Negative #	Address/Location	Type	Date Built	Historic Function	1994/95 Comments	2012/13 Comments and Photo Image #
226	19/21	19/21, IMG_4576	4124 (?) Peoria Rd.	2	Ca. 1950s	Drive-In (?)	Rather odd-looking, clapboard-sided structure; looks as if it could have been a drive-in – now “Magic Kitchen.”	It is unclear if this Thai restaurant is still open or not. It has, nevertheless, been expanded since the 1994/95 survey. IMG_4074

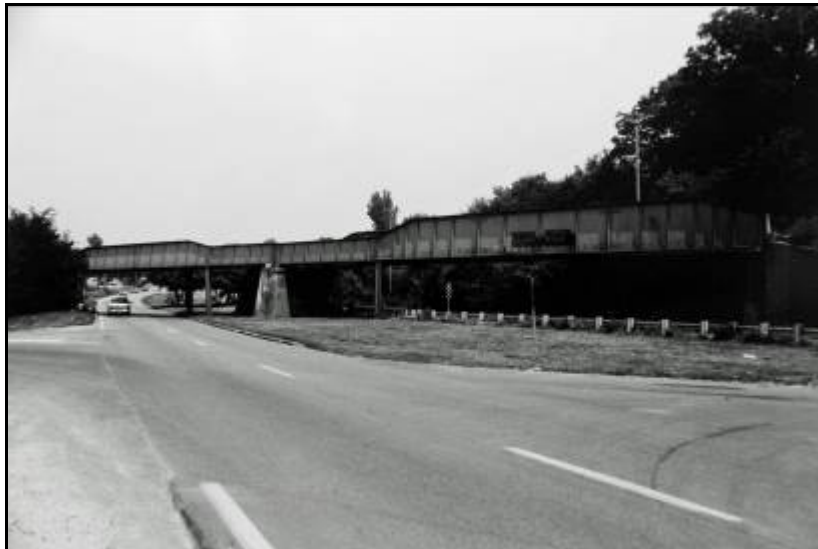
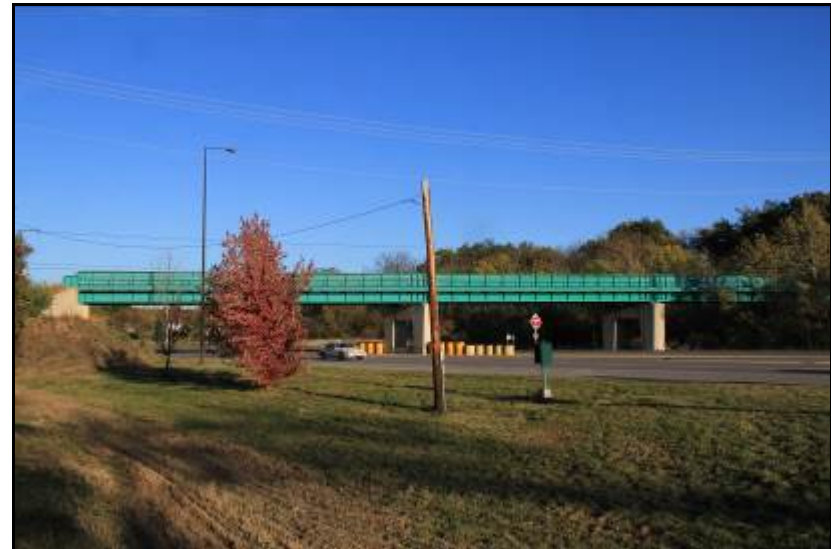
Sequence Number	Map Code	1994/95 Negative #	Address/Location	Type	Date Built	Historic Function	1994/95 Comments	2012/13 Comments and Photo Image #
227	19/19	19/19-20, IMG_4577	Peoria Rd. & C&IM Railroad	2	Unknown	RR overpass	Bridge #084-9903; two-span structure with "I" beams carries tracks over Old 66.	The railroad bridge from 1994/95 appears to have been replaced by a new facility. IMG_4075

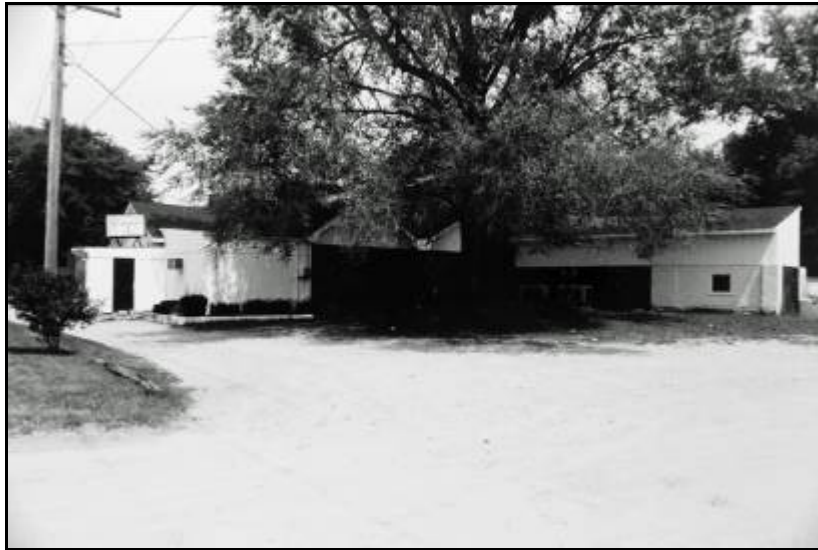
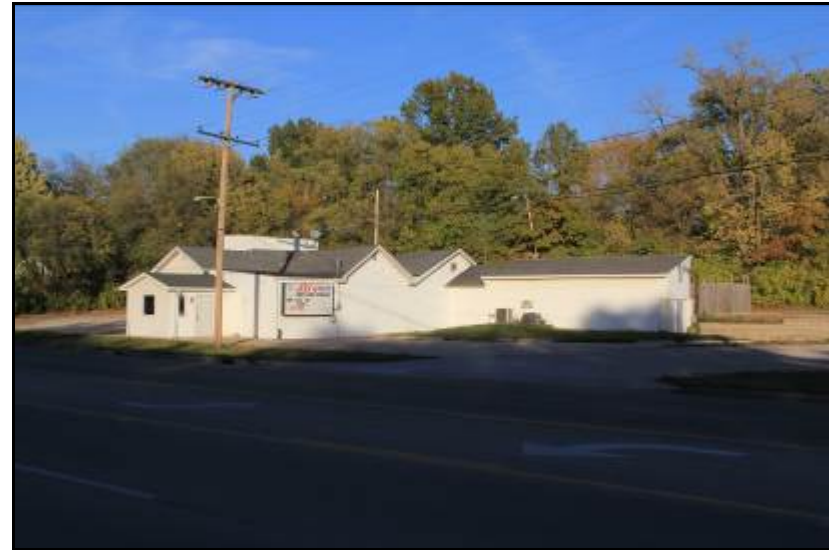
Sequence Number	Map Code	1994/95 Negative #	Address/Location	Type	Date Built	Historic Function	1994/95 Comments	2012/13 Comments and Photo Image #
228	19/18	19/18, IMG_4578	3036 Peoria Rd.	2	Unknown	Restaurant	Brick structure with several additions and modifications – looks to be vacant.	Some sheathing-related changes have clearly been made to this building, which is today closed and for sale. IMG_4076

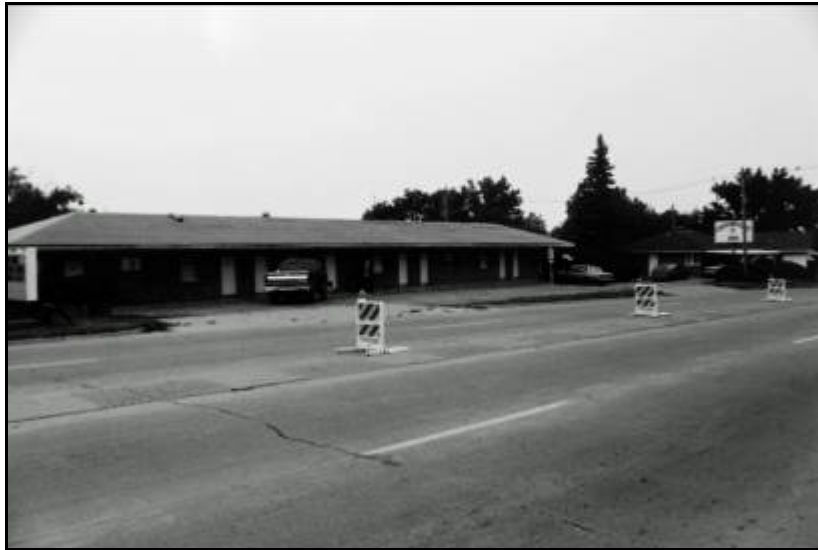
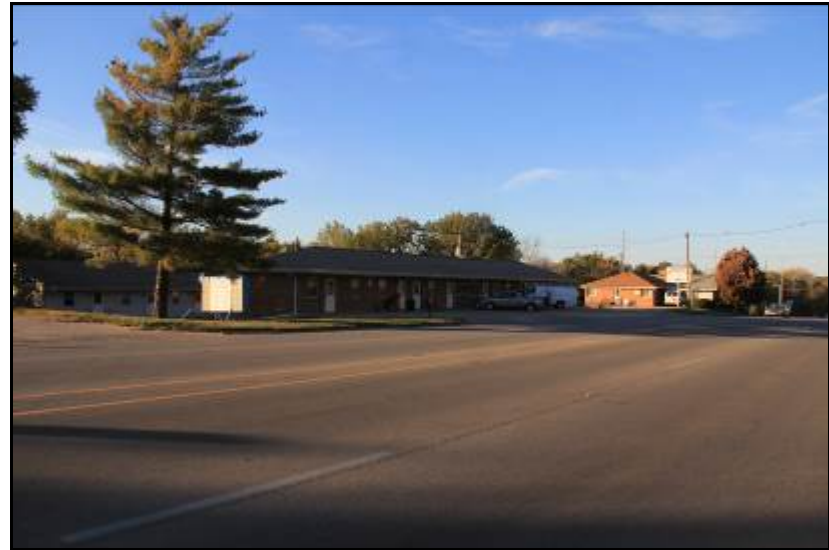
Sequence Number	Map Code	1994/95 Negative #	Address/Location	Type	Date Built	Historic Function	1994/95 Comments	2012/13 Comments and Photo Image #
229	19/17	19/17, IMG_4579	28— Peoria Rd.	2	Ca. 1960s	Motel	Brick motel with hip roof – “Countryside Inn.”	The “Countryside Inn” remains, although it appears to have been converted more to apartment use than use as a motel. IMG_4077

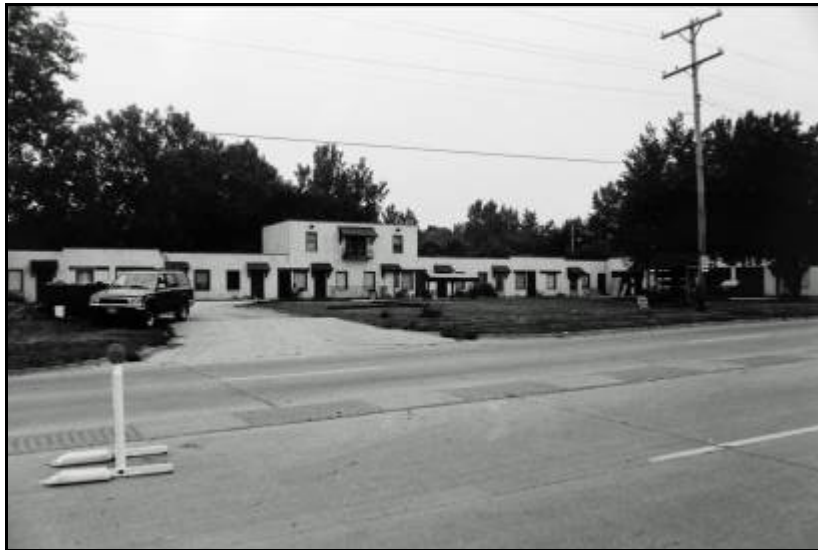
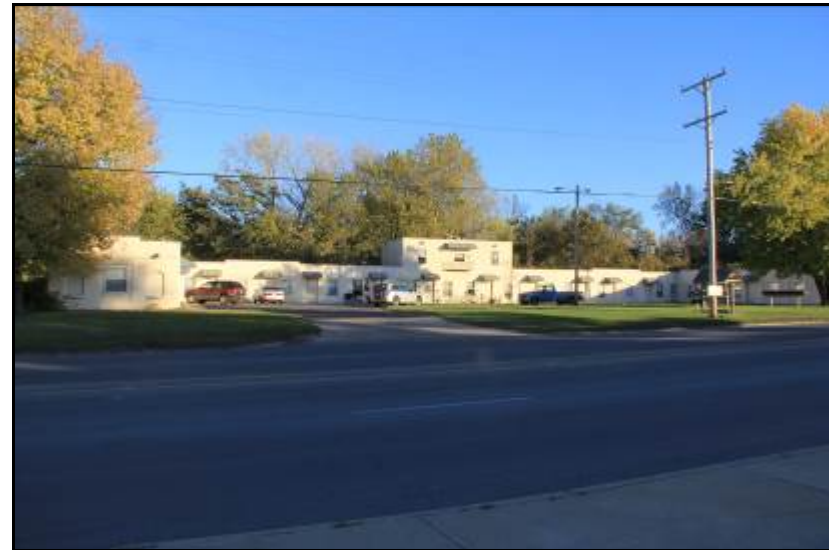
Sequence Number	Map Code	1994/95 Negative #	Address/Location	Type	Date Built	Historic Function	1994/95 Comments	2012/13 Comments and Photo Image #
230	19/16	19/16, IMG_4580	2840 Peoria Rd.	2	1949	Motel	Large, one-level "U" shaped motel with centered, two-story office and living quarters; has unique Mediterranean look – now "Prairie Village Apartments."	Although still the "Prairie Village Apartments" today, this facility was built in 1949 as the "Lazy-A-Motel." IMG_4080

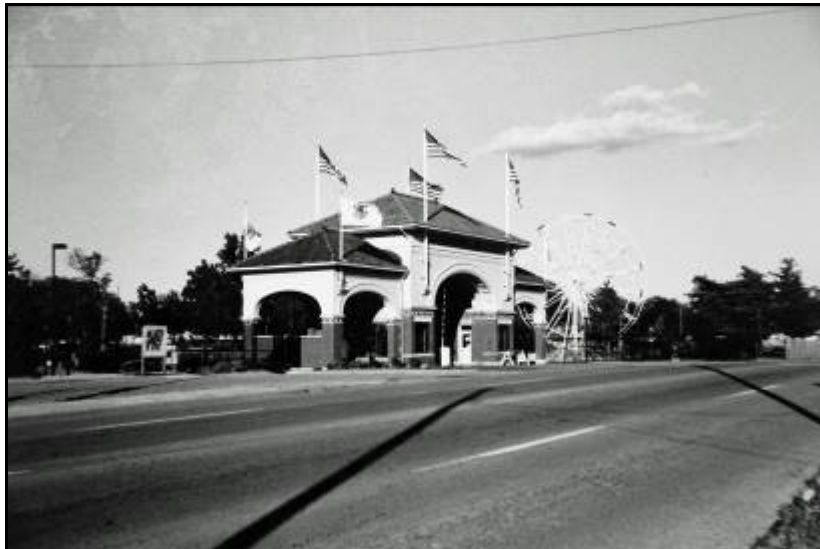
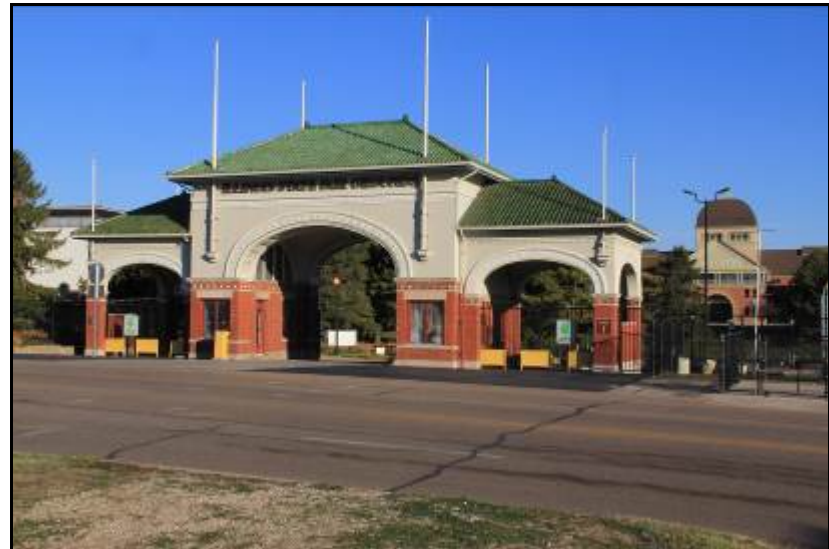
Sequence Number	Map Code	1994/95 Negative #	Address/Location	Type	Date Built	Historic Function	1994/95 Comments	2012/13 Comments and Photo Image #
231	23/10	23/10, IMG_4581	801 E. Sangamon Ave.	3	Unknown	State Fair	Illinois State Fair Grounds	The main entrance to the Illinois State Fair Grounds remains with few changes since 1994/5. IMG_4082

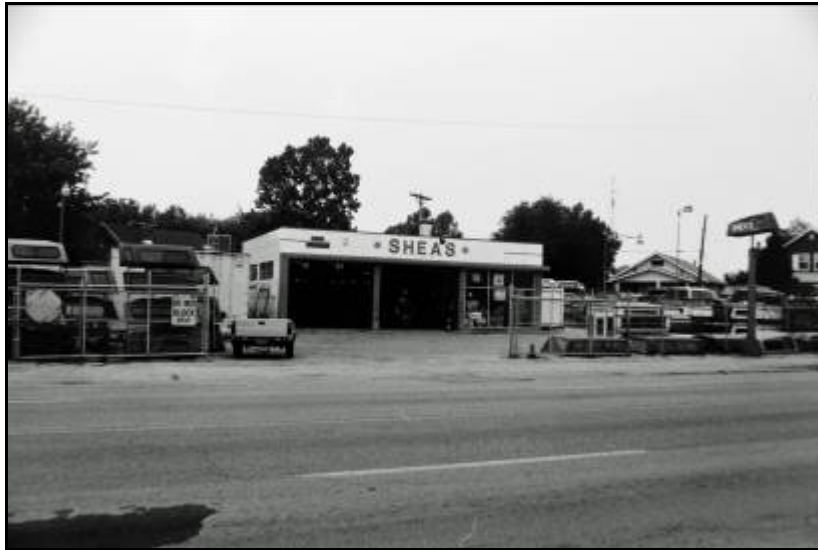
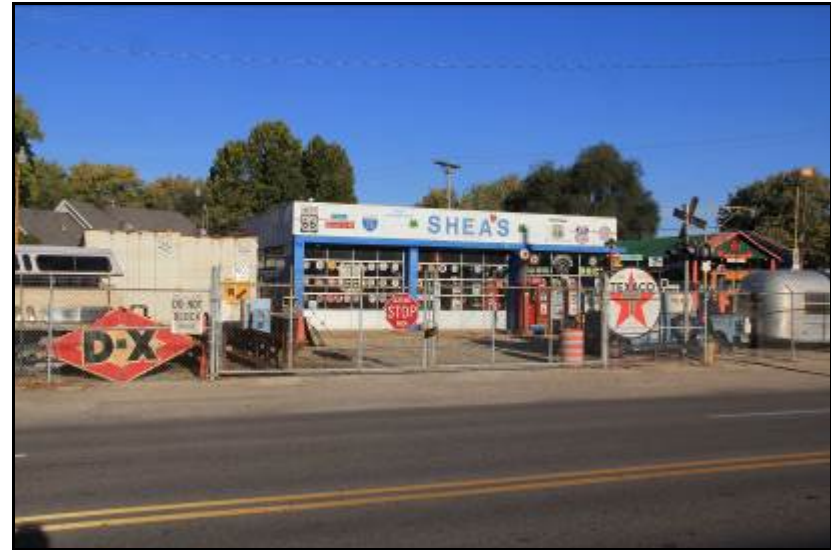
Sequence Number	Map Code	1994/95 Negative #	Address/Location	Type	Date Built	Historic Function	1994/95 Comments	2012/13 Comments and Photo Image #
232	19/15	10/15, IMG_4582	2075 Peoria Rd.	2	Ca. 1950s	Gas/Service	Old gas station sheathed with enamel panels -- now "Shea's."	"Shea's" has acquired much RT 66 memorabilia. It is unclear if the garage itself still operates as such. IMG_4083

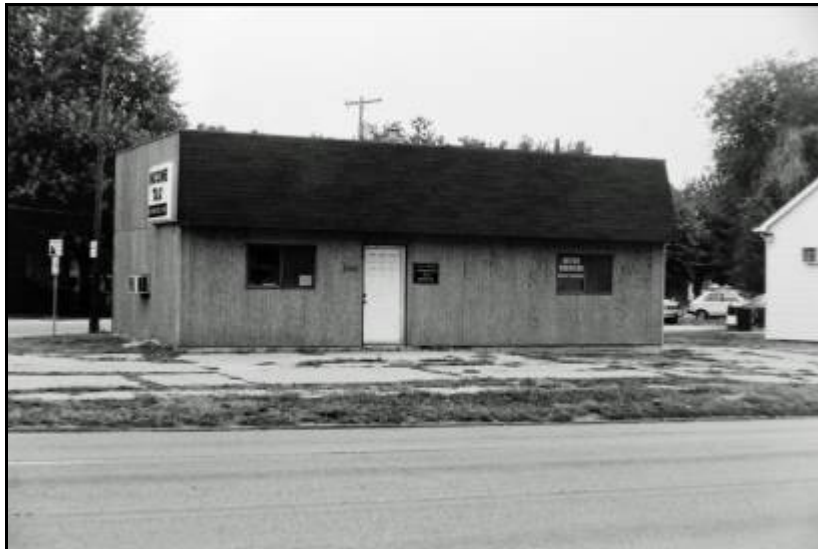
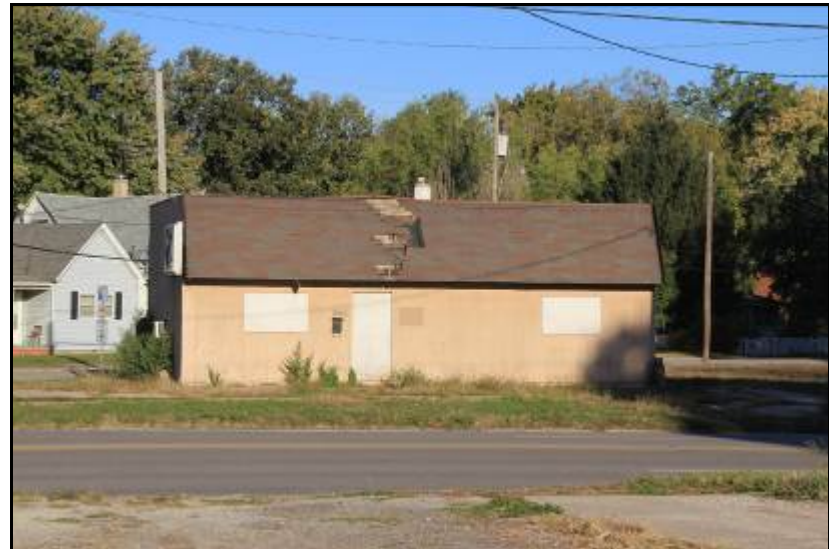
Sequence Number	Map Code	1994/95 Negative #	Address/Location	Type	Date Built	Historic Function	1994/95 Comments	2012/13 Comments and Photo Image #
233	19/14	19/14, IMG_4583	2001 Peoria Rd.	2	Ca. 1950s-60s	Gas/Service (?)	Completely resheathed and remodeled gas station – now serves as small professional office.	This building, thought to have possibly been an old gas station, is now closed and vacant. IMG_4084

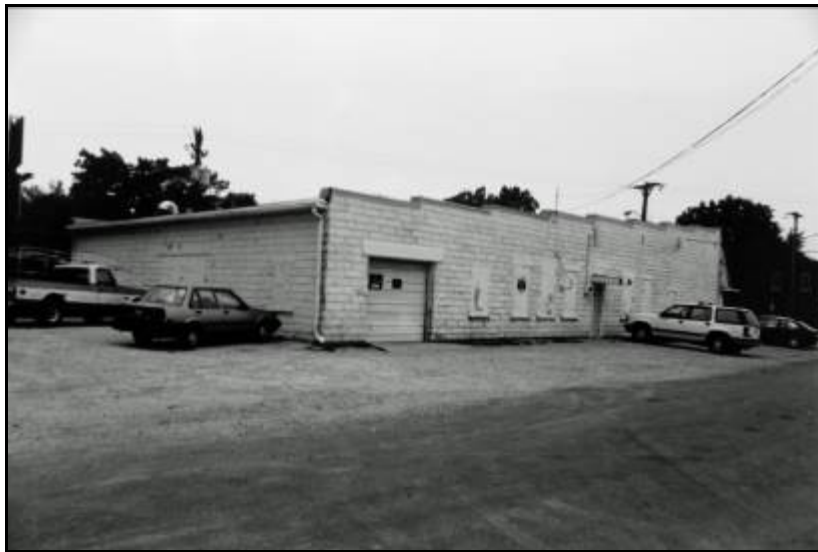
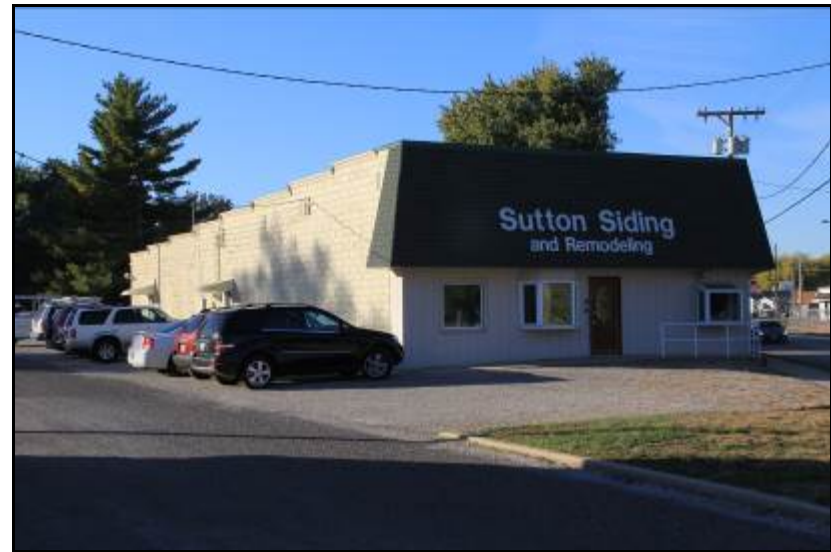
Sequence Number	Map Code	1994/95 Negative #	Address/Location	Type	Date Built	Historic Function	1994/95 Comments	2012/13 Comments and Photo Image #
234	19/13	19/13, IMG_4584	1926 Peoria Rd.	2	Ca. 1920s-30s	Auto Service (?)	Structure looks very much like it was built for auto service business; has stepped parapet and block construction.	Although the use of this building in 1994/5 was uncertain, it is thought to have been an historic period auto service facility. It is used today as the shop for "Sutton Siding and Remodeling." IMG_4085

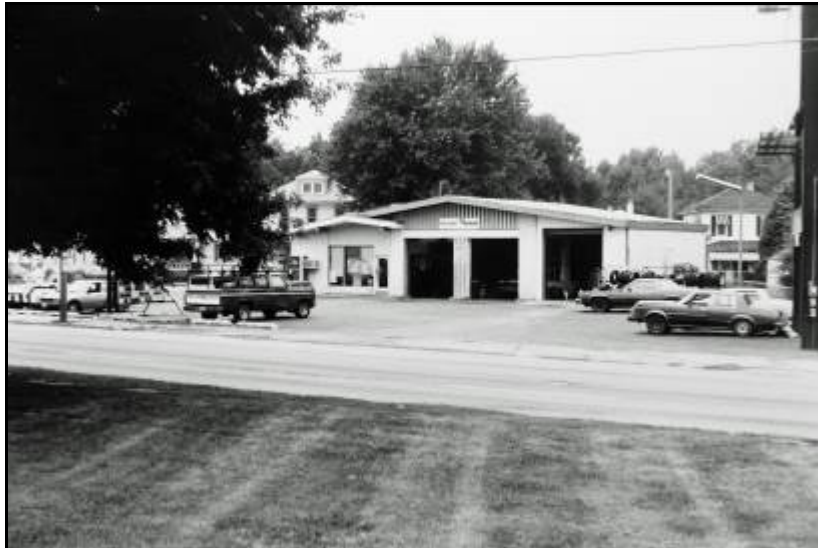
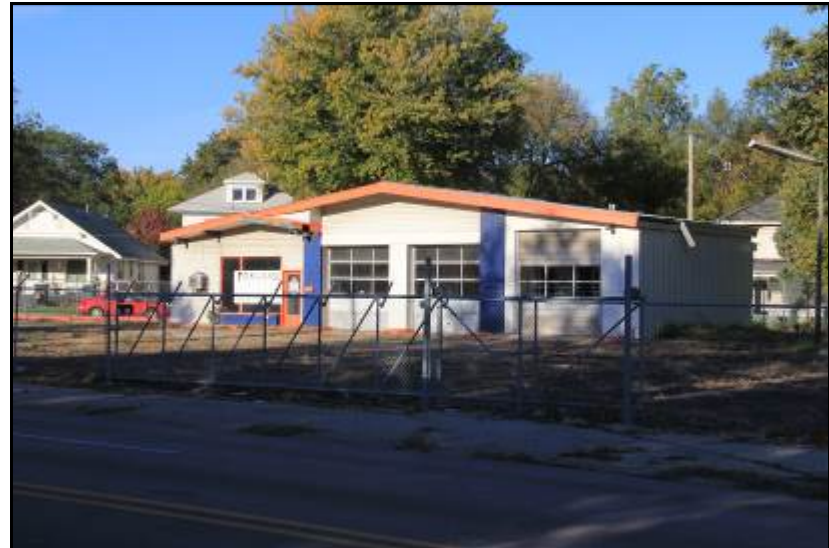
Sequence Number	Map Code	1994/95 Negative #	Address/Location	Type	Date Built	Historic Function	1994/95 Comments	2012/13 Comments and Photo Image #
235	19/12	19/12, IMG_4585	1921 Peoria Rd.	2	Ca. 1970s	Gas/Service	Possible former "Shell" station.	This old gas station is now vacant and for sale. IMG_4086
