Route 66 in Illinois:

(2012/13 Update and Expansion of the Original 1994/95 Survey)

IDOT Sequence #17337 & #17337A

22 December 2013

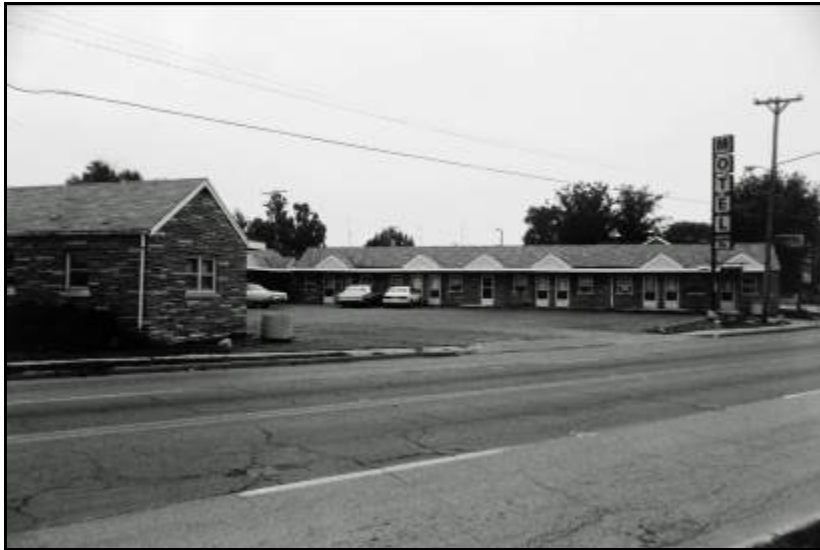
No longer extant

Sequence Number	Map Code	1994/95 Negative #	Address/Location	Type	Date Built	Historic Function	1994/95 Comments	2012/13 Comments and Photo Image #
236	19/11	19/11, IMG_4586	Peoria Rd. & Ridgely	2	Ca. 1950s	Motel	“U” shaped motel with stone veneer, gabled roof and small, gabled dormers over room doors – “Capital city Motel.”	Motel gone. Now a vacant lot.

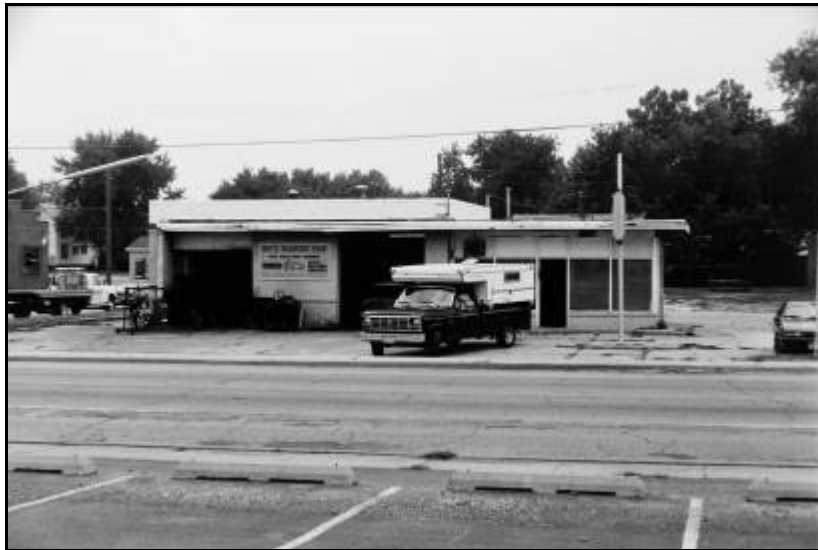
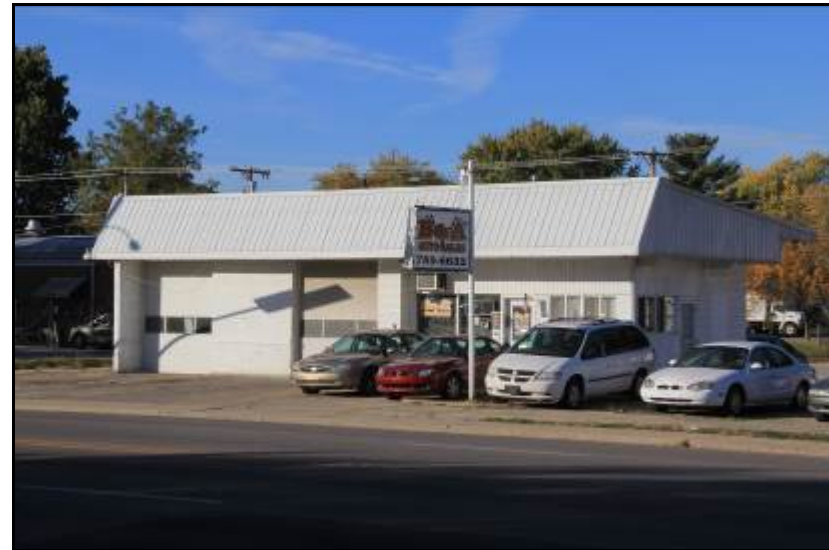
Sequence Number	Map Code	1994/95 Negative #	Address/Location	Type	Date Built	Historic Function	1994/95 Comments	2012/13 Comments and Photo Image #
237	19/10	19/10, IMG_4587	Peoria Rd. & Black Ave. (NW corner)	2	Ca. 1950s	Gas/Service	Brick garage with largely glass panel office – now “Ray’s Radiator Shop.”	Now “B& K Auto Sales,” this structure has been significantly changed with a new roof as well as new windows in the office area. IMG_4087

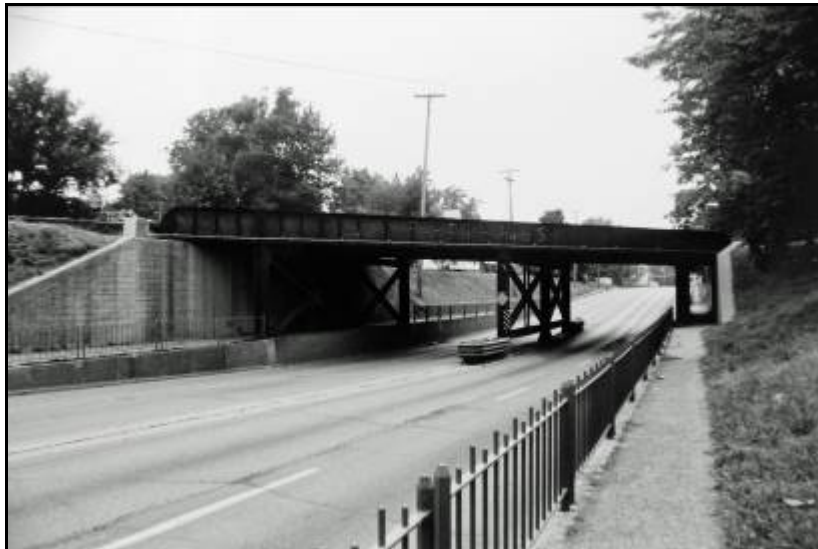
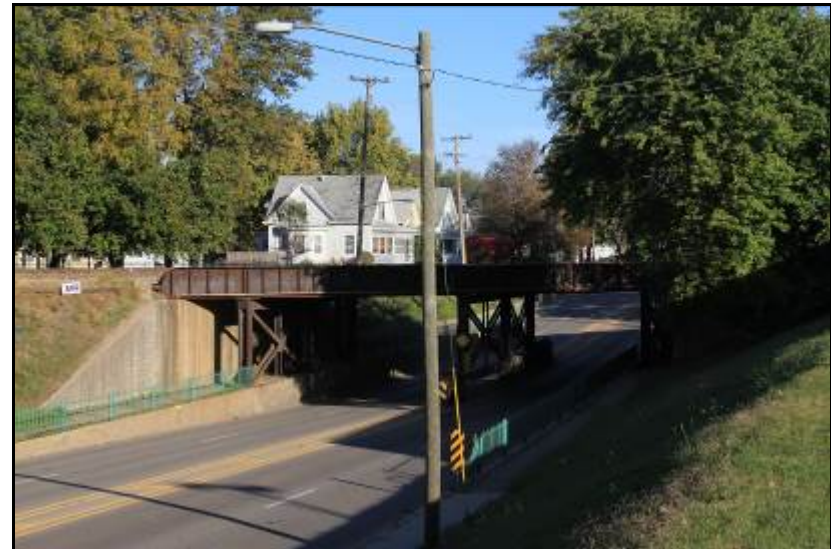
Sequence Number	Map Code	1994/95 Negative #	Address/Location	Type	Date Built	Historic Function	1994/95 Comments	2012/13 Comments and Photo Image #
238	19/09	19/09, IMG_4588	9 th St. & ICG RR	2	Ca. Early 20 th Century	RR Overpass	Heavy duty, fabricated "I" beam girders and uprights.	No significant changes appear to have affected this RR overpass. IMG_4088

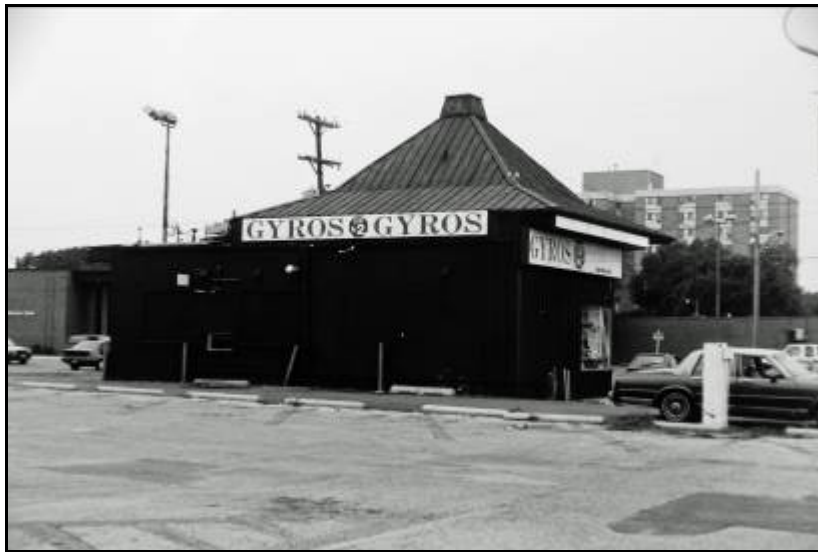
No longer extant

Sequence Number	Map Code	1994/95 Negative #	Address/Location	Type	Date Built	Historic Function	1994/95 Comments	2012/13 Comments and Photo Image #
239	19/08	19/08, IMG_4589	9 th St. & E. N Grand	2	Ca. 1960s	Restaurant	Building form suggests an old “Kentucky Fried Chicken” restaurant or possible drive-in; substantially remodeled – now “Gyros.”	This building has been replaced by a new “CVS” pharmacy.

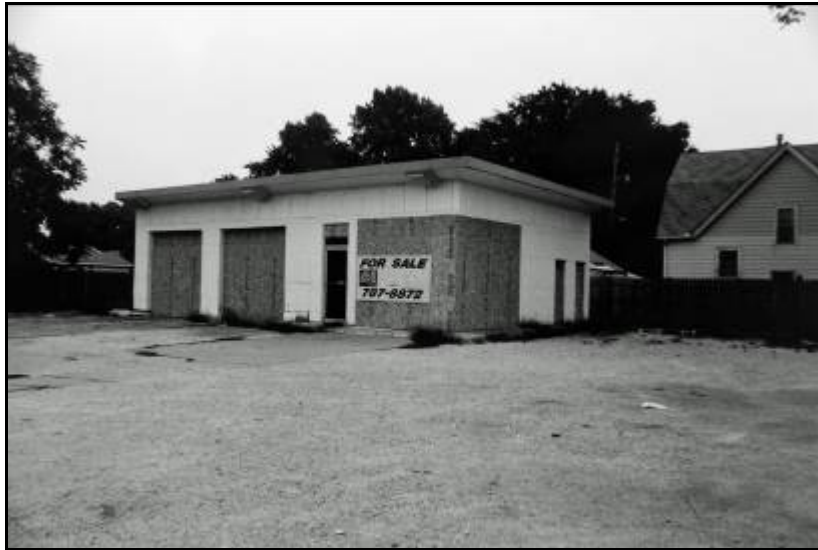
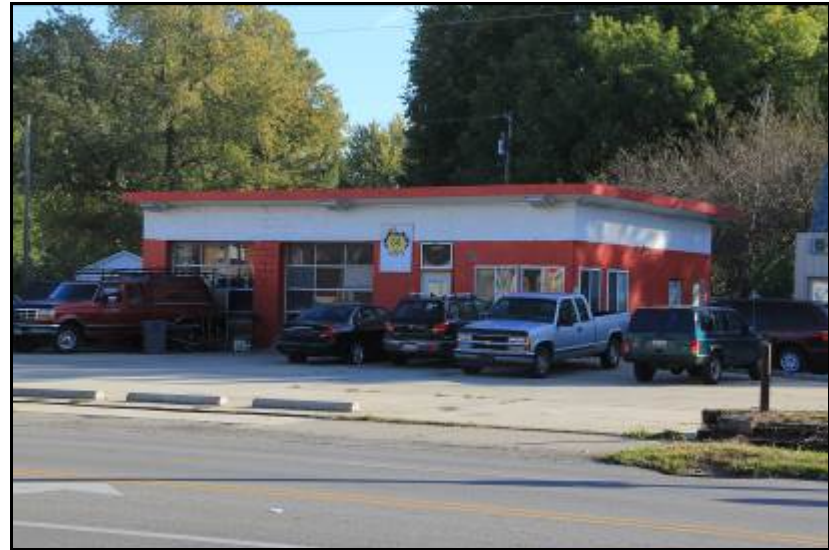
Sequence Number	Map Code	1994/95 Negative #	Address/Location	Type	Date Built	Historic Function	1994/95 Comments	2012/13 Comments and Photo Image #
240	19/07	19/07, IMG_4590	1108 9 th St.	2	Ca. 1950s-60s	Gas/Service	Former gas station with enamel panel sheathing – vacant and for sale.	Few, if any, stylistic changes have been made to this building, which now operates as “Route 66 Auto.” IMG_4089

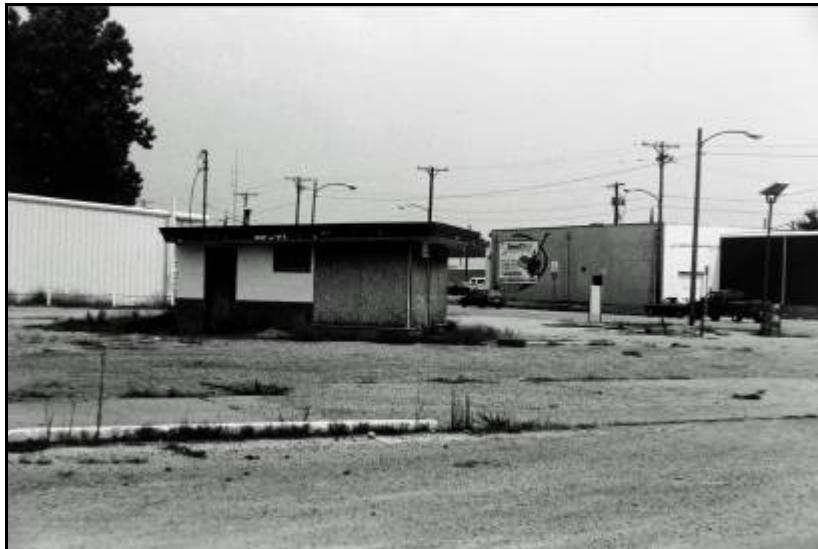
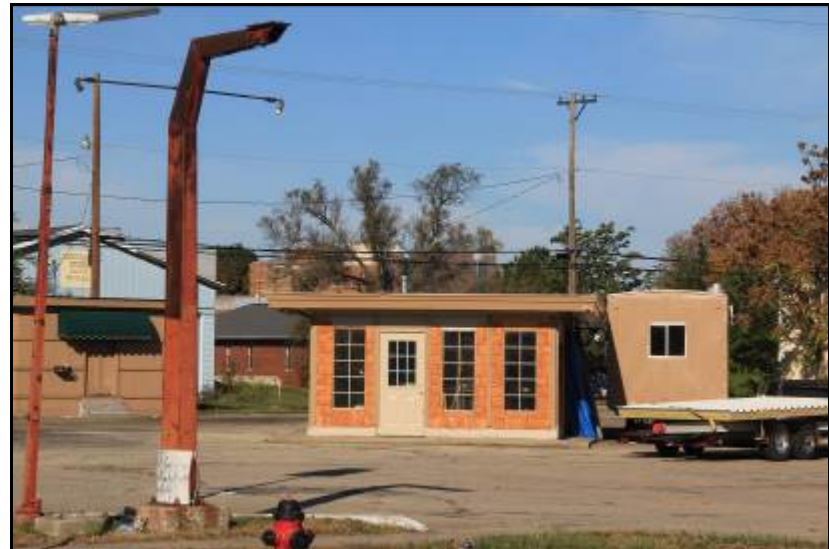
Sequence Number	Map Code	1994/95 Negative #	Address/Location	Type	Date Built	Historic Function	1994/95 Comments	2012/13 Comments and Photo Image #
246	19/04	19/04, IMG_4596	9 th St. & E. Allen St.	2	Ca. 1960s	Gas Station	Small, brick and glass gas station – vacant.	This small, former gas station remains, although it has been modified. IMG_4093

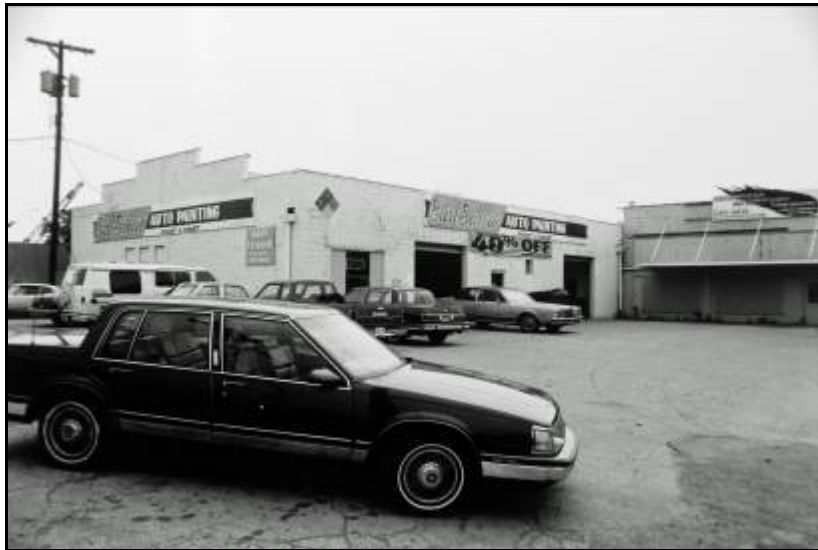
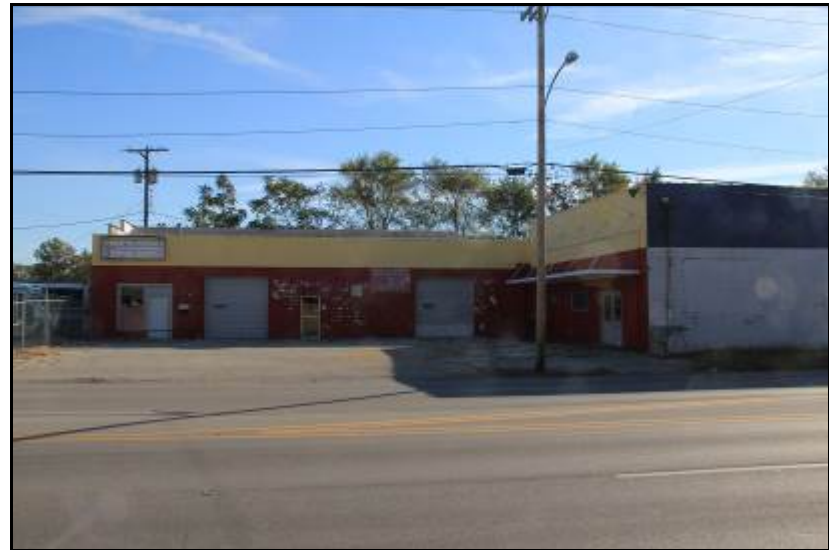
Sequence Number	Map Code	1994/95 Negative #	Address/Location	Type	Date Built	Historic Function	1994/95 Comments	2012/13 Comments and Photo Image #
247	19/03	19/03, IMG_4597	1110 S. 9 th St.	2	Ca. 1940s	Auto Sales/Service	Concrete block structure with stepped parapet endwalls – may have been associated with an auto sales/service business – now “Earl Scheib” auto painting.	This building remains, albeit with some changes. Its current disposition is unclear. IMG_4094

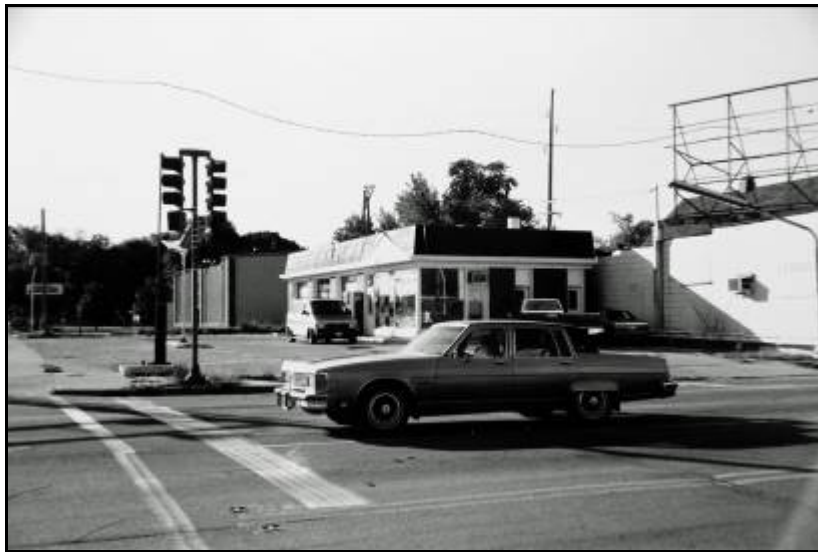
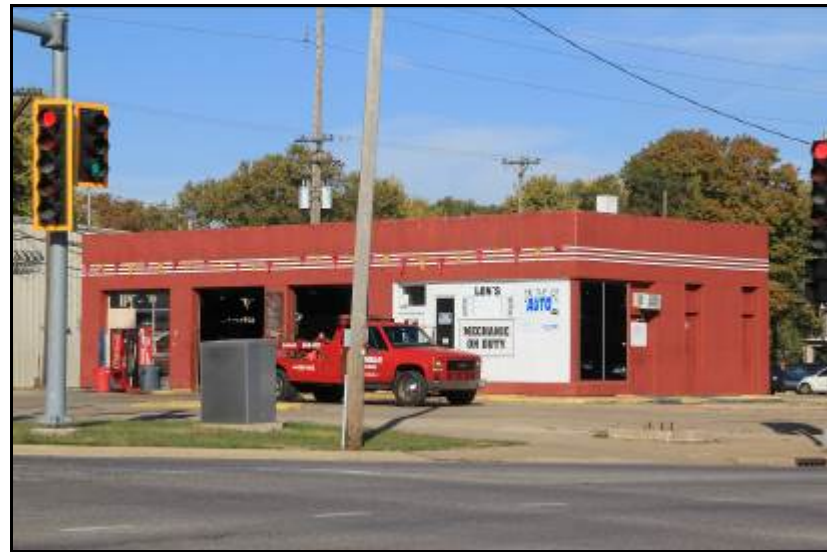
Sequence Number	Map Code	1994/95 Negative #	Address/Location	Type	Date Built	Historic Function	1994/95 Comments	2012/13 Comments and Photo Image #
248	23/06	23/06, IMG_4598	South Grand & 9 th St.	2	Ca. 1960s-70s	Gas/Service	Former gas station.	Now operating as “Lon’s On The Go Auto,” much of the building’s exterior fabric has been changed, as well as painted. IMG_4097

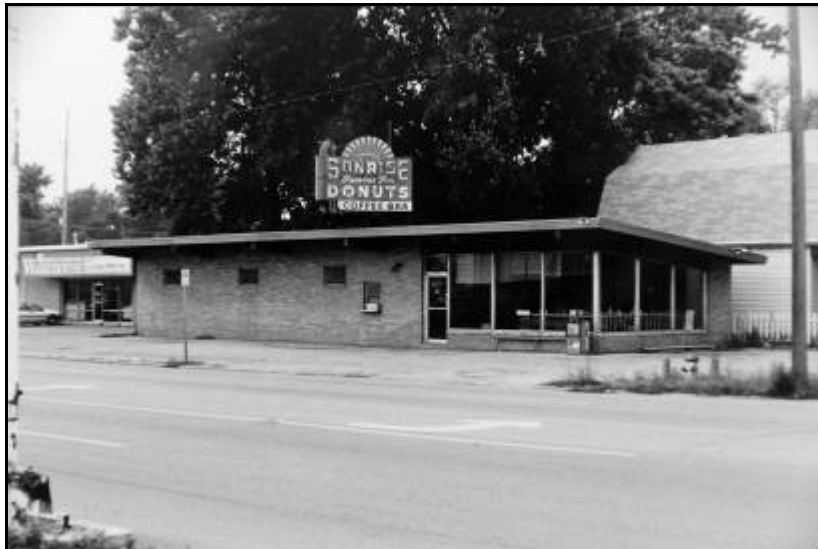
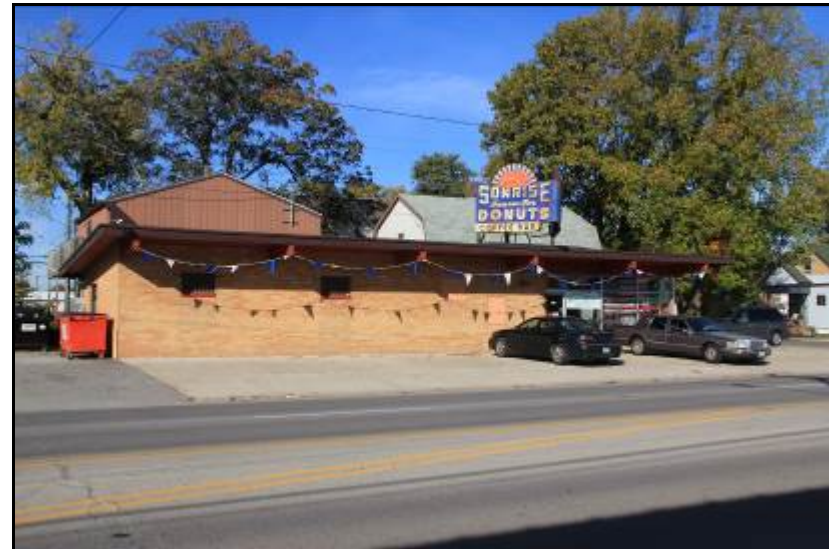
Sequence Number	Map Code	1994/95 Negative #	Address/Location	Type	Date Built	Historic Function	1994/95 Comments	2012/13 Comments and Photo Image #
249	19/01	19/01-02, IMG_4599	1101 S. 9 th St.	2	Ca. 1950s	Café	Brick and glass structure with gently-pitched, shed roof; closed (?) – “Sunrise Donuts.”	“Sunrise Donuts” remains today with few structural changes. IMG_4096

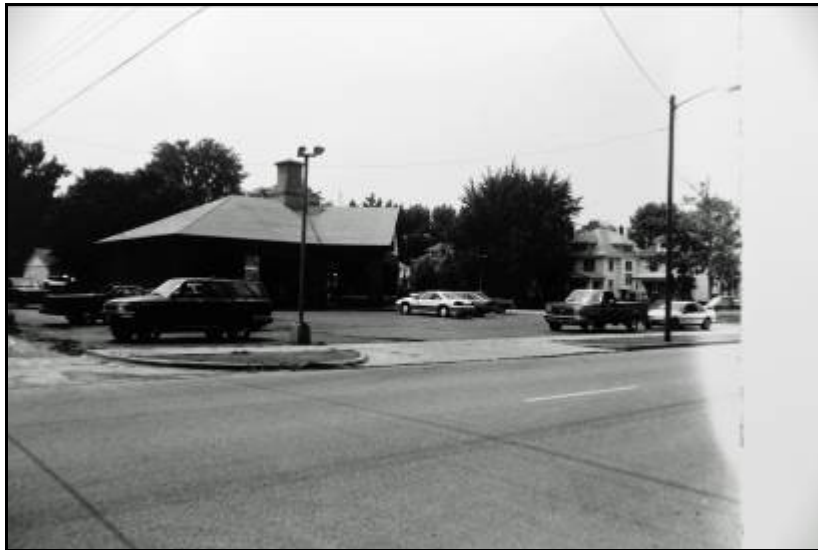
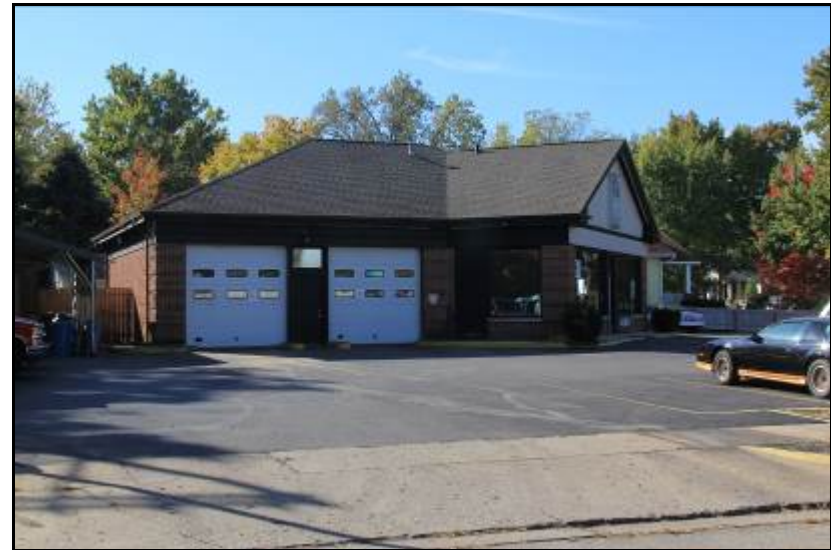
Sequence Number	Map Code	1994/95 Negative #	Address/Location	Type	Date Built	Historic Function	1994/95 Comments	2012/13 Comments and Photo Image #
250	18/25	18/25, IMG_4600	1900 S. 6 th St.	2	Ca. 1960s-70s	Gas/Service	Possibly built as a "Standard (Amoco)" station(?).	Some changes have occurred at this building, for instance the loss of the cupola. That notwithstanding, it houses today "Accent Auto." IMG_4101

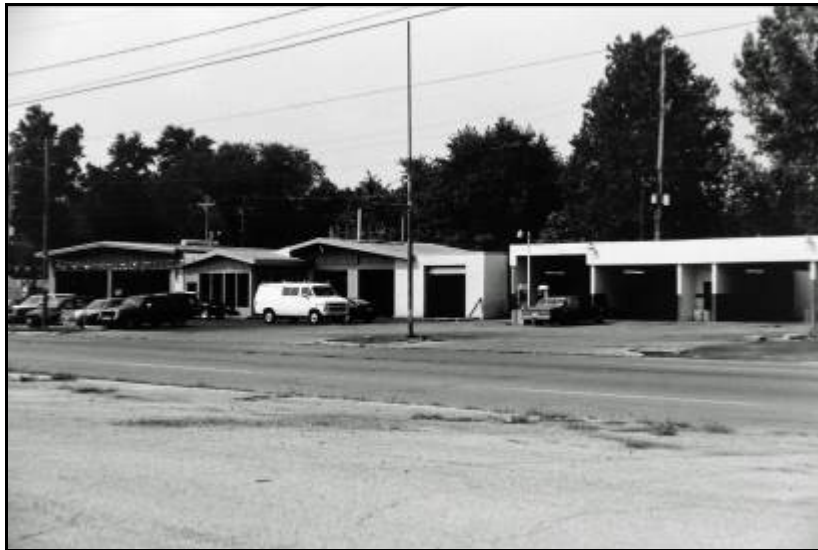
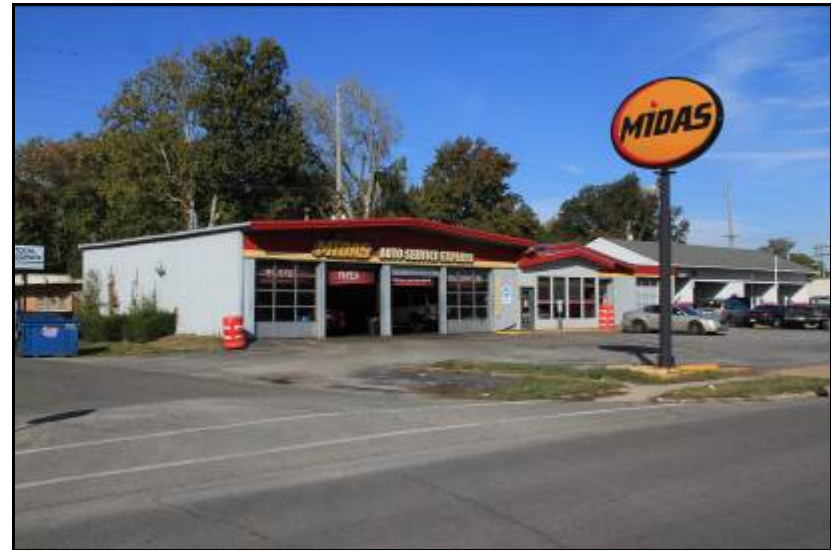
Sequence Number	Map Code	1994/95 Negative #	Address/Location	Type	Date Built	Historic Function	1994/95 Comments	2012/13 Comments and Photo Image #
251	18/24	18/24, IMG_4601	1529 S. 9 th St.	2	Ca. 1960s-70s	Gas/Service	Large auto care complex and car wash has developed around what looks like a 1960s or 1970s "Shell" station.	This facility today houses a "Midas Muffler" outlet. A shallow, gabled roof appears to have been built over the car wash portion of the business. IMG_4098

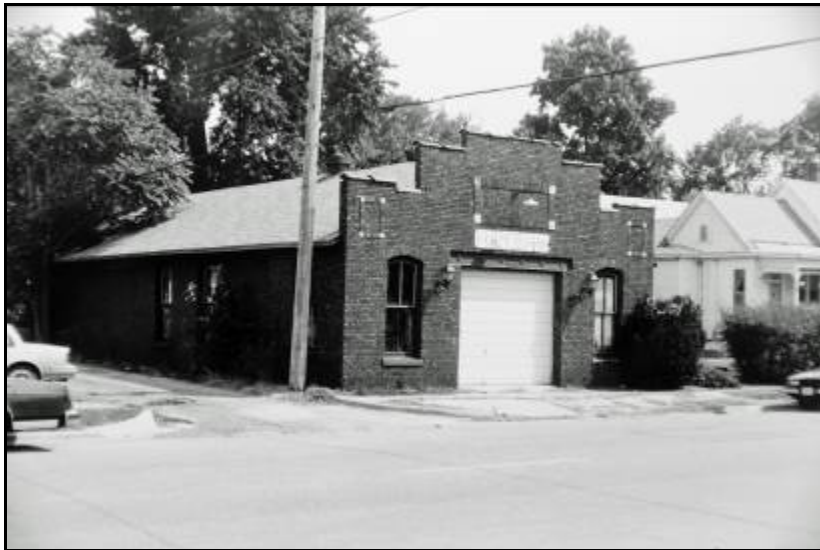
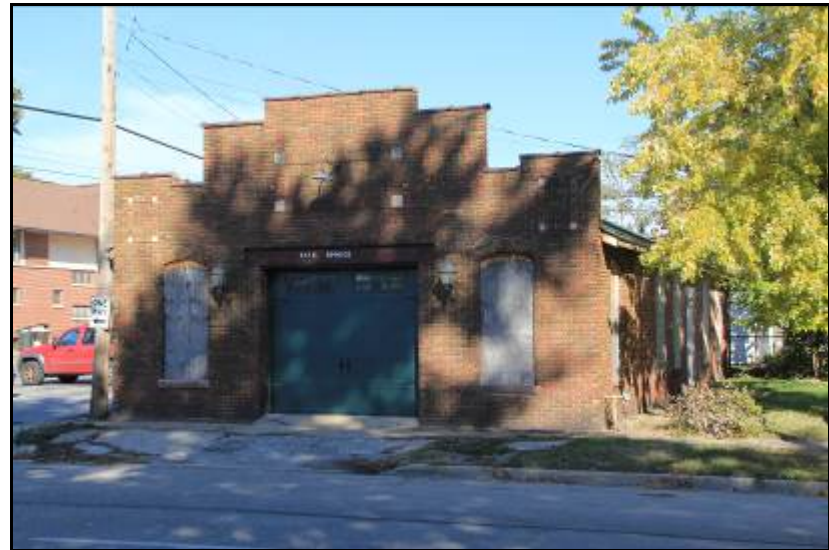
Sequence Number	Map Code	1994/95 Negative #	Address/Location	Type	Date Built	Historic Function	1994/95 Comments	2012/13 Comments and Photo Image #
252	18/23	18/23, IMG_4602	617 E. Spruce St.	2	Ca. 1910s-20s	Auto Service	Brick structure with stepped, parapet endwall and segmental-arched windows; substantially pre-dates the early 1960s use of Spruce for business 66.	Changes to this modest auto service building include the installation of a new overhead door, as well as the boarding over of its various windows. IMG_4102

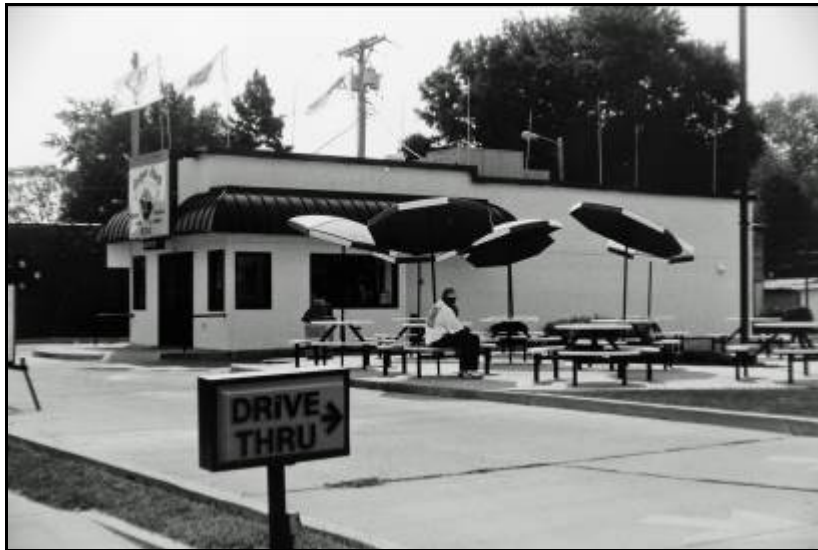
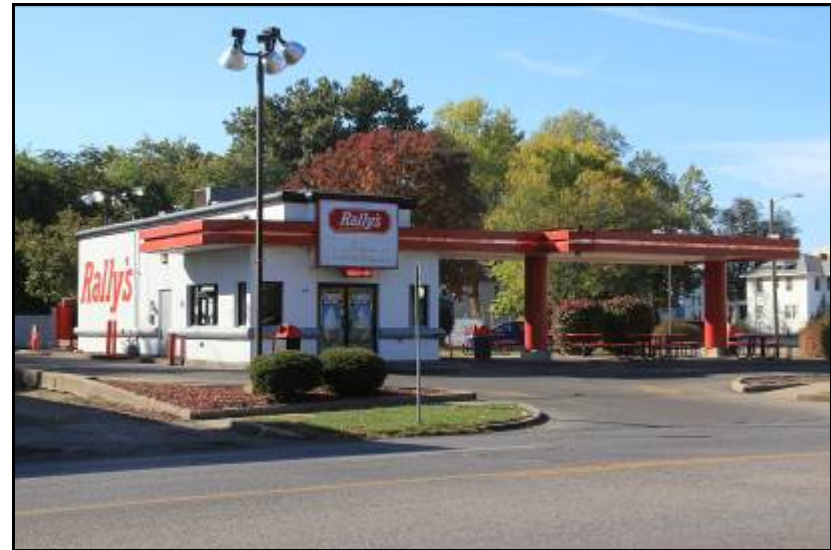
Sequence Number	Map Code	1994/95 Negative #	Address/Location	Type	Date Built	Historic Function	1994/95 Comments	2012/13 Comments and Photo Image #
253	18/22	18/22, IMG_4603	710 South Grand Ave. East	2	Ca. 1960s-70s	Drive-In	Structure very possibly post-dates the pre-1960 use of South Grand East for Business 66.	Acknowledging the possibility that this building does post-date Business 66, its character has been altered with the flat roof addition. IMG_4100

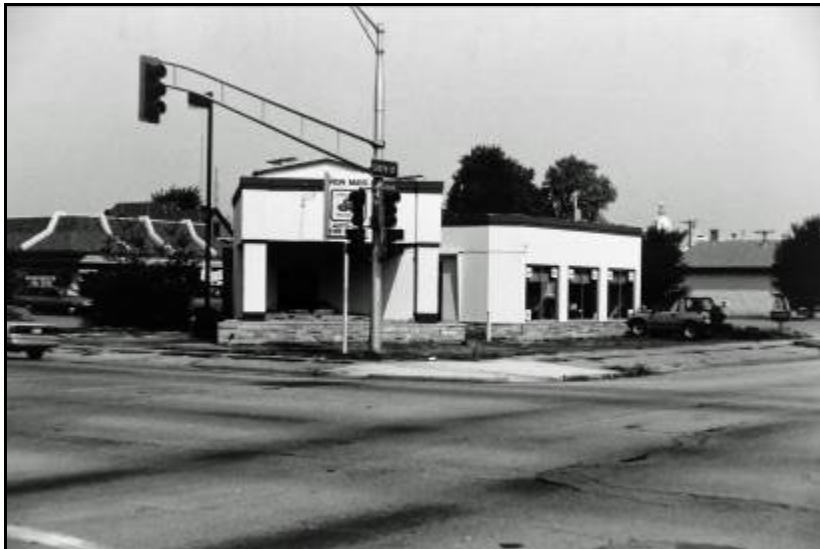
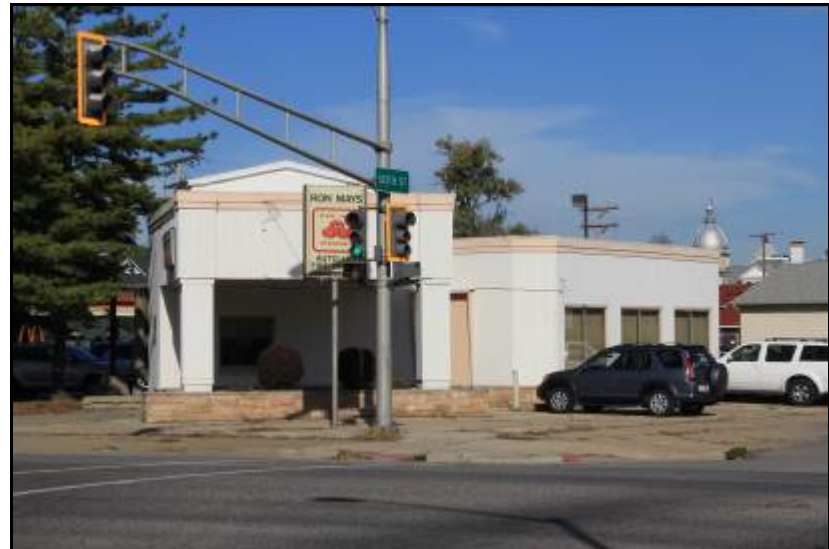
Sequence Number	Map Code	1994/95 Negative #	Address/Location	Type	Date Built	Historic Function	1994/95 Comments	2012/13 Comments and Photo Image #
254	18/21	18/21, IMG_4604	531 South Grand Ave. East	2	Unknown	Gas Station	Old gas station has been substantially remodeled – now used as office for “State Farm Insurance.”	Few consequential changes have occurred to this building. IMG_4099

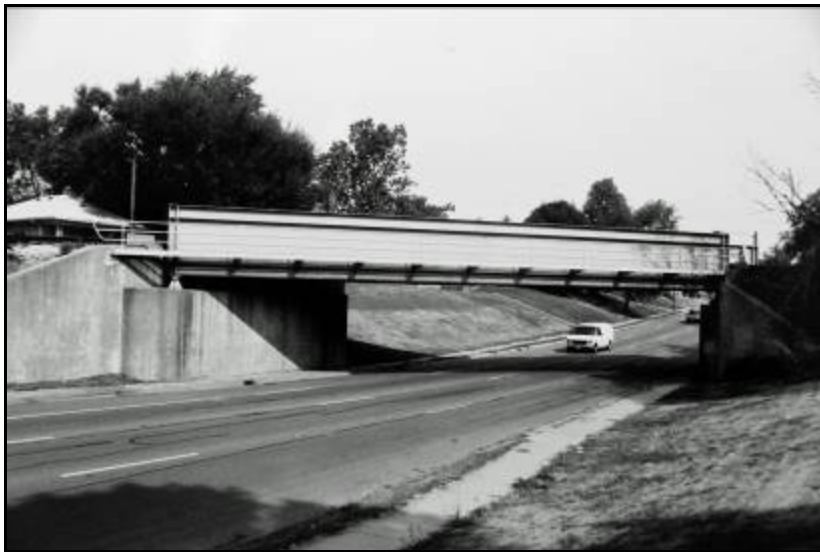
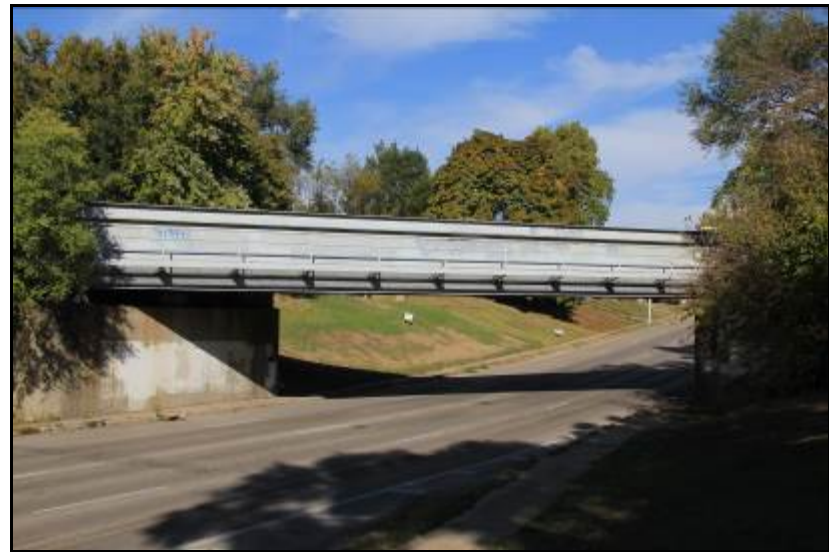
Sequence Number	Map Code	1994/95 Negative #	Address/Location	Type	Date Built	Historic Function	1994/95 Comments	2012/13 Comments and Photo Image #
257	18/18	18/18, IMG_4607	S. 5 th & N&W RR	2	1961	RR Overpass	Bridge #084-0032 – plate notes: “Wabash RR, Built 1961 by State of Illinois, F.A. RT. City 5, US 66 Sec 109, 1.SB Proj. UG 166-37, Station 21+27.40; built of heavy duty “I” beams.	This bridge appears to have not been changed. IMG_4104

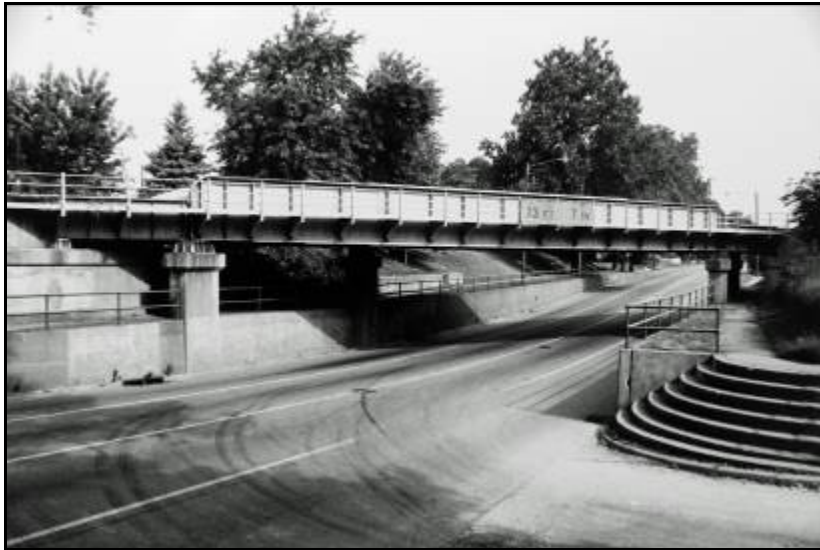
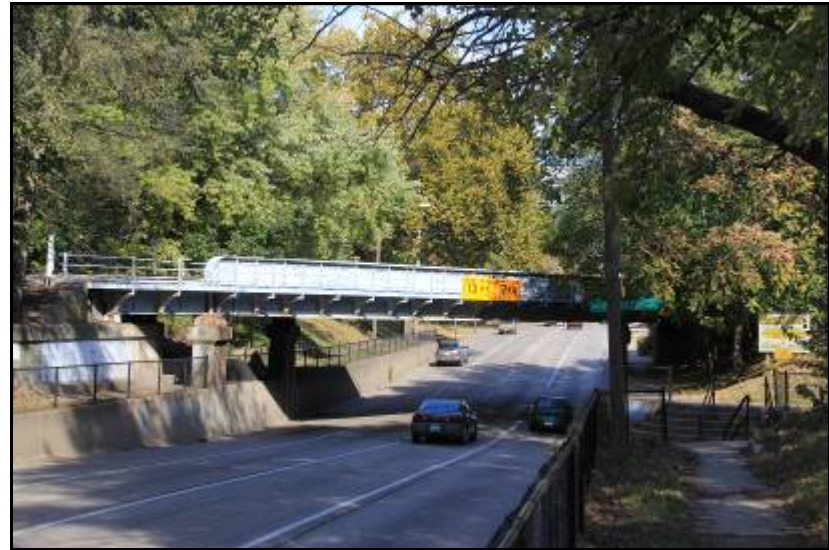
Sequence Number	Map Code	1994/95 Negative #	Address/Location	Type	Date Built	Historic Function	1994/95 Comments	2012/13 Comments and Photo Image #
258	18/17	18/17, IMG_4608	S. 6 th & N&W RR	2	Ca. 1940s-50s	RR Overpass	Bridge #084-9901 – no plate; heavy duty “I” beam construction.	This bridge appears to have not been changed. IMG_4106

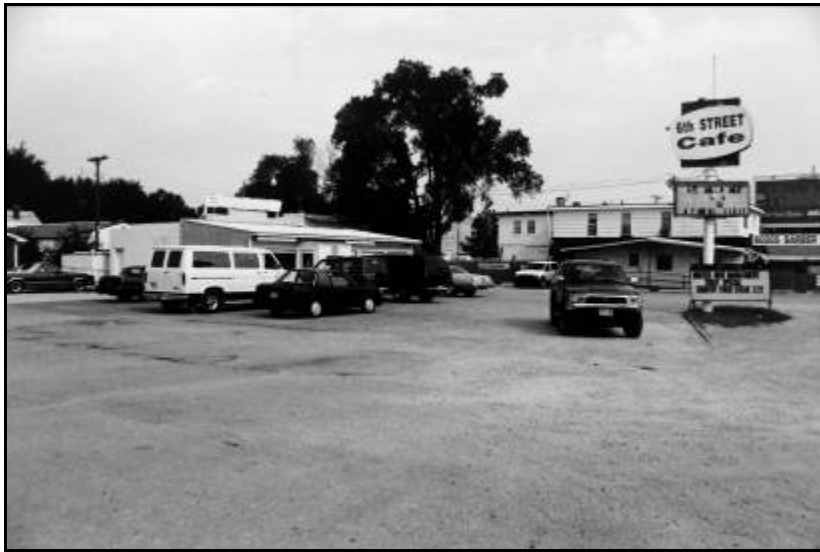
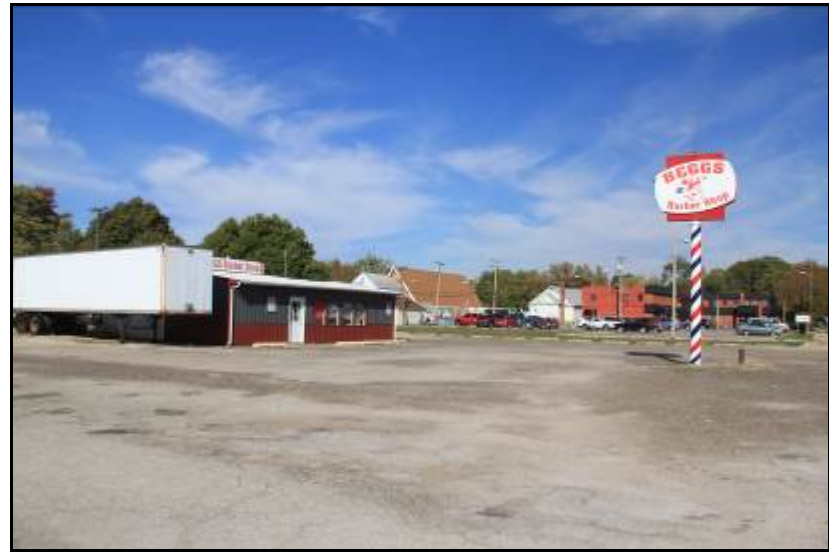
Sequence Number	Map Code	1994/95 Negative #	Address/Location	Type	Date Built	Historic Function	1994/95 Comments	2012/13 Comments and Photo Image #
259	18/16	18/16, IMG_4609	2645 S. 6 th St.	2	Ca. 1930s-40s	Café	An addition has been built onto the front of this block structure that has a stepped parapet.	The former “6 th Street Café” is now “Beggs Barber Shop.” The “Café” sign remains and has been adapted to the building’s current use. IMG_4107

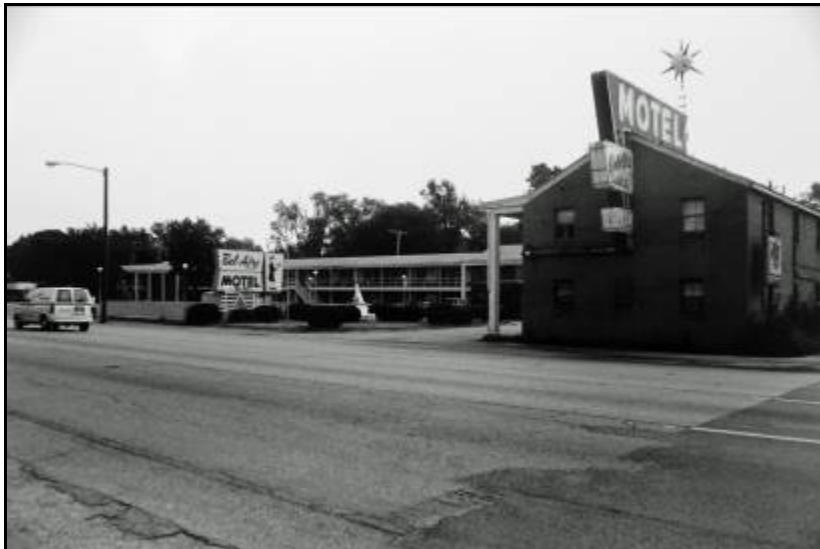
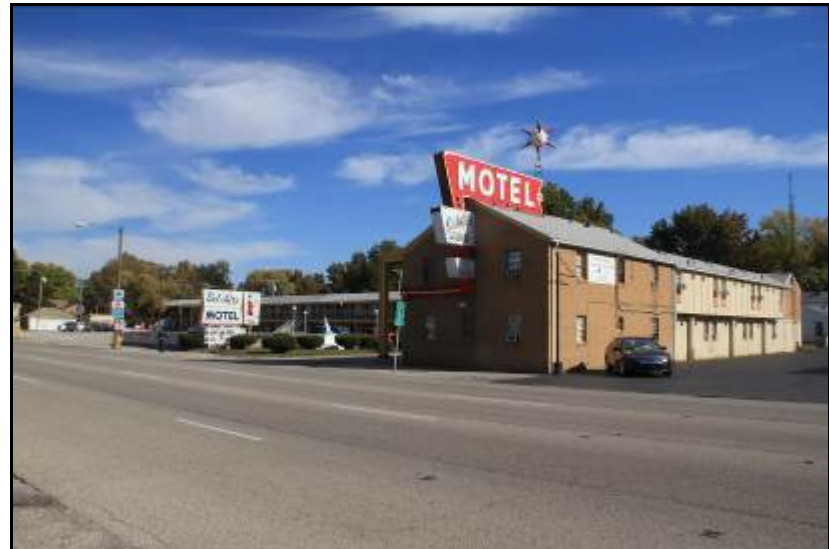
Sequence Number	Map Code	1994/95 Negative #	Address/Location	Type	Date Built	Historic Function	1994/95 Comments	2012/13 Comments and Photo Image #
260	18/15	18/15, IMG_4610	2636 S. 6 th St.	2	Ca. 1950s-60s	Motel	Two-story "L" shape, brick motel – "Bel-Aire Motel."	No consequential changes appear to have been made at the "Bel-Aire Motel." IMG_4108

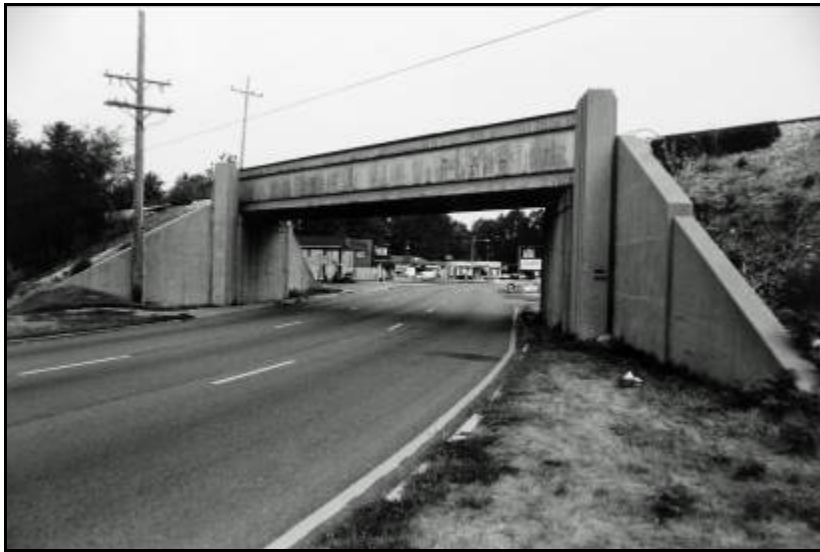
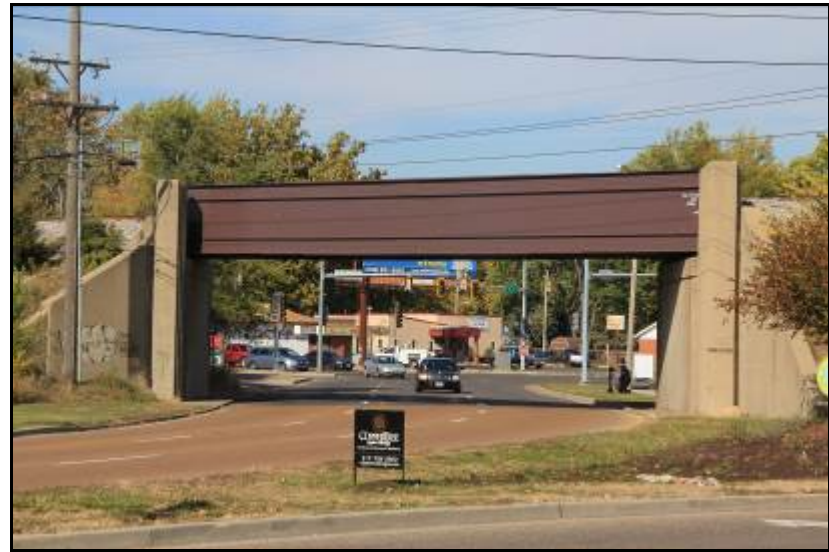
Sequence Number	Map Code	1994/95 Negative #	Address/Location	Type	Date Built	Historic Function	1994/95 Comments	2012/13 Comments and Photo Image #
261	18/14	18/14, IMG_4611	S. 5 th St. & Illinois Terminal RR	2	1961	RR Overpass	Bridge #084-0033 – plate notes “ITRR, Built 1961 by, State of Illinois, F.A. RTE.5 Sec. 110X-7SB, F.A. Pro. UG 166(40) STA. 8+22/70, Loading Cooper E50;” “I” beam construction.	This bridge would seem to have been repainted. Otherwise it is unchanged. IMG_4109

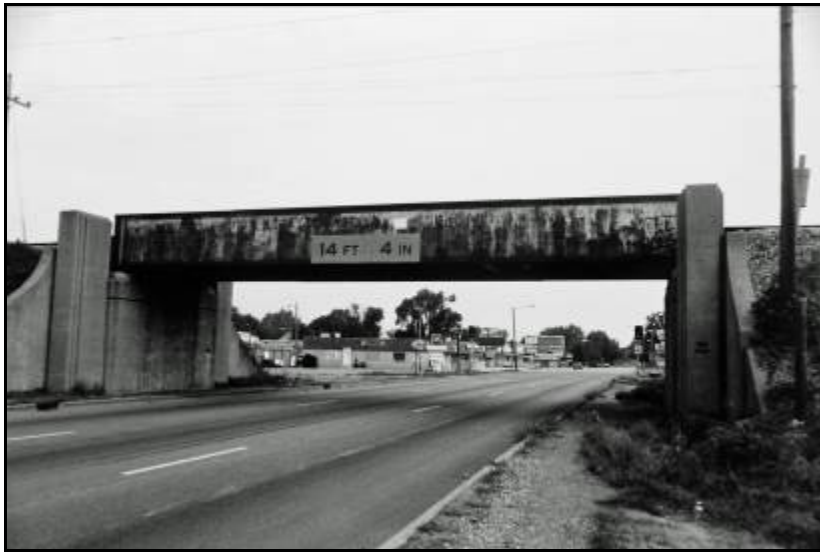
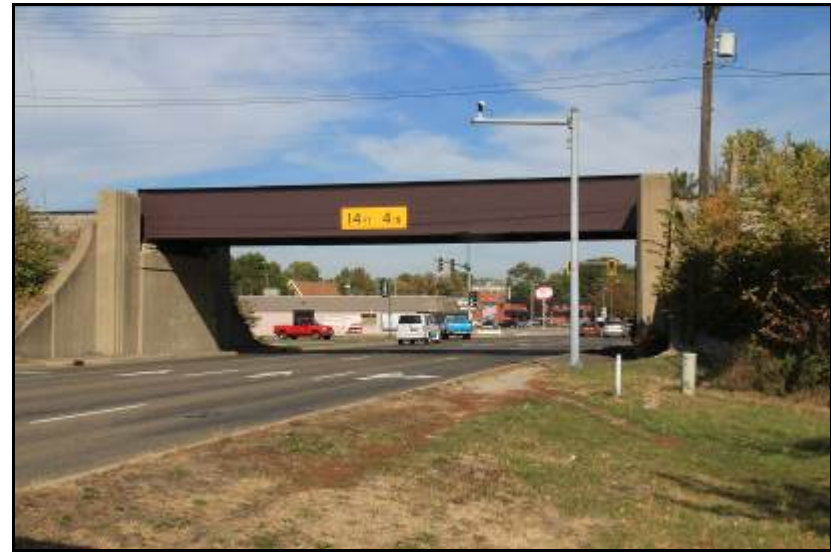
Sequence Number	Map Code	1994/95 Negative #	Address/Location	Type	Date Built	Historic Function	1994/95 Comments	2012/13 Comments and Photo Image #
262	18/13	18/13, IMG_4612	S. 6 th St. & Illinois Terminal RR	2	1949	RR Overpass	Bridge #084-9900 – plate notes: “ITRR Subway, Built 1949 by, State of Illinois, F.A. RT.5 – Sec. 110-SB-SF, F.A. Proj. FAGH-166(19) Sta. 2511, Loading E-50;” “I” beam construction.	This bridge was repainted. Otherwise it is unchanged. IMG_4110

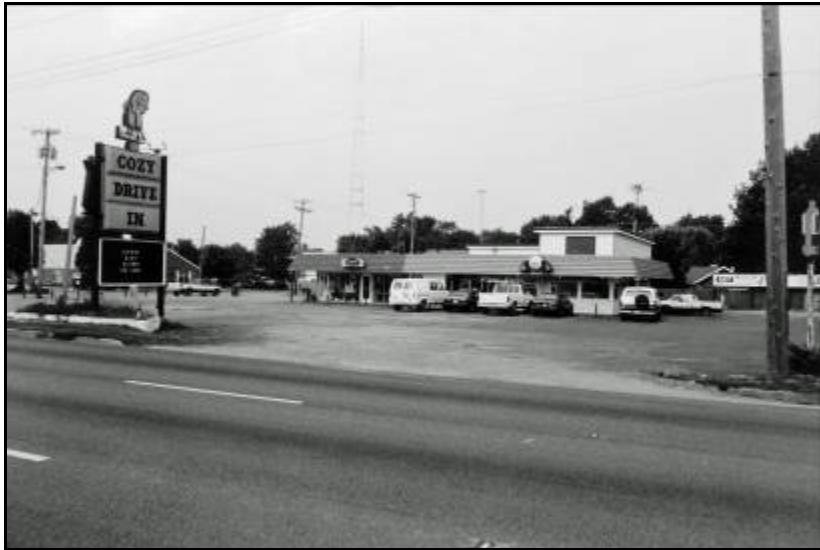
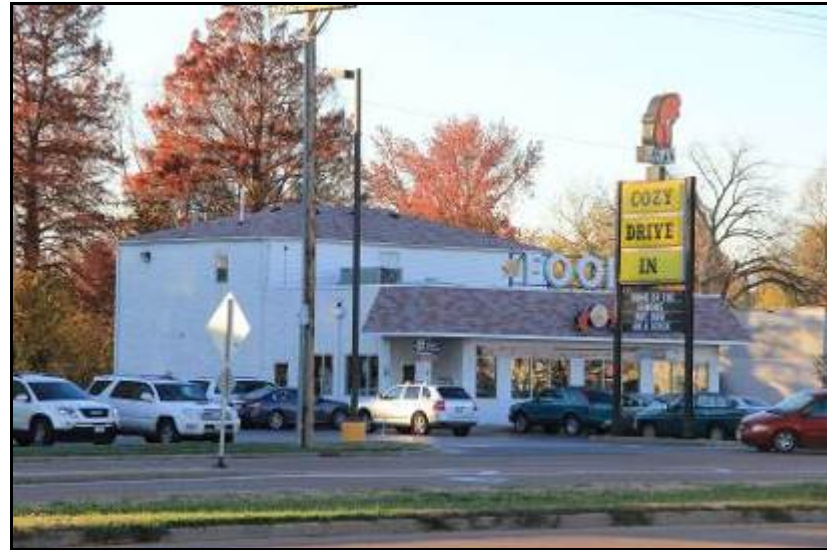
Sequence Number	Map Code	1994/95 Negative #	Address/Location	Type	Date Built	Historic Function	1994/95 Comments	2012/13 Comments and Photo Image #
263	18/12	18/12, IMG_1892	2935 S. 6 th St.	2	1949	Drive-In	"Cozy Drive-In;" see Waldmire Post Card for more information – RT 66 Hall of Fame member.	There appears to be a new, two-story, building associated with the drive-in, though the prominent "Cozy" sign remains. IMG_1426

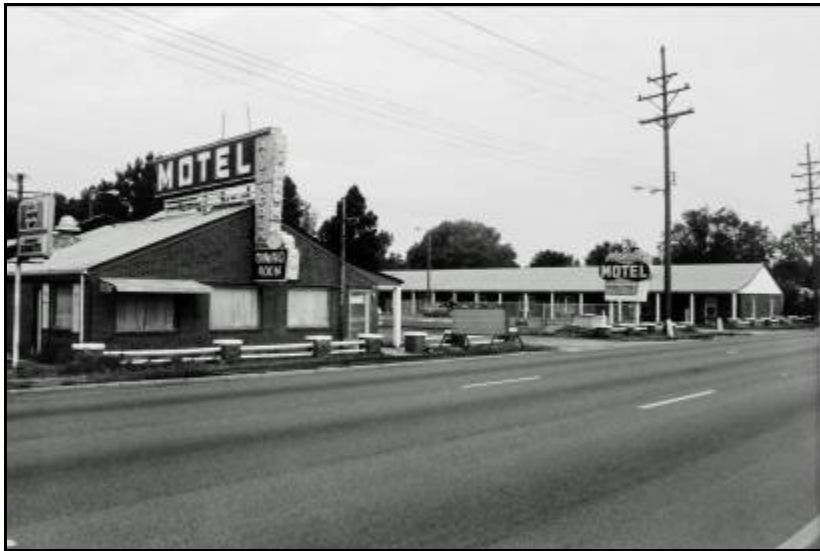
Sequence Number	Map Code	1994/95 Negative #	Address/Location	Type	Date Built	Historic Function	1994/95 Comments	2012/13 Comments and Photo Image #
264	18/11	18/11, 1893	20?? S. 6 th St.	2	Ca. 1950s	Motel	"U" shape motel built of brick – "A. Lincoln Motel" with air conditioning, TV and telephones.	Motel is now gone.

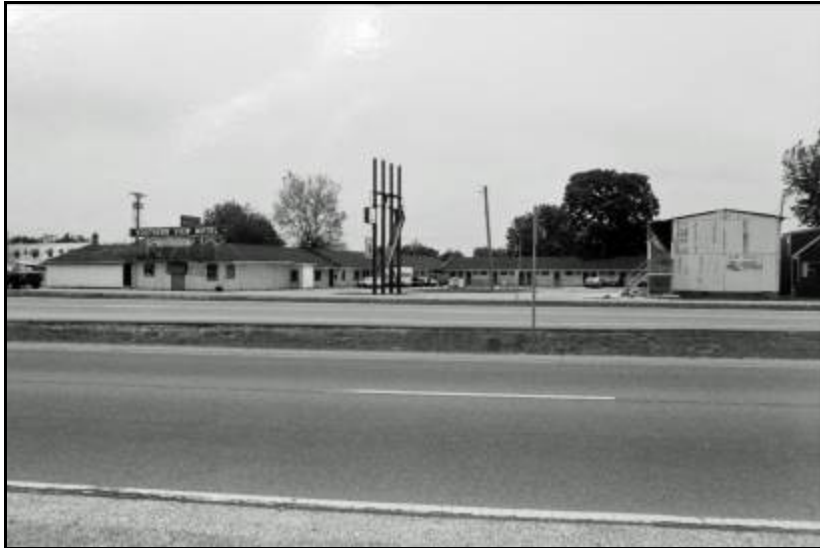
Sequence Number	Map Code	1994/95 Negative #	Address/Location	Type	Date Built	Historic Function	1994/95 Comments	2012/13 Comments and Photo Image #
265	13/27	13/27-28, IMG_1894	2??? S. 6 th St.	2	Ca. 1950s	Motel	“U” shape motel, one wing of which is two stories, brick and frame sheathing; vacant – formerly “Southern View Motel.”	Motel is now gone.

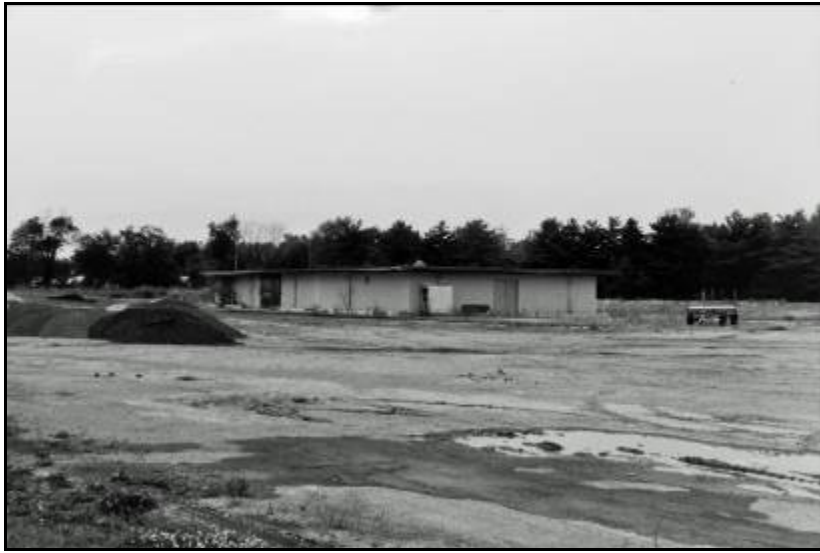
Sequence Number	Map Code	1994/95 Negative #	Address/Location	Type	Date Built	Historic Function	1994/95 Comments	2012/13 Comments and Photo Image #
266	13/30	13/30-31, IMG_1895	3??? S. 6 th St.	2	Ca. 1940s-50s	Drive-In Movie	Remains of old drive-in movie theater; including projection/snack bar building and ticket booths – formerly “66 Drive-In” according to Waldmire Post Card.	All remaining features of the former drive-in movie theater are gone. It is now a plowed farm field.
