Route 66 in Illinois:

(2012/13 Update and Expansion of the Original 1994/95 Survey)

IDOT Sequence #17337 & #17337A

22 December 2013

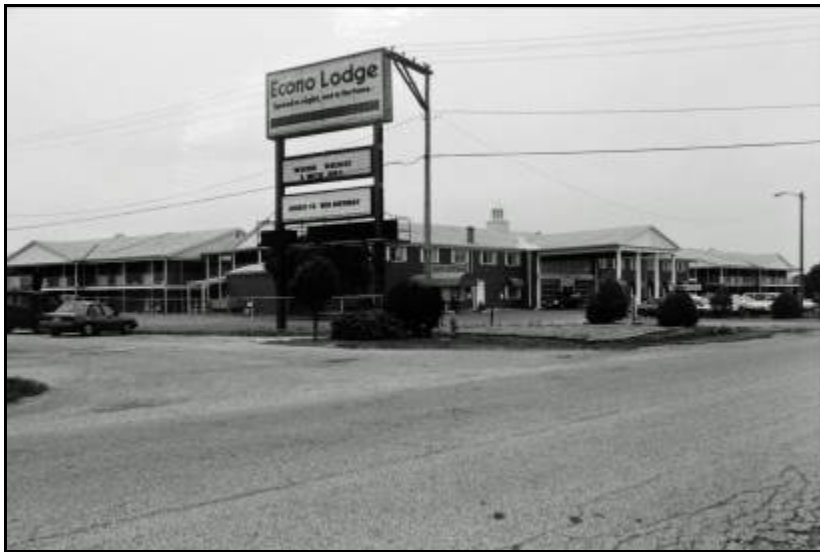
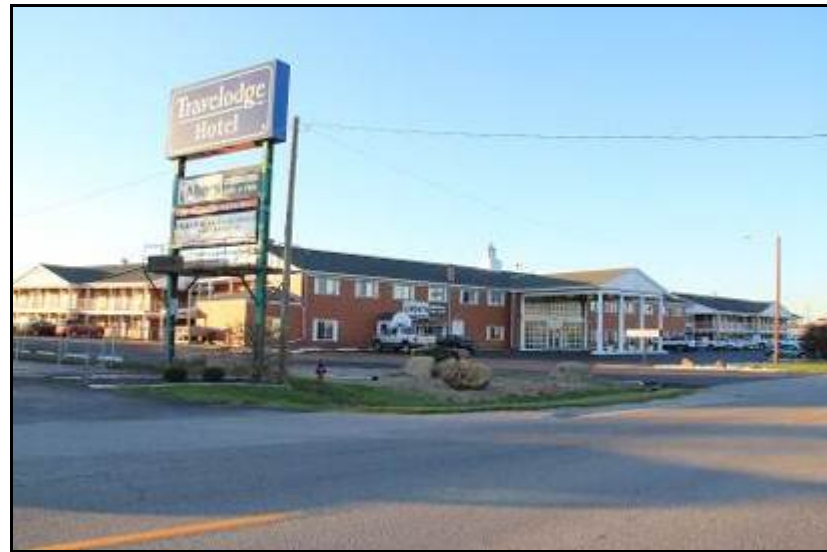
Sequence Number	Map Code	1994/95 Negative #	Address/Location	Type	Date Built	Historic Function	1994/95 Comments	2012/13 Comments and Photo Image #
267	13/29	13/29, IMG_1896	3751 S. 6 th St.	2	Ca. 1960s-70s	Motel	Large, two-story, brick, motel complex – “Econo Lodge.”	No significant changes to the old hotel were noted, except that it is now a “Travelodge,” as opposed to an “Econo-Lodge.” IMG_1427

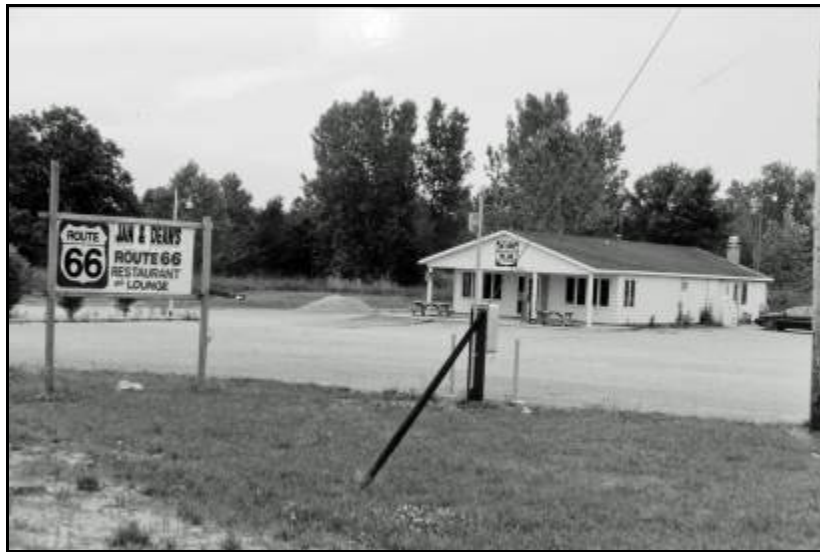
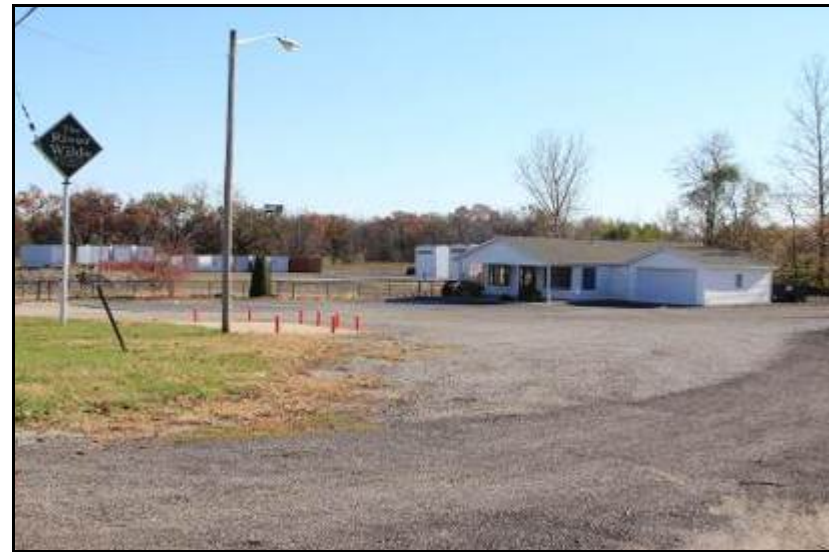
Sequence Number	Map Code	1994/95 Negative #	Address/Location	Type	Date Built	Historic Function	1994/95 Comments	2012/13 Comments and Photo Image #
268	13/12	13/12, IMG_1897	3955 Dirksen Pky.	2	Ca. 1970s-80s	Restaurant	Clapboard-sheathed building with shallow gabled-roof could well post-date USH 66 designation – “Jan & Dean’s Route 66 Restaurant and Lounge.”	The present function of this old restaurant is unknown. Note that a garage has been added to the structure. IMG_1412

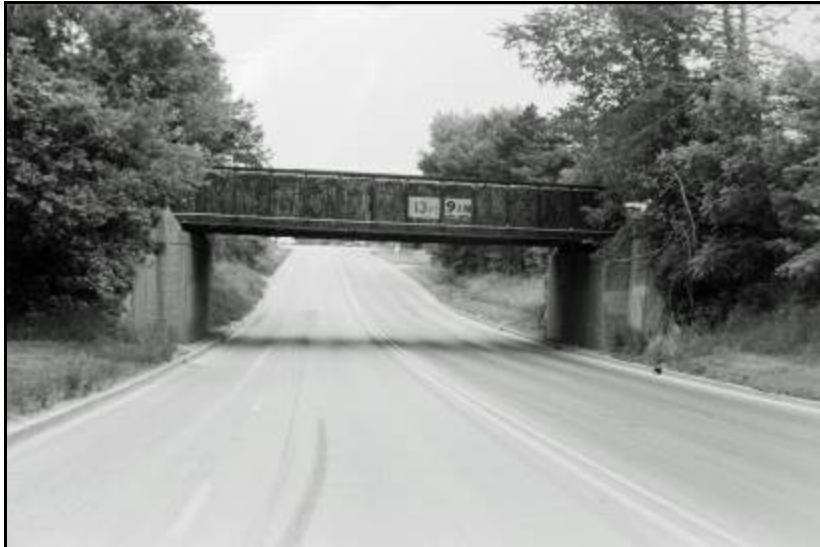
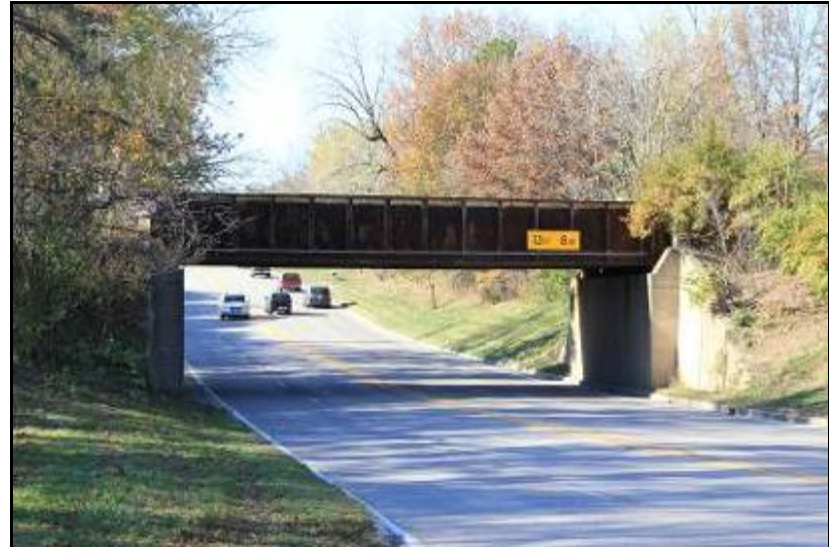
Sequence Number	Map Code	1994/95 Negative #	Address/Location	Type	Date Built	Historic Function	1994/95 Comments	2012/13 Comments and Photo Image #
269	13/13	13/13, IMG_1898	Dirksen Pky. & ICG RR	2	Unknown	RR Overpass	No plate; steel girder, single-span structure.	No apparent changes were observed on this old railroad bridge. IMG_1413

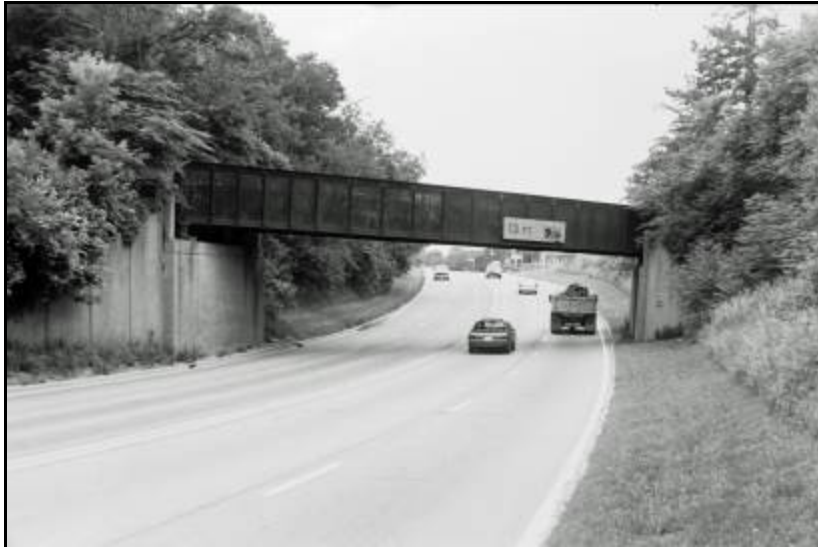
Sequence Number	Map Code	1994/95 Negative #	Address/Location	Type	Date Built	Historic Function	1994/95 Comments	2012/13 Comments and Photo Image #
270	13/14	13/14, IMG_1899	Dirksen Pky. & IT RR	2	Unknown	RR Overpass	Bridge #084-0072 – no plate; steel girder, single-span structure.	Structure is now gone.

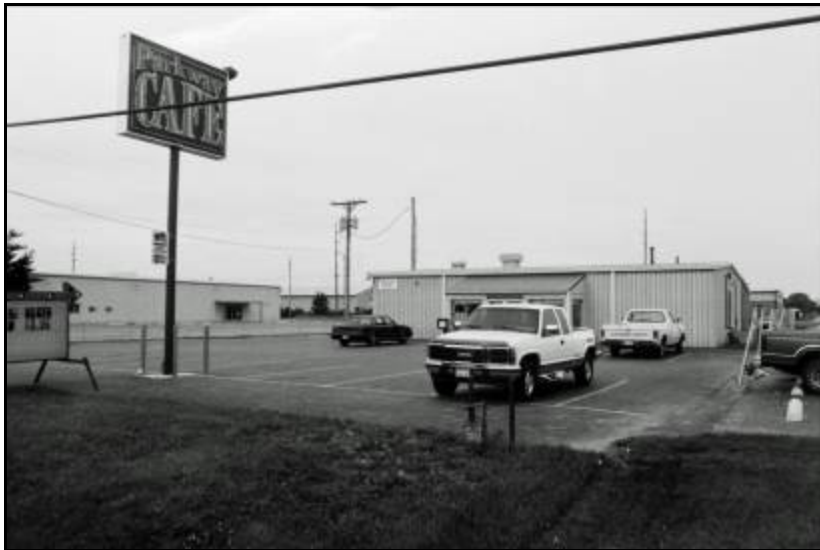
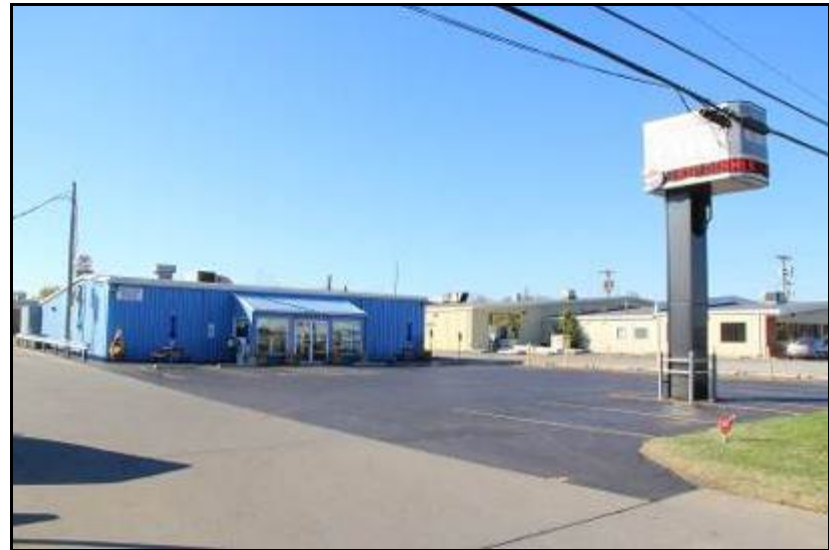
Sequence Number	Map Code	1994/95 Negative #	Address/Location	Type	Date Built	Historic Function	1994/95 Comments	2012/13 Comments and Photo Image #
271	13/15	13/15, IMG_1900	27?? Dirksen Pky.	2	Ca. 1960s-70s	Café	Simple, metal-sided structure that could post-date USH 66 designation – “Parkway Café.”	The café has a new sign on Dirksen Pky. IMG_1414

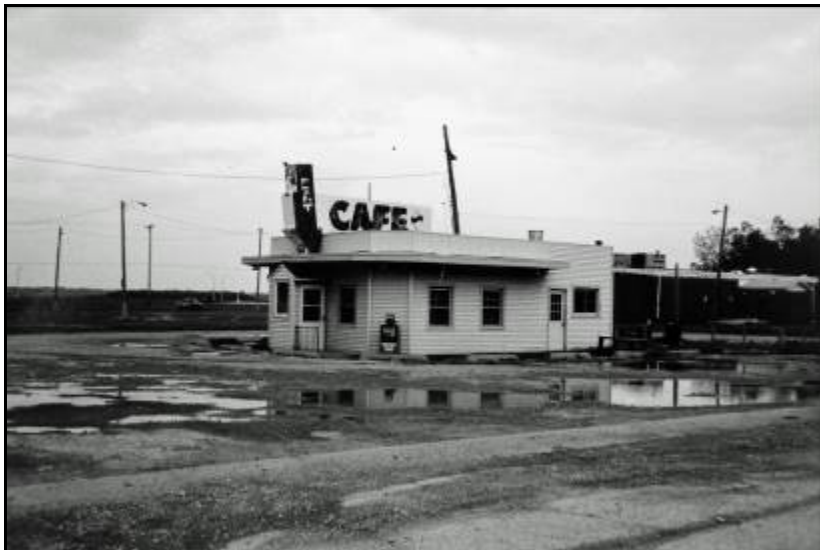
Sequence Number	Map Code	1994/95 Negative #	Address/Location	Type	Date Built	Historic Function	1994/95 Comments	2012/13 Comments and Photo Image #
272	21/01	21/01-02, IMG_1901	Dirksen Pky. & Sangamon (NE corner)	2	Ca. 1940s-50s	Café	Small, box-like café with modern, aluminum siding but a post-war era sign and shape – “Coffee Cup Café” – may be closed.	Café is now gone.

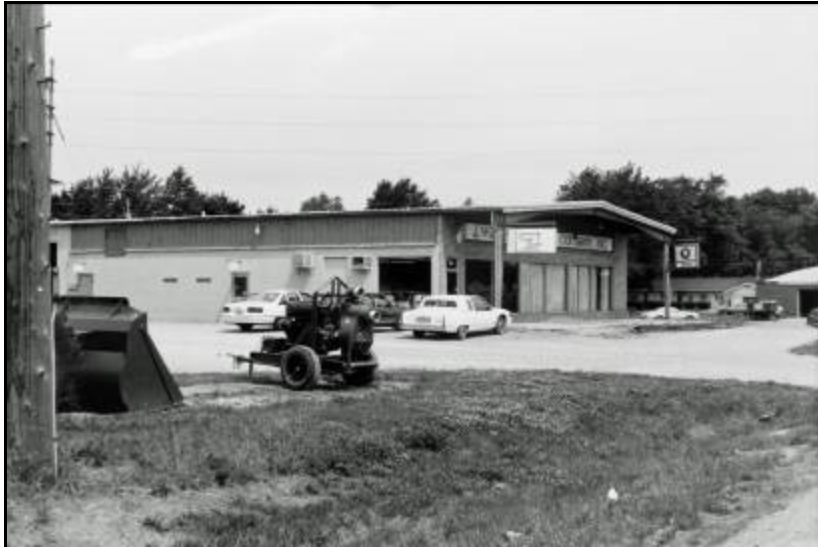
Sequence Number	Map Code	1994/95 Negative #	Address/Location	Type	Date Built	Historic Function	1994/95 Comments	2012/13 Comments and Photo Image #
274	13/17	13/17, IMG_1903	1259 Dirksen Pky.	2	Ca. 1960s	Auto Dealer (?)	Structure of block and metal siding – could possibly have been an auto dealer.	Building is now gone.

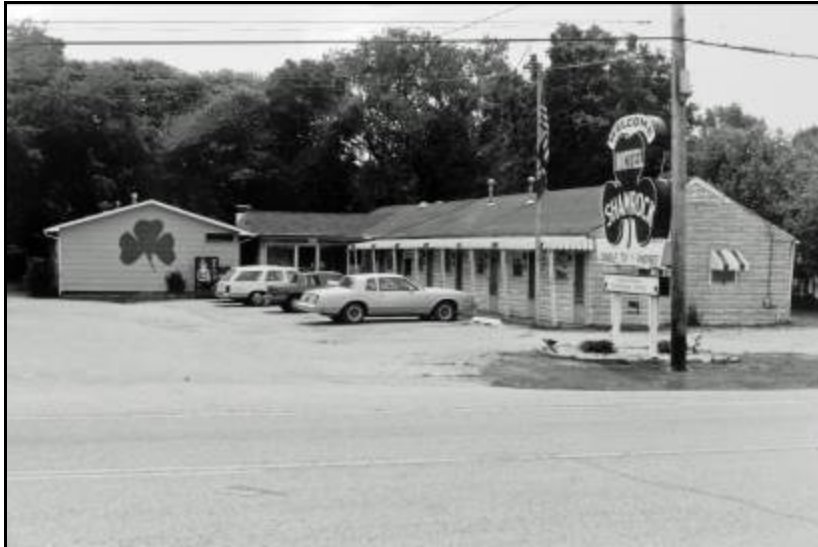
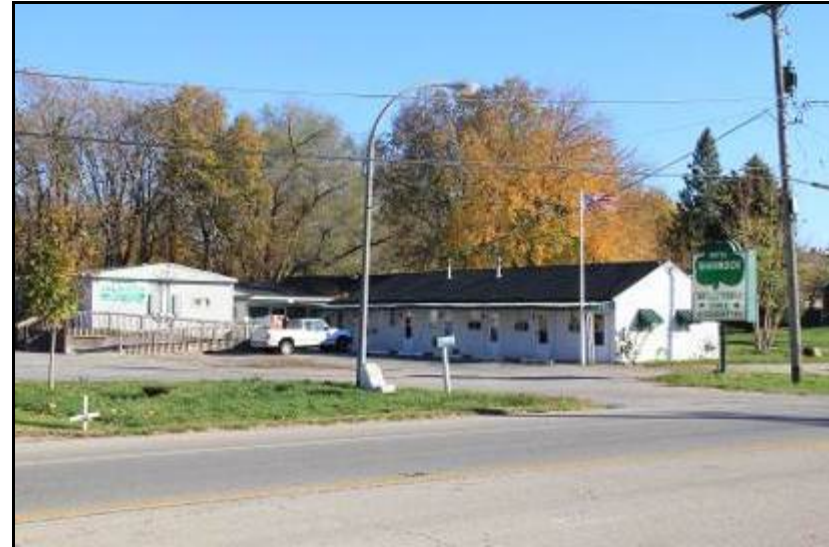
Sequence Number	Map Code	1994/95 Negative #	Address/Location	Type	Date Built	Historic Function	1994/95 Comments	2012/13 Comments and Photo Image #
275	13/18	13/18, IMG_1904	92?? Dirksen Pky.	2	Ca. 1950s-60s	Motel	Small, gable roof motel with stone sheathing – “Motel Shamrock.”	The motel remains, though with a new sign on the street. IMG_1415

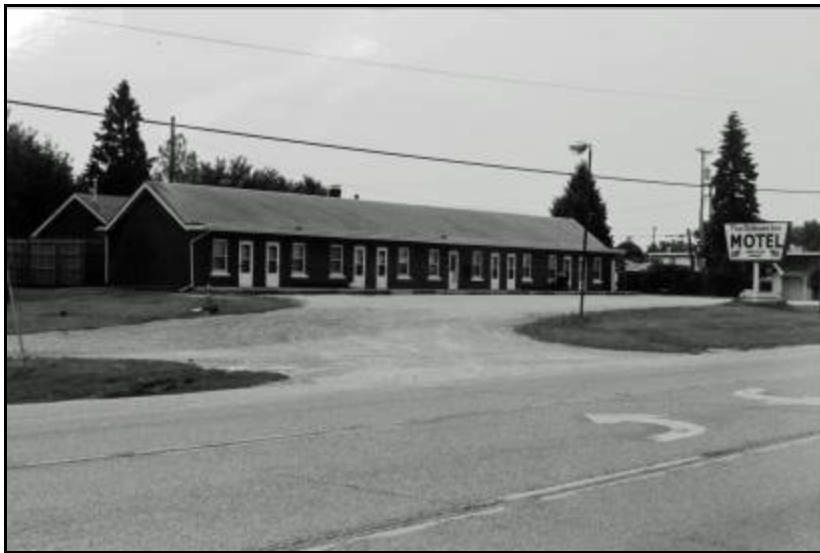
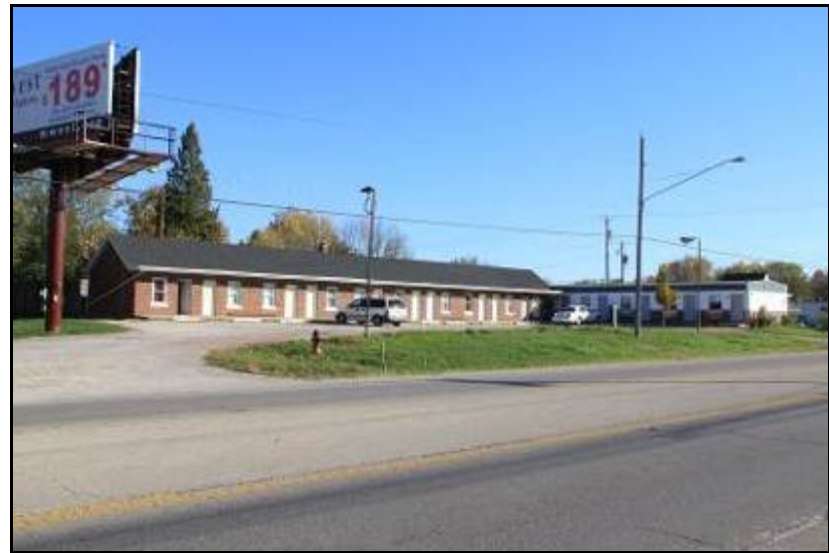
Sequence Number	Map Code	1994/95 Negative #	Address/Location	Type	Date Built	Historic Function	1994/95 Comments	2012/13 Comments and Photo Image #
276	13/19	13/19, IMG_1905	900 Dirksen Pky.	2	Ca. 1950s-60s	Motel	Brick motel with shallow, gable roof – “Dirksen Inn Motel.”	The old motel remains, though the sign on the street has been removed and an addition appears to have been erected on the structure’s S end. IMG_1416

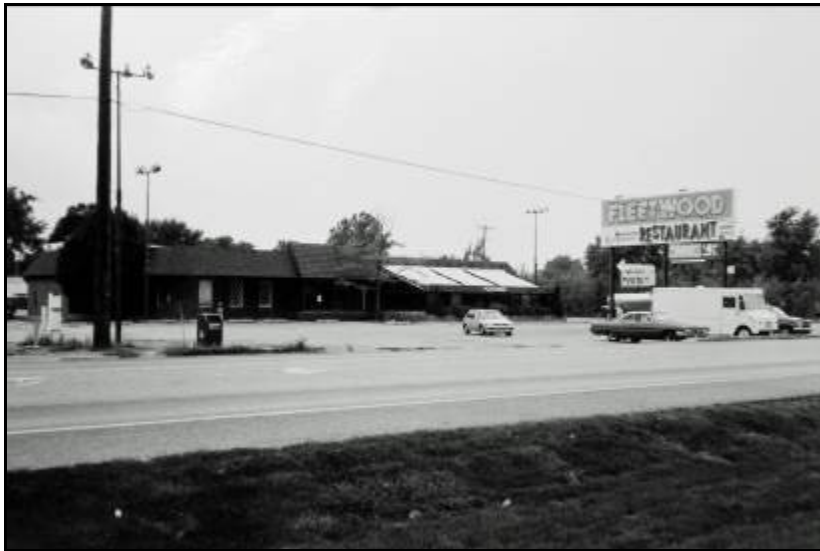
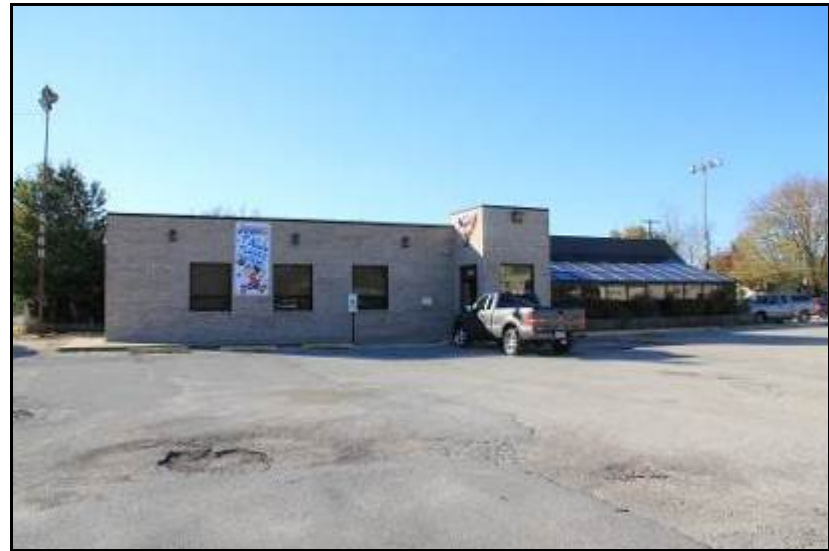
Sequence Number	Map Code	1994/95 Negative #	Address/Location	Type	Date Built	Historic Function	1994/95 Comments	2012/13 Comments and Photo Image #
277	20/36	20/36, IMG_1906	8?? Dirksen Pky. (SW corner at intersection with Elm)	2	Ca. 1960s-70s	Restaurant	Relatively modern-looking, brick and wood restaurant – “Fleetwood” is now closed.	Many changes have occurred at the old restaurant, including the construction of a new and dominant addition to the S. IMG_1417

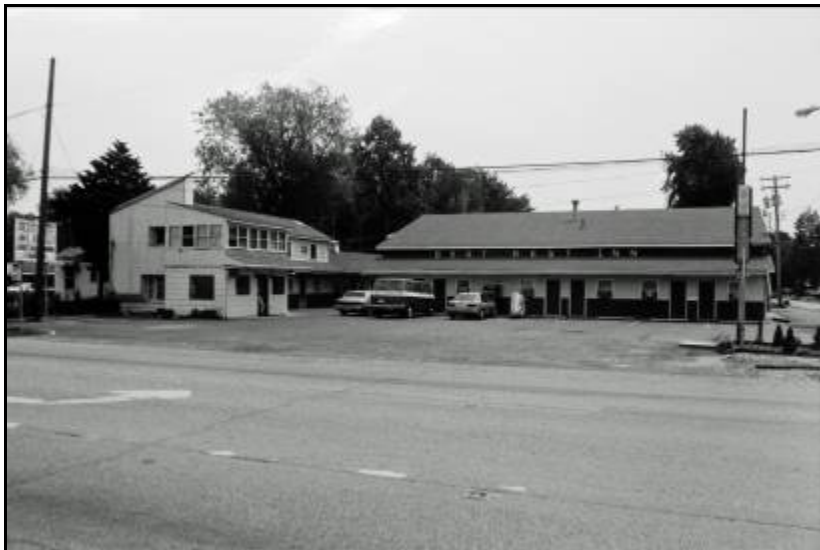
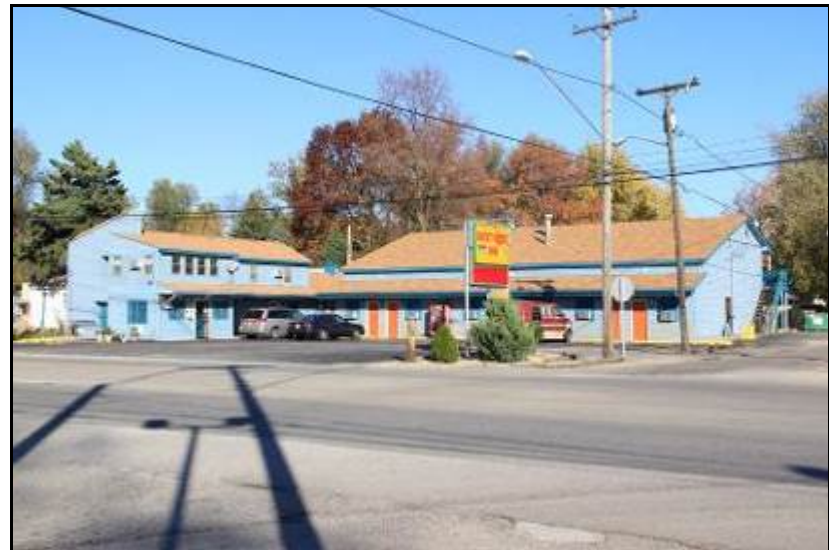
Sequence Number	Map Code	1994/95 Negative #	Address/Location	Type	Date Built	Historic Function	1994/95 Comments	2012/13 Comments and Photo Image #
278	13/20	13/20, IMG_1907	700 Dirksen Pky.	2	Ca. 1960s	Motel	"L" shape, 1.5-story structure with modern siding and other attempts at improvement.	Other than having been painted, there appear to be few changes at this motel. IMG_1418

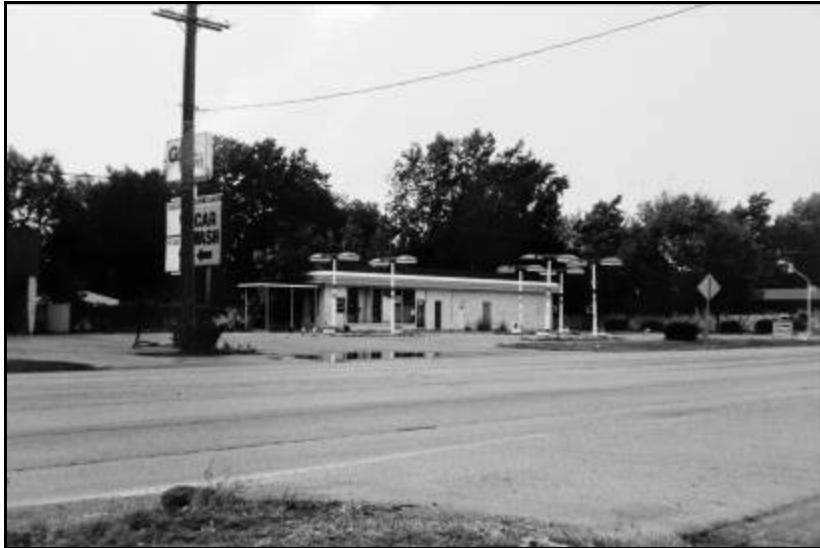
Sequence Number	Map Code	1994/95 Negative #	Address/Location	Type	Date Built	Historic Function	1994/95 Comments	2012/13 Comments and Photo Image #
279	20/34	20/34, IMG_1908	425 Dirksen Pky.	2	Ca. 1960s	Gas Station	Brick and glass gas station – now vacant.	Structure now gone.

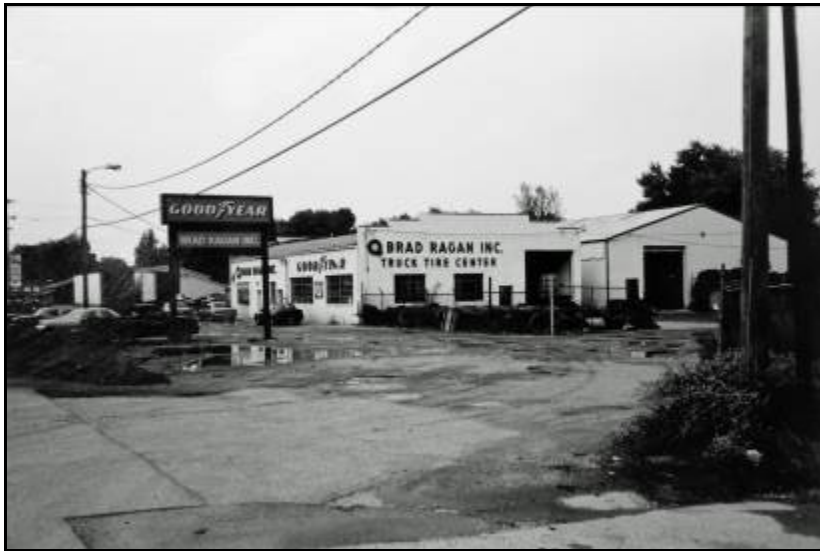
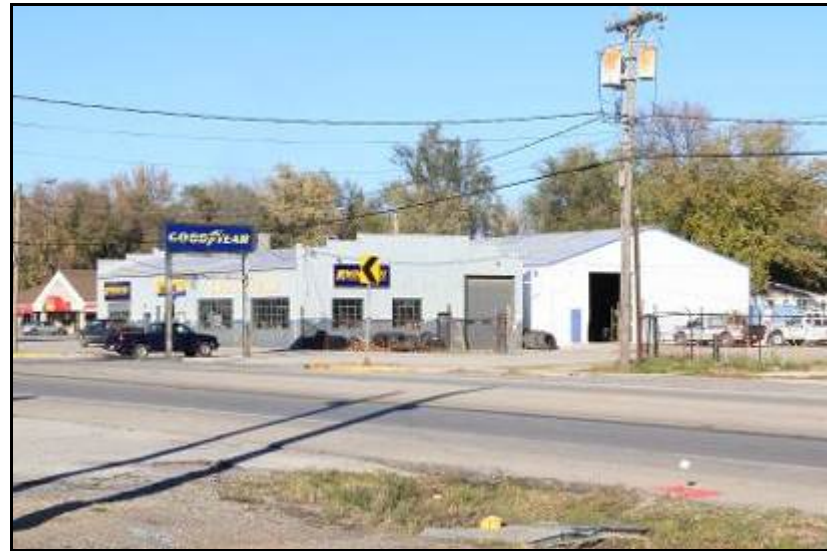
Sequence Number	Map Code	1994/95 Negative #	Address/Location	Type	Date Built	Historic Function	1994/95 Comments	2012/13 Comments and Photo Image #
280	20/35	20/35, IMG_1909	42? Dirksen Pky.	2	Ca. 1940s	Auto Service	Building with arched roof and three-stepped parapet endwalls with tile coping; may have been an auto service business – now “Brad Ragan, Inc.,” a truck/tire center.	This building now appears to be a “Goodyear” tire center. The integrity of the structure seems to be little changed. IMG_1419

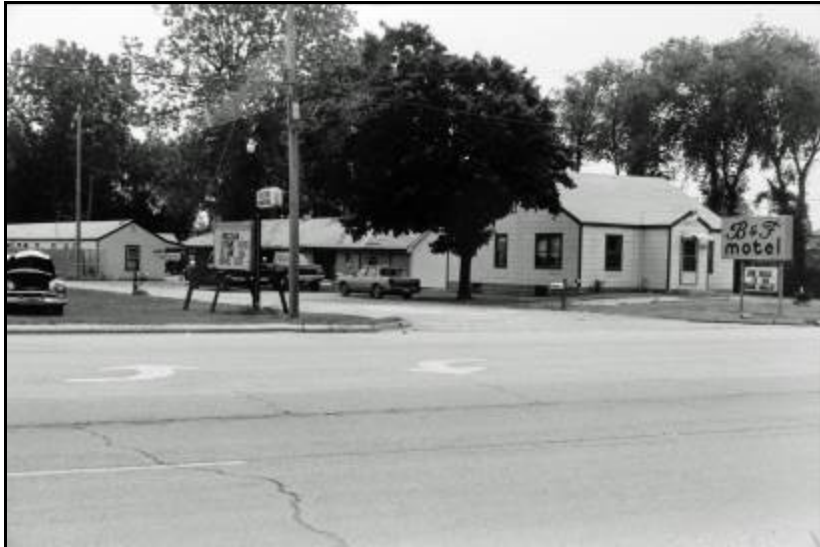
Sequence Number	Map Code	1994/95 Negative #	Address/Location	Type	Date Built	Historic Function	1994/95 Comments	2012/13 Comments and Photo Image #
281	13/21	13/21, IMG_1910	394 Dirksen Pky.	2	Ca. 1940s-50s	Motel	Side gable/Cape Cod motel office with two detached, long, gabled structures with rooms to rear, all appears to have wide, clapboard siding.	Motel now gone.

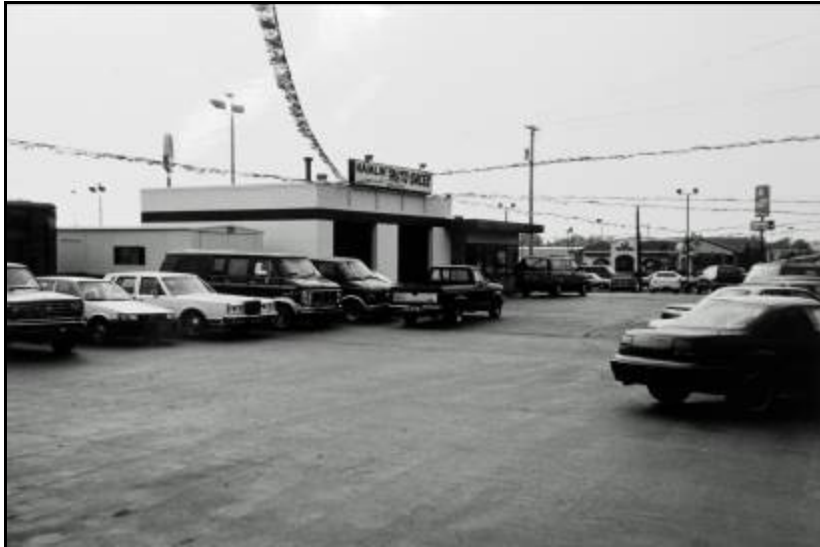
Sequence Number	Map Code	1994/95 Negative #	Address/Location	Type	Date Built	Historic Function	1994/95 Comments	2012/13 Comments and Photo Image #
282	20/32	20/32, IMG_1911	110 Dirksen Pky.	2	Ca. 1960s	Gas/Service	Concrete block and brick service station now used for auto sales – “Hamlin Auto Sales.”	Structure now gone.

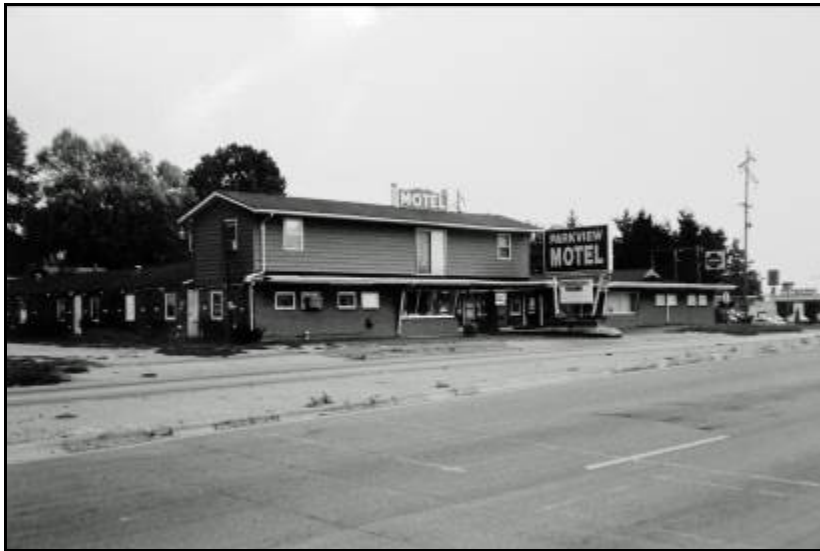
1994

Sequence Number	Map Code	1994/95 Negative #	Address/Location	Type	Date Built	Historic Function	1994/95 Comments	2012/13 Comments and Photo Image #
283	20/33	20/33, IMG_1912	Dirksen Pky. & Clear Lake (NW corner)	2	Ca. 1950s	Motel	Single-story, brick structure with shallow, gabled roof, partially closed "U" shape and two-story office building with clapboard sheathing on second floor – "Parkview Motel."	Motel now gone.

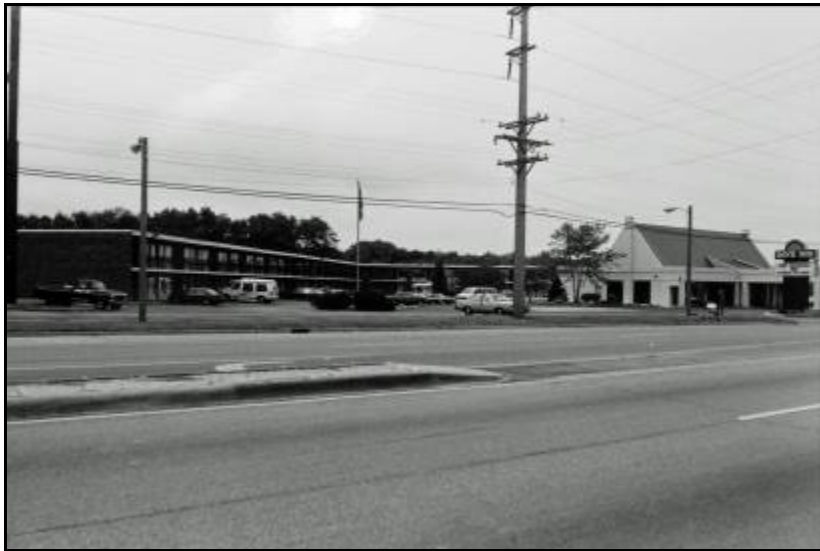
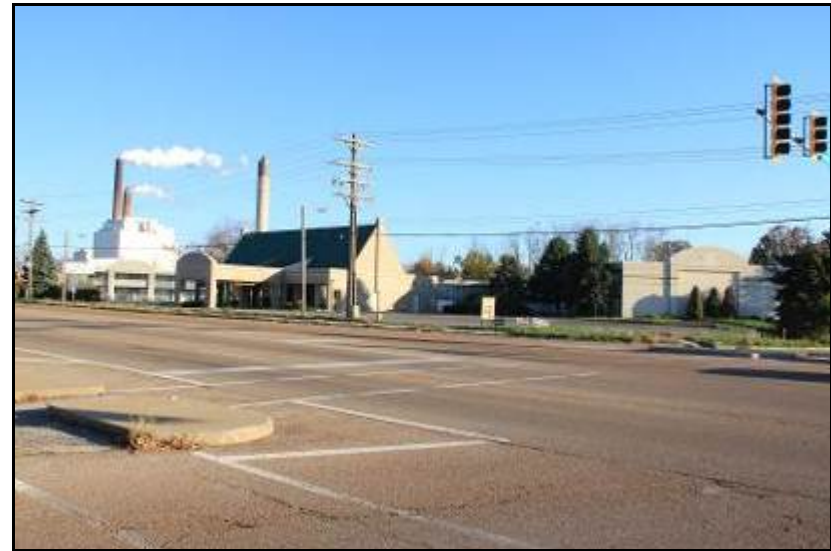
Sequence Number	Map Code	1994/95 Negative #	Address/Location	Type	Date Built	Historic Function	1994/95 Comments	2012/13 Comments and Photo Image #
285	13/26	13/26, IMG_1914	Stevenson & Dirksen Pky.	2	Ca. 1960s-70s	Motel	Motel has a modern office building, but structures with rooms look very much to be 1960s era with two-story, glass and brick construction and open walkway/balcony – now “Days Inn.”	Former “Days Inn” now closed and vacant. IMG_1420

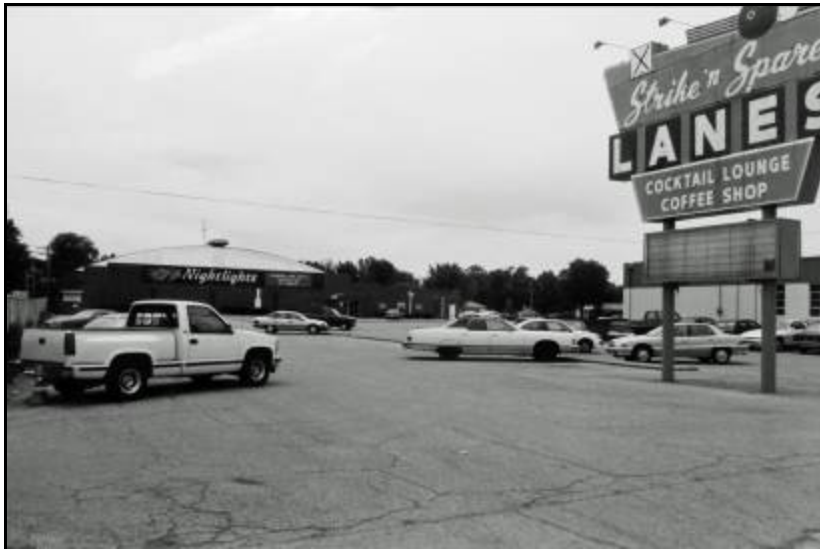
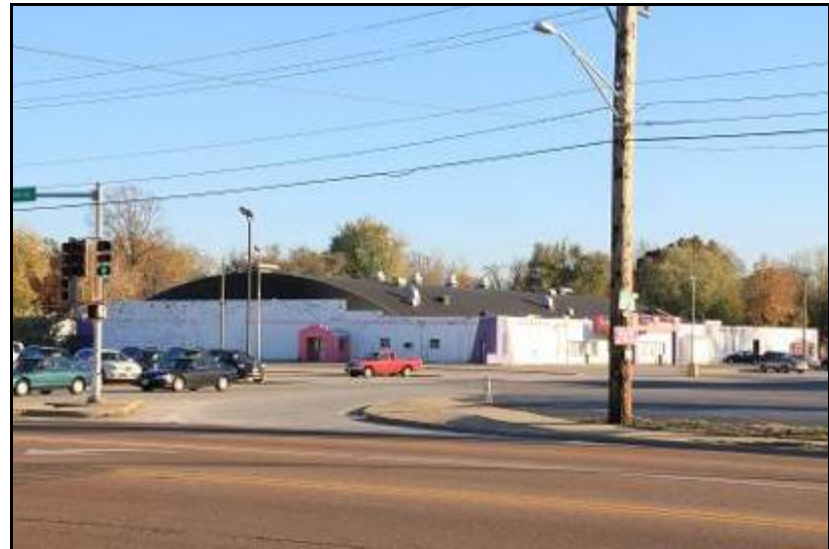
Sequence Number	Map Code	1994/95 Negative #	Address/Location	Type	Date Built	Historic Function	1994/95 Comments	2012/13 Comments and Photo Image #
286	13/25	13/25, IMG_1915	Stevenson & Sherman	3	Ca. 1950s	Entertainment	Brick building with arched roof and nice sign – “Strike ‘n Spare Lanes, Cocktail Lounge, Coffee Shop.”	The old bowling alley continues, although with some of its prior signage now gone. IMG_1421

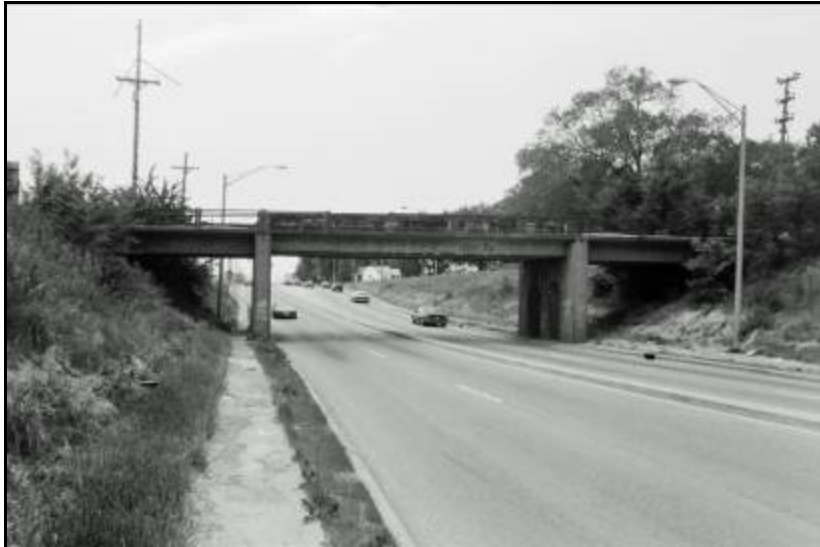
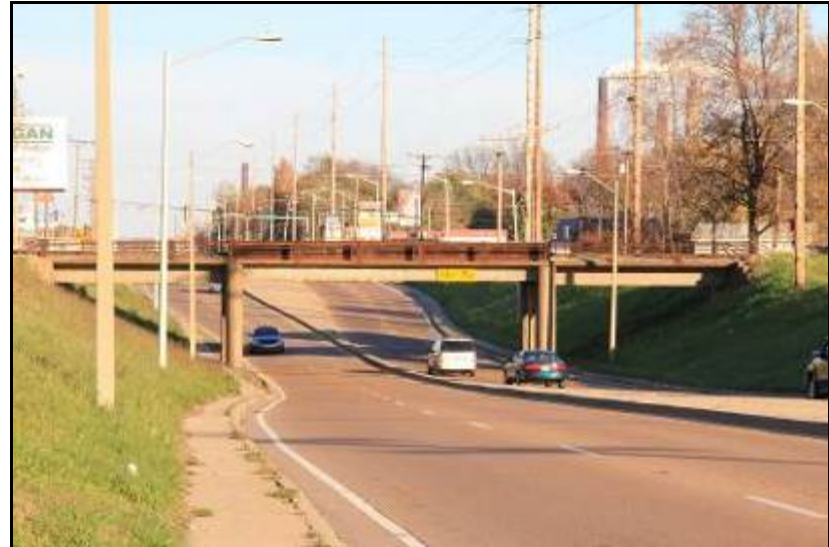
Sequence Number	Map Code	1994/95 Negative #	Address/Location	Type	Date Built	Historic Function	1994/95 Comments	2012/13 Comments and Photo Image #
287	13/24	13/24, IMG_1916	Stevenson & ICG RR	2	Unknown	RR Overpass	Bridge #9910 – no plate; steel beam structure.	Structure exhibits no noticeable changes. IMG_1422

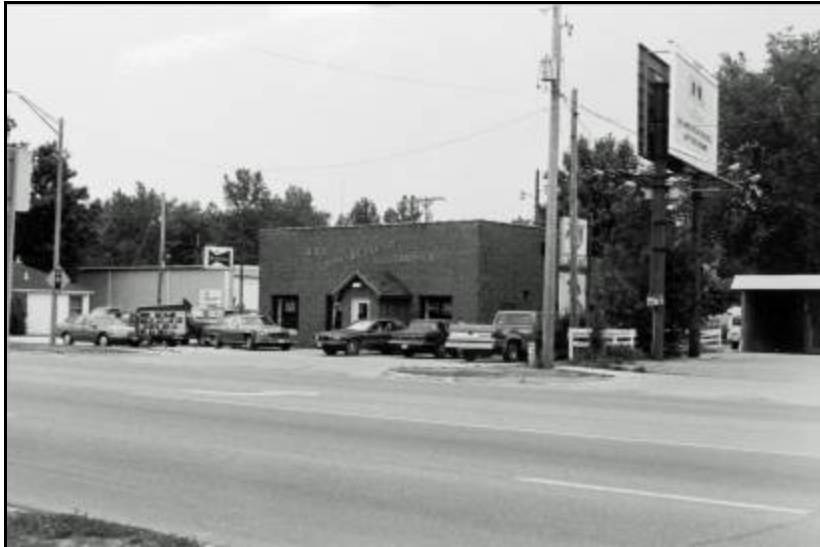
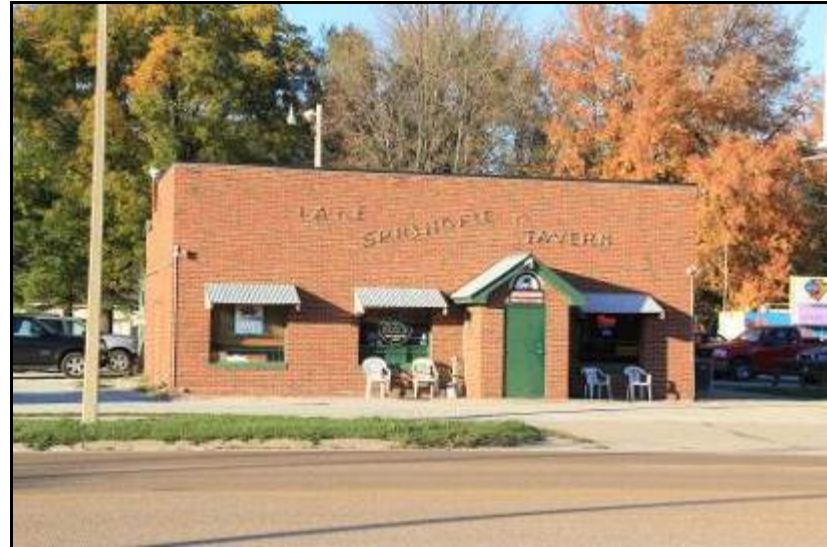
Sequence Number	Map Code	1994/95 Negative #	Address/Location	Type	Date Built	Historic Function	1994/95 Comments	2012/13 Comments and Photo Image #
288	13/23	13/23, IMG_1917	1221 Stevenson	2	Ca. 1930s-40s	Restaurant	Small, brick, box-like restaurant with straight parapet and coping – “Lake Springfield Tavern.”	Tavern remains today, the major change being the addition of the window awnings. IMG_1424

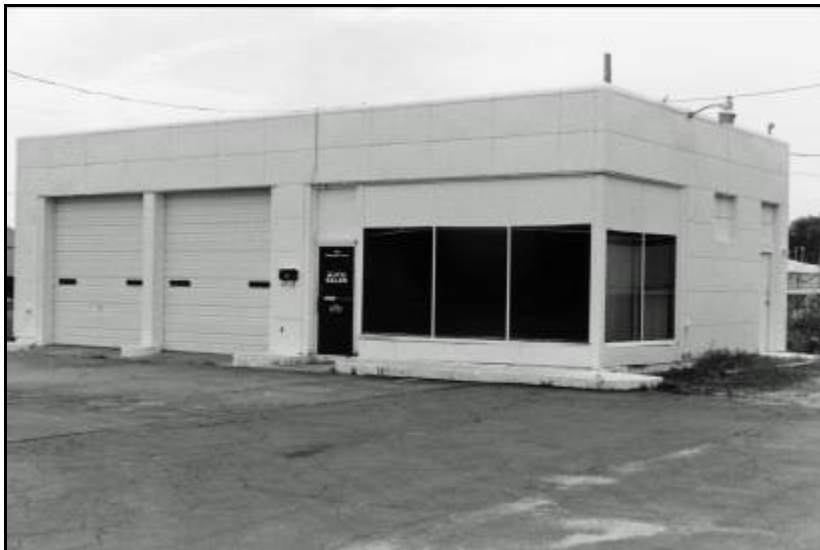
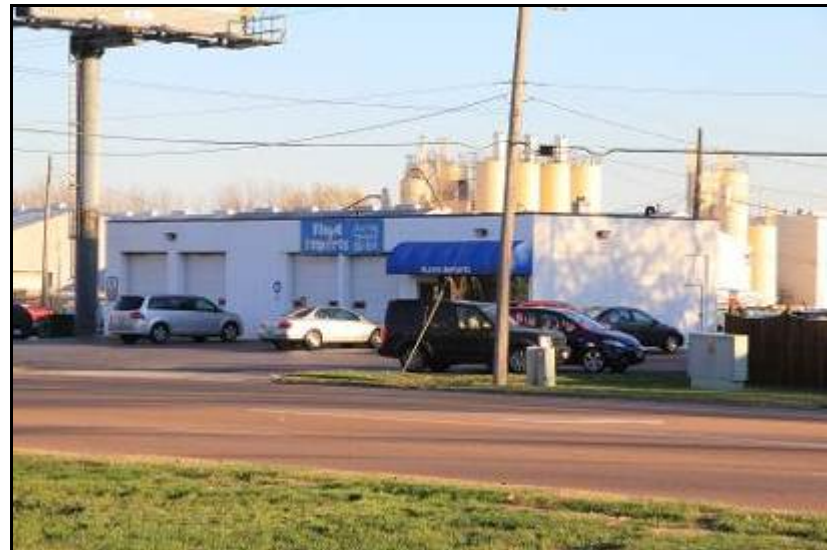
Sequence Number	Map Code	1994/95 Negative #	Address/Location	Type	Date Built	Historic Function	1994/95 Comments	2012/13 Comments and Photo Image #
289	13/22	13/22, IMG_1918	1026 Stevenson	2	Ca. 1950s	Gas/Service	Functional-type gas station sheathed with enamel panels – most recently “Tom Schoaff Auto Sales.”	This structure is now used as part of a “U-Haul” trailer outlet. Note the new awing, as well as the two garage door addition to the left. IMG_1425

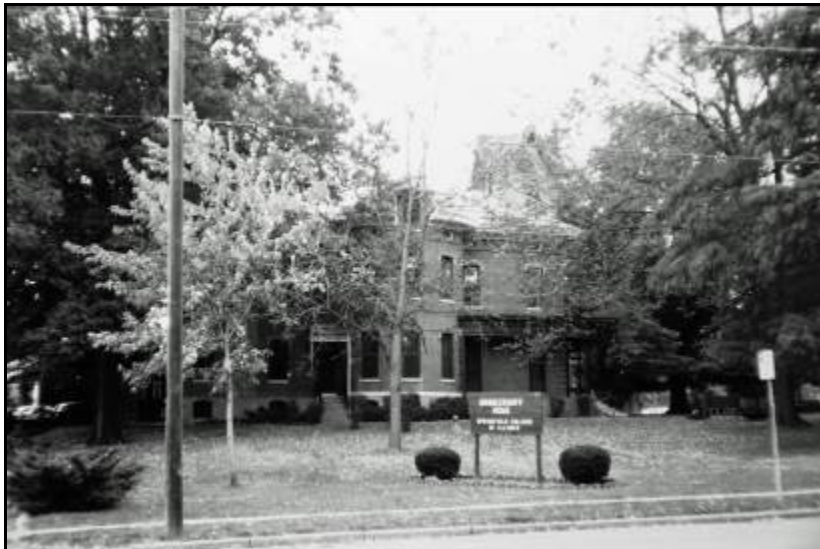
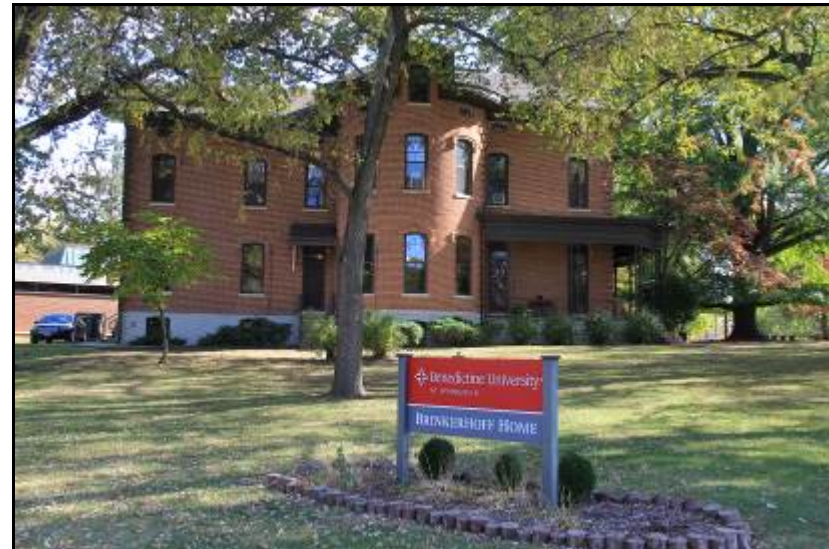
Sequence Number	Map Code	1994/95 Negative #	Address/Location	Type	Date Built	Historic Function	1994/95 Comments	2012/13 Comments and Photo Image #
290	21/03	21/03, IMG_4613	5 th St. (E side at Black & Keys)	3	Ca. Late 19 th Century	College	Springfield College.	This institution is now a "Benedictine University." IMG_4111

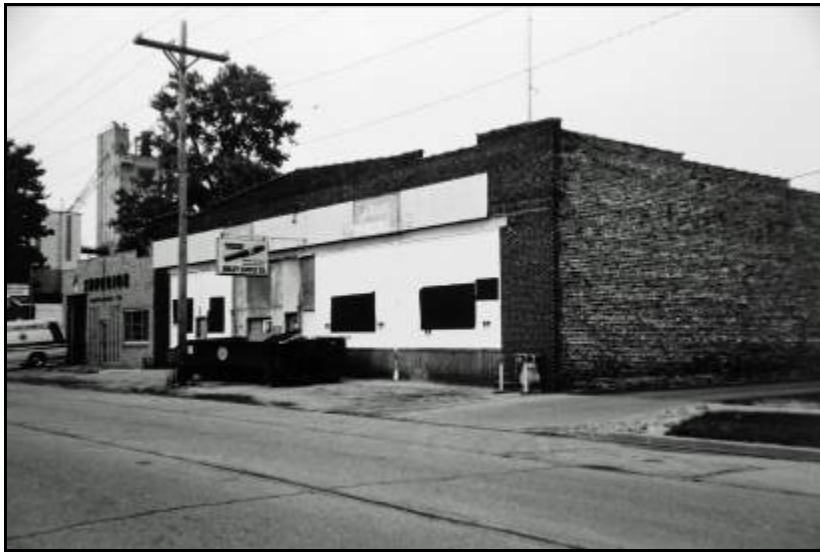
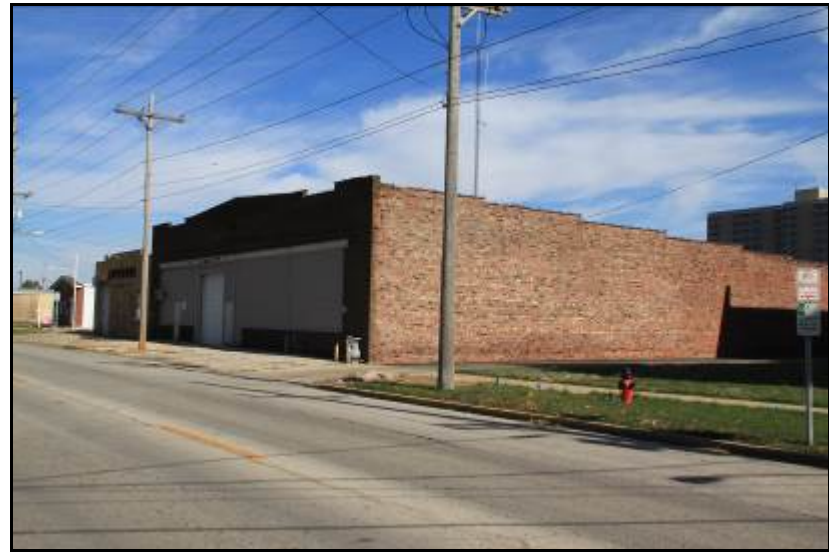
Sequence Number	Map Code	1994/95 Negative #	Address/Location	Type	Date Built	Historic Function	1994/95 Comments	2012/13 Comments and Photo Image #
291	21/04	21/04, IMG_4614	326 N. 2 nd St.	2	Ca. 1920s-30s	Auto Service (?)	Brick structure with parapet and tile coping; <u>could</u> have been an auto service business – even if it was, it <u>may</u> post-date USH 66 designation on 2 nd St.	While the association of this building with RT 66 is questionable, its front entrance openings have been completely covered since the 1990s. IMG_4112

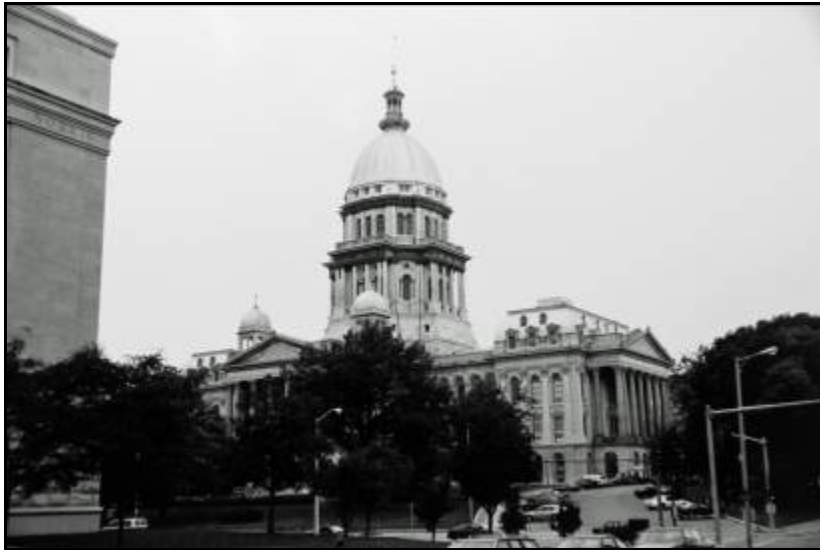
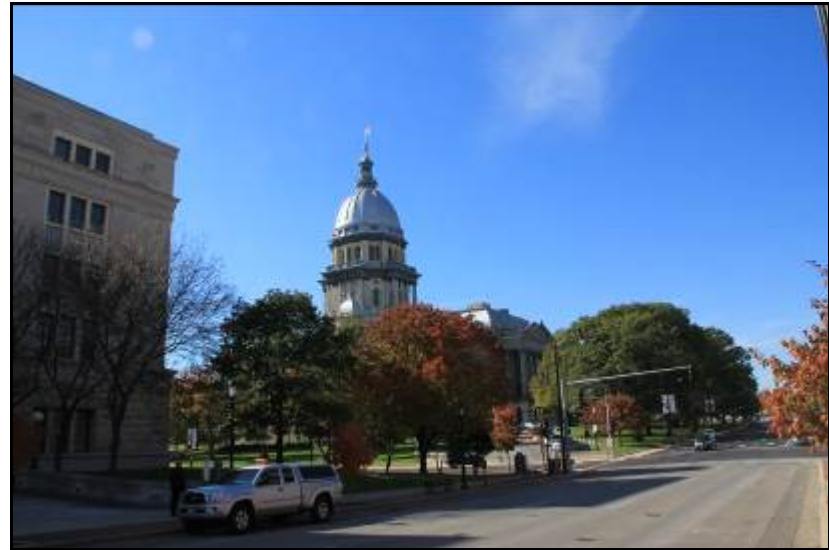
Sequence Number	Map Code	1994/95 Negative #	Address/Location	Type	Date Built	Historic Function	1994/95 Comments	2012/13 Comments and Photo Image #
292	21/05	21/05-06, IMG_4615	300-500 S. 2 nd	3	Ca. Late 19 th , Early 20 th Century	State Government	Illinois State Government complex includes state capital, state library, other related offices.	The Illinois State Government's complex remains. IMG_4114

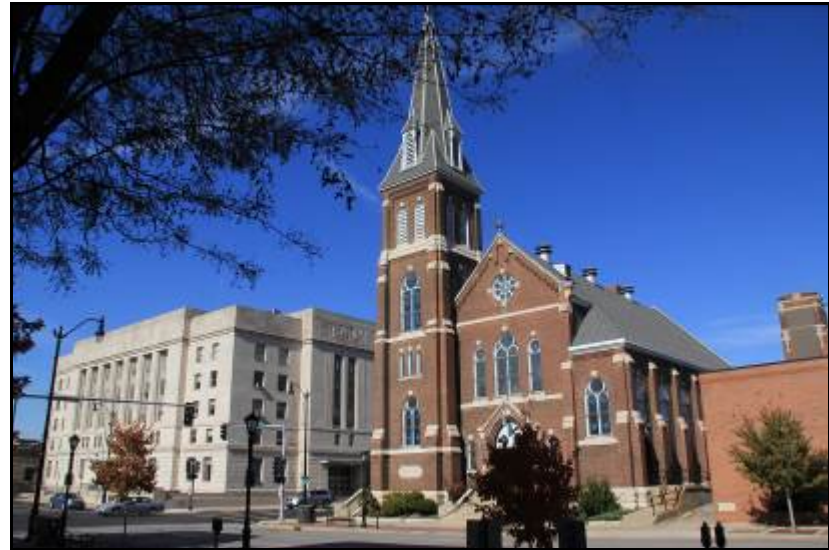
Sequence Number	Map Code	1994/95 Negative #	Address/Location	Type	Date Built	Historic Function	1994/95 Comments	2012/13 Comments and Photo Image #
293	21/07	21/07, IMG_4616	S 2 nd & Monroe (NE corner)	3	1888	Church	Large, brick, Gothic Revival church adjacent to state capitol building.	The “Evangelical Lutheran Trinity Church” building remains today and appears to be little changed. IMG_4113

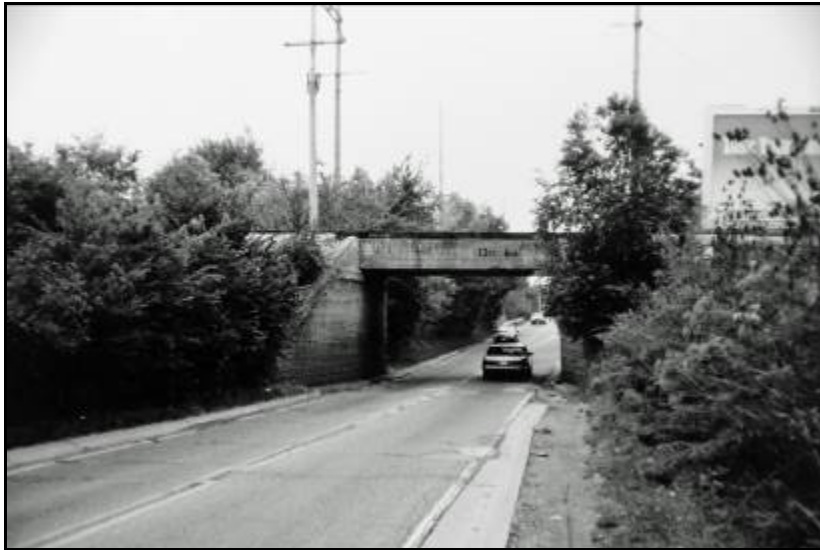
Sequence Number	Map Code	1994/95 Negative #	Address/Location	Type	Date Built	Historic Function	1994/95 Comments	2012/13 Comments and Photo Image #
294	21/18	21/18, IMG_4617	Chatham Rd. & RR (between Austin & Southwest)	2	Ca. 1920s	RR Overpass	Bridge #084-9917 – no plate: deteriorating structure with reinforced concrete wingwalls and abutments; tracks carried by deck with “I” beams.	This rail alignment may have been converted to a hiking/biking trail for which a new bridge was erected.

No longer extant

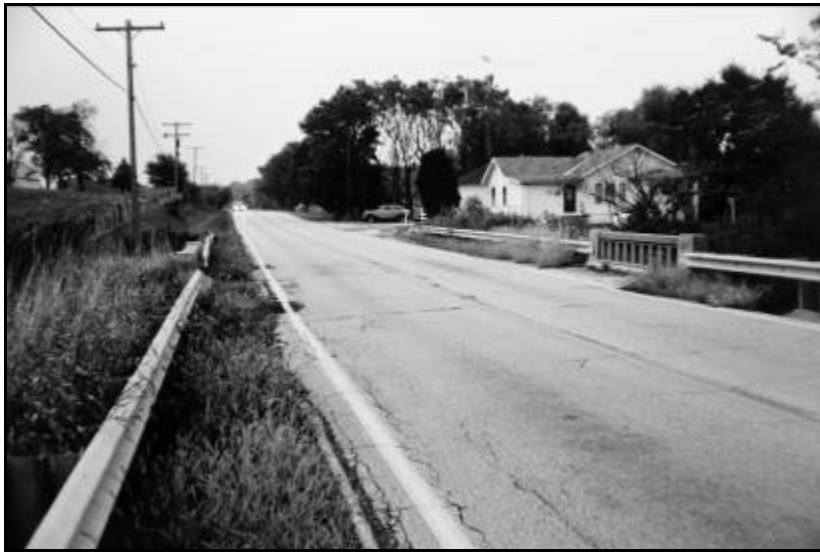
Sequence Number	Map Code	1994/95 Negative #	Address/Location	Type	Date Built	Historic Function	1994/95 Comments	2012/13 Comments and Photo Image #
295	21/19	21/19, IMG_4618	Chatham Rd. & branch of Lick Creek	1	Ca. 1940s-50s	Bridge	Bridge #084-0123 – no plate: single-span with concrete deck; squared voids between balusters and top rail suggest a construction date that post-dates USH 66.	No evidence of this bridge was observed.

No longer extant (?)
