Route 66 in Illinois:

(2012/13 Update and Expansion of the Original 1994/95 Survey)

IDOT Sequence #17337 & #17337A

22 December 2013

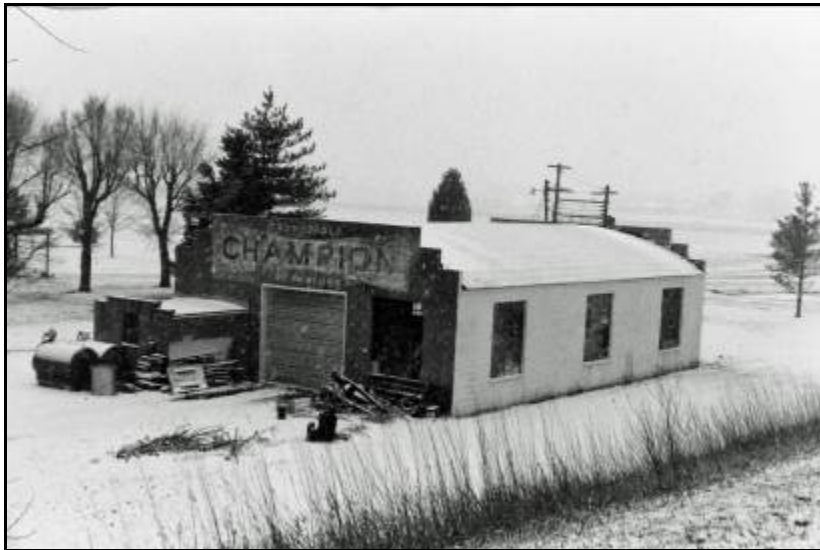
1994

Sequence Number	Map Code	1994/95 Negative #	Address/Location	Type	Date Built	Historic Function	1994/95 Comments	2012/13 Comments and Photo Image #
296	08/17	08/17, IMG_1919	Old 66 north of Glenarm	2	Ca. 1940s (?)	Auto Service	Structure has arched roof and stepped parapet endwalls; possible auto service.	The building has been substantially cleaned up and painted since 1994. Window sizes have been reduced and a gable roof erected on the small, one-story extension. IMG_1430

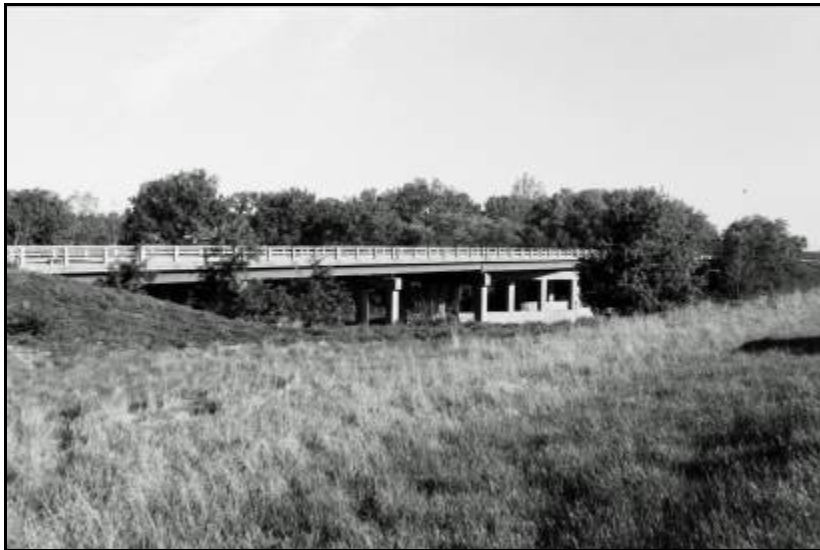
Sequence Number	Map Code	1994/95 Negative #	Address/Location	Type	Date Built	Historic Function	1994/95 Comments	2012/13 Comments and Photo Image #
297	12/12	12/12, IMG_1920	Old 66 over ICG RR	1	1955	Bridge	One structure remains: Bridge #0005/084 – plate notes: I.C.R.R., Built 1955 by, State of Illinois, F.A. TT.5 Sec. 110-X-3-VB-Vf-(3), Proj. FGI-FI-166(34) Sta. 372+52.0(2), Loading H-20 S-16; “T” beam support for deck.	Historic period bridge now gone. Replaced in 2011.

No longer extant

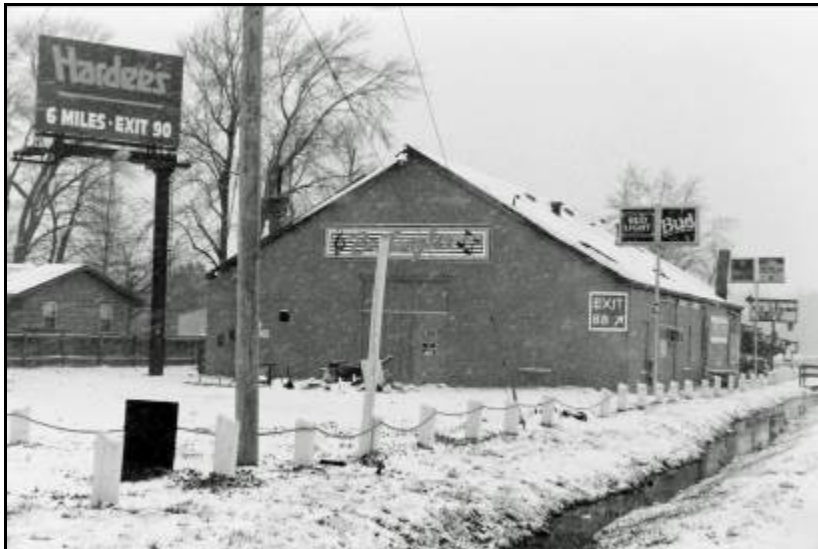
1994

Sequence Number	Map Code	1994/95 Negative #	Address/Location	Type	Date Built	Historic Function	1994/95 Comments	2012/13 Comments and Photo Image #
298	08/18	08/18, IMG_1921	Old 66 at GLENARM	2	Unknown	Night Club	Gabled, brick structure adjacent to highway could have been an entertainment stop.	Structure now gone.

No longer extant

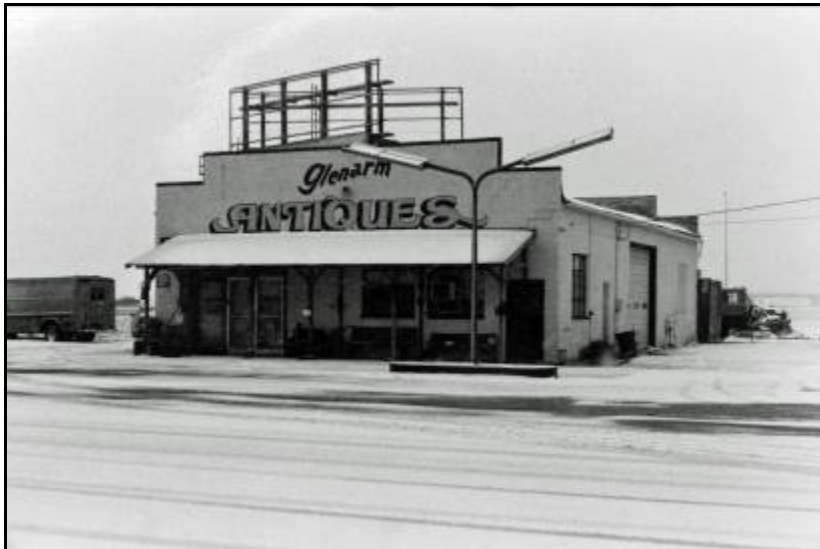
1994

Sequence Number	Map Code	1994/95 Negative #	Address/Location	Type	Date Built	Historic Function	1994/95 Comments	2012/13 Comments and Photo Image #
299	08/19	08/19, IMG_1922	Old 66 at GLENARM	2	Ca. 1930s-40s	Auto Service	Structure has arched roof and stepped parapet endwalls. Possible auto service.	Structure remains and has been painted. IMG_0000

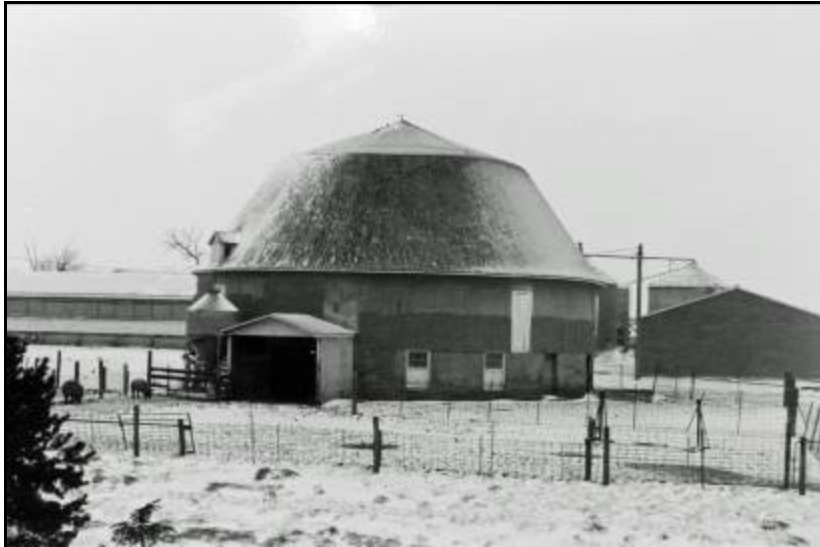
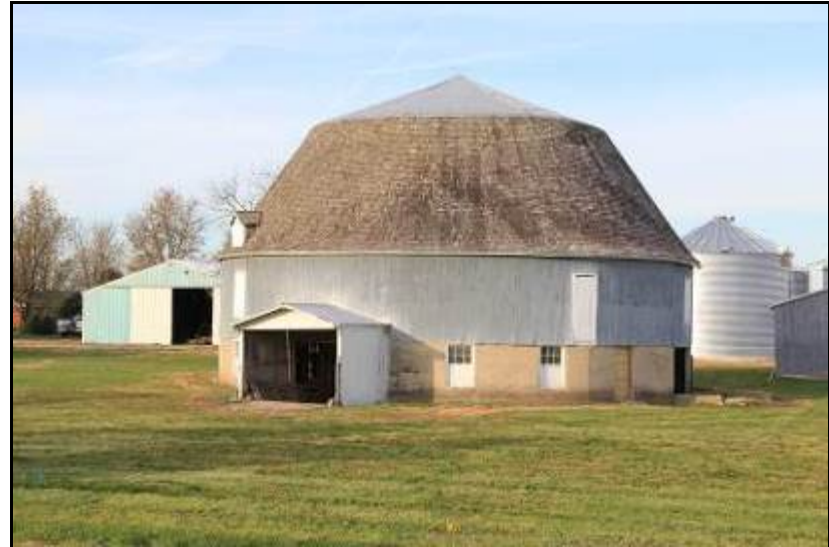
Sequence Number	Map Code	1994/95 Negative #	Address/Location	Type	Date Built	Historic Function	1994/95 Comments	2012/13 Comments and Photo Image #
300	08/20	08/20, IMG_1923	Old 66 at Rd. 13.75S	3	Ca. 20 th Century	Barn	Distinctive Round Barn.	The barn remains, largely unchanged. IMG_1431

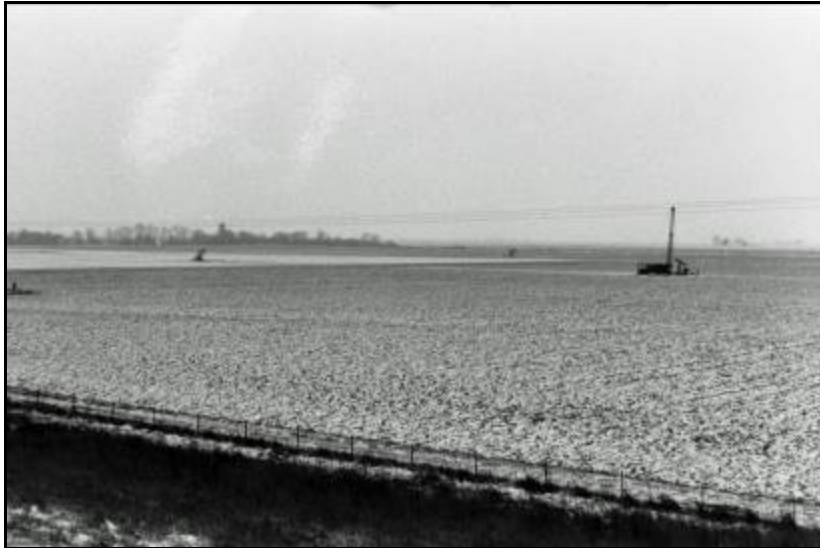
1994

Sequence Number	Map Code	1994/95 Negative #	Address/Location	Type	Date Built	Historic Function	1994/95 Comments	2012/13 Comments and Photo Image #
301	08/21	08/21, IMG_1924	Old 66 at IL 104	3	Ca. 20 th Century	Oil Field	Farm field with oil pumps common to area.	Oil pumps remain. IMG_1432

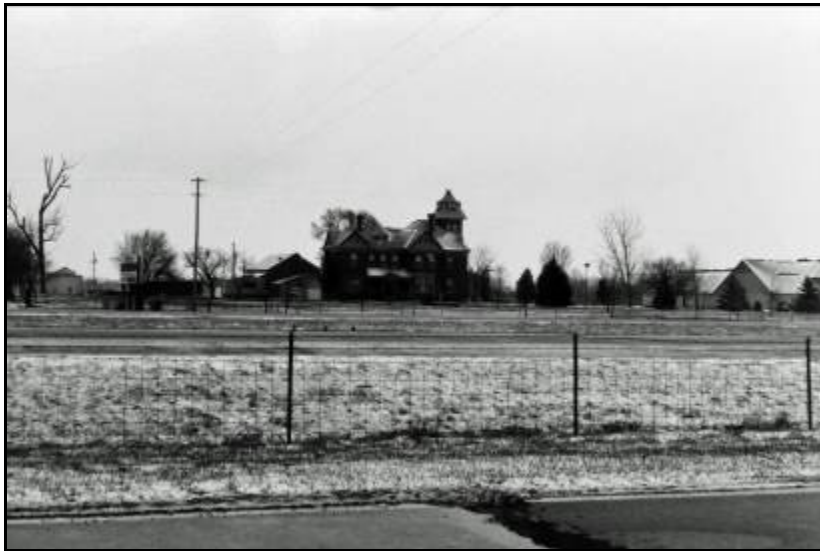
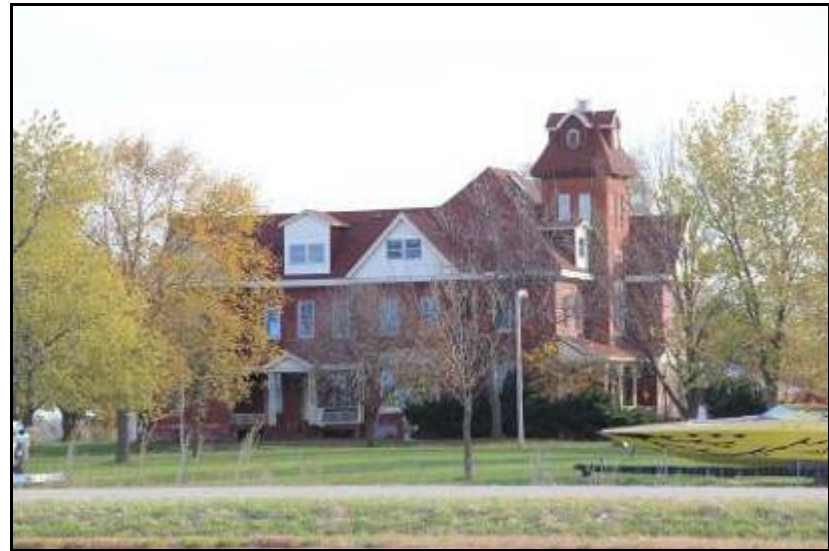
Sequence Number	Map Code	1994/95 Negative #	Address/Location	Type	Date Built	Historic Function	1994/95 Comments	2012/13 Comments and Photo Image #
303	08/23	08/23, IMG_1926	E side of I-55, between Rd 3600N & Rd. 3450N	3	Ca. Late 19 th Century	Residential	Two-story, brick structure with gabled wall dormers and impressive, 3.5 story tower.	The architectural integrity of this house appears to be intact, though it is some distance E of RT 66. IMG_1436

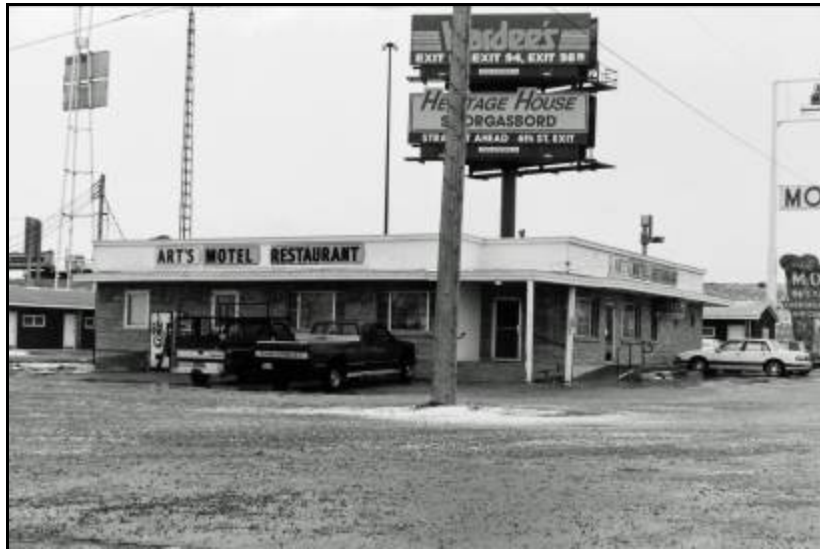
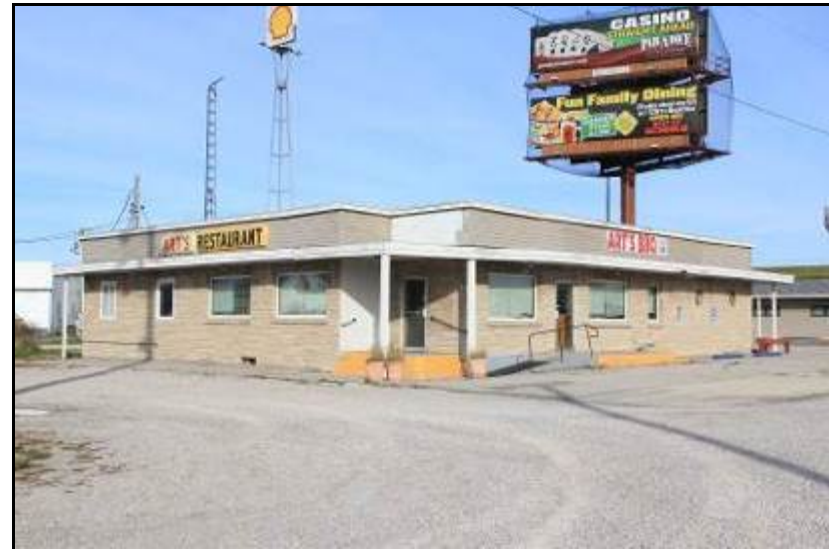
Sequence Number	Map Code	1994/95 Negative #	Address/Location	Type	Date Built	Historic Function	1994/95 Comments	2012/13 Comments and Photo Image #
304	08/24	08/24, IMG_1927	Old 66 & Rd. 3050N, FARMERSVILLE	2	Ca. 1950s	Restaurant	Single-story, stone veneer restaurant – “Art’s Motel Restaurant.”	The restaurant is now closed and vacant. IMG_1439

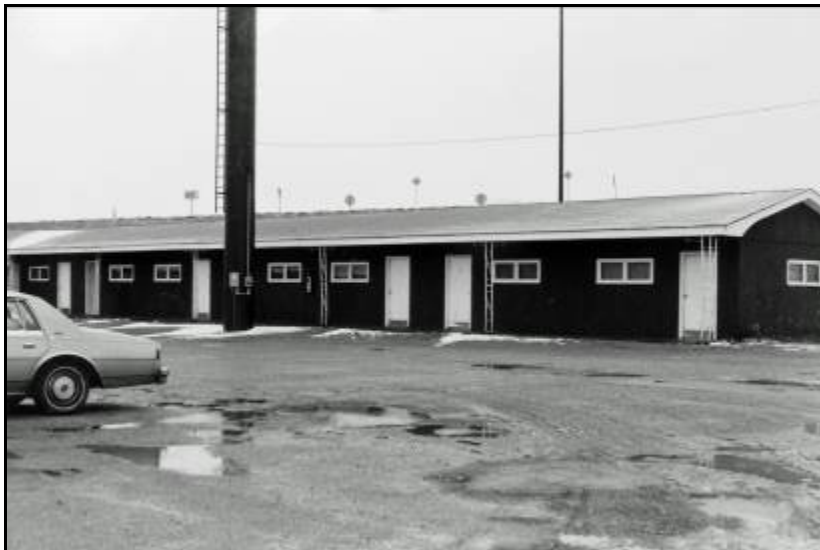
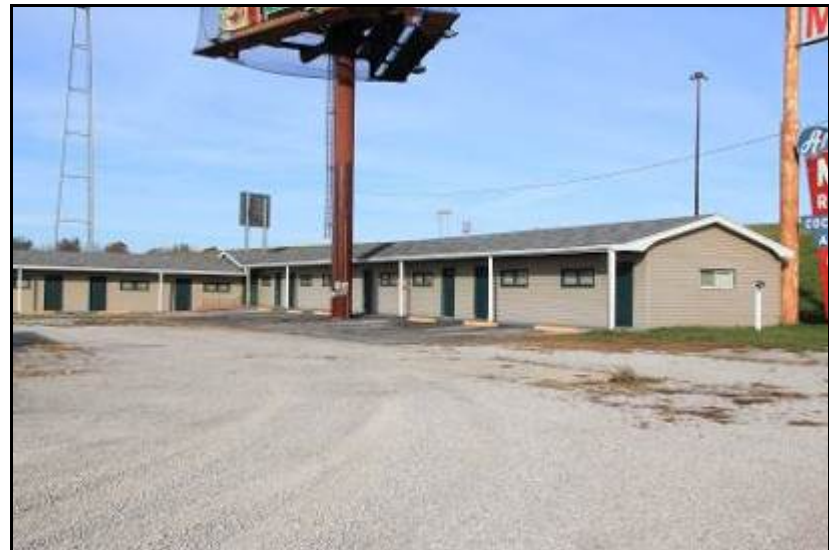
Sequence Number	Map Code	1994/95 Negative #	Address/Location	Type	Date Built	Historic Function	1994/95 Comments	2012/13 Comments and Photo Image #
305	08/25	08/25-26, IMG_1928	Old 66 & Rd. 3050N, FARMERSVILLE	2	Ca. 1950s	Motel	"L" shaped motel with wooden siding; note sign adversities cocktails, air conditioning and TV – "Art's Motel."	Motel is now closed and vacant. It appears to have been resided at some point since 1994. IMG_1441

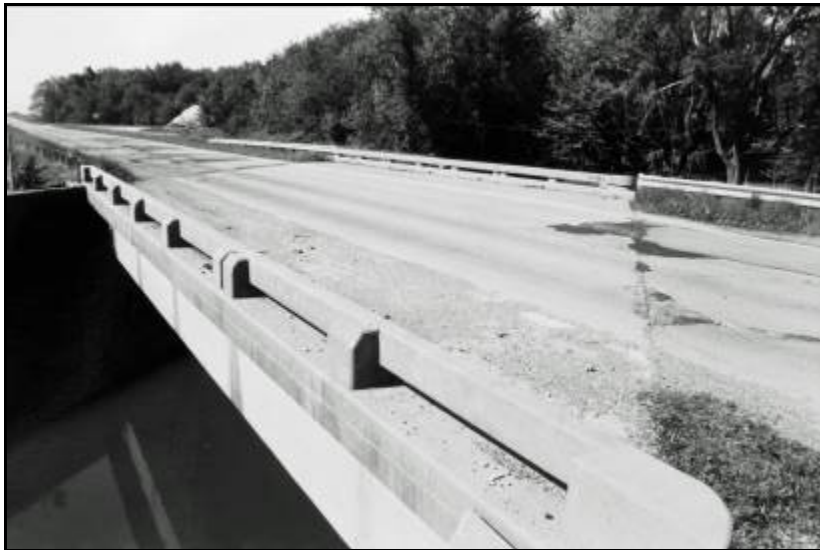
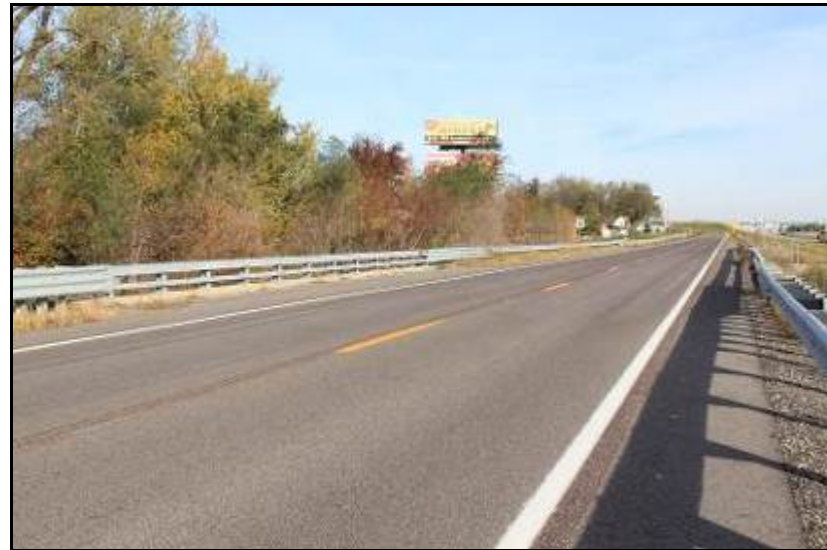
Sequence Number	Map Code	1994/95 Negative #	Address/Location	Type	Date Built	Historic Function	1994/95 Comments	2012/13 Comments and Photo Image #
306	12/15	12/15, IMG_1929	Old 66 over Macoupin Creek, FARMERSVILLE	1	1949	Bridge	One structure remains: Bridge #068/0054 – plate notes: “Station 1067+45.3(1), Built 1949 by, State of Illinois, S.B.I. RT. 126 Sec. 111-R-B, R.A. Proj. F.1-166(21, Loading H-20, S16; single-span structure with concrete “T” beam deck supports.	Bridge still has its 1949 plate, although it appears to be substantially rehabilitated, if not reconstructed (note the different railing). IMG_1442

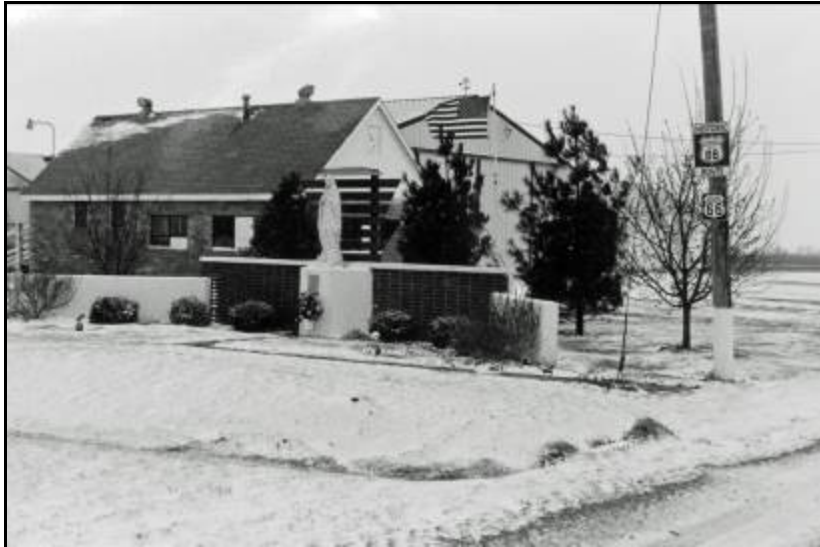
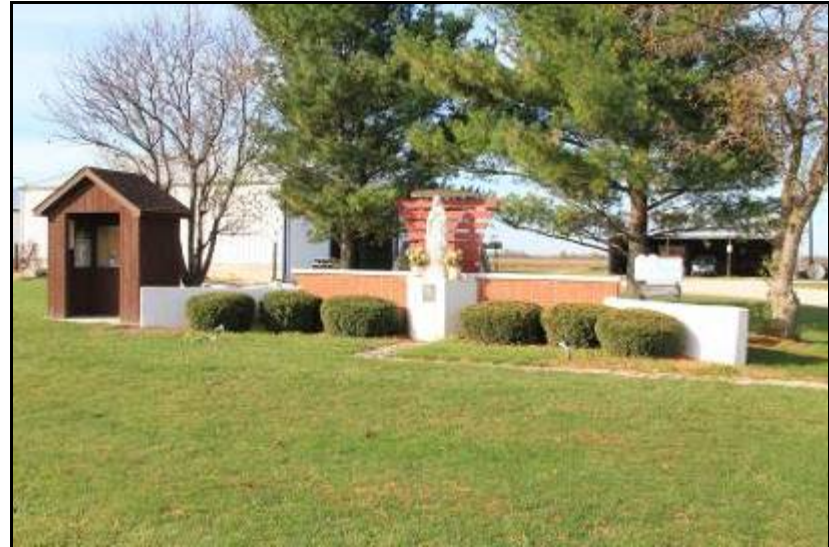
Sequence Number	Map Code	1994/95 Negative #	Address/Location	Type	Date Built	Historic Function	1994/95 Comments	2012/13 Comments and Photo Image #
307	08/27	08/27-30, IMG_1930	Old 66 at Rd. 2300N	2	Ca. 1959	Shrine	"Our Lady of the Highways Shrine" – see Waldmire Post Card for more information; also in USH 66 Hall of Fame in Illinois.	The Shrine remains today, with the addition of a small information enclosure (to left of photo). IMG_1446

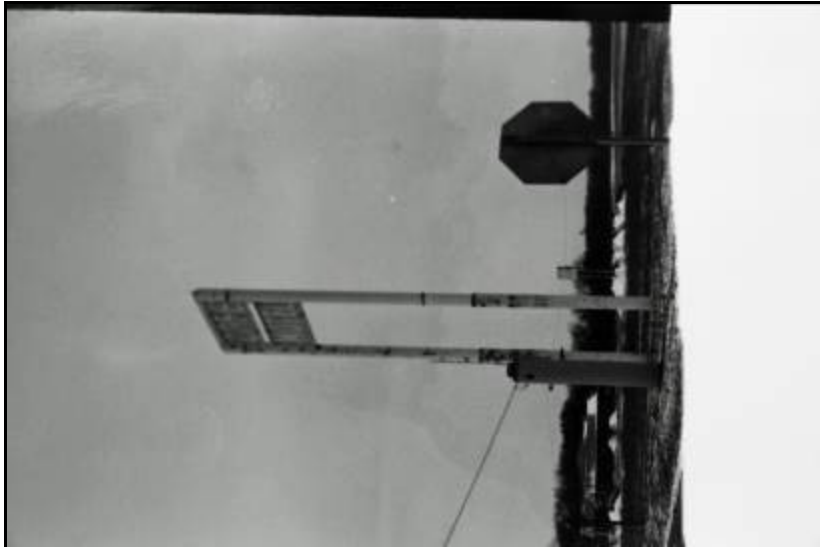
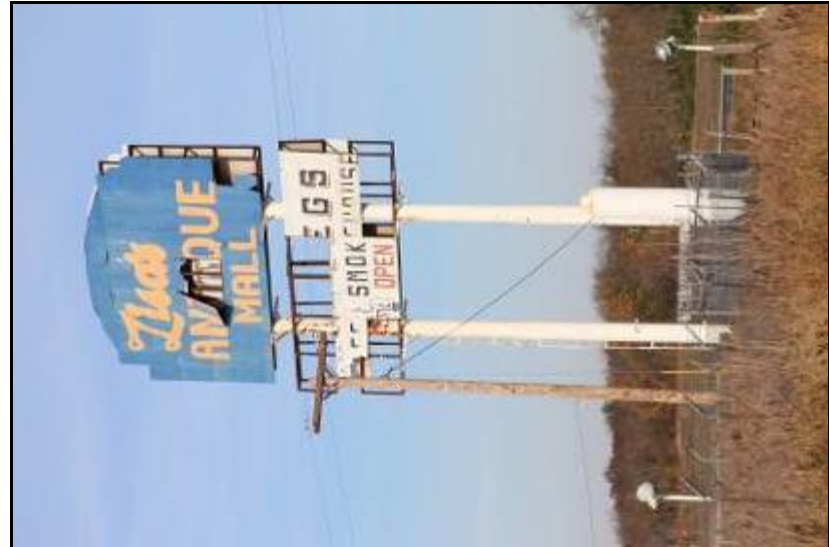
Sequence Number	Map Code	1994/95 Negative #	Address/Location	Type	Date Built	Historic Function	1994/95 Comments	2012/13 Comments and Photo Image #
308	08/31	08/31, IMG_1931	Old 66 at Rd. 1900N	2	Ca. 1950s	Motel Sign	Café & motel sign for business that no longer exists [now antique mall sign, October 1994].	The structure of the sign remains. IMG_1450

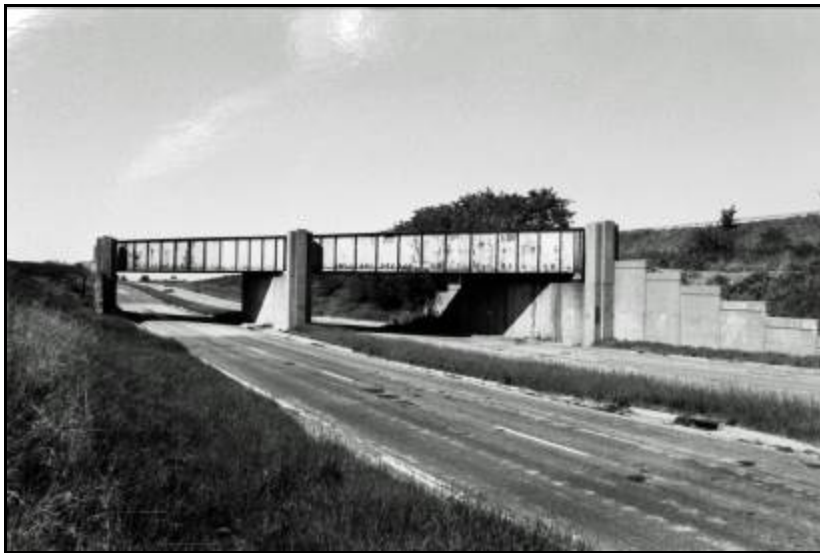
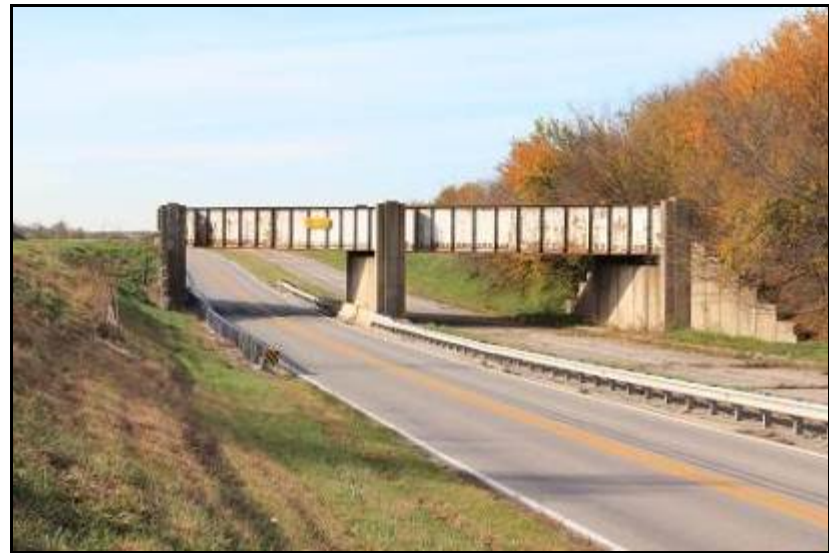
Sequence Number	Map Code	1994/95 Negative #	Address/Location	Type	Date Built	Historic Function	1994/95 Comments	2012/13 Comments and Photo Image #
309	12/16	12/16, IMG_1932	Old 66 over ICG, N of LITCHFIELD	2	1949	RR Overpass	No bridge number – plate notes: ICRR, Built 1949 by State of Illinois, F.A. RT.5-Section 117-1-SB-SF, F.A. Proj. F.G.I.-116(20)-Station 541+08.32, Loading Coopers E-72; two-span structure with steel beams.	This bridge remains with little changed. IMG_1451

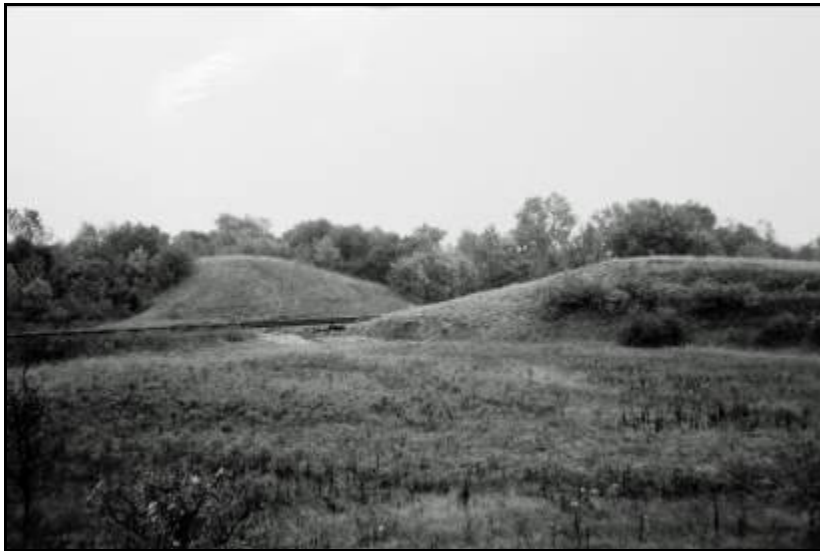
Sequence Number	Map Code	1994/95 Negative #	Address/Location	Type	Date Built	Historic Function	1994/95 Comments	2012/13 Comments and Photo Image #
310	21/24	21/24-25, IMG_1933	Old 66 over BN RR	1	Ca. 1930s	Bridge	Bridge itself is gone, but earthen ramps and alignment is clearly visible.	Earthen ramps and alignment were not found.

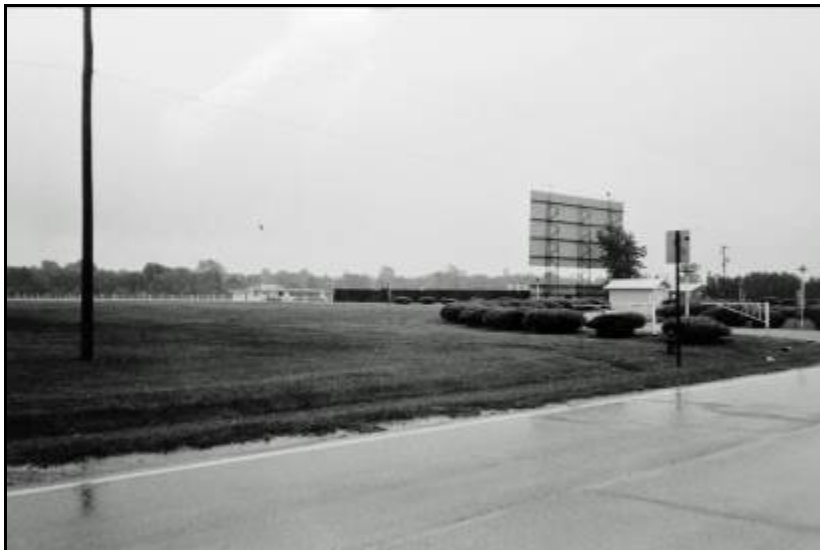
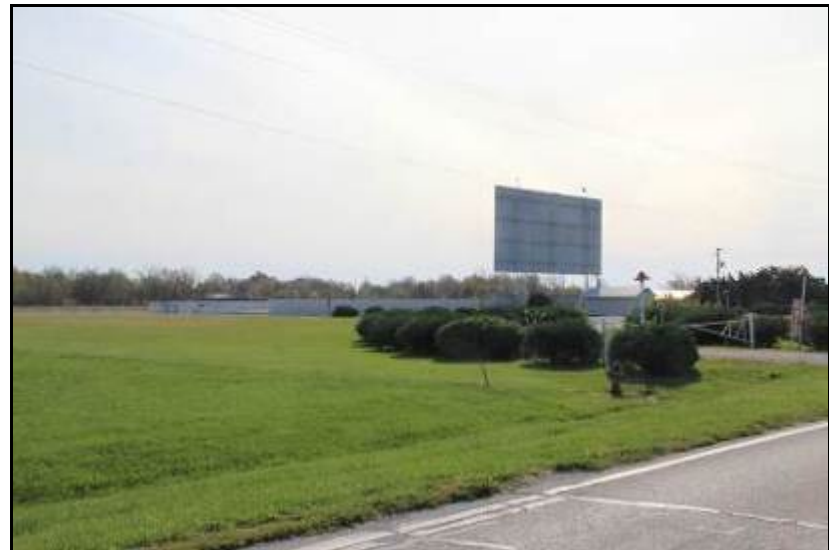
Sequence Number	Map Code	1994/95 Negative #	Address/Location	Type	Date Built	Historic Function	1994/95 Comments	2012/13 Comments and Photo Image #
311	22/00	22/00-02, IMG_1934	N. Sherman (S of Rd. 1300N)	2	Ca. 1960s	Drive-In Movie	Drive-in movie theater; has relatively modern screen with metal pole uprights.	This enterprise is thought to be the only remaining, operable drive-in theater on RT 66 in Illinois. IMG_1454

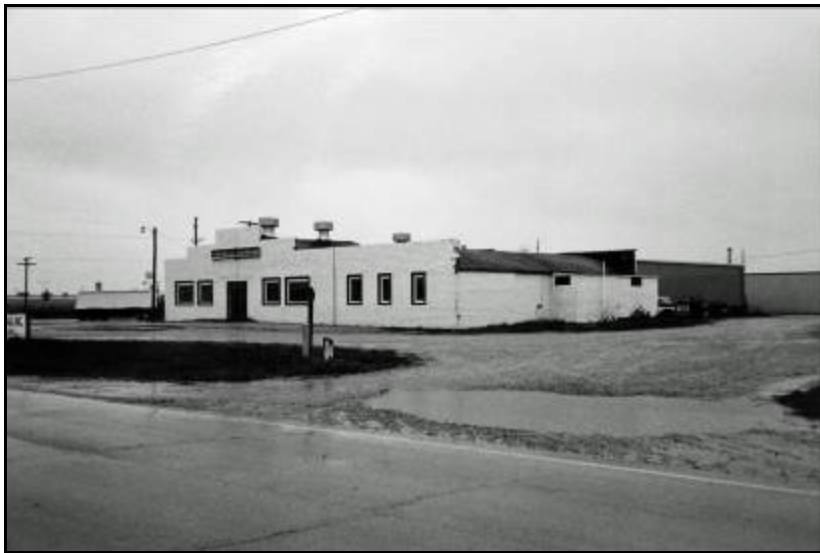
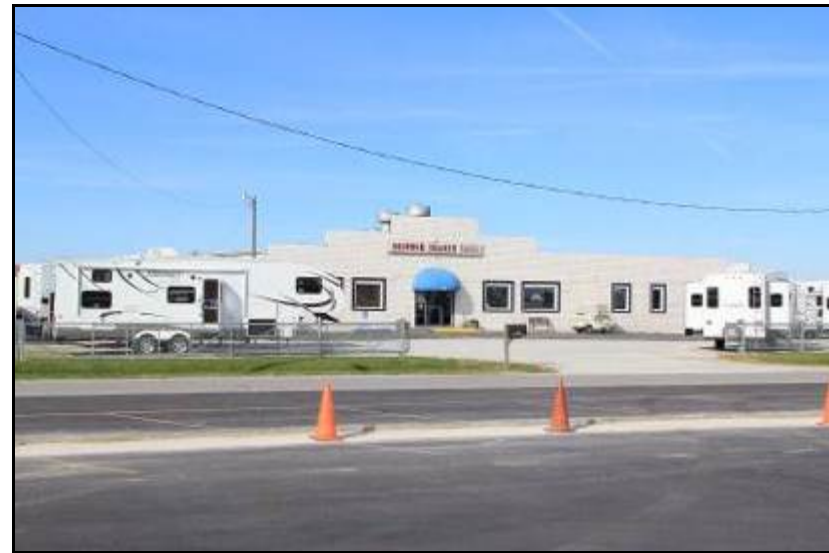
Sequence Number	Map Code	1994/95 Negative #	Address/Location	Type	Date Built	Historic Function	1994/95 Comments	2012/13 Comments and Photo Image #
312	22/04	22/04, IMG_1935	N. Sherman & W. Ferdow	2	Ca. 1930s-40s	Café	White, glazed brick building with arched roof and two-step parapet; was "Skinney's Café" – now utilized as a truck garage.	The building and its glazed brick sheathing remains, although it is now the venue for "Diamond Trailer Sales." IMG_1457

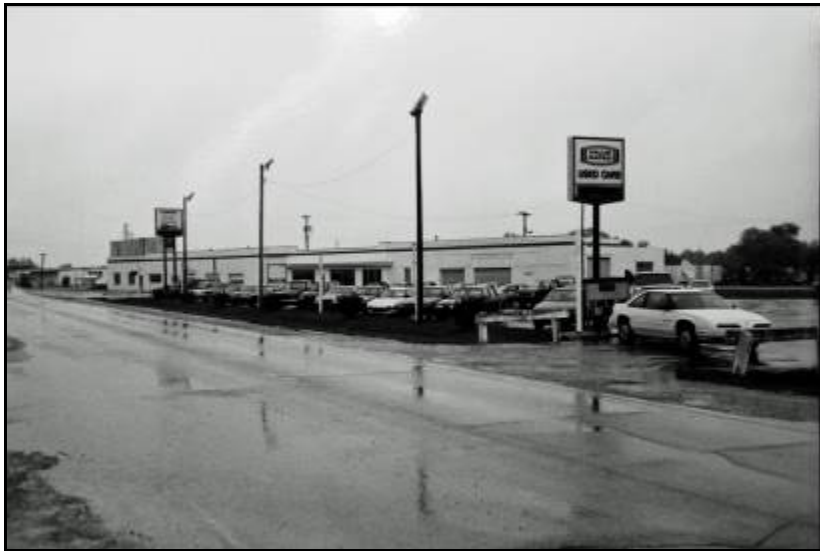
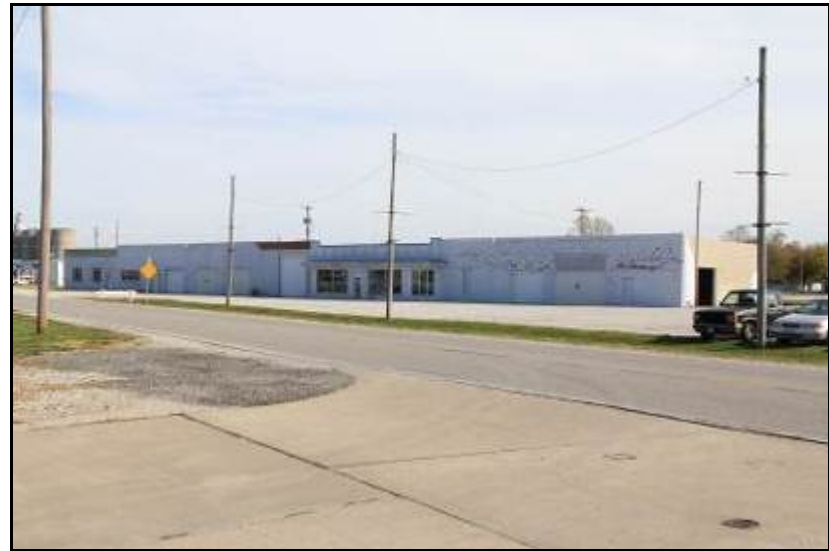
Sequence Number	Map Code	1994/95 Negative #	Address/Location	Type	Date Built	Historic Function	1994/95 Comments	2012/13 Comments and Photo Image #
313	22/05	22/05-06, IMG_1936	N. Sherman (between Ferdow & IL 16)	2	Ca. 1940s	Auto Dealer	Centrally located showroom may have enamel panel sheathing, concrete block sections with parapets to either side – “Schmidt Oldsmobile.”	This former “Oldsmobile” dealership building is now vacant. It appears to retain some good integrity, although it has been painted. IMG_1458

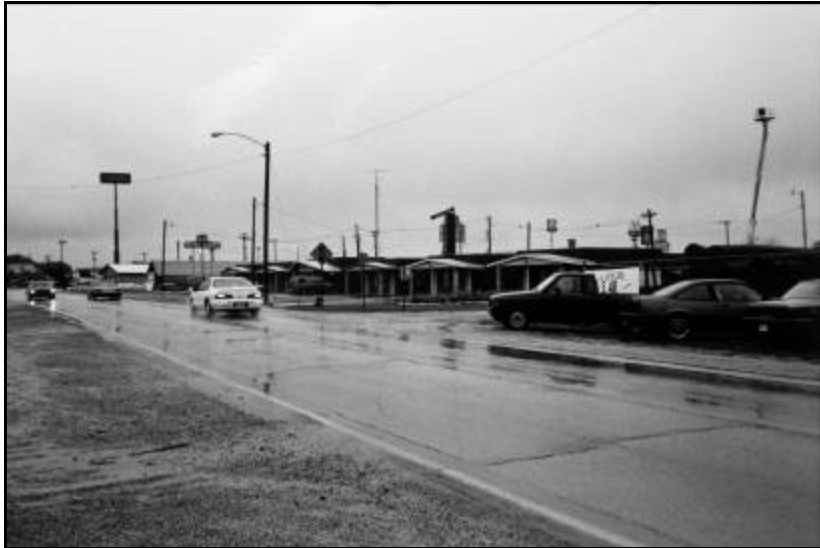
Sequence Number	Map Code	1994/95 Negative #	Address/Location	Type	Date Built	Historic Function	1994/95 Comments	2012/13 Comments and Photo Image #
314	22/07	22/07-08, IMG_1937	N. Sherman & W. Weir (NW corner)	2	Ca. 1940s-50s	Motel	Motel court with small, brick structures containing two rooms to a building – “66 Hotel Court.”	Motel now gone.

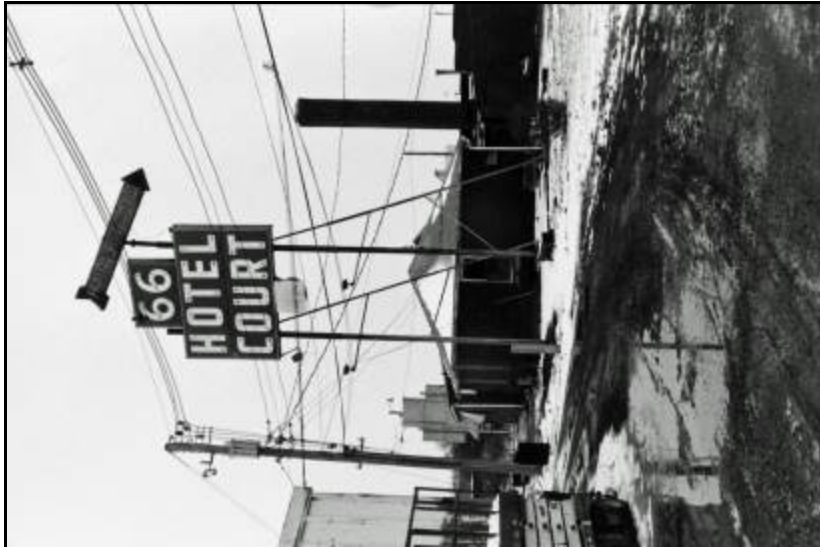
Sequence Number	Map Code	1994/95 Negative #	Address/Location	Type	Date Built	Historic Function	1994/95 Comments	2012/13 Comments and Photo Image #
315	09/01	09/01, IMG_1938	N. Sherman & W. Weir (NW corner)	2	Ca. 1950s	Motel Sign	Neon sign for "66 Hotel Court."	The motel sign is gone as well.

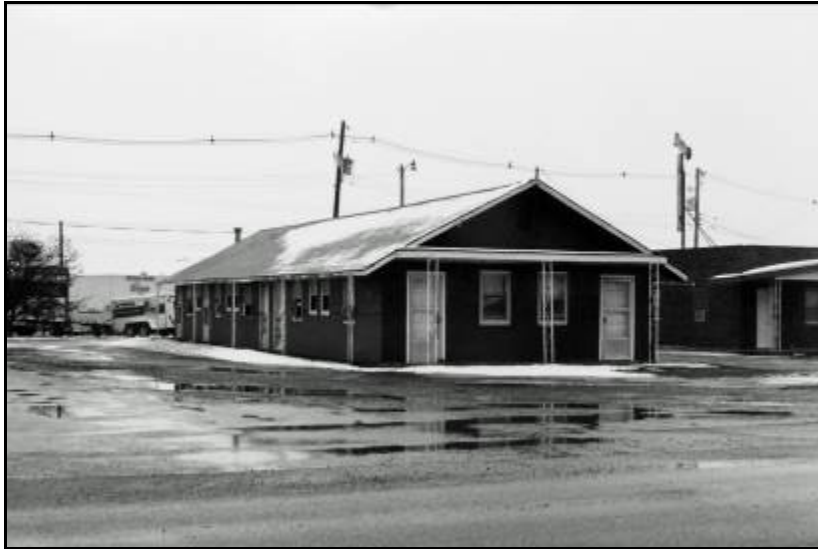
Sequence Number	Map Code	1994/95 Negative #	Address/Location	Type	Date Built	Historic Function	1994/95 Comments	2012/13 Comments and Photo Image #
316	09/02	09/02, IMG_1939	N. Sherman & W. Weir (SW corner)	2	Ca. 1950s	Motel	Small, gabled structure adjacent to (and part of??) "66 Hotel Court."	Structure now gone.

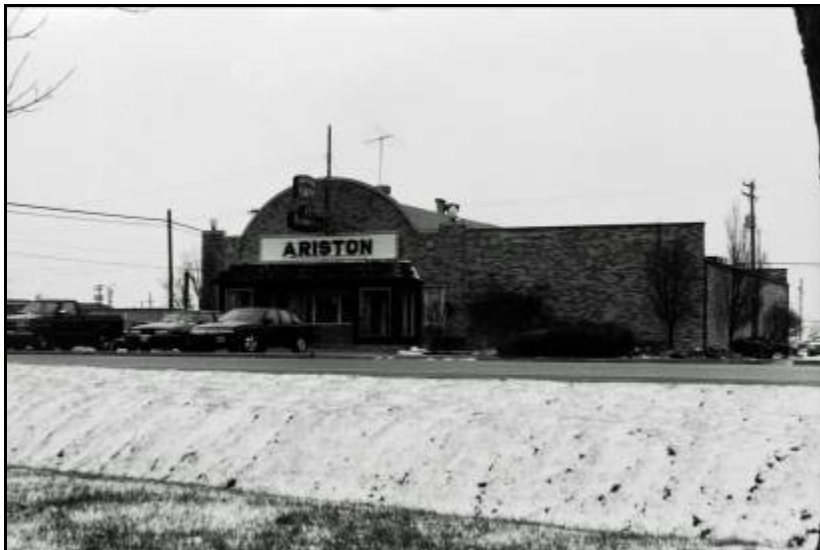
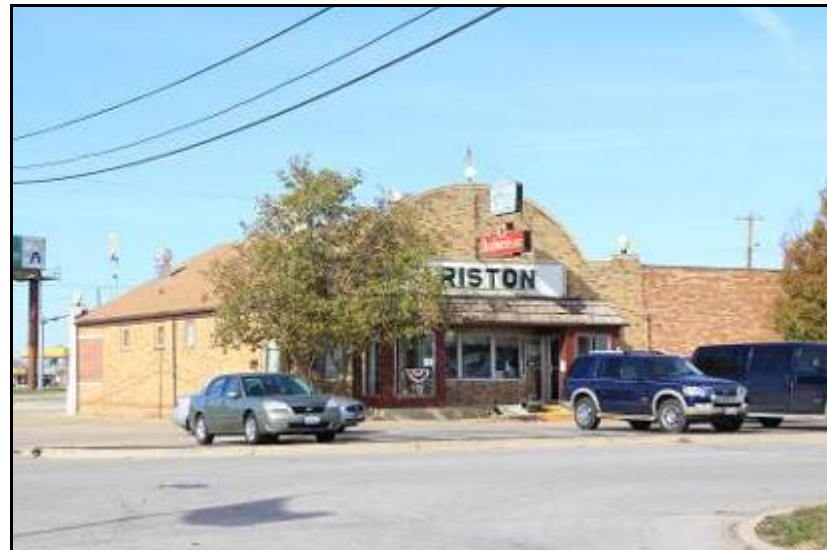
Sequence Number	Map Code	1994/95 Negative #	Address/Location	Type	Date Built	Historic Function	1994/95 Comments	2012/13 Comments and Photo Image #
317	09/03	09/03, IMG_1940	N. Sherman & IL 16	2	Ca. 1935	Café	Brick café with arched roof and distinctive parapet; new addition to N – “Ariston”—see Waldmire Post Card for more information.	Aside from some foliage out front, the “Ariston” appears to be largely what it was in 1994. IMG_1459

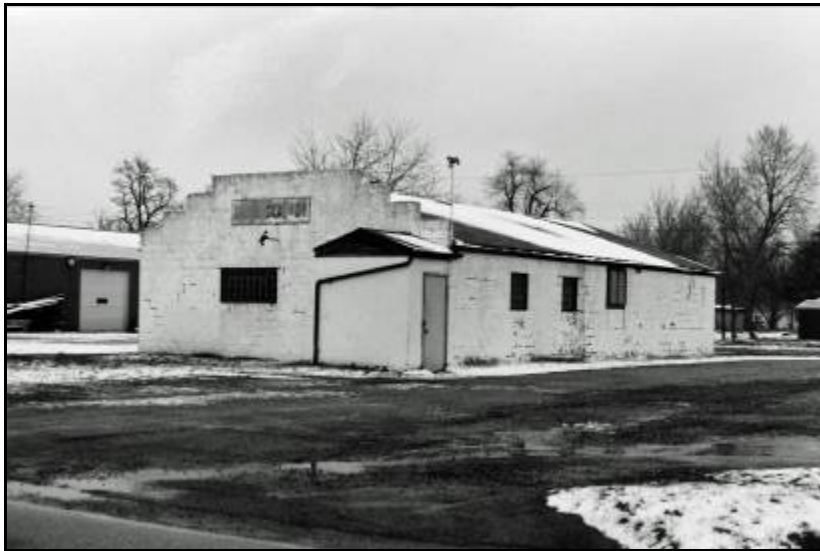
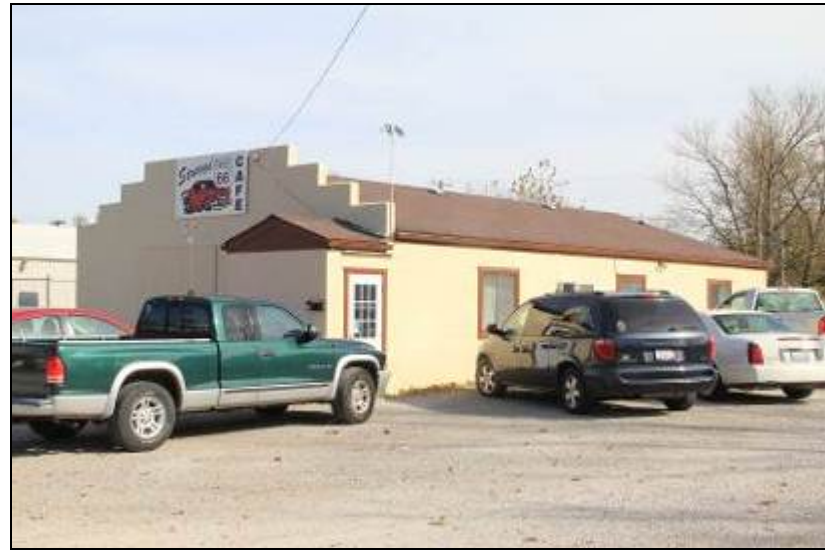
Sequence Number	Map Code	1994/95 Negative #	Address/Location	Type	Date Built	Historic Function	1994/95 Comments	2012/13 Comments and Photo Image #
318	09/04	09/04, IMG_1941	N. Sherman & W. Beeler (?)	2	Ca. 1930s-40s	Auto Service (?)	Concrete block structure with arched roof and stepped parapet; sign notes "Local 84," but the structure looks as if it could have been an auto service structure.	The building remains with some modifications (i.e., new doorway and enlarged windows). It is now the "RT 66 Café." IMG_1461

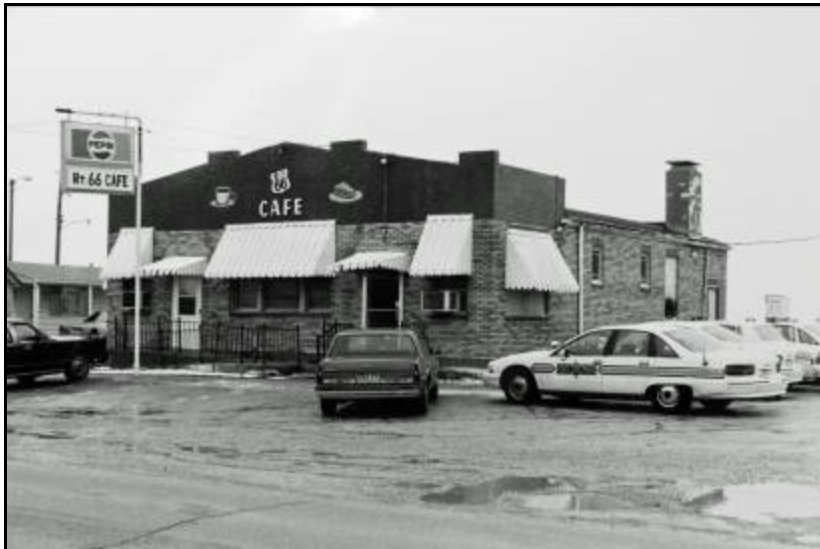
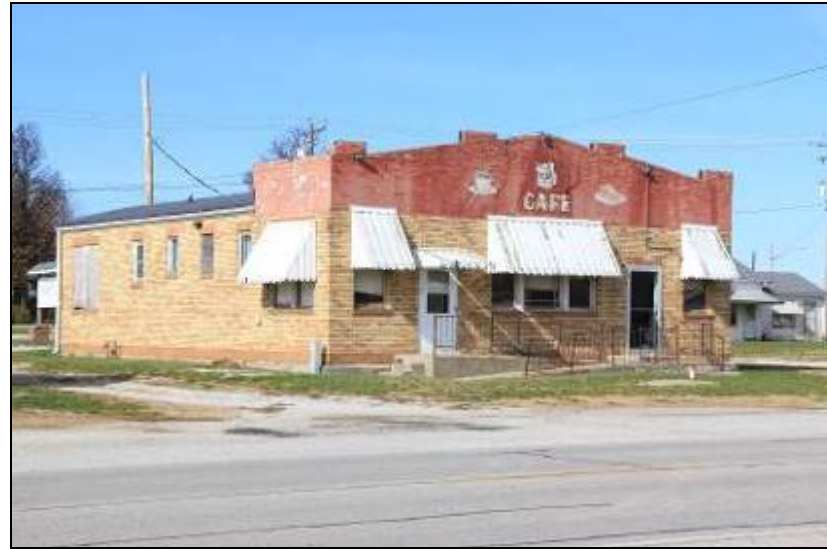
Sequence Number	Map Code	1994/95 Negative #	Address/Location	Type	Date Built	Historic Function	1994/95 Comments	2012/13 Comments and Photo Image #
319	09/05	09/05, IMG_1942	S. Sherman & W. Clyde (NW corner)	2	Ca. 1940s	Café	Brick structure with gabled parapet – “RT 66 Café.”	Old “RT 66 Café” structure now vacant. IMG_1462

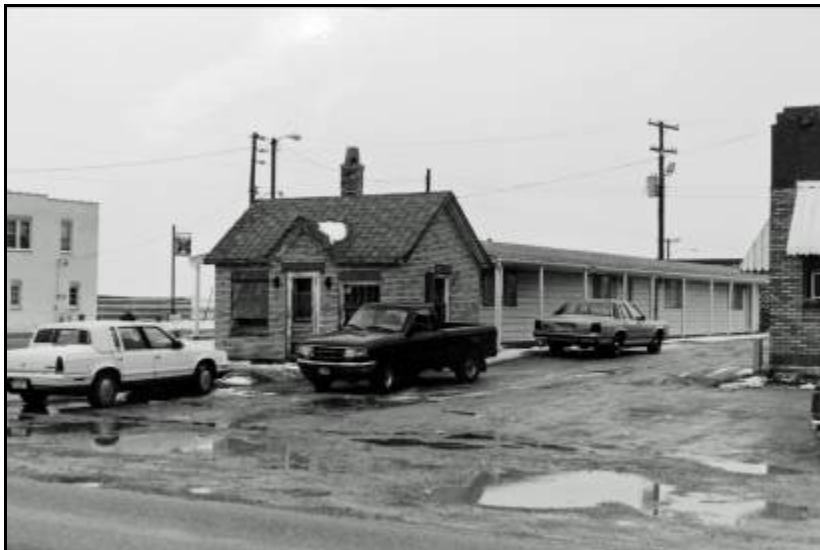
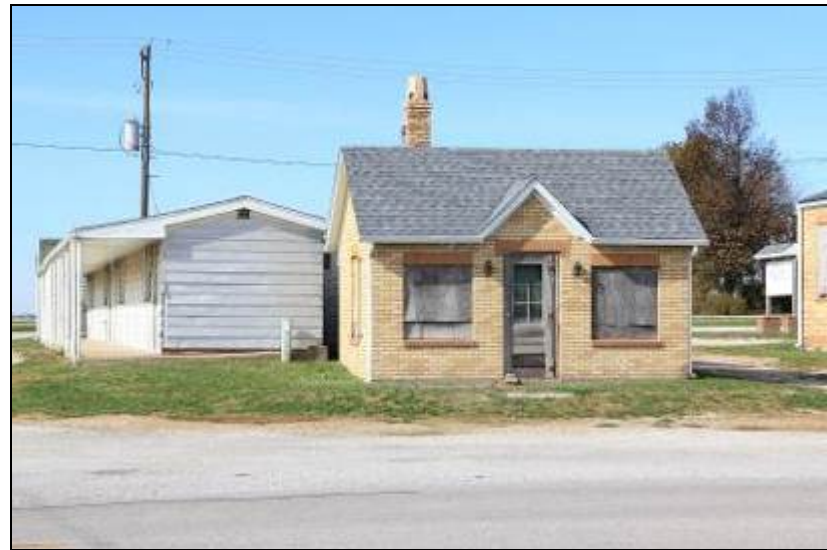
Sequence Number	Map Code	1994/95 Negative #	Address/Location	Type	Date Built	Historic Function	1994/95 Comments	2012/13 Comments and Photo Image #
320	09/06	09/06, IMG_1943	S. Sherman & W. Clyde (NW corner)	2	Ca. 1940s	Motel	Small, gabled, brick motel office having perpendicular, gabled, frame structure with rooms to rear. Adjacent to Rt 66 Café."	Motel facility appears to be vacant (which it may have been back in 1994, as well). IMG_1463

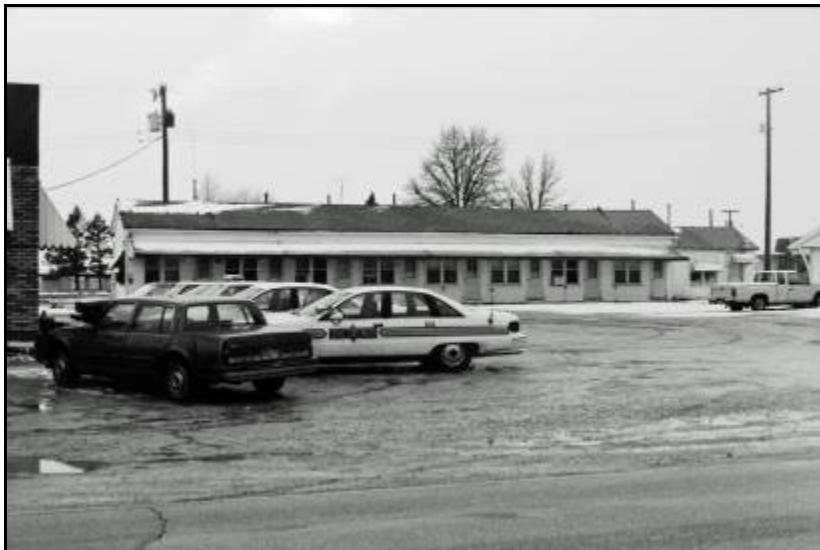
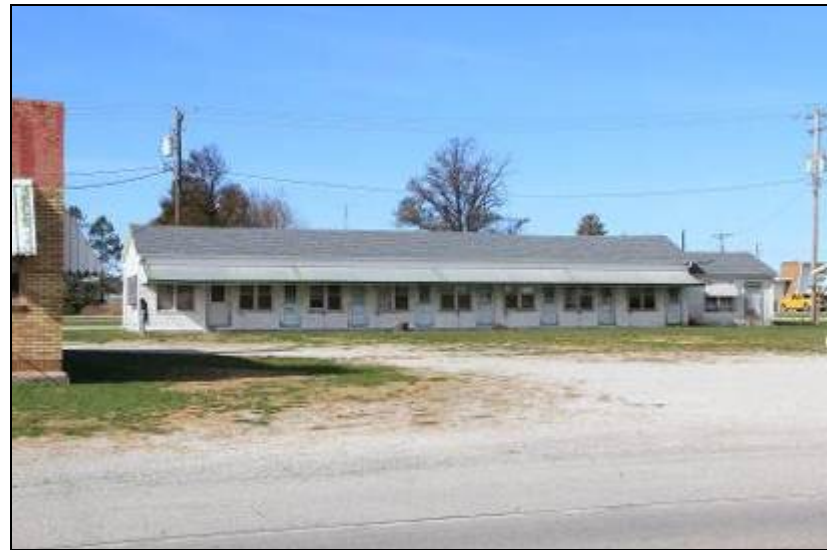
Sequence Number	Map Code	1994/95 Negative #	Address/Location	Type	Date Built	Historic Function	1994/95 Comments	2012/13 Comments and Photo Image #
321	09/07	09/07, IMG_1944	S. Sherman & W. Clyde (NW corner)	2	Ca. 1940s	Motel	Long, gabled structure with eight motel rooms and office at N end. Also adjacent to "RT 66 Café."	The integrity and character of the motel appears to be little changed since 1994. IMG_1464

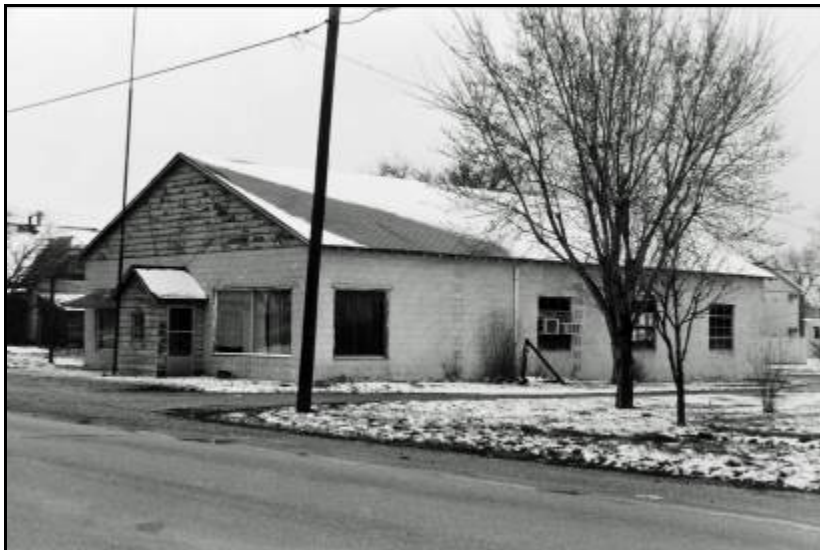
Sequence Number	Map Code	1994/95 Negative #	Address/Location	Type	Date Built	Historic Function	1994/95 Comments	2012/13 Comments and Photo Image #
322	09/08	09/08, IMG_1945	S. Sherman & W. Clyde (SE corner)	2(?)	Ca. 1950s	Entertainment (?)	Gabled, concrete block structure – looks much like a VFW-type hall; possible entertainment/restaurant stop on road?	Structure now gone.

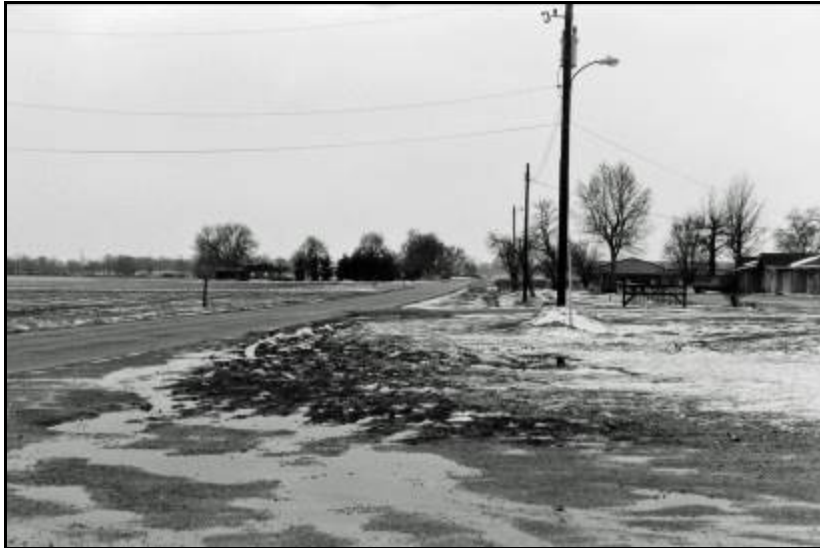
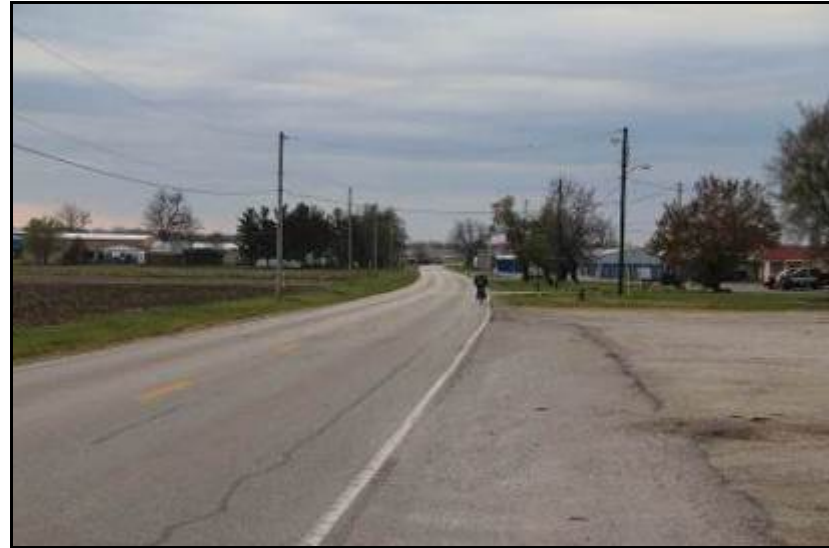
Sequence Number	Map Code	1994/95 Negative #	Address/Location	Type	Date Built	Historic Function	1994/95 Comments	2012/13 Comments and Photo Image #
323	09/09	09/09, IMG_1946	S. Sherman & W. Clyde	1	Ca. 1930s	USH 66	Two-lane, 1930 alignment S of Litchfield (view to S)	1930s RT 66 extending S of Litchfield appears little changed. IMG_1555
