Route 66 in Illinois:

(2012/13 Update and Expansion of the Original 1994/95 Survey)

IDOT Sequence #17337 & #17337A

22 December 2013

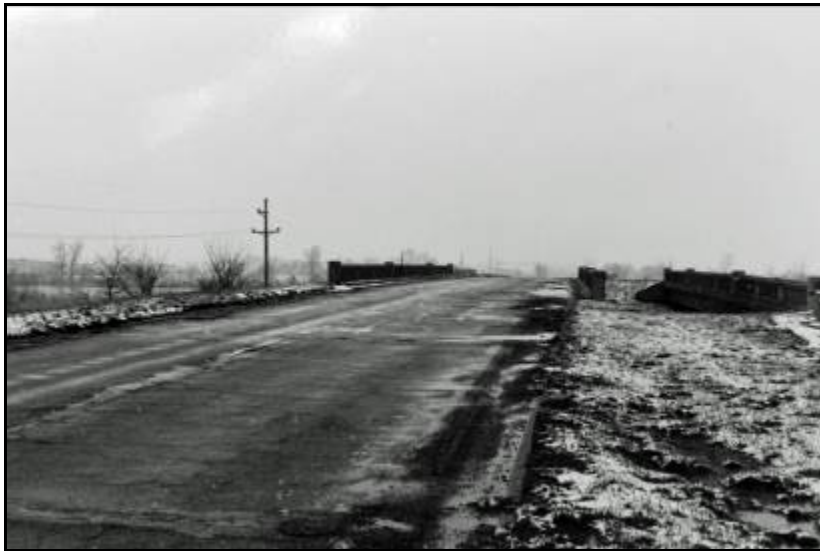
Sequence Number	Map Code	1994/95 Negative #	Address/Location	Type	Date Built	Historic Function	1994/95 Comments	2012/13 Comments and Photo Image #
324	09/11	09/11-12, 12/17-18, IMG_1947	Old 66 Bypass over BN RR	1	1948	Bridges	Two structures remain, each with a plate; Bridge #068-0032 (eastbound) – plate notes: CB&Q RR, Built 1948 by, State of Illinois, Fed. Aid RTE.5 Sec. 117-IVB, Proj. FAGH-1-166(17) Station 627+36.5, Loading H-20-S16-41; Bridge #068-0033 (westbound) – plate notes: CB&QRR, Built 1948 by, State of Illinois, Fed. Aid RTE.5 Sec. 117-IVB, Proj. FAGH-1-166(17) Station 627+36.5, Loading H-20-S16-41; both structures are three spans, each with rolled “I” beam support system for deck.	Historic period bridges now gone. Eastbound bridge rebuilt in 1998

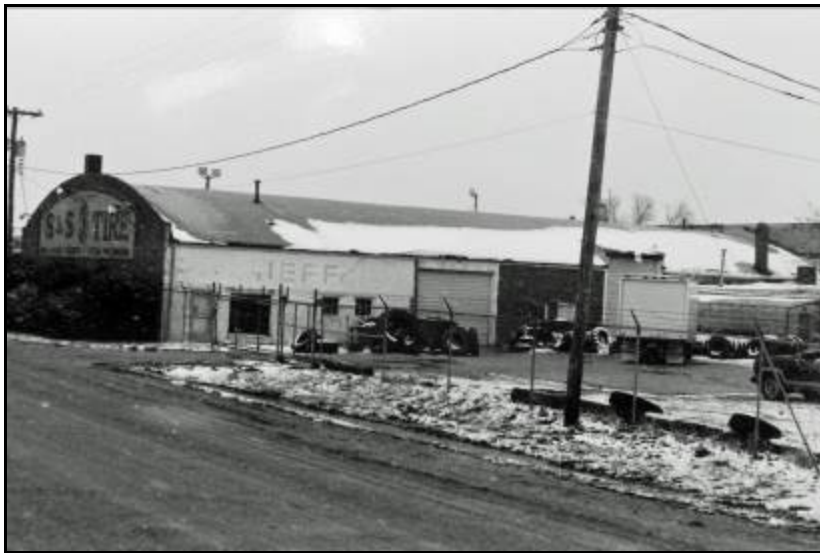
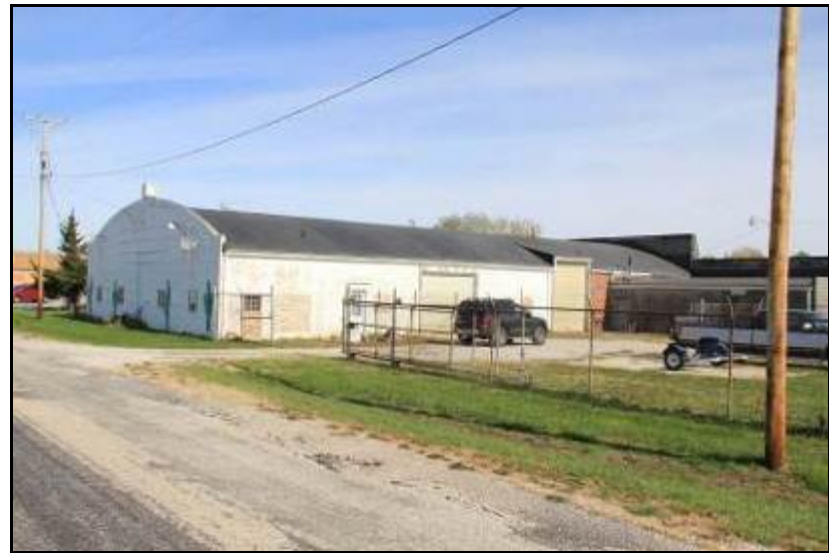
Sequence Number	Map Code	1994/95 Negative #	Address/Location	Type	Date Built	Historic Function	1994/95 Comments	2012/13 Comments and Photo Image #
325	09/14	09/14, IMG_1948	215 Old 66 Bypass	2	Ca. 1940s	Auto Service	Brick structure with arched roof could have provided auto service and care along 66 – now “S&S Tire.”	Old tire dealer now houses “Denny’s Package Liquor,” in addition to a printing/sign outlet. The building has been repainted and some windows closed. IMG_1468

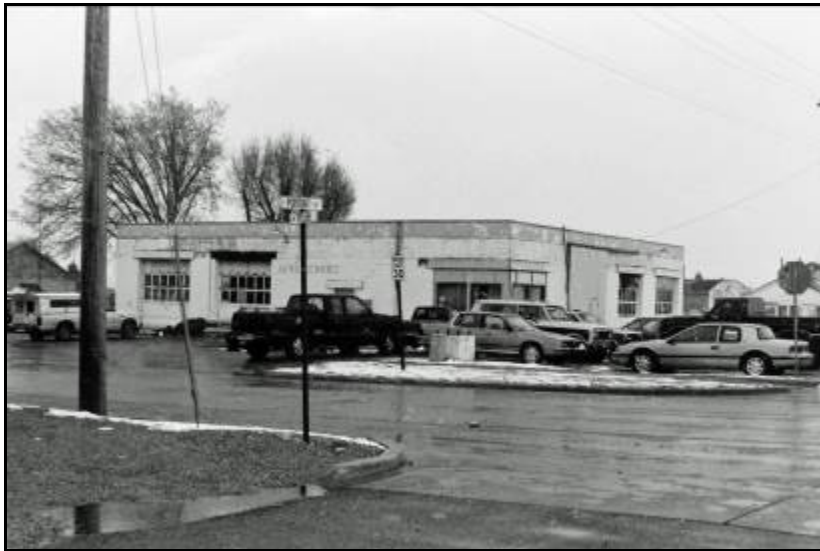
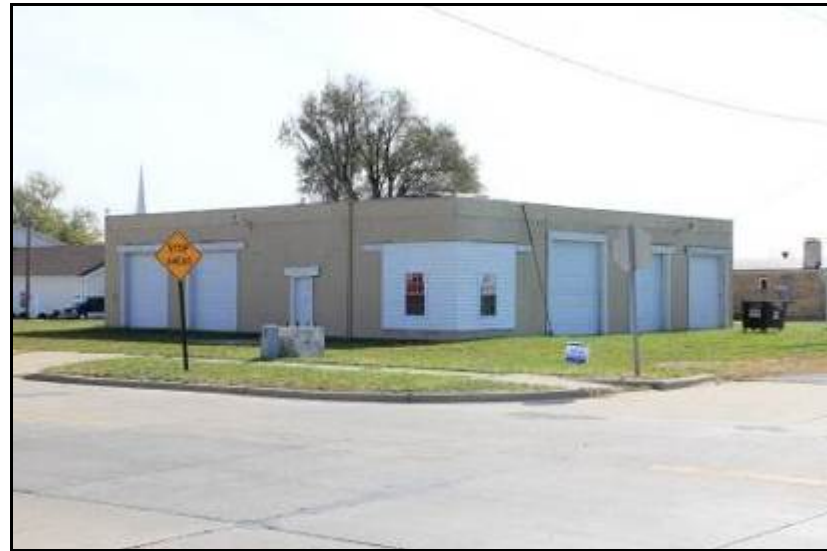
Sequence Number	Map Code	1994/95 Negative #	Address/Location	Type	Date Built	Historic Function	1994/95 Comments	2012/13 Comments and Photo Image #
326	09/13	09/13, IMG_1949	Old 66 bypass & Tyler	2	Ca. 1940s-50s	Auto Service	Relatively large, concrete block structure has at least four, overhead, garage doors; probably sold gas.	This service station building remains, but with substantial changes (i.e., new overhead garage doors, greatly reduced windows and painted). IMG_1467

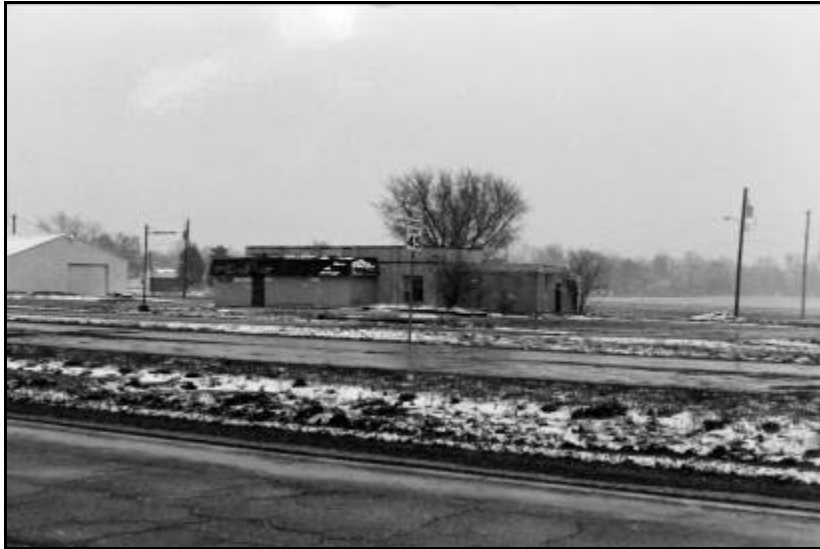
Sequence Number	Map Code	1994/95 Negative #	Address/Location	Type	Date Built	Historic Function	1994/95 Comments	2012/13 Comments and Photo Image #
327	09/15	09/15, IMG_1950	Old 66 Bypass (N of Rd. 1100N)	2	Ca. 1950s-60s	Gas/Service	Brick/block gas station – vacant.	Structure now gone.

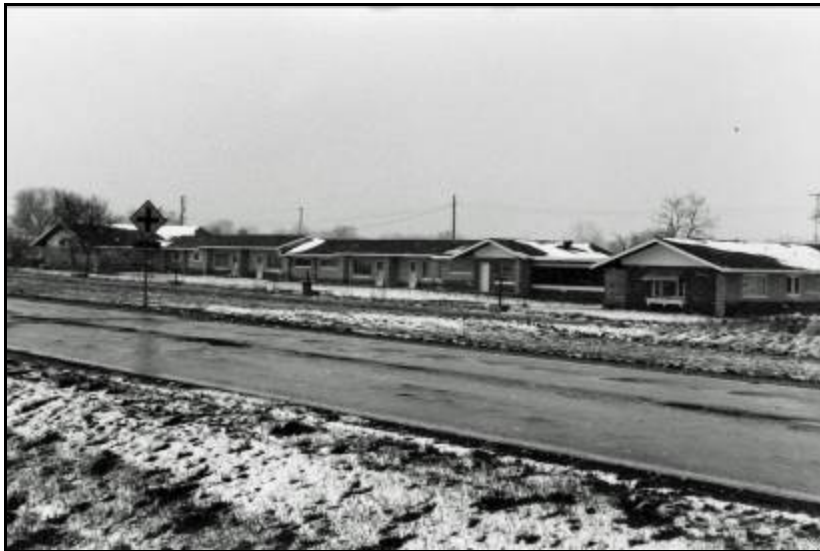
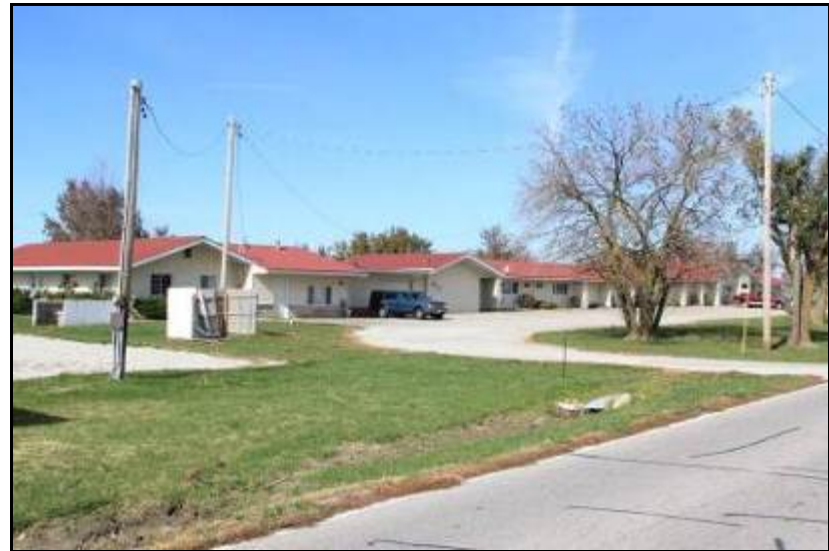
Sequence Number	Map Code	1994/95 Negative #	Address/Location	Type	Date Built	Historic Function	1994/95 Comments	2012/13 Comments and Photo Image #
328	09/16	09/16, IMG_1951	Old 66 Bypass (N of Rd. 1100N)	2	1960s	Motel	Sprawling, gabled, motel of brick; has been converted to apartments.	Old motel appears to have been resheathed since 1994. IMG_1466

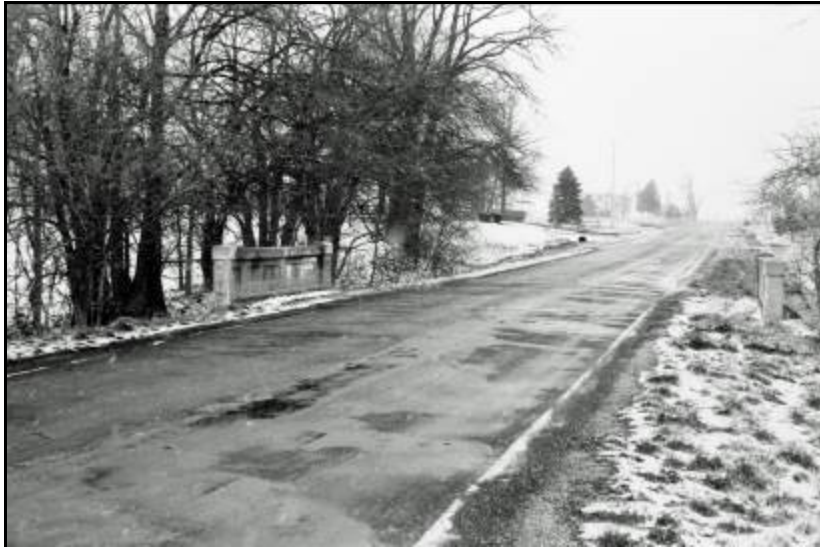
Sequence Number	Map Code	1994/95 Negative #	Address/Location	Type	Date Built	Historic Function	1994/95 Comments	2012/13 Comments and Photo Image #
329	09/10	09/10, 22/09, IMG_1952	Old 66 & unnamed creek (N of Rd. 1000N)	1	Ca. 1930s	Bridge	Bridge #068-0053 – bridge plate gone; single-span, concrete slab deck structure.	Bridge now gone. Replaced by beam-guard.

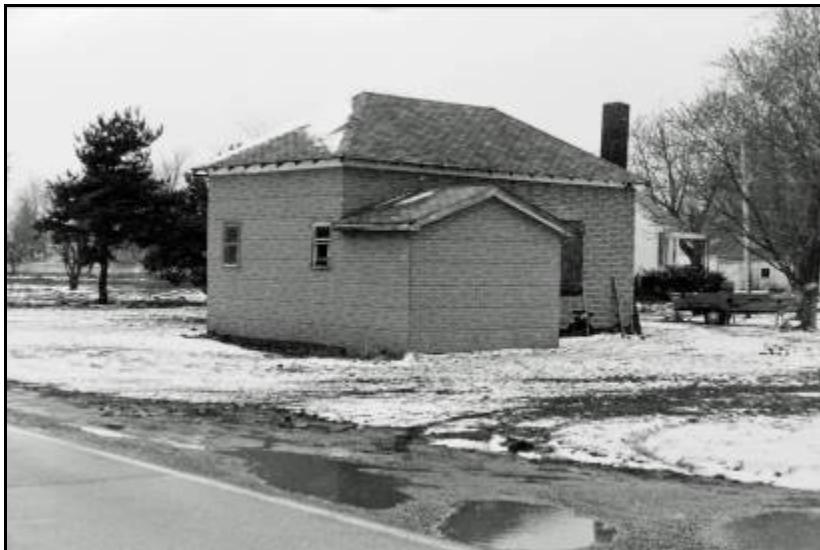
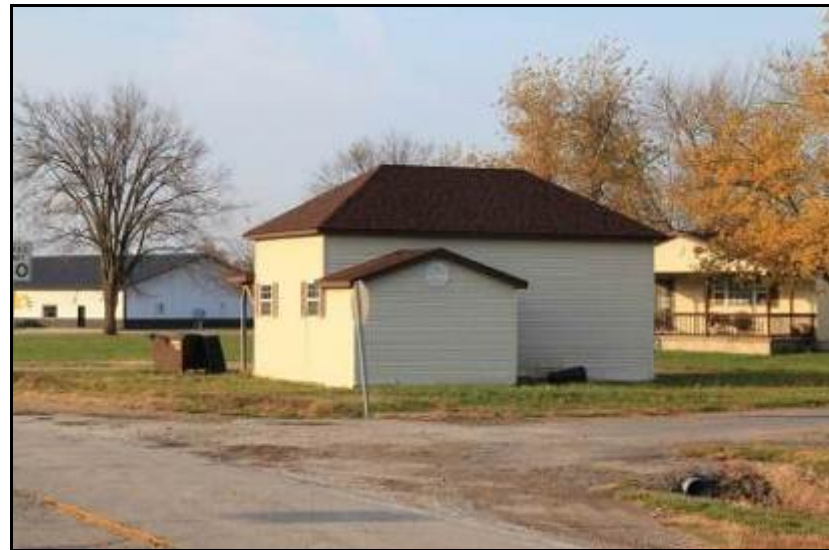
Sequence Number	Map Code	1994/95 Negative #	Address/Location	Type	Date Built	Historic Function	1994/95 Comments	2012/13 Comments and Photo Image #
330	09/17	09/17, IMG_1953	Old 66 (N of MT OLIVE)	2(?)	Ca. 1930s (?)	Gas (?)	Small, hip roof structure with brick or imitation brick siding – could have been a gas station or related building, but questionable [new, aluminum siding, October 1994].	Structure was resided in 1994, as well as lost its chimney. IMG_1558

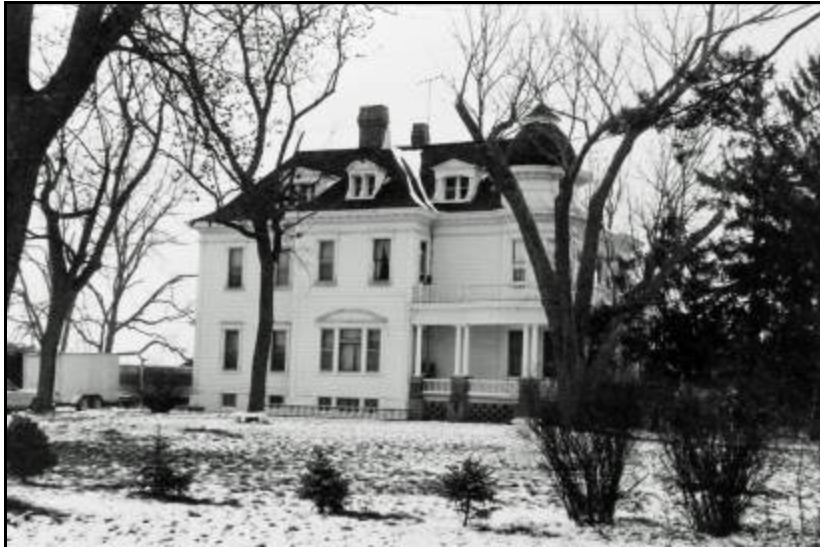
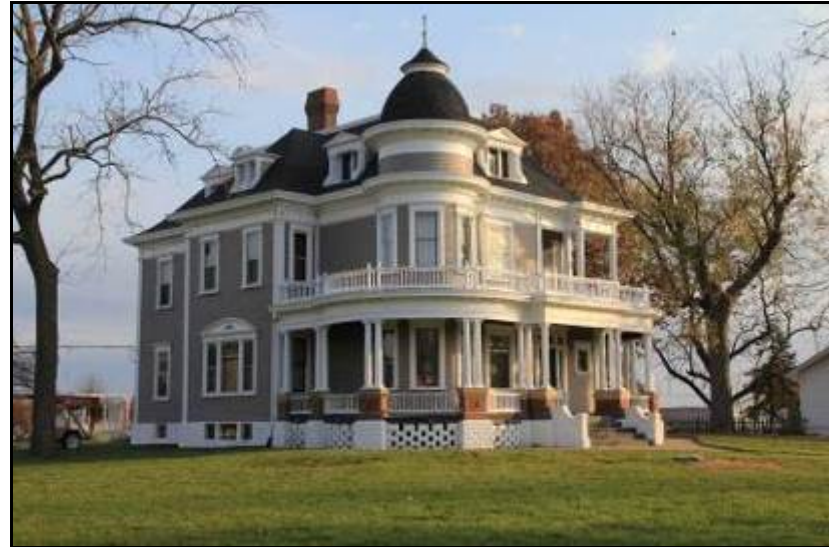
Sequence Number	Map Code	1994/95 Negative #	Address/Location	Type	Date Built	Historic Function	1994/95 Comments	2012/13 Comments and Photo Image #
331	09/18	09/18, IMG_1954	403 5 th St. North, MT OLIVE	3	Ca. 1890s	Residential	Large, Queen Anne house with clap-board siding, wrap-around porch, dentilled frieze with eave brackets and classical ornamentation.	This house has been repainted. It is an absolute jewel in Mt. Olive. IMG_1559

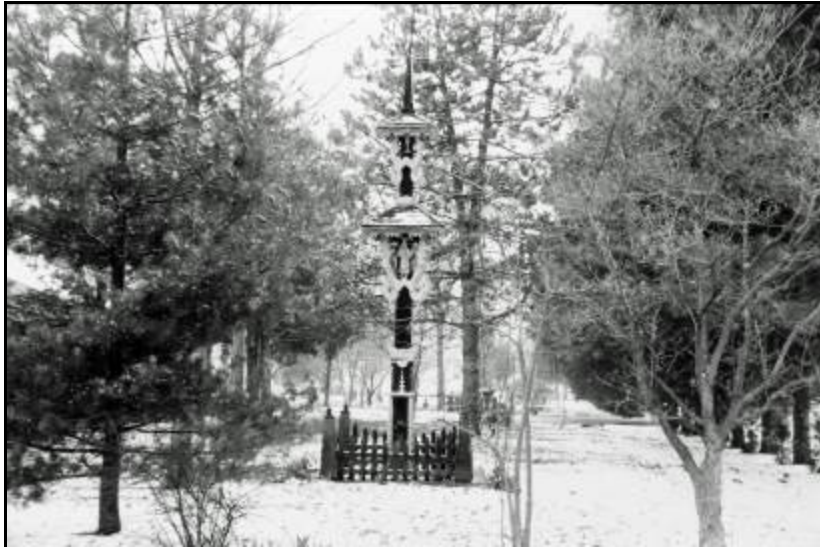
2012

Sequence Number	Map Code	1994/95 Negative #	Address/Location	Type	Date Built	Historic Function	1994/95 Comments	2012/13 Comments and Photo Image #
332	09/19	09/19, IMG_1955	202 5 th St. North, MT OLIVE	3	Unknown	Lawn Ornament	Prominent resource easily observed by RT 66 travelers if it predates 1950s bypass.	Lawn ornament now gone.

No longer extant

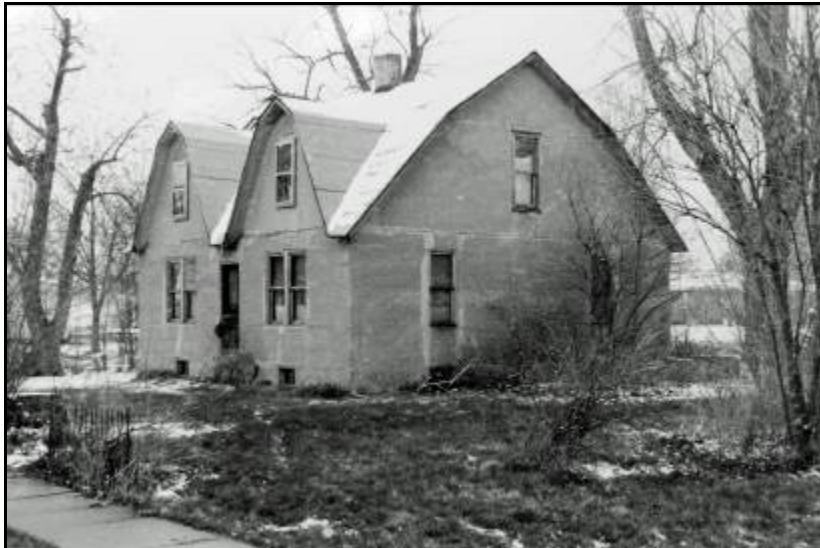
2012

Sequence Number	Map Code	1994/95 Negative #	Address/Location	Type	Date Built	Historic Function	1994/95 Comments	2012/13 Comments and Photo Image #
333	09/20	09/20, IMG_1956	5 th St. North (between Cherry & Walnut), MT OLIVE	3	Unknown	Residential	Unique-looking, reinforced concrete (or concrete veneer?) house with gambrel roof and gambrel wall dormers.	This building no longer remains.

No longer extant

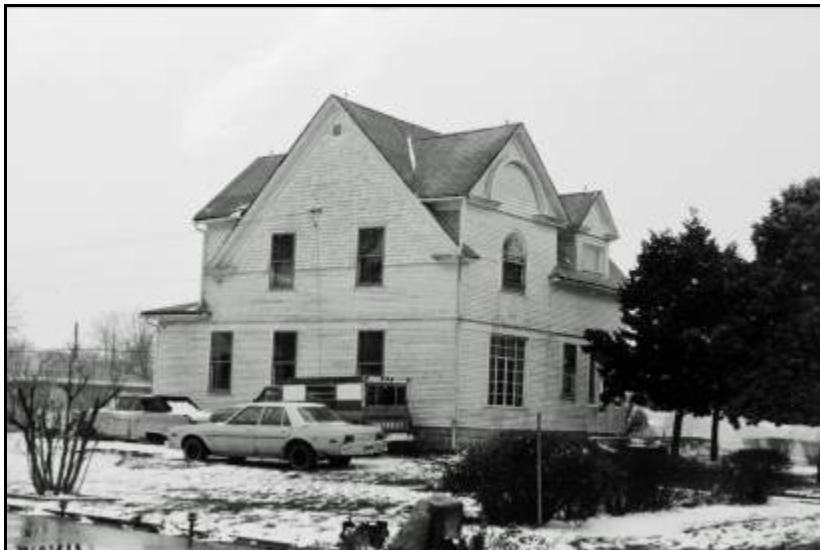
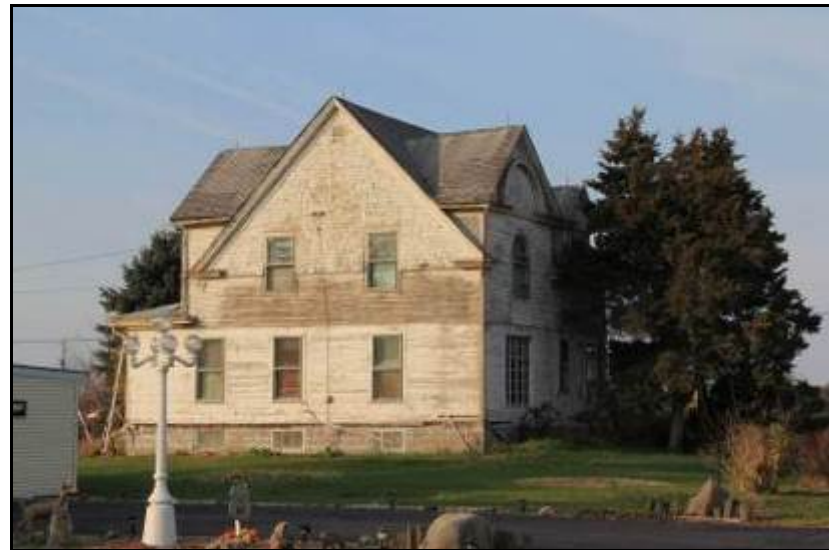
Sequence Number	Map Code	1994/95 Negative #	Address/Location	Type	Date Built	Historic Function	1994/95 Comments	2012/13 Comments and Photo Image #
334	09/21	09/21, IMG_1957	5 th St. North (between Lake & Cherry), MT OLIVE	3	Ca. Late 19 th , Early 20 th Century	Residential	Massive, 2.5 story house with clapboard siding, shake shingles in gabled dormers, roof returns and rock-faced, concrete block foundation.	Although its paint has faded more, this structure appears very much as it did in 1994. IMG_1560

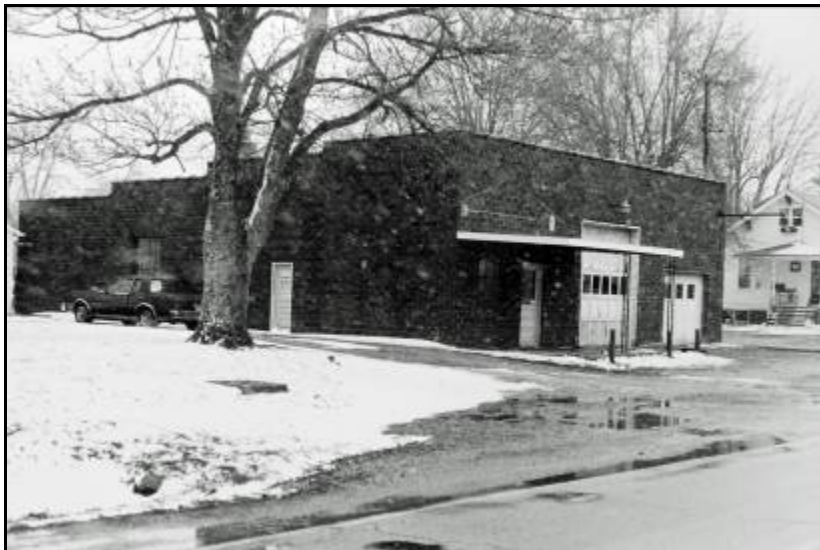
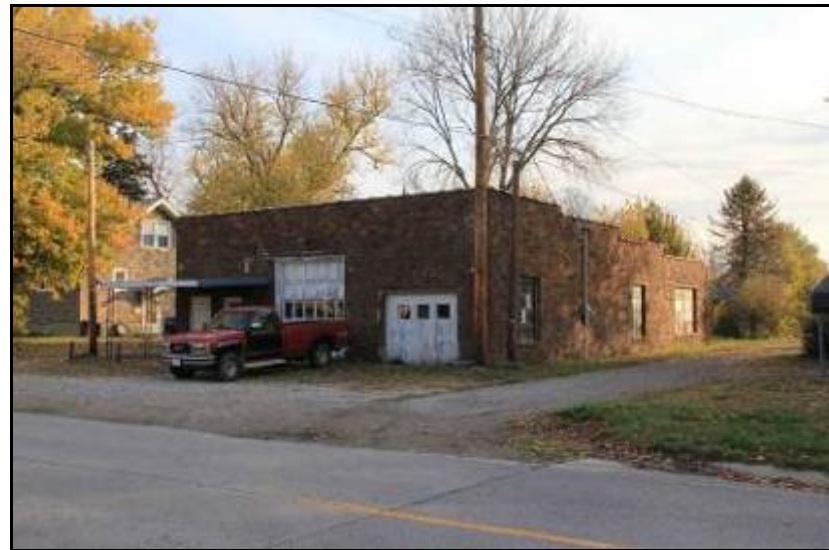
Sequence Number	Map Code	1994/95 Negative #	Address/Location	Type	Date Built	Historic Function	1994/95 Comments	2012/13 Comments and Photo Image #
335	09/22	09/22, IMG_1958	110 Illinois St., MT OLIVE	2	Ca. 1930s-40s	Auto Service	Brick/tile garage with parapets – “West End Garage” noted on structure.	This automobile garage appears little changed in the last 18 years. IMG_1561

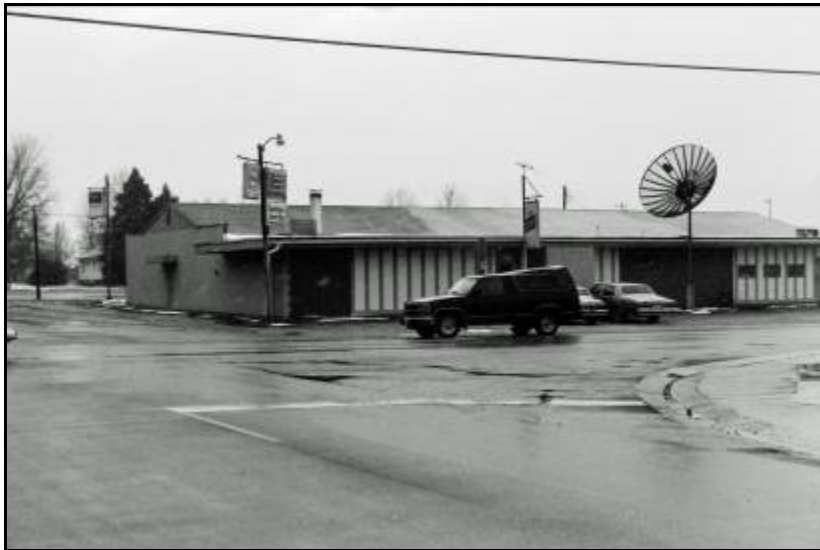
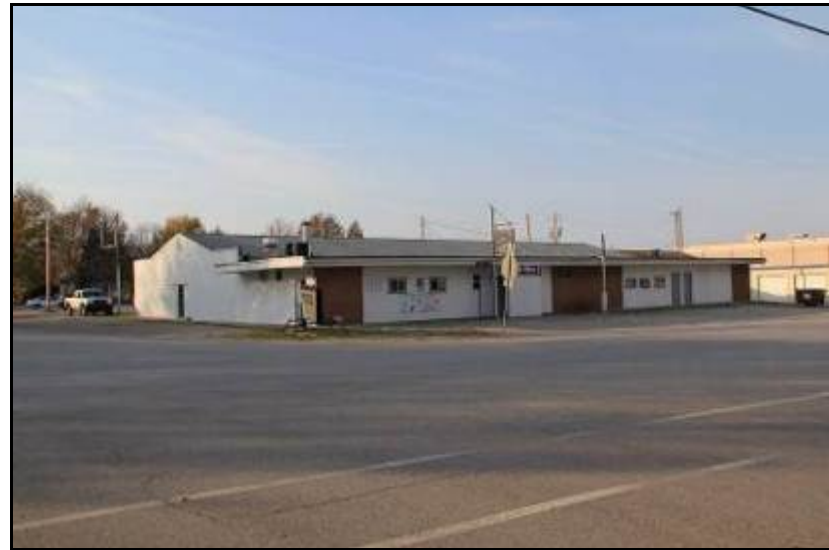
Sequence Number	Map Code	1994/95 Negative #	Address/Location	Type	Date Built	Historic Function	1994/95 Comments	2012/13 Comments and Photo Image #
336	09/25	09/25, IMG_1959	Illinois St. & IL 138, MT OLIVE	2	Ca. 1920s-30s	Tavern/Club	Old "Route 66 Club" – substantially remodeled, which includes the loss of a second floor (?).	Now the "Mt. Olive Bowl & Lounge," this building appears to have been rather substantially changed since 1994 (i.e., windows now in left part of building, a possible addition to the far right and changes to the exterior ornamentation). IMG_1562

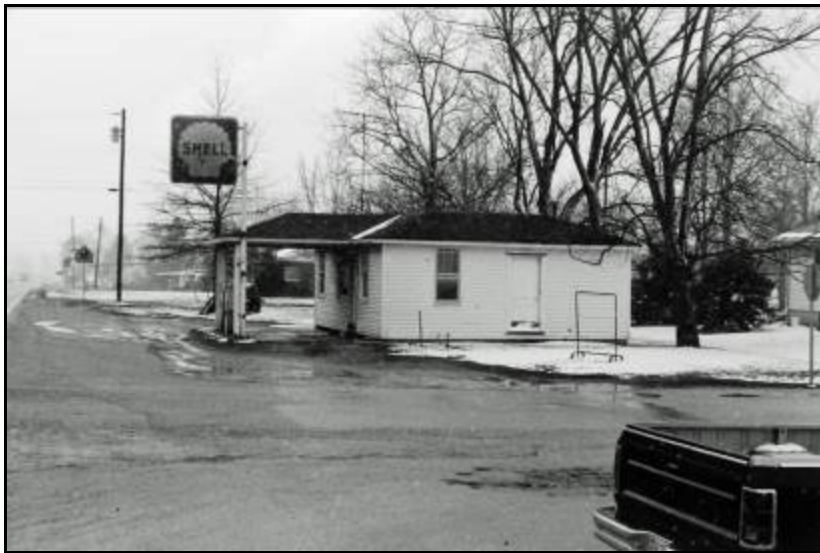
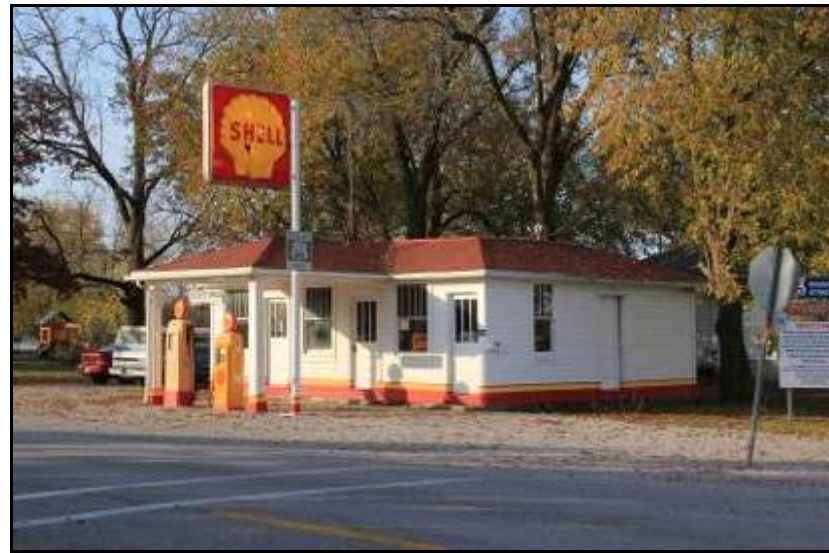
Sequence Number	Map Code	1994/95 Negative #	Address/Location	Type	Date Built	Historic Function	1994/95 Comments	2012/13 Comments and Photo Image #
337	09/23	09/23, IMG_1960	Illinois St. (between South & 2 nd St. South), MT OLIVE	2	Ca. 1920s	Gas Station	Small gas station with hip roof, clap-board siding and drive-through; Russell Soulsby was proprietor – see Waldmire Post Card for more information.	The Russell Soulsby gas station retains substantial historical and architectural integrity today. A RT 66 interpretive sign is adjacent. IMG_1563

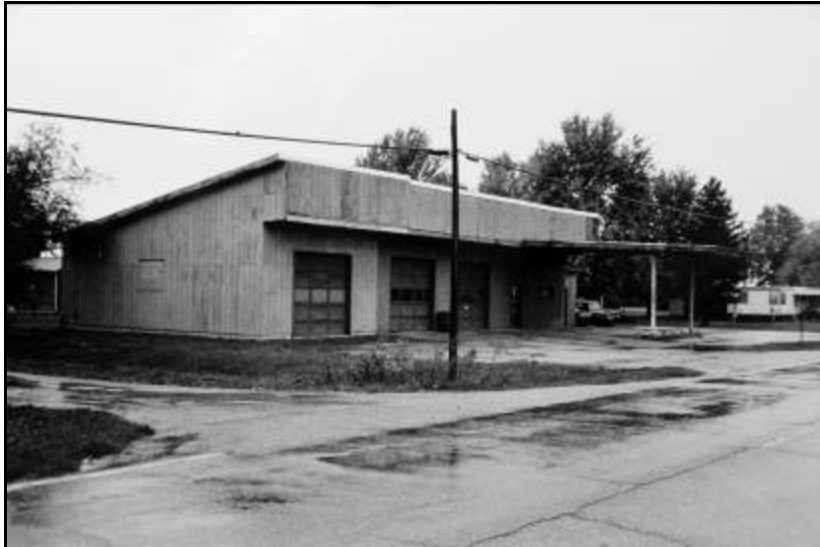
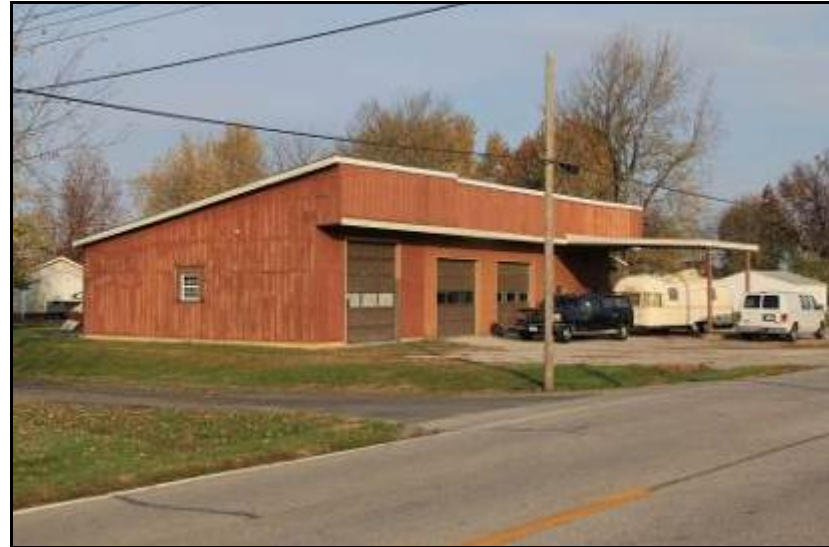
Sequence Number	Map Code	1994/95 Negative #	Address/Location	Type	Date Built	Historic Function	1994/95 Comments	2012/13 Comments and Photo Image #
338	22/10	22/10, IMG_1961	307 Illinois St., MT OLIVE	2	Ca. 1950s-60s (?)	Gas/Service	Concrete block (?) with vertical, board siding and projecting canopy over gas island.	The only evident change in this building over the last 19 years is the slight increase in height of the garage door to the left. IMG_1566

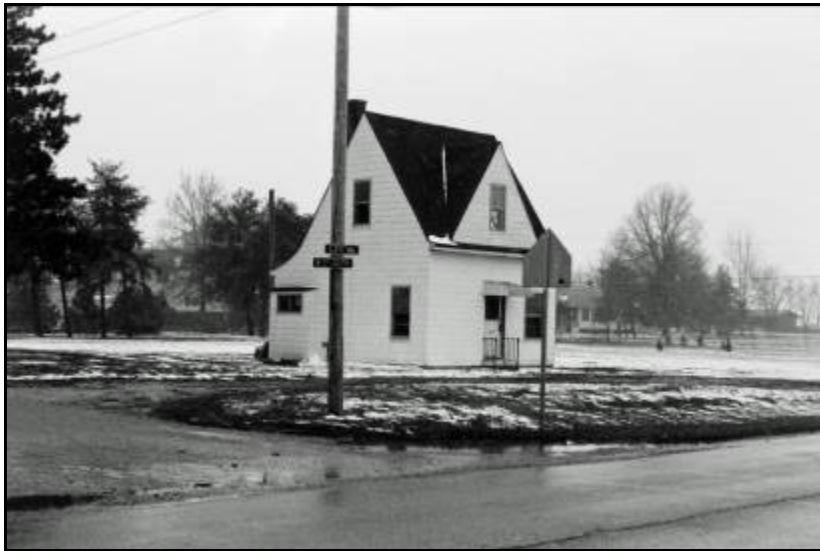
2012

Sequence Number	Map Code	1994/95 Negative #	Address/Location	Type	Date Built	Historic Function	1994/95 Comments	2012/13 Comments and Photo Image #
339	09/24	09/24, IMG_1962	Illinois St. (S of 3 rd St. South), MT OLIVE	2	Ca. 1930s-40s	Motel/Gas (?)	Small structure with steeply-pitched, gabled roof – although remodeled, it looks as if it could have either been a motel or cabin court office, or a gas station.	Structure now gone.

No longer extant

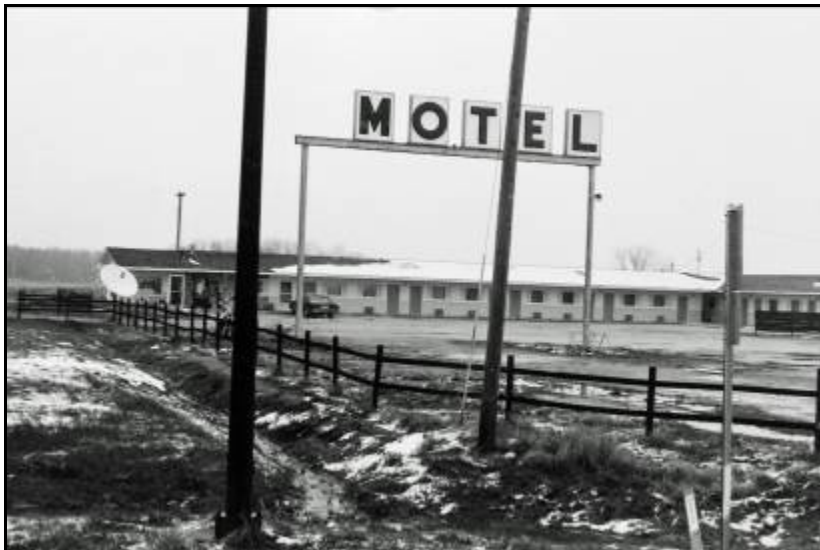
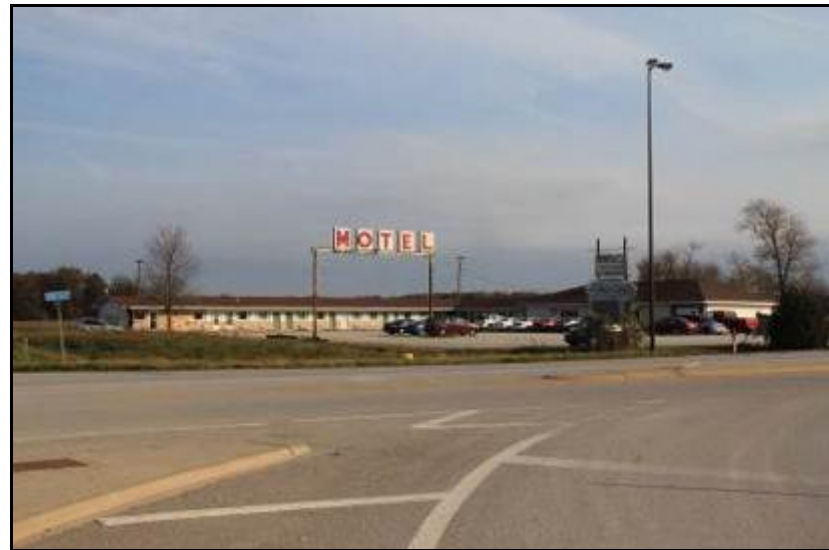
Sequence Number	Map Code	1994/95 Negative #	Address/Location	Type	Date Built	Historic Function	1994/95 Comments	2012/13 Comments and Photo Image #
340	10/02	10/02, IMG_1963	Old 66 Bypass & IL 138 (NE corner), MT OLIVE	2	Ca. 1960s	Motel	"L" shape motel, single level with shallow-pitched, gabled roof.	Changes to this motel appear to have been minor. IMG_1569

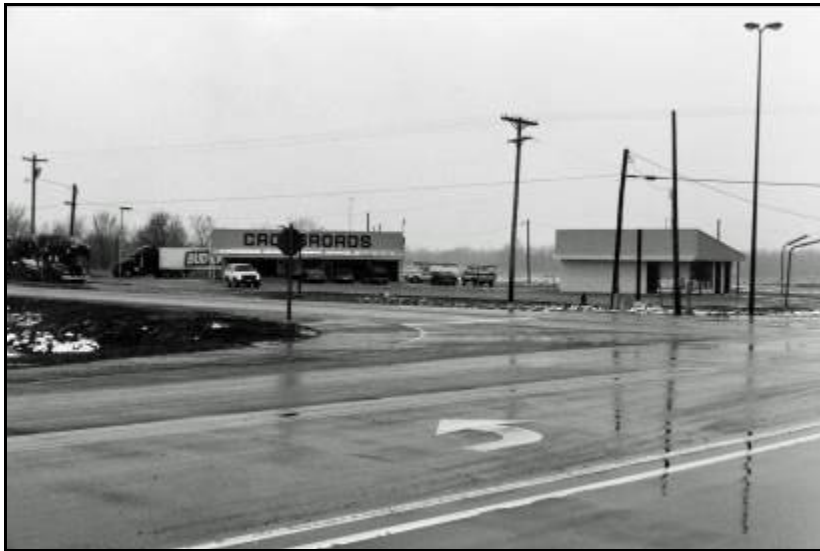
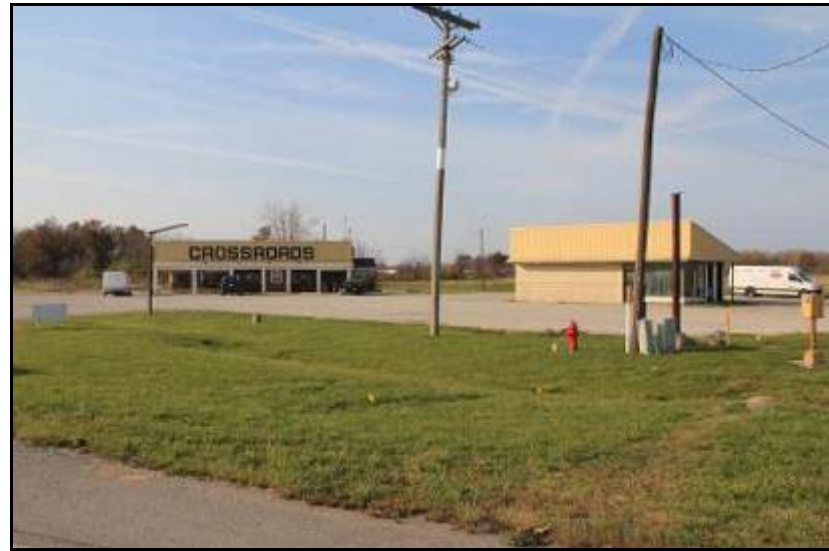
Sequence Number	Map Code	1994/95 Negative #	Address/Location	Type	Date Built	Historic Function	1994/95 Comments	2012/13 Comments and Photo Image #
341	10/03	10/03, IMG_1964	Old 66 Bypass & IL 138 (SW corner), MT OLIVE	2	Ca. 1960s	Restaurant	Relatively modern-looking restaurant – “Crossroads.”	The building to the right is very much unchanged. It is uncertain if the “Crossroads” restaurant is a going concern today or not. IMG_1570

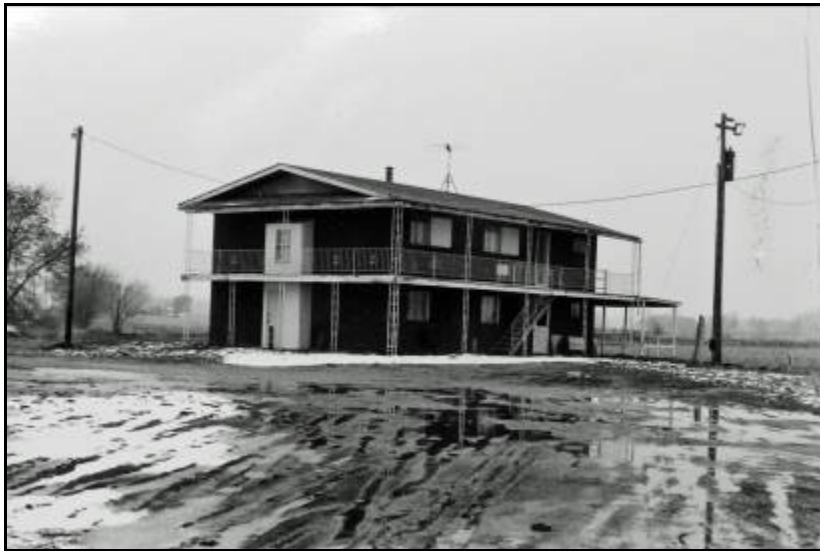
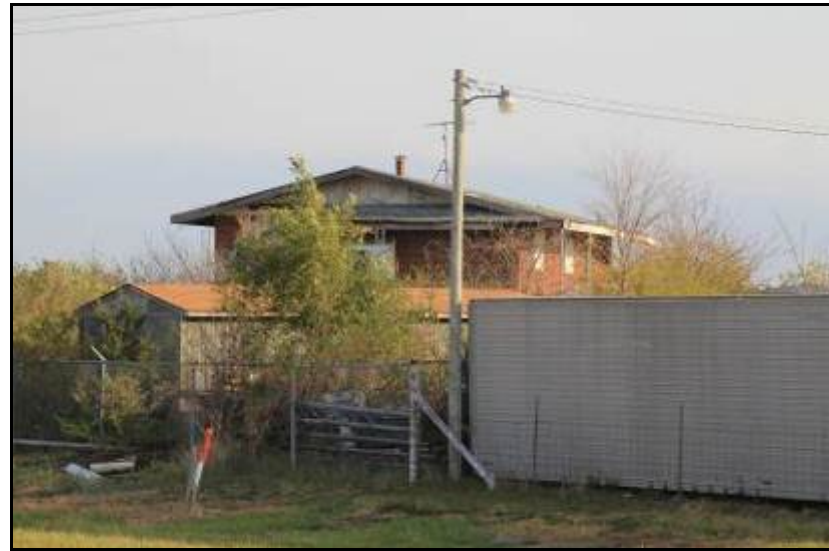
Sequence Number	Map Code	1994/95 Negative #	Address/Location	Type	Date Built	Historic Function	1994/95 Comments	2012/13 Comments and Photo Image #
342	10/04	10/04, IMG_1965	Old 66 & Old 66 Bypass (S of MT OLIVE)	2	Ca. 1960s	Motel	Two-story, structure with first-floor porch and second floor balcony; LOOKS as if it could have been a motel – may be vacant.	While the former, possible motel remains, it has been somewhat encircled by trailers and foliage, among other things. The use today is uncertain. IMG_1568

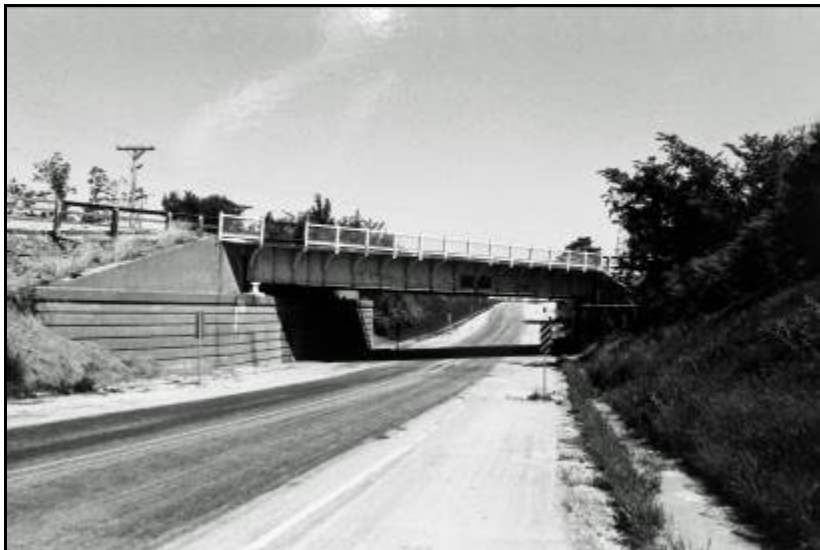
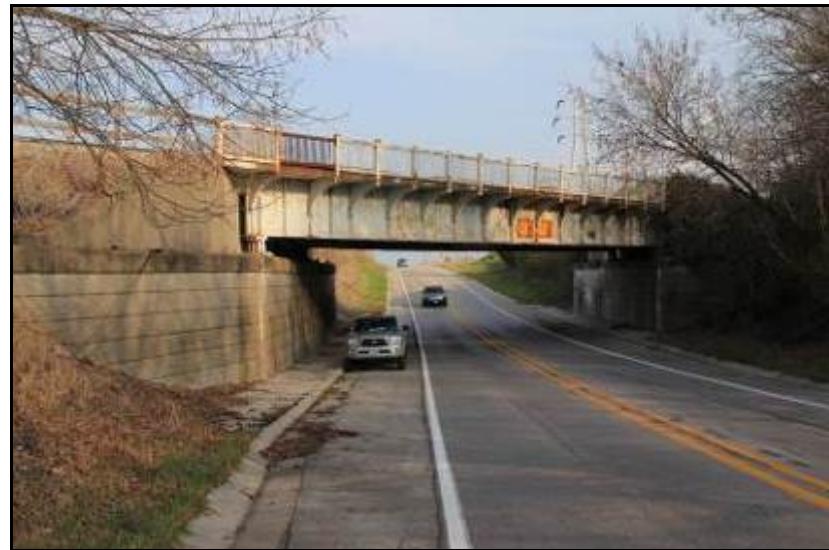
Sequence Number	Map Code	1994/95 Negative #	Address/Location	Type	Date Built	Historic Function	1994/95 Comments	2012/13 Comments and Photo Image #
343	12/19	12/19, IMG_1966	Old 66 & NW RR	2	Unknown	RR Overpass	No plate on bridge; steel girder structure with old 66 constricted to two lanes as it passes under (four lanes to either side).	The rail bridge is little changed since 1994. IMG_1567

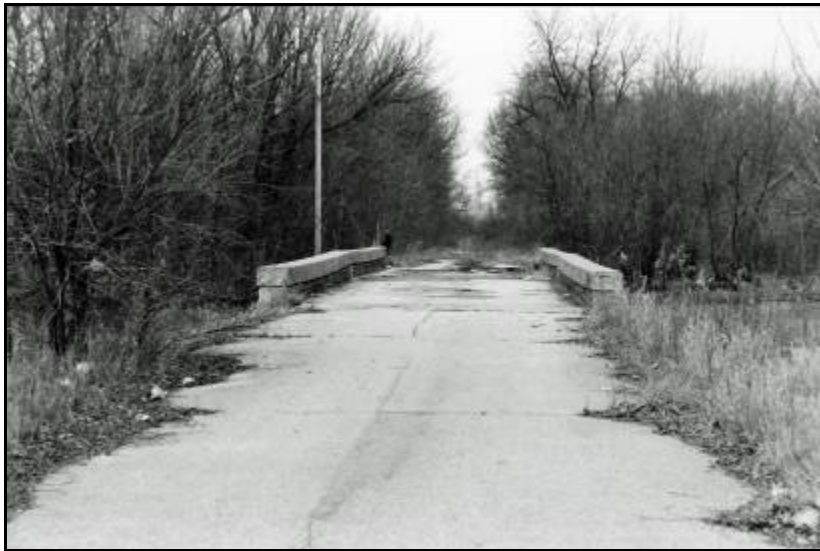
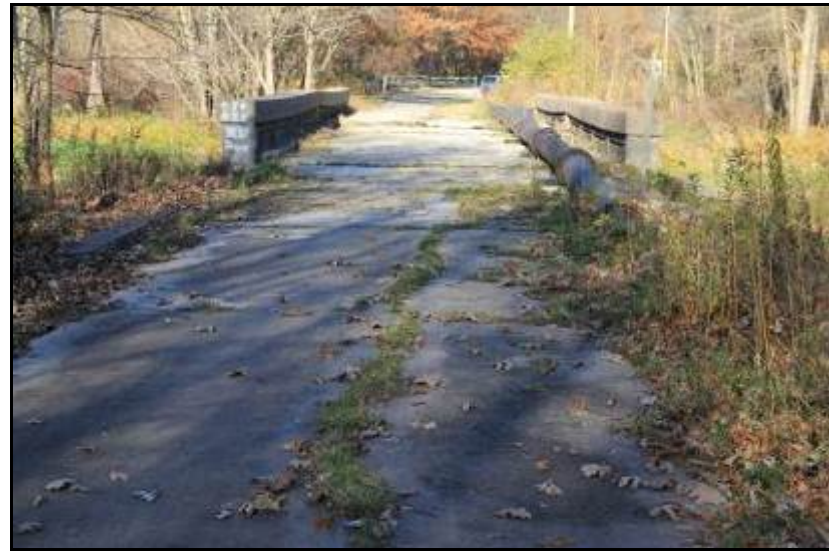
Sequence Number	Map Code	1994/95 Negative #	Address/Location	Type	Date Built	Historic Function	1994/95 Comments	2012/13 Comments and Photo Image #
344	04/10	04/10, IMG_1967	Old 66 over Lick Creek	1	Ca. 1920s	Bridge	No plate on bridge; two-span structure with solid concrete pier and deck, brick overlay (archaeological segment, view to SW).	The only apparent change to the bridge is the piping it now carries adjacent to the railing on the right (view to NE). IMG_1709

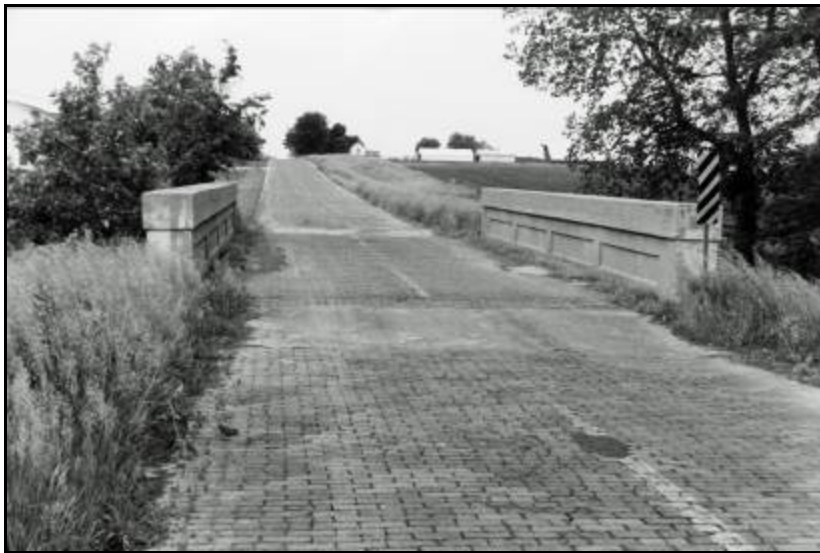
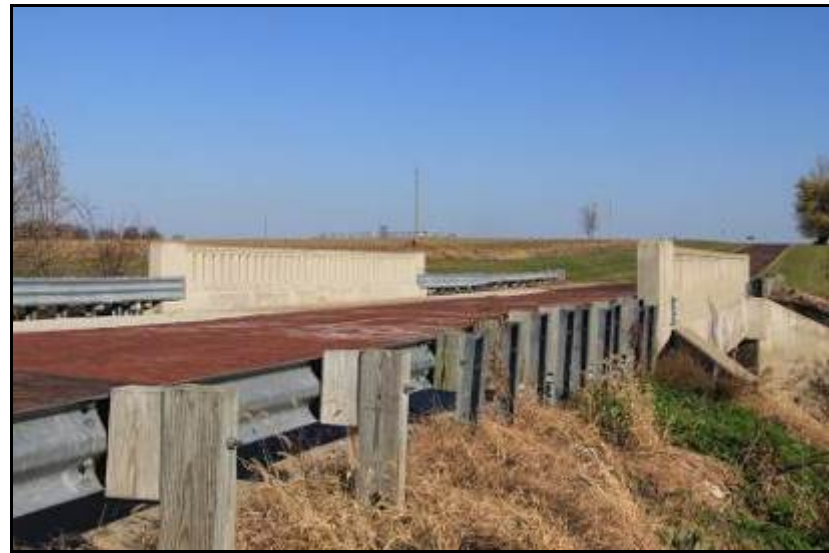
Sequence Number	Map Code	1994/95 Negative #	Address/Location	Type	Date Built	Historic Function	1994/95 Comments	2012/13 Comments and Photo Image #
345	16/18	16/18, IMG_1968	Rd. 12.5S over Little Panther Creek	1	1920	Bridge	Bridge #084-0094 – plate notes: Station 747-33, Built 1920 by, State of Illinois with, Federal Aid, Project 8 Section C; single-span structure with solid, massive rails and slab deck with brick overlay.	Bridge now gone. Recent replacement bridge mimics bridges of the 1930s-50s, but not the historic, 1920 structure. IMG_1708

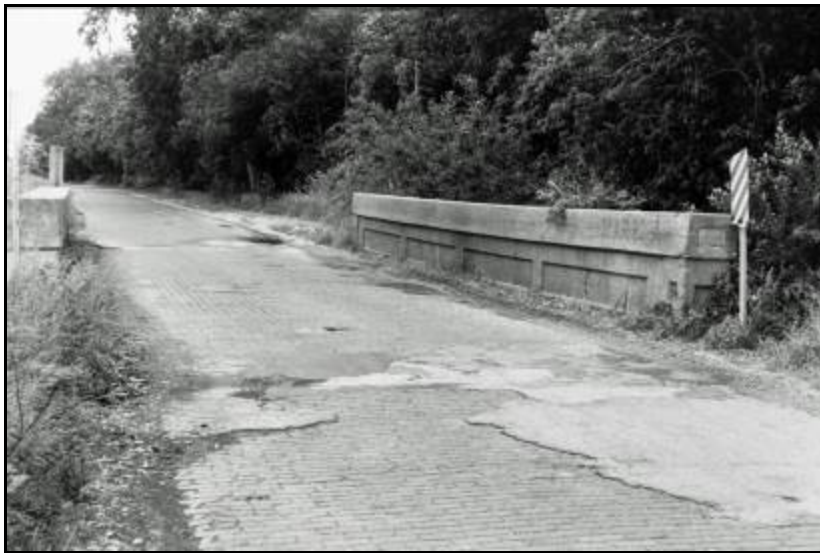
1994

Sequence Number	Map Code	1994/95 Negative #	Address/Location	Type	Date Built	Historic Function	1994/95 Comments	2012/13 Comments and Photo Image #
346	16/17	16/17, IMG_1969	Rd. 5.5W over Little Panther Creek	1	1920	Bridge	Bridge #084-0091 – plate notes: Station 781-00, Built 1920 by, State of Illinois, with, Federal Aid, Project 8 Section C; single-span structure with solid, massive rails and slab deck with brick overlay.	Bridge now gone. Recent replacement bridge mimics bridges of the 1930s-50s, but not the historic, 1920 structure.

No longer extant

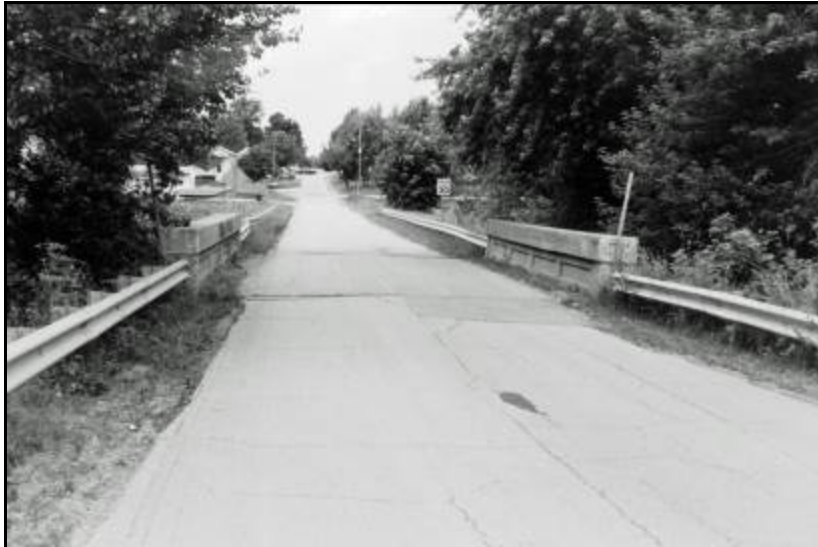
2012

Sequence Number	Map Code	1994/95 Negative #	Address/Location	Type	Date Built	Historic Function	1994/95 Comments	2012/13 Comments and Photo Image #
347	16/16	16/16, IMG_1970	Old 66 over Sugar Creek, THAYER	1	Ca. 1920	Bridge	Bridge #084-0095 – plate gone; single-span structure with massive rails and slab deck.	Bridge now gone. No date plate observed on new bridge.

No longer extant

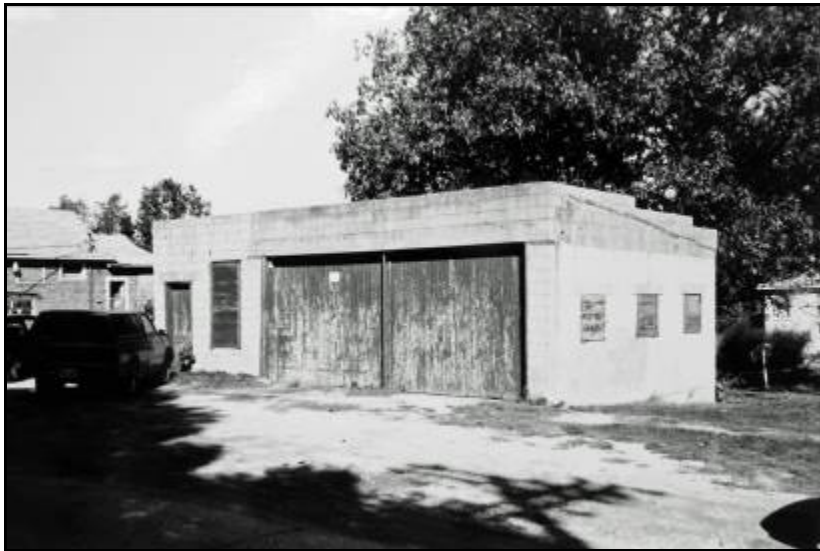
1994

Sequence Number	Map Code	1994/95 Negative #	Address/Location	Type	Date Built	Historic Function	1994/95 Comments	2012/13 Comments and Photo Image #
348	23/04	23/04, IMG_1971	Elm & Harrison (NE corner), THAYER	2	Ca. 1920s-30s	Gas/Service (?)	Old concrete block structure has two sliding, garage doors; could well have been an old gas/service station but it may post-date the RT 66 period of significance in the town.	This building no longer remains.

No longer extant

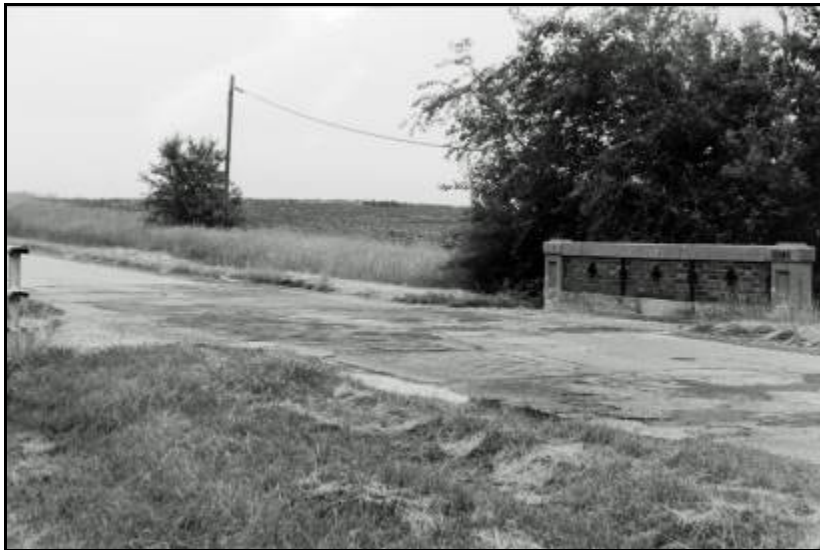
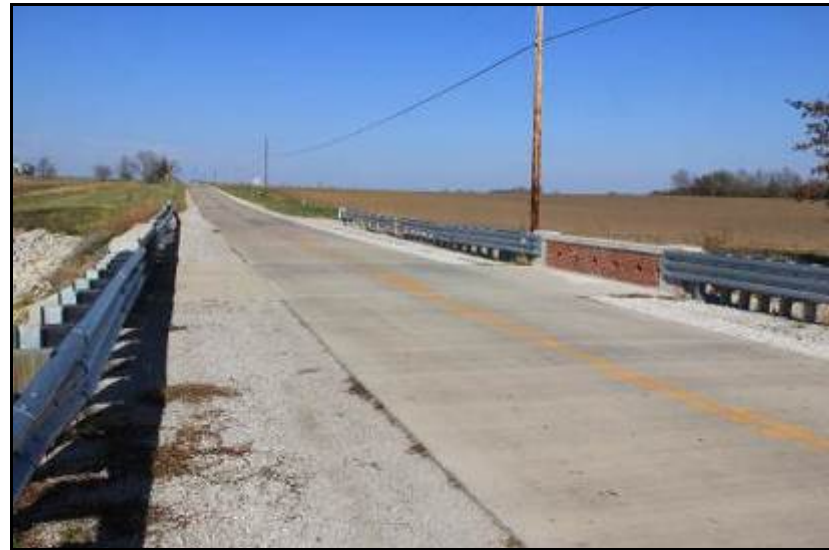
Sequence Number	Map Code	1994/95 Negative #	Address/Location	Type	Date Built	Historic Function	1994/95 Comments	2012/13 Comments and Photo Image #
349	16/14	16/14-15, IMG_1972	Rd. 1975E over Shearles Creek	1	1920	Bridge	Bridge #059-0046 – plate notes: Station 1616+70, Built 1920 by, State of Illinois, With, Federal Aid, Project 8 Section L-15D; single span, slab deck with railing comprised of concrete endposts and top chord, but brick infilling – one historic railing gone and replace with steel.	No longer extant. A recent replacement bridge now exists on the National Register segment north of Nilwood. IMG_1707
