Route 66 in Illinois:

(2012/13 Update and Expansion of the Original 1994/95 Survey)

IDOT Sequence #17337 & #17337A

22 December 2013

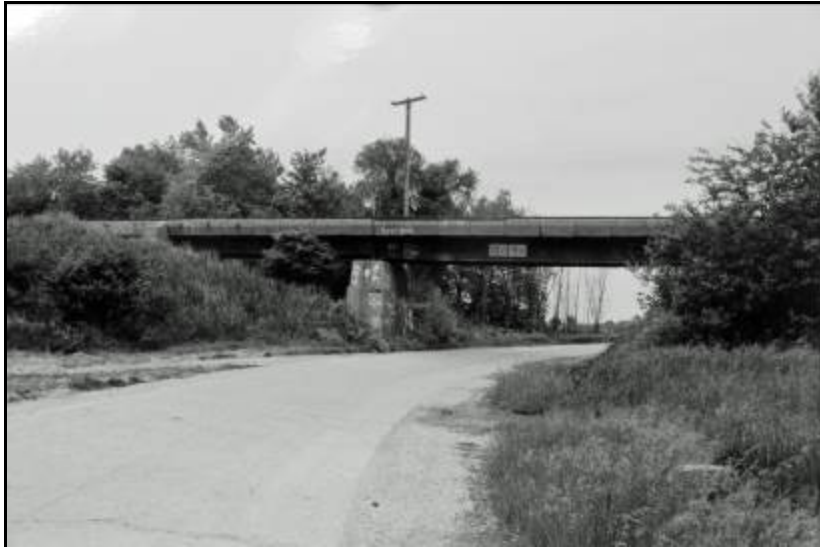
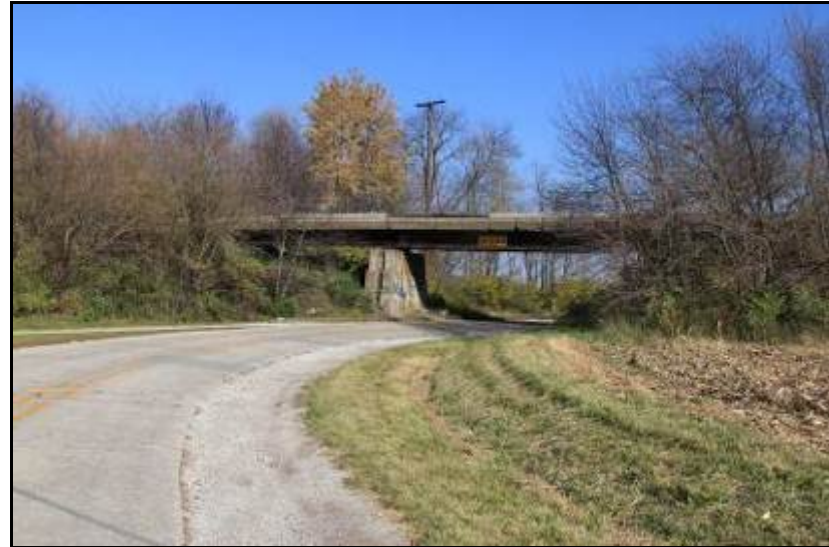
Sequence Number	Map Code	1994/95 Negative #	Address/Location	Type	Date Built	Historic Function	1994/95 Comments	2012/13 Comments and Photo Image #
350	16/13	16/13, IMG_1973	Rd. 1900E & CNW RR	2	1930	RR Overpass	Two massive, concrete piers support this "I" beam structure; date in each abutment.	There are no apparent changes or alterations to this bridge. IMG_1706

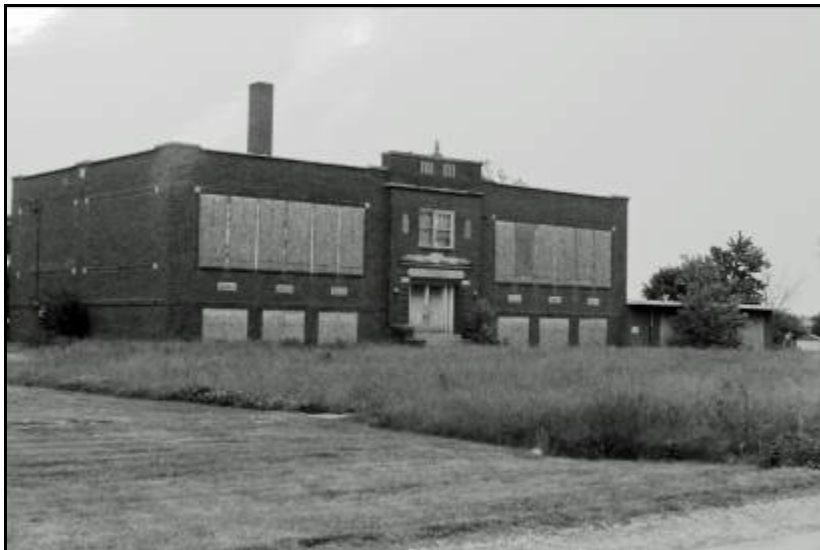
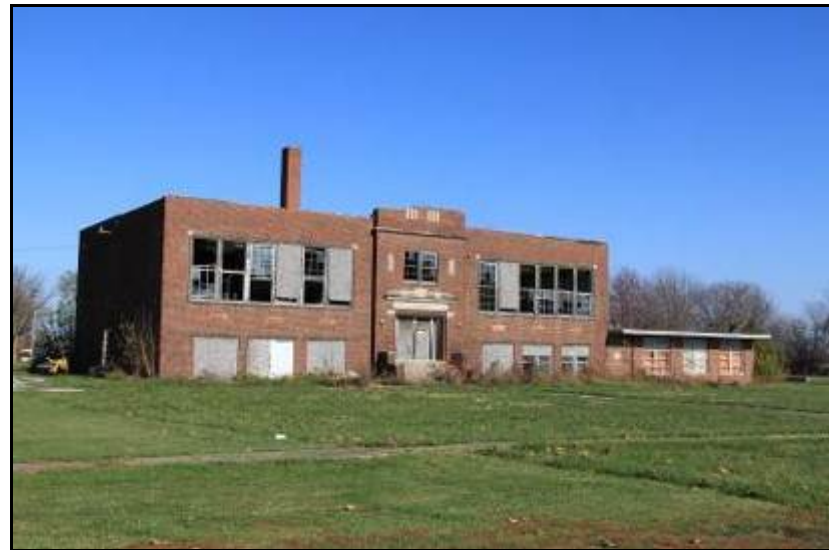
Sequence Number	Map Code	1994/95 Negative #	Address/Location	Type	Date Built	Historic Function	1994/95 Comments	2012/13 Comments and Photo Image #
351	16/12	16/12, IMG_1974	Morean & Pine (NW corner), NILWOOD	3	1927	School	Large, two-story, brick structure notes "Nilwood Public Schools" – vacant and thought to be for sale.	The school appears to have deteriorated substantially since 1994 (note window coverings removed—which opens the interior to the weather). IMG_1705

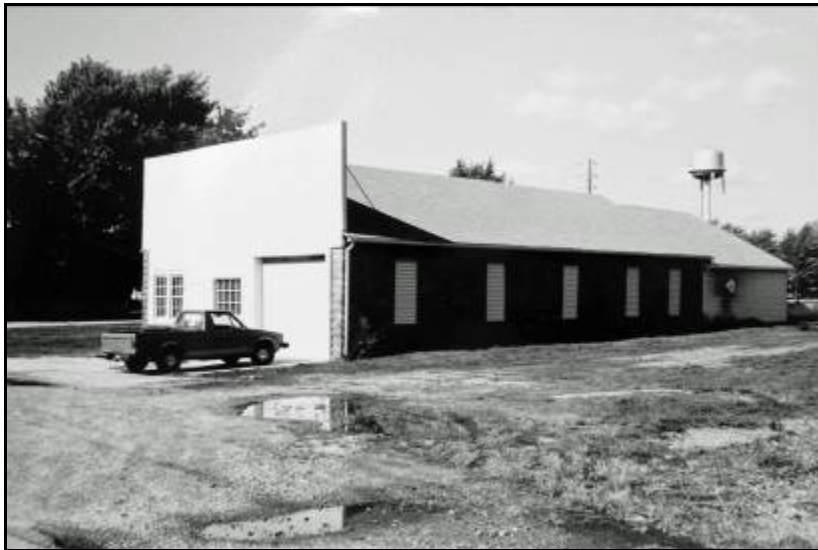
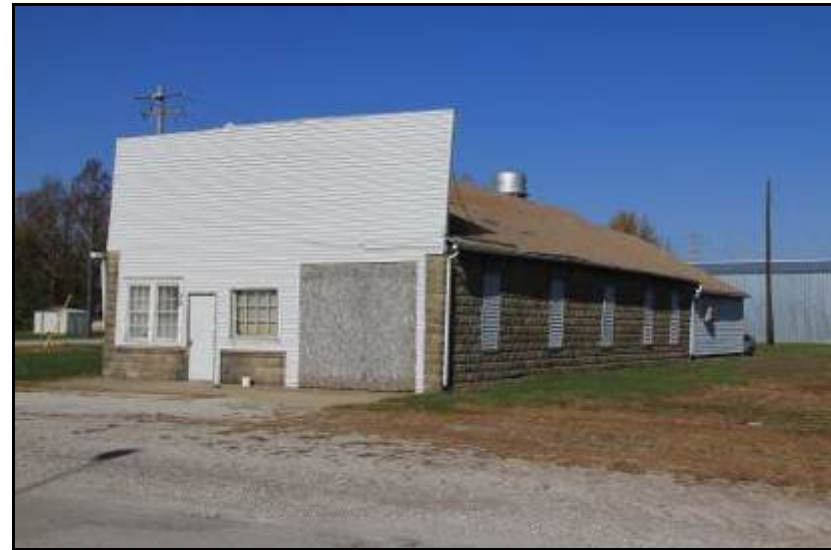
Sequence Number	Map Code	1994/95 Negative #	Address/Location	Type	Date Built	Historic Function	1994/95 Comments	2012/13 Comments and Photo Image #
352	23/03	23/03, IMG_1975	Morean & RR (NE corner), NILWOOD	2	Ca. 1930s	Auto Service (?)	Rock-faced, concrete block building with boomtown façade, gabled roof and modern siding on front – overhead garage door in front suggests that this could have been an auto service building, although it could post-date the RT 66 period of significance.	The major change appears to be the front garage door that is now boarded over. IMG_1704

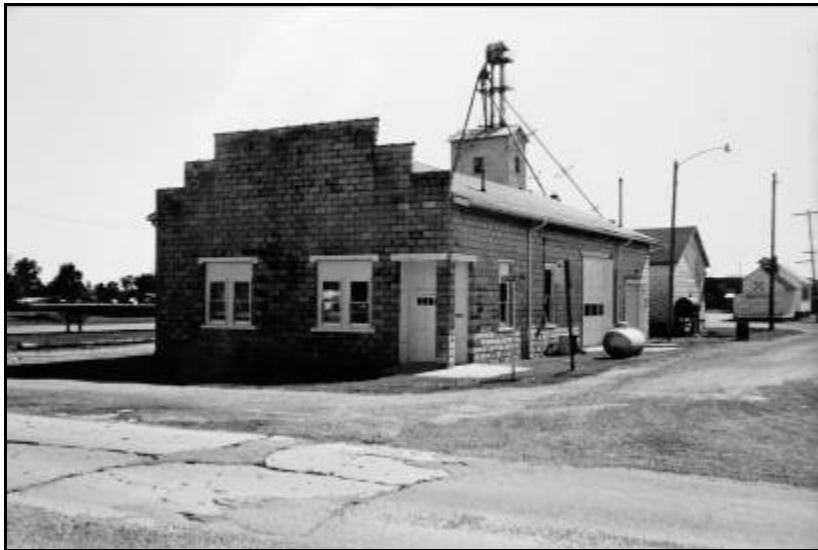
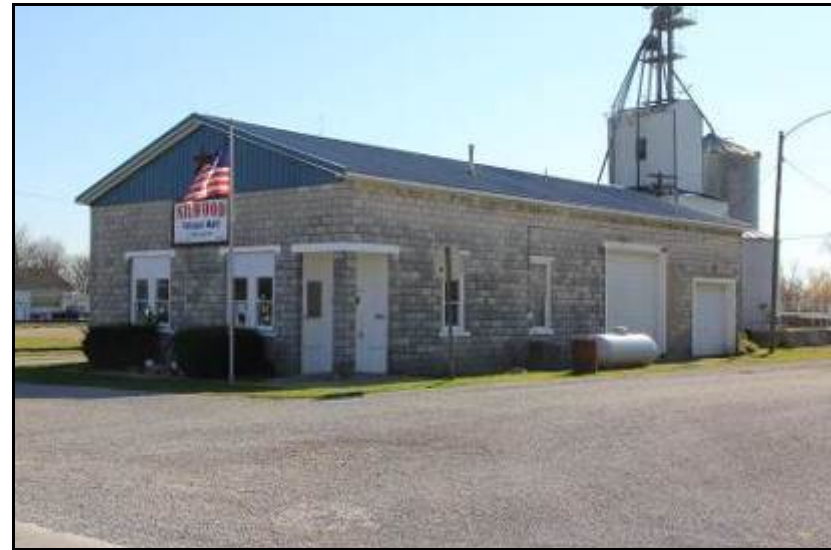
Sequence Number	Map Code	1994/95 Negative #	Address/Location	Type	Date Built	Historic Function	1994/95 Comments	2012/13 Comments and Photo Image #
353	23/02	23/02, IMG_1976	Morean & Heaton (SE corner), NILWOOD	2	Ca. 1920s-30s	Auto Service (?)	Block/brick structure with arched roof, three-step parapet endwalls with coping, overhead garage door on NW side and greatly reduced windows – could have been an auto service business, but it may post-date the period of RT 66 significance.	The most apparent change to this building is the removal of the three step parapet and its gabled replacement. IMG_1703

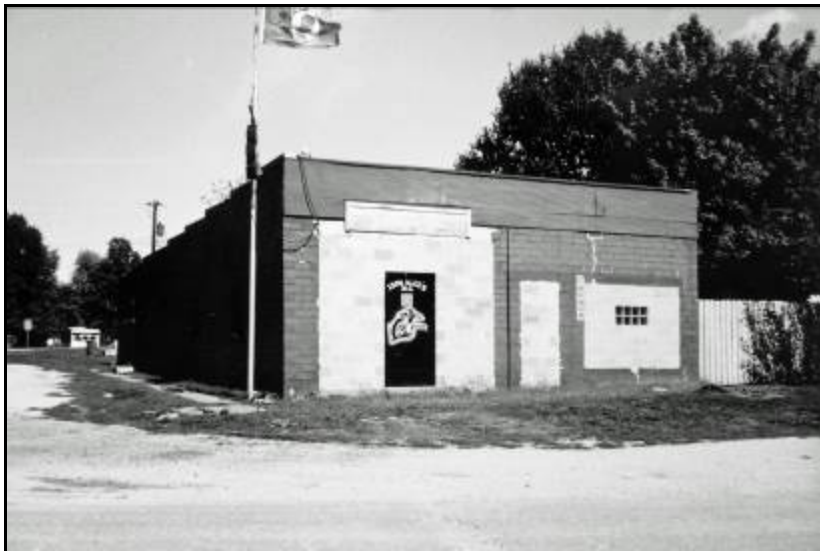
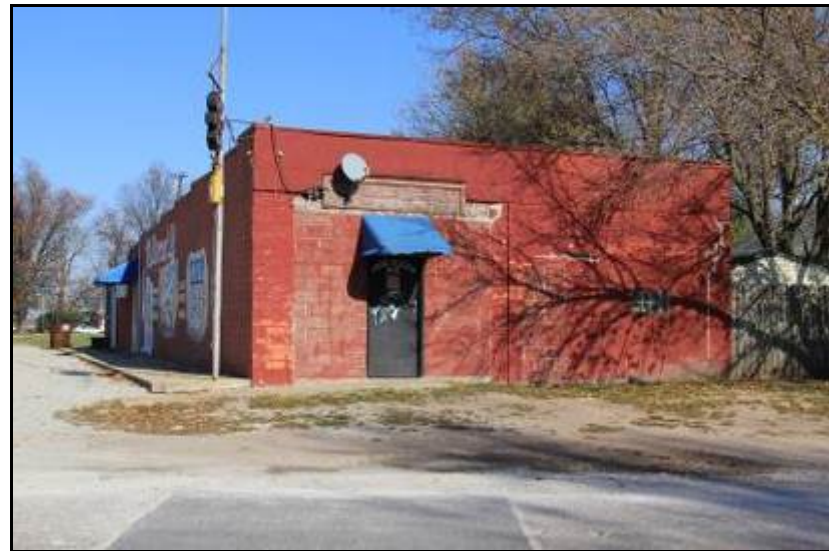
Sequence Number	Map Code	1994/95 Negative #	Address/Location	Type	Date Built	Historic Function	1994/95 Comments	2012/13 Comments and Photo Image #
354	23/00	23/00-01, IMG_1977	Morean & Ryder (NE corner), NILWOOD	2	Ca. 1920s	Auto Service (?)	Brick/tile building with straight front parapet and seven-step side wall parapets; likely location of overhead, front garage door is now bricked over – may have been a RT 66-related auto service business.	Minor changes to this building include its being painted, as well as the installation of a small awning over the front door. IMG_1702

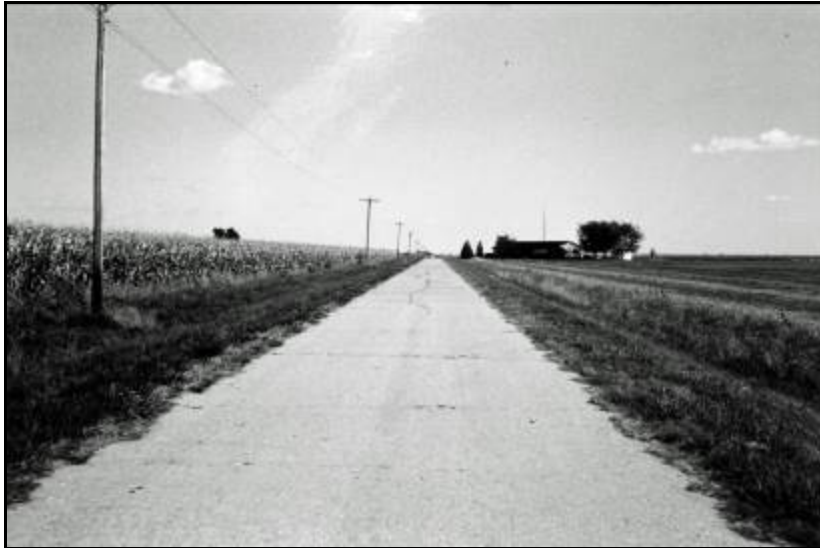
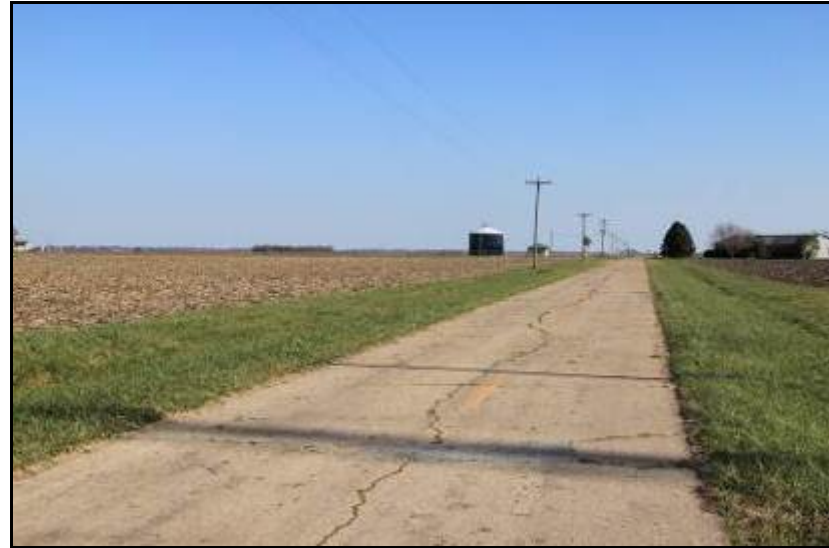
Sequence Number	Map Code	1994/95 Negative #	Address/Location	Type	Date Built	Historic Function	1994/95 Comments	2012/13 Comments and Photo Image #
355	22/24	22/24, IMG_1978	Old 66 (CR 2250N), SW of NILWOOD	1	Ca. 1920	IL 4/USH 66	Segment of original IL 4/RT 66 with no overlay, SW of Nilwood; view to E.	This original alignment of RT 66 has changed little. IMG_1696

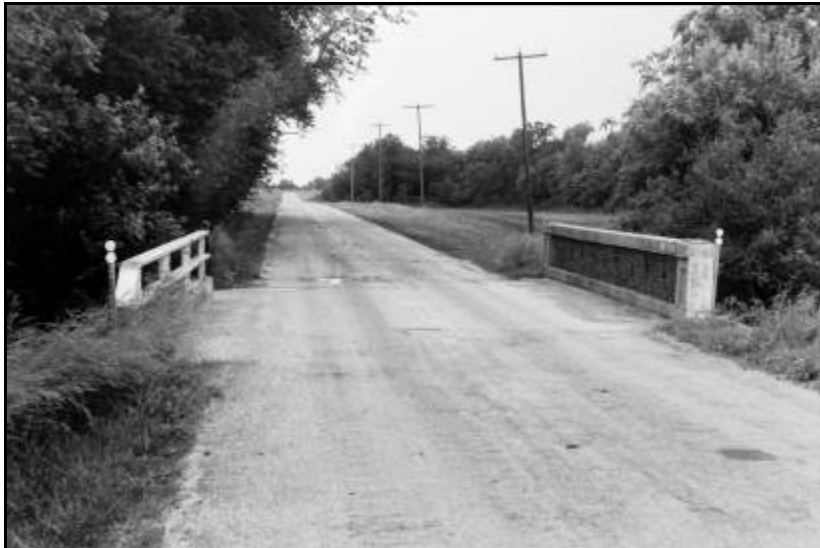
Sequence Number	Map Code	1994/95 Negative #	Address/Location	Type	Date Built	Historic Function	1994/95 Comments	2012/13 Comments and Photo Image #
356	16/11	16/11, IMG_1979	Rd. 1500E over unnamed branch of Hurricane Creek	1	Ca. 1920	Bridge	Bridge #059-0030 – plate gone: single-span structure with thick, slab deck and railing of concrete endposts and top chord with brick in-filling.	Bridge now gone.

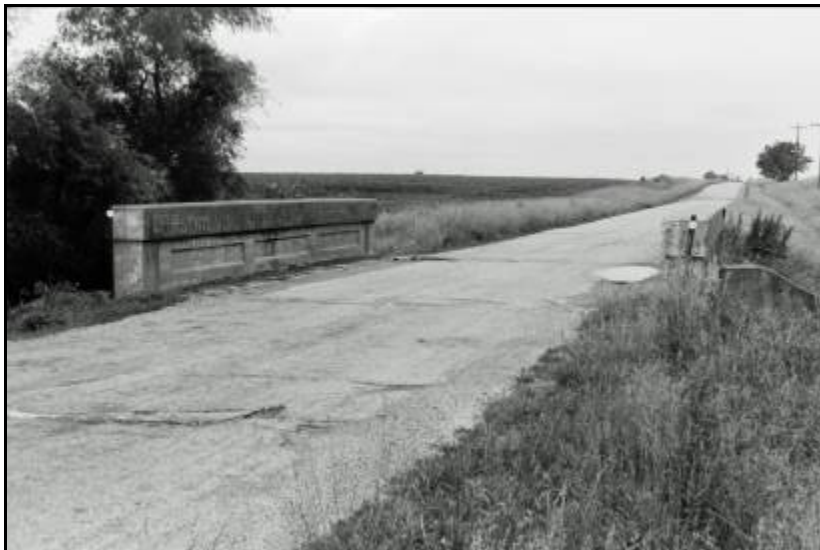
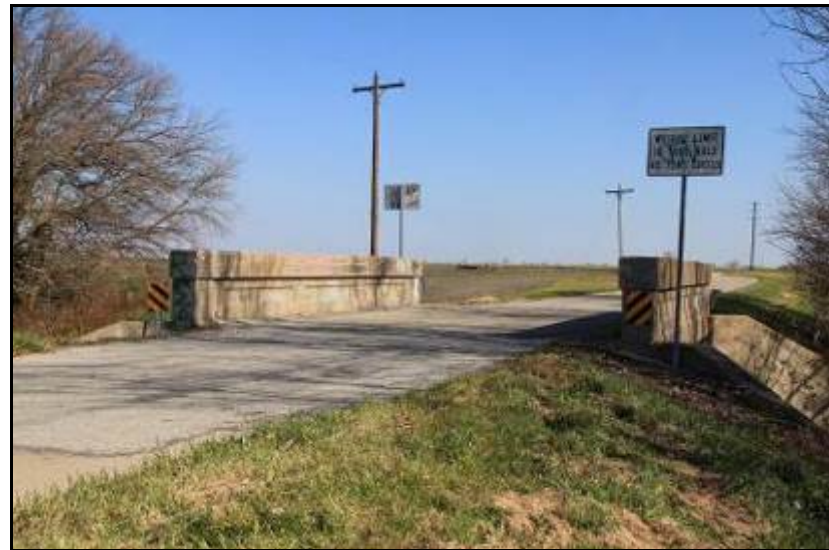
Sequence Number	Map Code	1994/95 Negative #	Address/Location	Type	Date Built	Historic Function	1994/95 Comments	2012/13 Comments and Photo Image #
357	16/10	16/10, IMG_1980	Rd. 2250 N over Hurricane Creek	1	Ca. 1920	Bridge	Bridge #059-0031 – plate gone: single-span structure with slab deck and prominent, solid concrete railings.	The general integrity of this 1920s bridge appears to be good. IMG_1694

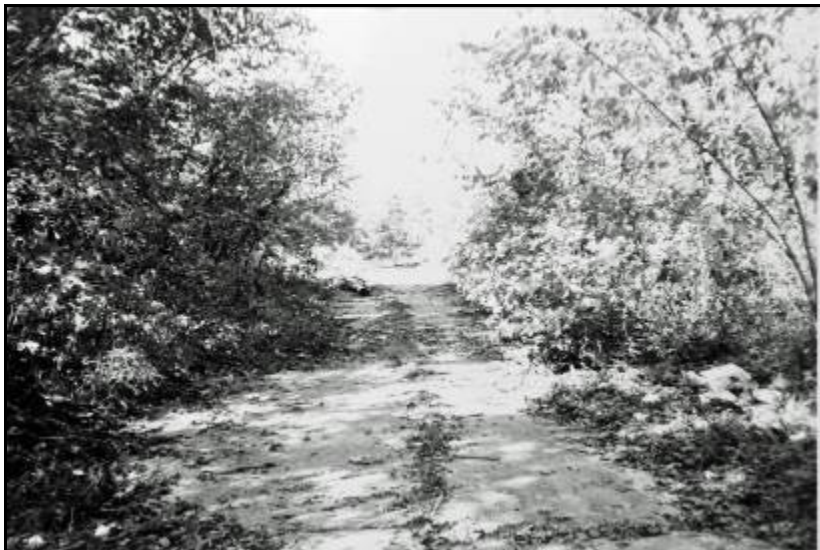
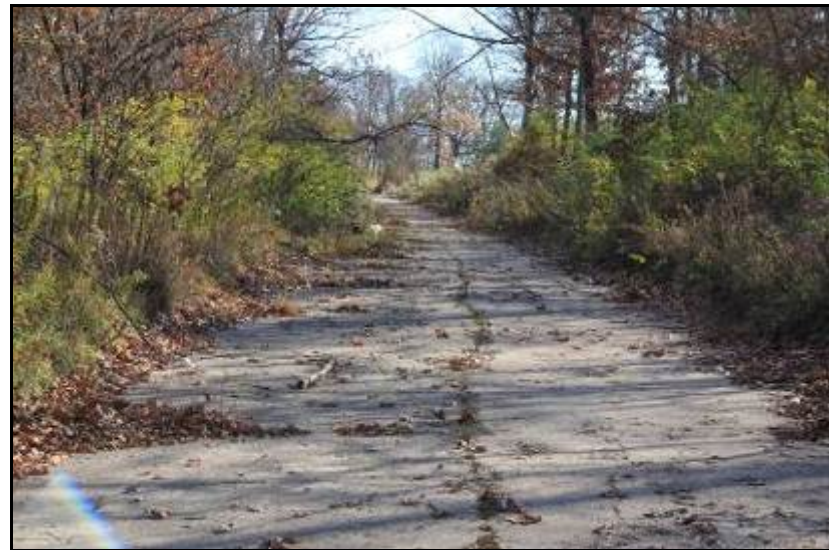
Sequence Number	Map Code	1994/95 Negative #	Address/Location	Type	Date Built	Historic Function	1994/95 Comments	2012/13 Comments and Photo Image #
358	22/22	22/22-23, IMG_1981	IL 4 & CR 1800N, SE of CARLINVILLE	1	Ca. 1920	IL 4/USH 66	Archaeological segment of original IL4/RT 66, now abandoned and being reclaimed by forest – also private property.	No particular changes to report. Investigated roadway with owner's permission. IMG_1691

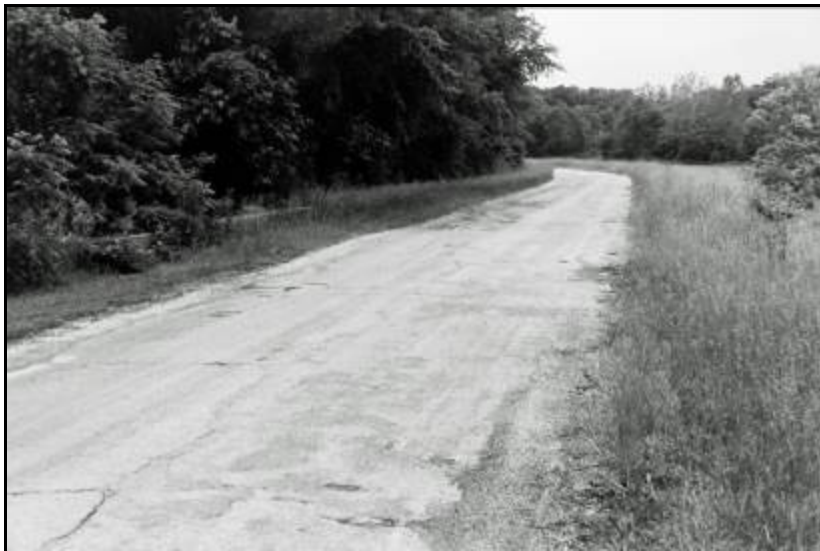
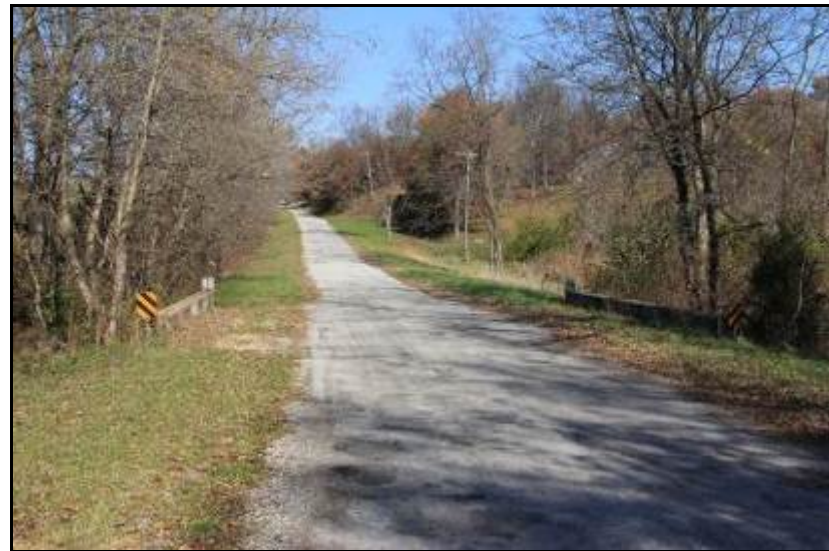
Sequence Number	Map Code	1994/95 Negative #	Address/Location	Type	Date Built	Historic Function	1994/95 Comments	2012/13 Comments and Photo Image #
359	16/09	16/09, IMG_1982	Old 66 (between Rds 1400N & 1550N) over unnamed branch of Honey Creek	1	1920	Bridge	No bridge number observed – plate notes: Station 317+17, Built 1920 by, State of Illinois, with, Federal Aid, project* Section T; single-span structure with slab deck and very short railings.	This segment of original RT 66 is much as it was in 1994. This view is to the N, as opposed to 1994, which was to the S. IMG_1687

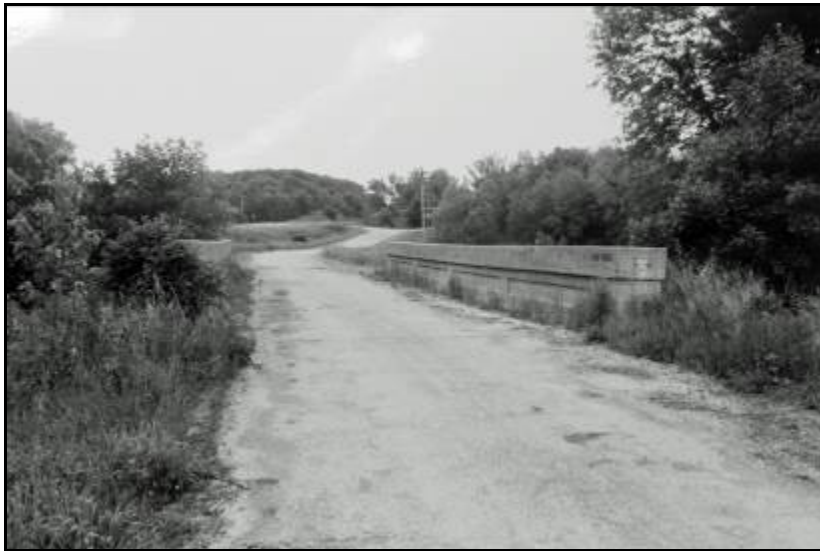
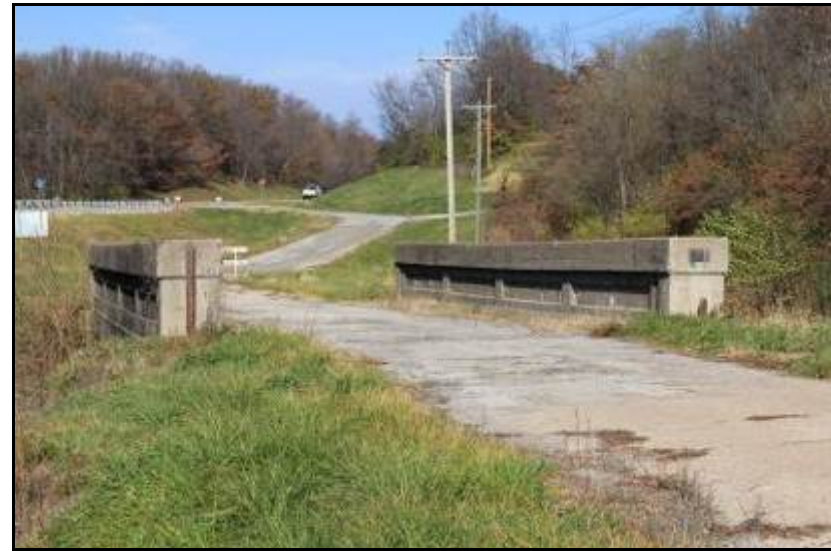
Sequence Number	Map Code	1994/95 Negative #	Address/Location	Type	Date Built	Historic Function	1994/95 Comments	2012/13 Comments and Photo Image #
360	16/06	16/06-07, IMG_1983	Old 66 (N of Rd. 1400N) over Honey Creek	1	1920	Bridge	Bridge #059-0032 – plate notes: Station 291+00, Built 1920 by, State of Illinois, with, Federal Aid, Project 8 Section T; single span-structure with approximately 2-foot thick, solid deck, also massive, solid concrete rails.	Bridge remains, visually, in good condition. It has recently been closed to traffic, however. IMG_1685

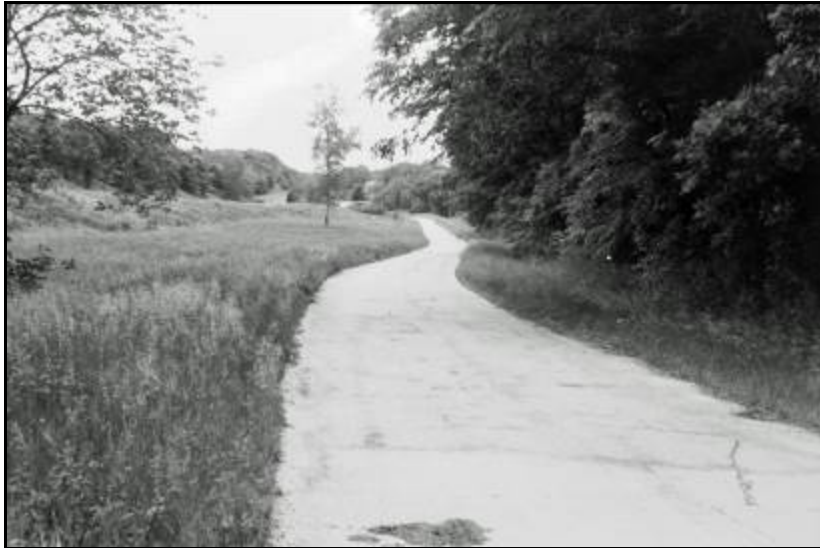
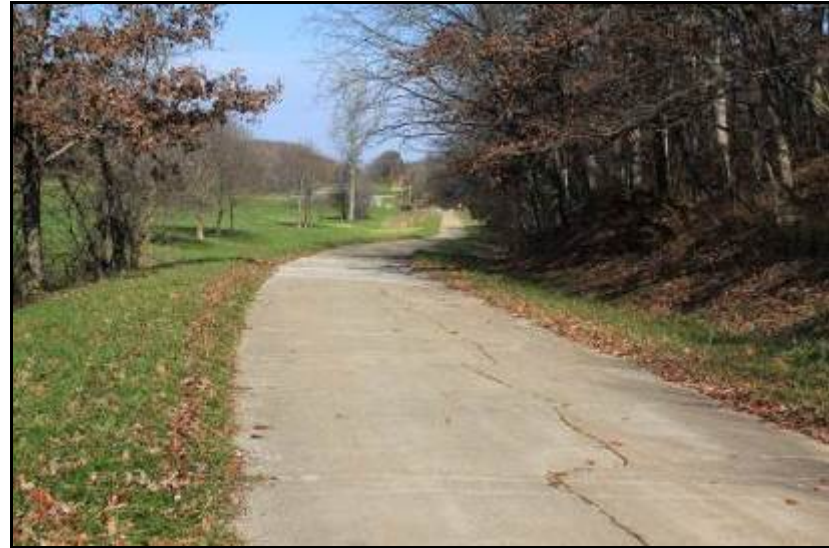
Sequence Number	Map Code	1994/95 Negative #	Address/Location	Type	Date Built	Historic Function	1994/95 Comments	2012/13 Comments and Photo Image #
361	16/08	16/08, IMG_1984	Old 66 (N of Rd. 1400N)	1	1920	USH 66	Segment of original IL 4/USH 66 (view to N).	This original alignment retains much of its integrity today. IMG_1684

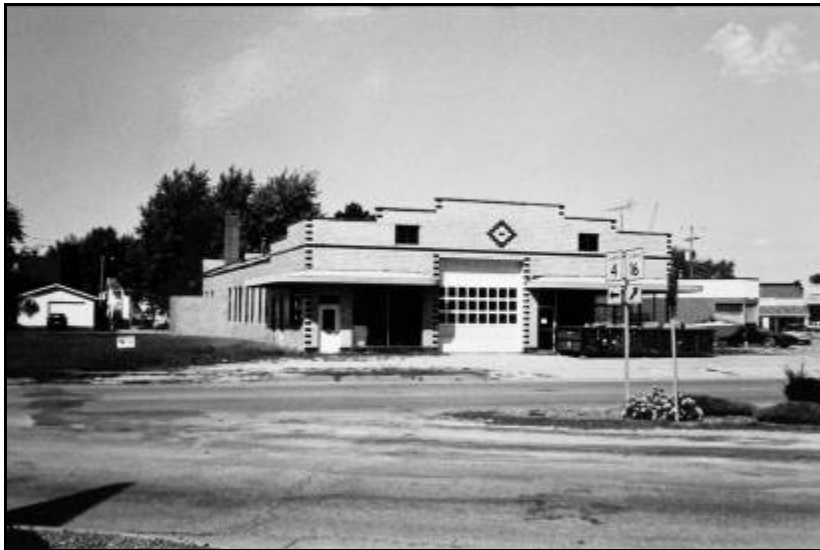
Sequence Number	Map Code	1994/95 Negative #	Address/Location	Type	Date Built	Historic Function	1994/95 Comments	2012/13 Comments and Photo Image #
362	22/21	22/21, IMG_1985	311 IL 4, GILLESPIE	2	Ca. 1930s	Auto Sales (?)	Glazed brick building with two step, front parapet, inset brick ornamentation and large, overhead, front garage door; could date to late 1920s or early 30s, more likely late 30s or early 40s thus it probably post-dates period of RT 66 significance.	Structure now gone.

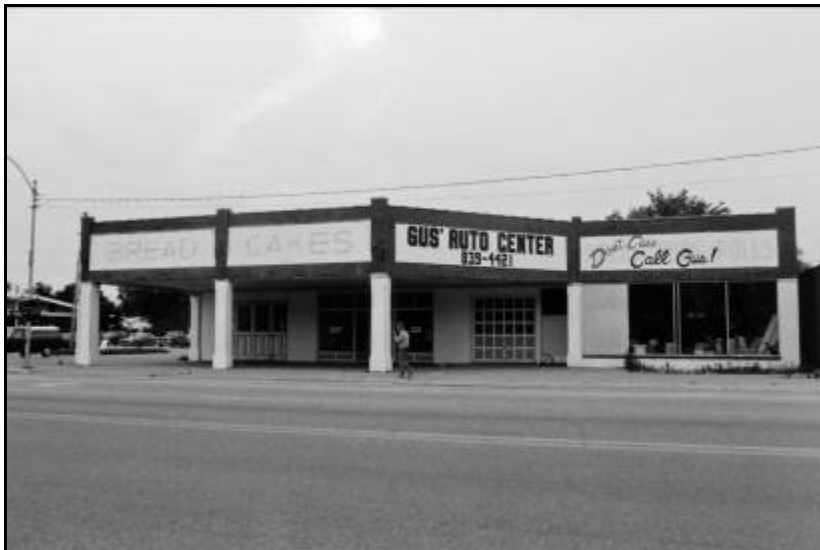
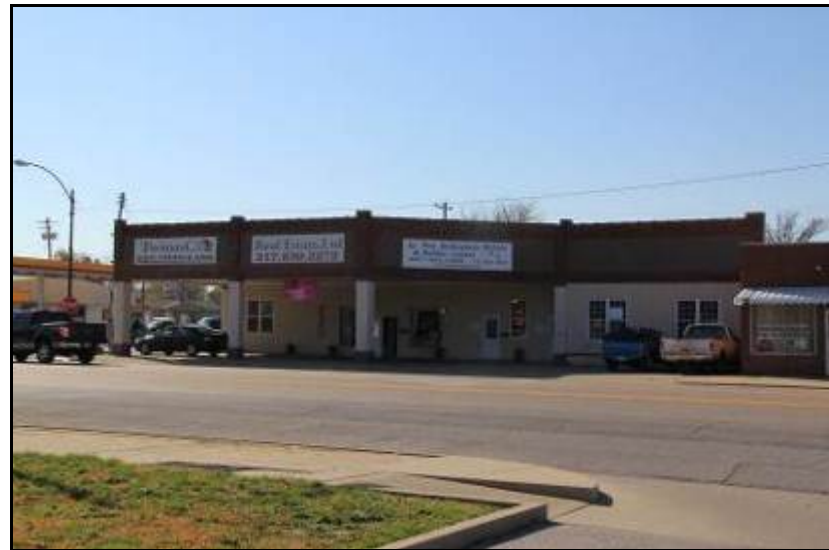
Sequence Number	Map Code	1994/95 Negative #	Address/Location	Type	Date Built	Historic Function	1994/95 Comments	2012/13 Comments and Photo Image #
363	16/05	16/05, IMG_1986	Macoupin & Pine, GILLESPIE	2	Ca. 1930s-40s	Auto Sales	Distinctive, brick structure with a prominent drive-through, very likely post-dates the RT 66 alignment through Gillespie.	Former car dealer building modified and now used for retail shops. IMG_1683

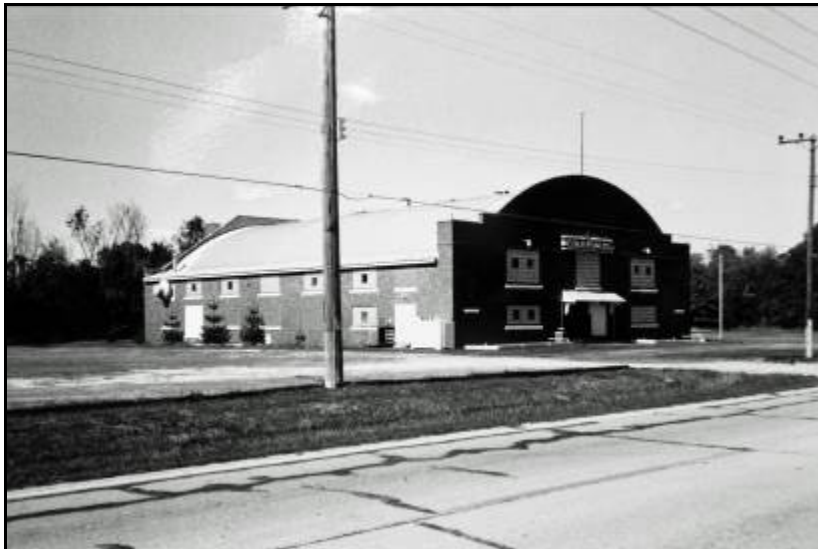
Sequence Number	Map Code	1994/95 Negative #	Address/Location	Type	Date Built	Historic Function	1994/95 Comments	2012/13 Comments and Photo Image #
364	22/20	22/20, IMG_1987	IL 4 (S side of BENELD)	2	Ca. 1930s	Ballroom/Coliseum	Ballroom/coliseum built of brick with arched roof and parapets – may well post-date RT 66 through Beneld.	Ballroom now gone. Parking lot area remains.

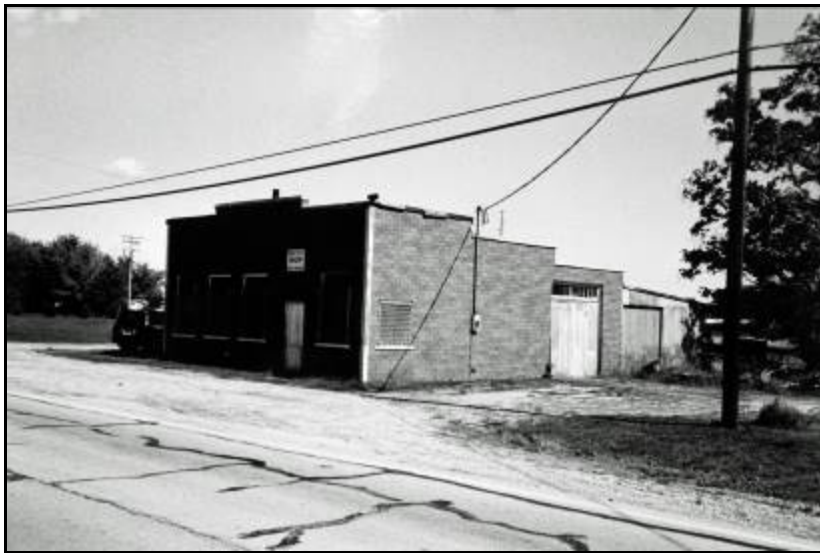
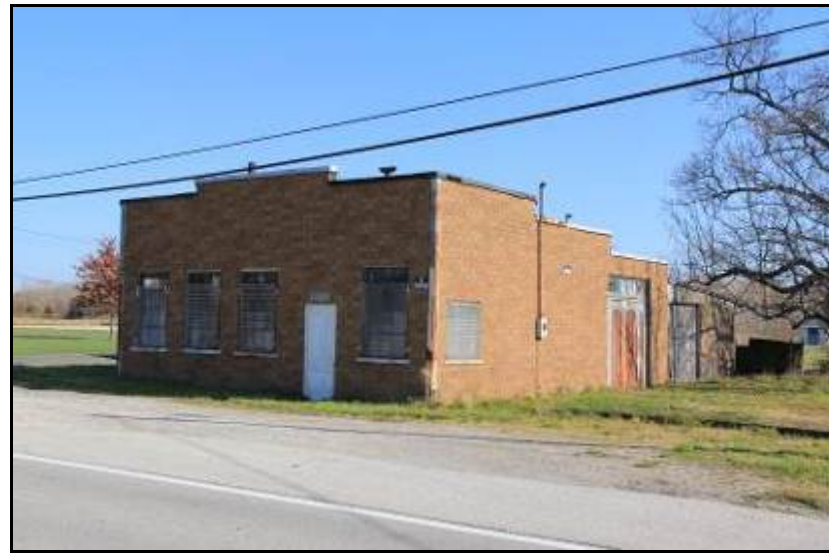
Sequence Number	Map Code	1994/95 Negative #	Address/Location	Type	Date Built	Historic Function	1994/95 Comments	2012/13 Comments and Photo Image #
365	22/19	22/19, IMG_1988	IL 4 (common BENELD/ SAWYERVILLE boundary)	2	Ca. 1920s-30s	Garage	Boomtown structure with brick-like shingle siding and overhead garage door on S side with multiple-light transom – could date to 1926 to 1930 period of significance.	Former garage appears to be nominally changed. IMG_1681

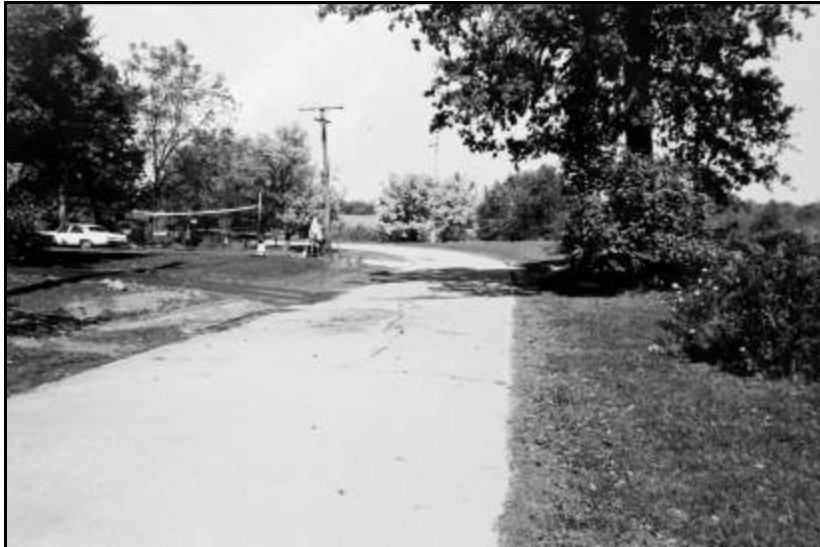
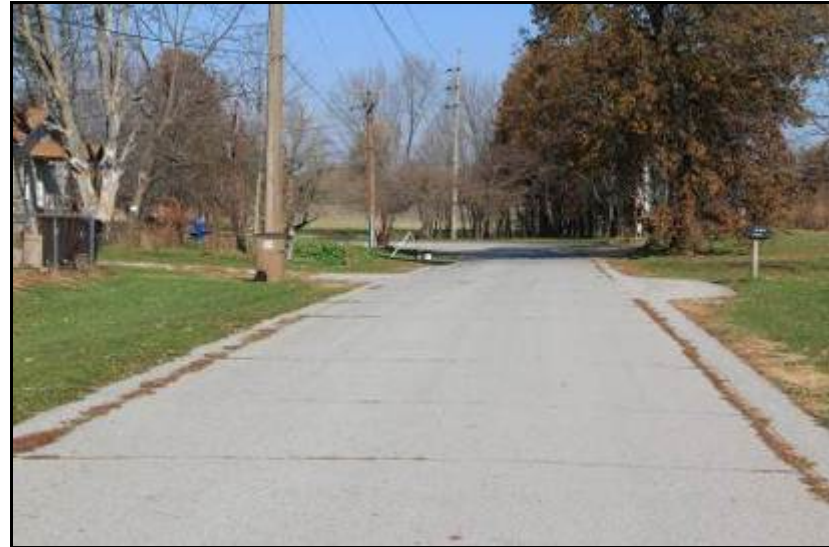
Sequence Number	Map Code	1994/95 Negative #	Address/Location	Type	Date Built	Historic Function	1994/95 Comments	2012/13 Comments and Photo Image #
366	22/18	22/18, IMG_1989	Old IL 4/USH 66, S of SAWYERVILLE	1	Ca. 1920	IL 4/USH 66	Small segment of IL 4/RT 66 with original pavement and several adjacent houses.	No significant changes to this segment of original RT 66. IMG_1680

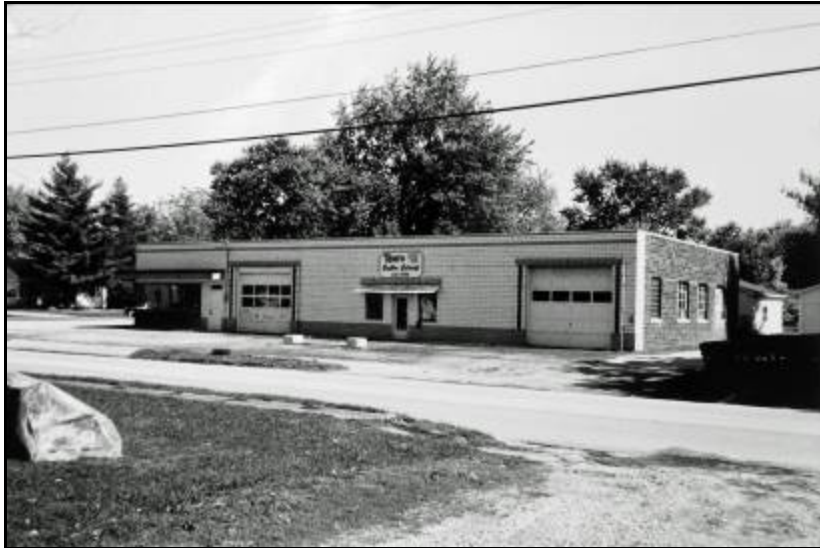
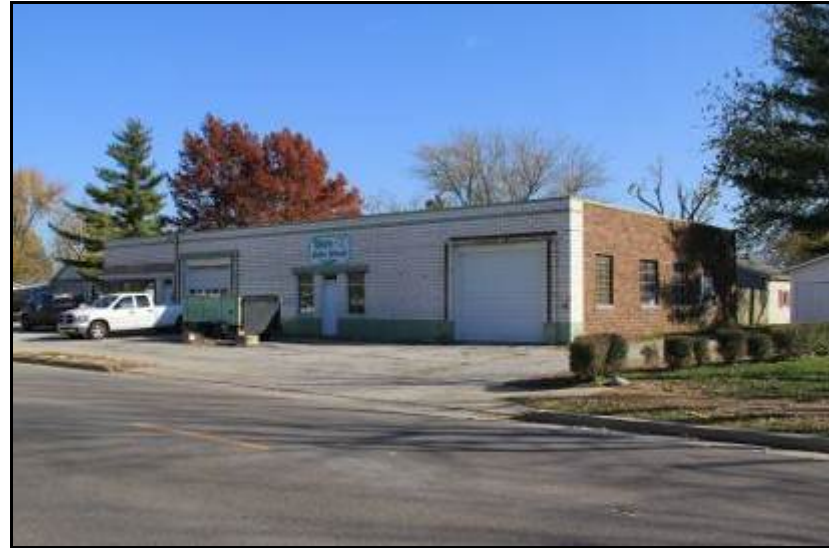
Sequence Number	Map Code	1994/95 Negative #	Address/Location	Type	Date Built	Historic Function	1994/95 Comments	2012/13 Comments and Photo Image #
367	22/17	22/17, IMG_1990	IL 4 & Page (SE corner), STAUNTON	2	Ca. 1930s-40s	Gas/Service	Glazed brick gas station with flat roof and two overhead doors – almost certainly post-dates RT 66 through Staunton.	Consequential changes to this building include the replacement of the garage doors. IMG_1679

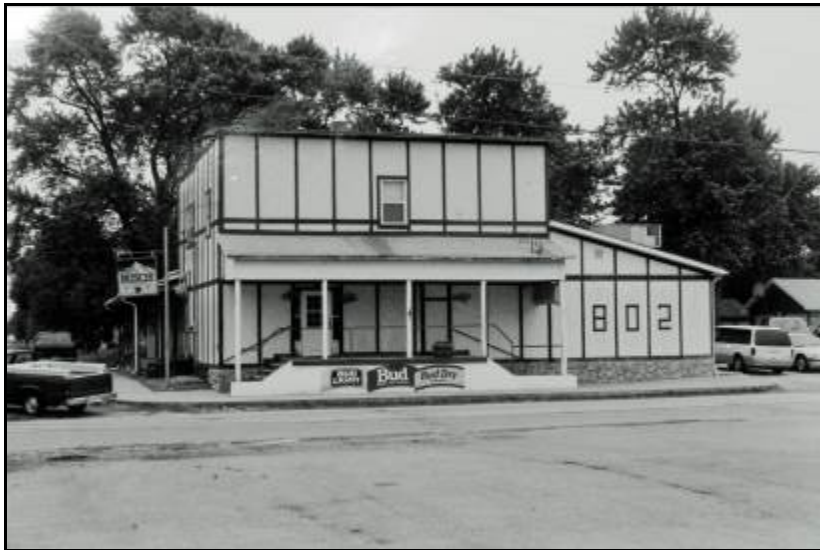
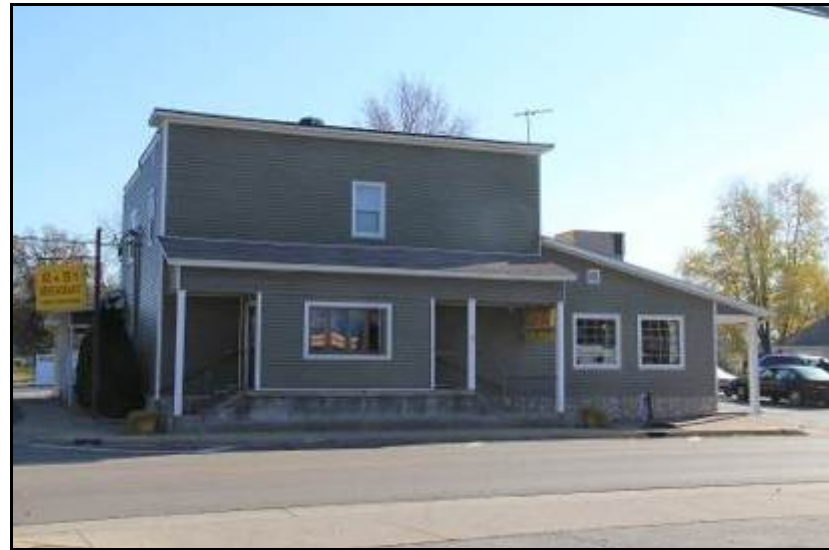
Sequence Number	Map Code	1994/95 Negative #	Address/Location	Type	Date Built	Historic Function	1994/95 Comments	2012/13 Comments and Photo Image #
368	16/04	16/04, IMG_1991	802 IL 4, STAUNTON	2	Unknown	Restaurant	Substantially remodeled building could (if it pre-dates 1930) have been an old IL 4/RT 66 eatery.	Several prominent changes have occurred to this building, including enclosing part of the front porch, installing windows in the shed-roof addition to the right, extending that shed roof to shelter a walkway and resheathing the entire structure. IMG_1678

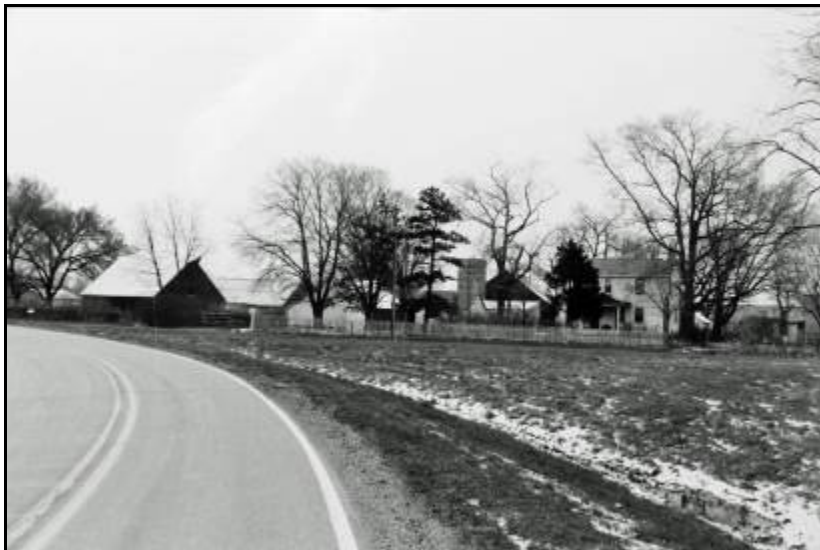
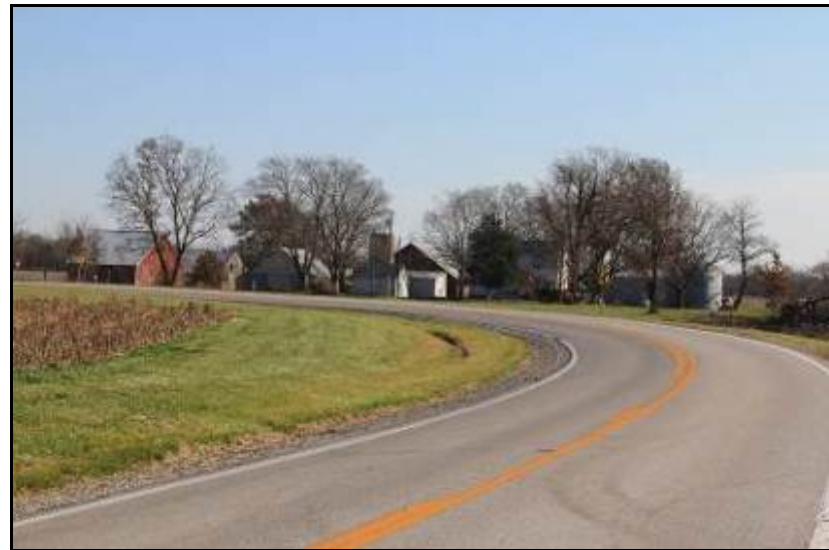
Sequence Number	Map Code	1994/95 Negative #	Address/Location	Type	Date Built	Historic Function	1994/95 Comments	2012/13 Comments and Photo Image #
369	10/05	10/05, IMG_1992	Williamson Rd. & Seivers Rd.	3	Ca. Late 19 th , Early 20 th Century	Farm	Farmstead with gabled house and some sense of integrity (?) – on 1930s alignment, E of Staunton.	The farm generally retains the buildings and integrity it had in 1994. IMG_1677

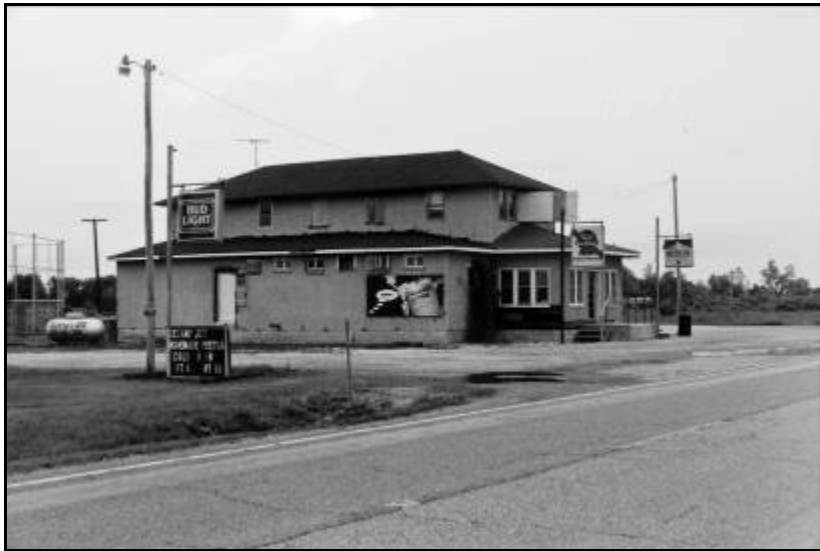
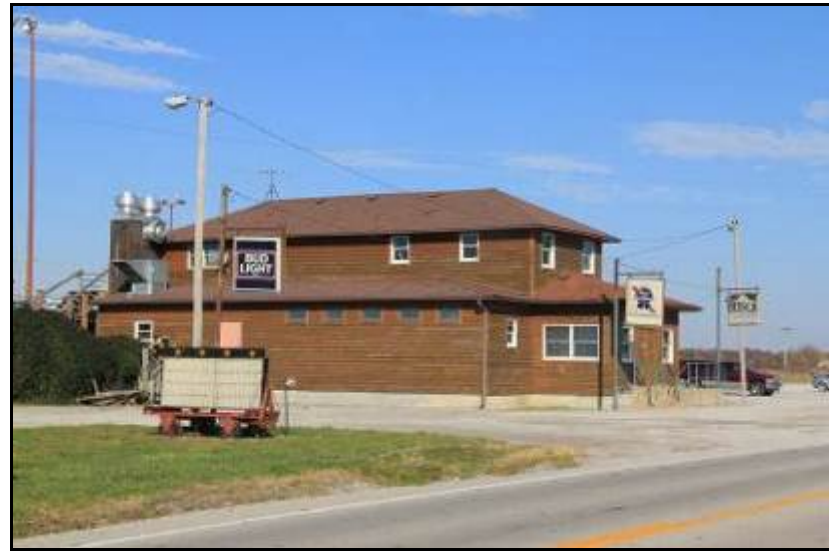
Sequence Number	Map Code	1994/95 Negative #	Address/Location	Type	Date Built	Historic Function	1994/95 Comments	2012/13 Comments and Photo Image #
370	16/02	16/02-03, IMG_1993	IL 4 & Spangle Rd.	2	Ca. 1920s-30s	Roadside Tavern	Two-story structure with hip roof, enclosed, hip roof porch and painted, fake brick siding – on IL 4 (1920s) and subsequent 1930s alignment S of Staunton.	This building has been resheathed, in addition to some windows having been covered and others resized. IMG_1676

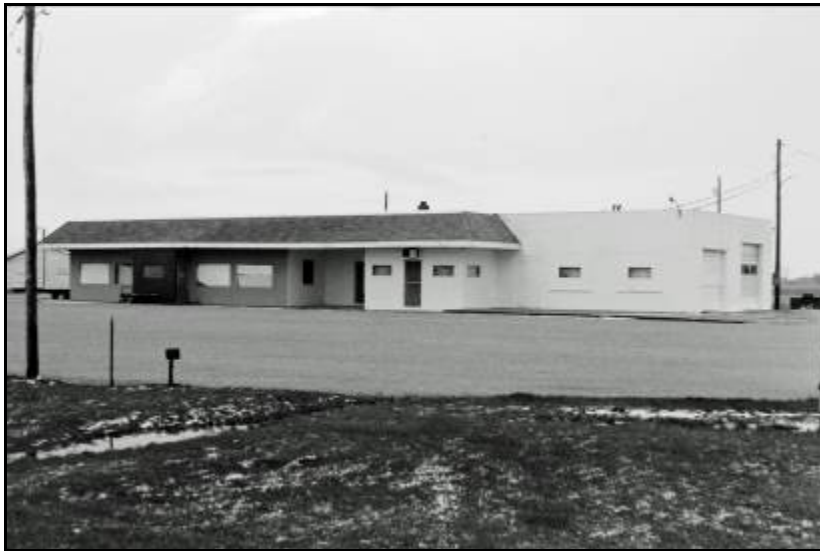
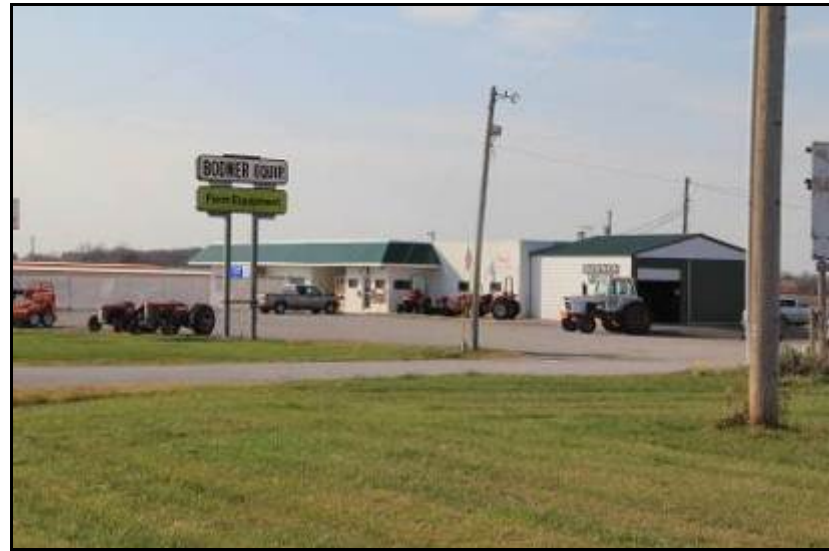
Sequence Number	Map Code	1994/95 Negative #	Address/Location	Type	Date Built	Historic Function	1994/95 Comments	2012/13 Comments and Photo Image #
371	10/06	10/06, IMG_1994	Old 66 (S of Rd. 50N)	2	Ca. 1950s	Gas/Diesel Truck Stop (?)	Possible old gas and/or diesel (truck) stop of concrete blocks – 1950s alignment E of Staunton.	This structure remains today, albeit with several modifications, including a gabled addition to the garage evident to the right. IMG_1584

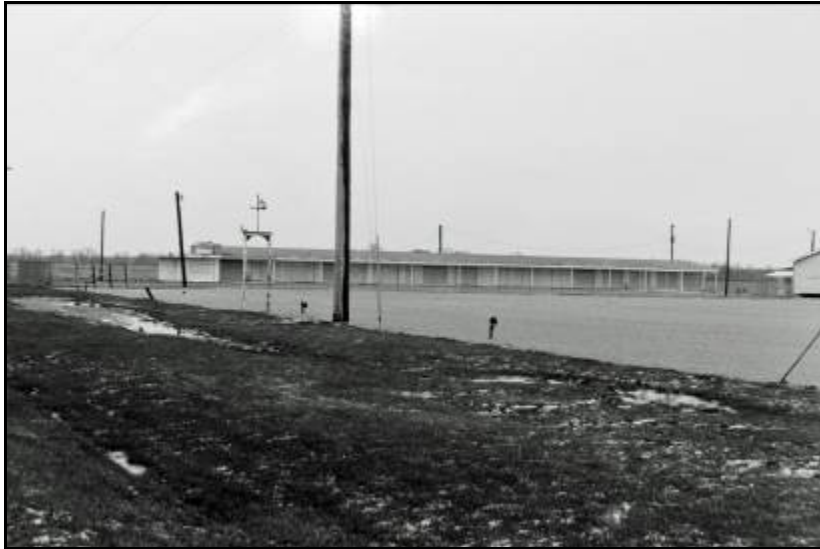
Sequence Number	Map Code	1994/95 Negative #	Address/Location	Type	Date Built	Historic Function	1994/95 Comments	2012/13 Comments and Photo Image #
372	10/07	10/07, IMG_1995	Old 66 (S of Rd. 50N)	2	Ca. 1950s	Motel	Motel converted to self-storage – 1950s alignment E of Staunton.	Structure now gone.

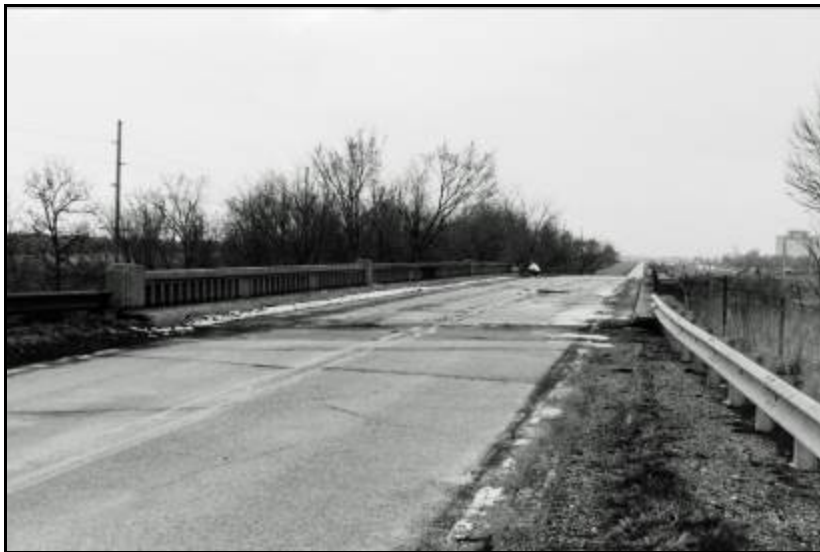
Sequence Number	Map Code	1994/95 Negative #	Address/Location	Type	Date Built	Historic Function	1994/95 Comments	2012/13 Comments and Photo Image #
373	10/08	10/08-09, 12/20-21, IMG_1996	Old 66 over UP RR	1	1939	Bridge	Only one bridge remains: Bridge #060-0004 – plate notes: C.C.C. & St. L. RR Viaduct, Built 1939 by, State of Illinois, Henry Horner – Governor, Federal Aid Route 5 Section 26V, Federal Aid Proj. 113-B; three-span structure with rolled “I” beams supporting deck – 1950s alignment SE of Staunton.	Bridge is gone. Replaced in 2002.
