Route 66 in Illinois:

(2012/13 Update and Expansion of the Original 1994/95 Survey)

IDOT Sequence #17337 & #17337A

22 December 2013

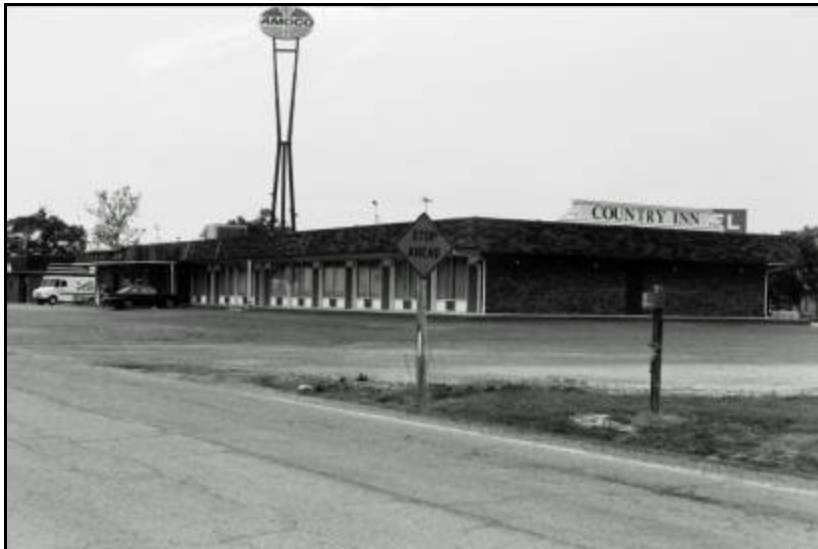
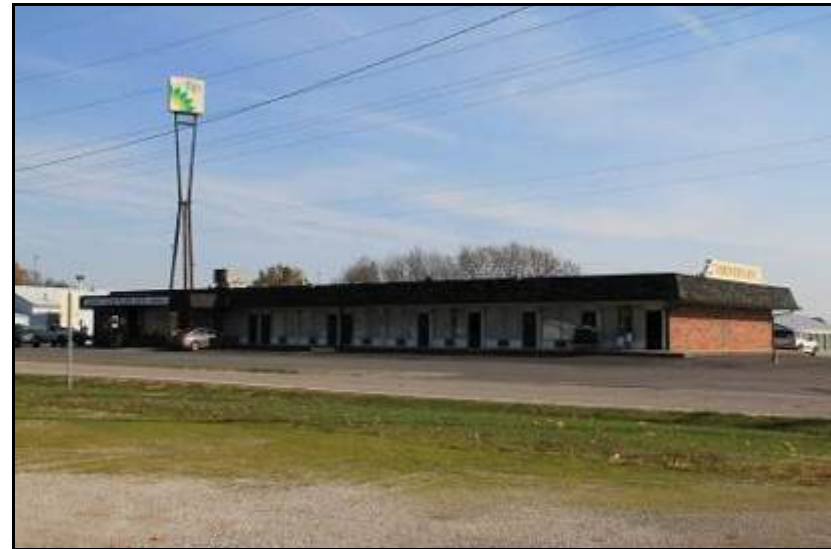
Sequence Number	Map Code	1994/95 Negative #	Address/Location	Type	Date Built	Historic Function	1994/95 Comments	2012/13 Comments and Photo Image #
374	13/32	13/32, IMG_1997	Henry St. & Maple, LIVINGSTON	2	Ca. 1960s	Motel	Largely glass and brick, one-story motel on 1950s alignment – now “Country Inn.”	This entity is little changed since 1994. IMG_1587

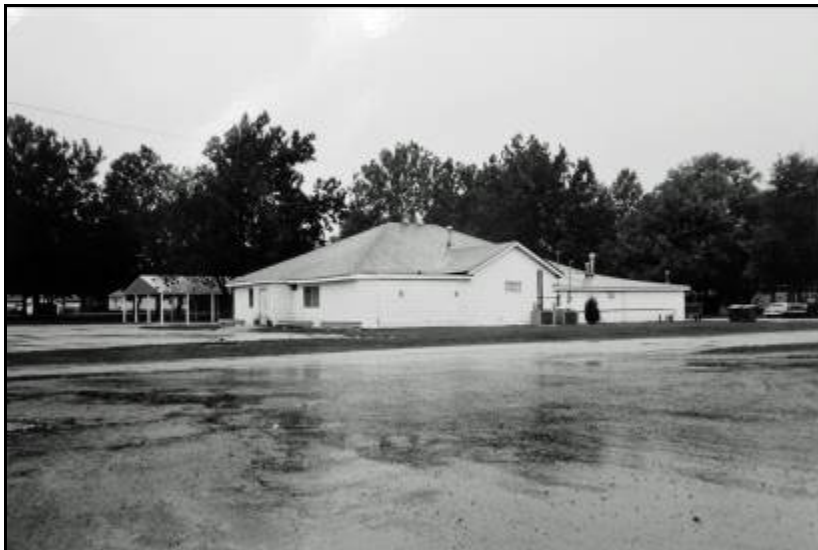
Sequence Number	Map Code	1994/95 Negative #	Address/Location	Type	Date Built	Historic Function	1994/95 Comments	2012/13 Comments and Photo Image #
375	22/11	22/11, IMG_1998	Henry St. & Maple, LIVINGSTON	3	Ca. 1940s-50s	Hall	Located across the road from "County Inn," this looks to have been something on the order of a night club/VFW/ dance hall.	Building now gone.

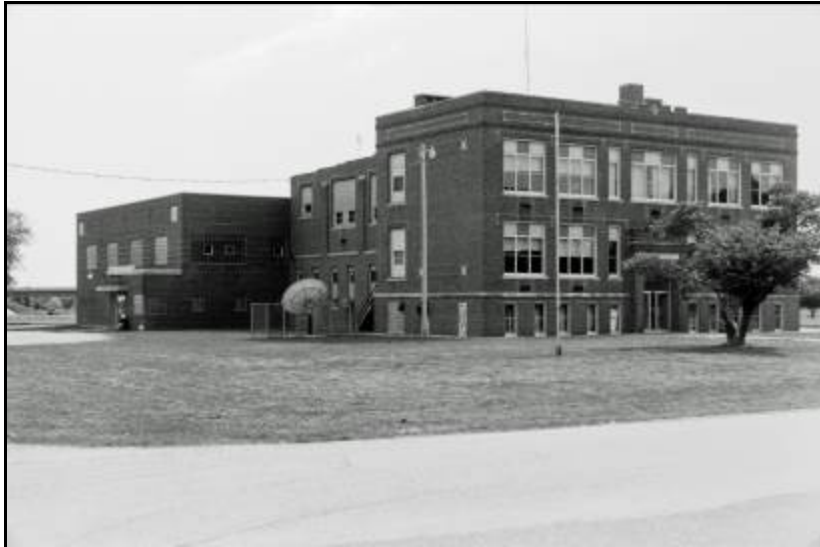
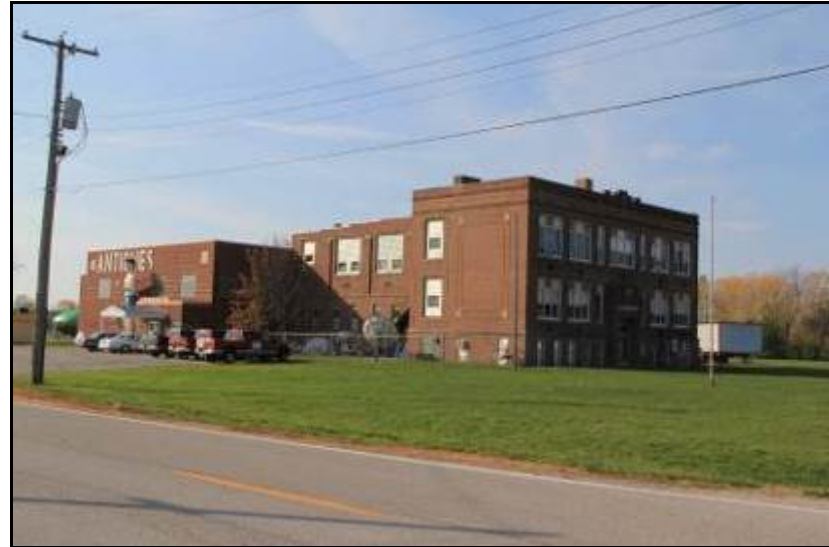
Sequence Number	Map Code	1994/95 Negative #	Address/Location	Type	Date Built	Historic Function	1994/95 Comments	2012/13 Comments and Photo Image #
376	13/33	13/33, IMG_1999	Alhambra & Livingston Dr., LIVINGSTON	3	Ca. 1930s	School	High school and gymnasium adjacent to 1950s alignment.	This former high school is now an antique store. IMG_1588

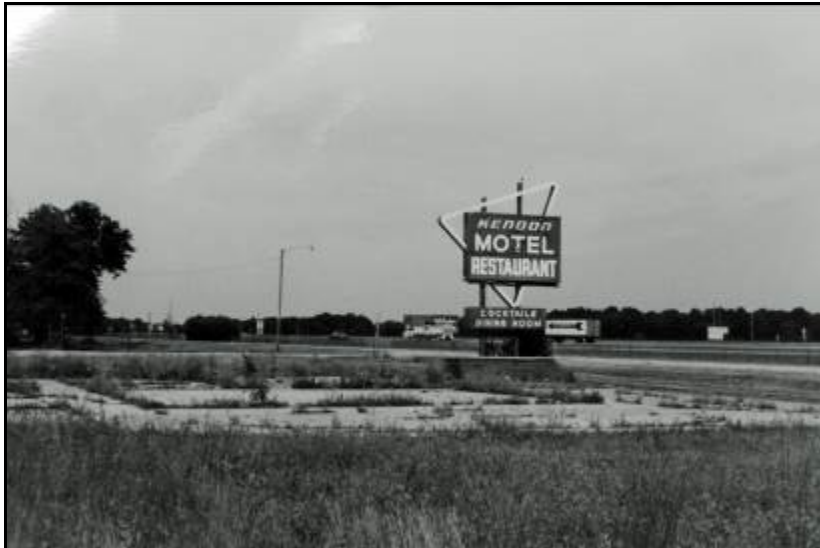
Sequence Number	Map Code	1994/95 Negative #	Address/Location	Type	Date Built	Historic Function	1994/95 Comments	2012/13 Comments and Photo Image #
377	13/34	13/34, IMG_2000	Alhambra & Livingston Dr., LIVINGSTON	2	Ca. 1950s	Motel Sign	Sign for old motel since removed along 1950s alignment – “Kendon Motel Restaurant, Cocktails/Dining Room.”	Sign now gone.

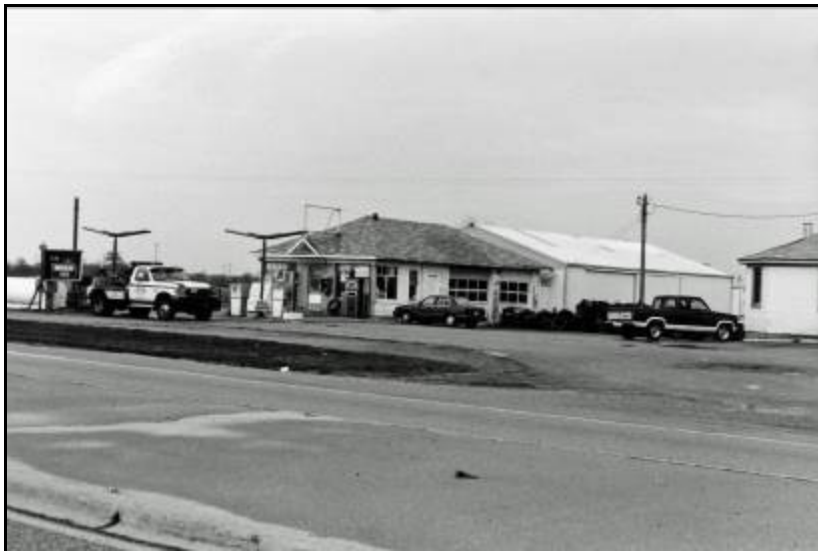
Sequence Number	Map Code	1994/95 Negative #	Address/Location	Type	Date Built	Historic Function	1994/95 Comments	2012/13 Comments and Photo Image #
378	10/12	10/12, IMG_2001	IL 4 & I-55	2	Ca. 1920s-30s	Gas/Service	Small, hip roof gas station with clapboard siding and two, original, overhead, garage doors to the rear (modern addition beyond that) – intersection of 1920s, 1930s and 1950s alignments S of Staunton.	Old service station is now for sale. Note new canopy over pumps and new garage doors. IMG_1591

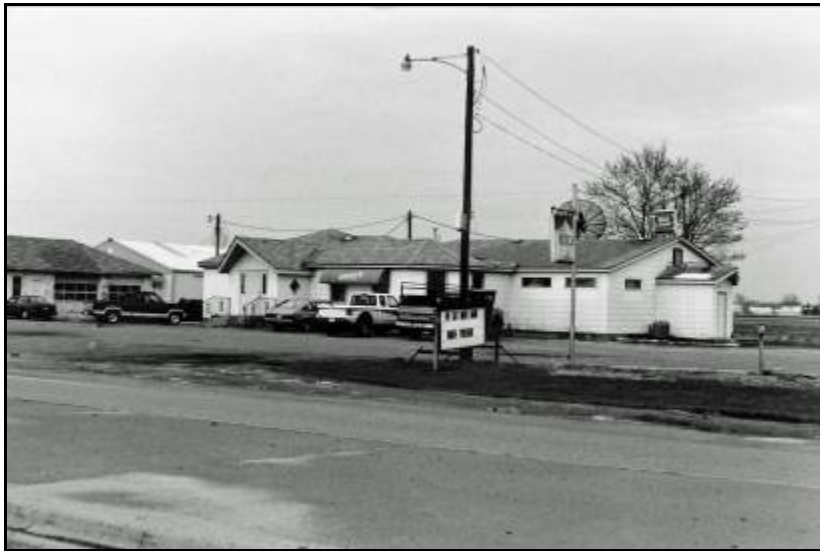
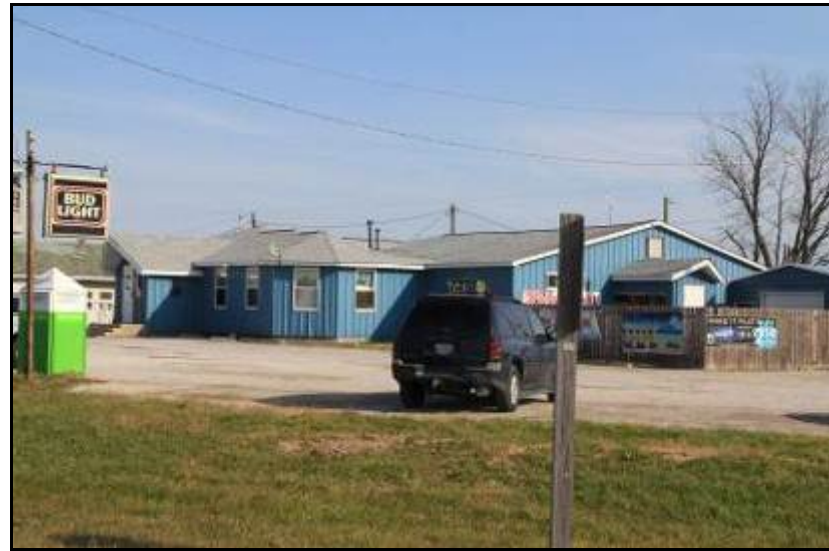
Sequence Number	Map Code	1994/95 Negative #	Address/Location	Type	Date Built	Historic Function	1994/95 Comments	2012/13 Comments and Photo Image #
379	10/11	10/11, IMG_2002	IL 4 & I-55	2	Ca. 1930s-50s	Tavern	Building has many additions, most significant of which is a large, gabled room to rear; entire structure has uniform, aluminum or asbestos siding – now “Shotzy’s” at intersection of 1920s, 1930s and 1950s alignments S of Staunton.	This building today has new window treatments and new (aluminum?) siding. IMG_1590

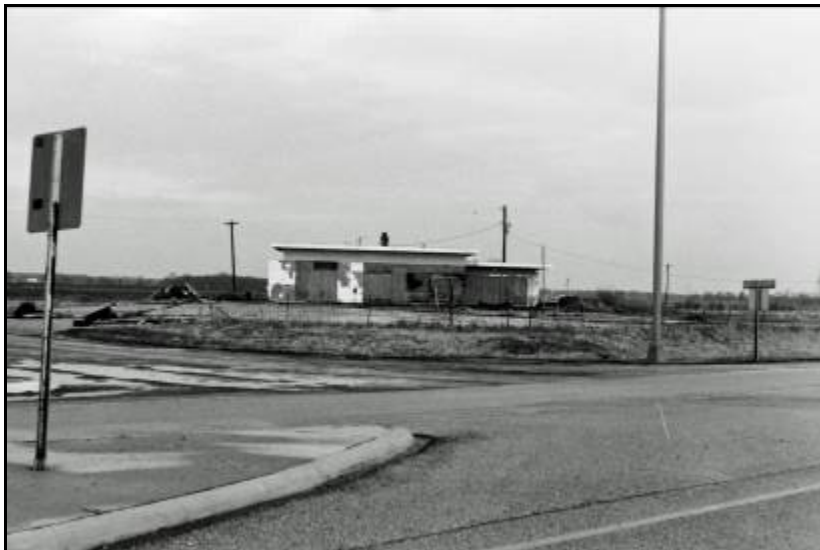
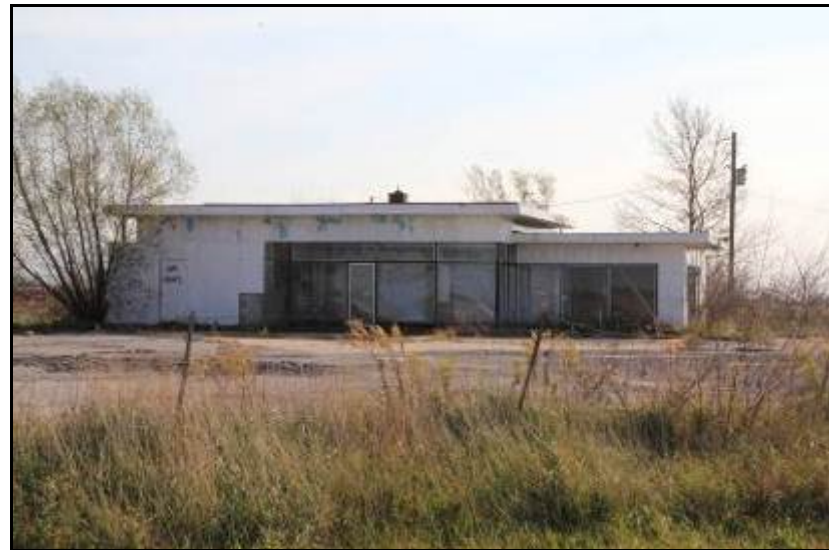
Sequence Number	Map Code	1994/95 Negative #	Address/Location	Type	Date Built	Historic Function	1994/95 Comments	2012/13 Comments and Photo Image #
380	10/10	10/10, 22/16, IMG_2003	IL 4 & I-55	2	Ca. 1960s	Gas/Service	Vacant gas station.	This gas station remains vacant and unused. IMG_1589

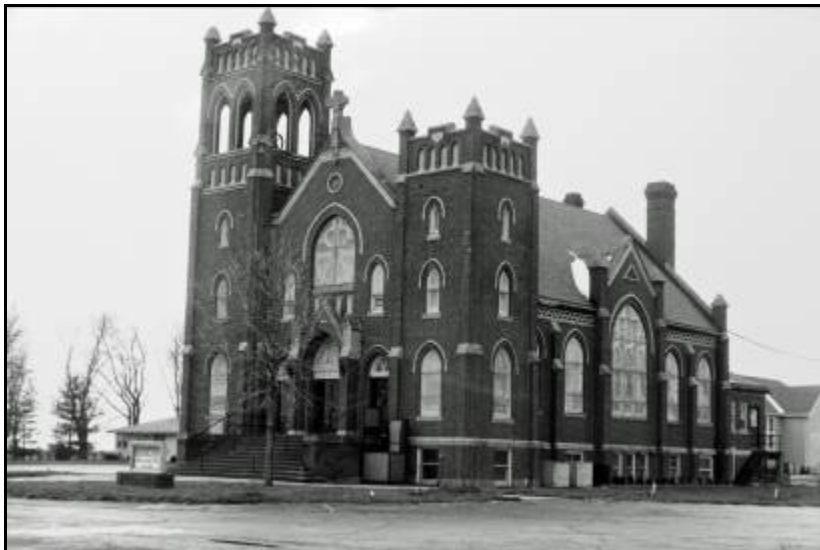
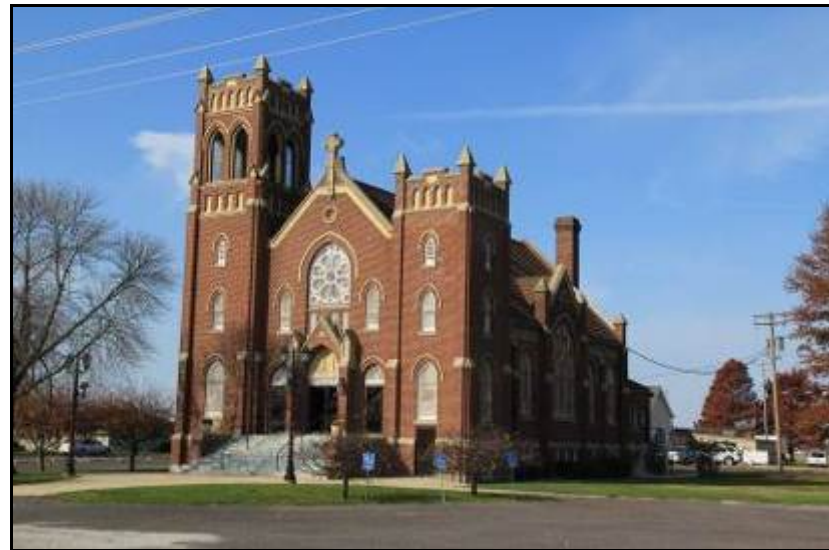
Sequence Number	Map Code	1994/95 Negative #	Address/Location	Type	Date Built	Historic Function	1994/95 Comments	2012/13 Comments and Photo Image #
381	10/13	10/13, IMG_2004	Old 66 & Church Rd.	3	Ca. 1930	Church	Prominent, brick, Gothic Revival church, cornerstone of which notes date of 1856-1931 – “St. Paul’s Lutheran Church.”	Church is unchanged. IMG_1592

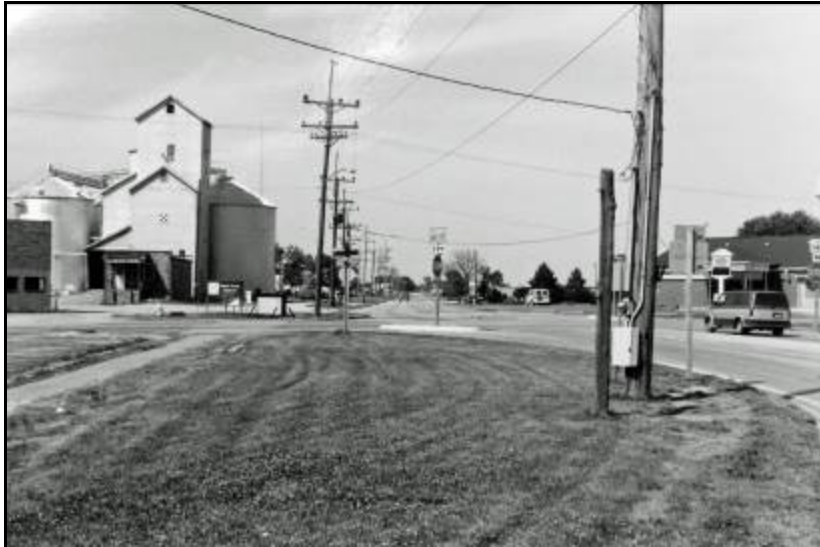
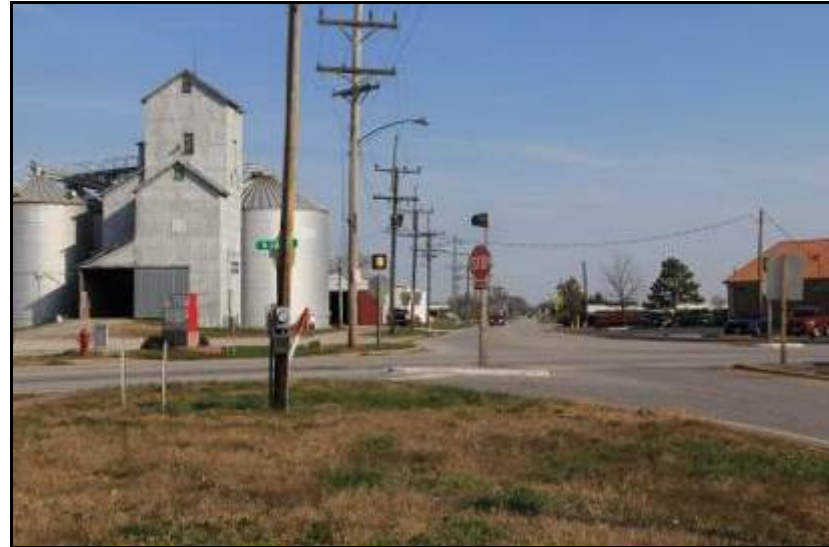
Sequence Number	Map Code	1994/95 Negative #	Address/Location	Type	Date Built	Historic Function	1994/95 Comments	2012/13 Comments and Photo Image #
382	13/37	13/37, IMG_2005	Old 66 at HAMEL	1	Ca. 1920s-50s	RT 66	RT 66 N of Hamel, alignment used from 1920s to early 1950s (view to NE).	Little has changed since 1994 in this general view to the NE. IMG_1593

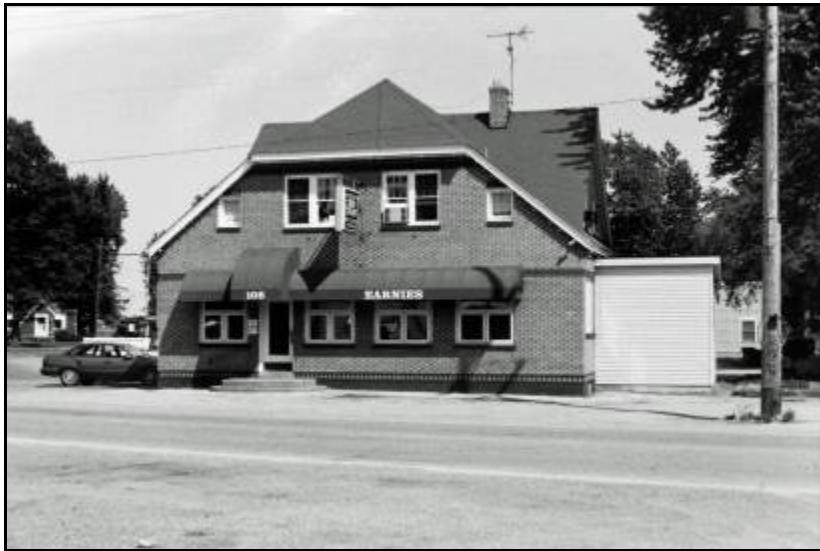
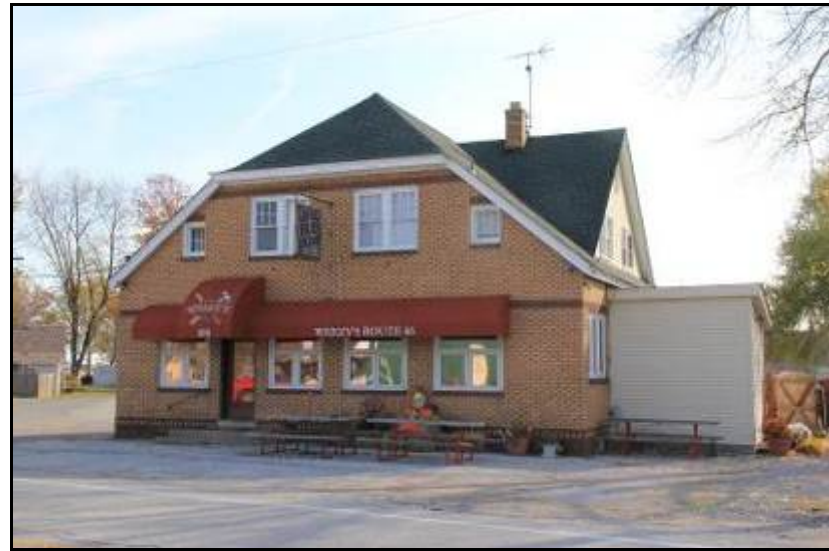
Sequence Number	Map Code	1994/95 Negative #	Address/Location	Type	Date Built	Historic Function	1994/95 Comments	2012/13 Comments and Photo Image #
383	10/15	10/15, 13/35, IMG_2006	IL 157 & IL 140, HAMEL	2	Ca. 1920s-30s	Restaurant	Two-story, brick, bungalow – “Earnies;” note that photo 10/14 is a photograph of a historic view of the intersection.	Exhibiting much, if not all, of its 1994 character, this building now houses “Weezr’s Bar & Grill.” IMG_1594

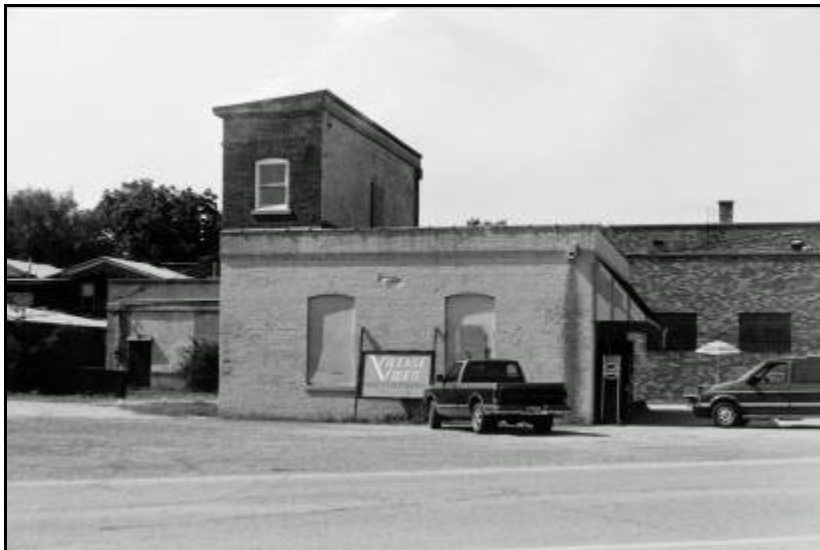
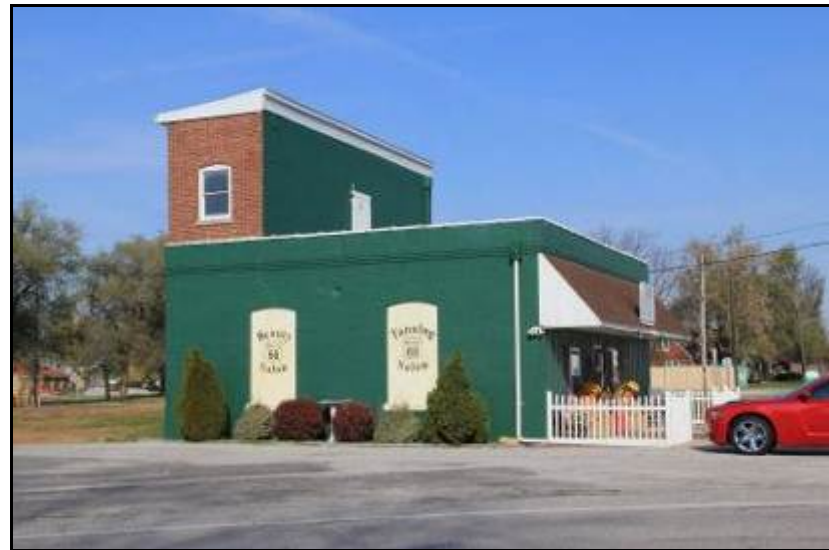
Sequence Number	Map Code	1994/95 Negative #	Address/Location	Type	Date Built	Historic Function	1994/95 Comments	2012/13 Comments and Photo Image #
384	13/36	13/36, IMG_2007	IL 157 & IL 140, HAMEL	3	Ca. 1920s-30s	Unknown	Unique, brick structure, use of which is unknown – “Village Video.”	Having been recently painted, this building now houses the “RT 66 Beauty & Tanning Salon.” IMG_1595

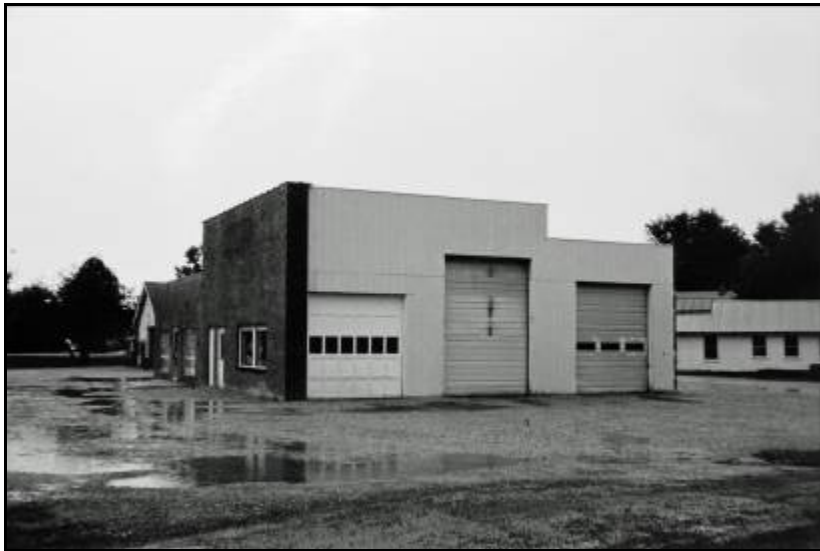
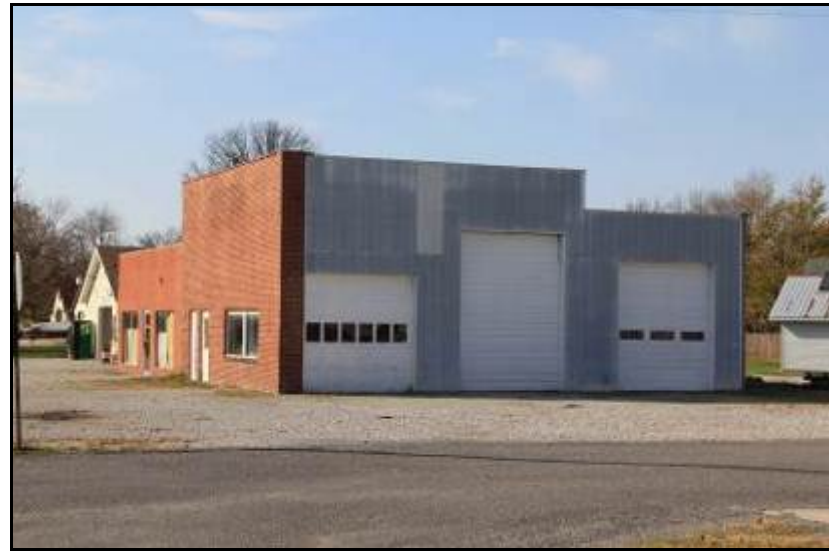
Sequence Number	Map Code	1994/95 Negative #	Address/Location	Type	Date Built	Historic Function	1994/95 Comments	2012/13 Comments and Photo Image #
385	22/12	22/12, IMG_2008	IL 157 & Broadway, HAMEL	2	Ca. 1940s-50s	Auto/Truck Service	Brick structure with parapet and coping; N side has metal siding and three overhead garage doors – could well have been auto/truck service business.	There have been few, if any, changes to this auto/truck service facility. IMG_1596

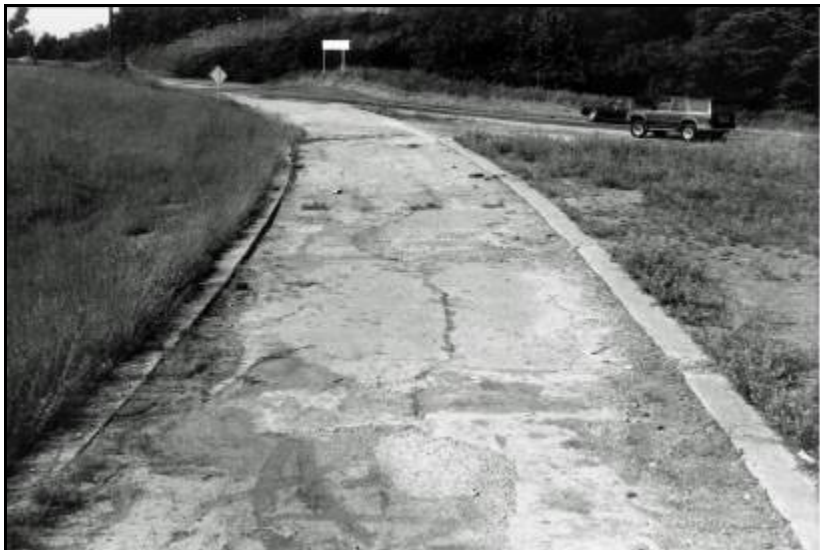
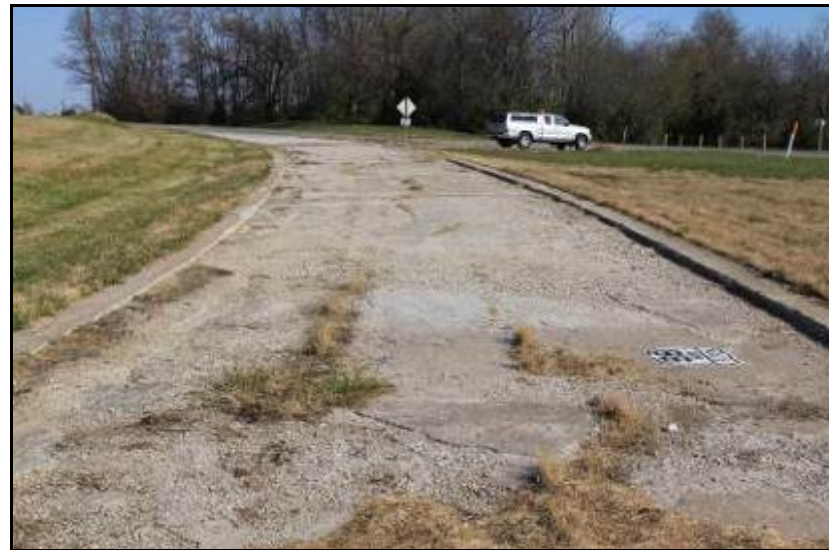
Sequence Number	Map Code	1994/95 Negative #	Address/Location	Type	Date Built	Historic Function	1994/95 Comments	2012/13 Comments and Photo Image #
386	14/01	14/01-03, IMG_2009	IL 157 & Staunton Rd.	1	Ca. 1920s	USH 66	Archaeological segment with concrete base, flanges and inset brick surface – nearby resident said this was built in 1920 and bricked over around 1930.	This short segment of old RT 66 largely remains unchanged. IMG_1597

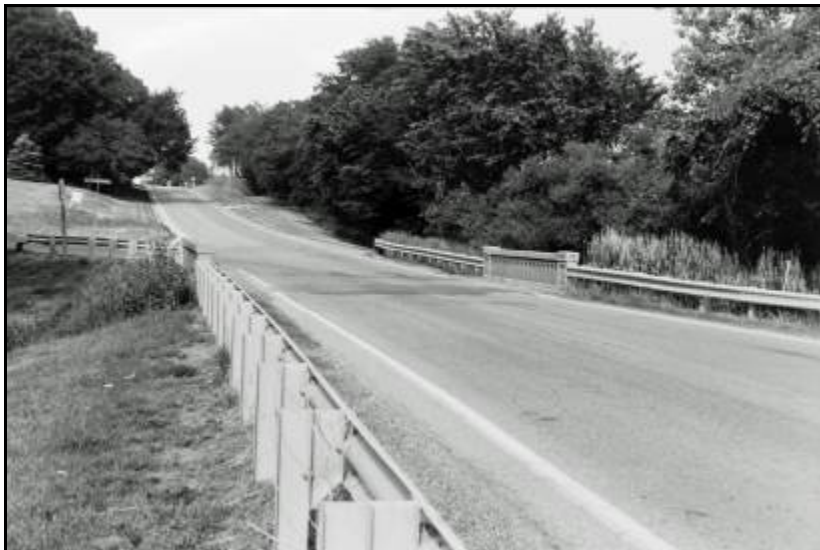
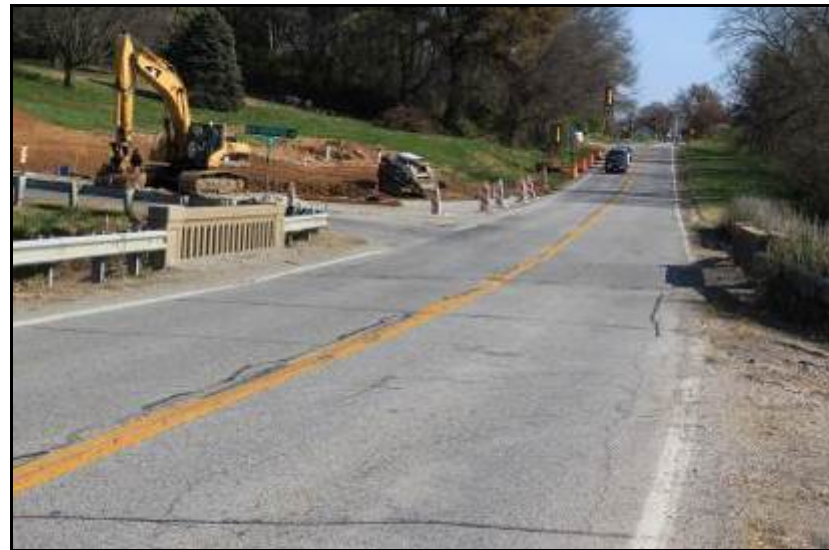
Sequence Number	Map Code	1994/95 Negative #	Address/Location	Type	Date Built	Historic Function	1994/95 Comments	2012/13 Comments and Photo Image #
387	10/16	10/16, 14/04-05, IMG_2010	Il 157 over Sugar Creek	1	Ca. 1930s	Bridge	Bridge #060-0072 – no plate; single-span structure with slab deck and a concrete railing with balusters.	The bridge remains, although there is some nearby, roadway construction. IMG_1598

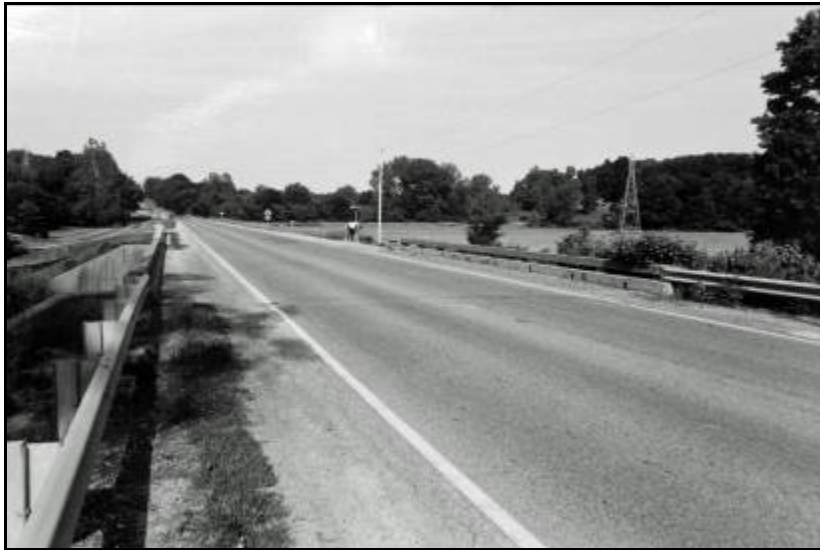
Sequence Number	Map Code	1994/95 Negative #	Address/Location	Type	Date Built	Historic Function	1994/95 Comments	2012/13 Comments and Photo Image #
388	14/06	14/06-08, IMG_2011	IL 157 over Mooney Creek	1	1953	Bridge	Bridge #0060-0071 – plate notes: Station 48+36.8, Built 1953 by, State of Illinois, S.B.I. Rt 4 Sec. 64B-???, Loading H-20; two-span structure with deck supported by concrete “T” beams – judging from downstream extension, the pier from an earlier bridge was utilized in this construction.	Bridge now gone. Replaced in 1999.

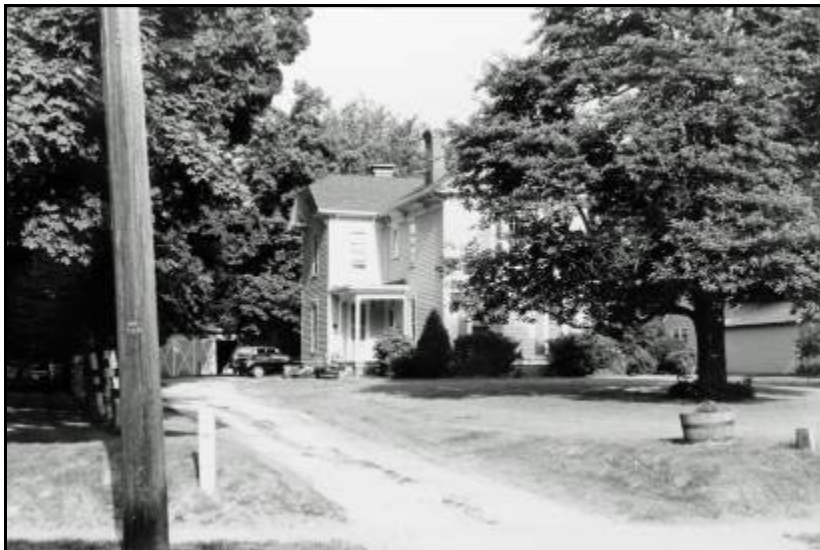
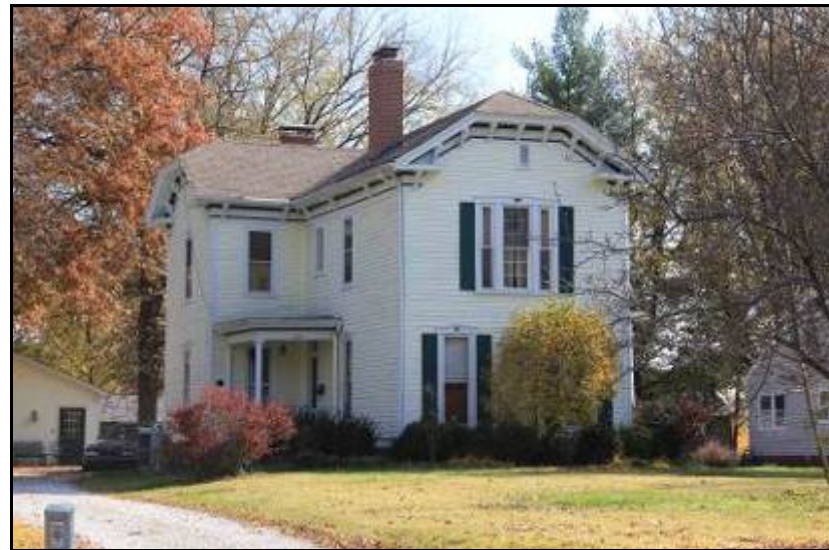
Sequence Number	Map Code	1994/95 Negative #	Address/Location	Type	Date Built	Historic Function	1994/95 Comments	2012/13 Comments and Photo Image #
389	14/09	14/09, IMG_2012	722 S. Andrews	3	CA. Late 19 th Century	Residential	Two-story, gabled house with clapboard siding and Italianate details.	This house may have been sided since 1994. IMG_1599

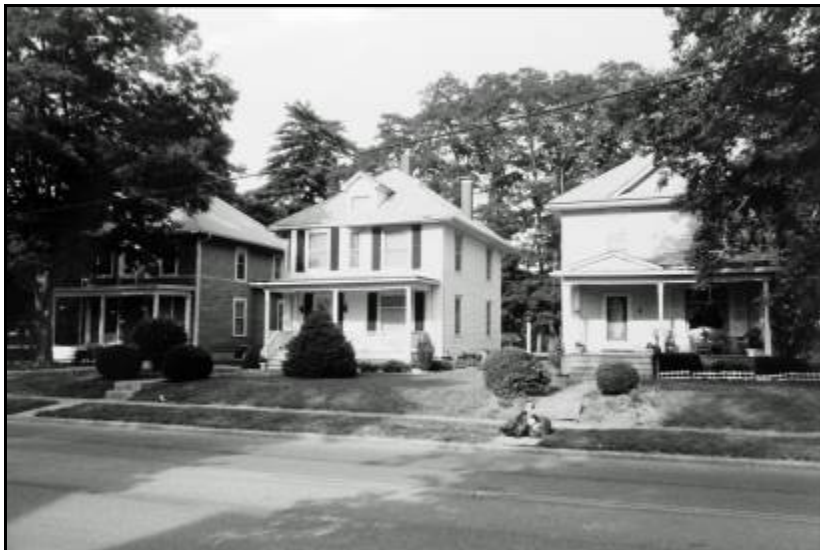
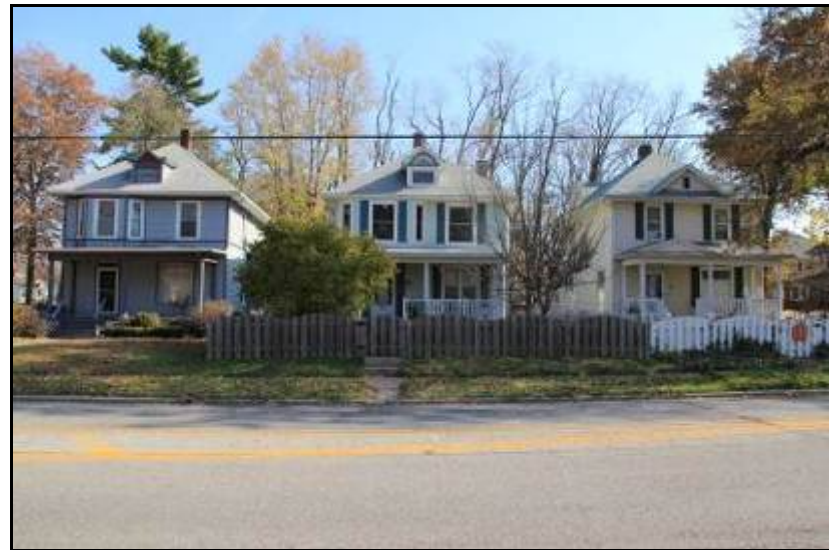
Sequence Number	Map Code	1994/95 Negative #	Address/Location	Type	Date Built	Historic Function	1994/95 Comments	2012/13 Comments and Photo Image #
390	14/10	14/10, IMG_2013	1?? St. Andrews	3	Ca. 1900	Residential	Three two-story, cube houses with hip roofs, full-width, open porches and clapboard siding.	There is some new lawn ornamentation (fences) and changes to some of the porches, but the three houses noted in 1994 remain. IMG_1600

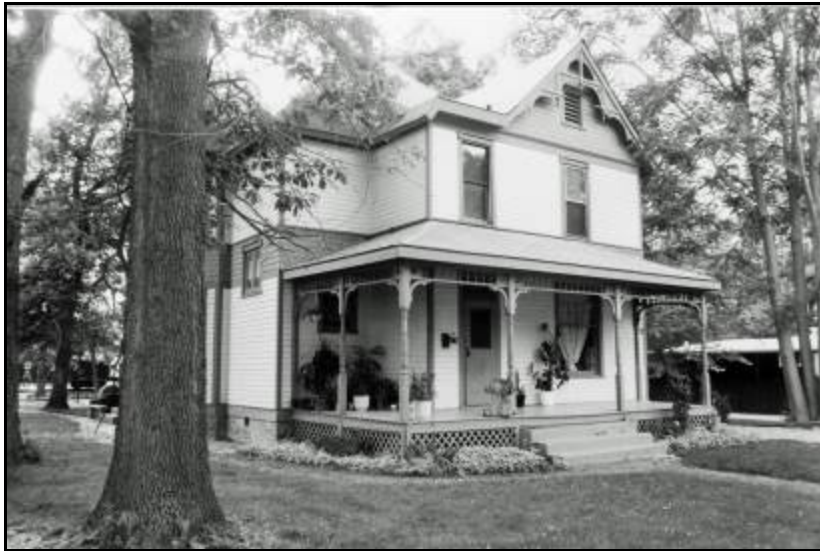
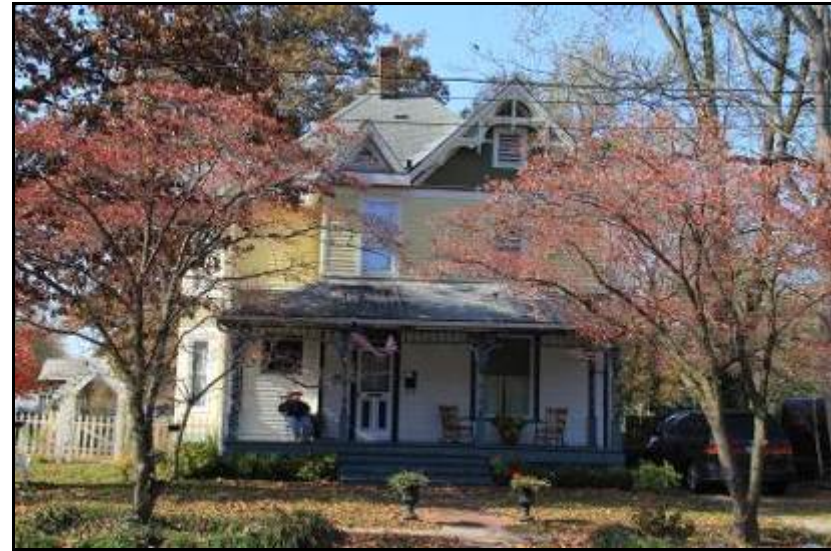
Sequence Number	Map Code	1994/95 Negative #	Address/Location	Type	Date Built	Historic Function	1994/95 Comments	2012/13 Comments and Photo Image #
391	14/11	14/11, IMG_2014	119 St. Andrews	3	Ca. 1880s-90s	Residential	Queen Anne house on brick foundation with clapboard siding, porch with spindled frieze and barge-boards in gable peak.	While this house retains its historic character, there have been many changes to it, including a small, second floor wall gable above the front door. IMG_1601

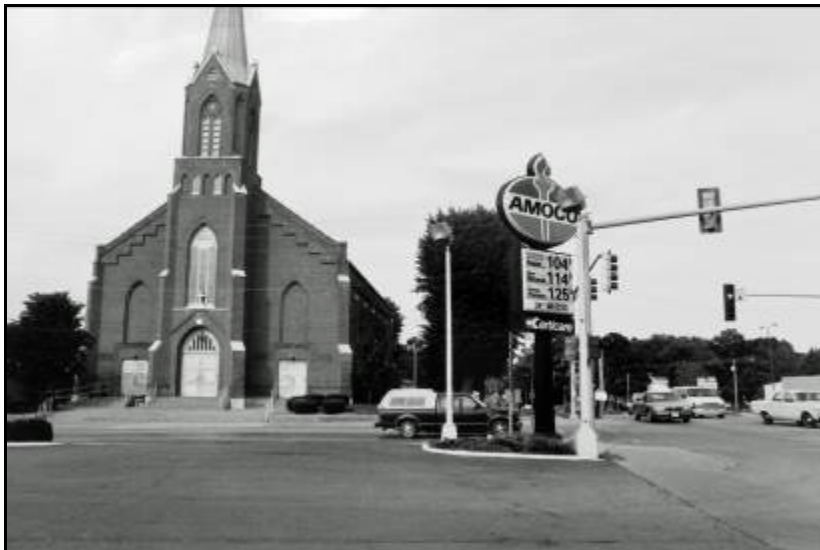
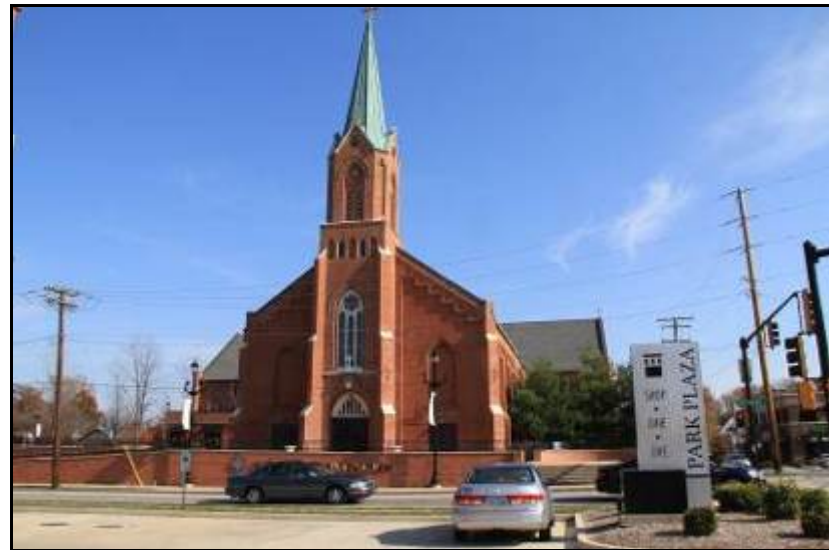
Sequence Number	Map Code	1994/95 Negative #	Address/Location	Type	Date Built	Historic Function	1994/95 Comments	2012/13 Comments and Photo Image #
392	10/17	10/17, 14/12, IMG_2015	Vandalia & Buchanan	3	Ca. 1870s	Church	Large, brick, Gothic Revival church – “St. Boniface.”	The parish was established in 1869. No notable changes to the church building were observed. IMG_1602

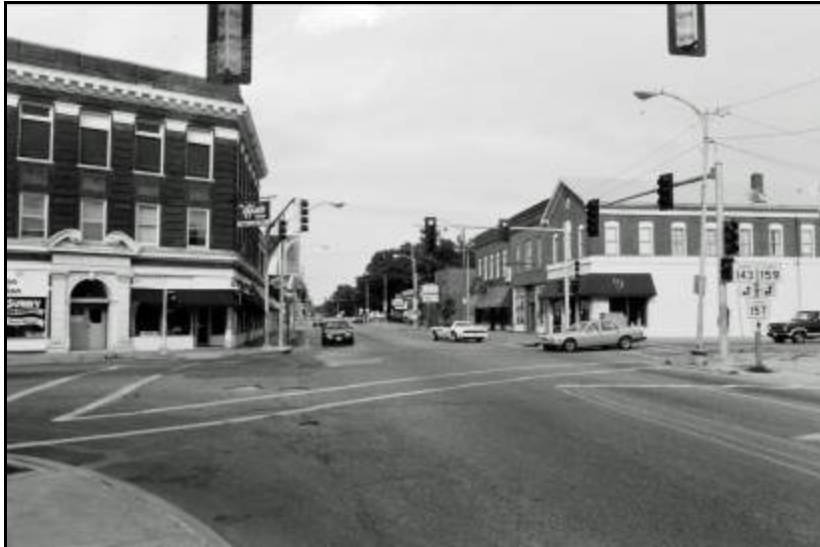
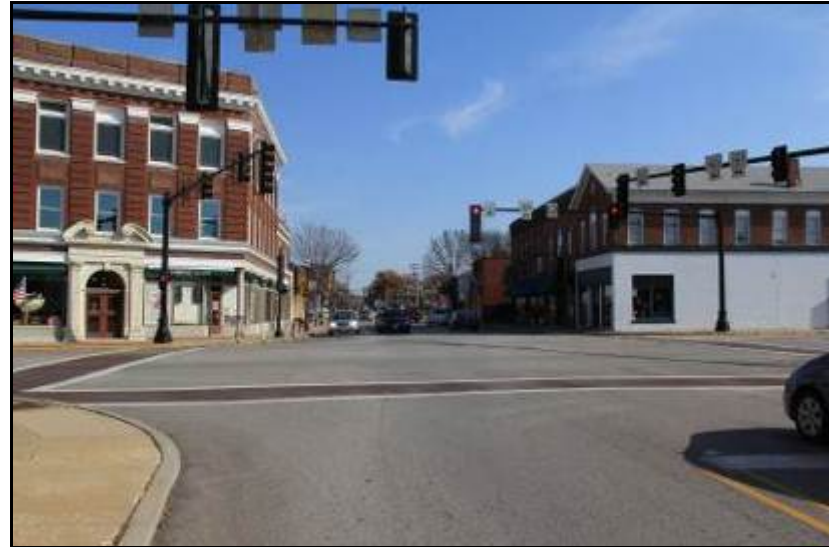
Sequence Number	Map Code	1994/95 Negative #	Address/Location	Type	Date Built	Historic Function	1994/95 Comments	2012/13 Comments and Photo Image #
393	14/13	14/13, IMG_2016	Vandalia & IL 143	1	Ca. 1920s-60s	USH 66	Bypass 66 through Edwardsville (view to E).	The historical integrity of RT 66 through Edwardsville remains generally intact. IMG_1603

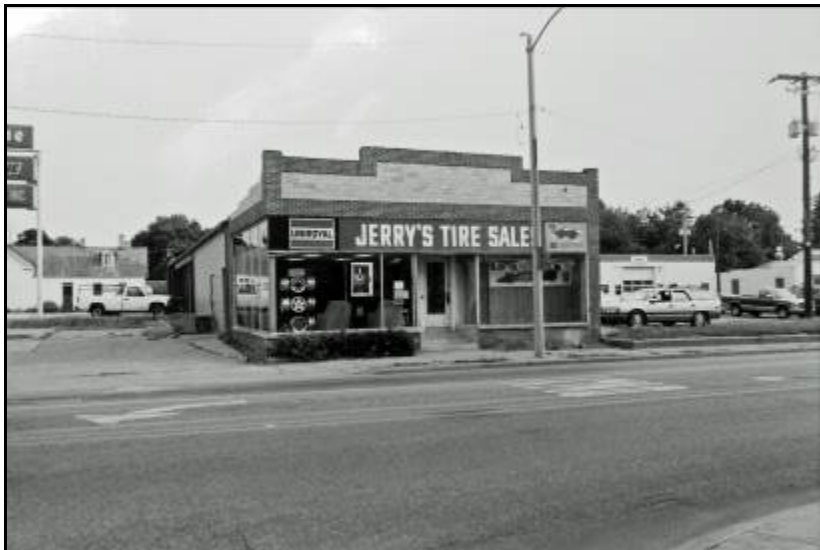
Sequence Number	Map Code	1994/95 Negative #	Address/Location	Type	Date Built	Historic Function	1994/95 Comments	2012/13 Comments and Photo Image #
394	14/14	14/14, IMG_2017	102(?) Vandalia	2	Ca. 1940s	Auto Service/Sales (?)	Brick and block structure with stepped parapet and reasonably large display windows; could have originally been an auto dealership (?).	This building no longer remains.

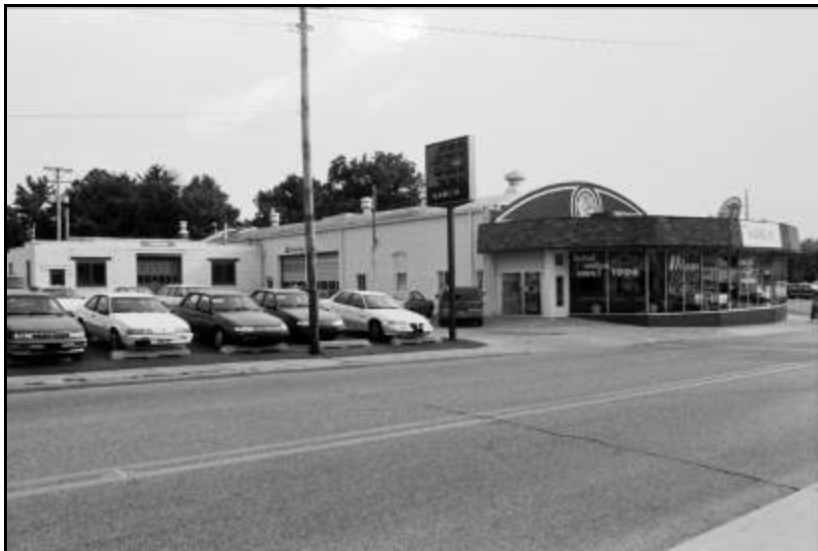
Sequence Number	Map Code	1994/95 Negative #	Address/Location	Type	Date Built	Historic Function	1994/95 Comments	2012/13 Comments and Photo Image #
395	10/18	10/18, 14/15, IMG_2018	122 (?) Vandalia	2	Ca. 1940s	Auto Service/Sales	Brick structure with arched roof and rock-faced, concrete block addition to the side; modern showroom added to front, but what appears to be a decorative, enameled, floral carving in the front endwall peak is still visible.	Auto dealership now gone.

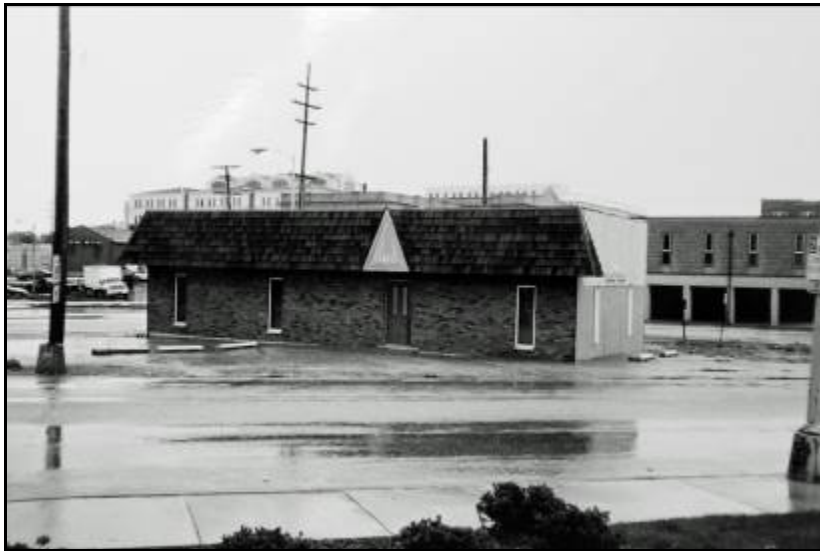
Sequence Number	Map Code	1994/95 Negative #	Address/Location	Type	Date Built	Historic Function	1994/95 Comments	2012/13 Comments and Photo Image #
396	22/13	22/13, IMG_2019	Vandalia & St. Louis	2	Ca. 1950s	Gas/Service	Substantially remodeled gas station with new brick façade and fake, mansard roof – underground storage tank covers clearly suggest historical use as gas a station.	Structure now gone.

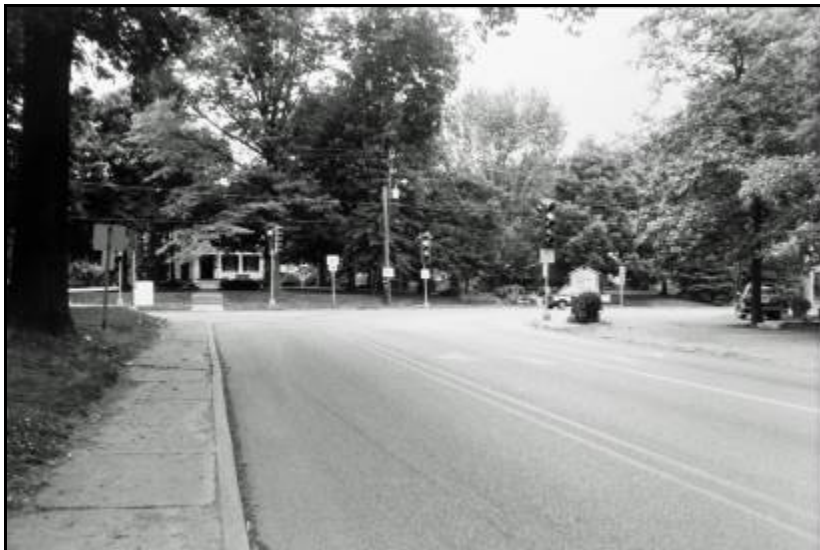
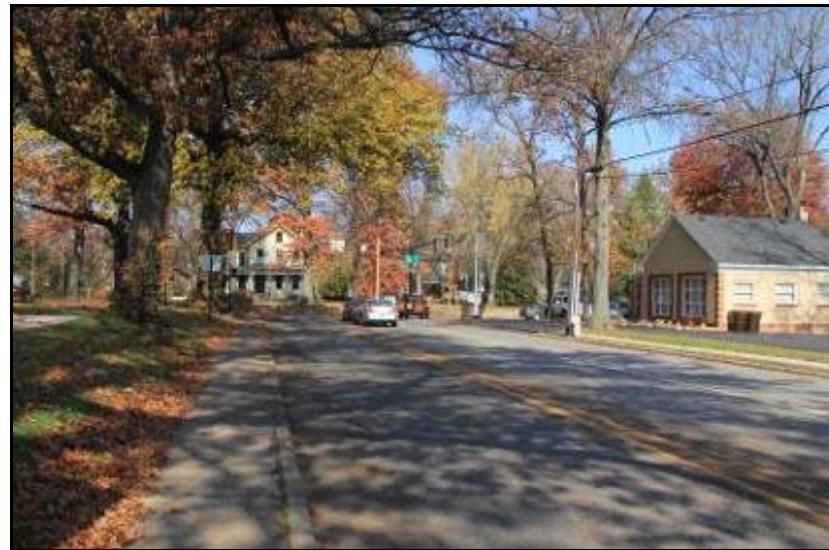
Sequence Number	Map Code	1994/95 Negative #	Address/Location	Type	Date Built	Historic Function	1994/95 Comments	2012/13 Comments and Photo Image #
397	14/16	14/16-17, IMG_2020	IL 157 & St. Louis	3	Ca. Late 19 th , Early 20 th Century	Residential	Neighborhood of impressive houses and prominent trees; notable to all driving N on RT 66.	Little appears to have changed at this RT 66 intersection in Edwardsville. IMG_1604

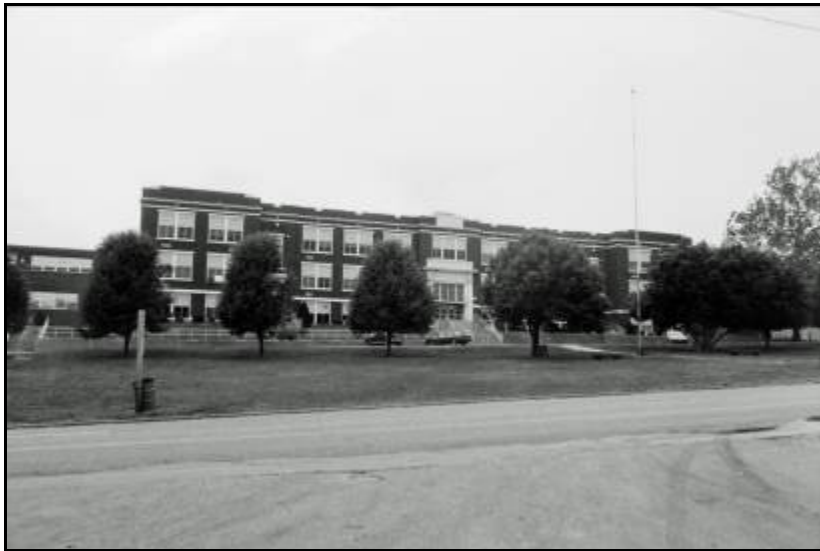
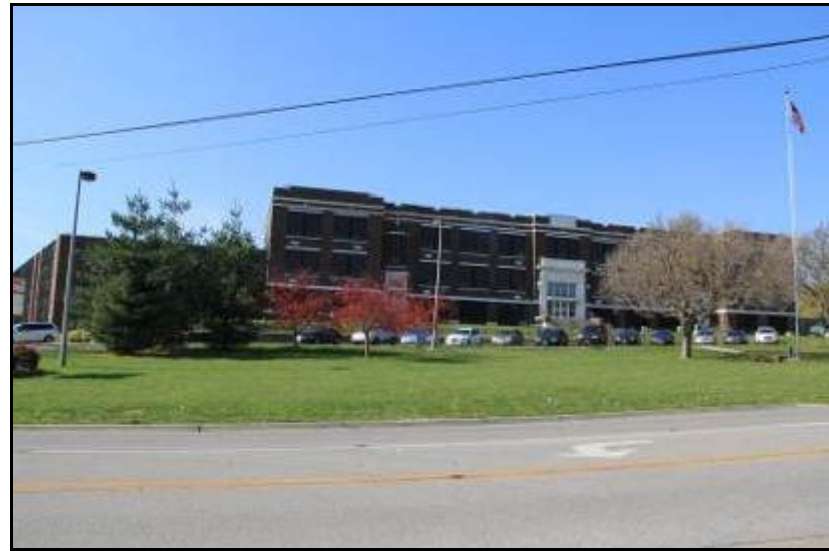
Sequence Number	Map Code	1994/95 Negative #	Address/Location	Type	Date Built	Historic Function	1994/95 Comments	2012/13 Comments and Photo Image #
398	14/18	14/18, IMG_2021	IL 157 & Schwartz	3	Ca. 1920s-30s	School	Massive, three-story brick high school.	This structure may possibly have new windows. IMG_1605

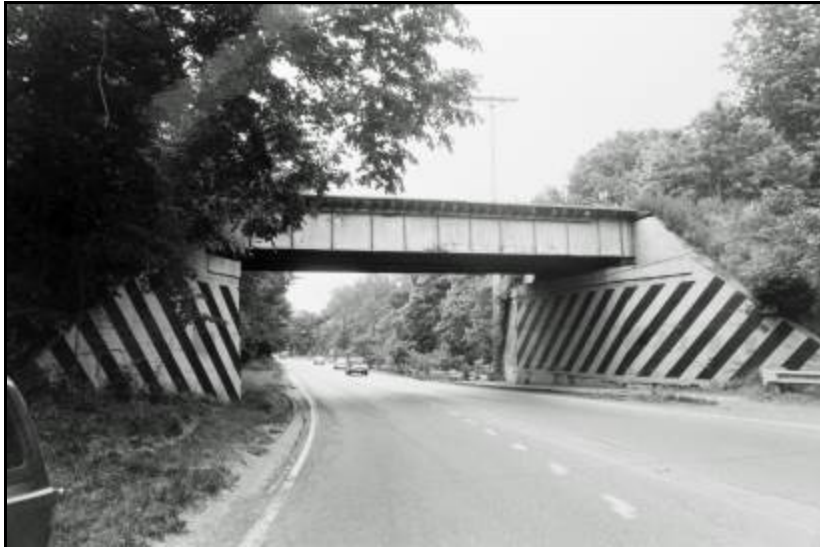
Sequence Number	Map Code	1994/95 Negative #	Address/Location	Type	Date Built	Historic Function	1994/95 Comments	2012/13 Comments and Photo Image #
399	14/19	14/19, IMG_2022	IL 157 & NW RR	2	Unknown	RR Overpass	No bridge number or plate; steel beam construction.	Railroad overpass now gone.
