Route 66 in Illinois:

(2012/13 Update and Expansion of the Original 1994/95 Survey)

IDOT Sequence #17337 & #17337A

22 December 2013

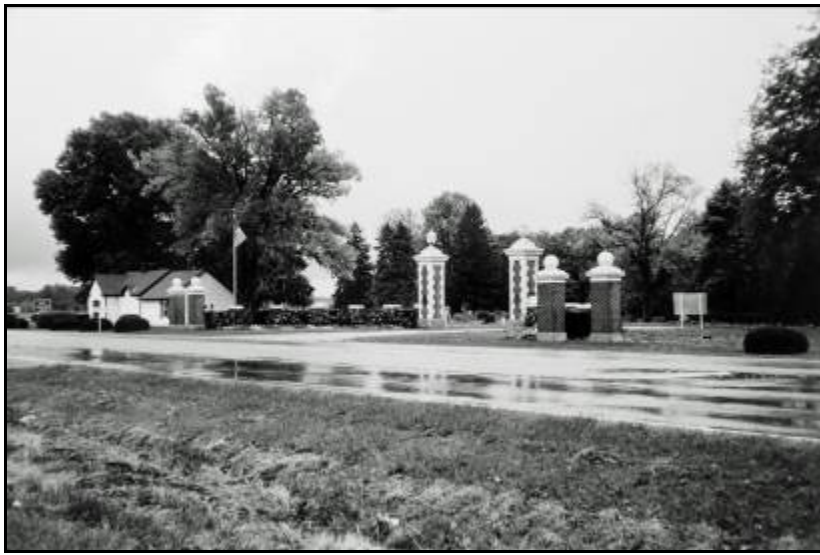
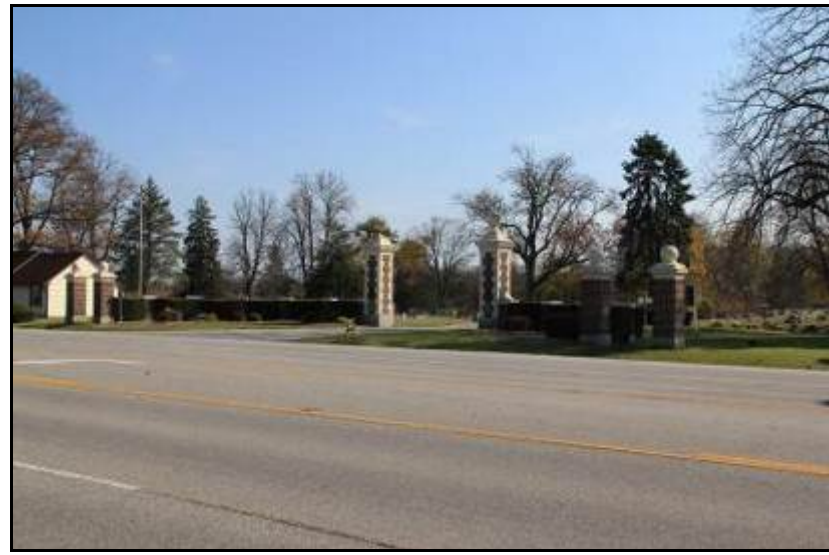
Sequence Number	Map Code	1994/95 Negative #	Address/Location	Type	Date Built	Historic Function	1994/95 Comments	2012/13 Comments and Photo Image #
400	22/14	22/14, IMG_2023	IL 157 (between Edwardsville & Chain of Rocks Road)	3	Unknown	Cemetery	Gates of "Sunset Hill Cemetery" – built of brick with glazed brick quoins at corners and vases with swags on top.	There appear to be few, if any, changes to the cemetery gates. IMG_1606

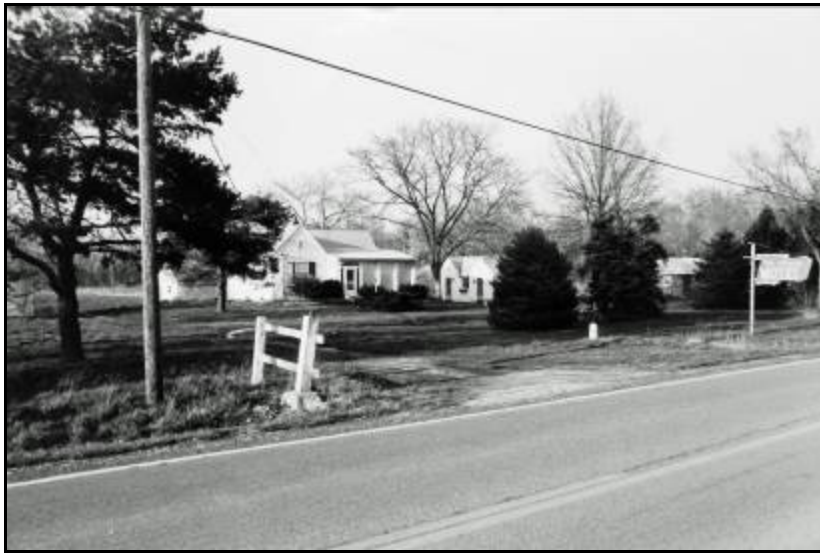
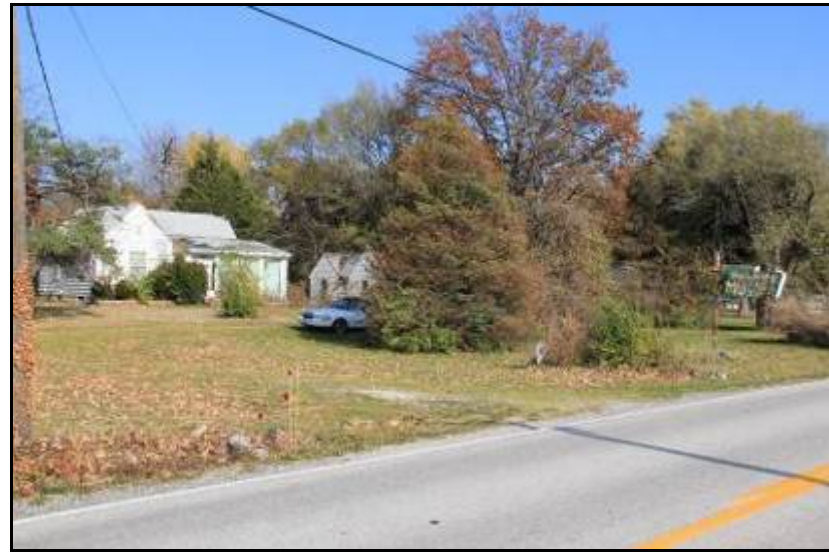
Sequence Number	Map Code	1994/95 Negative #	Address/Location	Type	Date Built	Historic Function	1994/95 Comments	2012/13 Comments and Photo Image #
401	10/19	10/19, 14/20, IMG_2024	533? Chain of Rocks Rd.	2	Ca. 1940s-50s	Motel	One-story, gabled house/office with adjacent two-room cabins, all with clapboard siding.	The trees on this property have grown larger, but at least a few cabins remain. IMG_1607

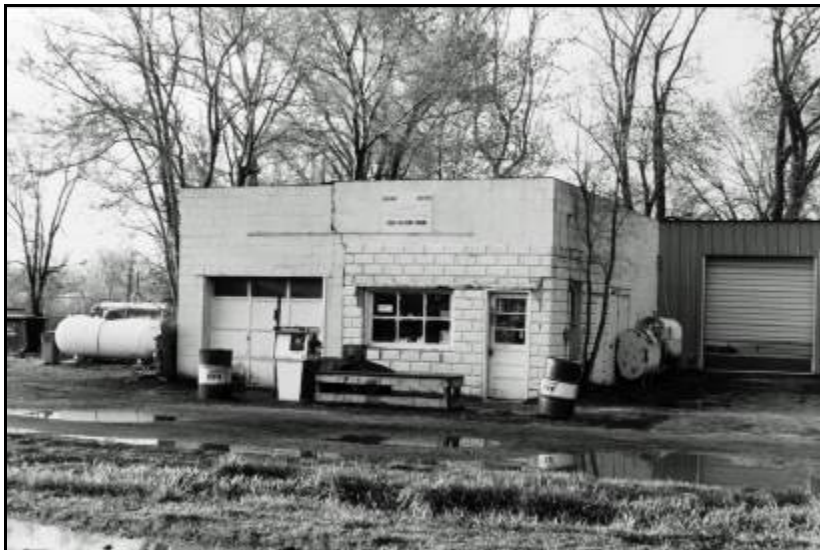
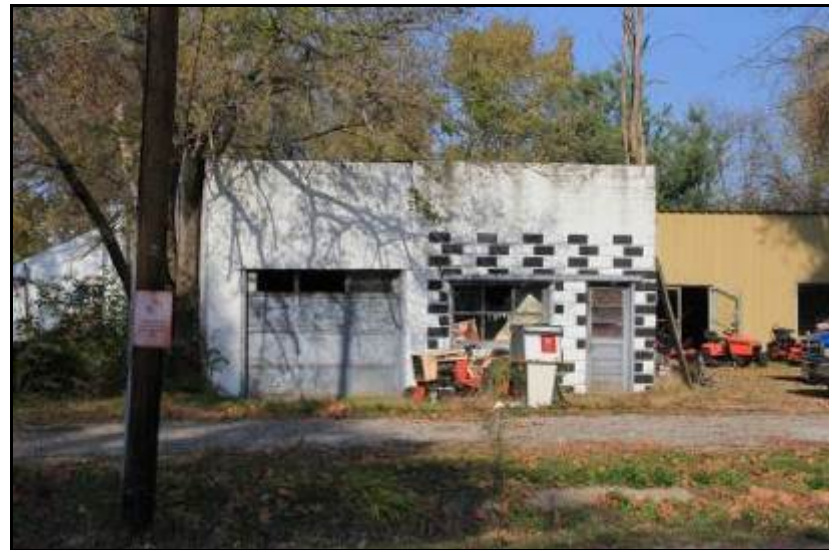
Sequence Number	Map Code	1994/95 Negative #	Address/Location	Type	Date Built	Historic Function	1994/95 Comments	2012/13 Comments and Photo Image #
402	10/20	10/20, 14/21, IMG_2025	52?? Chain of Rocks Road	2	Ca. 1930s	Gas/Service	Small, block station subsequently engulfed by modern block and metal garage additions.	A subsequent paint job notwithstanding, this former gas station appears to be little changed since 1994. IMG_1608

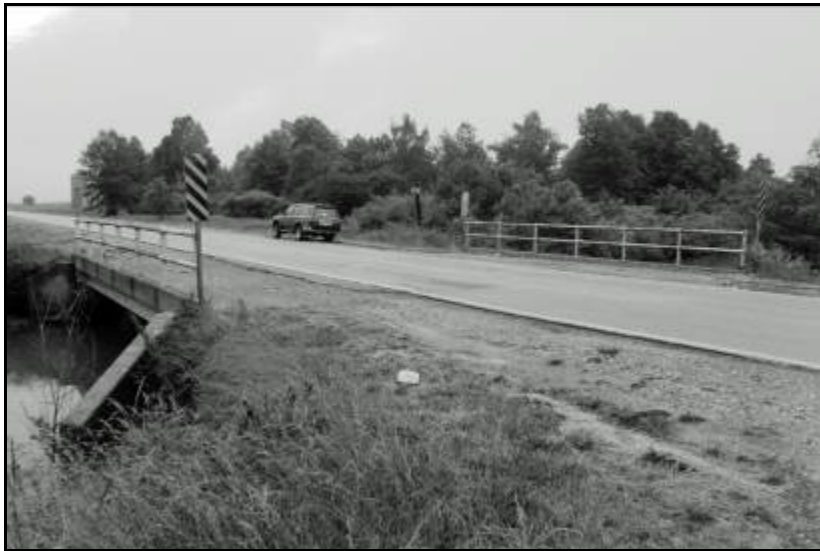
Sequence Number	Map Code	1994/95 Negative #	Address/Location	Type	Date Built	Historic Function	1994/95 Comments	2012/13 Comments and Photo Image #
403	14/22	14/22, IMG_2026	Chain of Rocks Road over County Ditch	1	Unknown	Bridge	Bridge #060-0069 – no plate; single-span structure with concrete deck supported by “I” beams.	Bridge now gone. Replaced in 20??

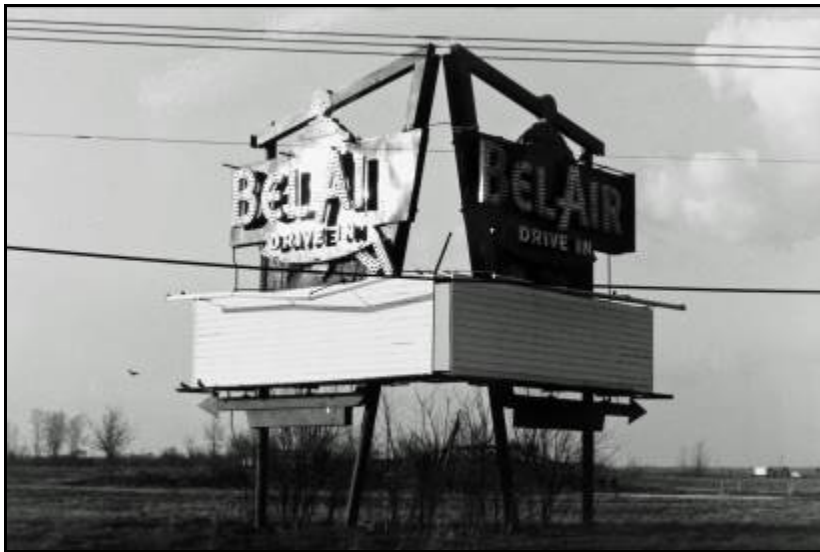
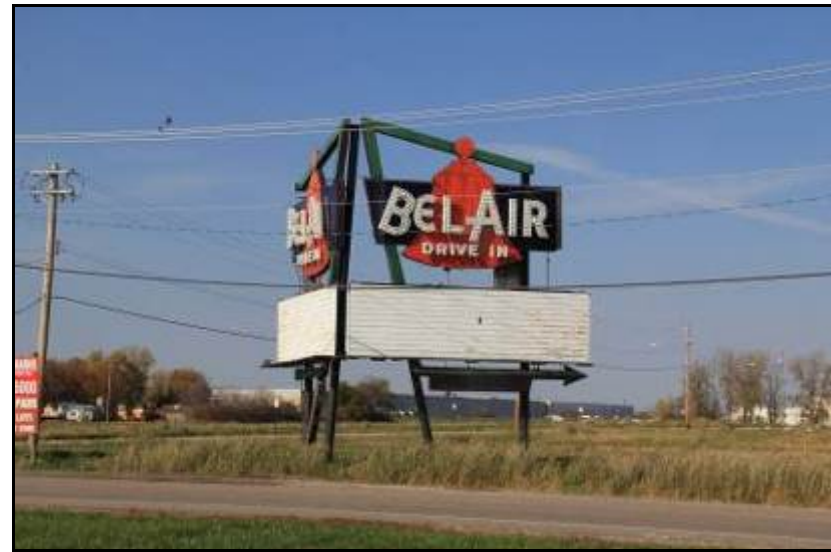
Sequence Number	Map Code	1994/95 Negative #	Address/Location	Type	Date Built	Historic Function	1994/95 Comments	2012/13 Comments and Photo Image #
405	10/22	10/22, 14/24-25, IMG_2028	Chain of Rocks Rd. & IL 111	2	Ca. 1950s	Drive-In Movie	Sign is all that remains of the "Bel Aire Drive-In."	Rather amazingly, this sign has survived for the last 19 years in fair condition. The drive-in itself is long gone. IMG_1609

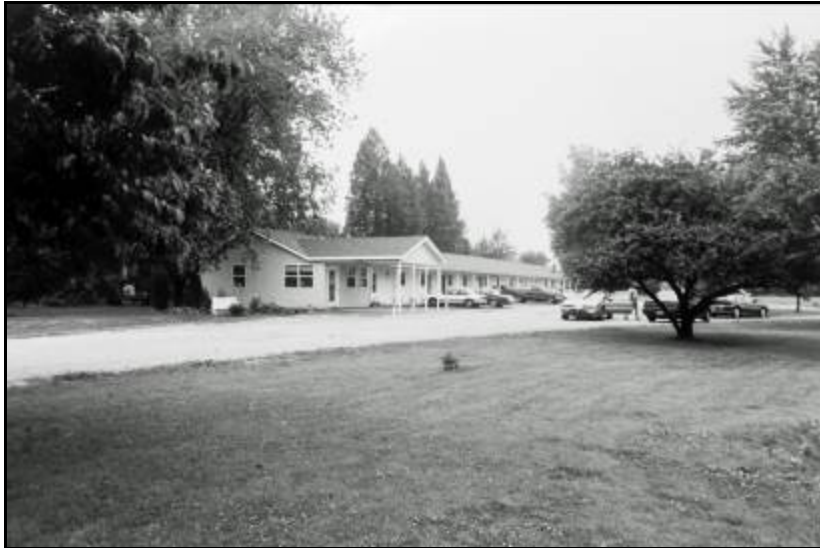
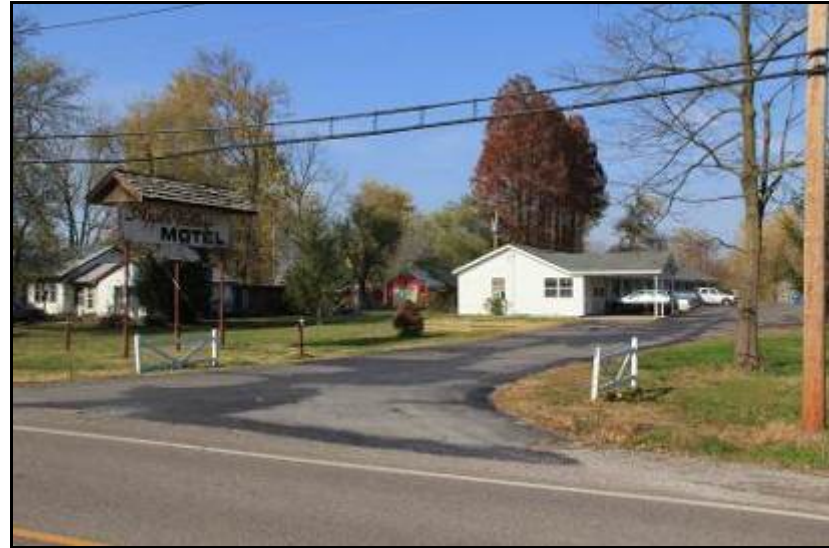
Sequence Number	Map Code	1994/95 Negative #	Address/Location	Type	Date Built	Historic Function	1994/95 Comments	2012/13 Comments and Photo Image #
406	14/26	14/26, IMG_2029	709 E. Chain of Rocks Rd.	2	Ca. 1950s	Motel	One level, low-pitched, gabled structure; office appears to have new siding – “Apple Valley Motel.”	The motel remains generally as it was in 1994. IMG_1613

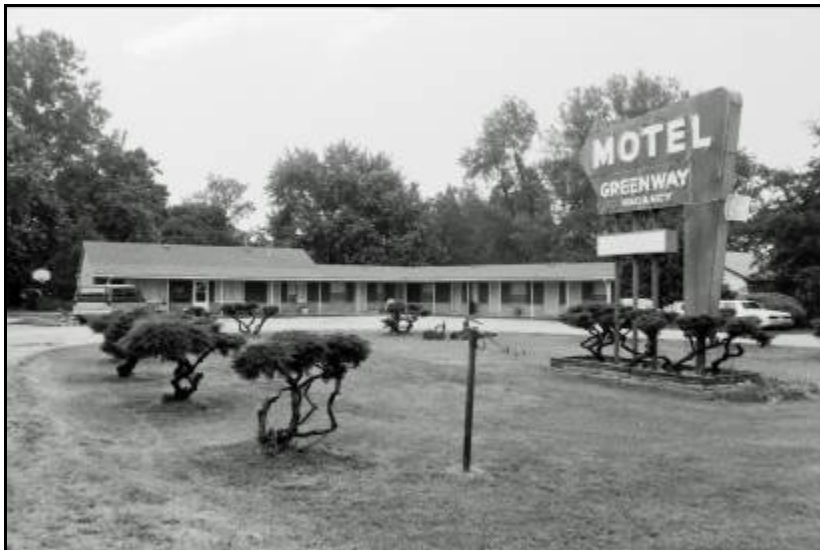
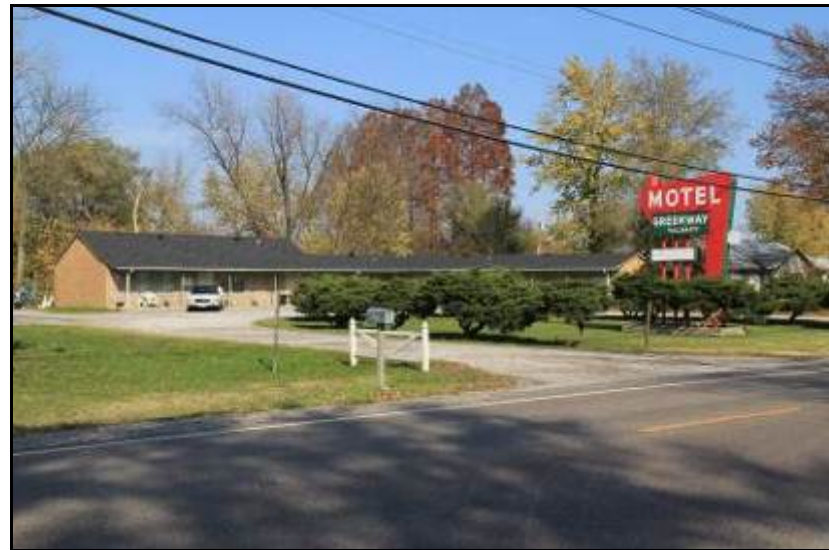
Sequence Number	Map Code	1994/95 Negative #	Address/Location	Type	Date Built	Historic Function	1994/95 Comments	2012/13 Comments and Photo Image #
407	14/27	14/27, IMG_2030	701 (?) E. Chain of Rocks Rd.	2	Ca. 1950s-60s	Motel	Somewhat modern looking motel with general "L" plan and combination stone/wood sheathing – "Motel Greenway."	Little has changed at the "Motel Greenway." IMG_1614

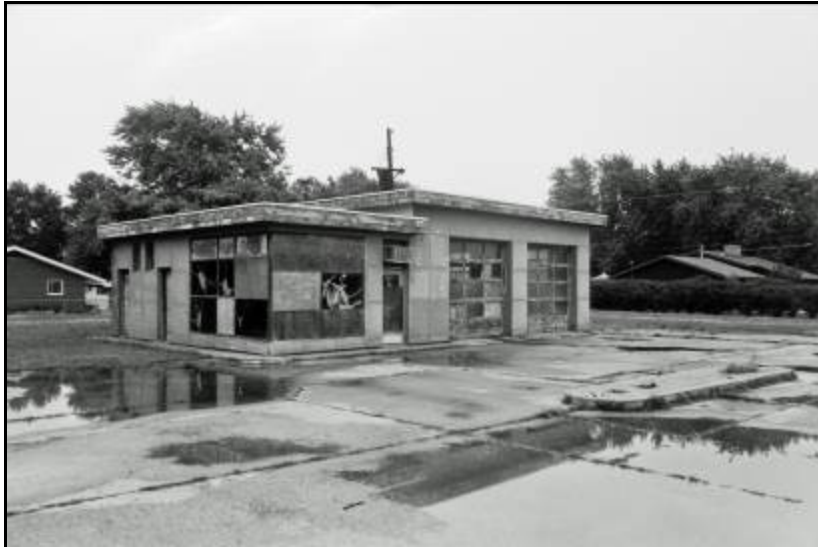
Sequence Number	Map Code	1994/95 Negative #	Address/Location	Type	Date Built	Historic Function	1994/95 Comments	2012/13 Comments and Photo Image #
408	14/28	14/28, IMG_2031	501 (?) E. Chain of Rocks Rd.	2	Ca. 1950s	Gas/Service	Gas station with flat roof and enameled/metal panel sheathing – vacant.	Structure no longer extant.

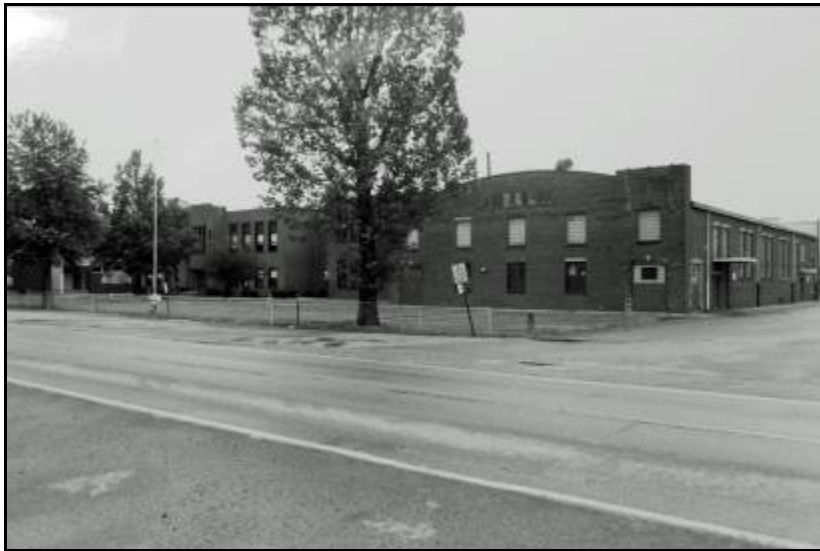
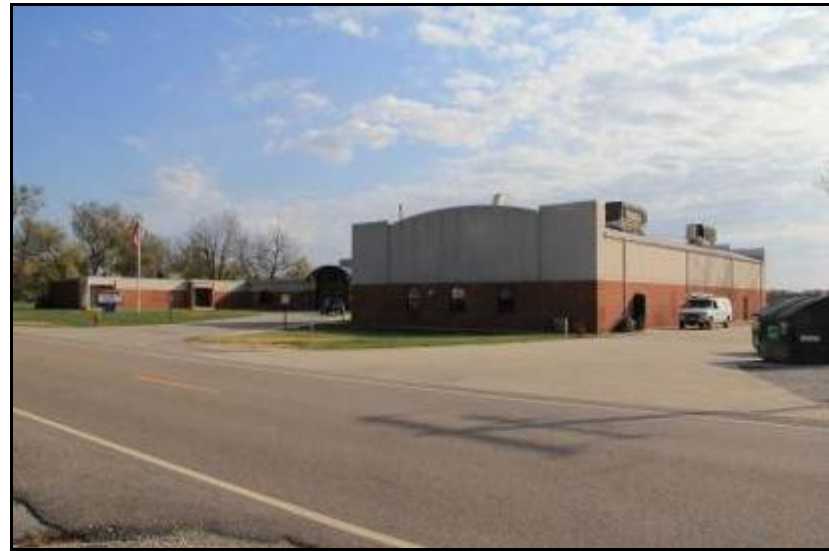
Sequence Number	Map Code	1994/95 Negative #	Address/Location	Type	Date Built	Historic Function	1994/95 Comments	2012/13 Comments and Photo Image #
409	14/29	14/29, IMG_2032	310 (?) E. Chain of Rocks Rd.	3	Ca. 1930s-40s	School	Prominent, brick building adjacent to RT 66 – “Mitchell School.”	Significant changes have occurred to this school, including the complete resheathing of that part of the building to the right. IMG_1615

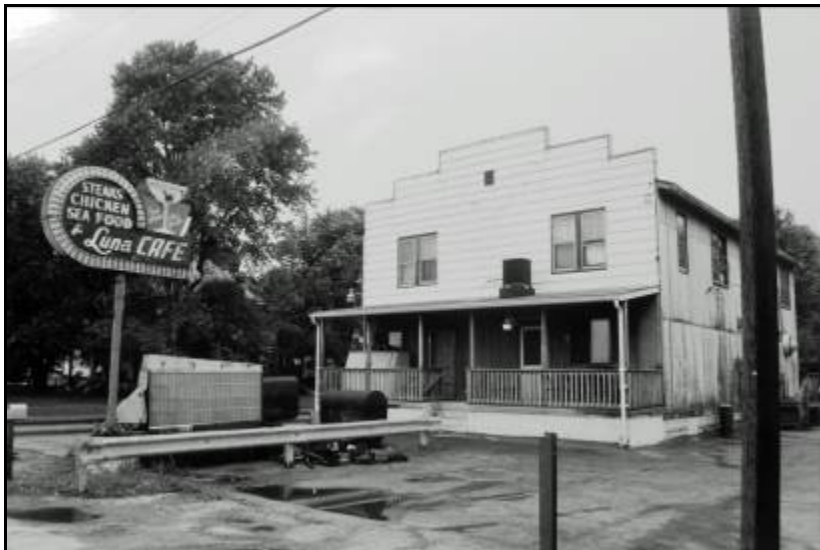
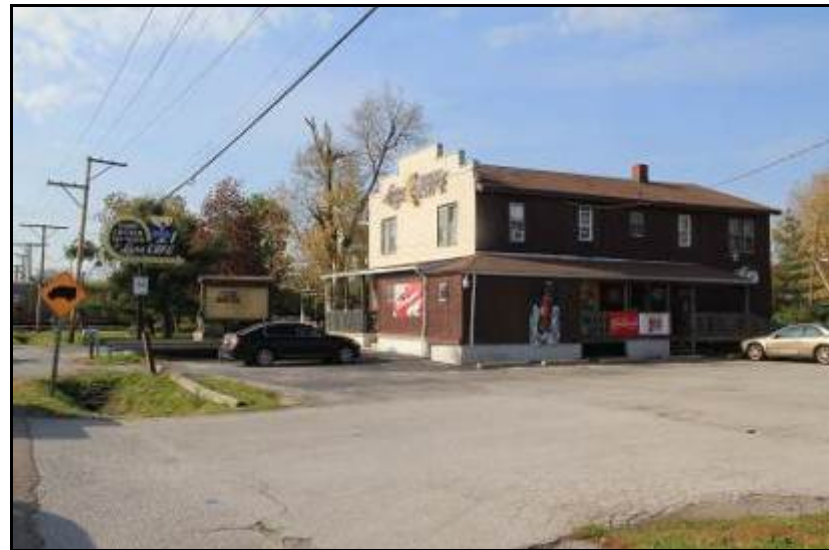
Sequence Number	Map Code	1994/95 Negative #	Address/Location	Type	Date Built	Historic Function	1994/95 Comments	2012/13 Comments and Photo Image #
410	14/30	14/30, IMG_2033	1?? E. Chain of Rocks Rd.	2	Ca. 1920s-30s	Restaurant	Two-story building with variety of sidings, although front appears to be generally wide aluminum (?); also has stepped parapet front wall –“Luna Café.”	Perhaps the biggest change to this structure in the last 18 years is the construction of the porch roof along its right side. The distinctive “Luna Café” sign remains. IMG_1616

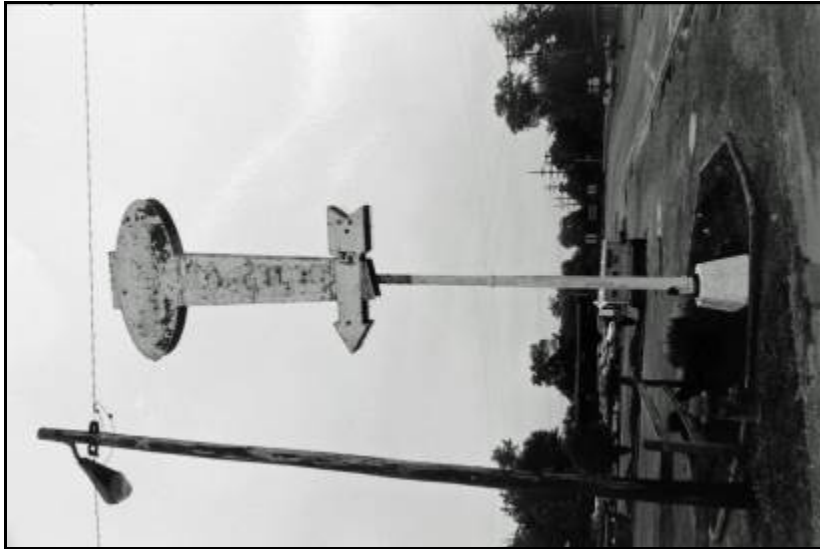
Sequence Number	Map Code	1994/95 Negative #	Address/Location	Type	Date Built	Historic Function	1994/95 Comments	2012/13 Comments and Photo Image #
411	14/31	14/31, IMG_2034	126 E. Chain of Rocks Rd.	2	Ca. 1950s(?)	Café Sign	Peeling, neon sign for "Donaldson's Café."	Sign now gone.

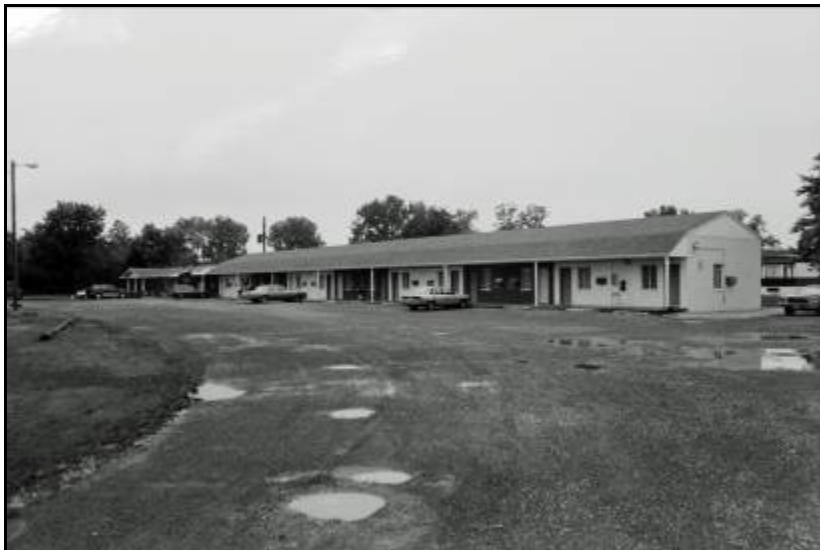
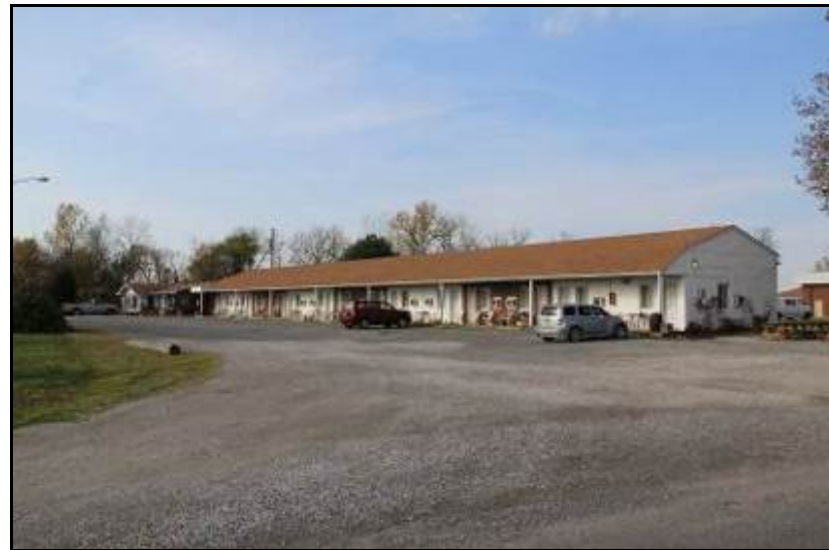
Sequence Number	Map Code	1994/95 Negative #	Address/Location	Type	Date Built	Historic Function	1994/95 Comments	2012/13 Comments and Photo Image #
412	14/32	14/32, IMG_2035	912 Thorngate Dr.	2	Ca. 1950s	Motel	Brick and concrete block motel, probably originally had a flat roof, now with a gabled roof variation – “Midwest Motel.”	There appear to be few changes at the old “Midwest Motel.” IMG_1619

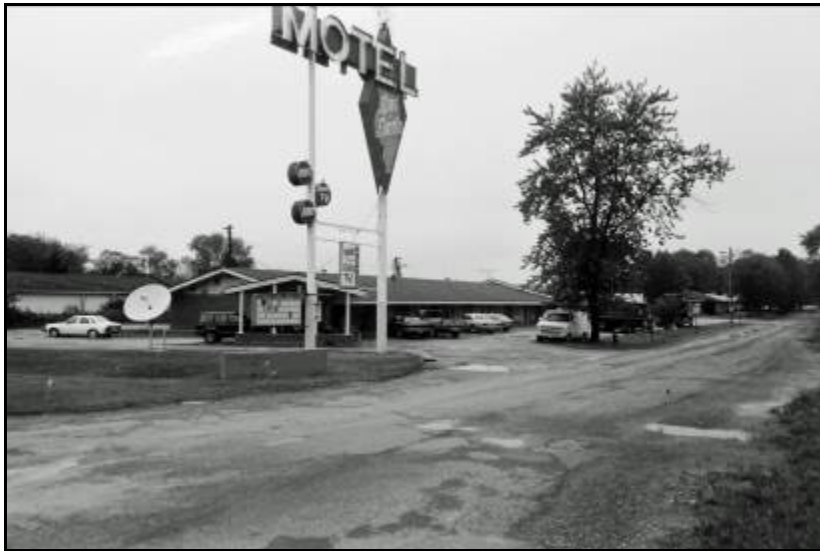
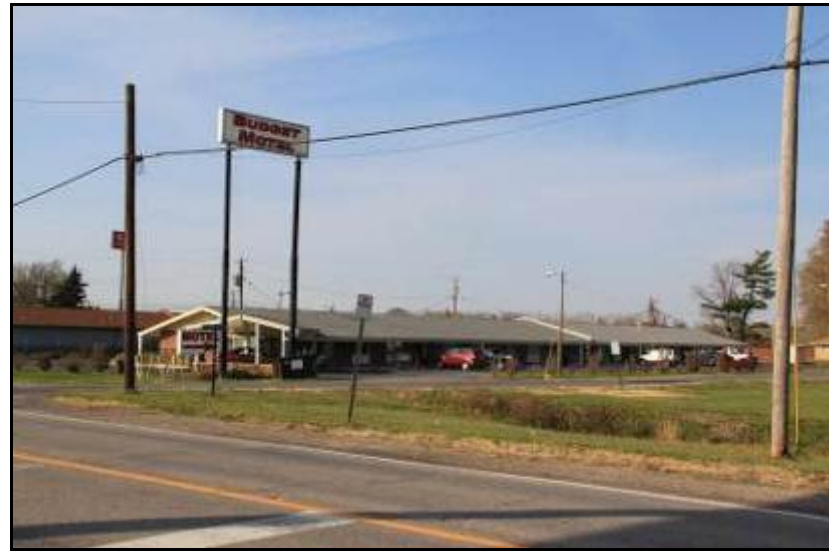
Sequence Number	Map Code	1994/95 Negative #	Address/Location	Type	Date Built	Historic Function	1994/95 Comments	2012/13 Comments and Photo Image #
413	14/33	14/33, IMG_2036	32?? Chain of Rocks Rd.	2	Ca. 1950s	Motel	Brick structure with shallow-pitched gabled roof – “Land of Lincoln Motel.”	The general integrity of this motel seems to have survived. The sign, however, extant in 1994, did not. IMG_1620

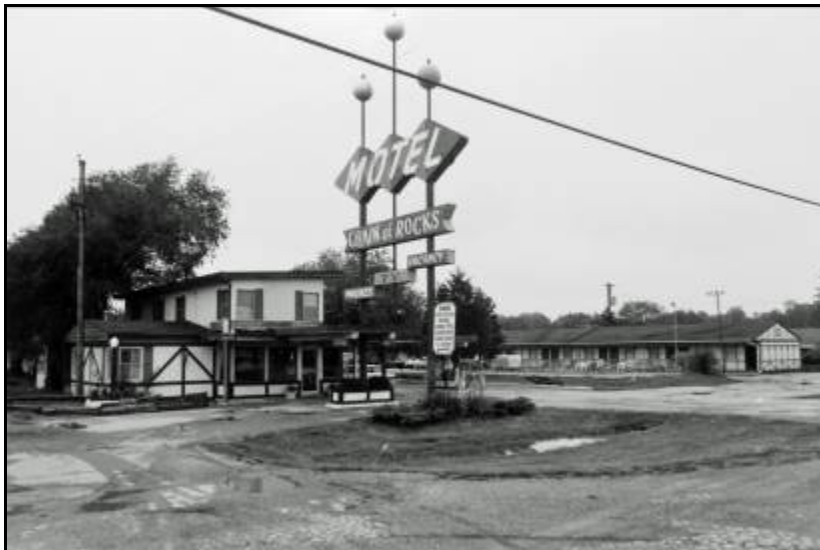
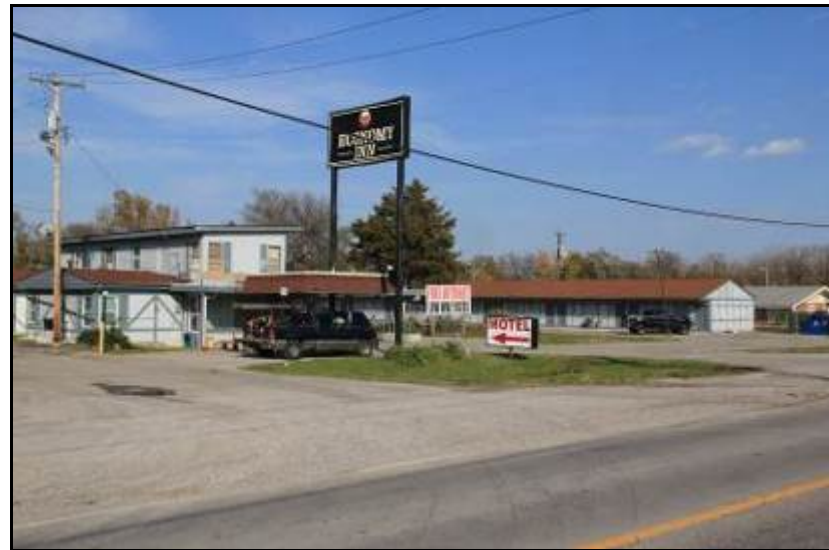
Sequence Number	Map Code	1994/95 Negative #	Address/Location	Type	Date Built	Historic Function	1994/95 Comments	2012/13 Comments and Photo Image #
414	14/34	14/34-35, IMG_2037	3228 Chain of Rocks Rd.	2	Ca. 1950s	Motel	"U" shaped complex, wing to E appears to be newer – "Chain of Rocks Motel," featuring TV and phones.	The distinctive "Chain of Rocks Motel" sign is gone, but the general building and business survives, though under a new name. IMG_1622

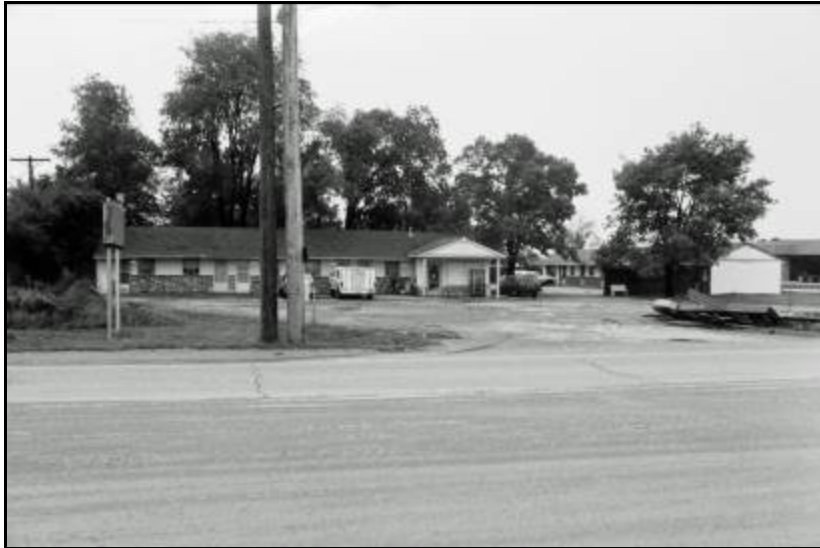
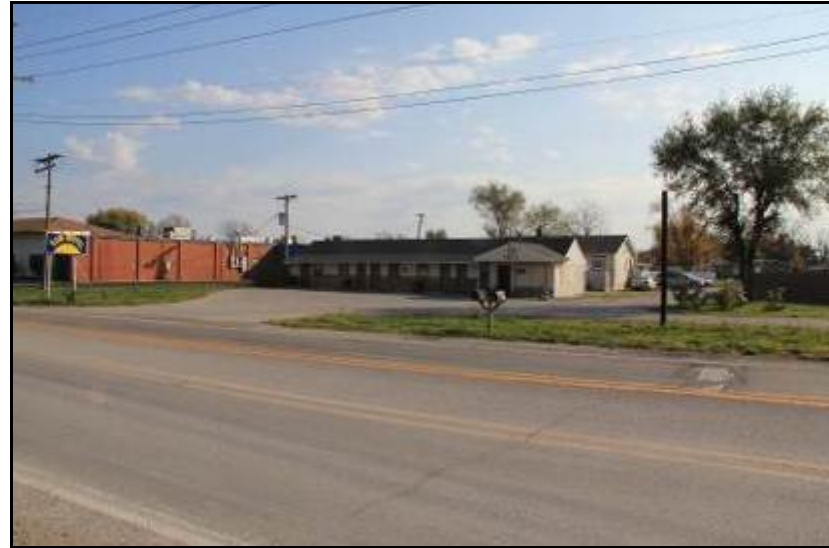
Sequence Number	Map Code	1994/95 Negative #	Address/Location	Type	Date Built	Historic Function	1994/95 Comments	2012/13 Comments and Photo Image #
415	14/36	14/36, IMG_2038	3241 Chain of Rocks Rd.	2	Ca. 1950s-60s	Motel	Small motel with stone and clapboard sheathing – “Sun Motel.”	The “Sun Motel” survives in generally good shape. IMG_1623

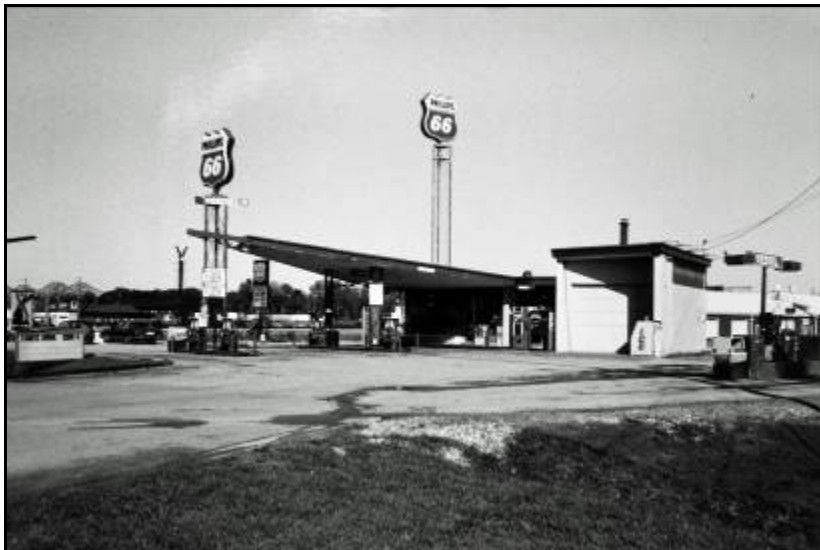
Sequence Number	Map Code	1994/95 Negative #	Address/Location	Type	Date Built	Historic Function	1994/95 Comments	2012/13 Comments and Photo Image #
416	22/15	22/15, IMG_2039	IL 3 & Chain of Rocks Rd. (NE corner)	2	Ca. 1950s-60s	Gas/Service	Concrete block structure with prominent, projecting canopy.	Structure now gone.

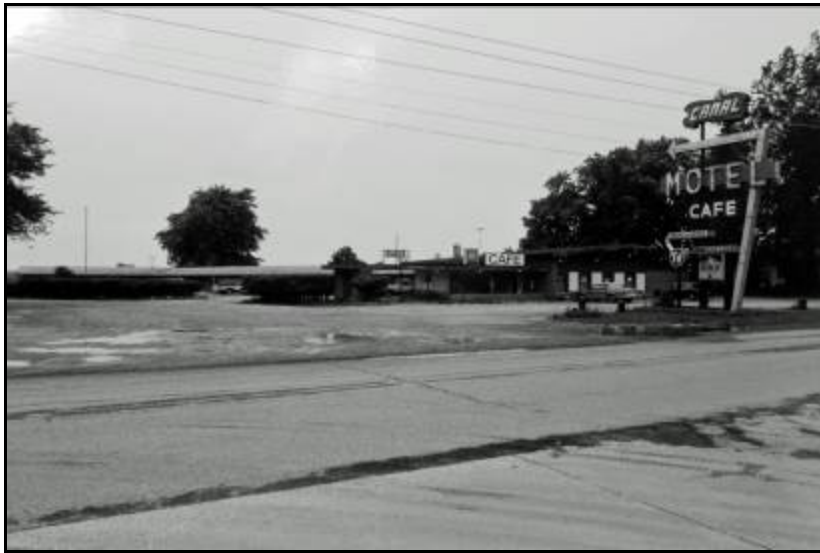
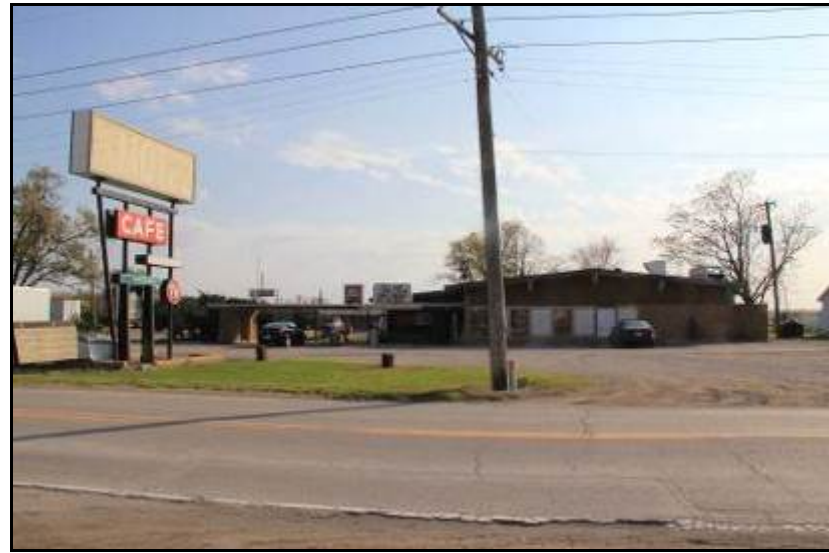
Sequence Number	Map Code	1994/95 Negative #	Address/Location	Type	Date Built	Historic Function	1994/95 Comments	2012/13 Comments and Photo Image #
417	15/04	15/04-05, IMG_2040	3317 Chain of Rocks Rd.	2	Ca. 1950s	Motel/Café	Generally brick-built complex with low-pitched, shallow roof; café adjacent – “Canal Motel & Café,” featuring TV.	This motel survives generally as it was in 1994. Its original sign is gone. IMG_1624

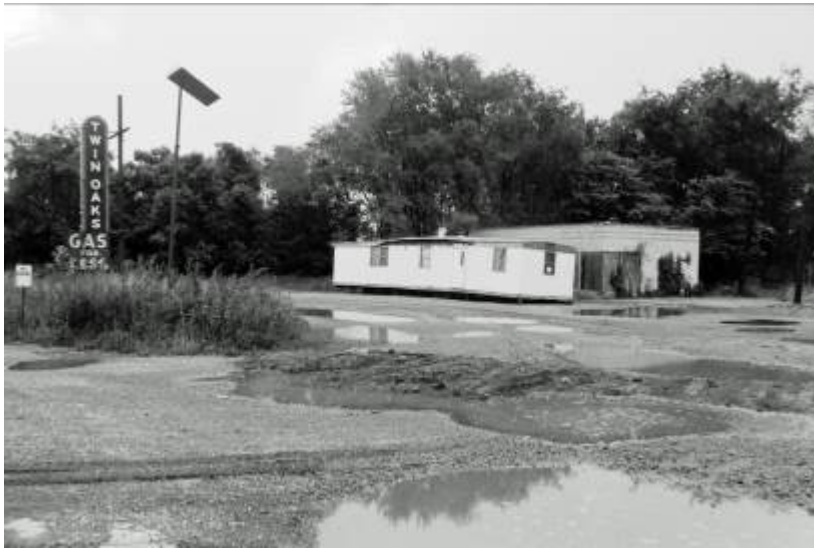
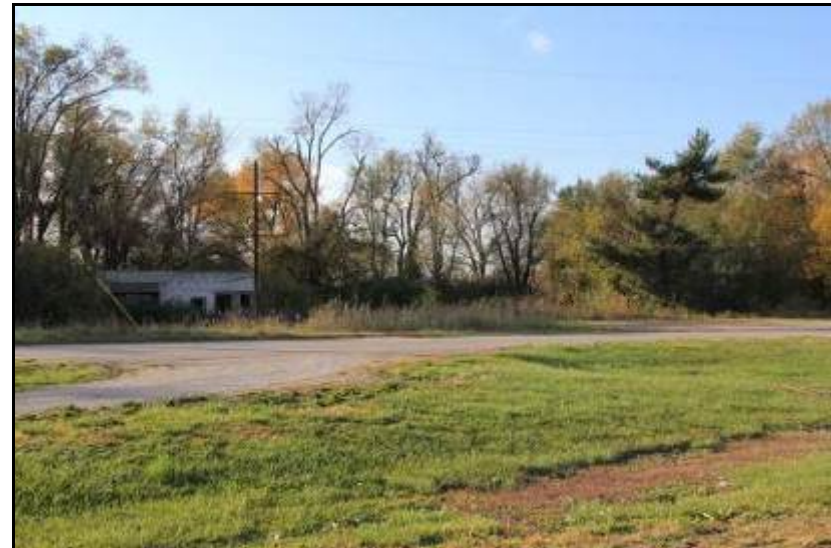
Sequence Number	Map Code	1994/95 Negative #	Address/Location	Type	Date Built	Historic Function	1994/95 Comments	2012/13 Comments and Photo Image #
418	15/06	15/06, IMG_2041	34?? Chain of Rocks Rd.	2	Ca. 1950s (?)	Gas/Service	Functional gas station of brick – vacant; nice sign notes “Twin Oaks Gas for Less.”	What appears to be a concrete block building shell is all that remains of the “Twin Oaks Gas for Less” operation. IMG_1675

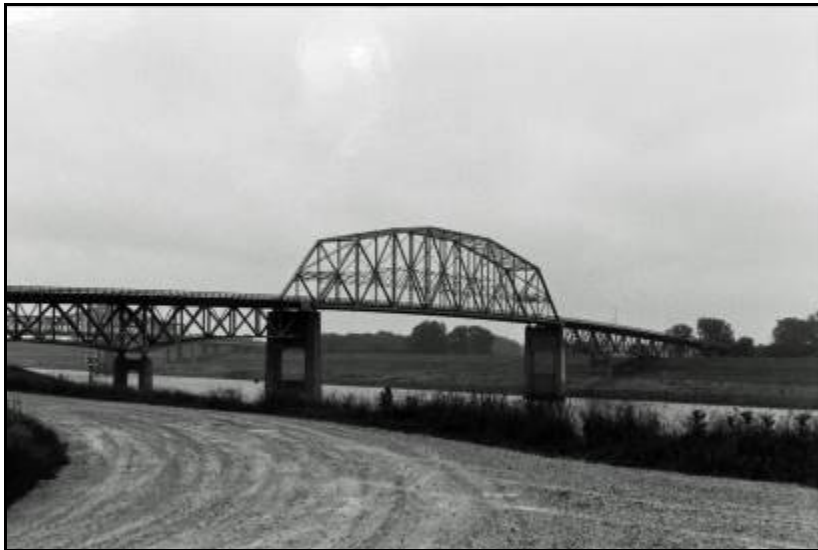
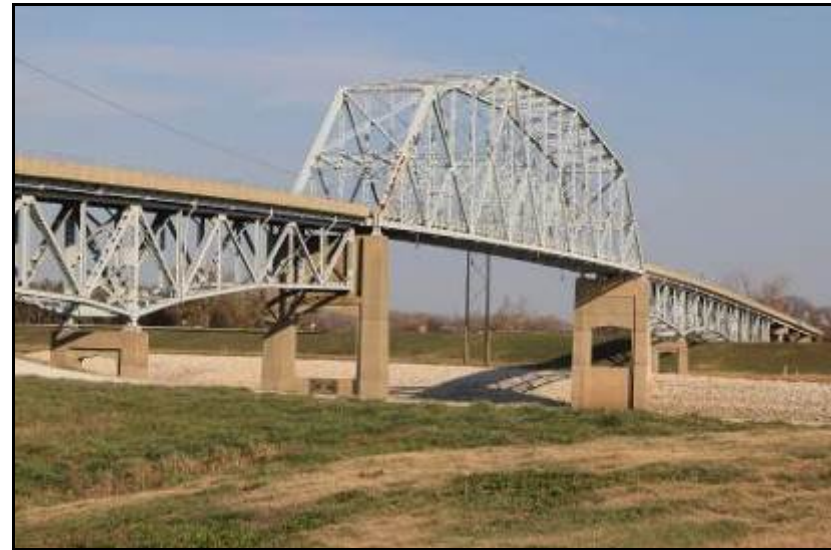
Sequence Number	Map Code	1994/95 Negative #	Address/Location	Type	Date Built	Historic Function	1994/95 Comments	2012/13 Comments and Photo Image #
419	15/07	15/07, 11-15, IMG_2042	Chain of Rocks Rd. at Canal	1	1946-1949	Bridge	Main span is a Parker Truss with deck truss approaches; plate notes Chain of Rocks Canal, Highway Bridge, Designed and Constructed Under the Direction of, the St. Louis District Corps of Engineers, United States Army, 1946-1949, Contractor [-] Fushman Construction Co.”	This bridge is now signalized on each end, thus accommodating a one-lane roadway. The second lane has been devoted to bike and pedestrian traffic. IMG_1645

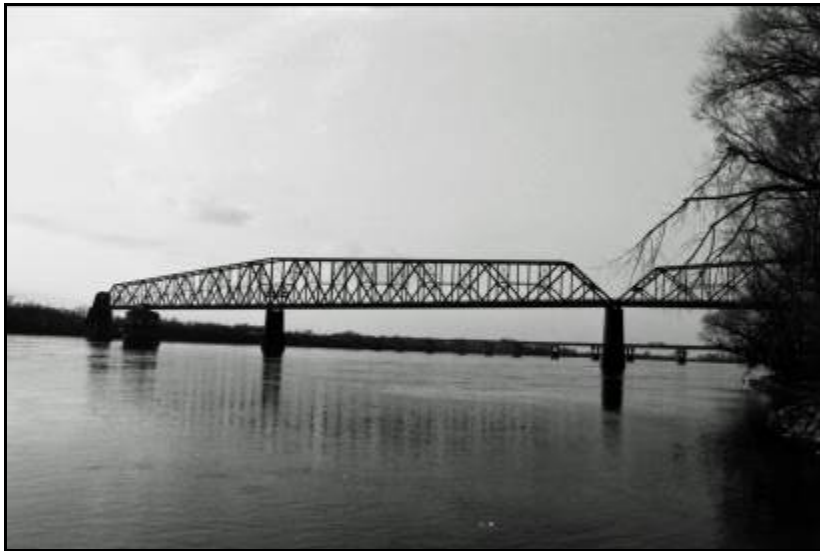
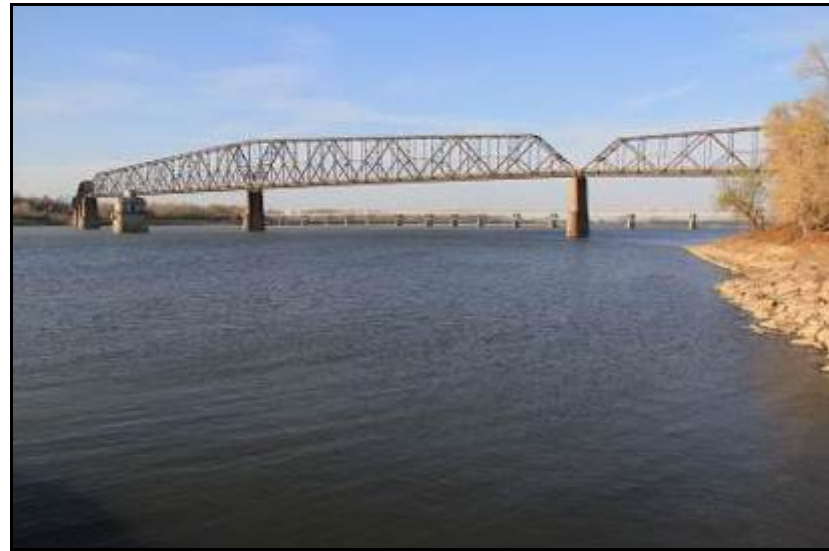
Sequence Number	Map Code	1994/95 Negative #	Address/Location	Type	Date Built	Historic Function	1994/95 Comments	2012/13 Comments and Photo Image #
420	10/23	10/23-25, 15/08-10, 16-25, IMG_2043	Chain of Rocks Rd. at Mississippi River	1	Ca. 1929	Bridge	Chain of Rocks Road is a long, multiple-span, cantilevered truss bridge that spans the Mississippi River N of St. Louis; see Waldmire Post Card for more information.	Since 1994, the Chain of Rocks Bridge has been rehabilitated and opened for pedestrian and bicycle traffic. IMG_1641

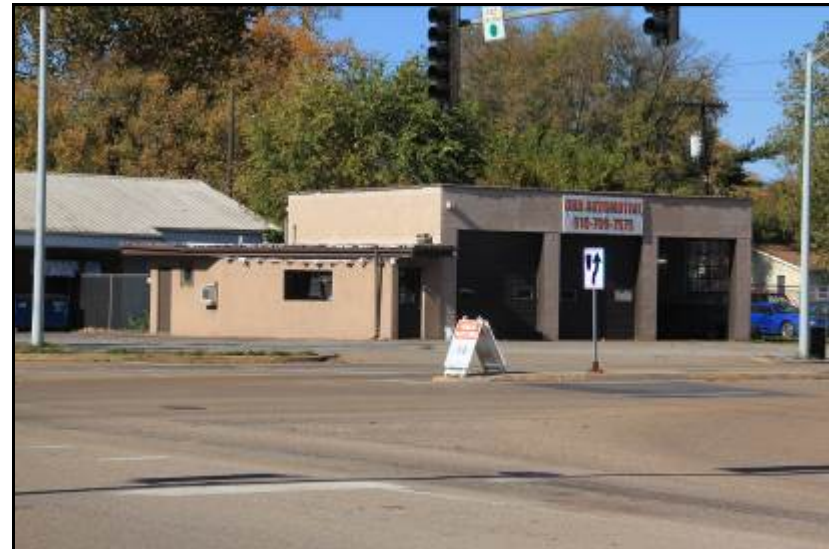
Sequence Number	Map Code	1994/95 Negative #	Address/Location	Type	Date Built	Historic Function	1994/95 Comments	2012/13 Comments and Photo Image #
B2	N/A	None	2301 Nameoki Rd., GRANITE CITY	2	Ca. 1950s	Service Station	Not surveyed in 1994/5	This facility, constructed of concrete blocks, now houses "DRB Automotive." IMG_4142

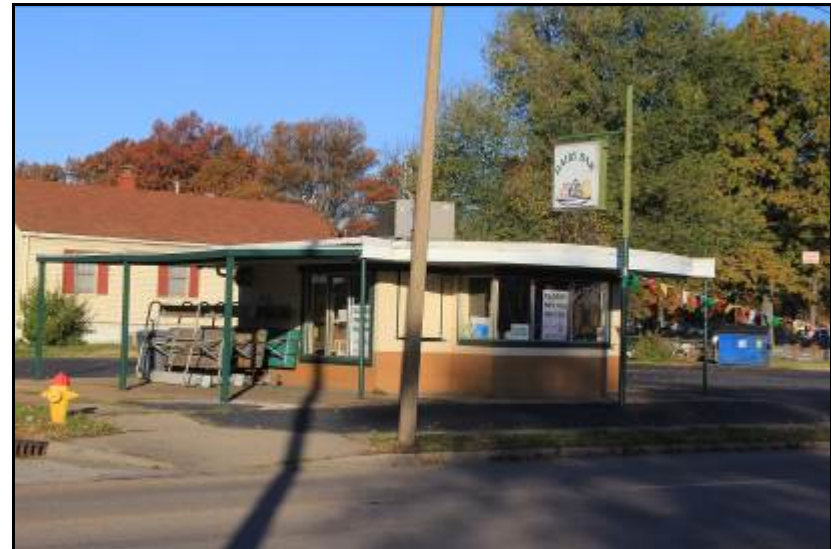
Sequence Number	Map Code	1994/95 Negative #	Address/Location	Type	Date Built	Historic Function	1994/95 Comments	2012/13 Comments and Photo Image #
B3	N/A	None	2673 Nameoki Rd., GRANITE CITY	2	Ca. 1950s-60s	Restaurant	Not surveyed in 1994/5	It is likely the "Dairy Bar" Drive-In postdates the use of Nameoki Road as RT 66. IMG_4115

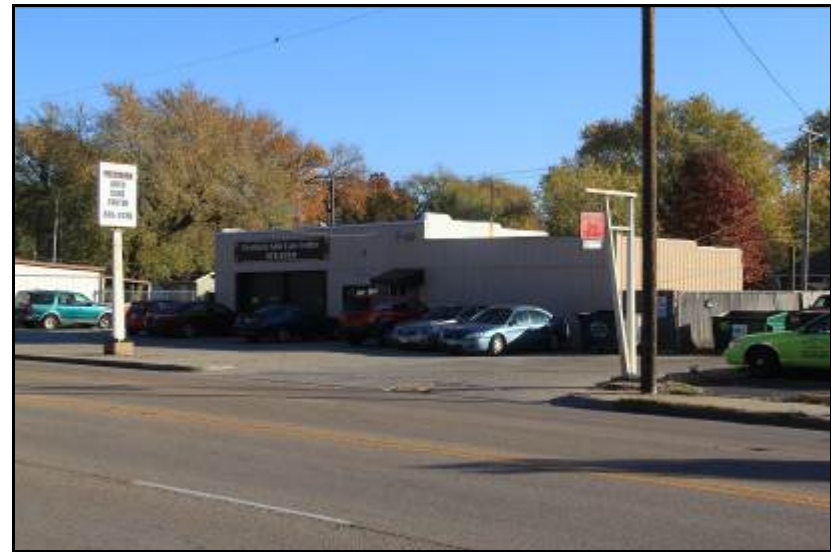
Sequence Number	Map Code	1994/95 Negative #	Address/Location	Type	Date Built	Historic Function	1994/95 Comments	2012/13 Comments and Photo Image #
B4	N/A	None	2814 Nameoki Rd., GRANITE CITY	2	Ca. 1950s (?)	Gas Station	Not surveyed in 1994/5	This auto care facility, which now houses "Precision Auto Care," appears to be sheathed with metal siding. IMG_4116

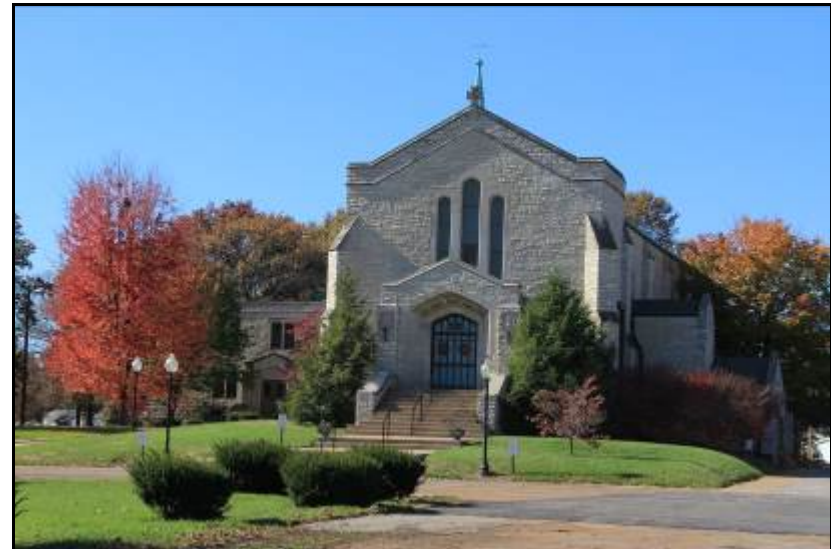
Sequence Number	Map Code	1994/95 Negative #	Address/Location	Type	Date Built	Historic Function	1994/95 Comments	2012/13 Comments and Photo Image #
B5	N/A	None	2901 Nameoki Rd., GRANITE CITY	3	Ca. Early 20 th Century	3	Not surveyed in 1994/5	This handsome building is the home of "St. John United Church of Christ." IMG_4144

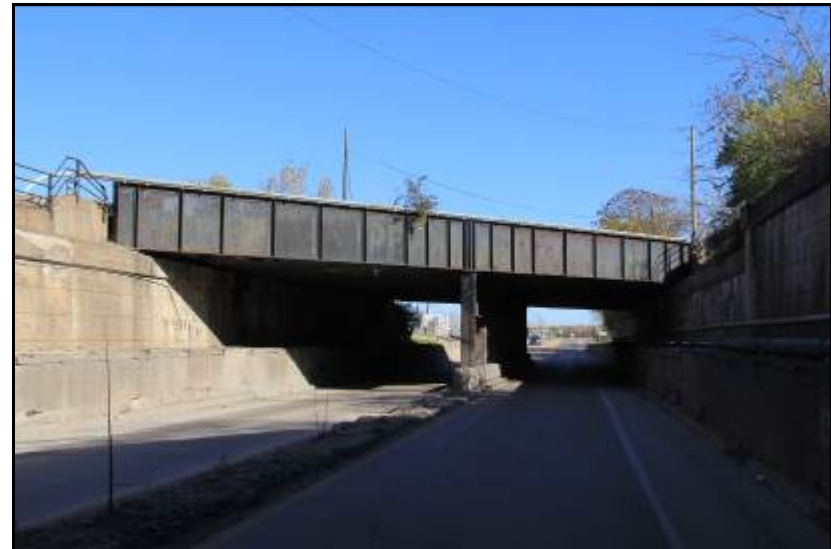
Sequence Number	Map Code	1994/95 Negative #	Address/Location	Type	Date Built	Historic Function	1994/95 Comments	2012/13 Comments and Photo Image #
B16	N/A	None	---- Collinsville Rd., EAST ST. LOUIS	2	Unknown	Railroad Bridge	Not surveyed in 1994/5	Another post-and-beam bridge, this structure is immediately SE of IMG_4129. IMG_4128

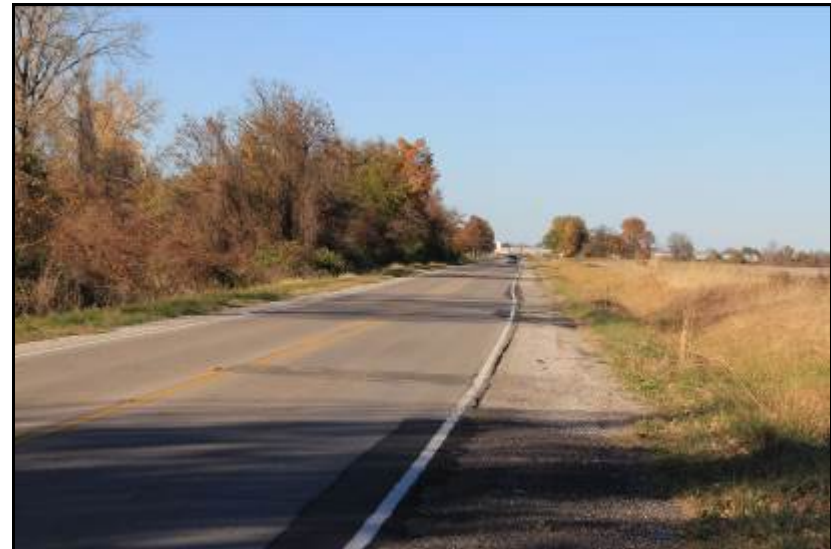
Sequence Number	Map Code	1994/95 Negative #	Address/Location	Type	Date Built	Historic Function	1994/95 Comments	2012/13 Comments and Photo Image #
B30	N/A	None	SR 111, FAIRMONT CITY	1	Unknown	RT 66 (?)	Not surveyed in 1994/5	It is unknown if, though possible that, this old pavement immediately N of the bridge over Cahokia Canal carried RT 66. IMG_4166

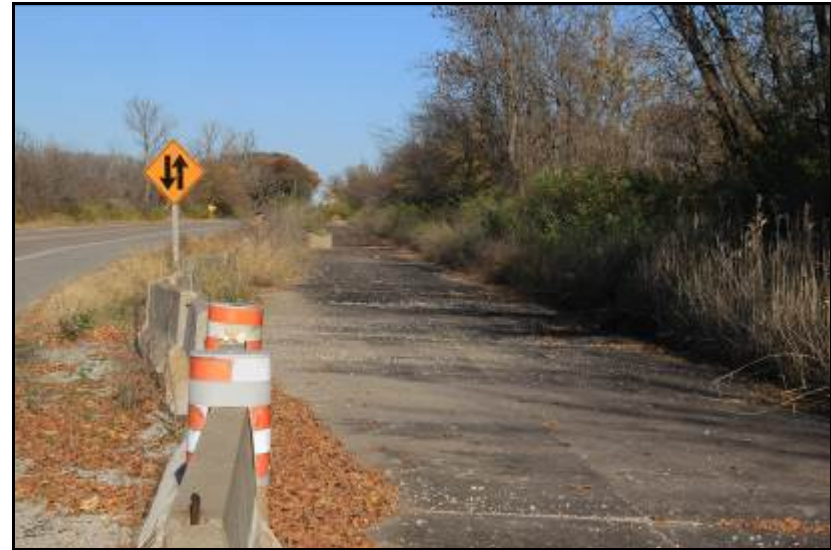
Sequence Number	Map Code	1994/95 Negative #	Address/Location	Type	Date Built	Historic Function	1994/95 Comments	2012/13 Comments and Photo Image #
B31	N/A	None	SR 111 & Cahokia Canal, FAIRMONT CITY	1	Ca. 1950s	Bridge	Not surveyed in 1994/5	The historical character of this bridge over the Cahokia Canal suggests that it could well have carried RT 66 for the year or two the IL 111 alignment was used in the mid-1950s. IMG_4165
