Route 66 in Illinois:

(2012/13 Update and Expansion of the Original 1994/95 Survey)

IDOT Sequence #17337 & #17337A

22 December 2013

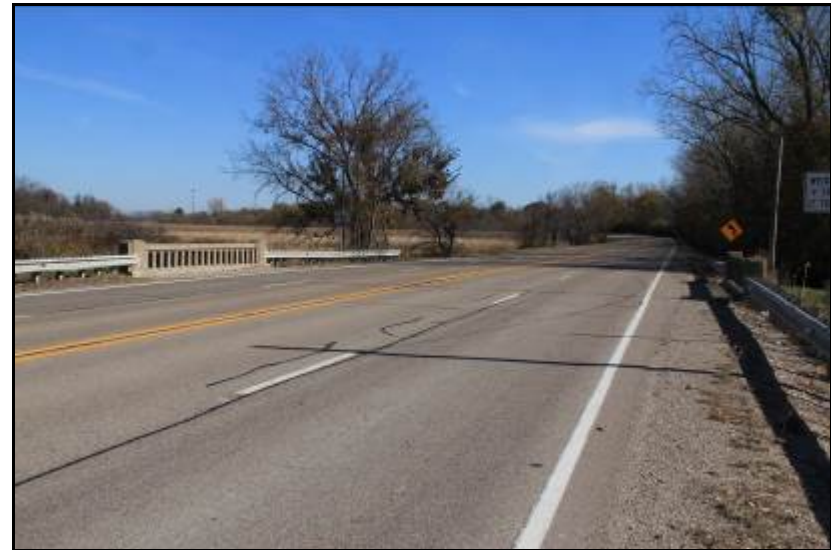
Sequence Number	Map Code	1994/95 Negative #	Address/Location	Type	Date Built	Historic Function	1994/95 Comments	2012/13 Comments and Photo Image #
B38	N/A	None	Collinsville Rd. & Unnamed Creek, FAIRMONT CITY	1	Ca. 1940s - 50s	Bridge	Not surveyed in 1994/5	A simple, four-lane, post-and-beam bridge, this structure carries the highway across Canteen Creek. IMG_4227

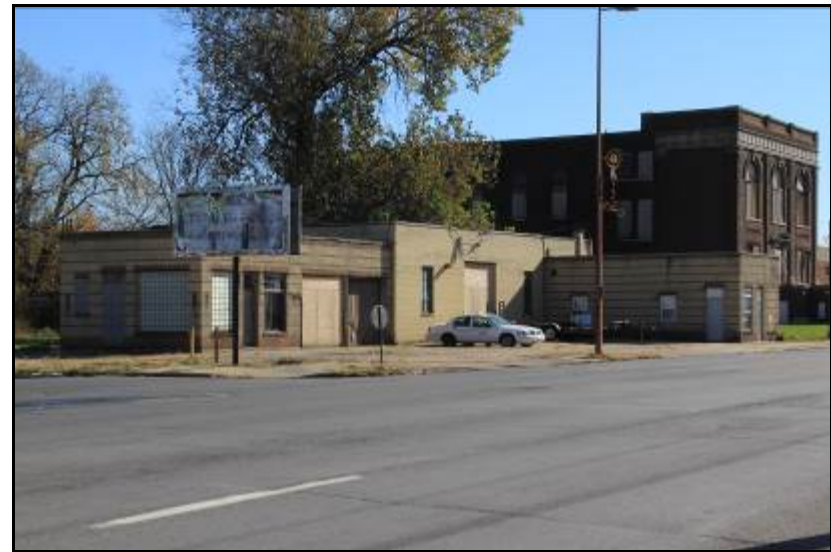
Sequence Number	Map Code	1994/95 Negative #	Address/Location	Type	Date Built	Historic Function	1994/95 Comments	2012/13 Comments and Photo Image #
B39	N/A	None	MLK Dr. & 8 th St., EAST ST. LOUIS	2	Ca. 1940s	Gas Station	Not surveyed in 1994/5	Located on what is today MLK Dr., this abandoned facility would have serviced RT 66 travelers from the mid-1950s until the highway's relocation on IH-55 just to the north. IMG_4127

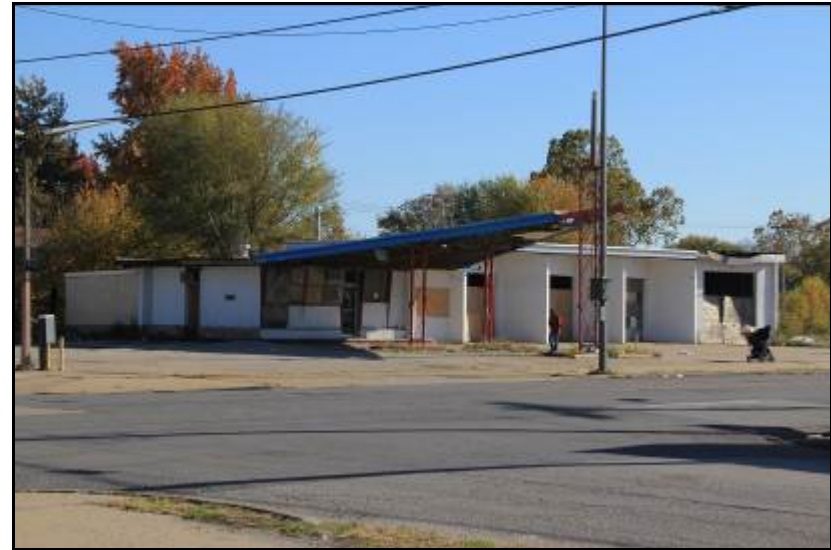
Sequence Number	Map Code	1994/95 Negative #	Address/Location	Type	Date Built	Historic Function	1994/95 Comments	2012/13 Comments and Photo Image #
B40	N/A	None	MLK Dr. & 5 th St., EAST ST. LOUIS	2	Ca. 1950s-60s	Gas Station	Not surveyed in 1994/5	Based on the flared canopy as a stylistic element, it is likely that this abandoned structure served travelers in the early 1960s. IMG_4216

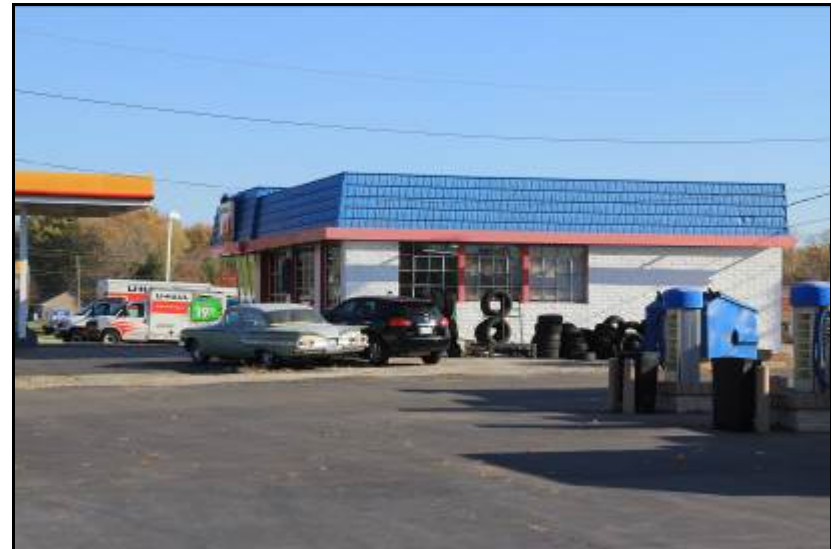
Sequence Number	Map Code	1994/95 Negative #	Address/Location	Type	Date Built	Historic Function	1994/95 Comments	2012/13 Comments and Photo Image #
B42	N/A	None	1900 Vandalia St., COLLINSVILLE	2	Ca. 1960s	Service Station	Not surveyed in 1994/5	It is possible that this gas station existed in the final years that RT 66 used Vandalia St. IMG_4194

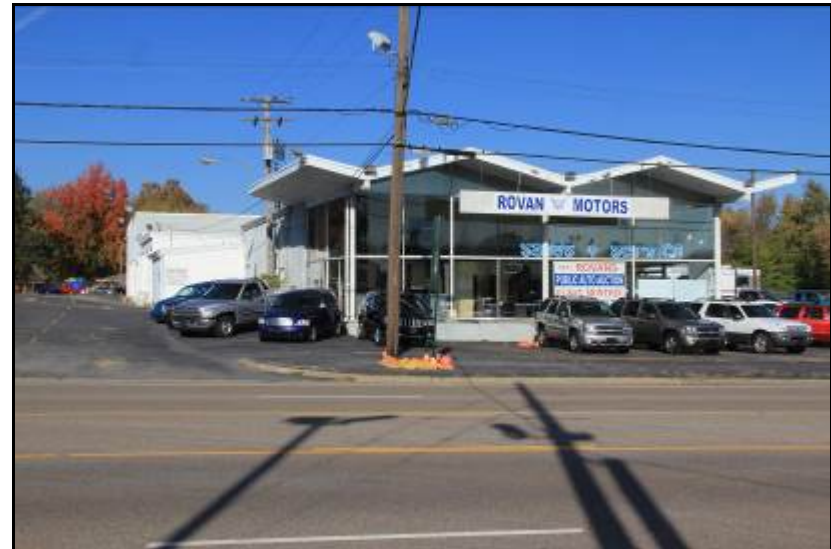
Sequence Number	Map Code	1994/95 Negative #	Address/Location	Type	Date Built	Historic Function	1994/95 Comments	2012/13 Comments and Photo Image #
B43	N/A	None	1833 Vandalia St., COLLINSVILLE	2	Ca. 1960s	Auto Dealer	Not surveyed in 1994/5	The 1960s era integrity of this auto sales facility appears to be good. IMG_4195

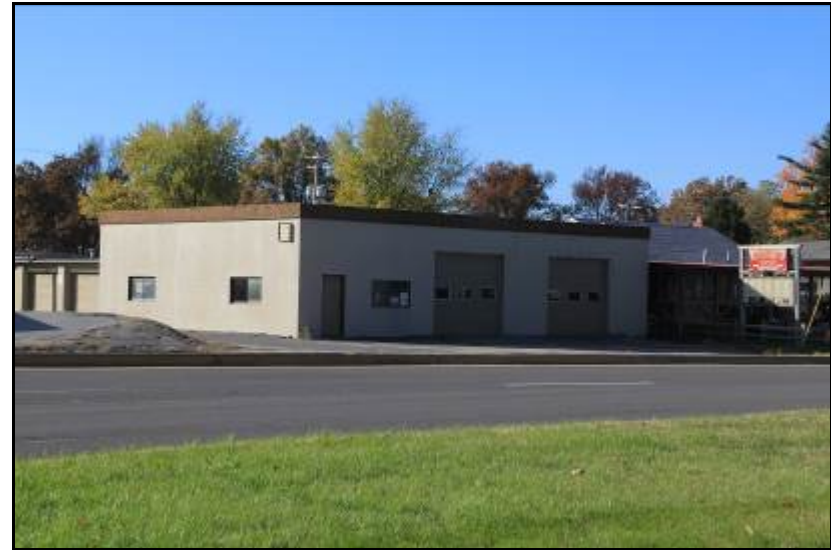
Sequence Number	Map Code	1994/95 Negative #	Address/Location	Type	Date Built	Historic Function	1994/95 Comments	2012/13 Comments and Photo Image #
B44	N/A	None	400 (?) Belt Line Rd., COLLINSVILLE	2	Ca. 1960s-70s	Auto Service	Not surveyed in 1994/5	It is possible that this building serviced or repaired automobiles during the time RT 66 passed by. IMG_4196

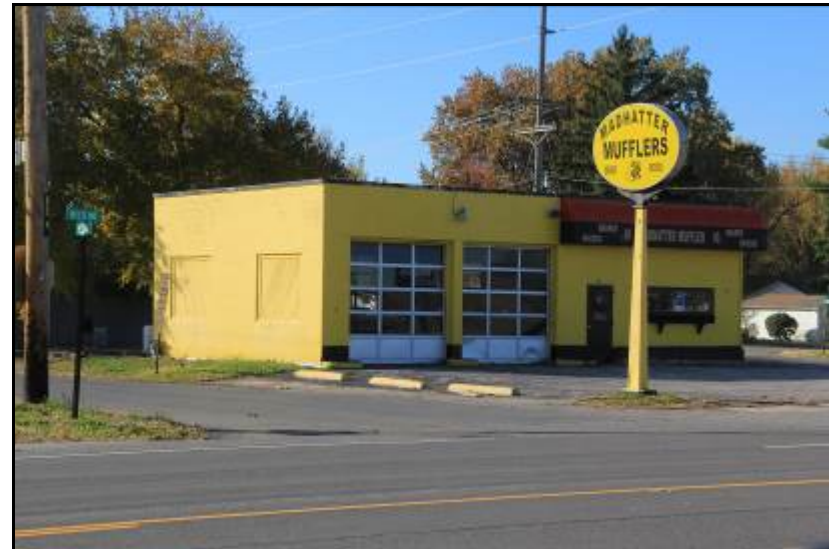
Sequence Number	Map Code	1994/95 Negative #	Address/Location	Type	Date Built	Historic Function	1994/95 Comments	2012/13 Comments and Photo Image #
B45	N/A	None	420 Belt Line Rd., COLLINSVILLE	2	Ca. 1960s	Service Station	Not surveyed in 1994/5	What is today “Mad Hatter Mufflers,” was likely a RT 66 era gas and service station. IMG_4197

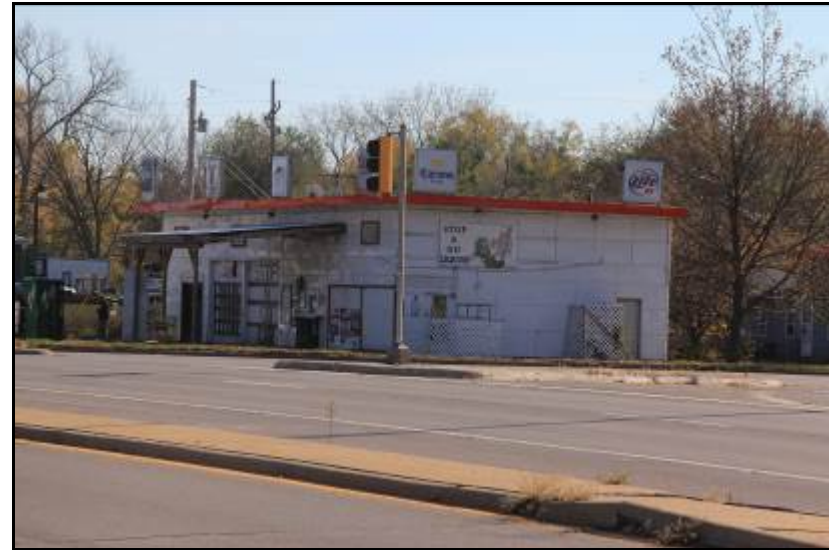
Sequence Number	Map Code	1994/95 Negative #	Address/Location	Type	Date Built	Historic Function	1994/95 Comments	2012/13 Comments and Photo Image #
B48	N/A	None	Collinsville Rd. & Black Ln, COLLINSVILLE	2	Ca. 1940s - 50s	Gas/Service Station	Not surveyed in 1994/5	Enameled panels sheath this old gas station and make it rather distinctive. It is today "Stop & Go Liquor." IMG_4202

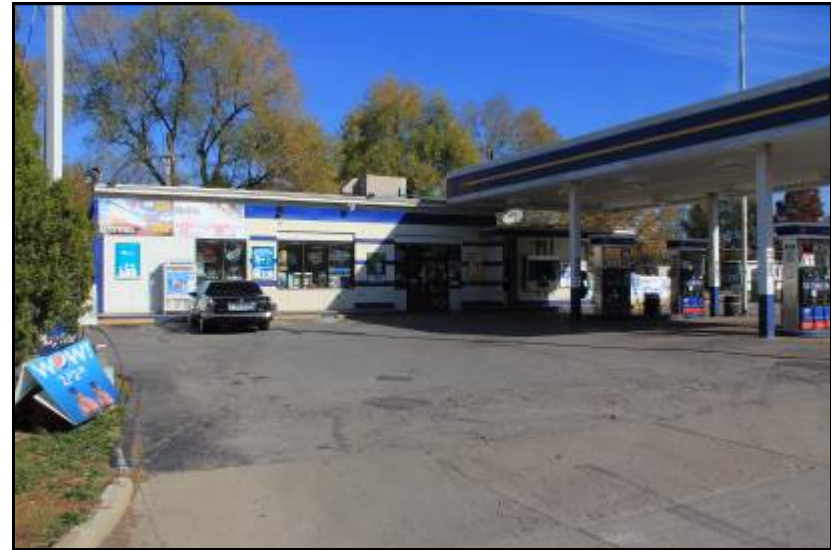
Sequence Number	Map Code	1994/95 Negative #	Address/Location	Type	Date Built	Historic Function	1994/95 Comments	2012/13 Comments and Photo Image #
B50	N/A	None	8407 Collinsville Rd., COLLINSVILLE	2	Ca. 1960s - 70s	Gas/Service Station	Not surveyed in 1994/5	Thought to be sheathed with brick and vertical panels, this gas station continues to operate today. IMG_4203

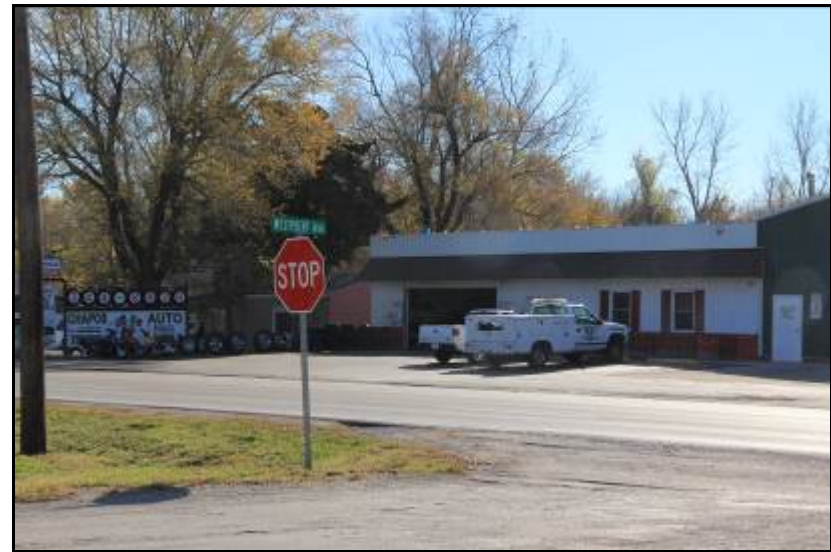
Sequence Number	Map Code	1994/95 Negative #	Address/Location	Type	Date Built	Historic Function	1994/95 Comments	2012/13 Comments and Photo Image #
B51	N/A	None	8110 Collinsville Rd., COLLINSVILLE	2	Ca. 1960s - 70s	Auto Service	Not surveyed in 1994/5	The “Chapos Auto” building is now sheathed with aluminum siding. It MAY have serviced RT 66 travelers in the 1960s. IMG_4204

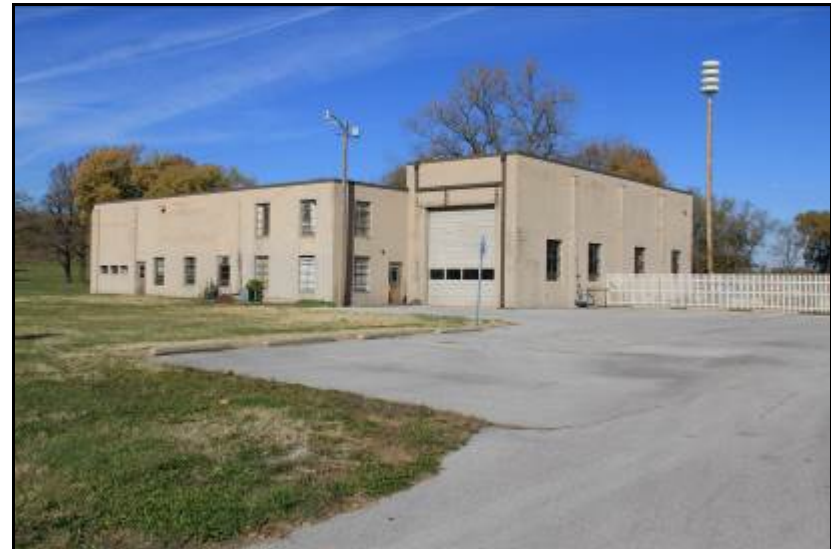
Sequence Number	Map Code	1994/95 Negative #	Address/Location	Type	Date Built	Historic Function	1994/95 Comments	2012/13 Comments and Photo Image #
B53	N/A	None	Collinsville Rd. & Ramey St., COLLINSVILLE	2	Ca. 1940s-50s	County Highway Dept.	Not surveyed in 1994/5	This building appears to have been a highway maintenance facility. IMG_4206

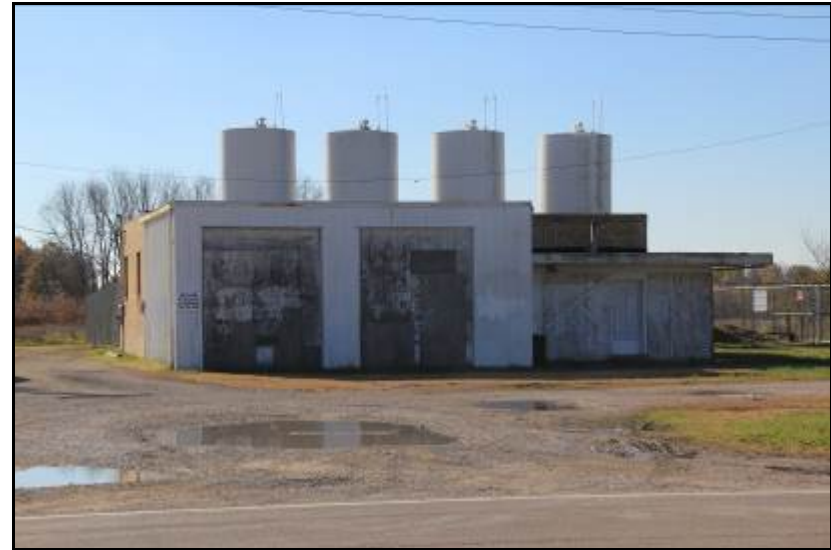
Sequence Number	Map Code	1994/95 Negative #	Address/Location	Type	Date Built	Historic Function	1994/95 Comments	2012/13 Comments and Photo Image #
B56	N/A	None	---- Collinsville Rd., COLLINSVILLE	2	Ca. 1950s – 60s	Gas Station	Not surveyed in 1994/5	This facility could have been a retail location for gasoline sales, as well as a site from which oil was distributed. IMG_4209
